## CHAPTER 4 EVALUATION OF EXISTING AIRPORT FACILITIES

4.1 Airside Facilities

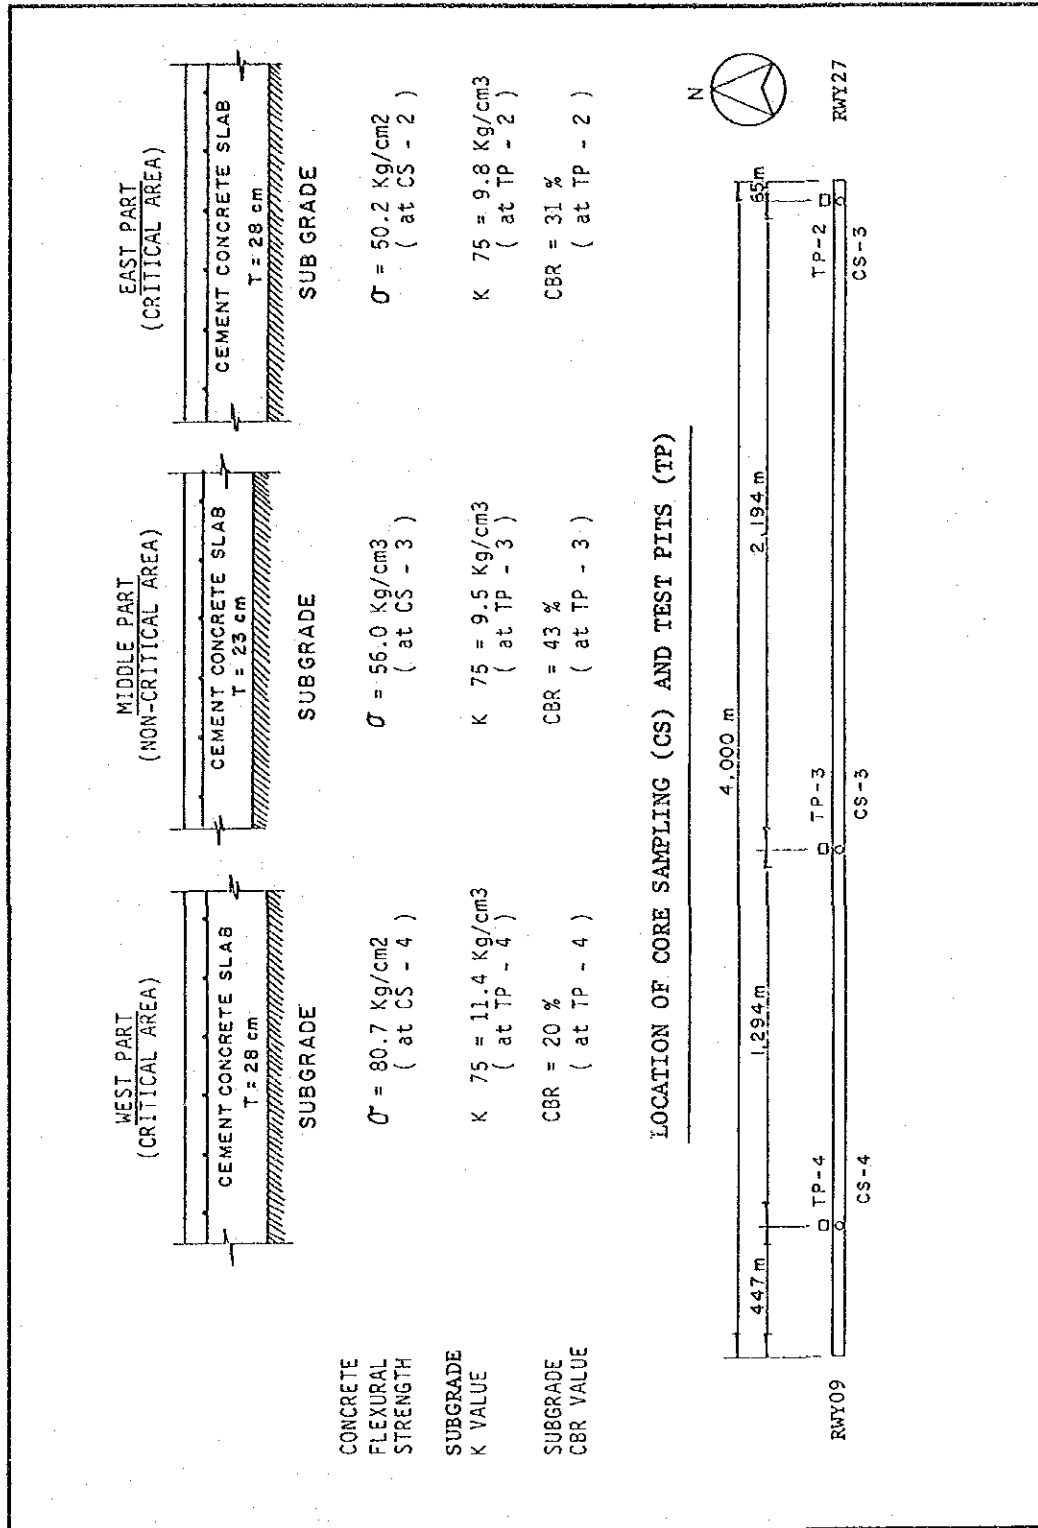
Figure 4.1.12 Existing Runway Pavement

The surface condition of the existing runway pavement is summarized as follows based on the results of the visual observations.

- In the 1,740 m length from runway 09 threshold, the pavement surface condition is seriously damaged.
- In this same portion, there are some transverse and longitudinal cracks. In addition, the surface of the concrete slab spalled at spots near the joints.
- Most of the joint material is already deteriorated or hardened, and in some cases completely gone.

- The runway pavement located at 1,740 m from runway 09 threshold is seriously damaged and requires the improvement as soon as possible.

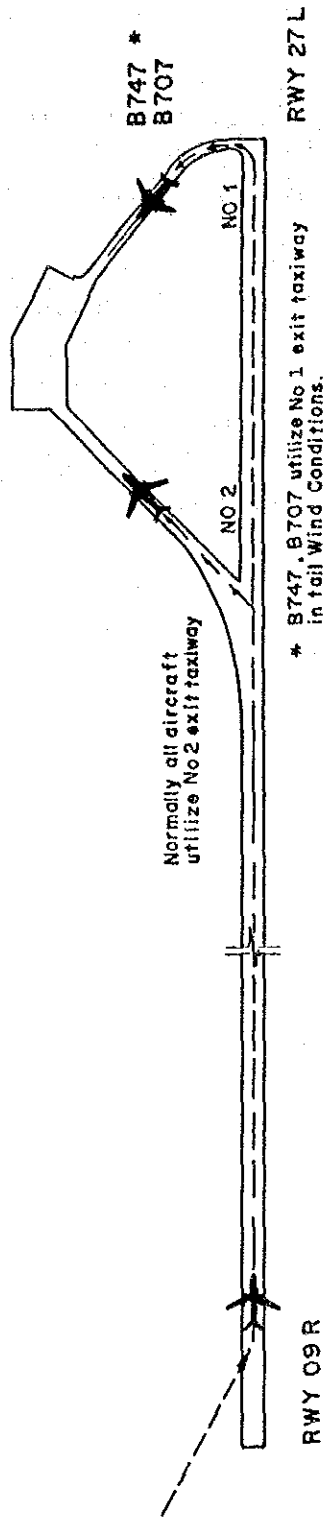
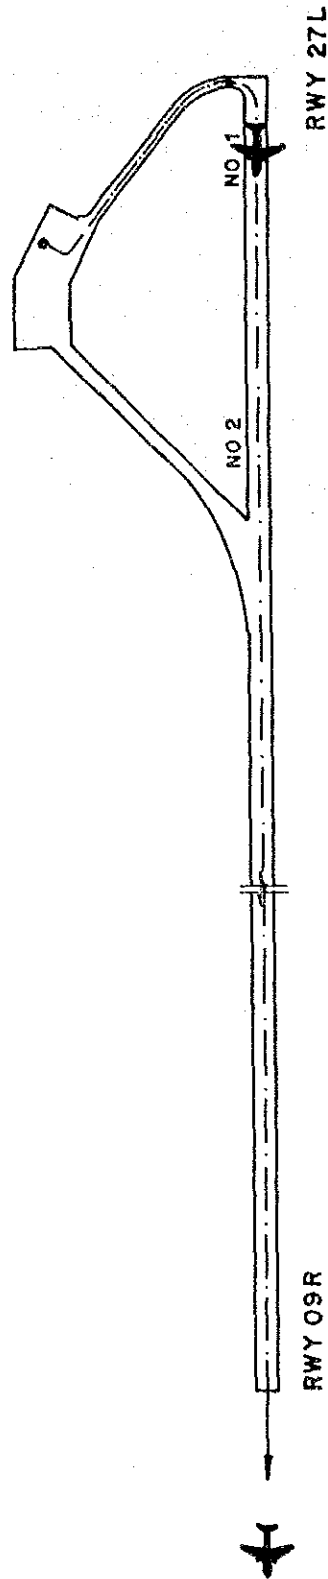
Figure 4.1.13 Existing Taxiway Operation

- (2) Existing taxiway was constructed in 1963. The surface conditions of the existing No. 1 and No. 2 taxiways are not so good. At some locations on these taxiways, there are corner cracks and the tortoise shell like deterioration. Along the shoulders of these taxiways, there are some longitudinal cracks. The pavement structure of the existing taxiway is the same as the critical area of the runway.

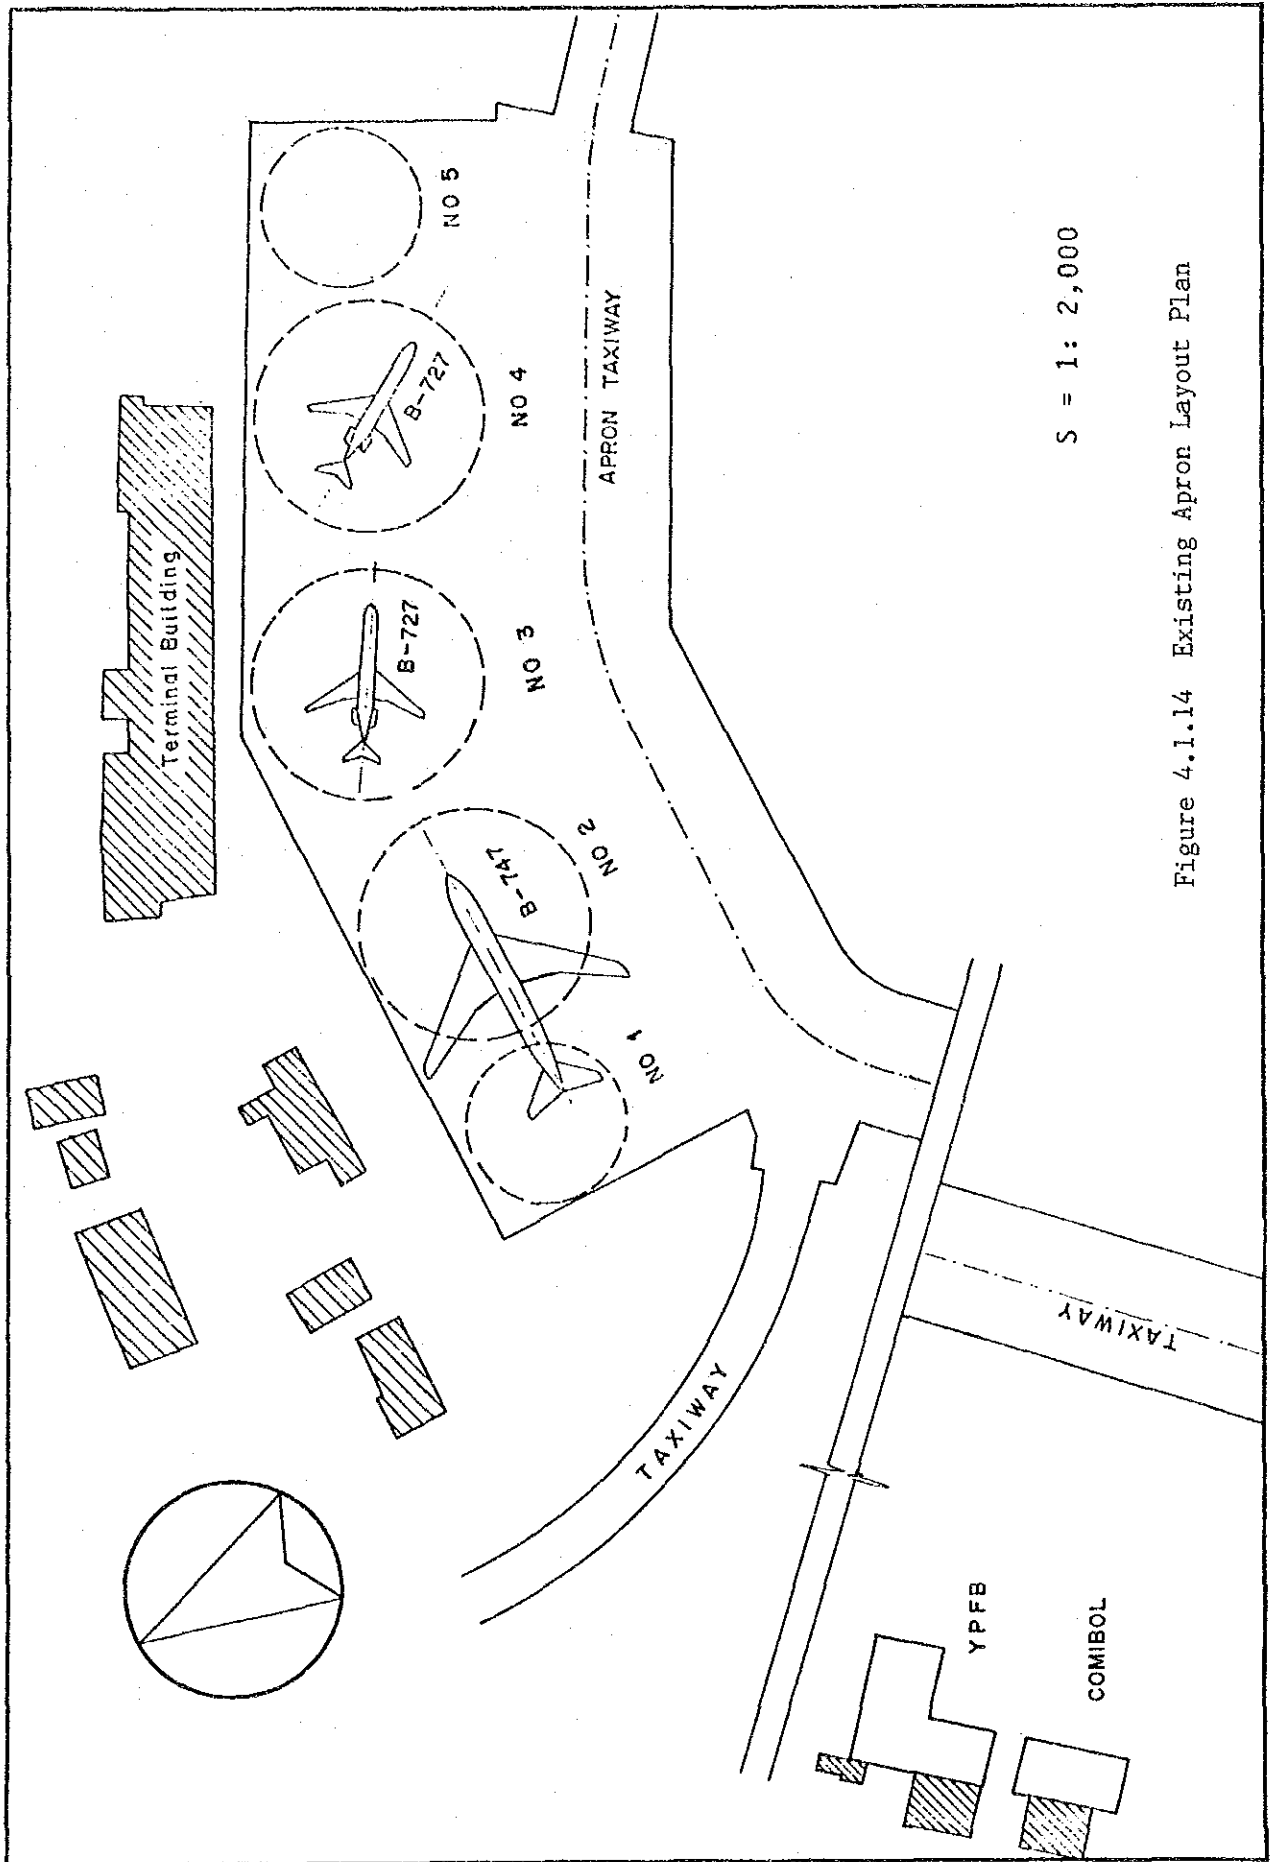
Figure 4.1.14 Existing Apron Layout Plan

The surface condition of existing apron pavement is also not good. There are many initial cracks and some transverse cracks, especially at aircraft stands No. 3 and No. 4. In addition, the surface of the concrete slab is spalled in spots near the joint. At the apron shoulder, there are also many tortoise shell like deteriorations.

Most of the joint material is already deteriorated and hardened. Some of the material is completely gone.

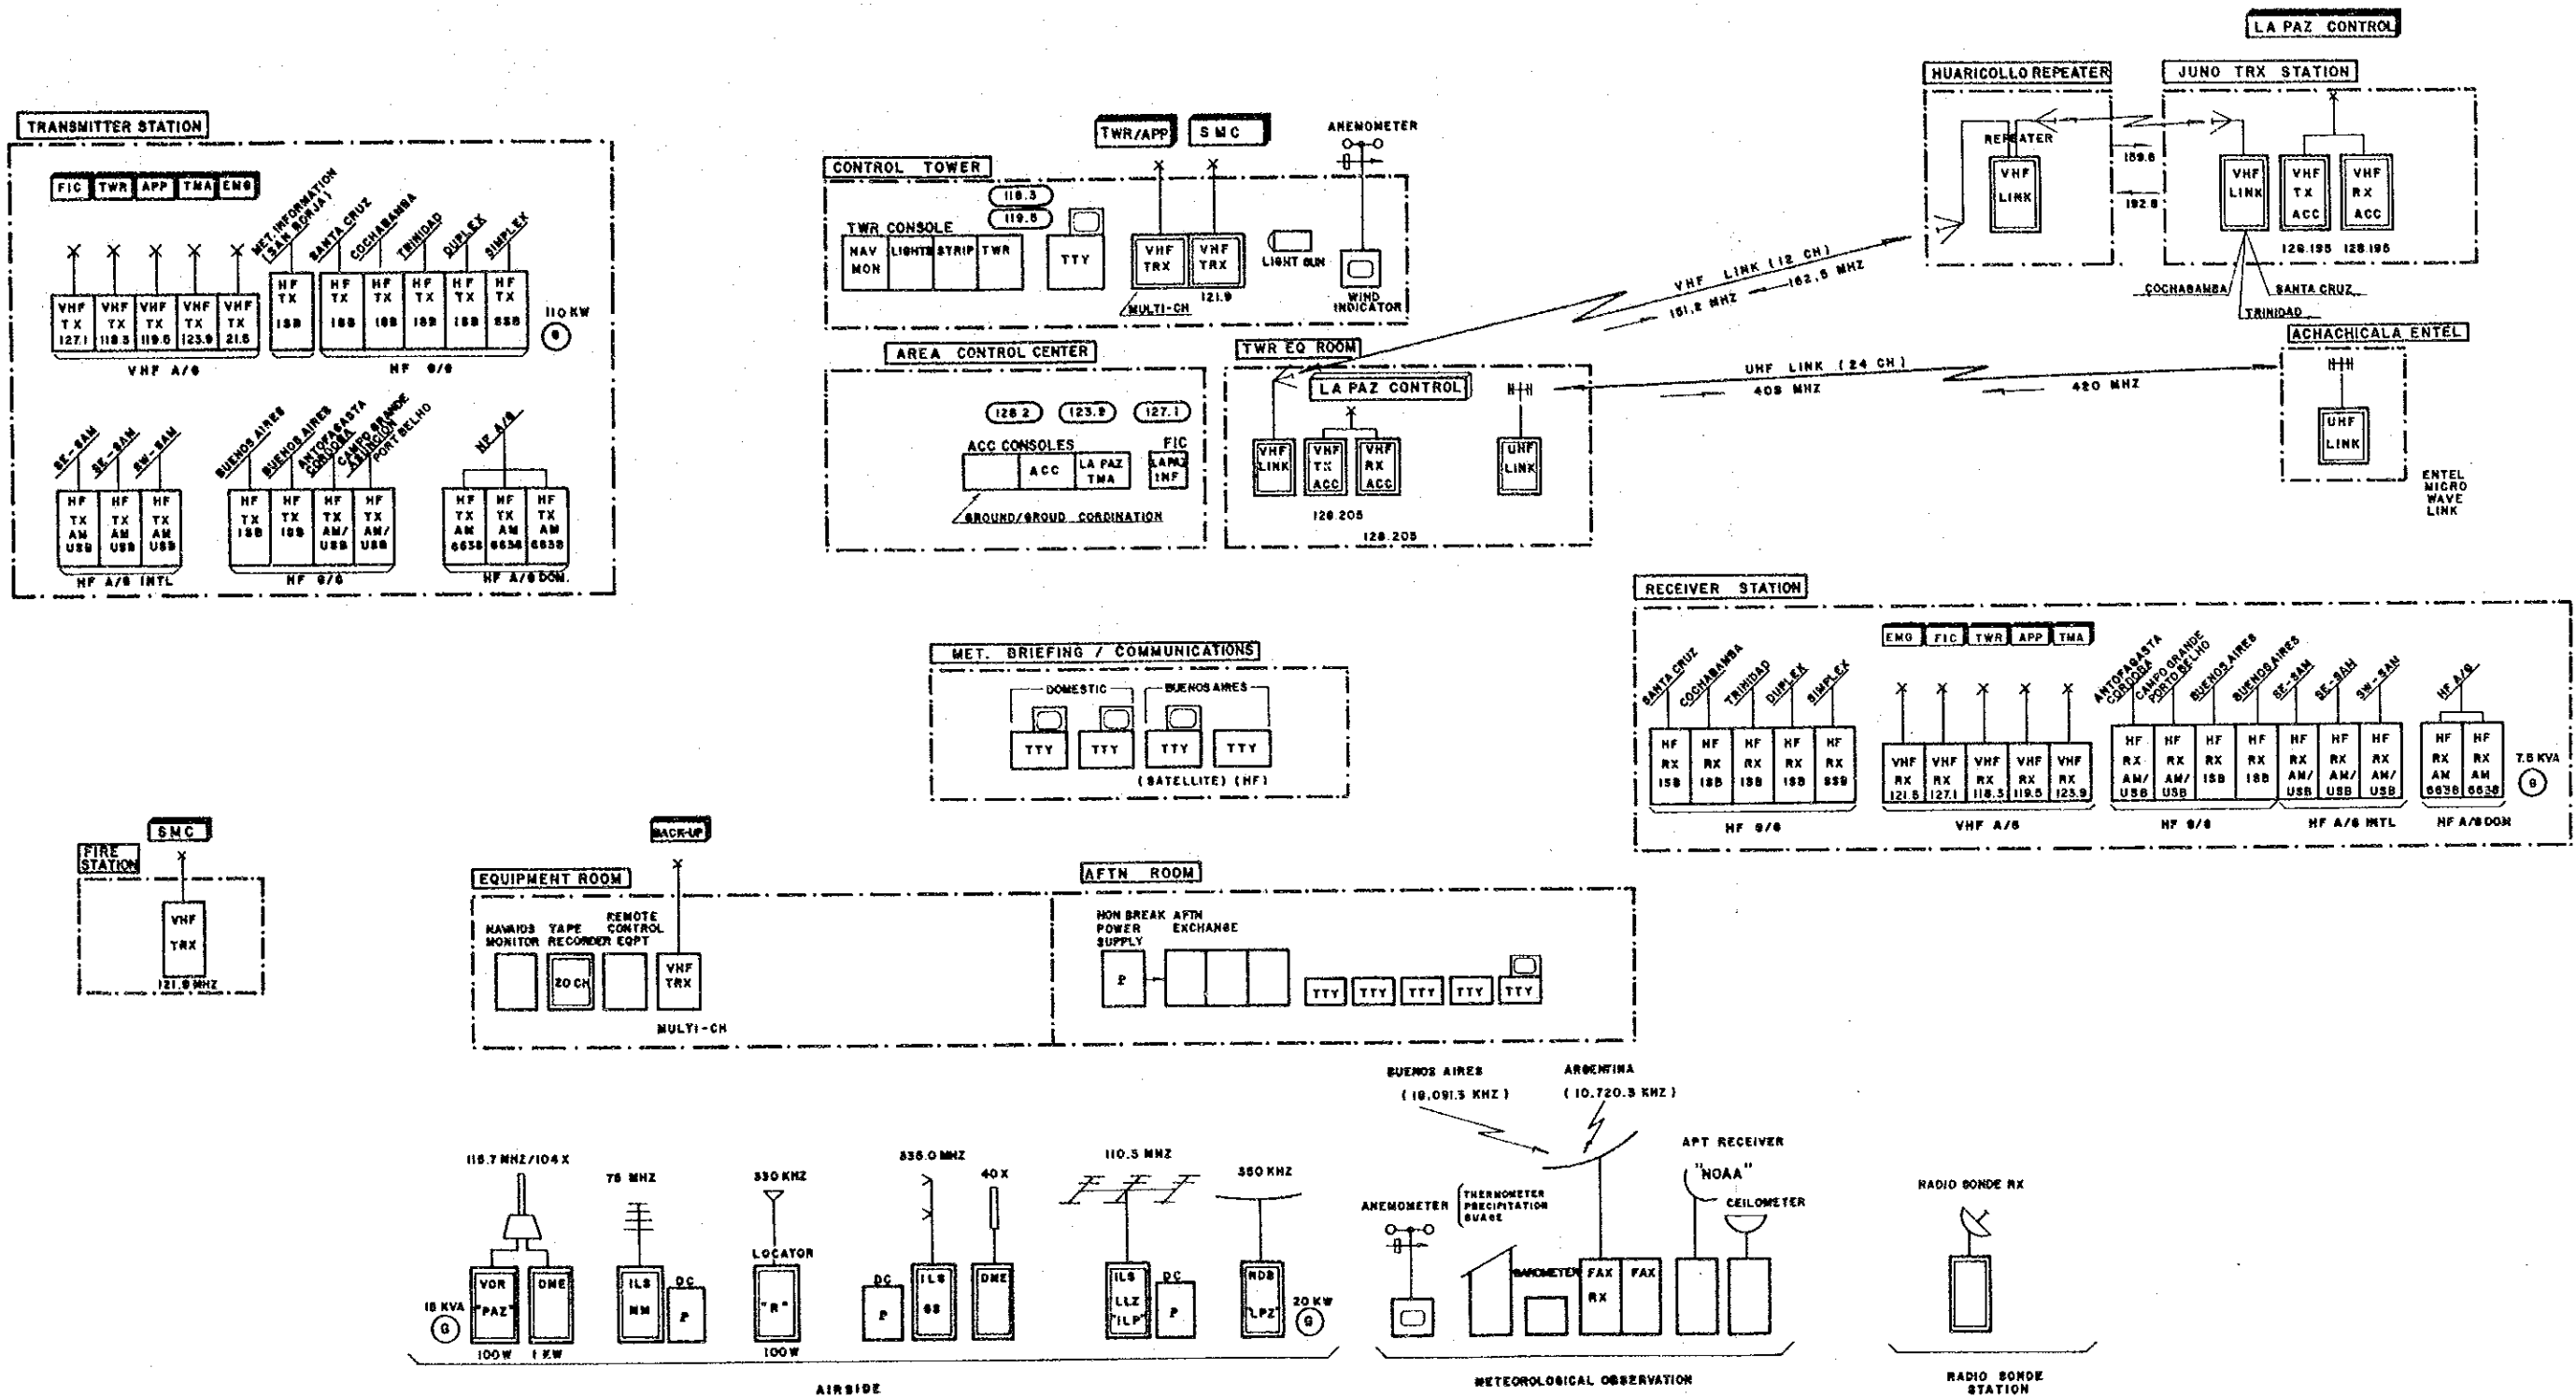
FIGURE 4.5.1 BLOCK DIAGRAM OF EXISTING AIR NAVIGATION SYSTEMS

As evaluated in the subsequent sections, almost all the equipment and systems for air navigation are obsolete. Positive investment for maintenance and replacement of the old equipment has not been made but new equipment was installed when the need arose.

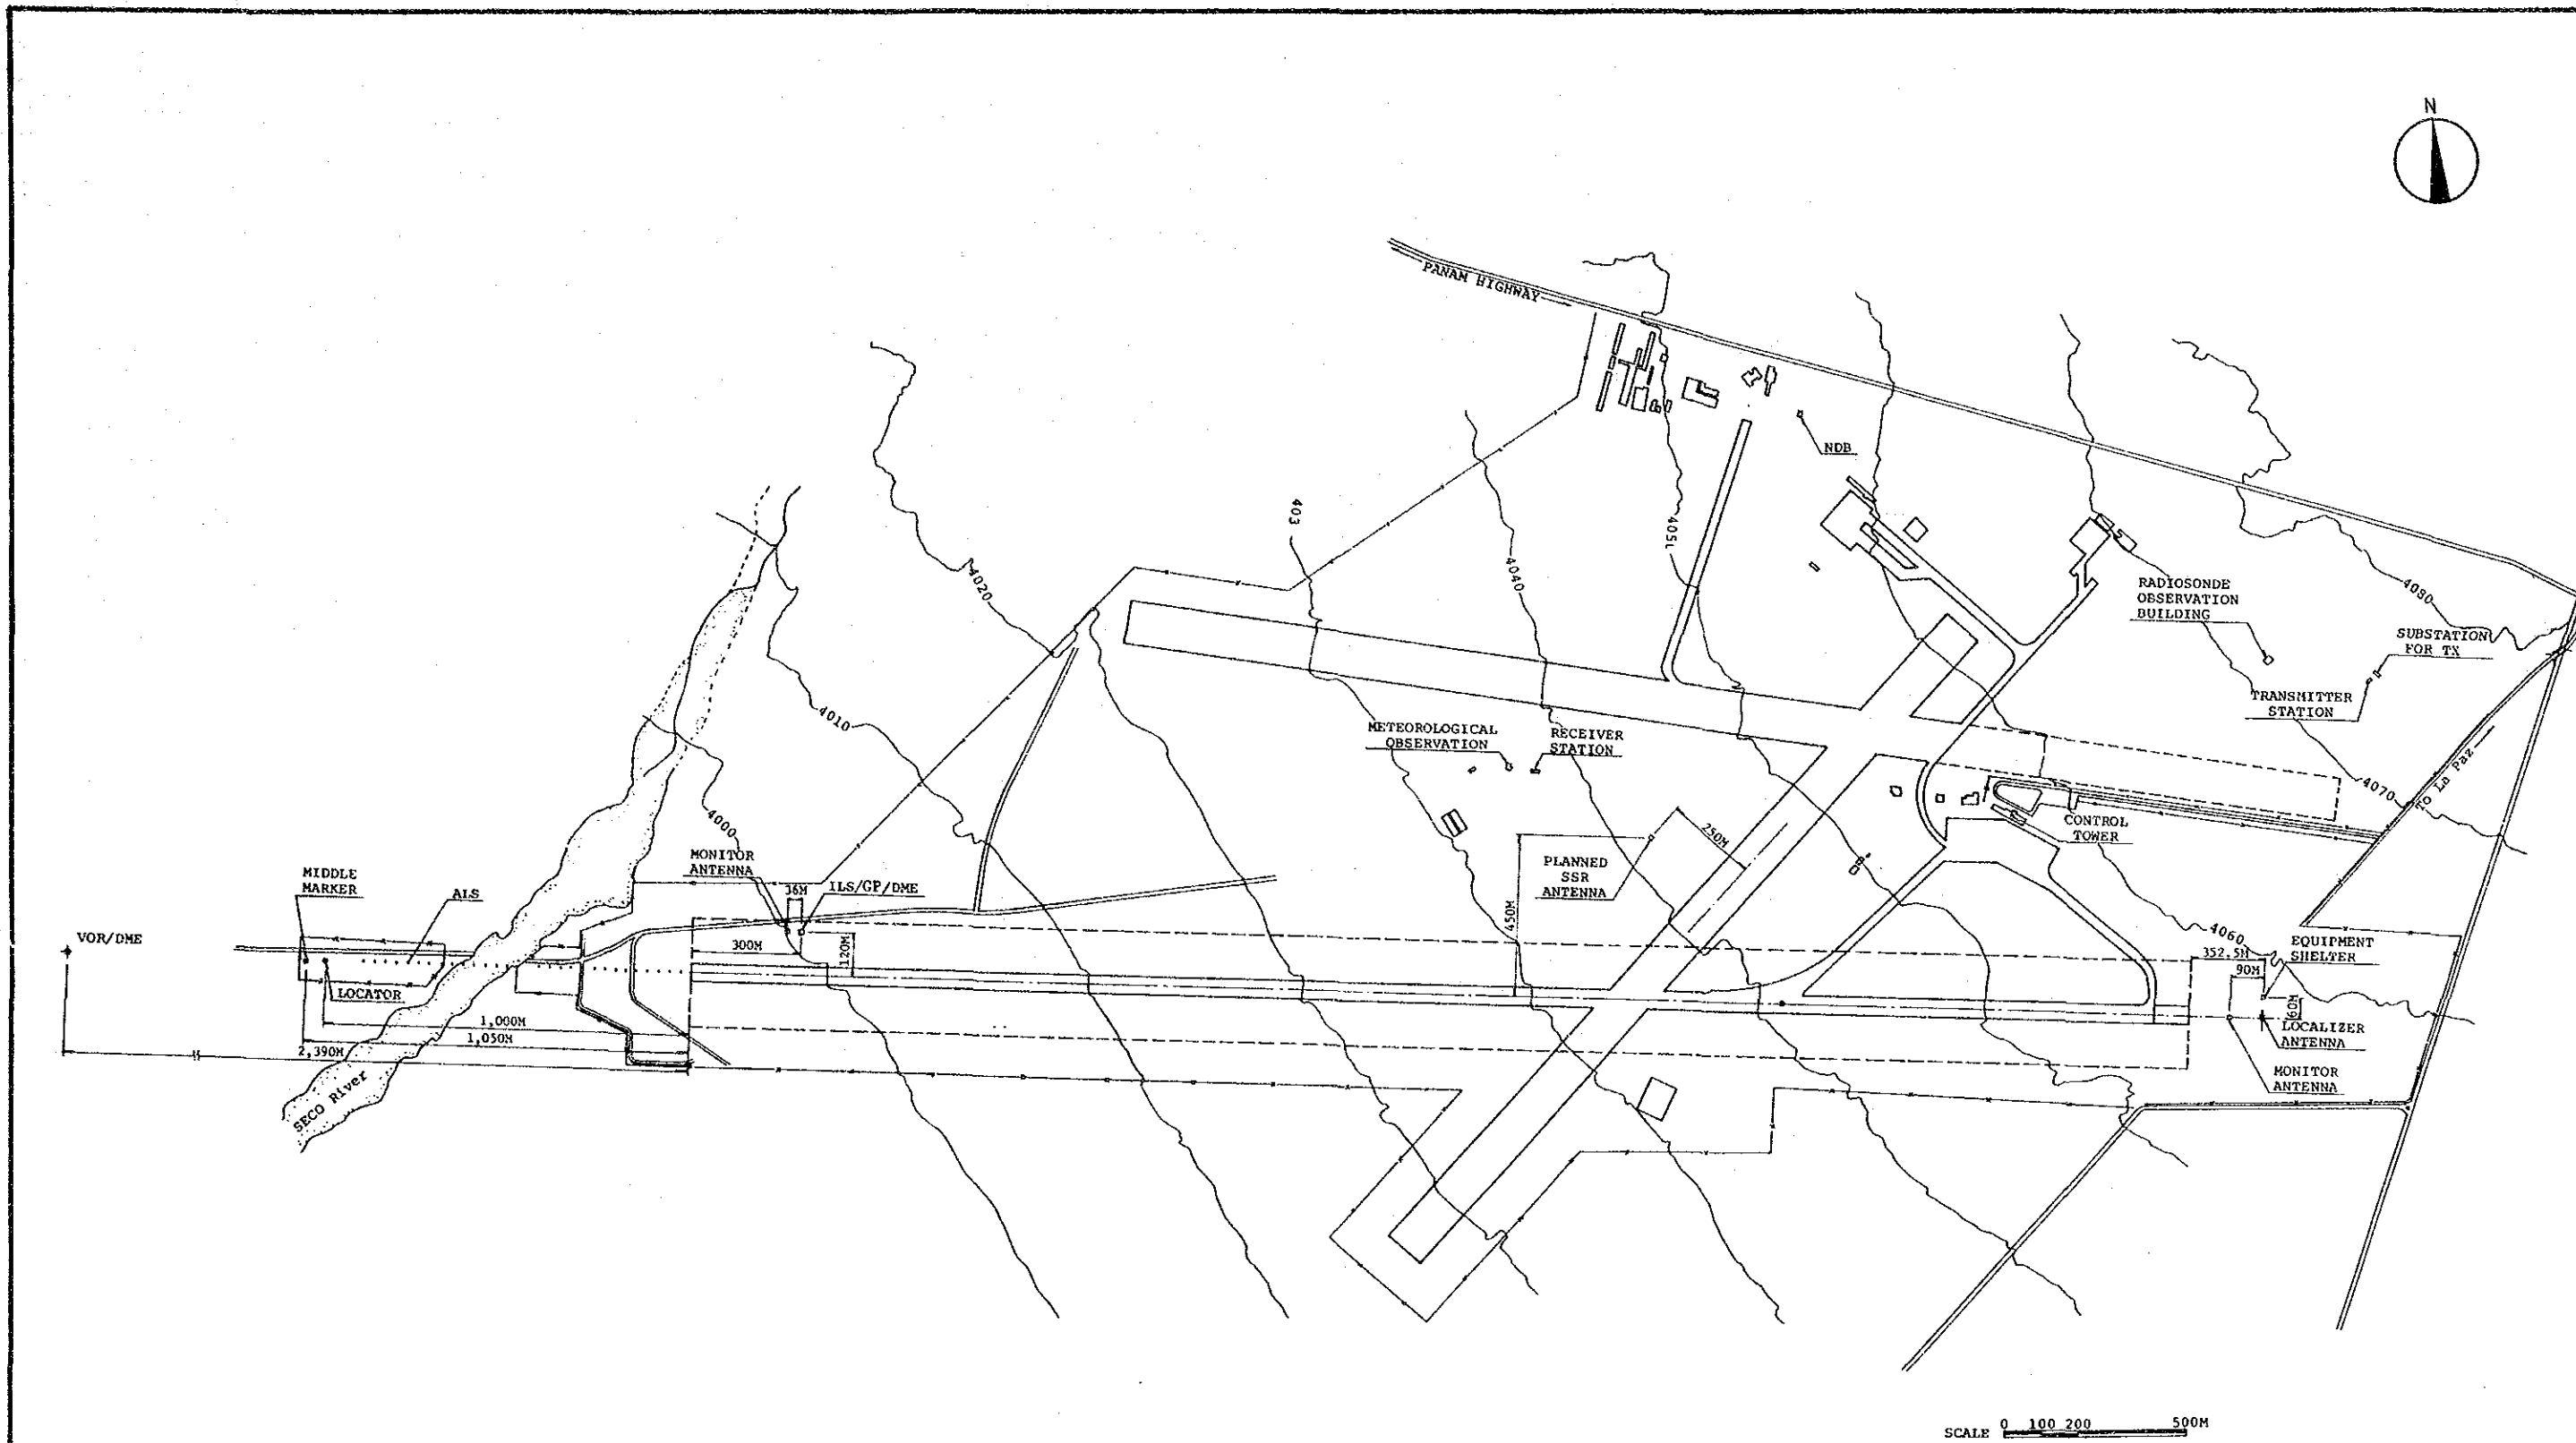
FIGURE 4.5.2 LAYOUT OF EXISTING NAVIGATIONAL AIDS

- (1) The ILS of category II radio signals, and the terminal DME co-located with glide path facilities were installed in 1983. The ILS/DME equipment are new, one manufactured by Philips and no problem has been noted.
- (2) The VOR and co-located DME were replaced in 1982 and 1975, respectively. The VOR/DME are operated by AC power and backed up by the 15KVA emergency generator. A non interrupted power supply to VOR/DME is preferable in order to meet the change-over time of 10 seconds.
- (3) The NDB and locator were installed in 1945 and 1968, respectively. These are considered obsolete pieces of equipment. The locator with a 20 meter high vertical antenna is installed 1000 m west of the runway 09 threshold and on the extended runway centerline. The antenna was broken by aircraft taking-off twice in the past. Relocation of the locator or change of antenna type will be required.
