APPENDIX VI

CONDITIONS OF PAST DISASTER AND DAMAGE

APPENDIX VI
CONDITIONS OF PAST DISASTER AND DAMAGE

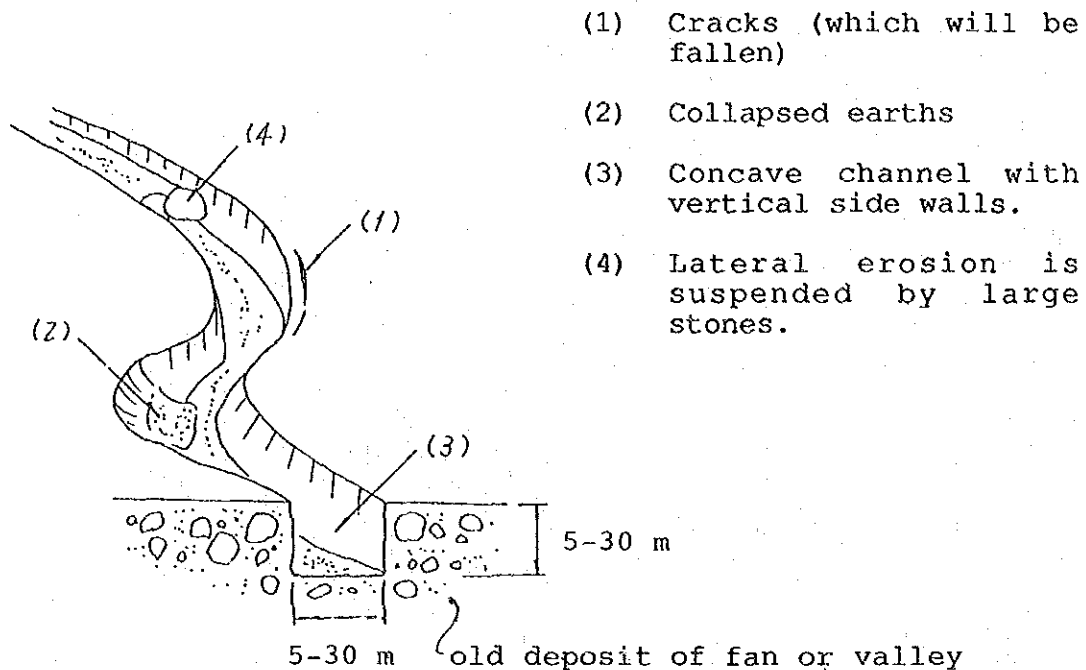
Example of Erosion in Quebrada

A great deal of quebradas in which the debris flow occurred have erosion channel in the upstream stretch of deposit zone. The erosion channel with more or less bending is formed by erosion action of fan or old deposit surface in the valley. The marks of violent downcutting and lateral erosion in the past are seen in such channels. Sometimes, the deep erosion channel is formed by only a debris flow along the small channel.

The debris flow is like ordinary flood flow and erode the old deposit violently on the way.

The stretch with this typical erosion channel has a slope of 5 - 15% and usually be located in the downstream side of flowing (transportation) zone. It is considered that the most parts of deposit in the downstream stretch are transported from the flowing zone where the boulders and earths are eroded by debris flow.
