APPENDIX III

Inspection Report on
Damaged Flood Embankment of
Demonstration Unit of
N-N Irrigation Project

DEMONSTRATION UNIT OF N-N IRRIGATION PROJECT

T. AMANO
Irrigation and Drainage Planning
JICA Basic Design Study Team
for N-N Irrigation Project
(Block A-1)

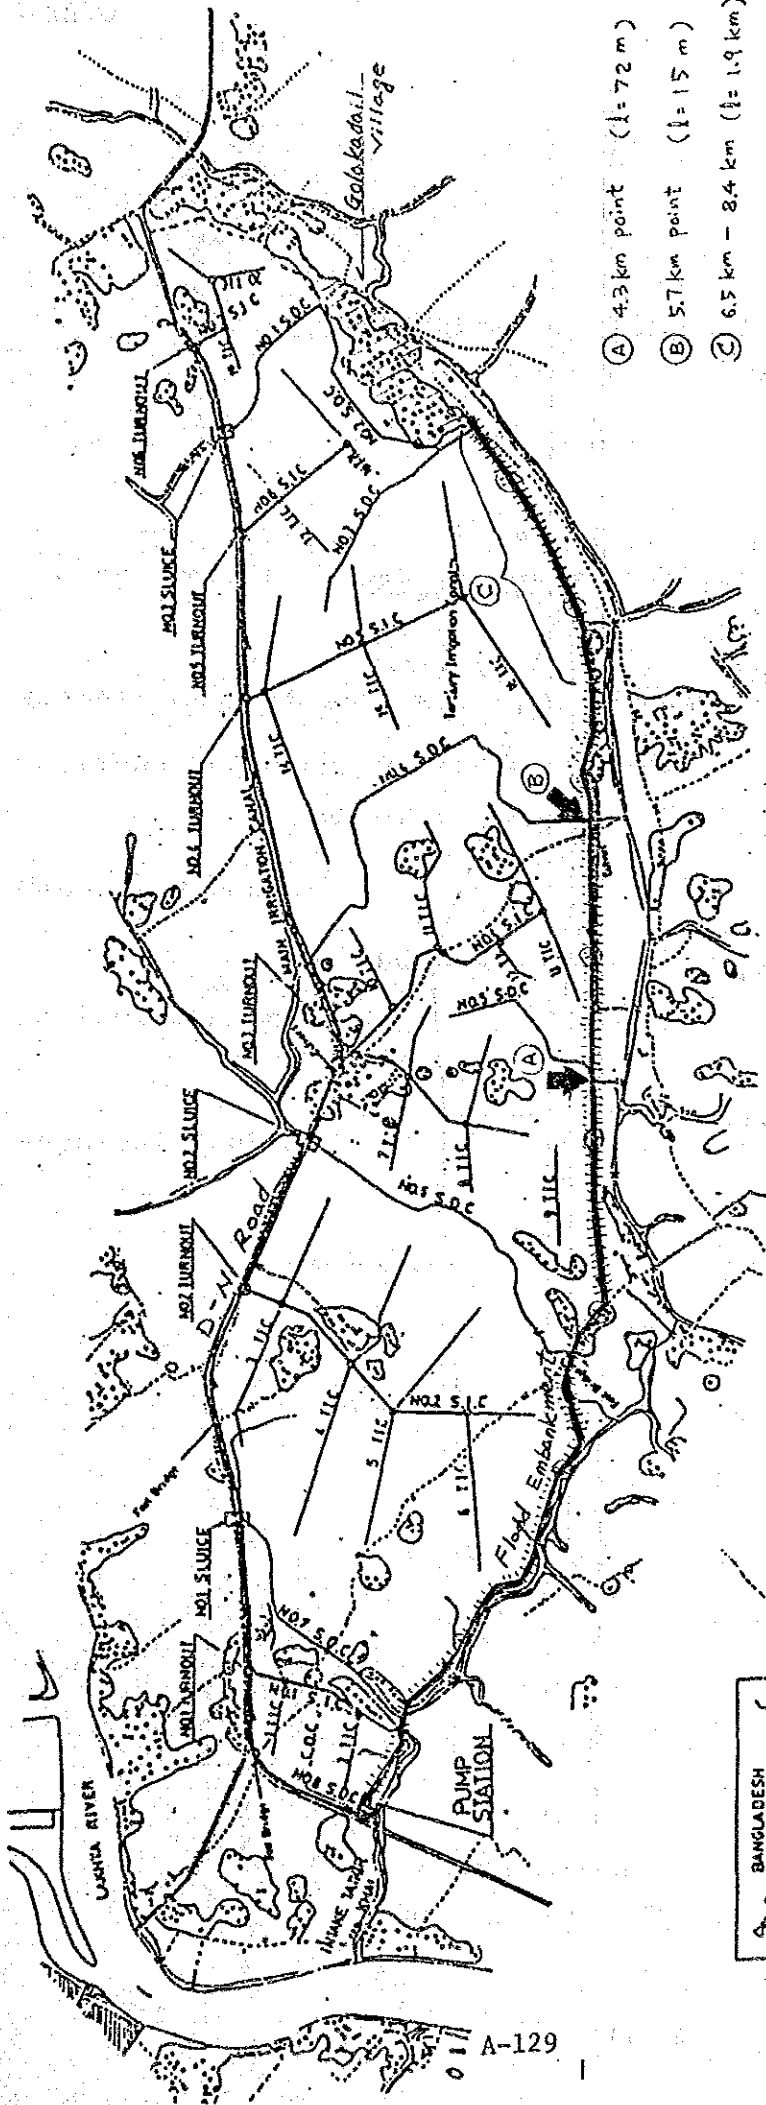
PLAN

Location : 4.3 km from the pumping station. (Marked as (A) given in Annex-1, attached hereto) According to the topographic map, it seems to be a place where a tributary of the Tatkir Khal had been flowing.

Location : 5.7 km from the pumping station (Marked as (B) given in Annex-1)

Situation : The embankment has been settled through a height of about 1.2 m and the innerside of the embankment has almost been eroded and washed away. If (A) portion has not been broken down, this portion must have been breached.

Situation : Serious slope failure along the entire length of the portion was witnessed. The cross-section of the embankment above the flood water level seemed to be half of its original size and the top width of the embankment has

- (A) 4.3 km point (l = 72 m)
- (B) 5.7 km point (l = 15 m)
- (C) 6.5 km - 8.4 km (l = 1.9 km)

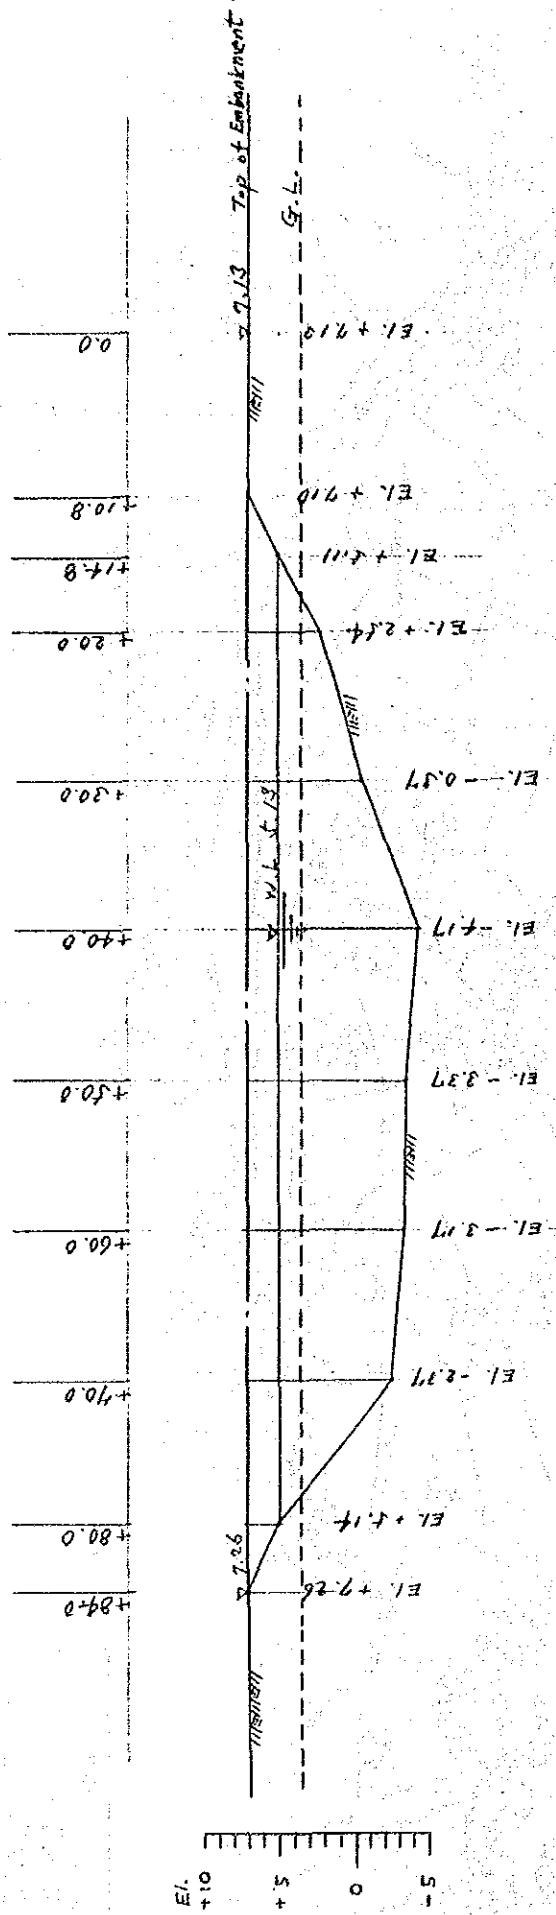
LONGITUDINAL SECTION OF BREACHED PORTION

Length of breaching : 73.2 m long.

Depth of scouring: About 9.3 m deep from G.L. (See Annex-2)

Cause of breaching: It is judged that the direct cause of breaching is piping failure due to the rat holes barrowed into the embankment.

Surveyed on 22-09-1987
