REPORT ON STUDY

AMBUKLAO DAM REHABILITATION PROJECT

MARCH 1988

JAPAN INTERNATIONAL COOPERATION AGENCY

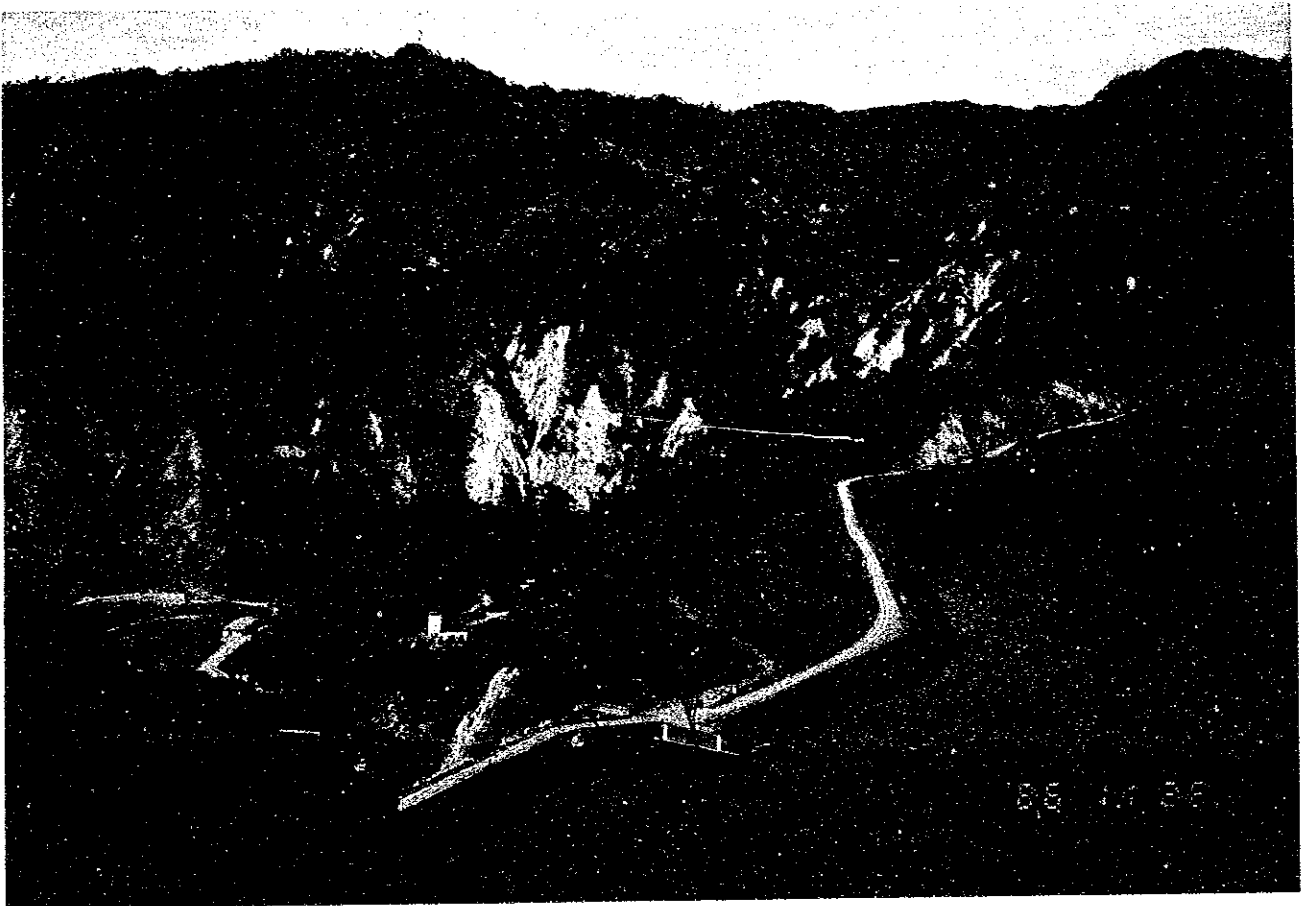
Downstream Face of the Dam

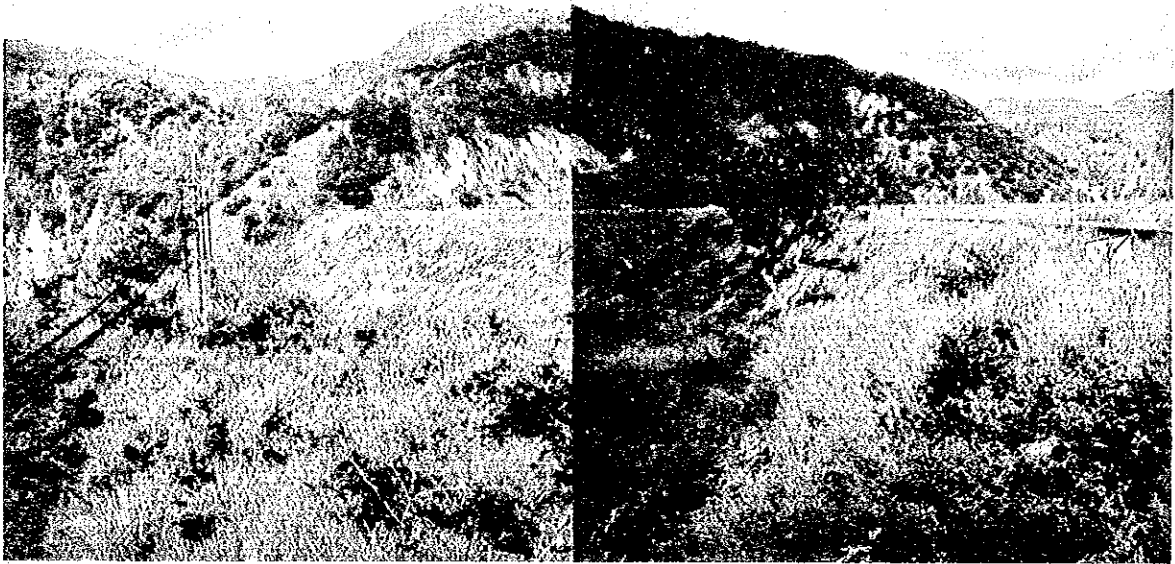
Upstream Face of the Dam

(W.L. 717.00 m)

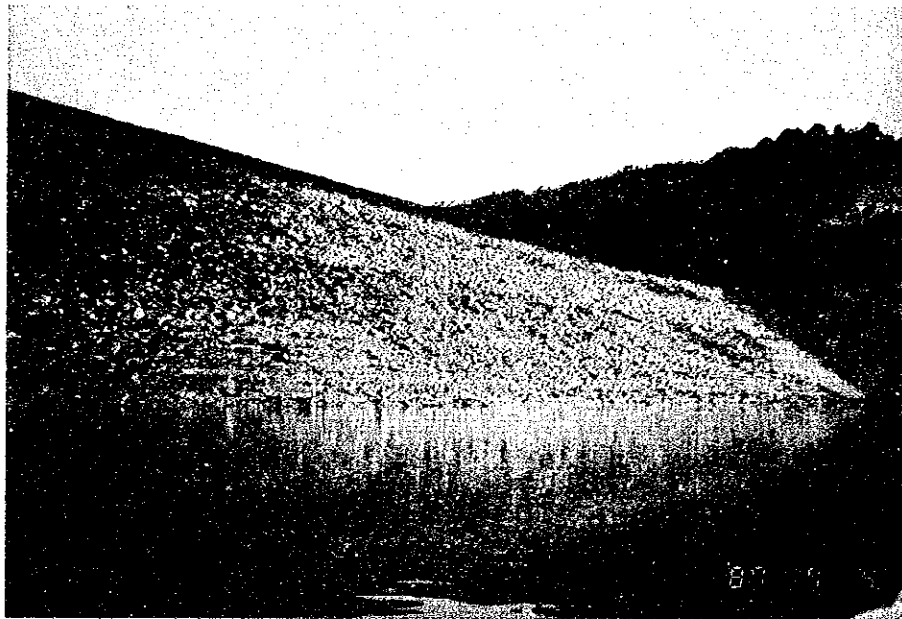
Sedimentation in the Labey River (W.L. 717.10 m)

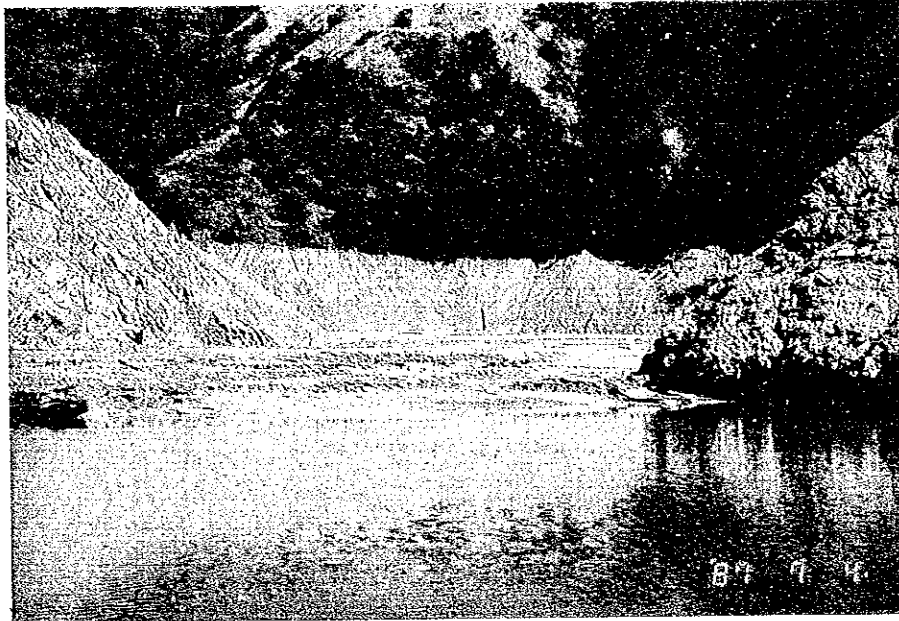
Sedimentation in the Bantay River (W.L. 717.10 m)

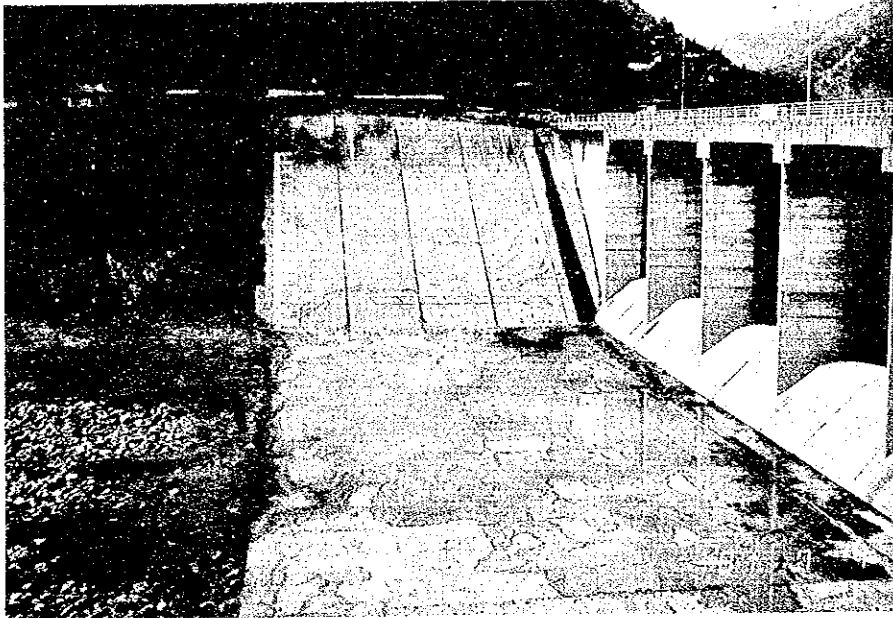
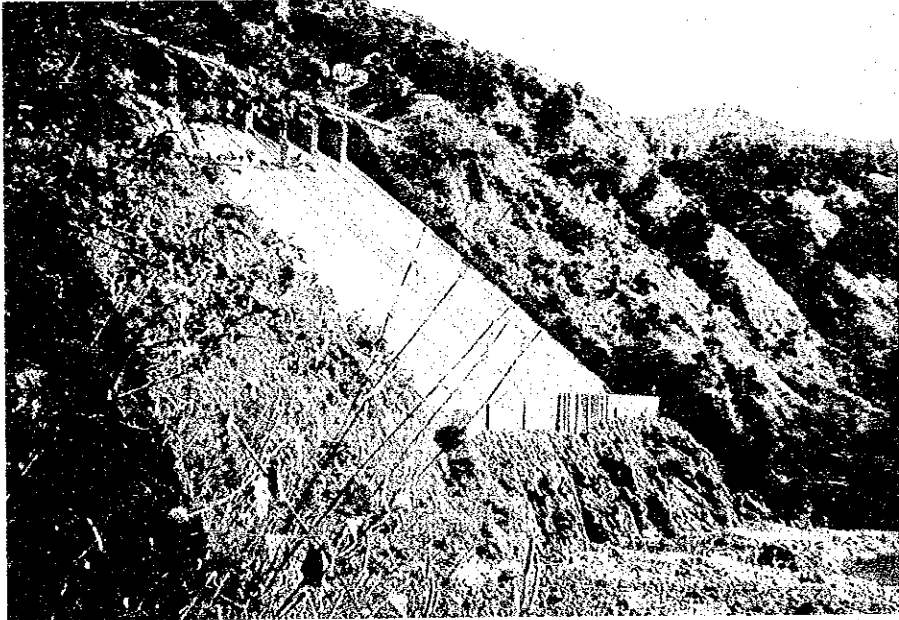
Sedimentation at the Tailrace

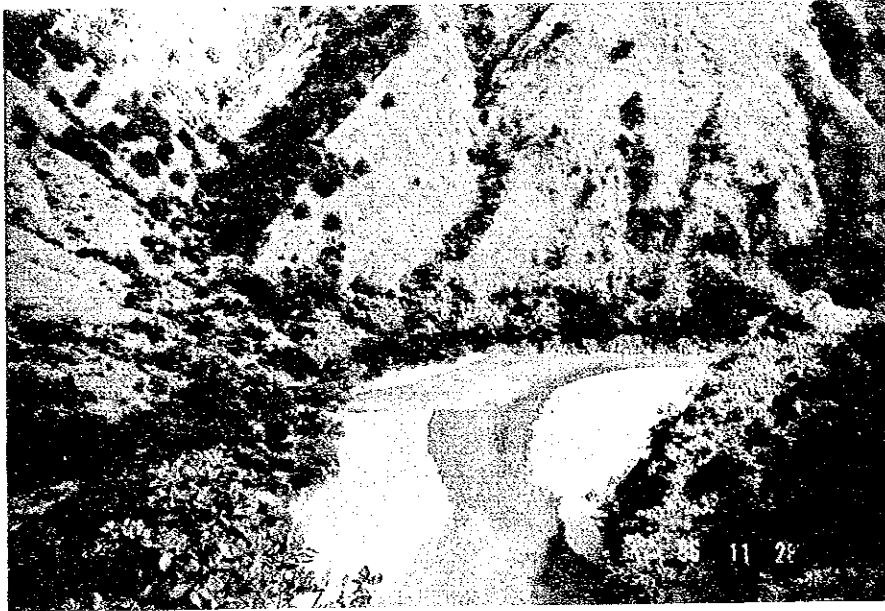
River Conditions at the Tailrace
