## 5.6.2. Results of Field Investigation

Fig - 5.1  
 THE AMBUKLAO DAM REHABILITATION PROJECT  
 DAM CREST ALIGNMENT  
 Alignment - 1  
 Alignment - 2  
 SCALE 1:4000    DATE  
 THE JAPAN INTERNATIONAL COOPERATION AGENCY

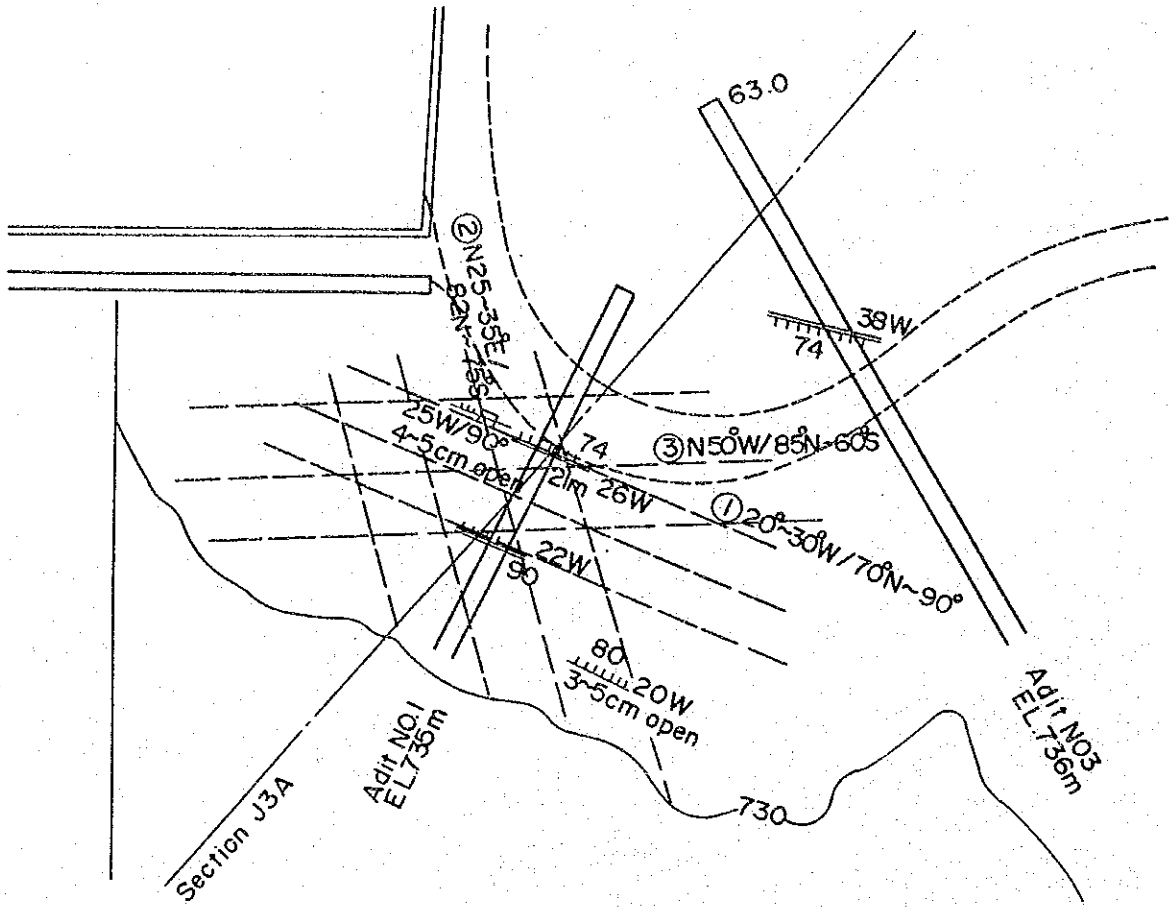
Fig-5.8 Horizontal Slice at EL.730m of Spillway Left Abutment

The main fractured planes are, (1) N20 - 30°W/74°N - 90°, (2) N25 - 35°E/82°N - 75°S, (3) N50°W/85°N - 60°S.

The combination of these fractured planes seems to be concerned with the open crack developed in the flood time of 1976. But it is very significant that all these planes are high-angled and no low angled slip planes are there.

Judging from these facts the surface rock mass of the upper portion of spillway left abutment seems to be not slid but slightly toppled in a range of at least 23 m in horizontal as illustrated on Fig.-5.8 and 5.9.

The values above-mentioned are only assumed by experience. Considering the important situation of the spillway structure and some particular geological differences between this site and others, it is recommendable to carry out in-situ rock shearing tests here to determine the actual rock strength.

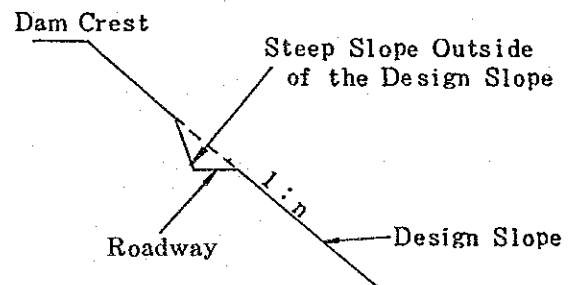
Fig - 8.4 Design Concept of Roadway on the Dam Slope

The steep slope caused by the construction of the access road on the downstream face of the dam is considered not to have any relation with the design slope of the dam. (See Fig.-8.3 and Fig.-8.4(b))

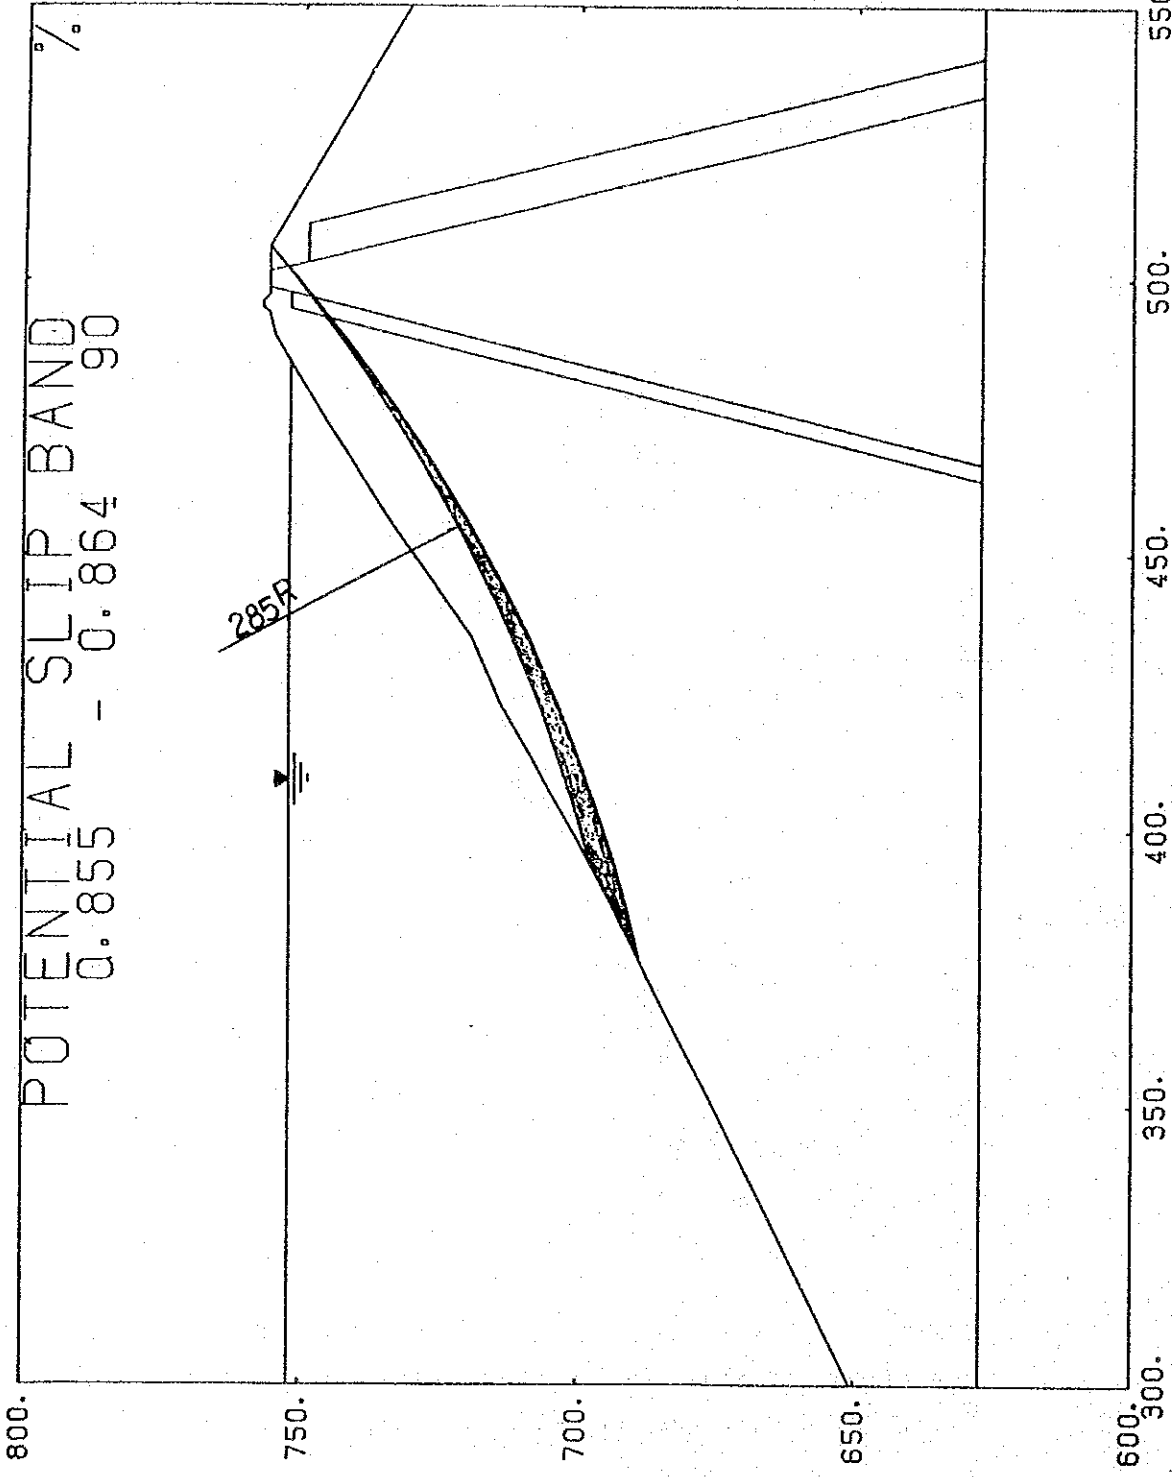
Fig - 8.6 Critical Slip Circle on the Upstream Slope

However, Cases 2 and 4 for which seismic effects were considered, as shown in Fig.-8.6, yield safety factors of 0.855 and 0.857, respectively, was below 1.0. For Case

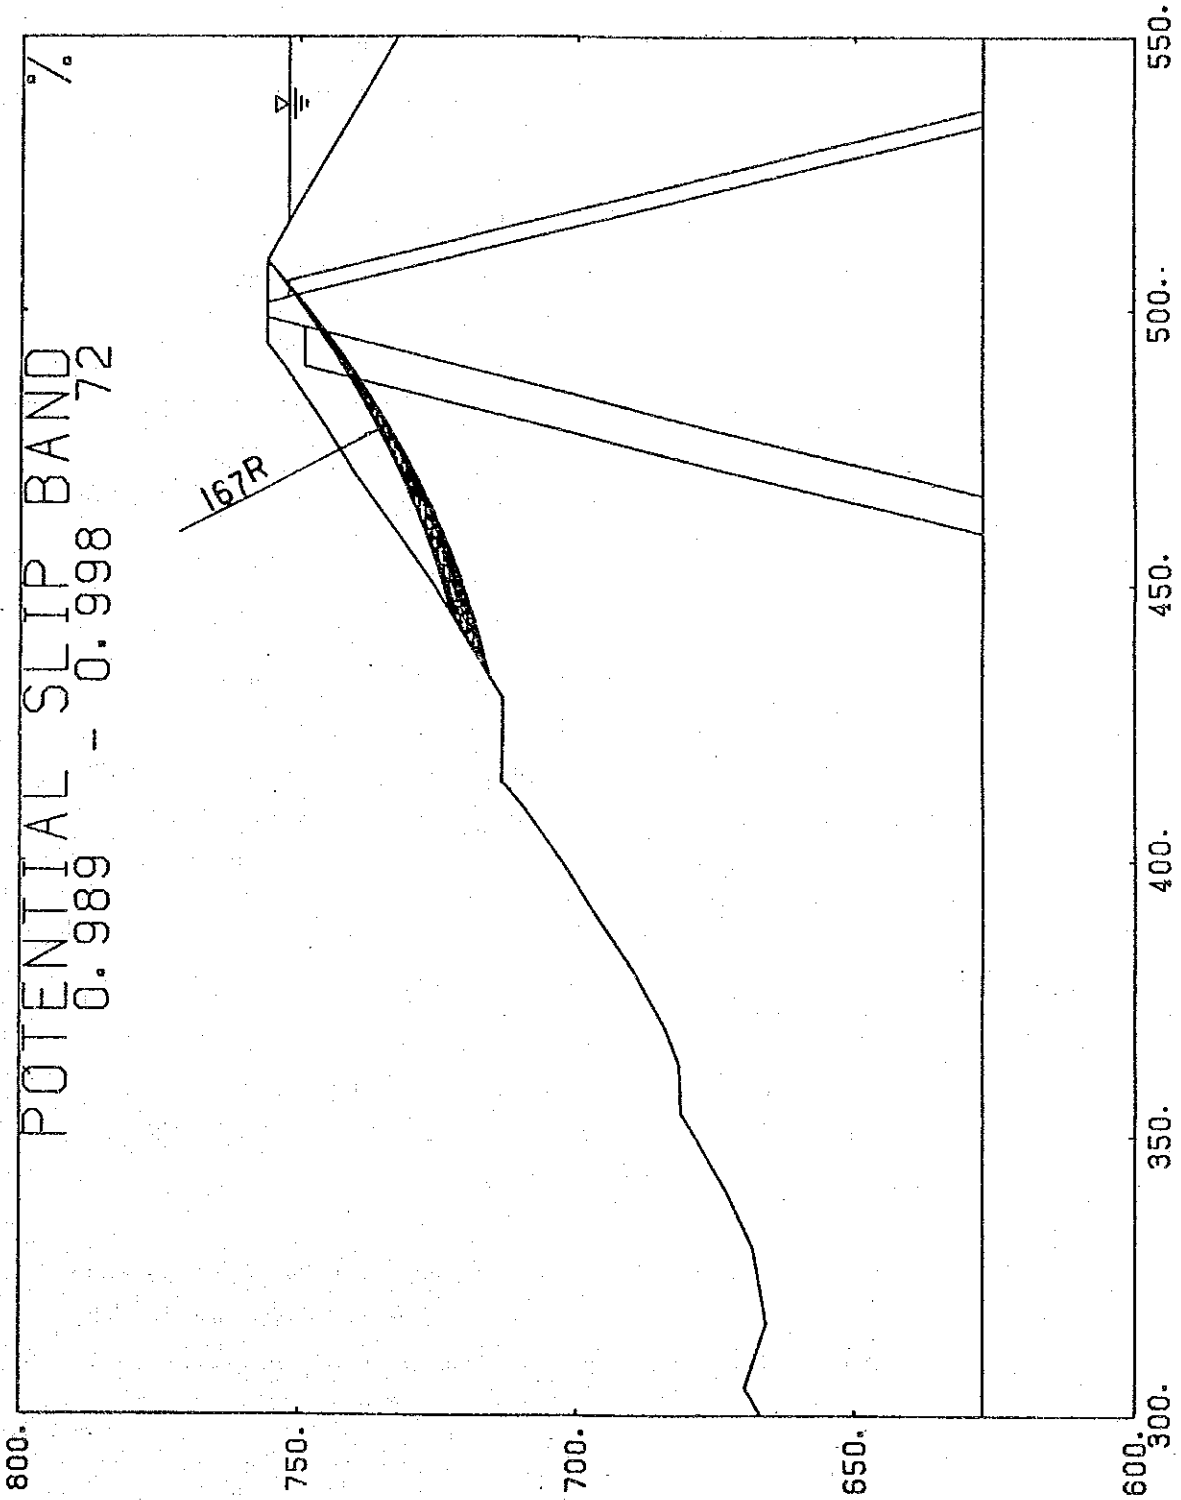
Fig - 8.8 Critical Slip Circle on the Downstream Slope

satisfactory. The results for Cases 2 and 6, both of which were analyzed with the seismic conditions included, show safety factors of 0.989 and 0.984 (see Fig.-8.8.), respectively. Although they are below 1.0, considering the low value of the angle of friction used, they are also considered to be satisfactory.

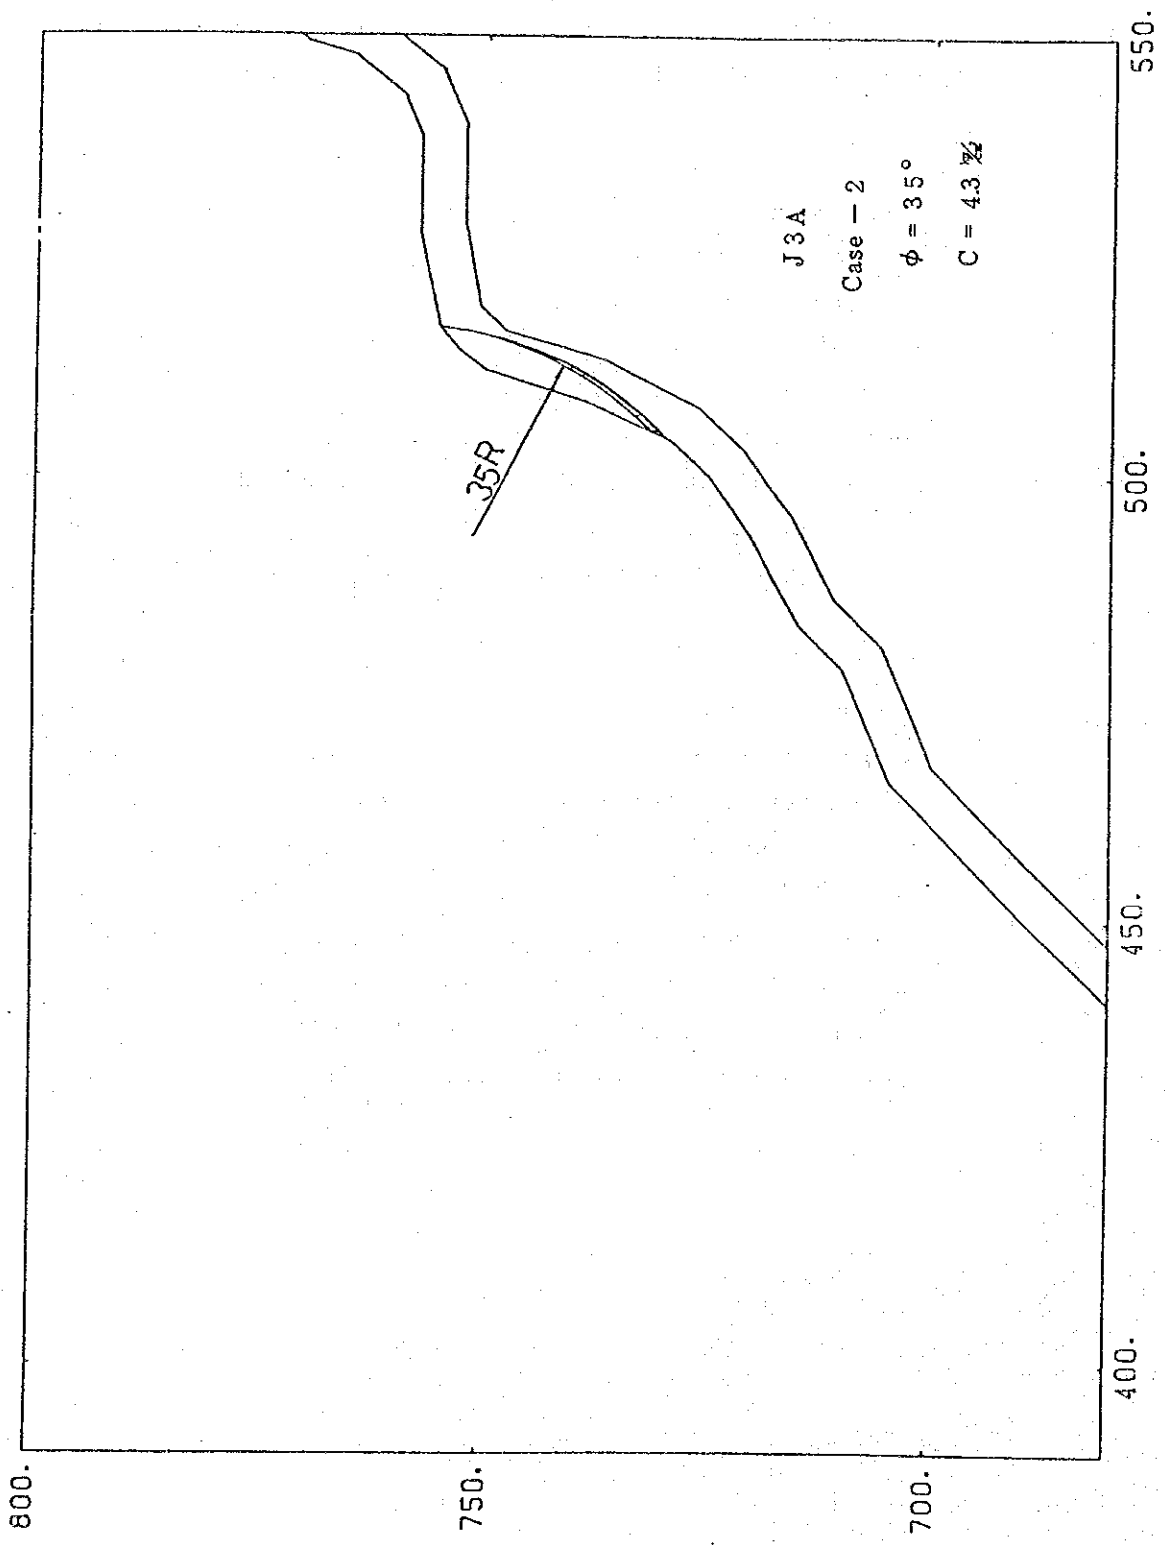
Fig - 8.11 Critical Slip Circle in Case of Shallow Slide

It was found that for a safety factor of 1.0 and internal angle of friction of  $\phi = 35^\circ$ , the required cohesion of the underlying bedrock was  $C = 4.3 \text{ kg/cm}^2$  (see Fig.-8.11). The above included the earthquake effects.

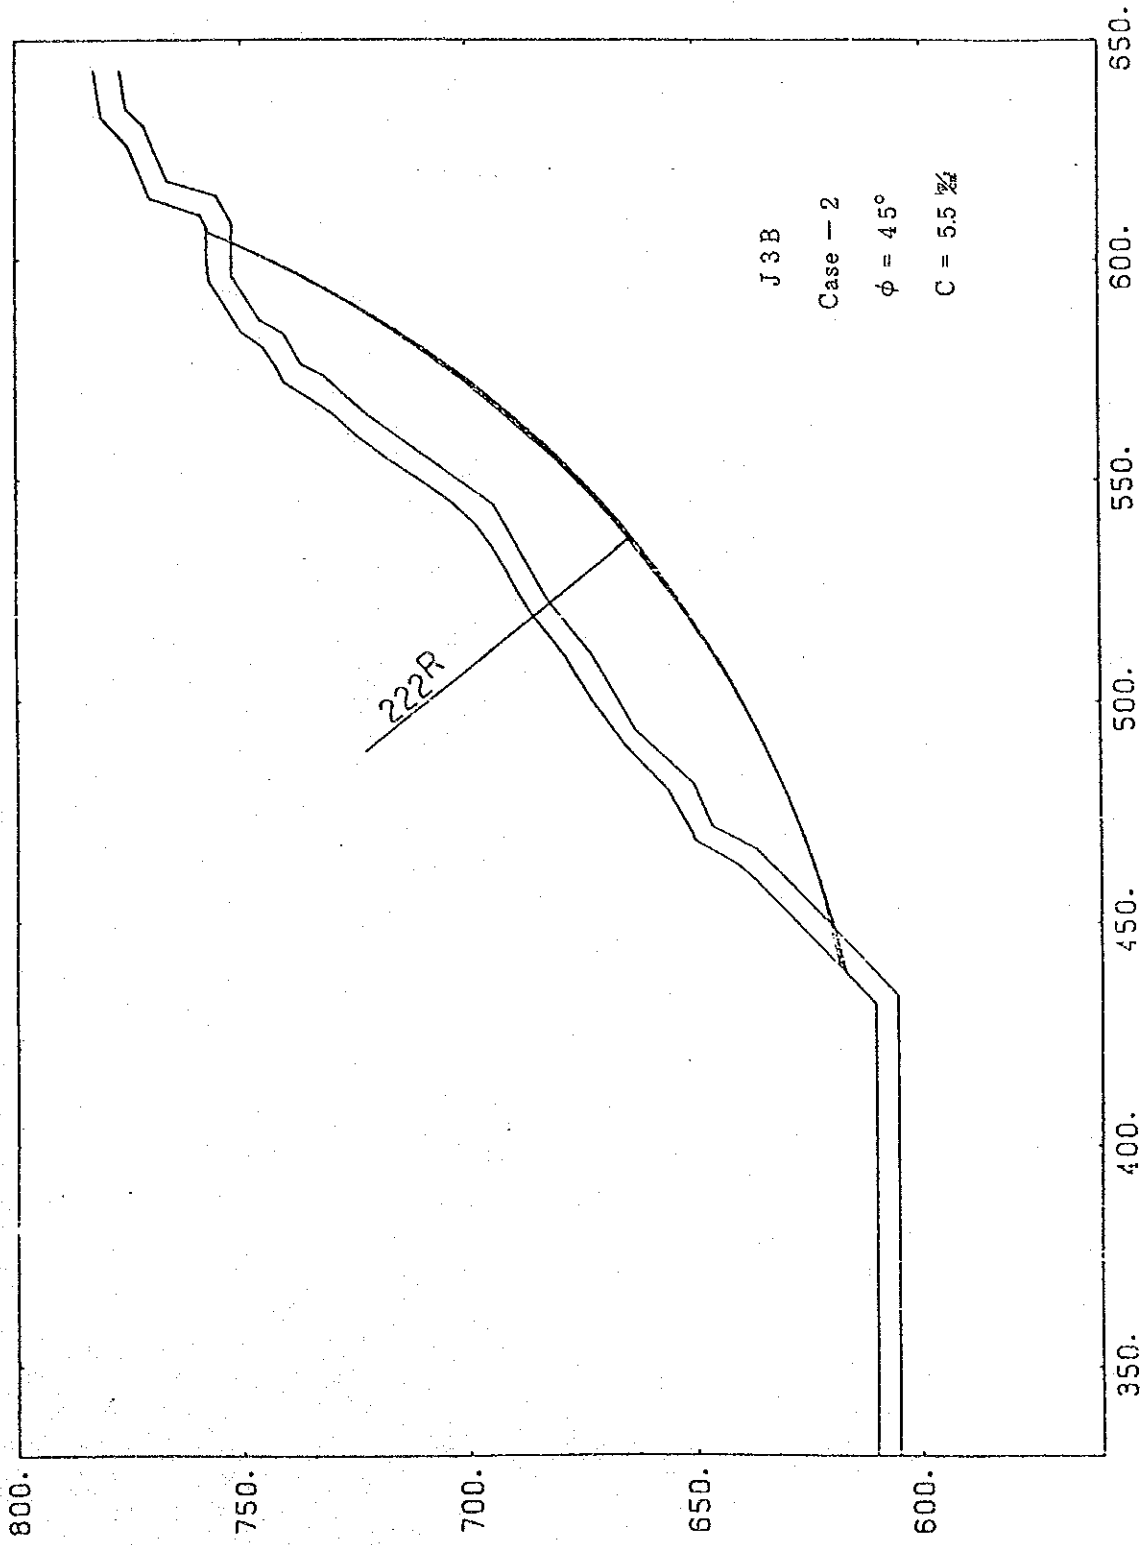
Fig - 8.12 Critical Slip Circle in Case of Deeper Slide

For this section, the sliding surface is assumed to be deep-seated and slicing through the underlying diorite of the abutment. The shearing strength of diorite, being a better rock, is assumed to be considerably higher than that of the metamorphic rock. As shown in Table-8.9, for Case 2, which considers stability of the abutment with 80 percent of pore pressure in the bedrock, it is found that the cohesion can be only  $C = 5.5 \text{ kg/m}^2$  if the safety factor of 1.0 is to be maintained. The assumed sliding surface for this case is shown in Fig.-8.12.
