BASIC DESIGN STUDY  
ON  
THE PROJECT FOR REHABILITATION  
OF  
N-N DEMONSTRATION UNIT  
IN  
THE PEOPLE'S REPUBLIC OF BANGLADESH

MAY, 1988

JAPAN INTERNATIONAL COOPERATION AGENCY

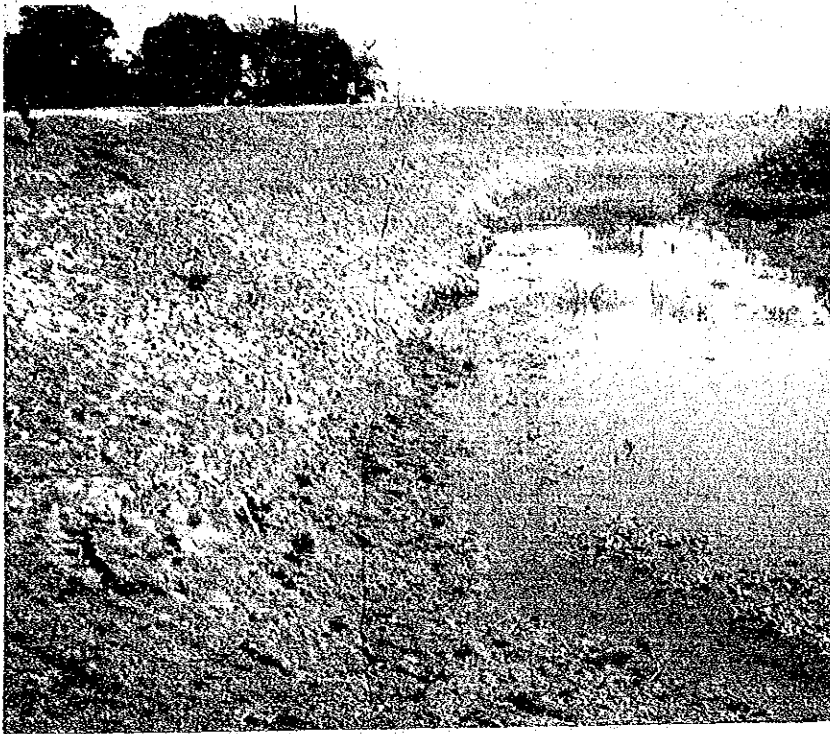
A part of Flood Embankment scoured by Tatkir River  
(about 0.40km away from Pumping Station)

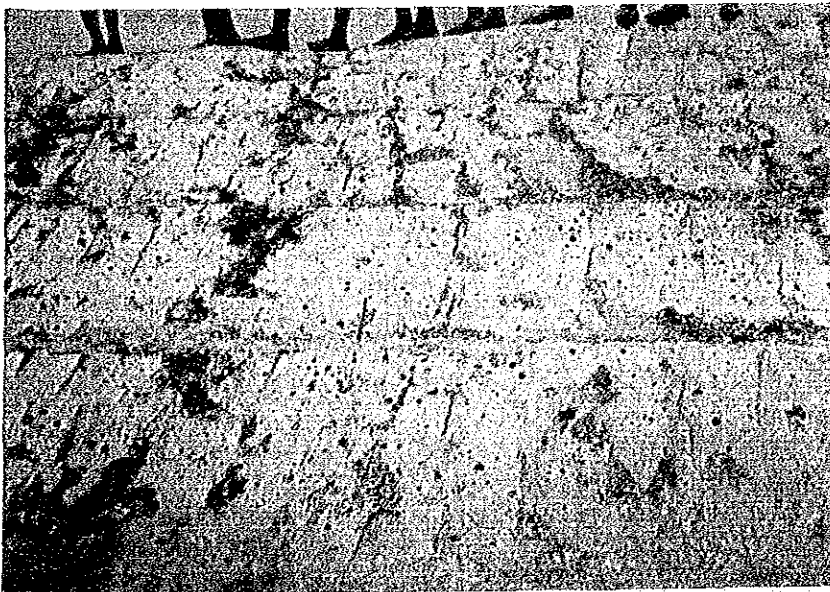
Many holes found in the existing embankment body  
during the emergency work (made by some kind of  
insect)

Animal holes were found along the entire length of the flood embankment and were particularly noticeable in the section between the 3.4 km point from the pumping station and the far end of the embankment where sand fraction is high. In addition to animal holes, snake eggs were also found at cut sections of emergency rehabilitation work sites. According to interviews, rats, lizards and some insects (something like mole crickets and ants) are responsible for the holes.

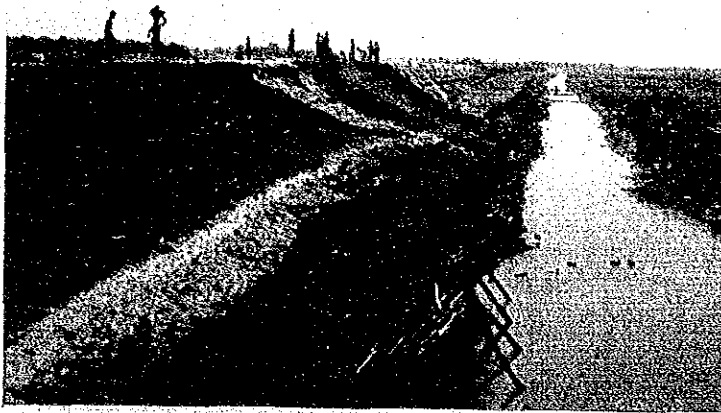
Emergency work under construction and timbering  
by local inhabitants  
(about 5.7km away from Pumping Station)

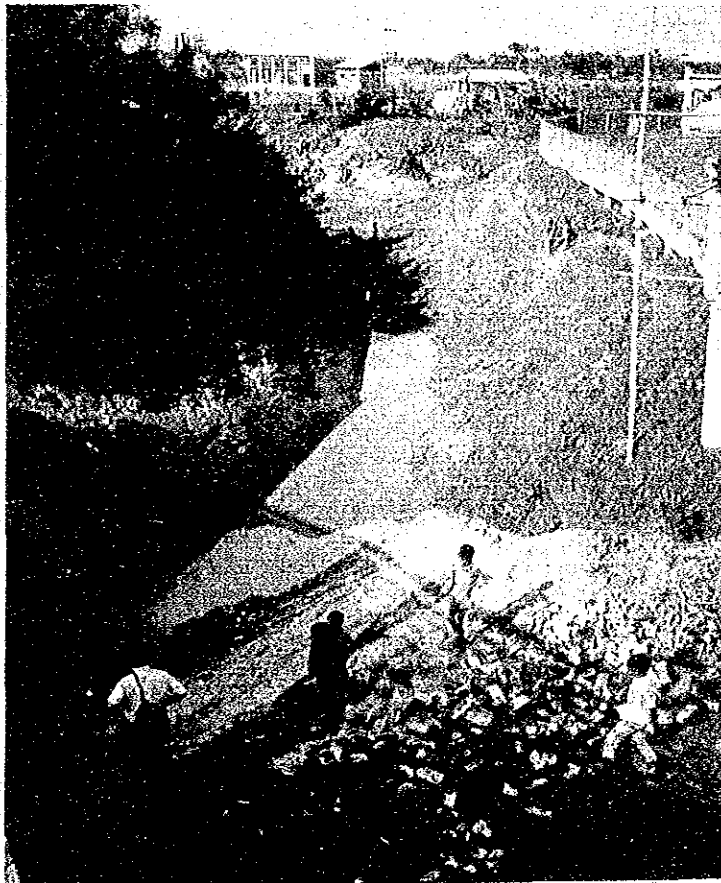
Intake Canal and Pumping Station  
(dredging by BWDB)

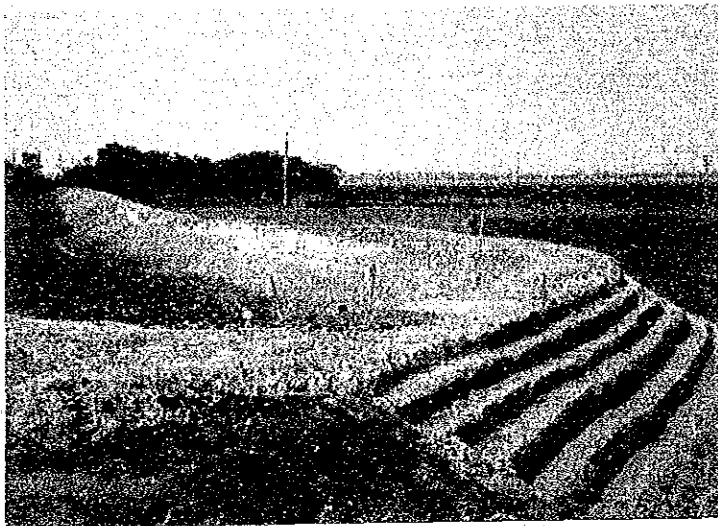
Main Irrigation  
Canal Embankment  
nearby Barba Village  
(under reinforcement  
work by BWDB)

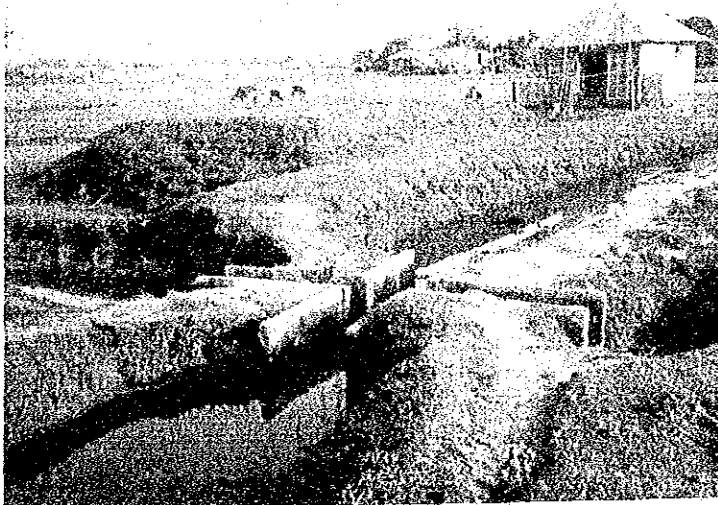
Turnout from Secondary  
Irrigation Canal No. 2  
to Tertiary Irrigation  
Canal No. 3

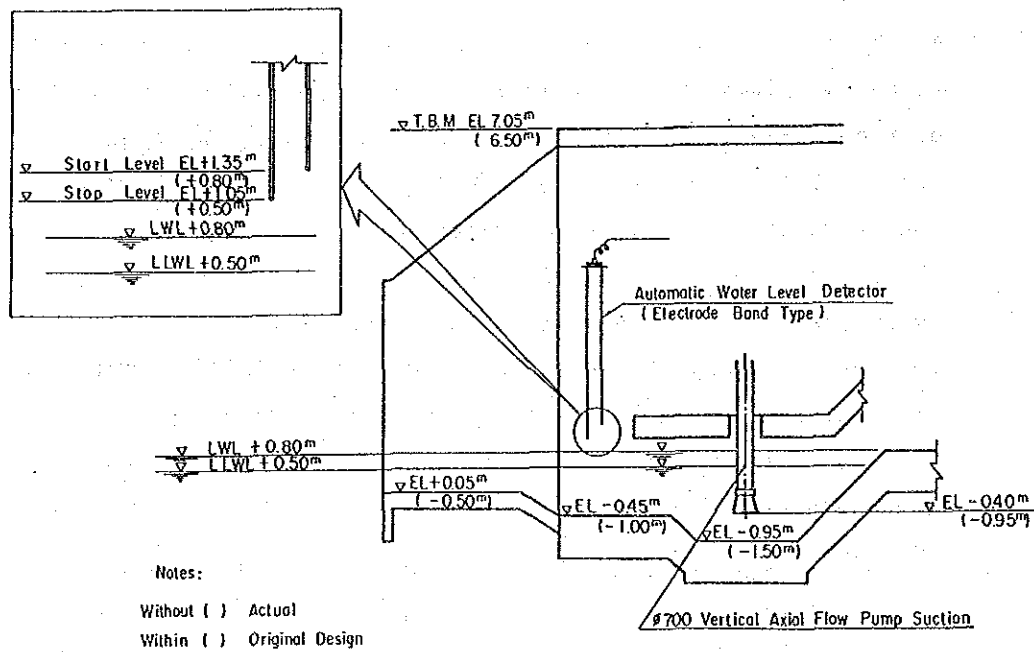
Fig. 5-1-3 Part Elevation at Pumping Station

Sequent on surveying at the major points of the pumping station, the elevation of the station was found 0.55 m higher than in the original design, as shown in Fig. 5-1-3. The fixed water level for an automatic water level detection equipment, which controls pumping operations, is also set at 0.55 m higher than originally given.

To be more precise, as the fixed water level for the automatic water level detection equipment (which stops pumping operations when the water level of the intake canal falls during the dry season) is 0.55 m higher than given in the original design, the pumping station cannot pump up irrigation water at the water level designed originally.

In order to increase the supply of irrigation water to the Demonstration Unit, therefore, the water level detection equipment should be improved within the limitation of being capable of ensuring safety against cavitation of the pumps.
