1. MUSA MIJANGA

2. KIFAKU CHINI

3. KONUGAI

9. IQUINI

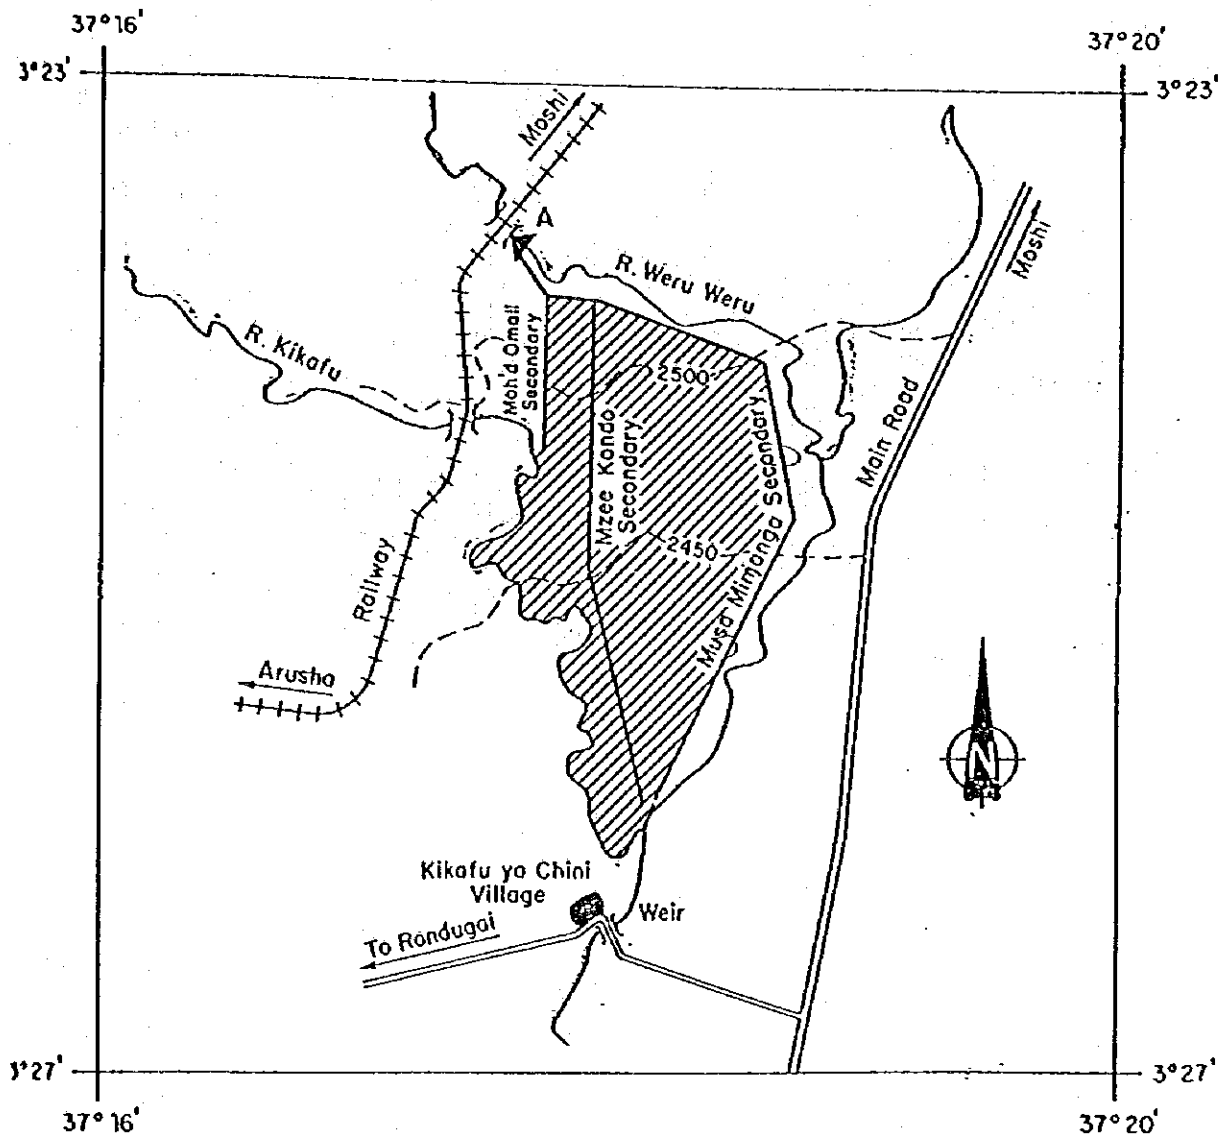
Fig. A1

The approximate layout of the present irrigation system is shown in Figure A1. Traditionally water was abstracted from the Weru Weru River by means of a traditional weir under the railway bridge, point A on the figure. This was replaced by a concrete weir and gated intake, which has still to operate, in 1982.

Main Intake: The cause of the failure of the weir in 1983 appears to have been overtopping of the left bank wing walls and erosion of the bank during a high flood. In 1986 the weir was extended to about twice its original length and now has a crest length of some 30 m. Whether this will be adequate to reduce the risk of overtopping of the wing walls significantly during high floods is not known. However, it would be prudent to protect the backfill around the wing walls and the upper slopes in the area of the wing walls with either grouted stone pitching or gabions. Erosion at the downstream end of the new left bank wing wall was already evident at the time of the visit, and additional protection to this area is necessary.

It was not possible to inspect the stilling basin but it was reported that it had not been completed in the new section. Also the breast wall at the intake control gate was not completed and is about 1 m too low. The general quality of workmanship on the structure is poor. No scour sluice is provided and the intake will require frequent desilting.

Main Canal: For the first 100 m downstream of the intake the main canal has a masonry lining on its left bank with rock outcropping along its right bank. The bed width in this reach is approximately 1.5 m and the depth of flow 0.5 m. Downstream the canal has been re-aligned as the previous alignment was damaged by floods. The present flow section is wide (up to 3 m) and shallow (about 0.3 m). It has been excavated in soft material with the spoil dumped on the left bank to provide some protection from river flooding. The section is irregular and susceptible to damage by erosion and flooding. After about 500 m it is unlikely

Main Canal Structures: The two principal structures on the main canal are the offtake for the Mohammed Omali secondary and the division box to the Mzee Kondo and Musa Mijanga secondaries. All need minor repair and the provision of slide gates.

The most urgent item of work is the completion of the main weir and intake structure and the provision of additional protection works to ensure its long-term stability, particularly under flood conditions. To effect this, the following items of work are necessary:

- completion of stilling basin in new section
- provision of gabion protection to bed and banks downstream of the stilling basin
- provision of grouted stone pitching on upper slopes of the river banks in the area of the weir
- raising of the wing wall over the intake gate.

- culvert first 500 m (1.0 m dia pipes assumed)
- install check and escape at ch 500 m
- lining to next 500 m (60 mm thick concrete assumed)
- trim back slopes in this section to 1:1½
- provide 3 gated division boxes.

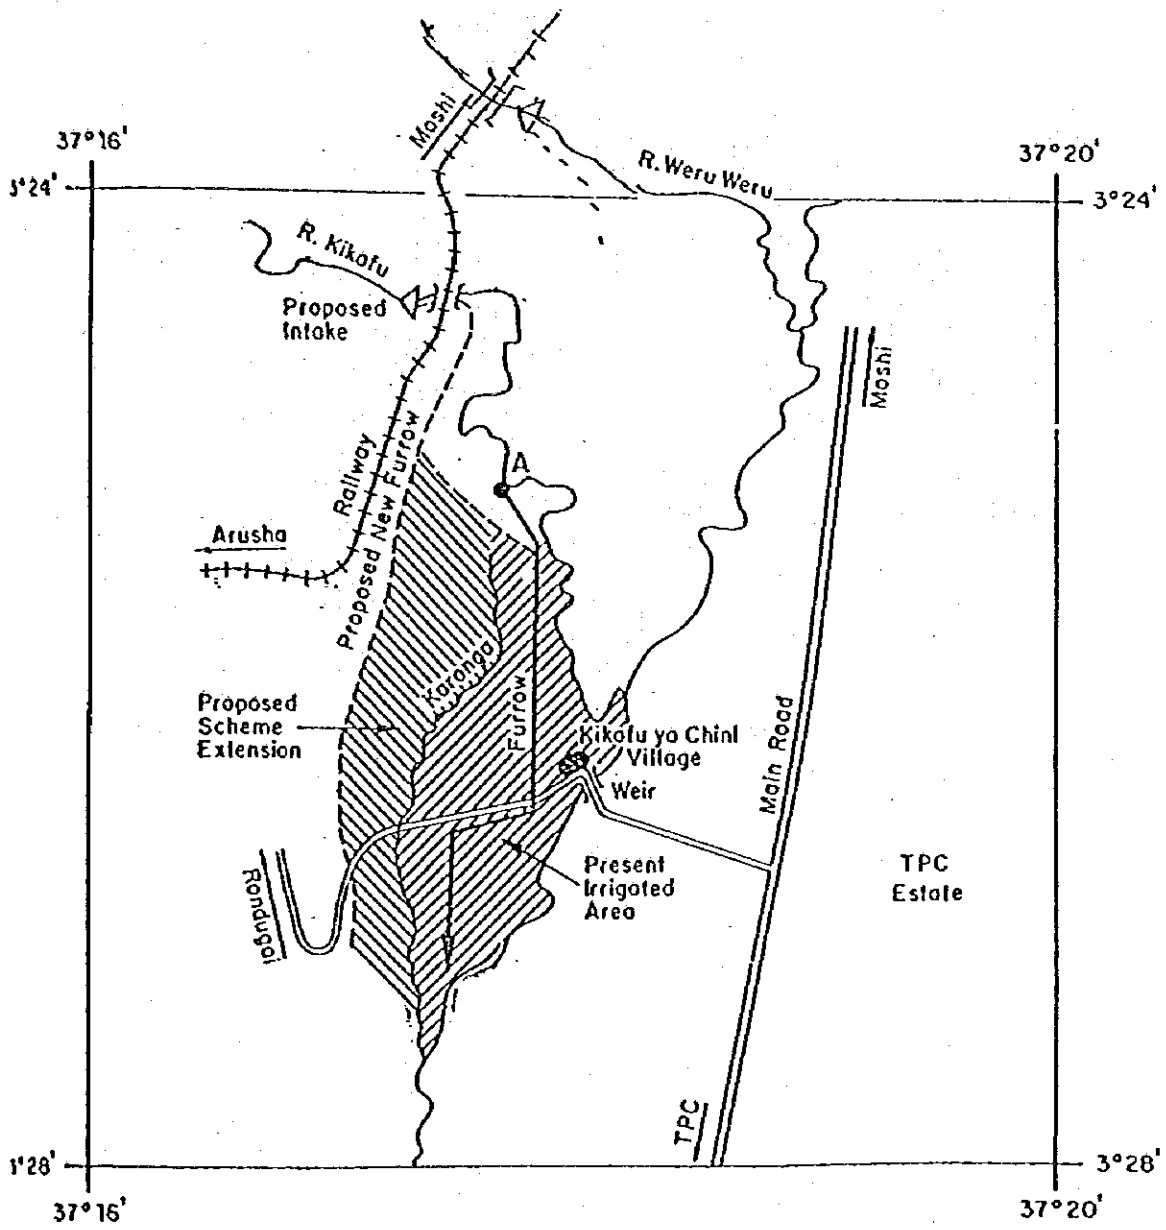
Fig. A2 APPROXIMATE LAYOUT - KIKAFU CHINI SCHEME
 Scale 1:50,000: Reference Map Series Y742,
 Sheet 56/3.

The approximate alignment of the existing furrow is shown on Fig. A2. Water is abstracted from the River Kikafu by means of a gated intake structure (point A). The furrow flows south for 2.5 km until it crosses the Kikuletwa road where it turns east for about 1 km before turning south again to terminate at the Weru Weru River.

Intake Structure: The intake structure consists of a concrete headwall and gated intake, which were completed in 1983, located on a 90° bend in the Kikafu River. No weir is provided and during times of low flow the water level is raised by construction of a traditional weir. Because of its location in the river, the intake is susceptible to river bank erosion and, in 1985, the backfill to the downstream section of head wall was breached,

allowing a flood down the main canal. The structure has been extremely poorly sited, and should be replaced by a better designed and constructed installation at a tenable site.

Main Canal: Prior to the construction of the intake structure in 1983 the main canal was subject to flood damage, as no control of inflows was possible. As a result of the damage to the intake in 1985 this is still the case. Approximately the first 1 km of main canal is now badly eroded to a deeply incised, wide channel. Bank overspill in a stretch of 100 m has necessitated the construction of a masonry wall, which is presently being undermined by seepage.

Other: Access through the area is made difficult by a number of broken culverts on both the main and secondary furrows. Four minor culverts and one large culvert need replacement.

The existing intake and headreach of the main canal require replacement if a water supply to the scheme is to be assured and further flood damage prevented. The location of the new intake depends on the command required, which is in turn dependent upon the technical and economic feasibility of extending the scheme. In view of experience with the present intake, the new one should be located at a stable site. The site selected by the District

From the bifurcation a branch canal would be required to join the existing furrow about 1 km downstream of the present intake, making a total length of 1.5 km. Within the existing irrigation area, control structures are required at the heads of all secondary canal offtakes and the repair or replacement of existing culverts is necessary.

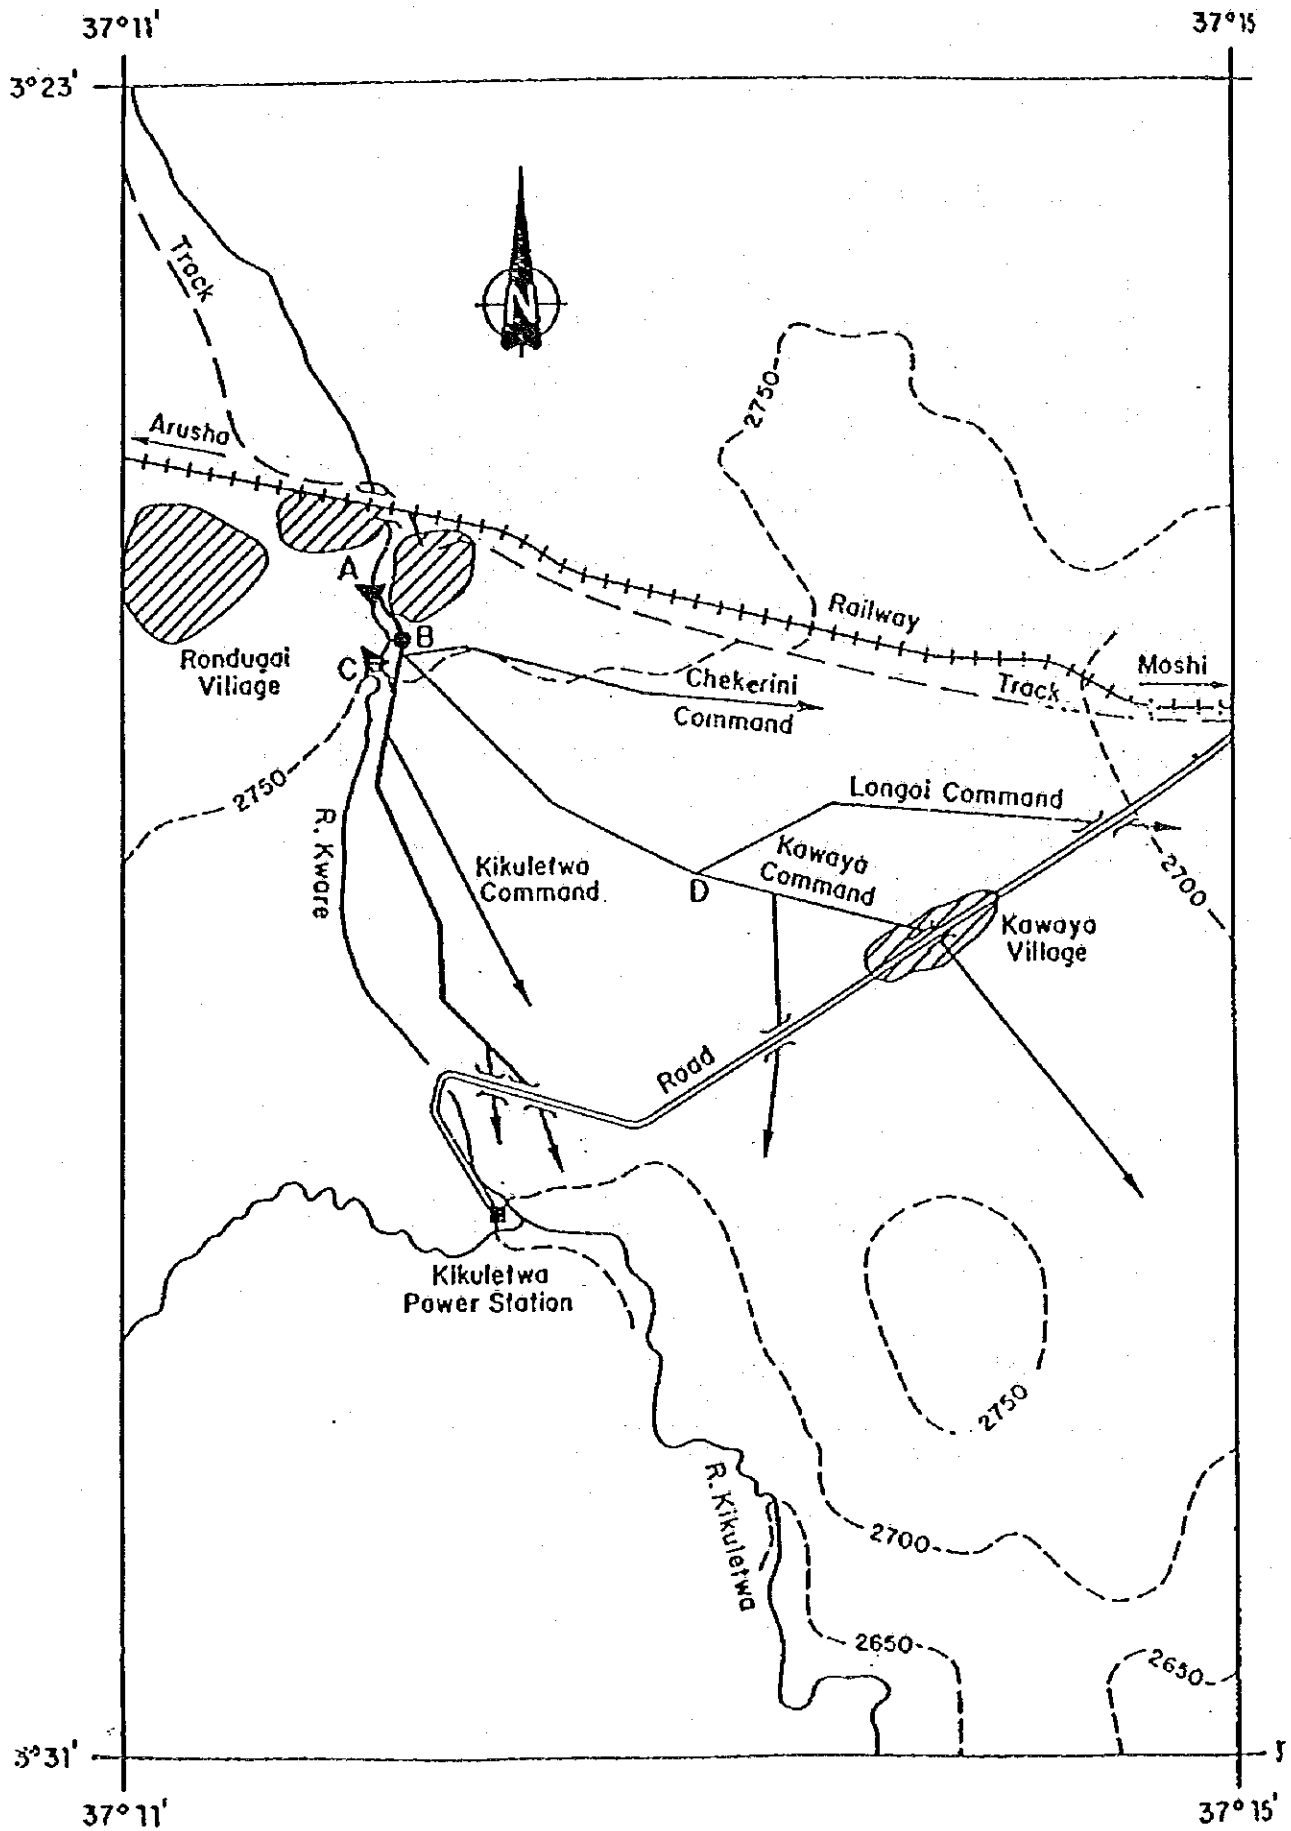
Fig. A3 APPROXIMATE LAYOUT - RONDUGAI SCHEME

Intake Works: The main Rondugai intake is a sophisticated structure comprising a 3 m high concrete weir of crest length approximately 15 m. The inlet works comprise a gated orifice into a 4 m wide concrete channel, the right wall of which is an escape spillway, discharging into and just downstream of the main weir stilling basin. The downstream end of this concrete channel is a concrete wall incorporating a second orifice. The main weir also incorporates a desilting gate at its centre. Due to flood damage the main inlet gate and desilting gate are no longer operable, and the inlet gate has been removed. Because of the absence of a gate on the orifice at the downstream end of the overspill section it has been impossible to control flows into the furrow and this has resulted in washouts of the main furrow. The stilling basin to the weir is not long enough and has been reportedly undercut and there is considerable erosion to the river channel immediately downstream.

The Ismaili intake is of simpler design, comprising a 15 m long concrete weir with a gated inlet. The inlet gate is missing and, as the stilling basin is not long enough, there is considerable erosion in the channel downstream.

Canal Headreaches: The headreach of the main furrow from the intake to the distribution box has been subject to considerable erosion, of both banks and bed, and repeated breaches of its right bank due to inflows exceeding its capacity. At the time of the visit the right bank had once again been breached and until this is repaired, no irrigation water will be available to the scheme. At present the furrow has a bed width of 4-5 m and has eroded to some 2 m below ground level, where its bed is cobbles and rock or boulder outcrops.

Secondary Canal System: The secondary canal system starts at the main distribution box (B on Figure A3) which is in extremely poor condition and has no gates. Consequently effective allocation of water to the branches is impossible. It was not possible to inspect the total length of the secondary system but spot checks showed the canals to be of irregular cross section with little command.

- Repairs to main intake, including provision of gates at inlet and orifice downstream of overspill section, extension of stilling basin, provision of gabion revetement to river channel downstream of stilling basin and minor repairs.
- Repairs to Ismaili intake, including provision of gate at inlet, installation of a second gated orifice and overspill section, extension of stilling basin, provision of gabion revetement to river channel downstream and minor repairs.
- Rondugai furrow headreach to be flumed in concrete/masonry to division box.
- Ismaili furrow headreach to be flumed in concrete/masonry to junction with Kikuletwa Branch.
- Main division box to be replaced with gated structure.

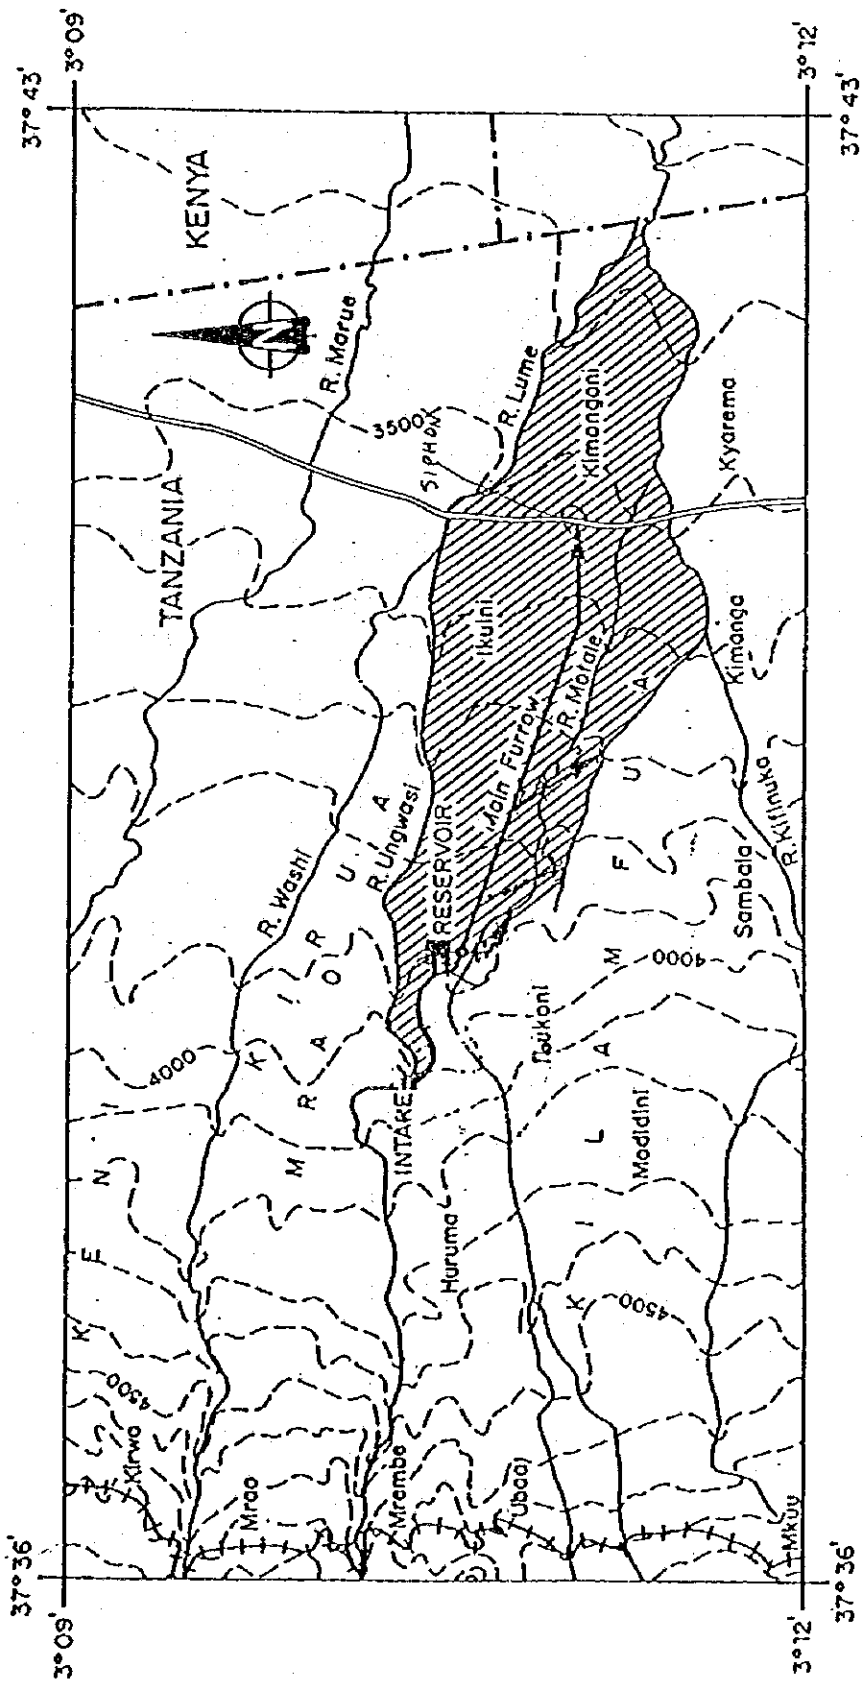
Fig. A9

Intake Structure: The river water level is controlled by a low weir of triangular cross section built on rock outcrops. Some seepage occurs under the structure but its stability is not threatened. The gated intake structure to the furrow is in satisfactory condition.

Reservoir: The reservoir is constructed on a slope, excavation from the upper slope being used for compacted earthfill to the embankments. The embankments appear in good condition with no evidence of seepage. The storage capacity is estimated to be about 5000 m³. Stilling arrangements at the intake are satisfactory but the outlet is controlled by a single sluice gate with no flow measurement device. It is therefore difficult to control the outlet discharge. No escape is provided, surplus water flows over the top of the outlet gate. The channel from the reservoir to the main division box is very steep and badly eroded.

Branch Canals: The Ikuini Branch has six offtakes, none of which are controlled, and irrigation to the east of the lower Rombo road is difficult because there is no road culvert. The upper Ibukoni Branch discharges into the Motale River, at a point where a weir has been built to retain the water. On the other bank an uncontrolled intake abstracts the water. This arrangement is extremely inefficient and the abstracting furrow suffers frequent flood damage. The lower Ibukoni Branch crosses the River Motale in an inverted siphon and divides to two uncontrolled tertiary branches.

- flume main canal for first 350 m
- line main canal for next 550 m
- line main canal around night storage reservoir
- provide stilling basin, measurement structure and flume on outlet from night storage reservoir
- replace present main division box with gated structure
- provide gated control for upper Ibukoni branch
- provide inverted siphon on upper Ibukoni branch crossing of River Motale
