EMBANKMENT SLOPE STABILITY CHECK TABLE

APPENDIX C

**QUANTITATIVE ANALYSIS OF
SELECTED ALTERNATIVE ROUTES**

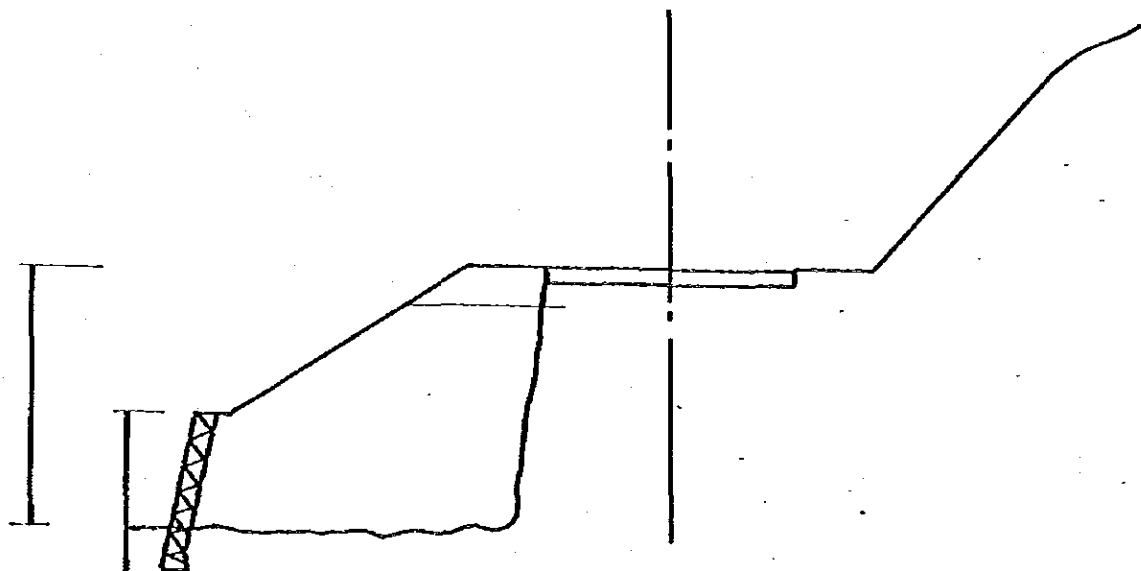
(C) KM 216 + 580 To KM. 218 + 000	L = 1,420m	
1) Drainage		(285.0 '000P)
Side Ditch 650m x 433.18 ^P		282.0 '000P
Clean and repair Existing Culvert		
4 pipes x 13.0m x 62.38 ^P		3.0
2) KM. 216 + 800	Shoulder Scorded	(475.0)
L = 160 m

Earth Work	$36 \text{ m}^2/\text{m} \times 160 \text{ m} \times 34.1^{\text{P}}$	196.0
Crushed Gravel Base Course	$3 \text{ m}^2/\text{m} \times 160 \text{ m} \times 115.43^{\text{P}}$	55.0
Stone Masonry H = 4 m	$160 \text{ m} \times 14000^{\text{P}}$	224.0
