THE RAMA VI BRIDGE CONSTRUCTION PROJECT

SUPPLEMENTARY REPORT

**Strengthening and Rehabilitation
for Krung Thon and Krung Thep Bridges**

MARCH 1982

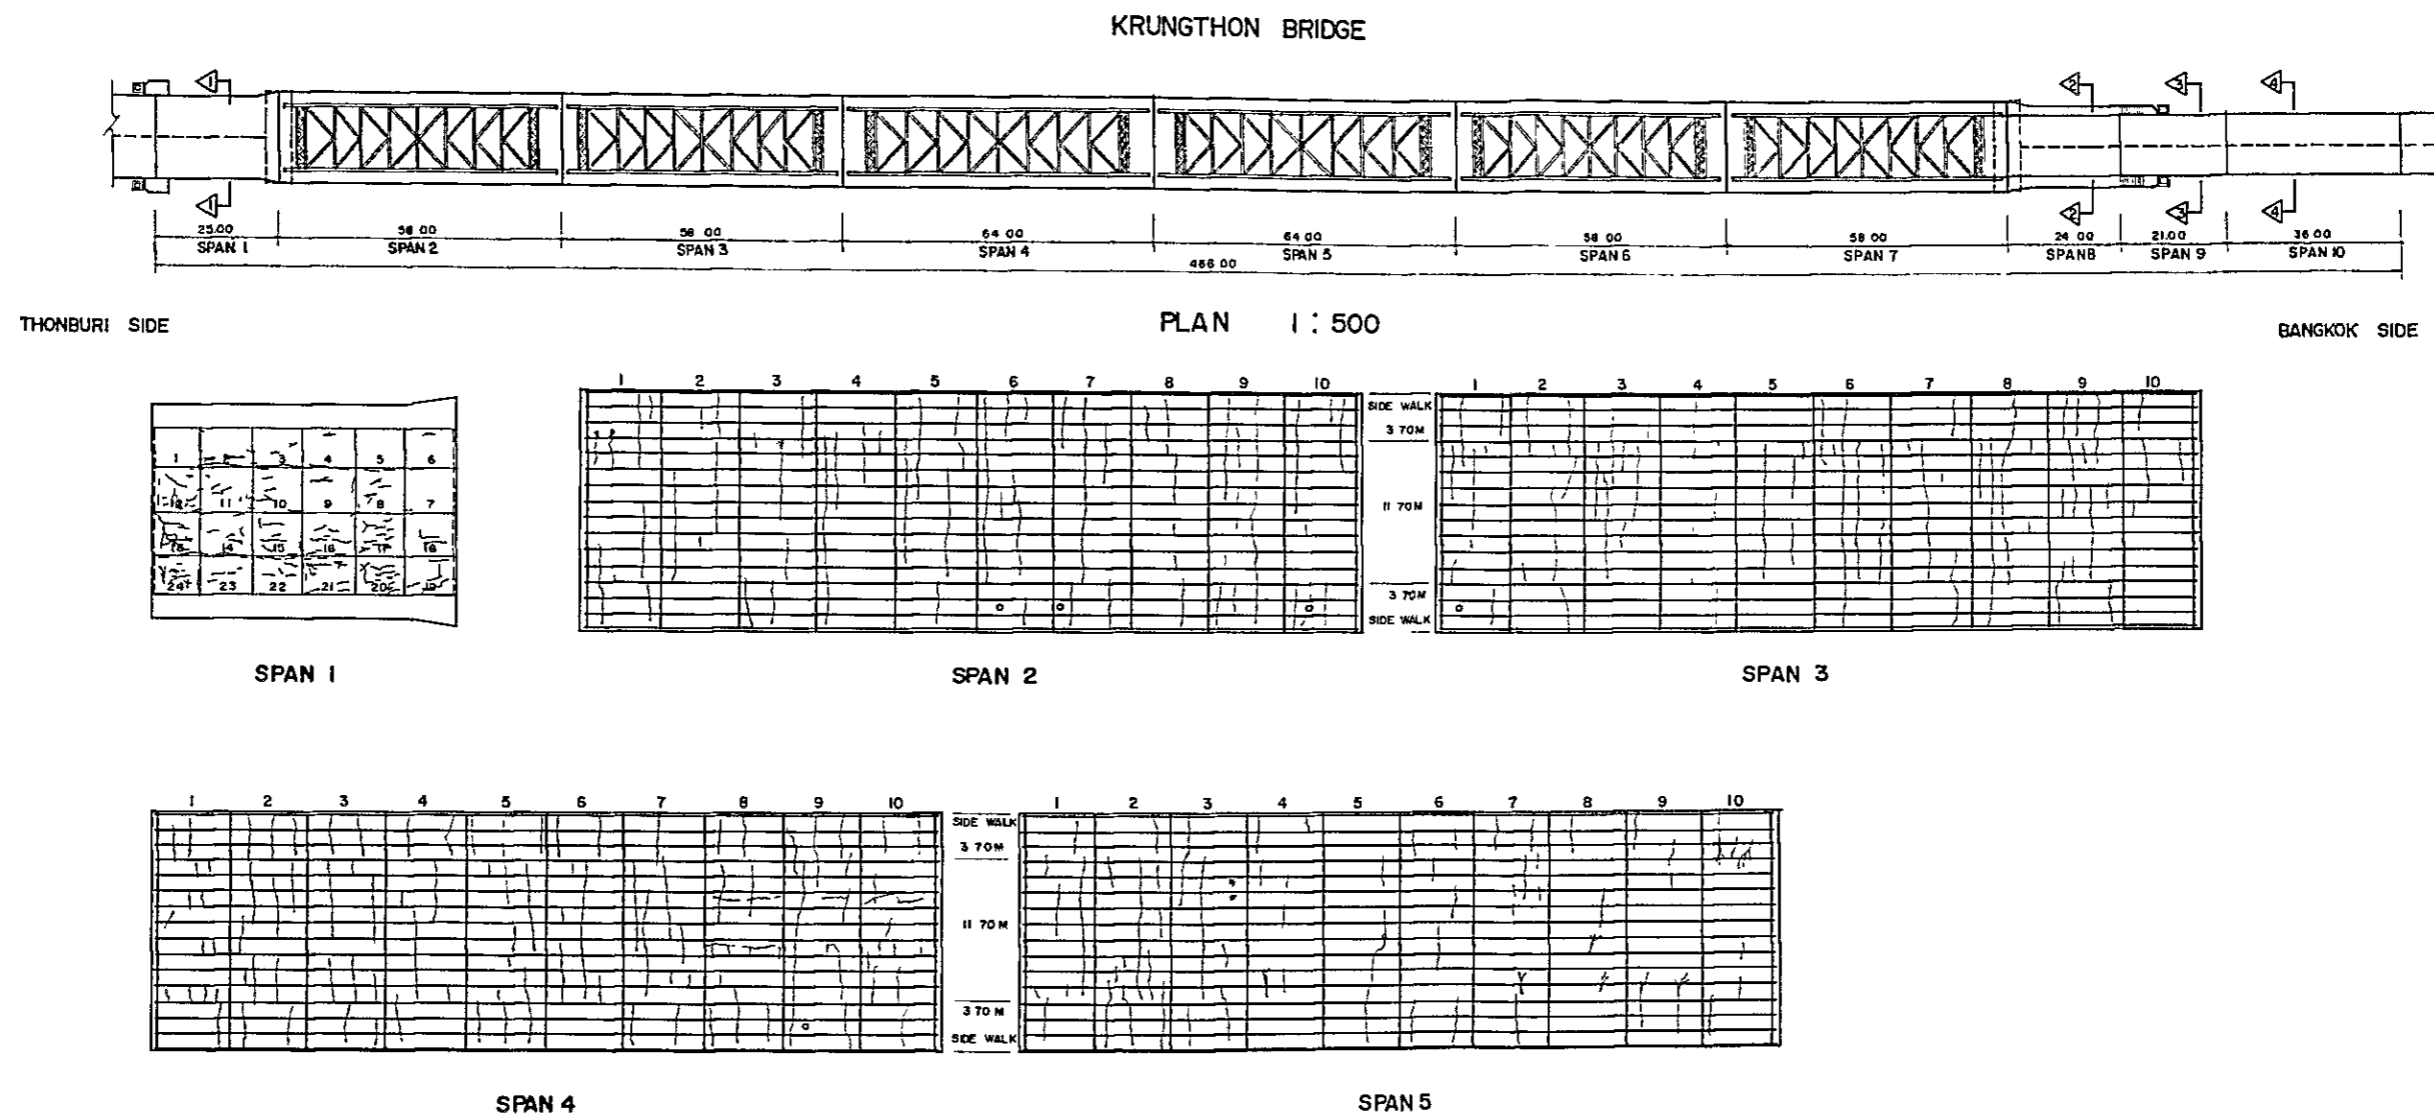
Fig. 3-3.2 CRACKS DEVELOPED ON THE CONCRETE FLOOR SLABS OF THE
MAIN AND APPROACH BRIDGE — KRUNG THON BRIDGE

As shown in Figure 3-3.2 through Figure 3-3.5, the concrete block pavements on the footpath of the KRUNG THON Bridge and KRUNG THEP Bridge present cracks everywhere, but they do not cause hindrances to the pedestrian flow. (Refer to Photo 3-1.3 through Photo 3-1.6).

The results of examination of the cracks taking place in these RC slabs are shown in Figure 3-3.2 and Figure 3-3.3.

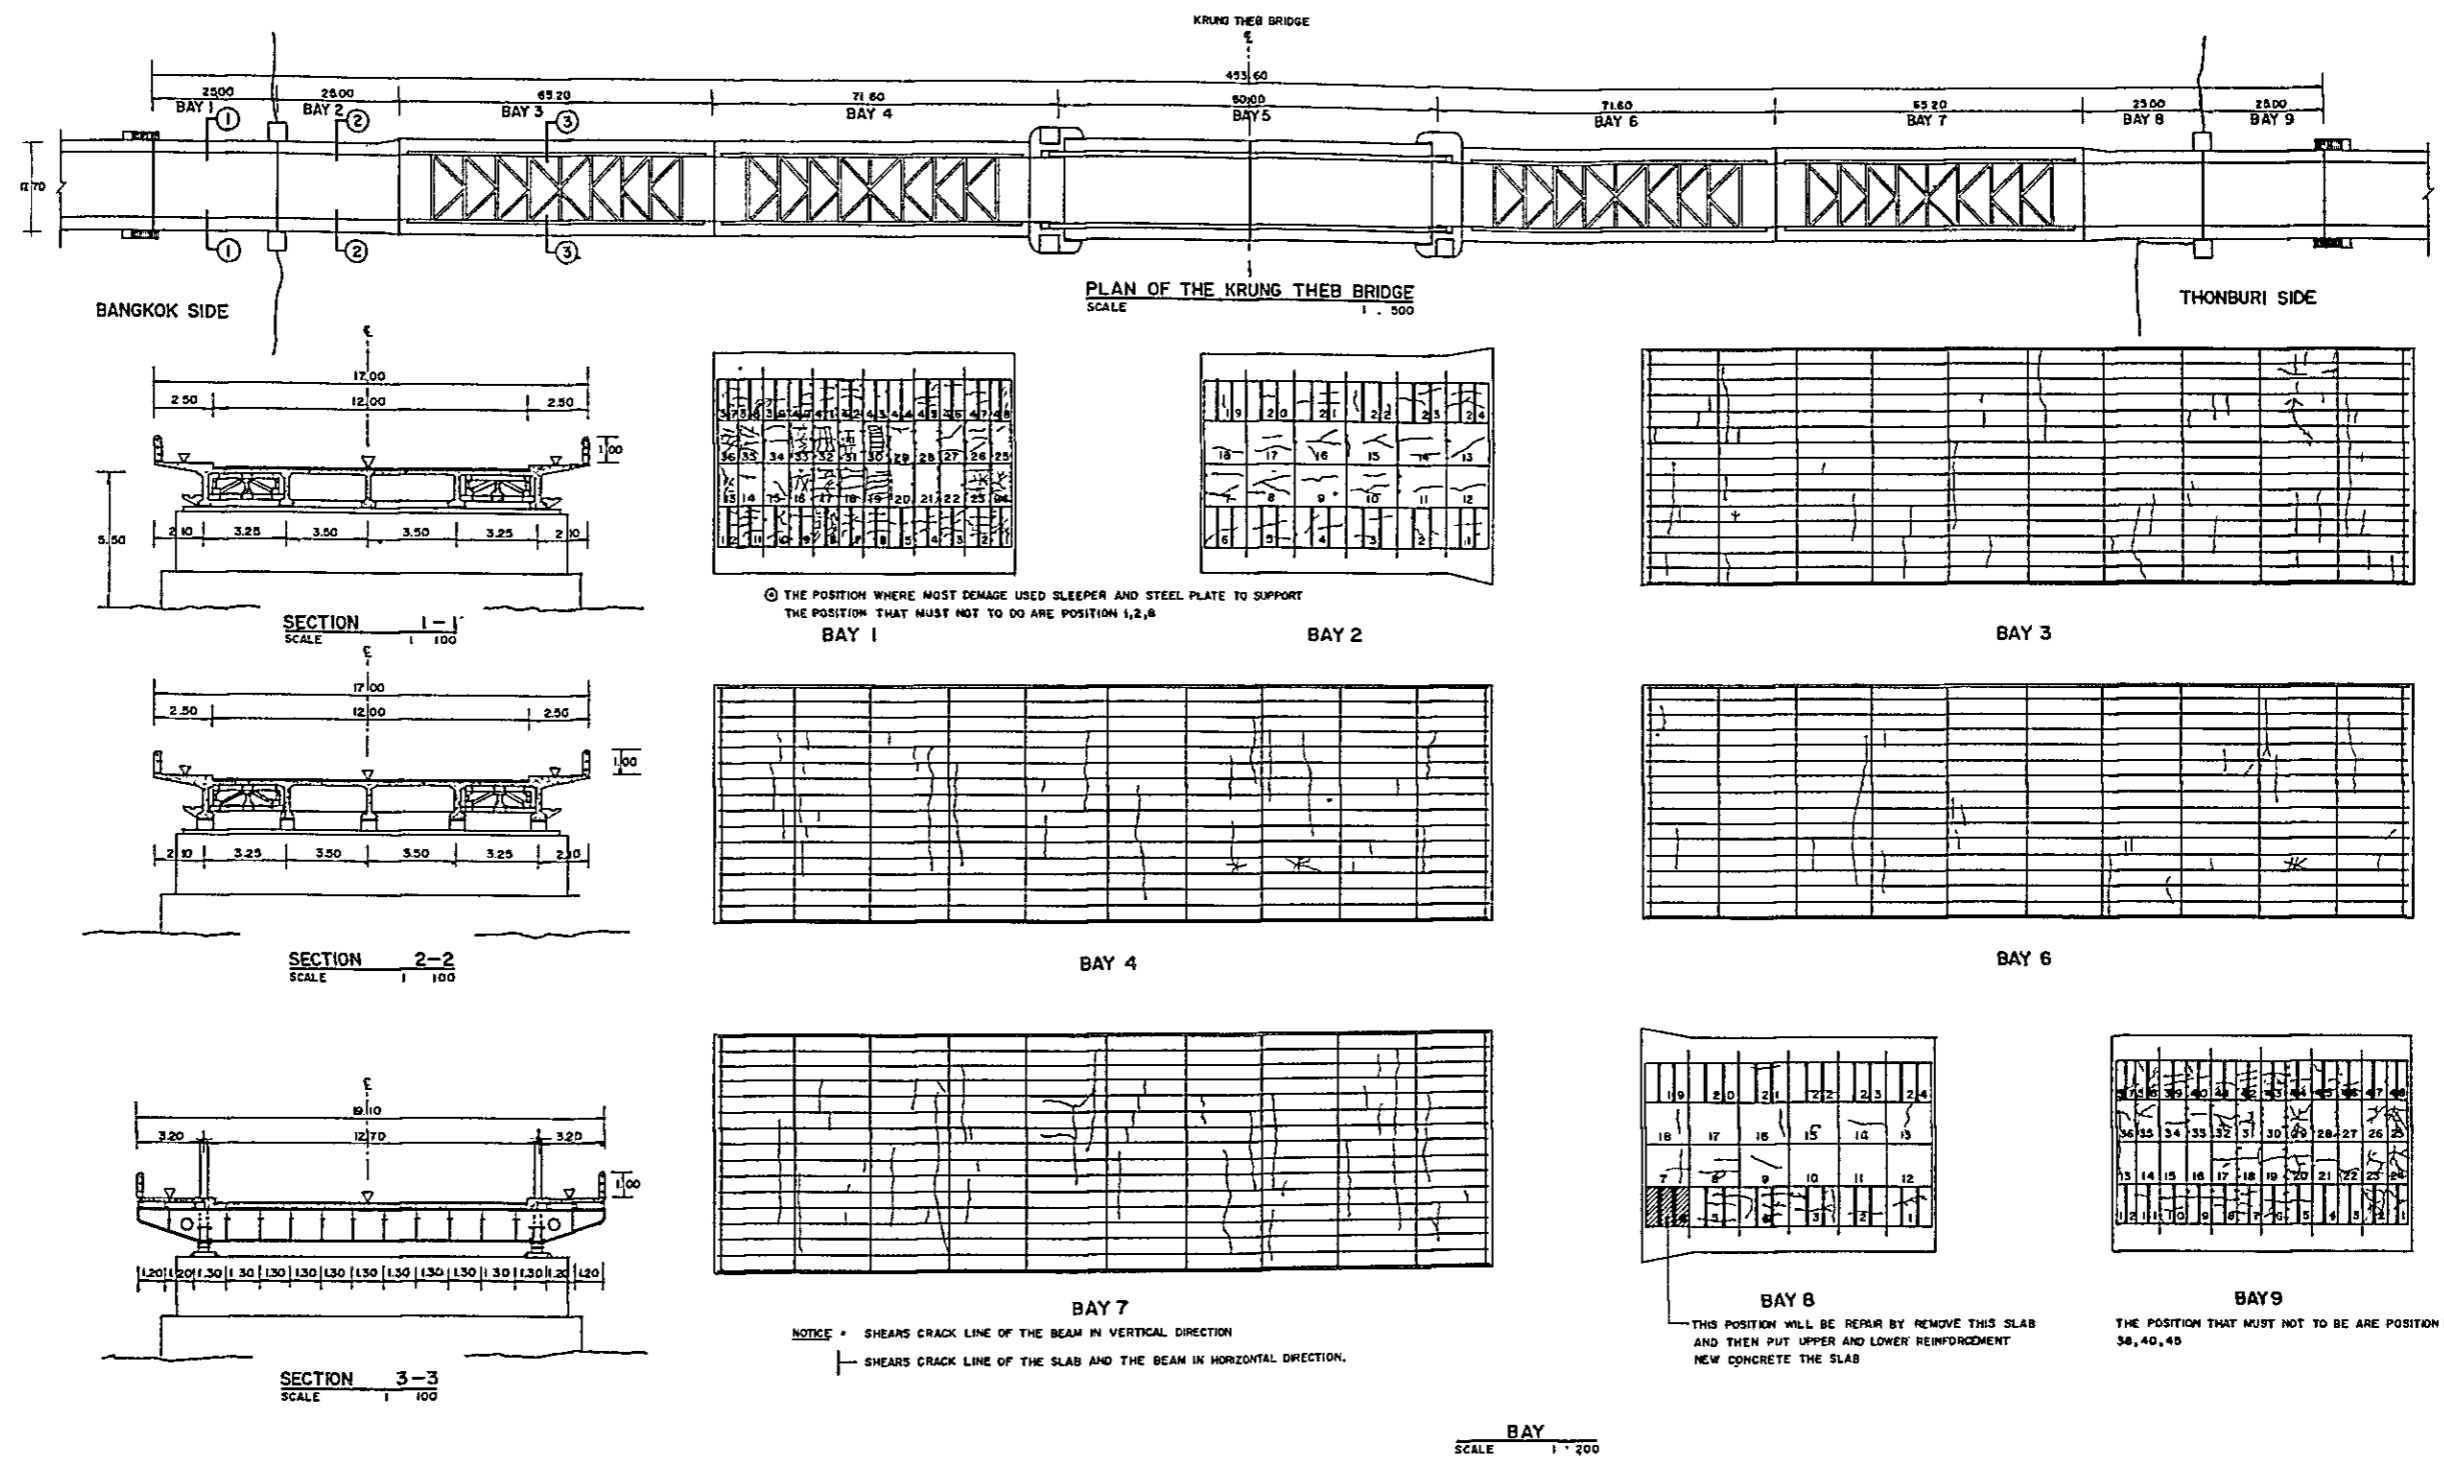
Fig. 3-3.4 CRACKS DEVELOPED ON THE CONCRETE FLOOR SLABS OF THE MAIN AND APPROACH BRIDGE — KRUNG THEB BRIDGE

The results of the examination of the cracks taking place in these RC slabs are shown in Figure 3-3.4. The fine "net" of cracks has developed particularly at the 1st span at both sides for about 13 years. Accordingly, as shown in Figure 3-3.1 and Figure 3-3.4, cross beams have been provided between the originally existing cross beams,

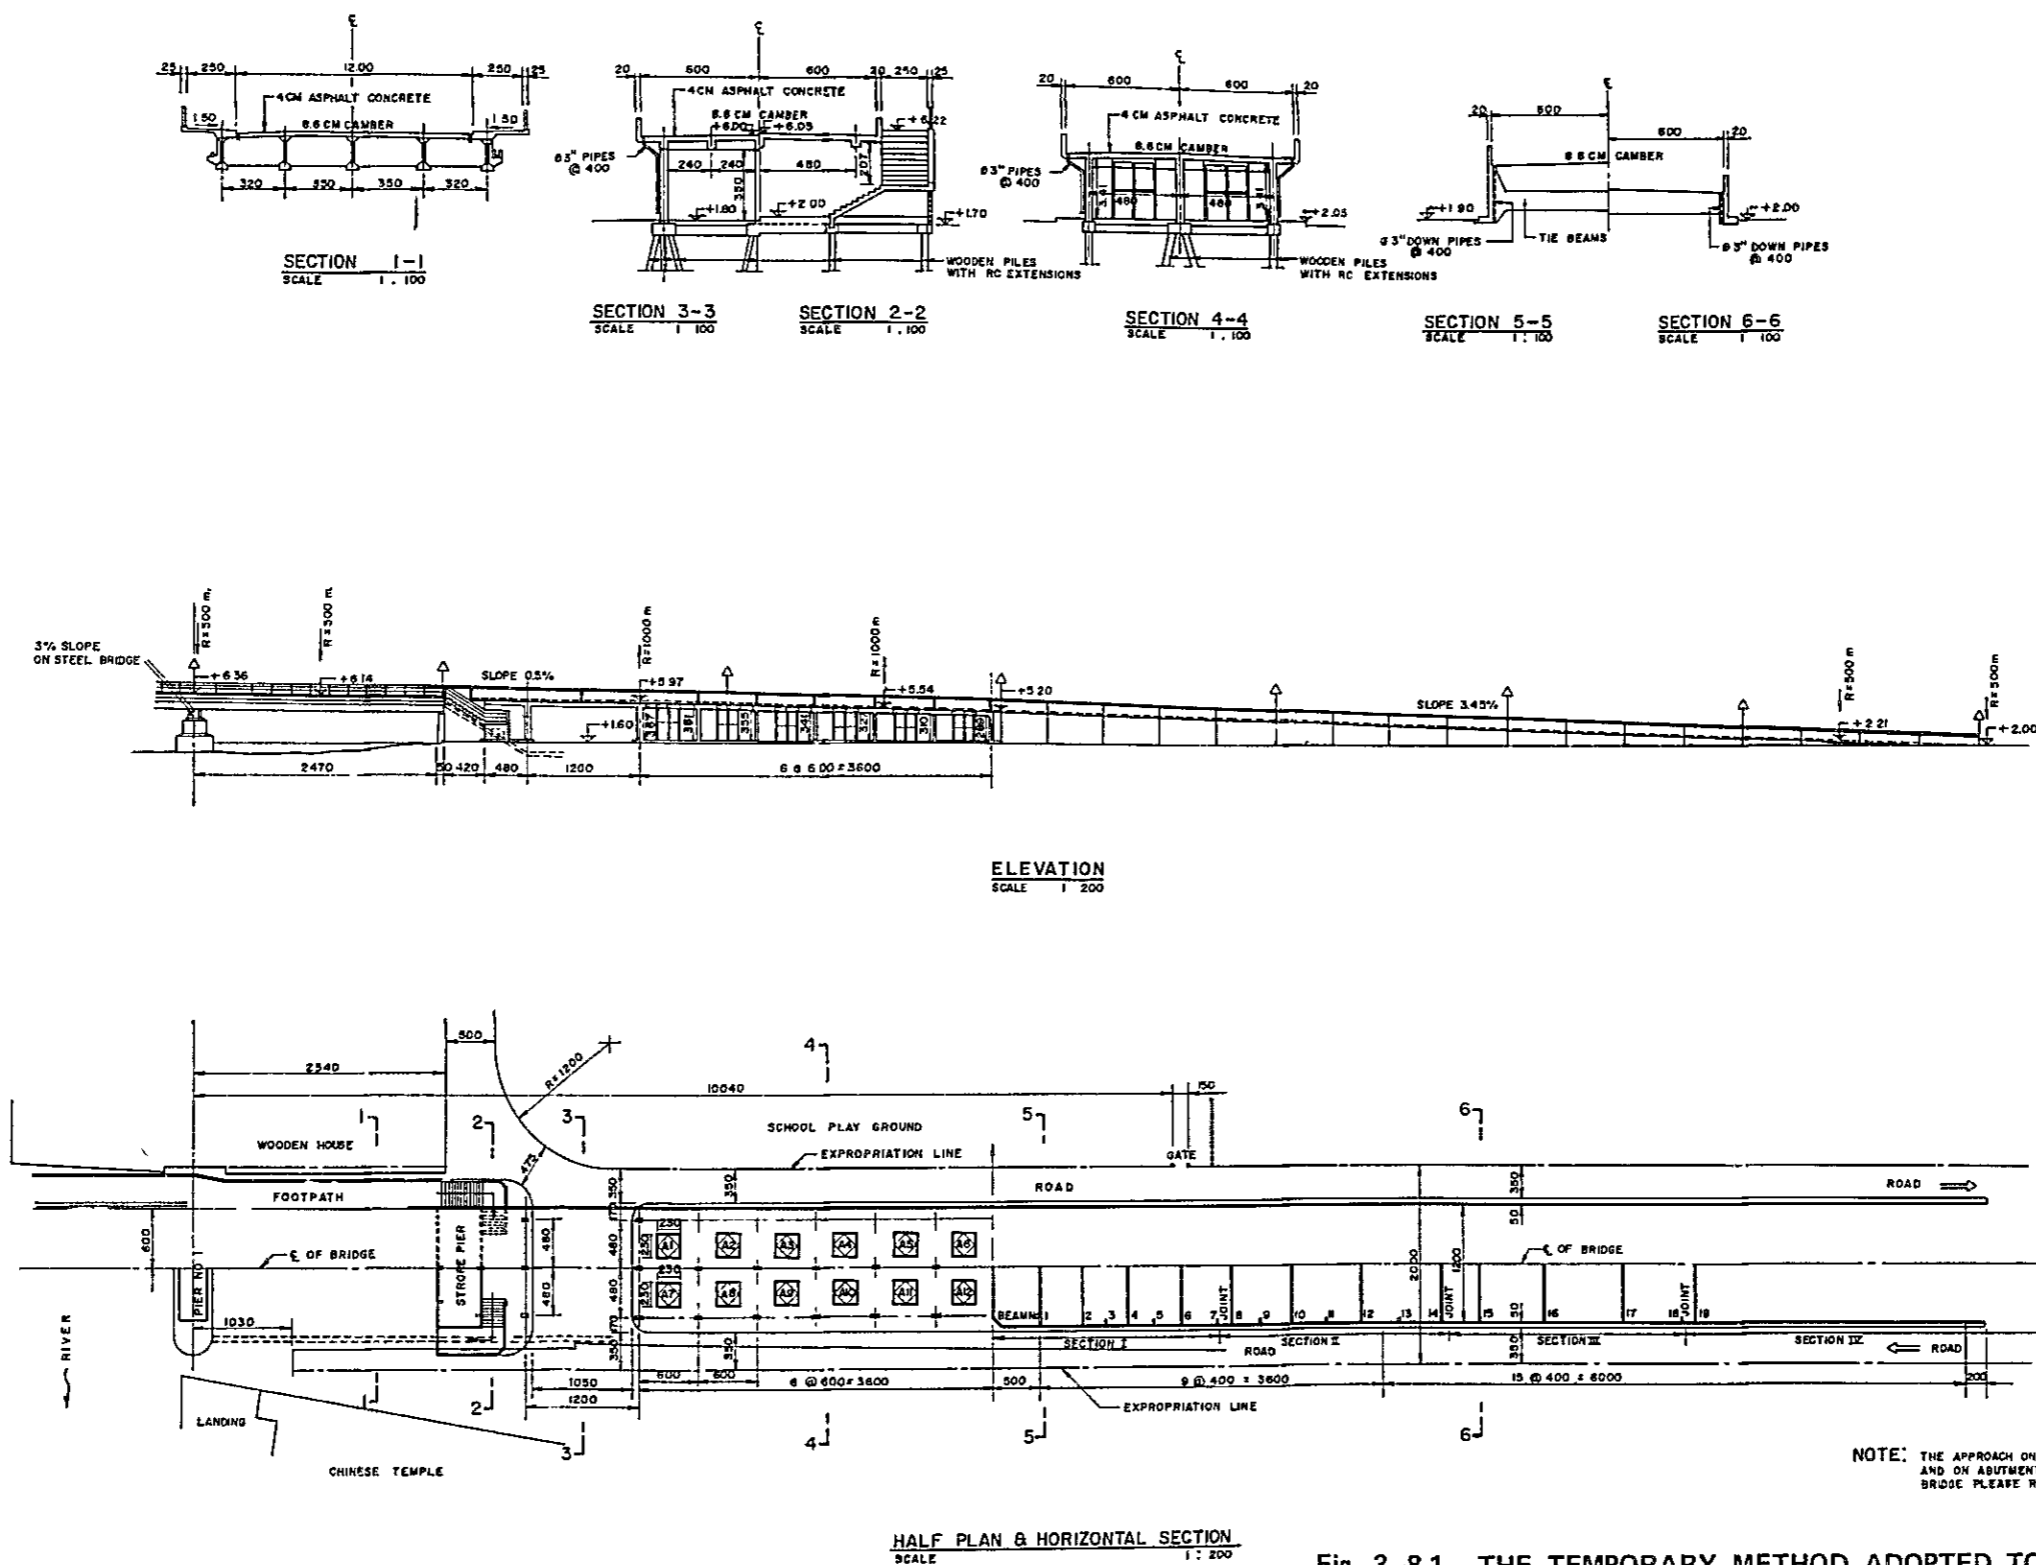
Fig. 3-8.1 THE TEMPORARY METHOD ADOPTED TO STRENGTHEN THE CONCRETE FLOOR SLAB OF THE APPROACH BRIDGE — KRUNG THON BRIDGE

Particularly the RC-T-rigid-frame beams extending over 6 continuous spans have a slab thickness of only 20 cm which is very slender compared with the spacing of 4.800 M between the main beams as shown in Fig. 3-8.1. The cracks taking place in that section are quite serious, forming a fine "net" of cracks. The said part of the bridge is in a dangerous state, and at the end of August, 1981, supports were provided temporarily as shown in Fig. 3-8.2, aiming at preventing peeling off. (Photo 3-8.1 through Photo 3-8.6)

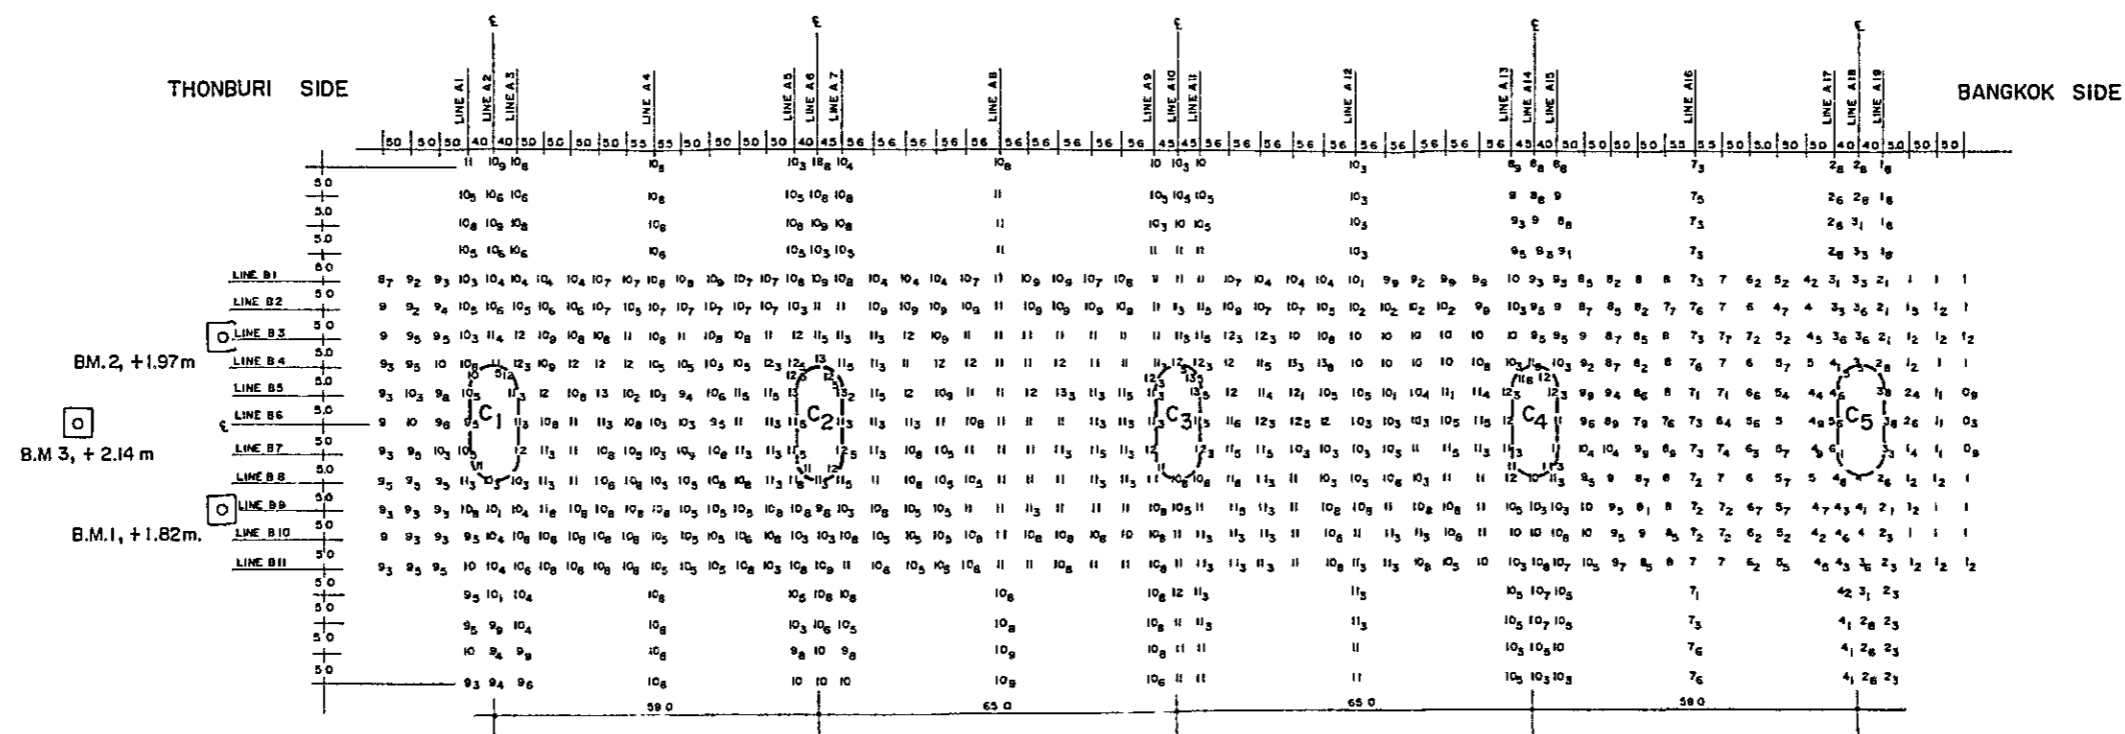
Fig. 3-9.3 SPOT ELEVATION ON CHAOPHRAYA RIVER
UNDER THE KRUNG THON BRIDGE

As for the river bed scouring at the foundations, the results of the examination carried out approximately 2 years ago are shown in Figure 3-9.3 through Figure 3-9.12. (Refer to Photo 3-9.1 through Photo 3-9.4).

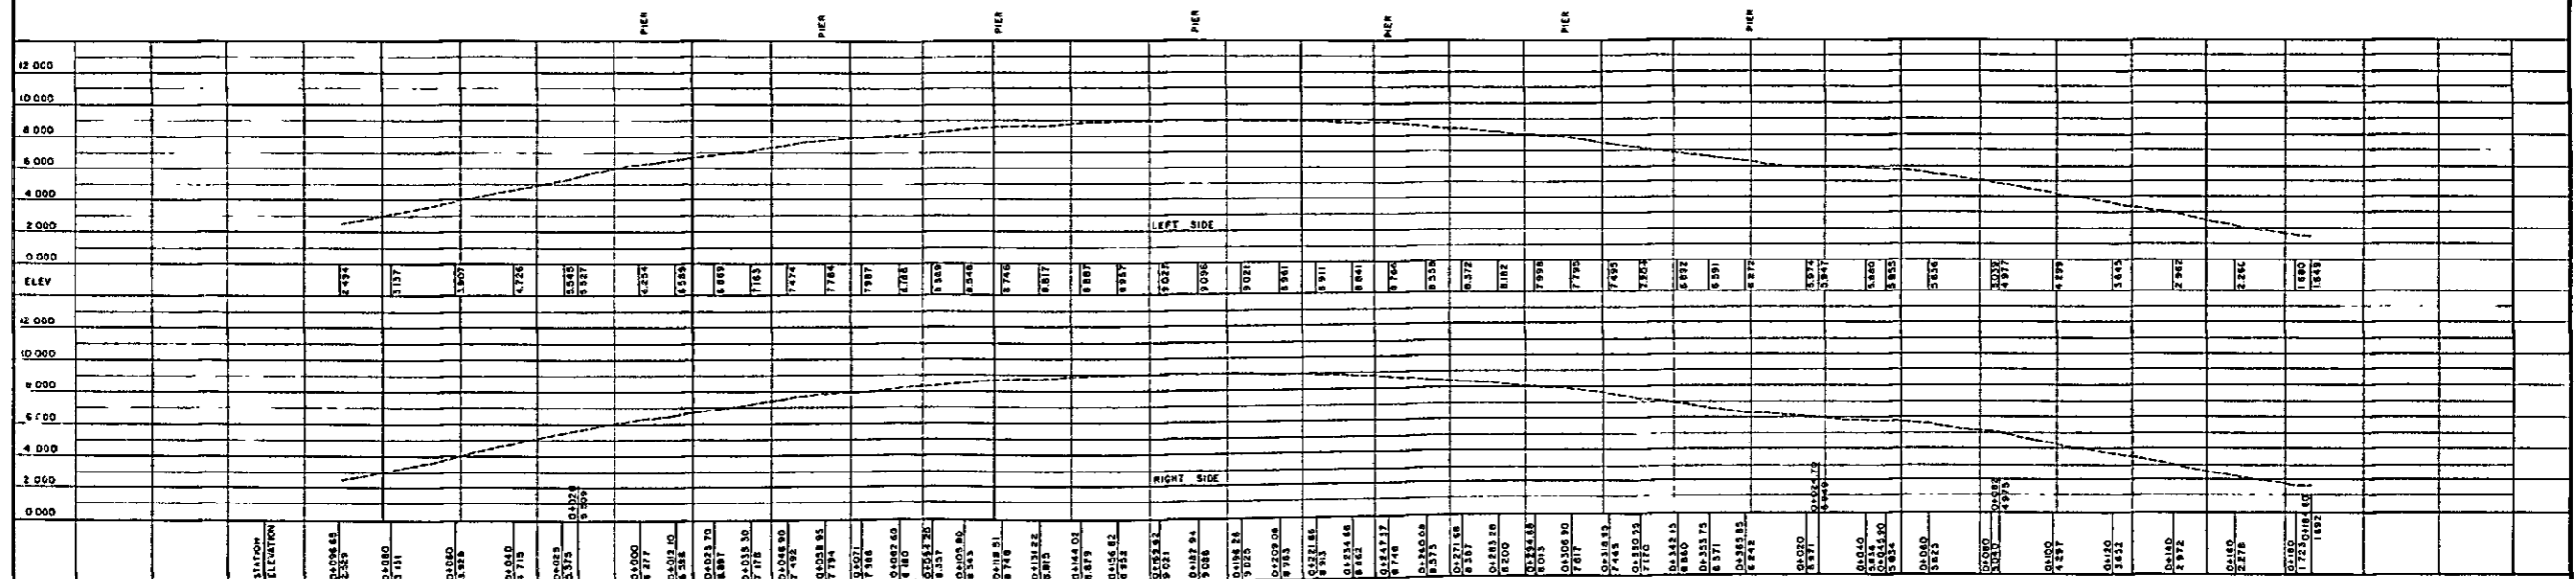
Fig. 3-9.13 LONGITUDINAL ELEVATIONS ON THE CURBSTONE OF THE ROAD SURFACE - KRUNG THON BRIDGE

Longitudinal cross section surveying was carried out aiming at investigating the unequal settlement of the foundations, but the obtained results shows that no remarkable unequal settlement of piers is taking place. (Refer to Figure 3-9.13 and Figure 3-9.14).

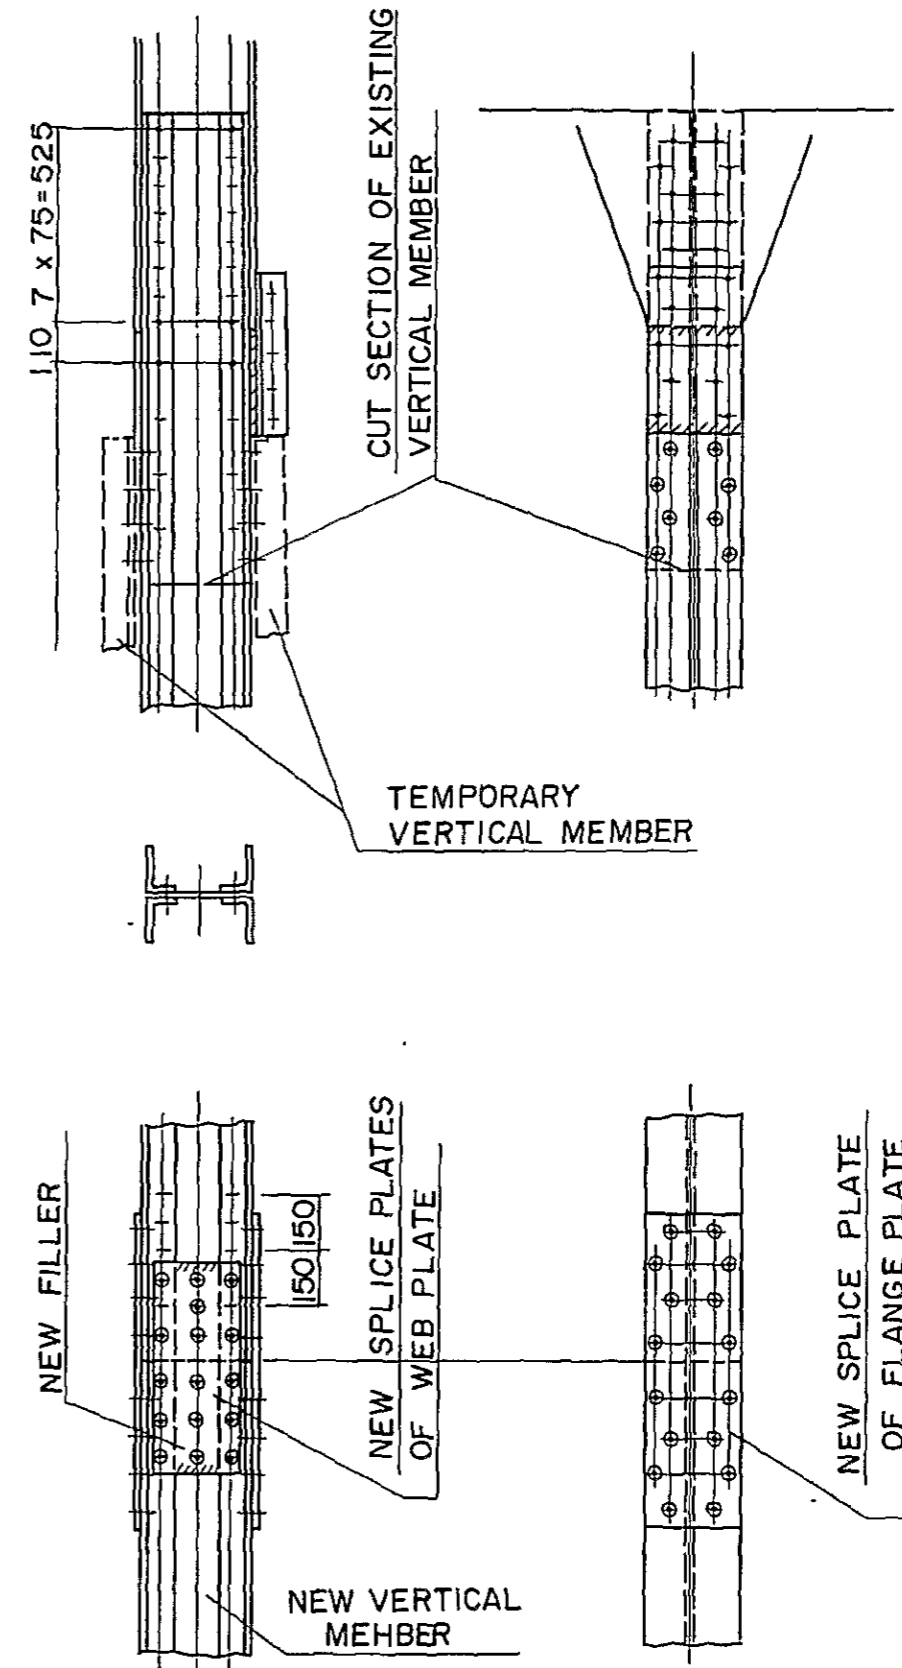
Fig. 6-2.4 CHANGE OF VERTICAL MEMBER

Also in the KRUNG THEP Bridge, a pronounced twisting of the vertical member caused by a vehicle collision was observed at the Thonburi Side.
