LIGHT VEHICLES MANUFACTURING FACILITY

3-1 Painting and Light Vehicles Assembly Shop

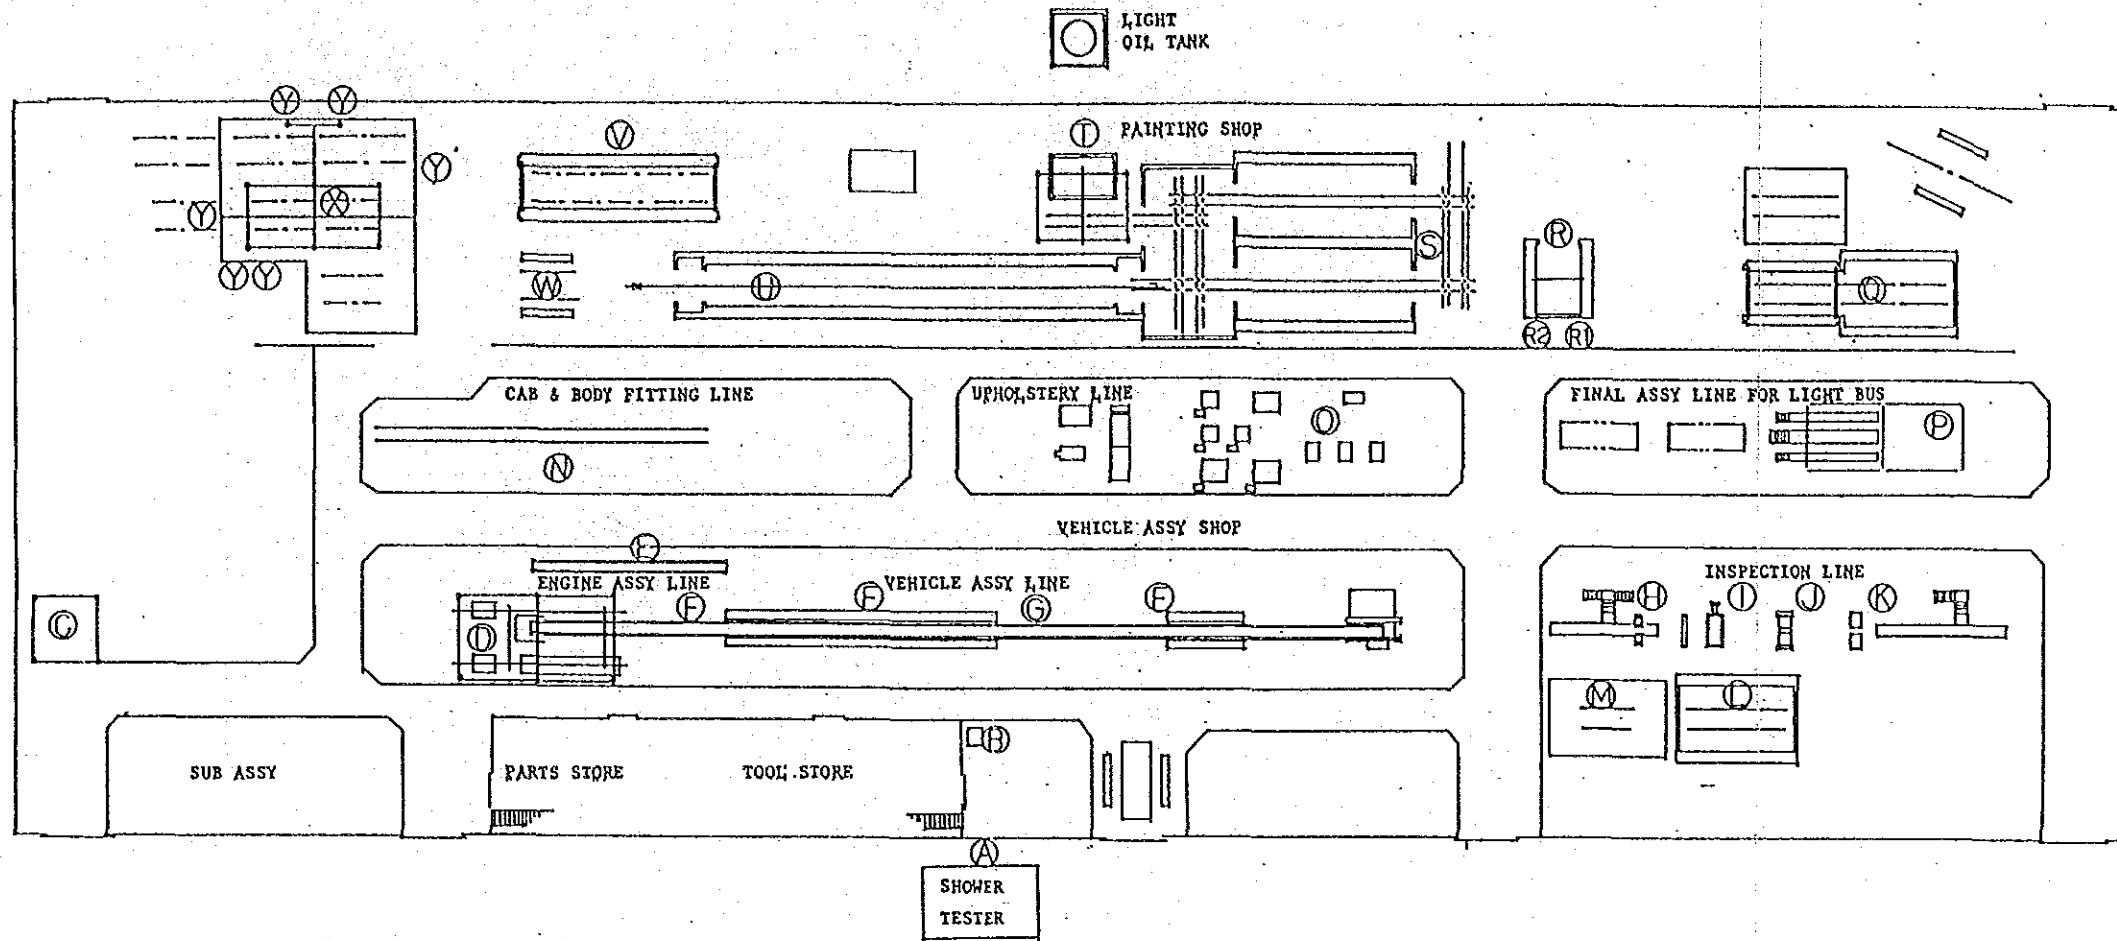
Figure AI-3-1-1 LAYOUT OF PAINTING & VEHICLE ASSEMBLY SHOP

Co de	Equipment	Qty	Condition			Remarks	Co de	Equipment	Qty	Condition			Remarks	Co de	Equipment	Qty	Condition			Remarks
			De-terio-ration	Failure	Idle					De-terio-ration	Failure	Idle					De-terio-ration	Failure	Idle

(A)	Shower Tester	1		X		Water pump damaged and removed.	(K)	Speed Meter Tester	1		X		Free roller lift is malfunctioning so that removal of vehicle is difficult.	(S)	Painting Booths	1				Water circulation pump in preparation area is out of service.

(B)	Wheel Balancer DWB-4500	1			X	Accuracy is not known.	(L)	Spraying Booth	1		X	X	Filter on the wall is missing.	(T)	Dipping Tank & 0.5 Ton Hoist	1			X	Out of service. "R" is being used for black painting of frame.

(C)	1 Ton Hoist & Gantry	1	X			Wire rope wires are broken.	(M)	Infrared Lay Dryer	4				Two each bulbs are off.	(U)	Drying Oven	1	X			Wall partially damaged, rust and holes on duct, fan belt is missing.

(D)	0.5 Ton Hoist & Gantry	1	X			Magnet starter is repaired temporarily, with broken wire cover or without wire cover.	(N)	Roller Conveyer for Cab & Body Complete	1					(V)	Ditto Illumination	4			X	Fluorescent lamps are removed. Structure is idle.

(E)	Roller for Engine Complete Assy	1			X	Removed.	(O)	Sewing Machine	8		X(3)		Three sets are failed from deterioration but no spare part is available.	(W)	1 Ton Hoist & Gantry Surface Treatment Area	1			X	Filter on the wall is removed.

(F)	0.5 Ton Hoist & JIB Crane	3	X			Wire ropes are with broken wires or twisted.	(P)	2 Ton Hoist & Gantry	1			X		(X)	Phosphating Treatment	6			X(5)	Burner, nozzle, etc. are failed and removed.

(G)	Slat Conveyer	1				No Lubrication on chain, Driving gear, etc.	(Q)	Spraying Room & Drying Oven	1		X	X	Drying oven burner is removed and missing.	(Y)	Hand Truck for B600 Box, 2050X900	8			X(3)	Wheel and axle are failed.

(H)	Head Lamp Tester	1		X		Condenser of light lay can not be adjusted.	(R)	0.5 Ton Hoist Vibration Paint Booth	1	X			Booth wall around filter is damaged.	(Z)	Ditto for X2000 BODY 3150X900	28			X(7)	Wheel and axle are failed.

(I)	Slide Slip Tester	1					(S)	Paint Mixer & Pump	1	X			Vibration painting machine capacity decreased.							
(J)	Brake Tester	1		X		Indication of meter is not constant.	(T)	Control Panel	1		X		Damaged.

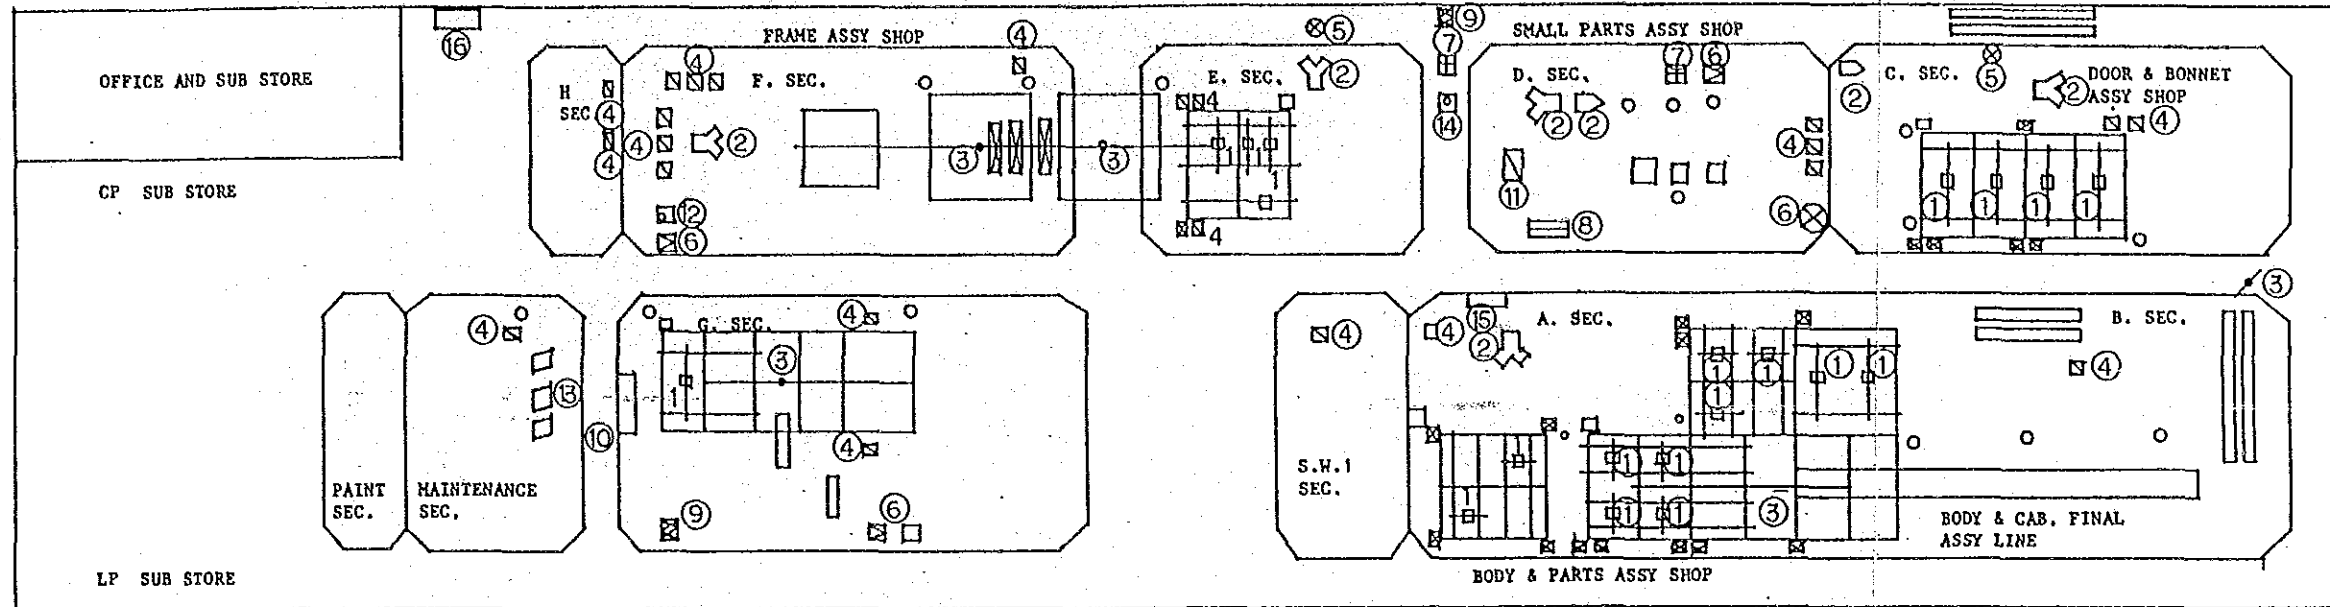
Figure AI-3-2-1 NO.4 HEAVY INDUSTRY BODY ASSEMBLY SHOP EQUIPMENT LAYOUT

No.	Equipment	QTY	Condition			Remarks
			De-terio-ration	Failure	Idle	
①	Portable Spot Welder	20	x(20)			Spare parts for ignition control, printed circuit board and others are missing.
②	Stationary Spot Welder	6		x(2)		
	Single	(2)				
	Double	(4)				
③	Hoists	5		x(1)		Magnet switches of jlg cranes in body complete pool are wrong.

0.5 Ton	(4)				
	1 Ton	(1)				
④	ARC Welder	22	x(6)			Noise and drop of performance: 2- in Sec. A, 1 in Sec. C, 3 in Sec. F Burnt motor and drop of performance in Sec. D in Sec. D & F
⑤	Bench Drill	3	x(1)	x(1)		
⑥	Upright Drill	3	x(2)			
⑦	Grinding Machine	2				
⑧	Pipe Bending Machine	1	x(1)			Inferior profile of bent parts
⑨	High Speed Cut-Off Machine	2				
⑩	Shearing Machine	1	x(1)			Inferior Performance. Clearance between upper and lower blades enlarge in operation
⑪	Seam Welding Machine	1				
⑫	Hydraulic Press	1				Sec. F
⑬	80 Ton Crankless Press	3				
⑭	Vibro-shear	1				
⑮	Bending Machine	1	x(1)			Insufficient bending capacity
⑯	Surface Plate, 2400 x 1200	1			x(1)	
	Transformer NH2-75-MB for portable spot welder(PSW)				x(6)	Cannot be combined with PSW as the model is obsolete

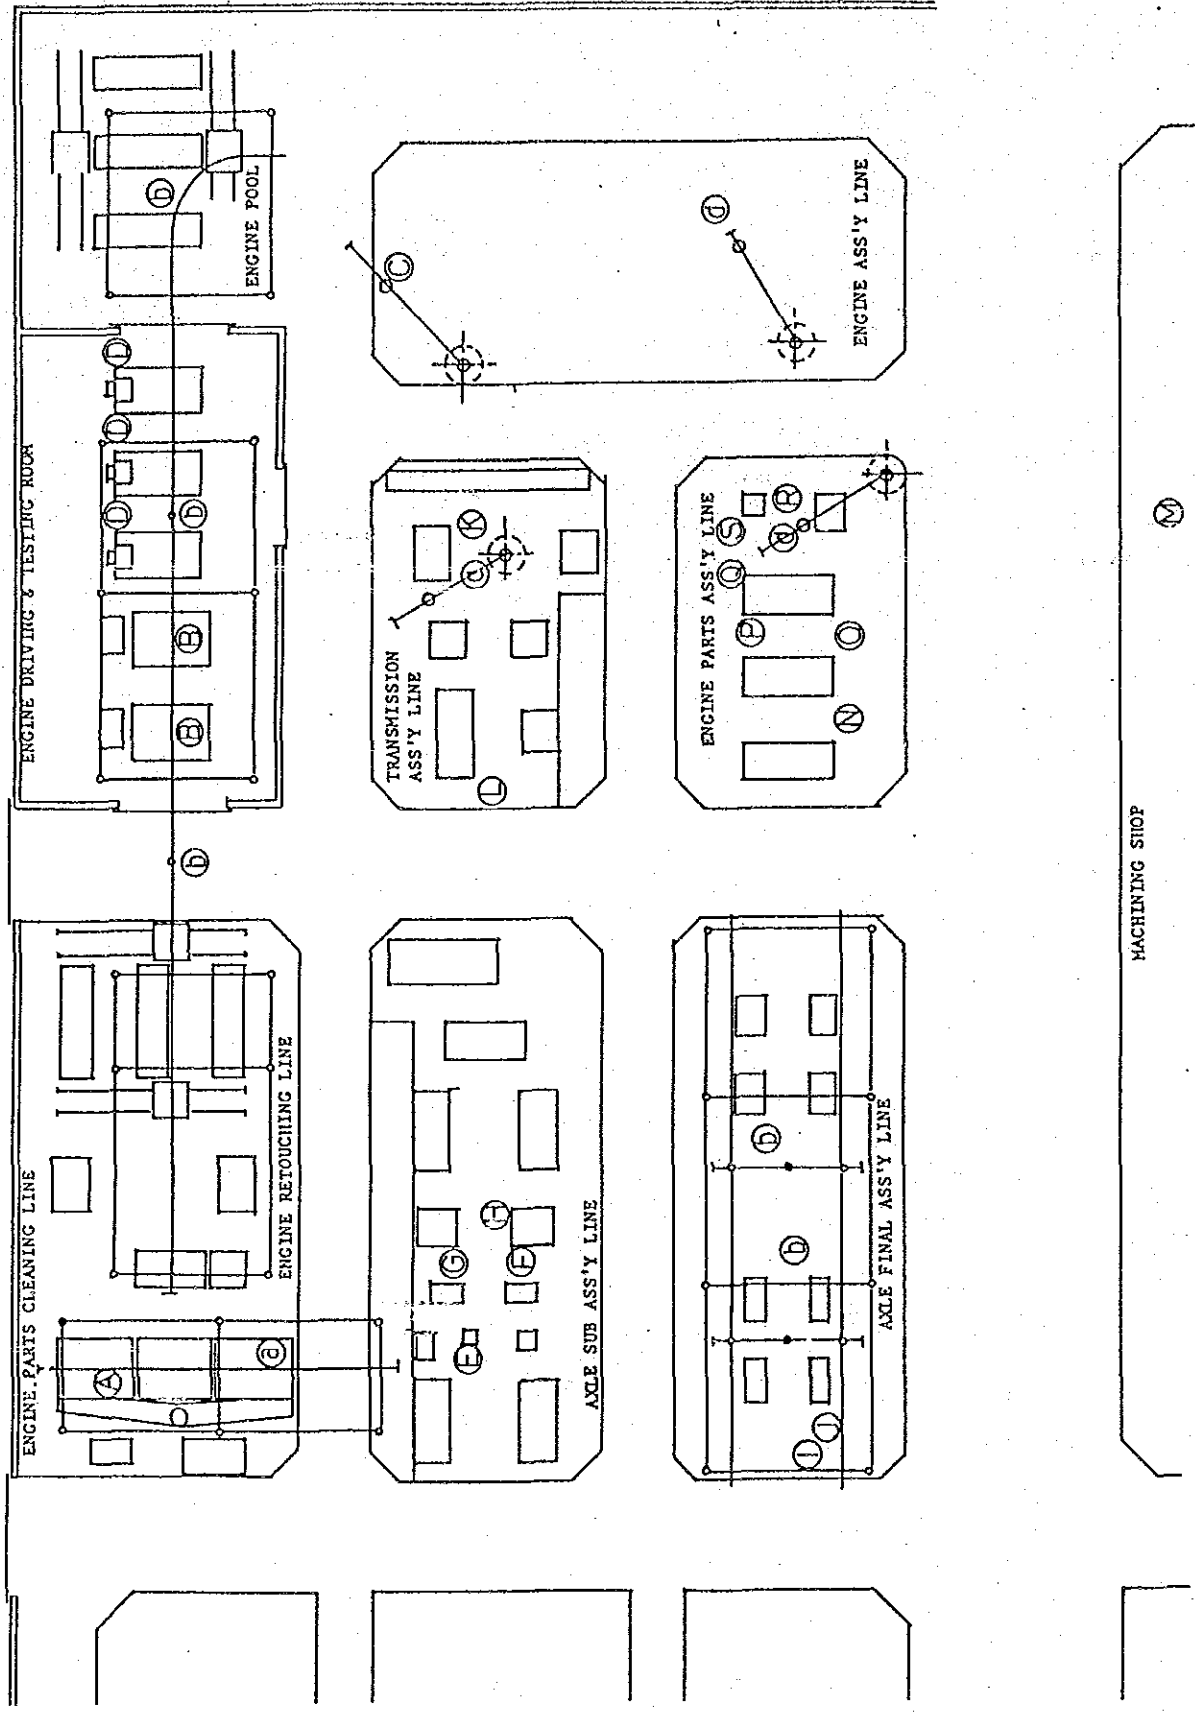
Figure AI-3-3-1 NO.4 HEAVY INDUSTRY MACHINE SHOP LAYOUT OF ASSEMBLY SHOP

No.	Line/Equipment	Qty. Unit	Condition		Remarks	Out of Service	Remarks
			Partly Damaged	Out of Service			
1	Axle Sub-Assy Line	1			B600 differential gear carrier CPT & X2000 F&R axle		
	TKK Hydraulic Press	1			Pressing bearing case in dif. gear carrier		
	TKK Leak Tester	1			Testing leakage of wheel cylinder		
	Adjusting Eqmpt for Drive Pinion Mounting Distance	1			For X2000 dif. gear carrier		
	Ditto	1			For B600 dif. gear carrier		
2	Axle Final Assy Line						
	Gantry & 1/2 Ton Hoist	2					
	Injection Press for Propeller Shaft Searing	1			B600 2783 25 960		
	TKK Hydraulic Press	1			For caulking		
3	Transmission Assy Line						
	Jig Hoist 1/4 Ton	1			Transferring transmission to the next step		
	Running-in Equipment	1			Manufactured by HIC		
	TKK Hydr. Press	1			Injection of B600 valve guide and transmission housing bearing		
4	Engine Parts Assy Line						
	Jig Hoist 1/4 Ton	1			For B600, X2000 & T2000

8	Engine Retouching Line						
9	Engine Parts Cleaning Line						
	Parts Cleaning Equipment	1					x(1) Service has been discontinued since the beginning of Project due to cleaning liquid shortage
	Gantry and 1 Ton Hoist	1
