**ANGAT DAM REHABILITATION PROJECT**

**SUMMARY**

**MARCH 1989**

**JAPAN INTERNATIONAL COOPERATION AGENCY**

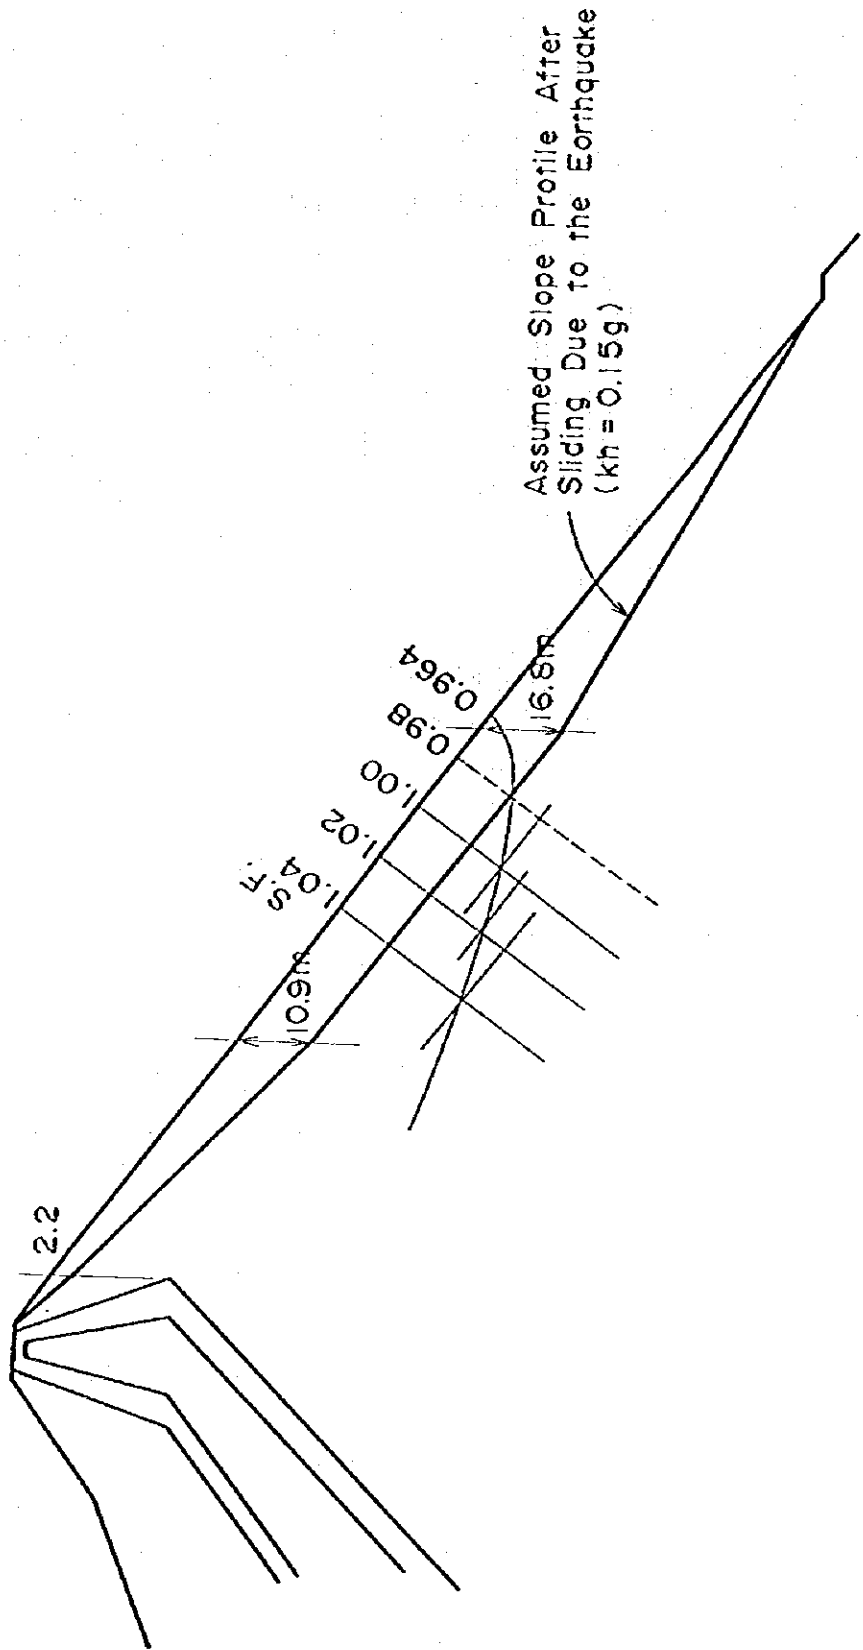
Fig. 2.4

The safety factor against sliding of the downstream face slope would be larger than 1.2 in static condition, when assuming  $\phi$  value of the rockfill materials is  $43^\circ$ , but would come down to 0.964 or smaller than 1.0 under the loading conditions with the earthquake with  $K_h$  of 0.15 g. The sliding, if happened, however, would be limited only to the portion close to the slope surface of the dam. Though it may not necessarily be said that the slope is absolutely safe against any large earthquake, the occurrence of such earthquake may not lead to a disruption of the dam. The stability analysis of the slope profile after removing the earth slidden due to the earthquake indicates that the safety factor against further sliding would be 1.0 in static condition. (Refer to Fig. 2.4.)

Change By Depth in the Safety Factors  
Against Sliding of the Downstream Face  
Slope of the Main Dam During Earthquake  
( $\phi$  Value of Rockfill Materials Assumed at  $43^\circ$ )

The pertinent conclusion from the above analysis is that it is not necessary to do anything to the existing Angat dam structures under the present circumstance, and any rehabilitation work should be implemented only when a large  $K_h$  earthquake would occur, and unfortunately, it would cause any surface layer sliding on the downstream face of the dam. The dam stability may be retained by rebuilding the embankment to make the gradient gentler (from 1:1.4 to 1:1.46).

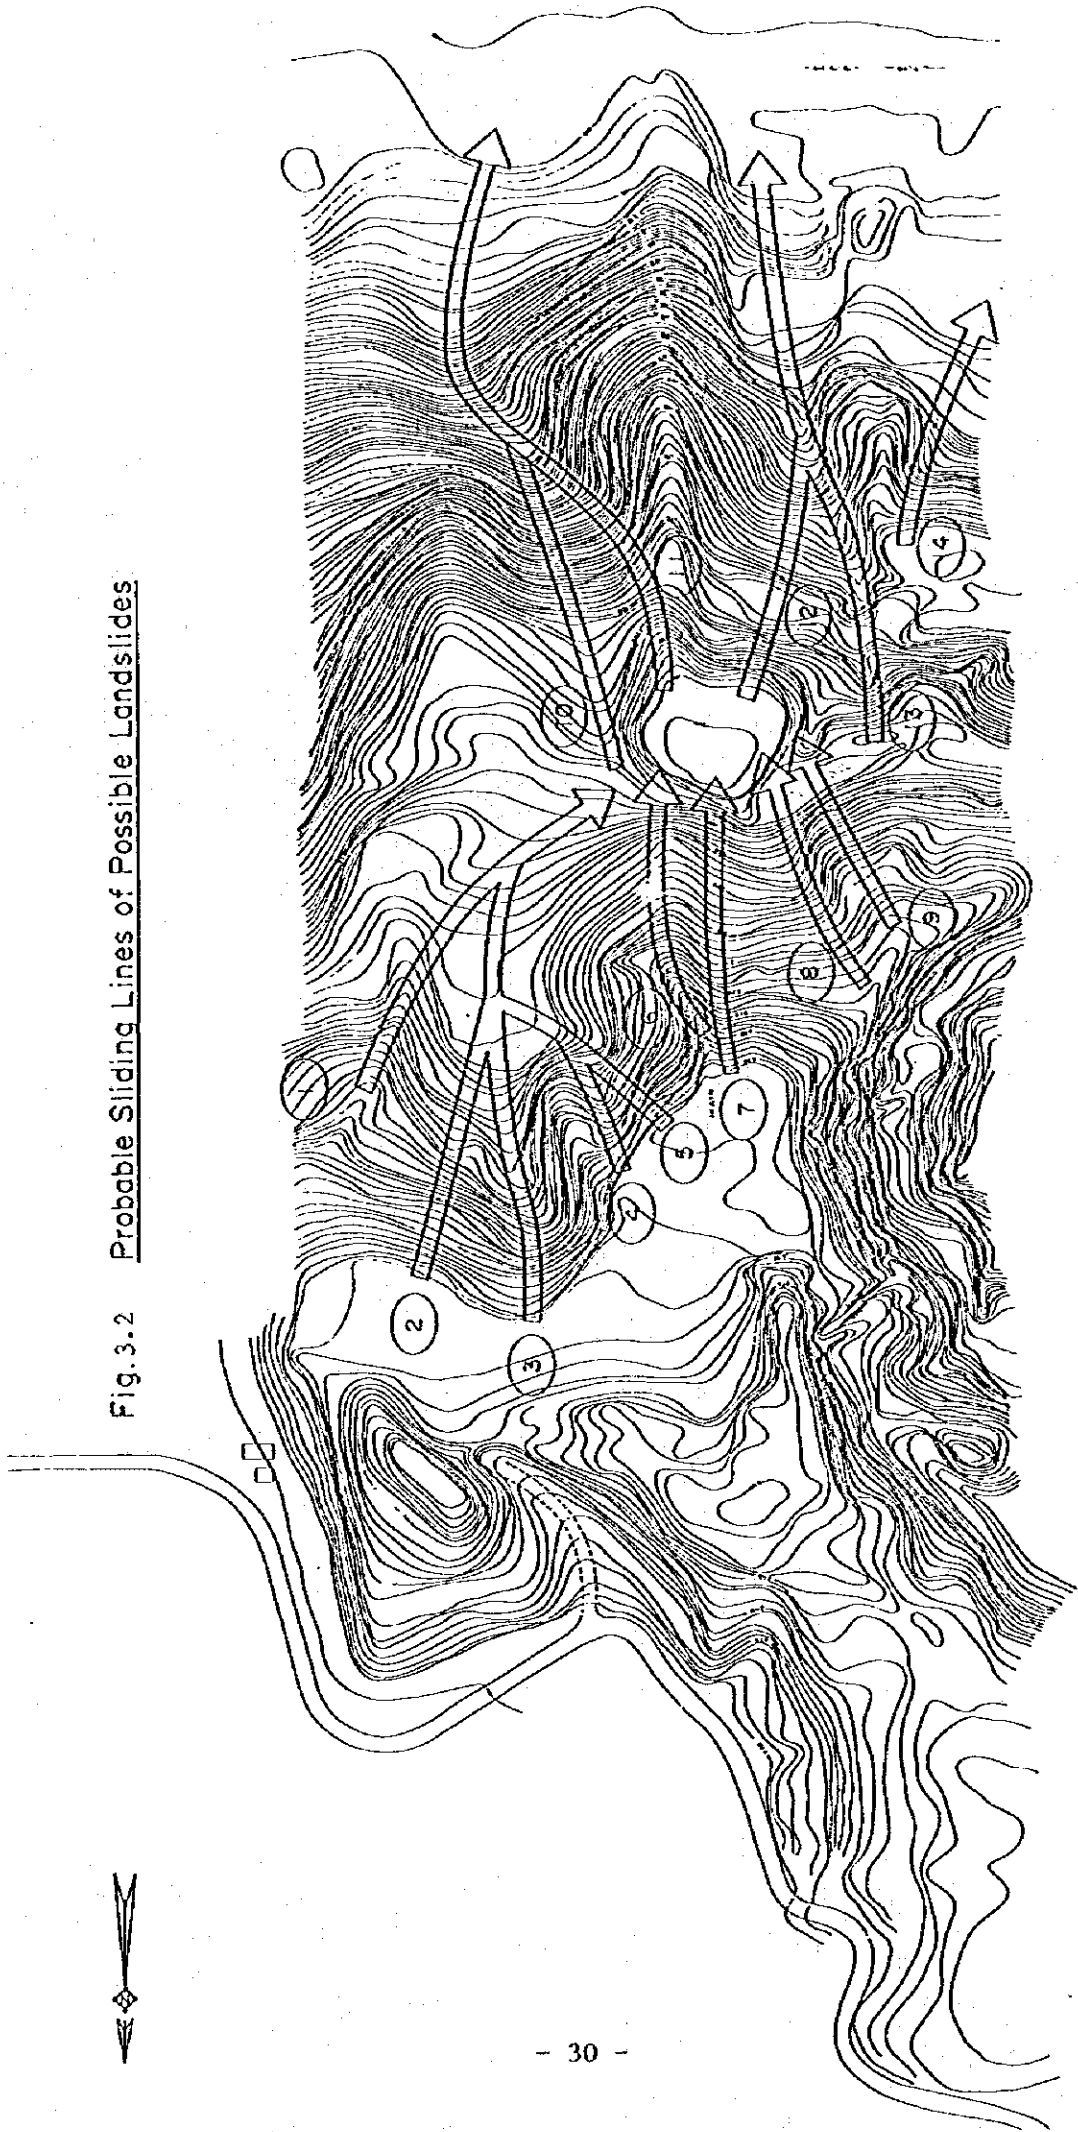
Fig. 3.2 Probable Sliding Lines of Possible Landslides

As the result, it was found that the mountain masses at the elevations higher than EL.180 m would be stable against landsliding if  $\phi$  value is assumed to be  $10^\circ$ , but would be unstable (with the safety factor against sliding lower than 1.0) in Case A (when the ground water would come up to the surface) or in Case C (when an earthquake would occur in Case A), if  $\phi$  value is assumed to be  $20^\circ$ . (Refer Fig. 3.2.)

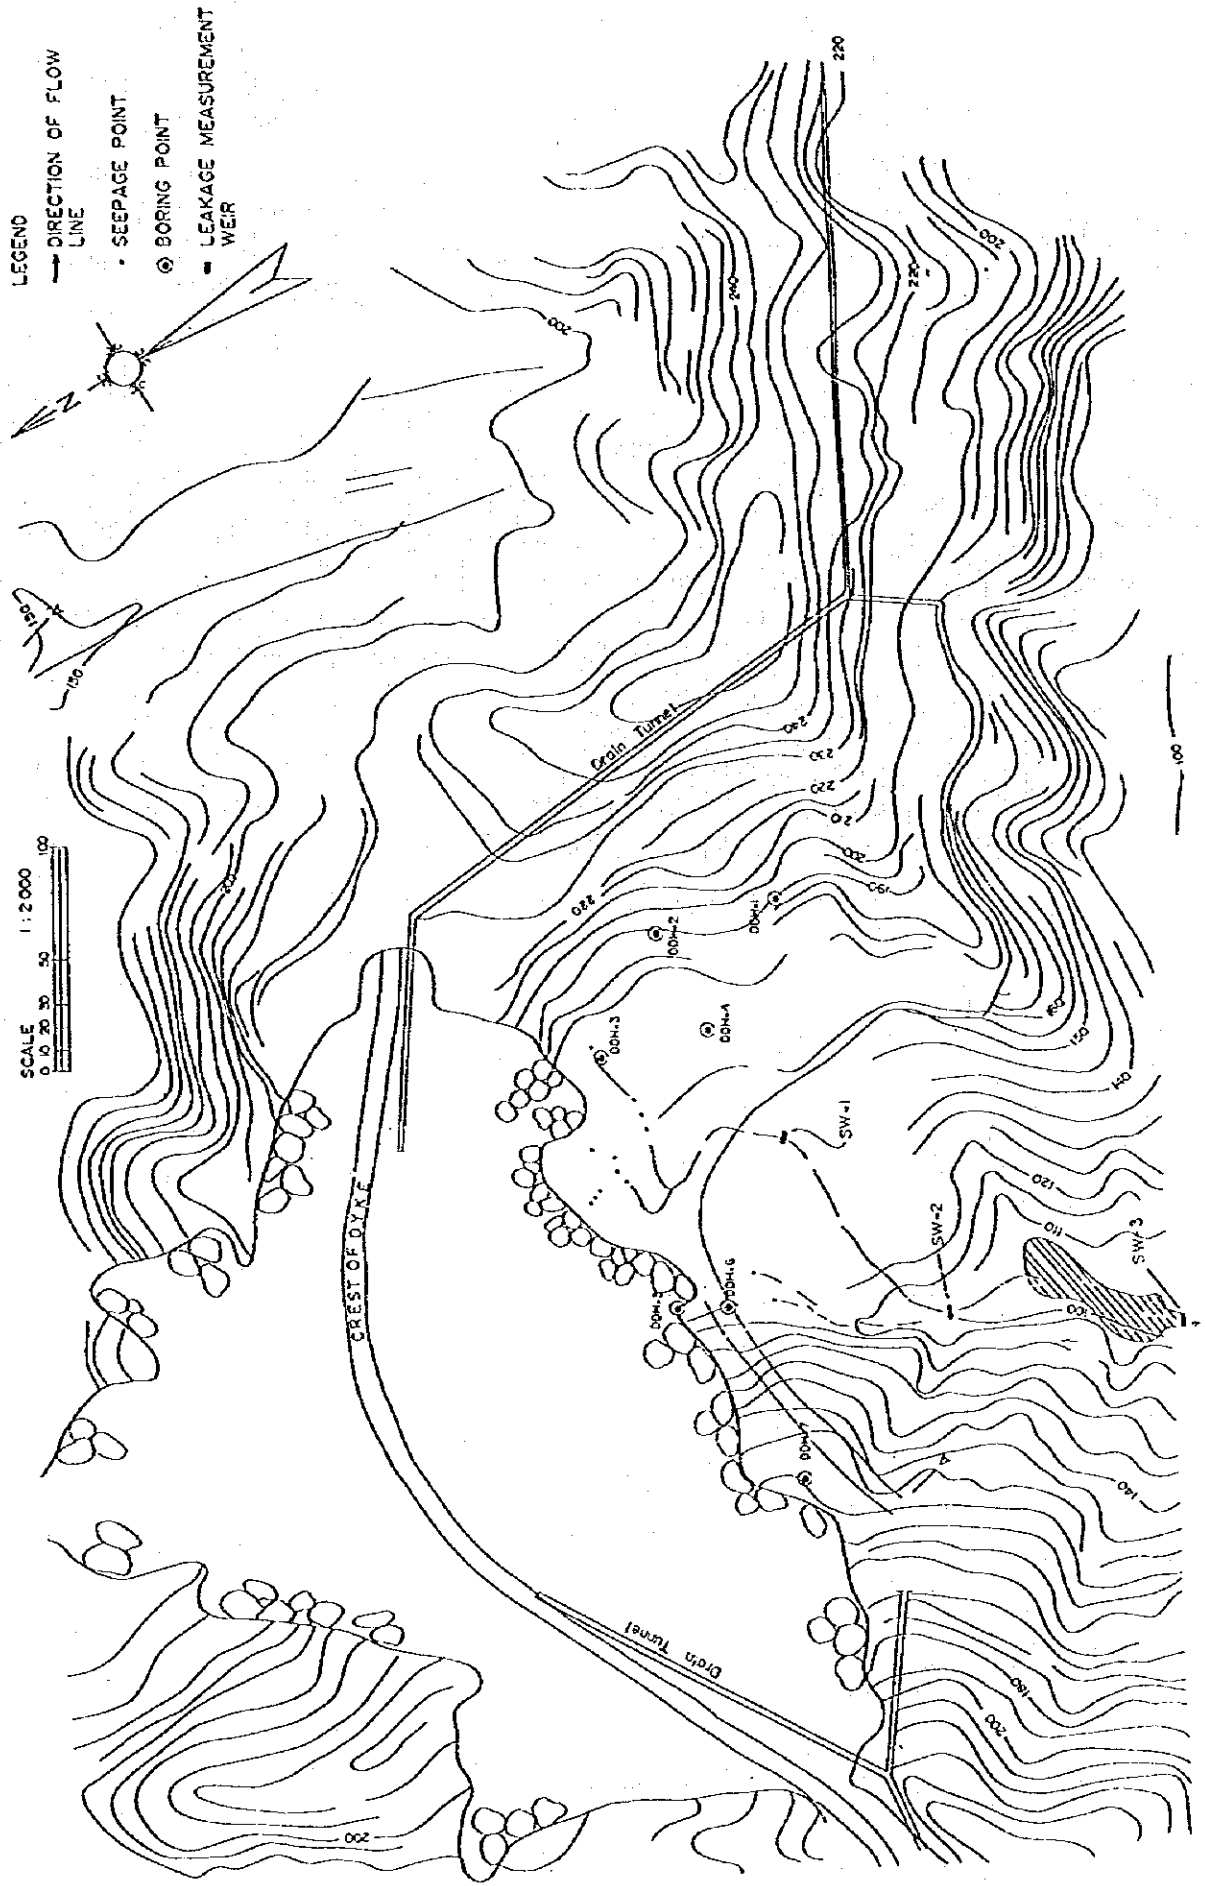
Fig.4.1 Location of Measurement Weir  
 SW - 1, SW - 2, SW - 3

The state of seepage through the dyke seems to remain unchanged at present, but it may change if some outer forces such as an earthquake of large magnitude would act on the dyke and surrounding mountain masses. It is therefore very essential to continue monitoring of seepage on a long-term basis.

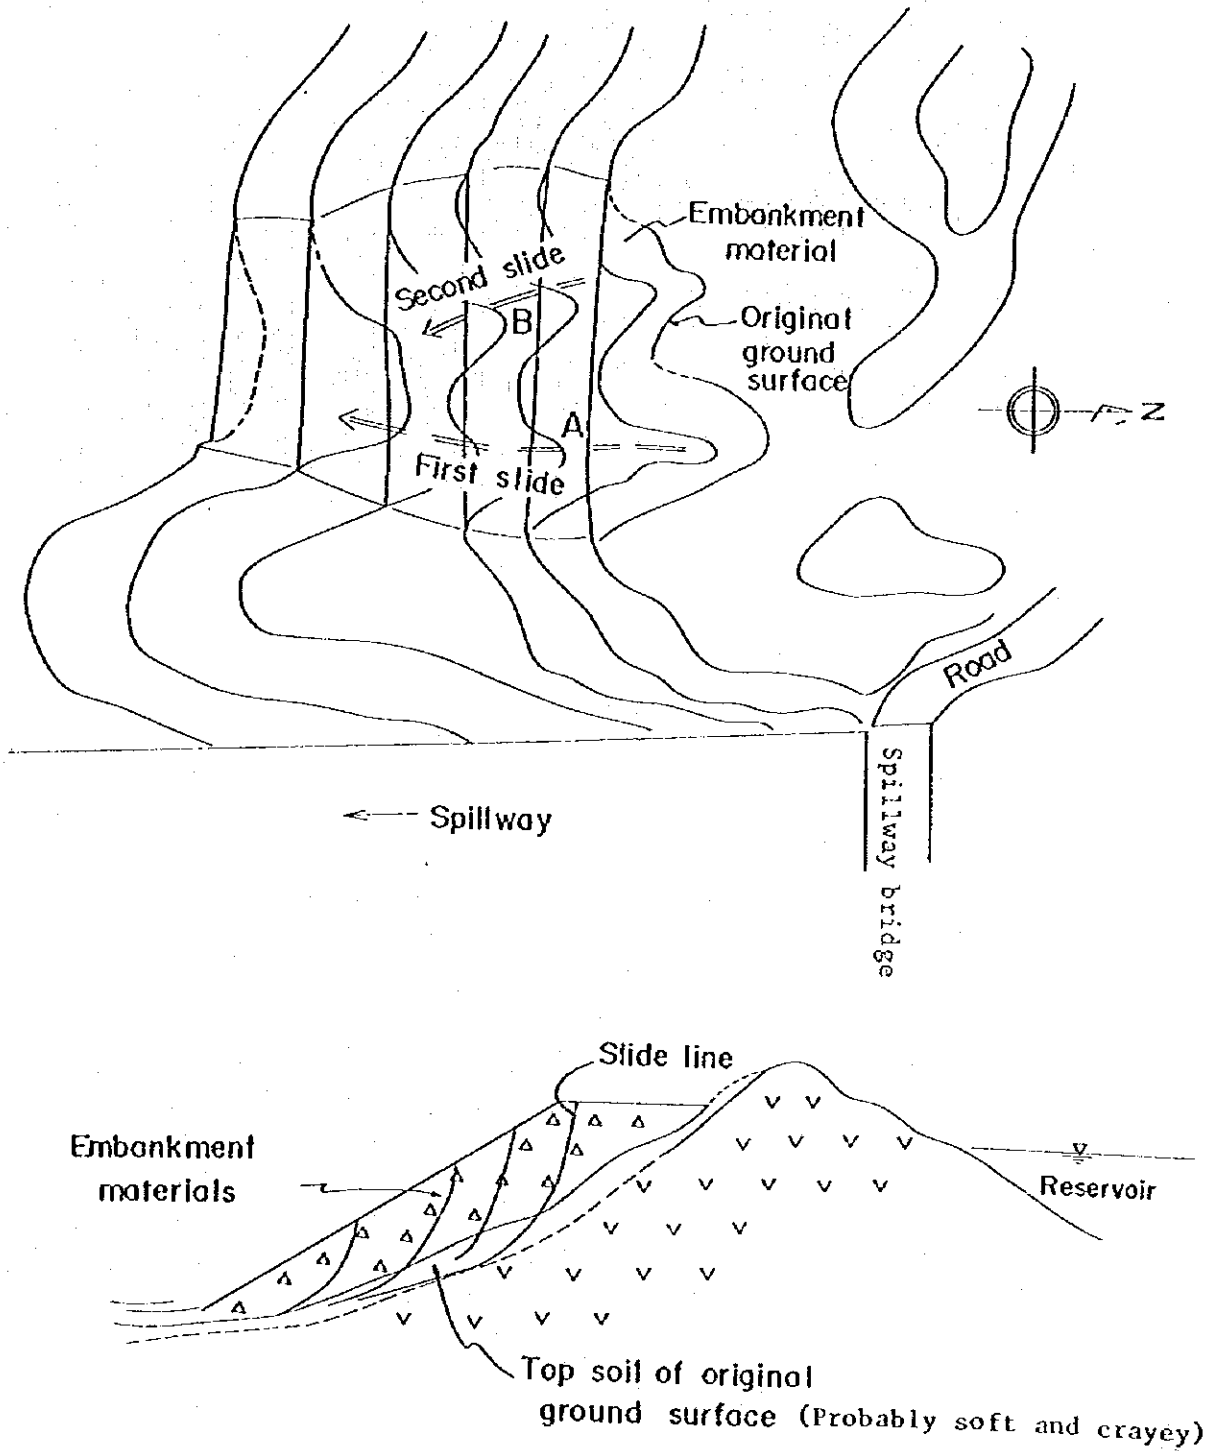
Fig. R6 Movement of Earth at the 1986 Landslide

A large-scale landslide occurred at the ex-batcher plant site in 1986, and it blocked a stream flow of the Angat river. Any recurrence of landsliding may cause disruption of water discharge into the Ipo dam, and may produce a serious effect on the water supply to Metro Manila.
