REPORT ON STUDY

BINGA DAM REHABILITATION PROJECT

FEBRUARY 1989

JAPAN INTERNATIONAL COOPERATION AGENCY

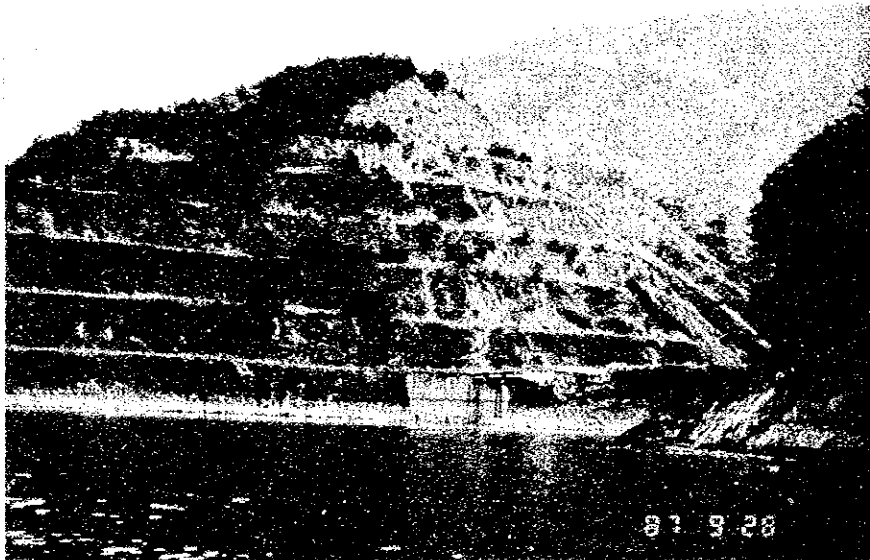
Left Bank Open-cut Excavation Slope

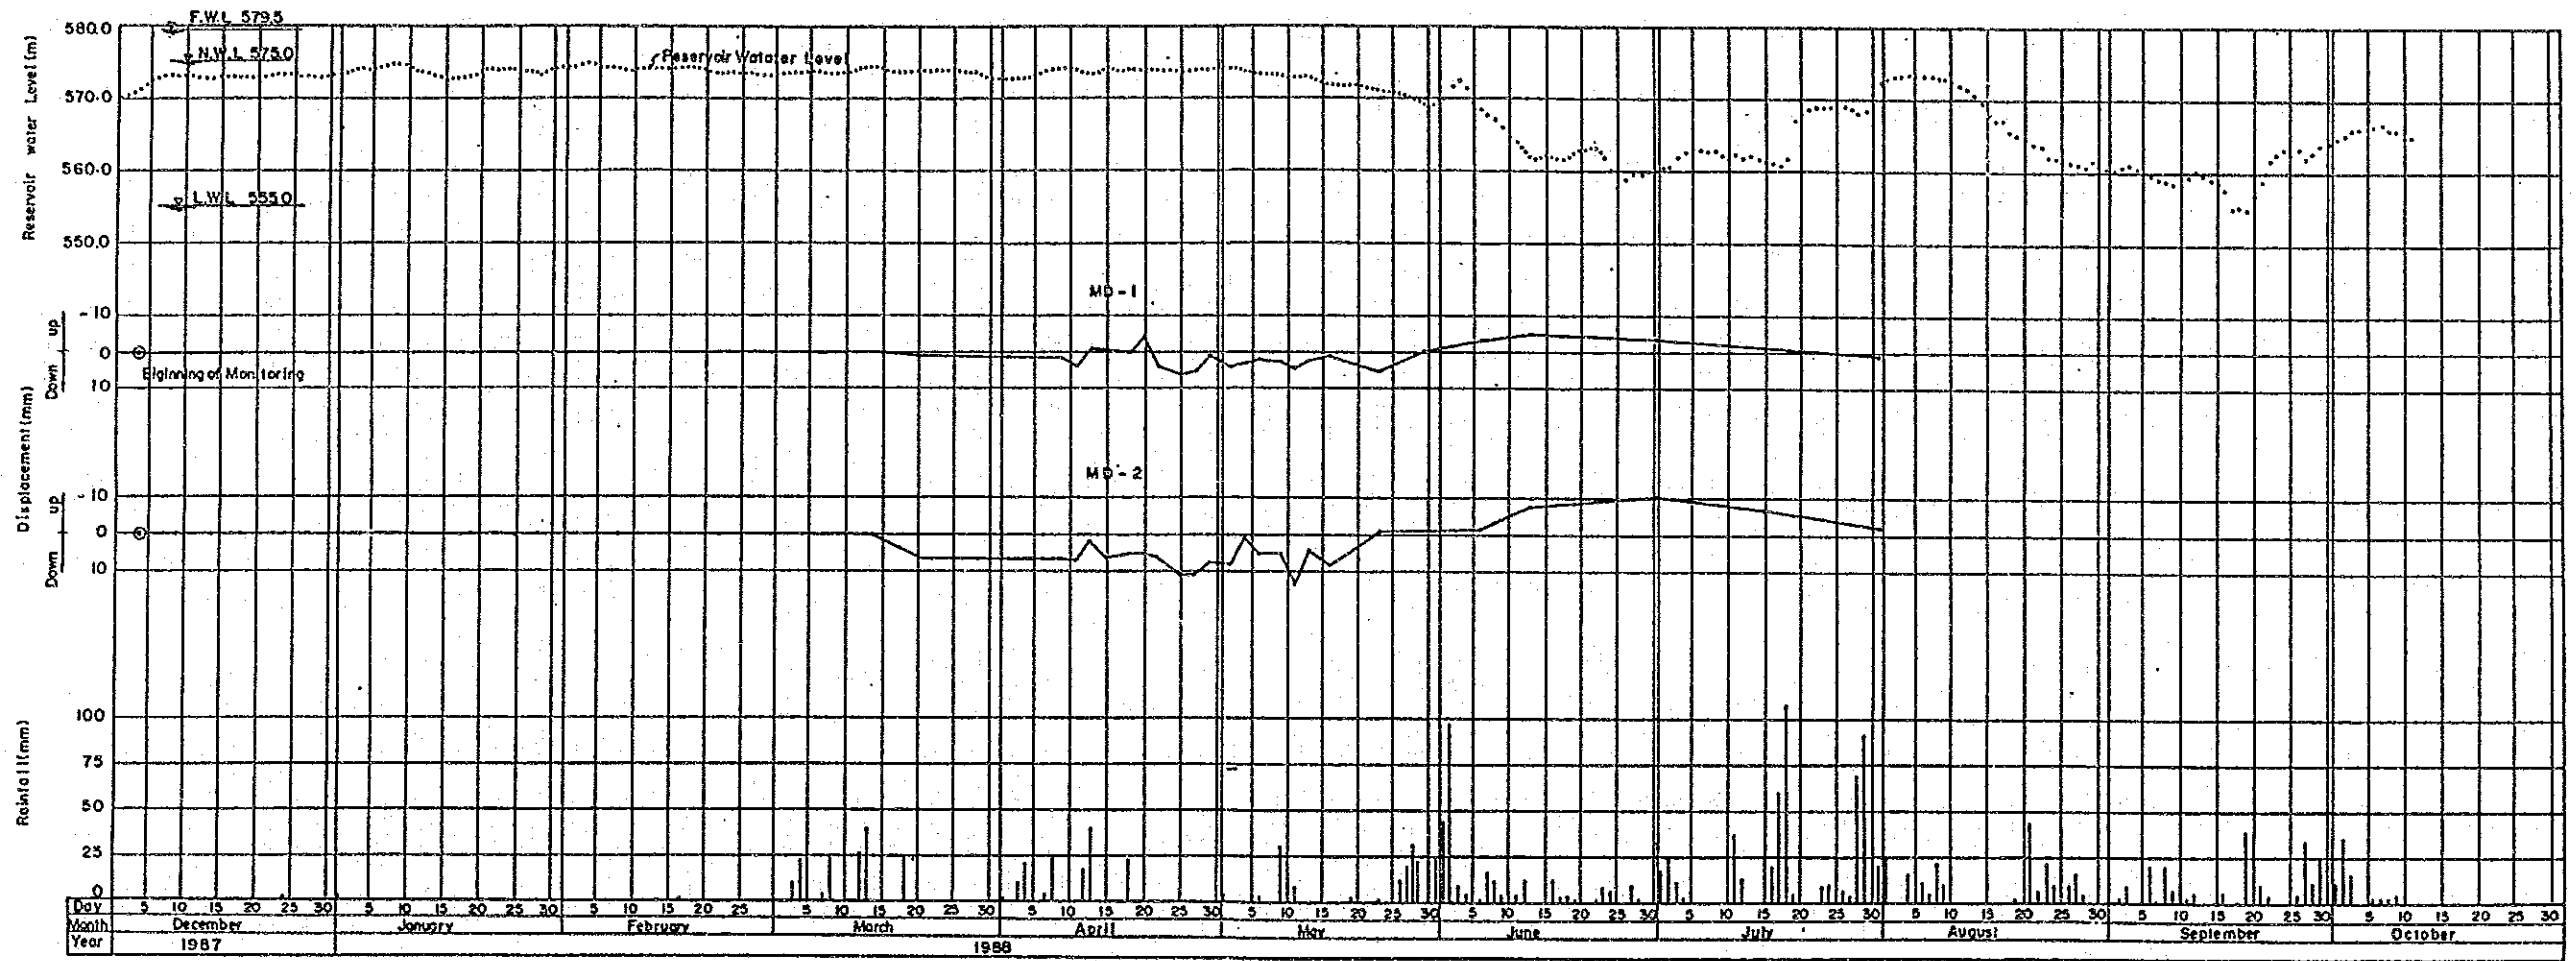
Fig. 5.3 Record of Dam Displacement

Displacement of the Damcrest
(Horizontal displacement)

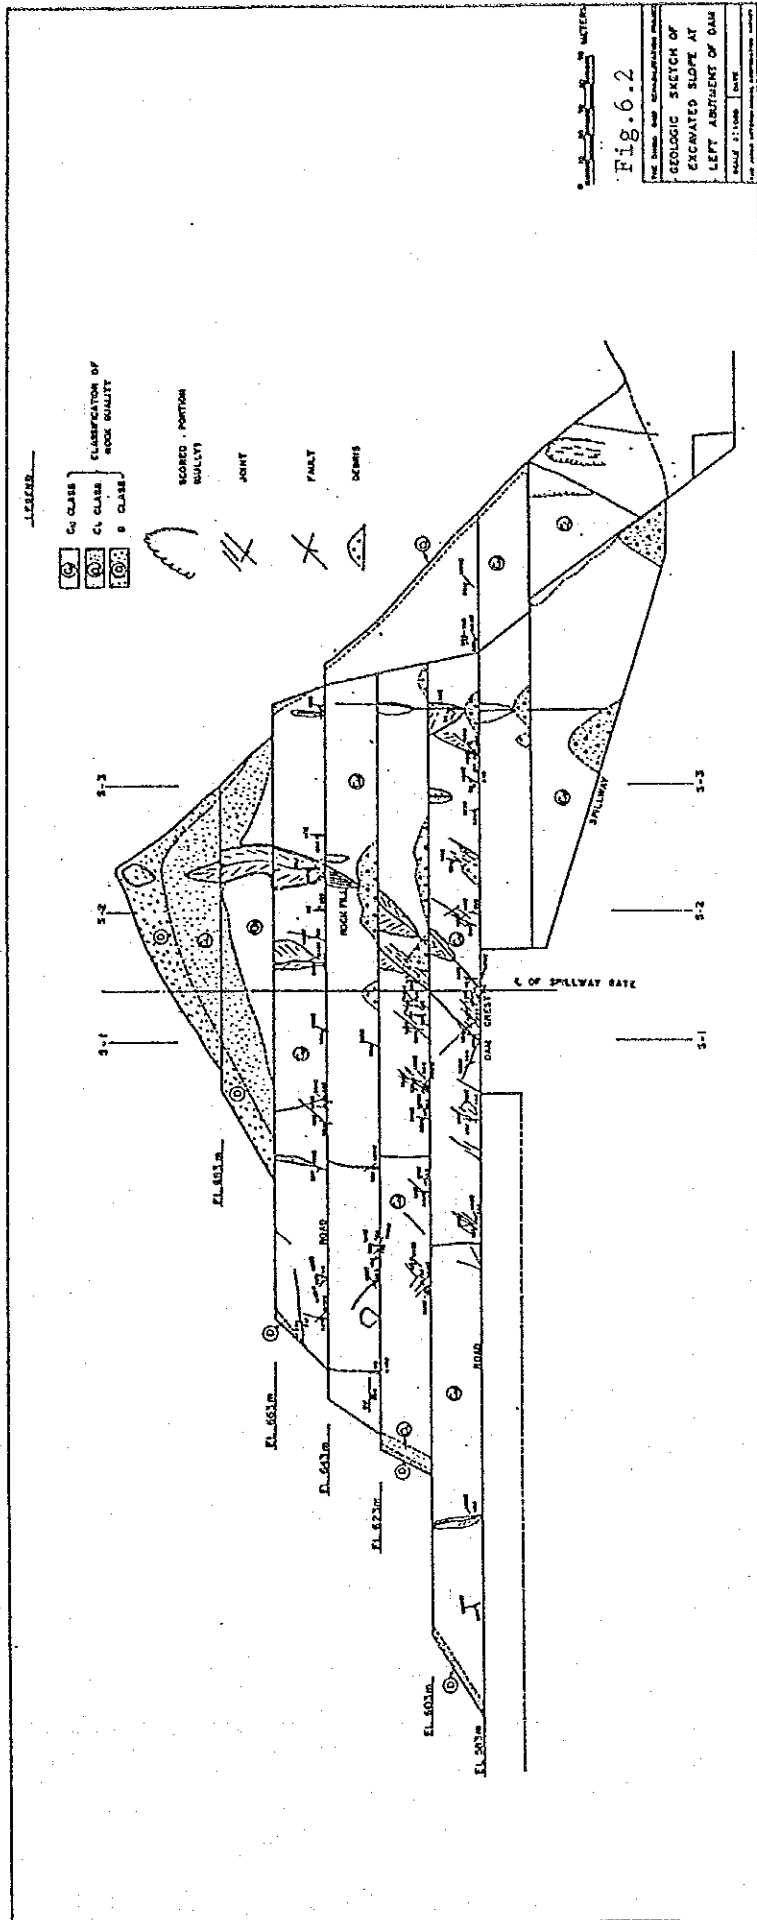
Fig. 6.2

GEOLOGIC SKETCH OF
 EXCAVATED SLOPE AT
 LEFT ABUTMENT OF DAM
 SCALE 1:1000 DATE

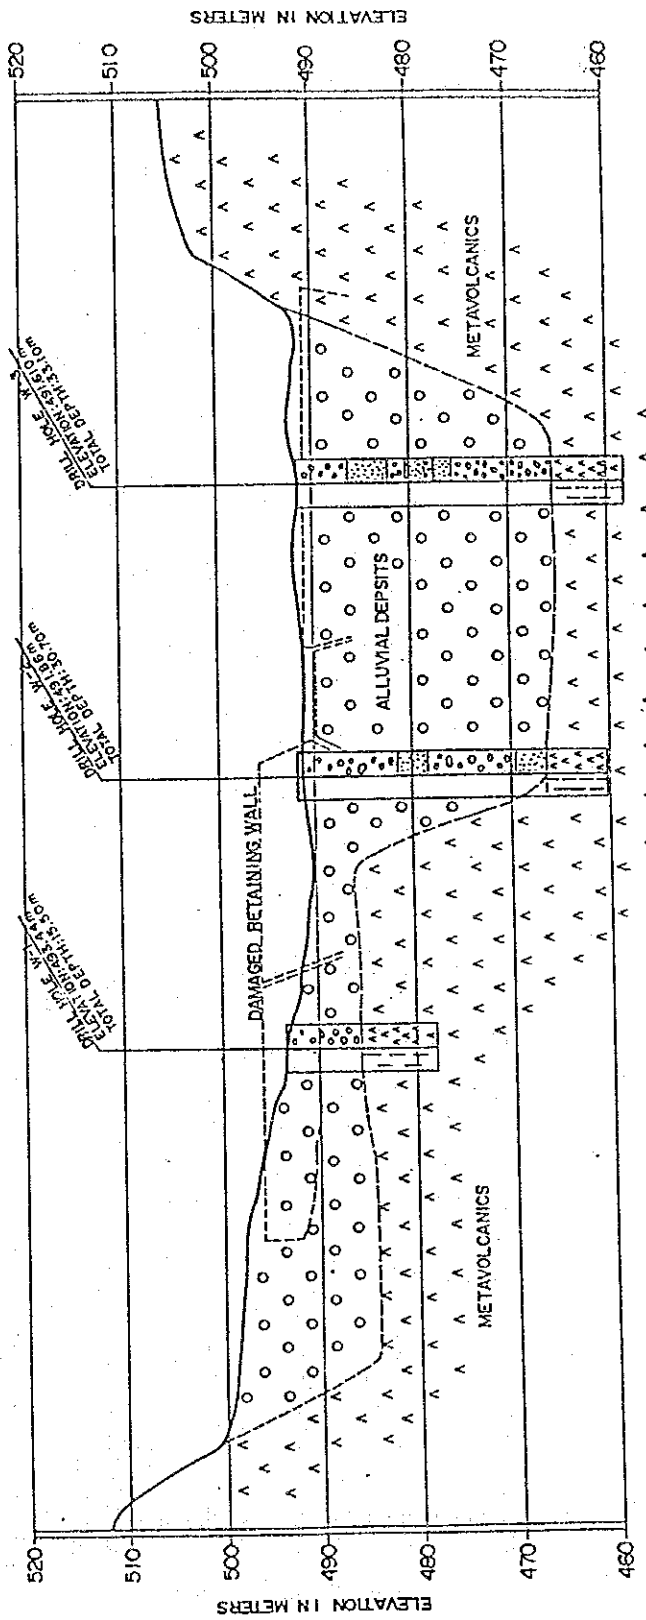
The retaining wall at the toe of the dam, approximately 130 meters long, has been damaged by floods. The damages to the wall have never been repaired. The field investigations indicated that the greater part of the wall had not been founded on the bedrock, but on the riverbed deposits. Metamorphic rocks are observed under the wall near both abutments.

About 30 meters of the wall next to the spillway (left abutment) was placed on the rock. The rock at this location contains cracks, but it is adequately hard, and, therefore, it is quite suitable as a foundation for the wall. The drilling investigations carried out recently have indicated that the depth of the bedrock along the retaining wall is about 5 meters near the spillway flip bucket and about 25 meters toward the other end of the wall near the right abutment.

GEOLOGIC SECTION
ALONG DAMAGED
RETAINING WALL

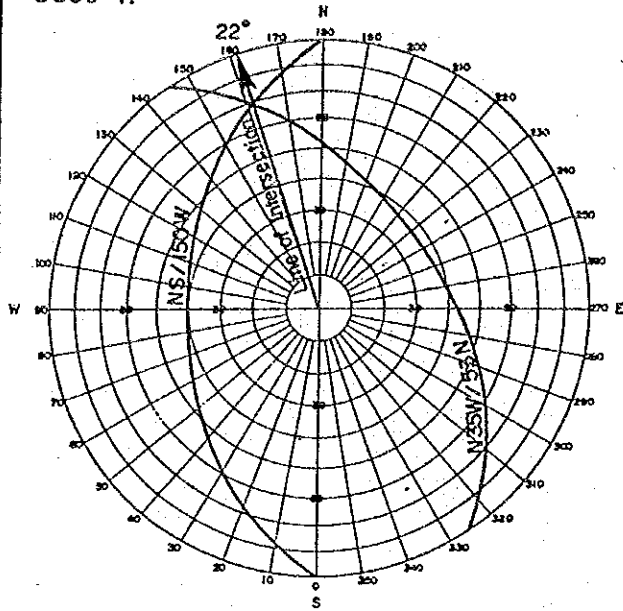
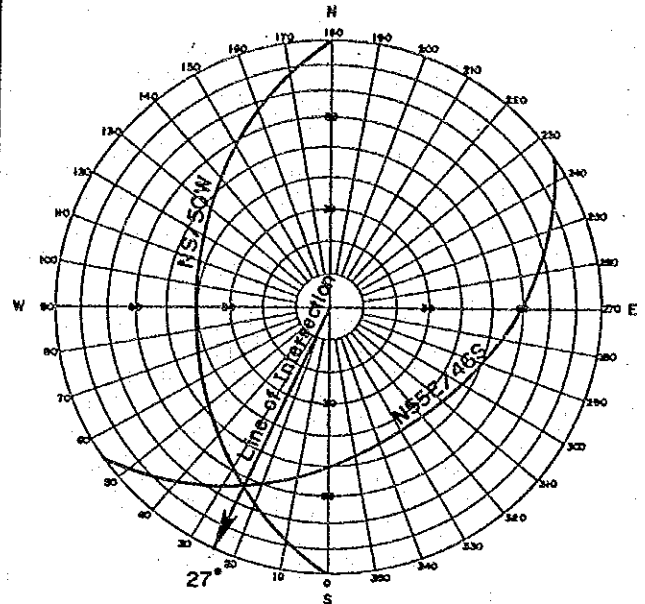
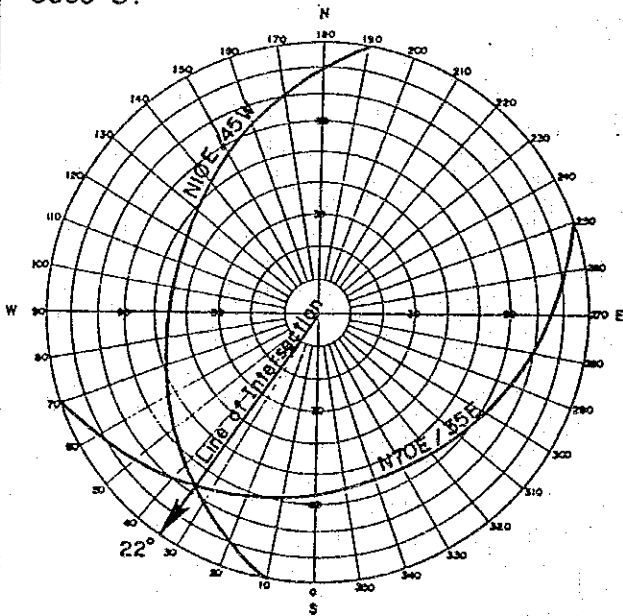
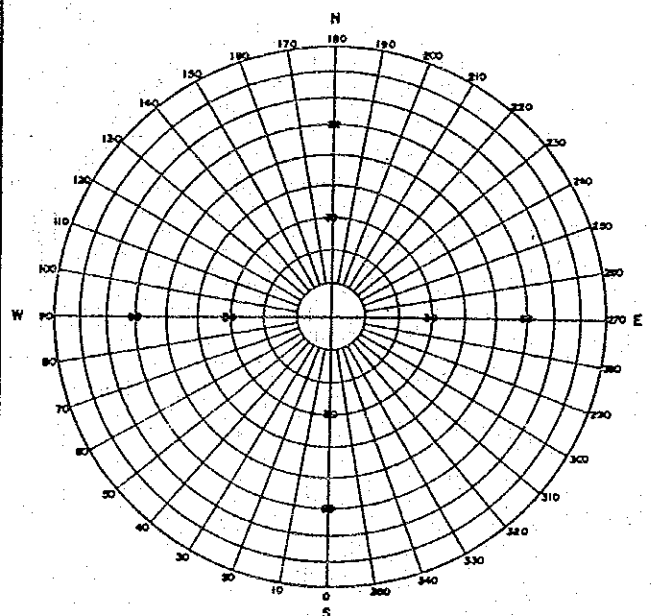
Fig. 6.9 Stereo Graph Of Sliding Planes

In case of sliding along the geological fissures, more than two sliding surfaces are usually involved, and therefore the study was conducted for possibilities on sliding which involves two sliding surfaces by the illustrating method with a stereograph. Sliding surfaces to be studied are combined for the following three cases all of which include a continuous fracture.

NS / 50W and N35W / 53N
(Lower Hemisphere)

NS / 50W and N55E / 46S
(Lower Hemisphere)

N10E / 45W and N70E / 35E
(Lower Hemisphere)
