RESULTS OF VISUAL INSPECTION OF 52 BRIDGES (5/11)

DIAGNOSTIC RECORD OF THE 22 EXISTING BRIDGES (2/22)

DIAGNOSTIC RECORD OF THE 22 EXISTING BRIDGES (13/22)

DETAILED SURVEY OF DETERIORATION AND DAMAGES (1/3)

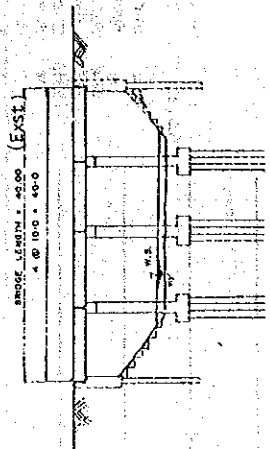
REGION	I	DETERIORATION AND DAMAGES					REHAB. METHODS	PHOTOGRAPHS	REMARKS
		SL	SU	SUB	FDTN	EMB			
Bf. NO	54								
Bf. NAME	TAGAMUSING								
RATING	A								
TYPE	RCDG								
LENGTH	40.00								
YEAR BUILT	1936								
WIDTH	6.20								
		DETERIORATION DAMAGES		RATING	QTY. OF DAMAGE				
PAVEMENT									
CURB & RAILING									
EXPANSION JOINT									
DECK SLAB	Excessive cracks and exposure of reinforcing bars underside of slab.	A							
CONCRETE BEAM	Serious cracks and exposure of reinforcing bars at support of pier 1.	A							
STEEL BEAM									
PAINTING COND.									
SHOE									
ABUTMENT	Settlement of approach pavement.	A							
PIER	Scouring of riverbed around the piers.	A							
SLOPE PROTECTION	Scouring of slope protection at approach no.1.	A							
DRAINAGE									
APPROACH ROAD									
RIVER CONDITION									
OTHERS	Too narrow carriageway width.	A

- River Study
- Bridge width = 7.94 m
- Sidewalks = 2 0.76 m

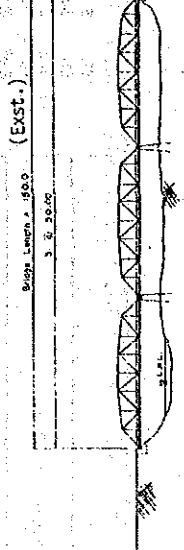
REGION	III	DETERIORATION AND DAMAGES					REHAB. METHODS		PHOTOGRAPHS	REMARKS
		SL	SU	SUB	FDTN	EMB	OTHER	Qty.		
Br. NO.	43

Construction --- half lane each Bridge width : 7.40 m Sidewalks : 1.15 m
Br. NAME	SIGSICAN	●	△					40 mm thickness @ curb 56 mm thickness @ centerline of roadway Slope = 1.5% Railing Height = 1.07 m Curb Height = 0.20 m from top of pavement		
RATING	A	1. Serious cracks at the bottom of the slab. 2. Bottom chord and gusset plates are rusty.					Replacement of deck slab.			
TYPE	TRUSS						Reinforcing of deck slab.			
LENGTH	150.00									
YEAR BUILT	7.40									
		DETERIORATION DAMAGES		RATING	Qty. OF DAMAGE		REHABILITATION METHOD			
PAVEMENT										
CURB & RAILING										
EXPANSION JOINT										
DECK SLAB	Numerous diagonal cracks and repair works at underside of slab.			A		All spans.	Replacement of deck slab and additional stringer. Thickness = 165 mm, fc' = 4000 psi

CONCRETE BEAM										
STEEL BEAM							Additional stringer (3 piece) at each span			
PAINTING COND.	Bottom chord and gusset plates are rusty.			B		30% of truss members.	100% of truss members			
SHOE										
ABUTMENT										
PIER										
SLOPE PROTECTION										
DRAINAGE										
APPROACH ROAD										
RIVER CONDITION										
OTHERS

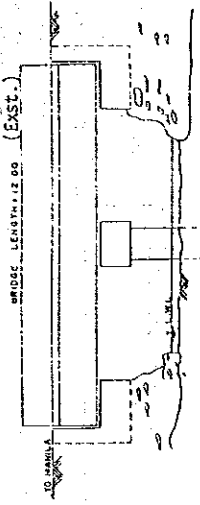
REGION	V		DETERIORATION AND DAMAGES				REHAB. METHODS		PHOTOGRAPHS	REMARKS
	Br. NO.	19	SL	SU	SUB	FOTN	EMB	OTHER		
Br. NAME	SUJE (RIZAL)		●	●

RATING	A	Replacement of super-structure 1 @ 12.0, PCT beam. Link slab Widening of abutment Slope protection								
TYPE	RC-SLAB									
LENGTH	12.00									
YEAR BUILT	1958									
WIDTH	7.35									
		DETERIORATION DAMAGES				RATING	QTY. OF DAMAGE		REHABILITATION METHOD	
PAVEMENT										
CURB & RAILING	Steel railing on timber postbolted to curb in bad condition.					8	50% missing 50% in bad condition			40 mm thickness @ curb 96 mm thickness @ centerline of roadway Slope = 1.5% Railing height = 1.07 m Curb height = 0.20 m from pavement
EXPANSION JOINT										Dummy joint
DECK SLAB	Cracks and evidence of repair works (patching).					A	Whole roadway area of Span 1 and Span 2.			Thickness = 127 mm
CONCRETE BEAM	Exposed rebars, spalling of all beams. All beams on one span with temporary support.					A	A1 - P1.			Replacement of superstructure Use one span 12 m precast PC-T beam

STEEL BEAM										
PAINTING COND.										
SHOE										Elastomeric bearing pads
ABUTMENT										Widening of bearing seat
PIER										
SLOPE PROTECTION										Grouted riprap
DRAINAGE										
APPROACH ROAD										Approach Road length = 20 m x 2
RIVER CONDITION										
OTHERS

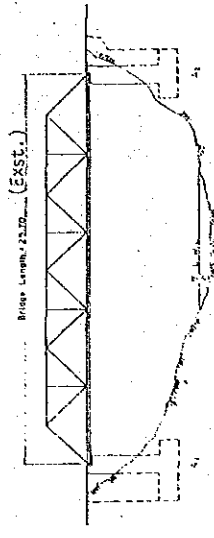
Br. NAME	MAGAPONG	●	●						
RATING	A	1. Cracks and potholes on deck slab and asphalt pavement. 2. Steel members are rusty and partially corroded particularly the bottom chords, floor beams and stringers. 3. Carriageway width is too narrow (6.00m).							
TYPE	PONY								
LENGTH	25.70								
YEAR BUILT	1946								
WIDTH	6.00								
		DETERIORATION DAMAGES		RATING		QTY. OF DAMAGE		REHABILITATION METHOD	
PAVEMENT		Abrasion, cracking and potholes at pavement.		B		Whole area of bridge pavement		40 mm thickness @ curb 68 mm thickness @ centerline of roadway Slope = 1.5%	
CURB & RAILING		Breakage of railing.		B		30% in bad condition.		Railing height = 1.07 m Curb height = 0.20 m from top of pavement	
EXPANSION JOINT									
DECK SLAB		Cracks and potholes at bottom portion of slab.		B		A1 - A2.		Thickness = 190 mm

CONCRETE BEAM								Use 25.7 m span prestressed concrete I-beam (Type IV)	
STEEL BEAM									
PAINTING COND.		Discoloration and rusty structural members.		A		Whole truss members (A1-A2).			
SHOE		Rusty bearing plate.		B		Width of A1 and A2.		Elastomeric bearing pads	
ABUTMENT								Reinforcement of abutment	
PIER									
SLOPE PROTECTION								Grouted riprap	
DRAINAGE									
APPROACH ROAD								30 m x 2	
RIVER CONDITION									
OTHERS		Too narrow carriageway width.		A		5.00 m. carriageway.

Bridge width = 7.32 m  
Sidewalk: 2 @ 0.76 m

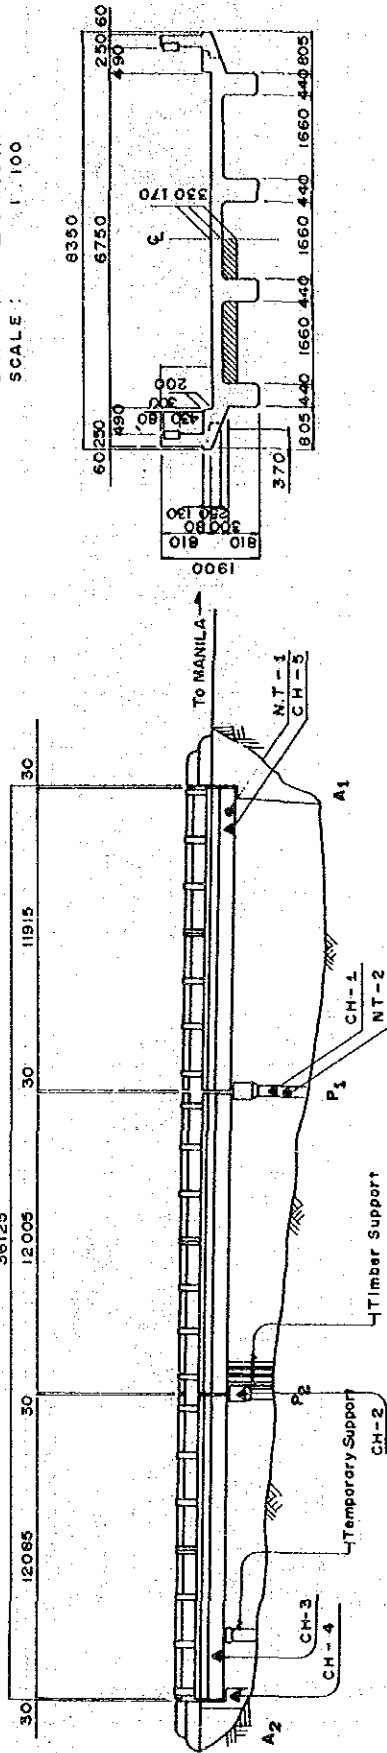
CROSS SECTION  
SCALE: 1:100

NOTE:  
1. CONCRETE HAMMER TEST (CH)  
CH-1 PIER 1 420 kg/cm<sup>2</sup>  
CH-2 PIER 2 380 kg/cm<sup>2</sup>  
CH-3 GIRDER No.3 SPAN 400 kg/cm<sup>2</sup>  
CH-4 ABUTMENT 380 kg/cm<sup>2</sup>  
CH-5 GIRDER No.1 SPAN 380 kg/cm<sup>2</sup>  
2. NEUTRALITY TEST (N.T.)  
NT-1 GIRDER NEUTRALITY DEPTH 25 mm  
NT-2 PIER 1 NEUTRALITY DEPTH 20 mm
