**FEASIBILITY STUDY
ON
SMALL-SCALE POWER PLANTS
REHABILITATION PROJECT
IN
THE REPUBLIC OF COLOMBIA**

**PUENTE GUILLERMO HYDROELECTRIC
POWER PLANT**

MARCH 1990

Japan International Cooperation Agency

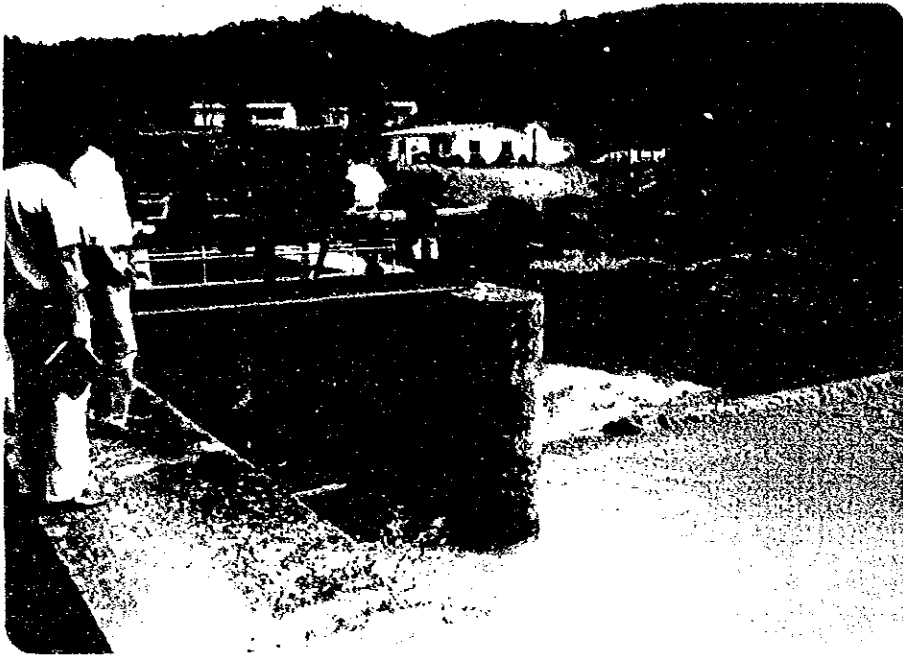
Rio Suarez and Intake

The diversion weir is constructed of cobble-mixed concrete. Its length of overflowing crest, crest elevation and height are 18 m, 102 m and 7.50 m respectively. The foundation of the diversion weir is built on the bedrock. Piers are built at intervals of 1 m at the crest portion on the left bank. Water level at the intake can be adjusted by means of the wooden boards inserted between the piers.

The dimensions of the intake entrance are 1.50 m wide and 1.50 m height. Two intakes are constructed in parallel with the river. Sill height of the intake entrance is 100 m. Two gates are installed in the intake. Two gates are installed in the sand trap located at the downstream edge of the intake. The dimensions of the sand trap are 1.50 m wide and 1.50 m high. Concrete quality of the intake facilities is in fairly good condition.

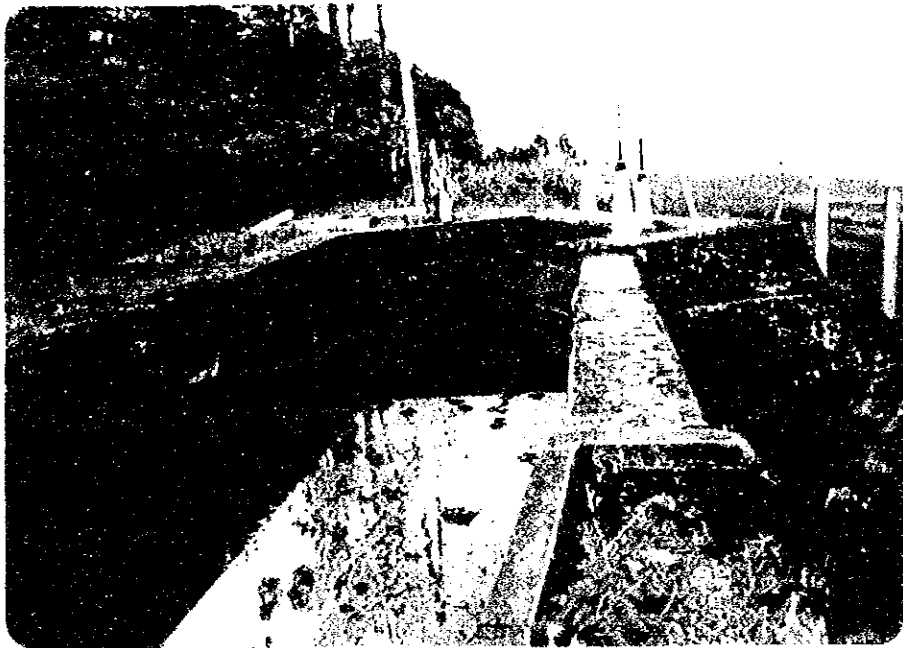
Head Tank

The head tank has a rectangular section. Its width, length and depth are 4 m, approx. 10 m and 2.50 m respectively. The head tank is built at right angles to the conduction channel. One sand trap gate (1.00 x 1.00 m) is installed at the wall of the river side. A bend angle between the center line of the conduction channel and that of tunnel entrance to the penstock is 120 degrees.

The structure is built of cobble-mixed concrete. Although some part of the concrete peels off, the structure is in good condition.

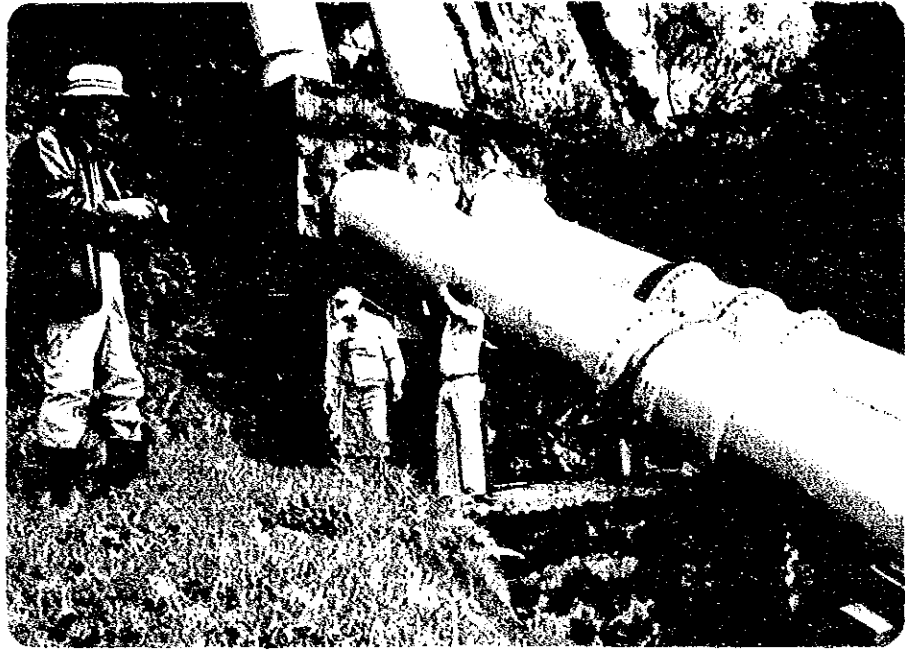
Penstock

Steel conduit pipes (diameter: 0.80 m) are laid to construct the penstocks in two rows, with a total length of 180 m. The penstocks are supported by five concrete blocks, concrete and saddles. The penstocks built upstream were damaged due to the deformed bedrock.

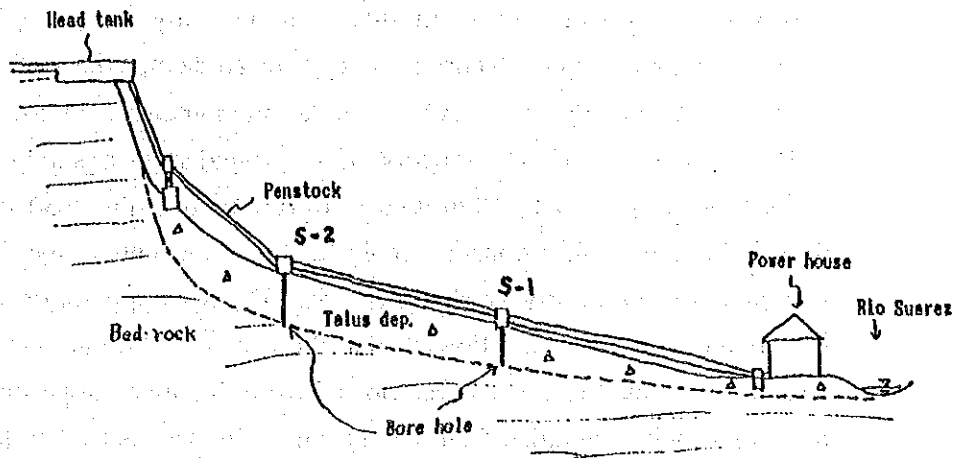
Fig. 3.1 Schematic Geological Profile

Excluding two marshes, the headrace is built on the bedrock. The penstock is grounded in the talus deposits formed in the foundation of the marsh, except under the cliff section beneath the head tank.

- 3) Part of the talus deposit of the penstock foundation has slipped. There are no observable "landslide scars" in this area, nor any history of landslide occurrences for this area. A boring survey showed the thickness of debris to be over 30 m, with many stones over one meter in diameter. The location of the slide surface is unclear. Deformation of the ground surface is only visible in a vicinity of the penstock, 10 m wide and 100 m from the head of the talus deposit through the third foundation block. Thus, the depth of the slide surface is assumed to be relatively shallow. The slide was apparently a localized landslide caused by debris flowing into the penstock through the conduction channel and tank. The water was flowed from the upper slope through talus deposits which accumulated on the bottom of the penstock, and the resulting rise of the groundwater level caused an increase in water pressure against the talus deposits, resulting in the landslide.

Proper countermeasures for protecting the penstock foundation against landslide include building the penstock foundation on the bedrock using piles, and lowering the groundwater level as far as possible.

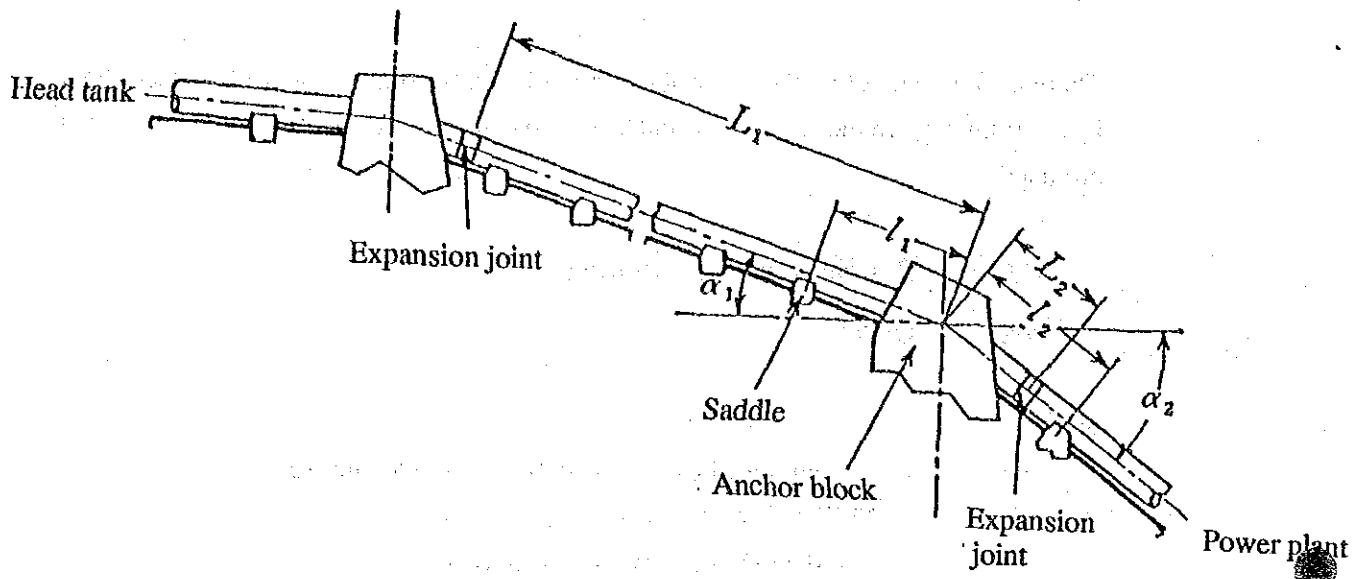
Fig. 4.4 Longitudinal Section of Penstock

The results of the overturning, sliding and vertical normal stress at No.2 and No.3 anchor blocks caused by forces exerted by the penstock are given below:

No.2 anchor block	No.3 anchor block
Overturning		in the middle third one	in the middle third one
Sliding (horizontal force) (t)	Normal condition	1.0	4.9
	During earthquake	2.3	7.7
Vertical normal stress (t/m)	Normal condition	10	12
	During earthquake	13	14

Damage to the penstocks is caused by non-uniform settlement at the anchor blocks or insufficient depth of footing base up to the bedrock of the anchor blocks. Judging
