APPENDIX C

EXISTING SEWERAGE FACILITIES

This Appendix C presents the results of the investigation of the existing sewerage facilities carried out during the first on-site works period from December, 1988 till March, 1989 in compact tables and figures. Contents of tables and figures have been compiled from data and information collected and those obtained through observations and measurements made by the study team.

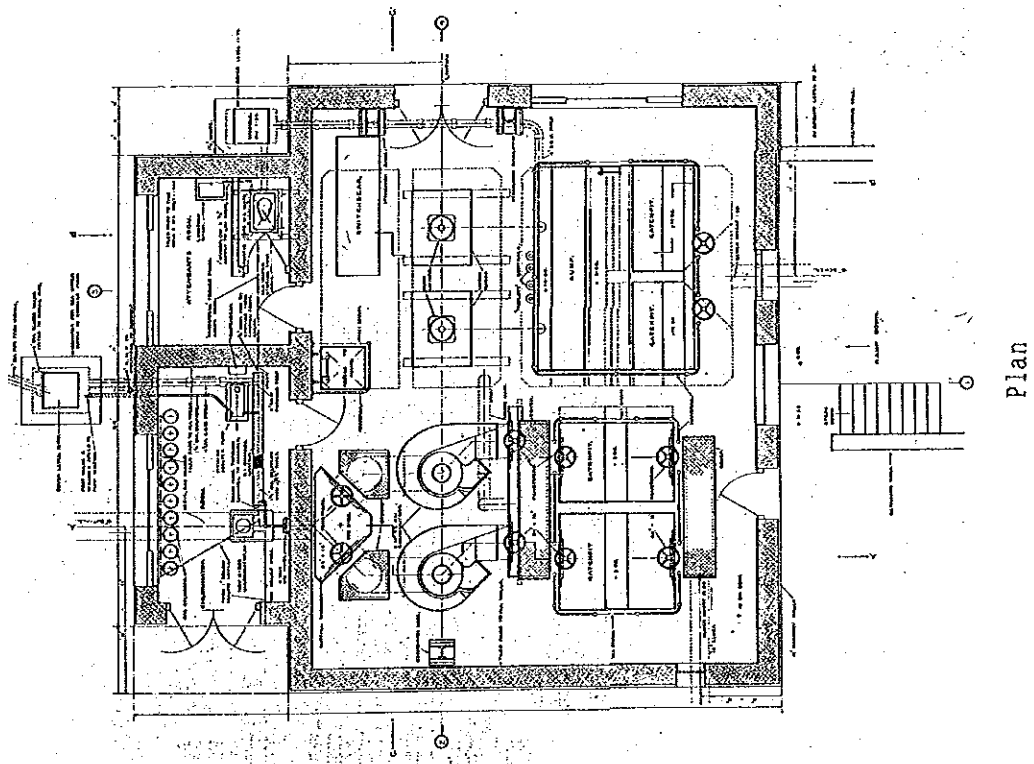
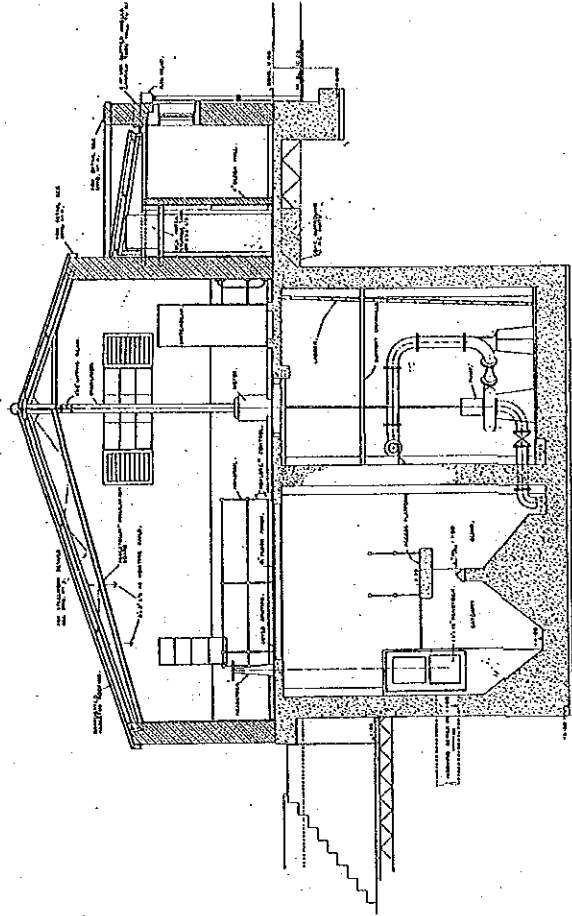
Figure C. 7 Structure of Chlorinator Station

Overflow of Sewage from Upstream Manholes : Y e s		
<u>Structural Damage</u>		
<u>Location of Damage:</u>	<u>Degree of Damage:</u>	<u>Cause of Damage:</u>

1. Inlet manhole	a	Hydrogen sulphide gas
2. Channel	a	Hydrogen sulphide gas
Note: a. corrosion of concrete; b. exposure of steel bar; c. corrosion of steel bar		
<u>Remarks</u>

1. All pump nuts were replaced in 1982. 2. Comminutors were broken about 10 years ago. 3. Powder, most likely crystallized calcium, is remarkably observed on the bottom of the inlet manhole. 4. Strength of concrete by Schmidt concrete test hammer, 220-360 kg/cm ² comminutor room, 200-220 kg/cm ² pump room. 5. H ₂ S gas, 50 mg/l in wet well (without cover) (14:00 Feb. 2, 1989)

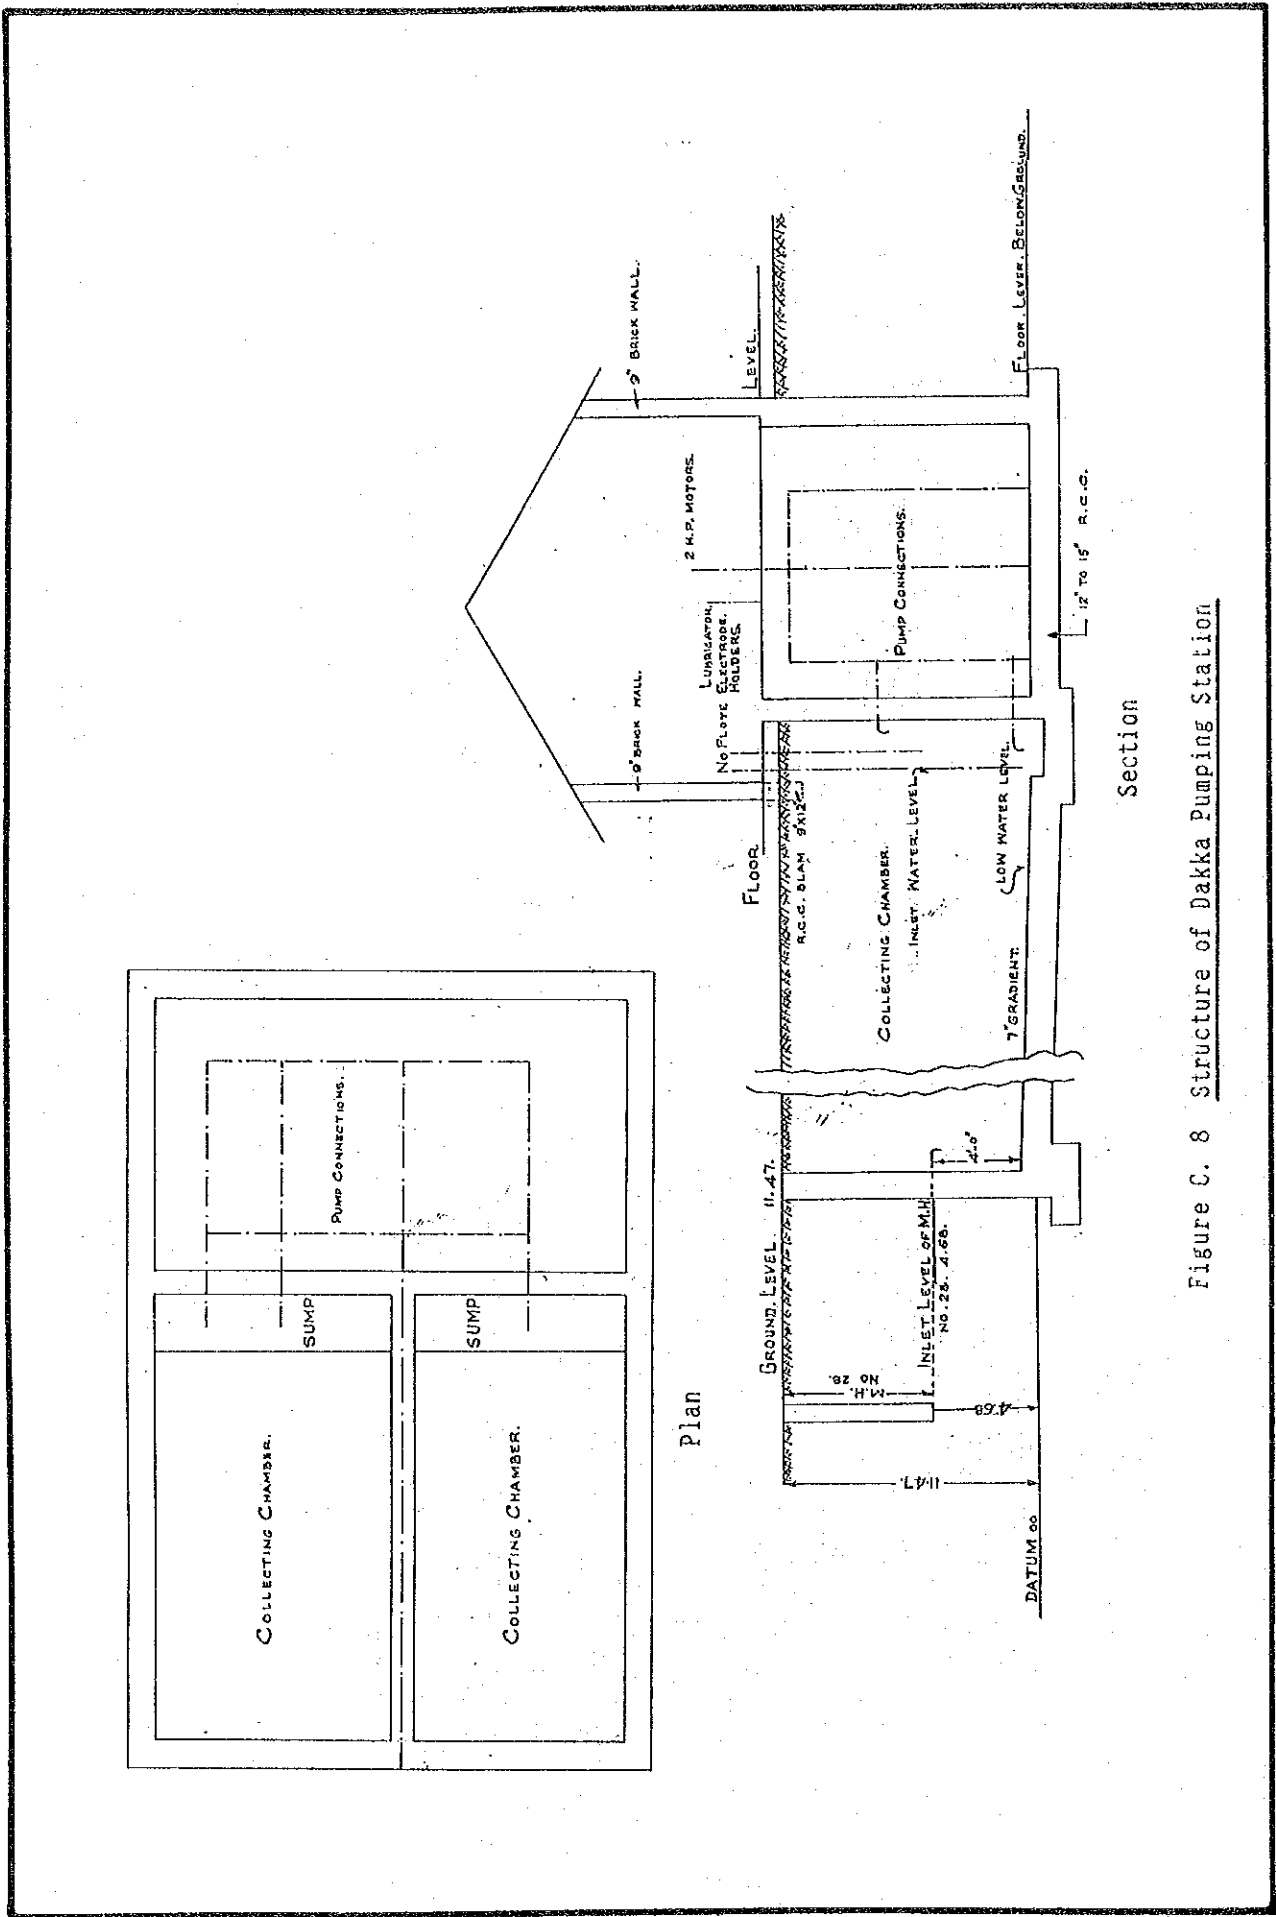
Figure C. 8 Structure of Dakka Pumping Station

<u>Structural Damage</u>			
<u>Location of Damage:</u>	<u>Degree of Damage:</u>	<u>Cause of Damage:</u>	
No damage			
Note: a. corrosion of concrete; b. exposure of steel bar; c. corrosion of steel bar			
<u>Remarks</u>

1. One motor was removed and not yet equipped. 2. One operator stays all day at the station. 3. Pressure pipes, installed originally in 1956 were broken at two points in 1982, and these were replaced by the municipality.

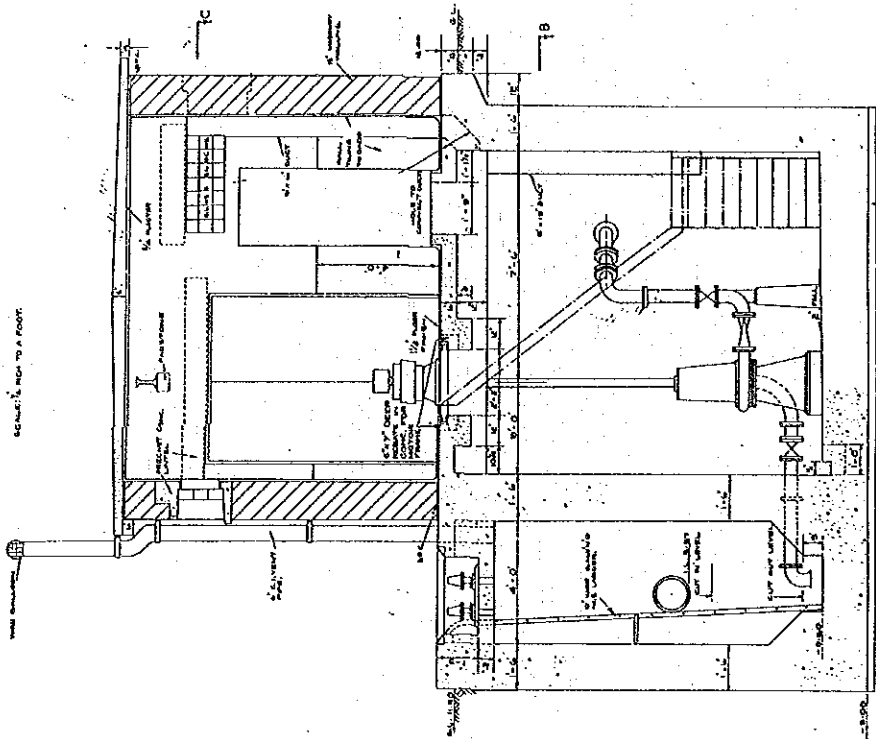
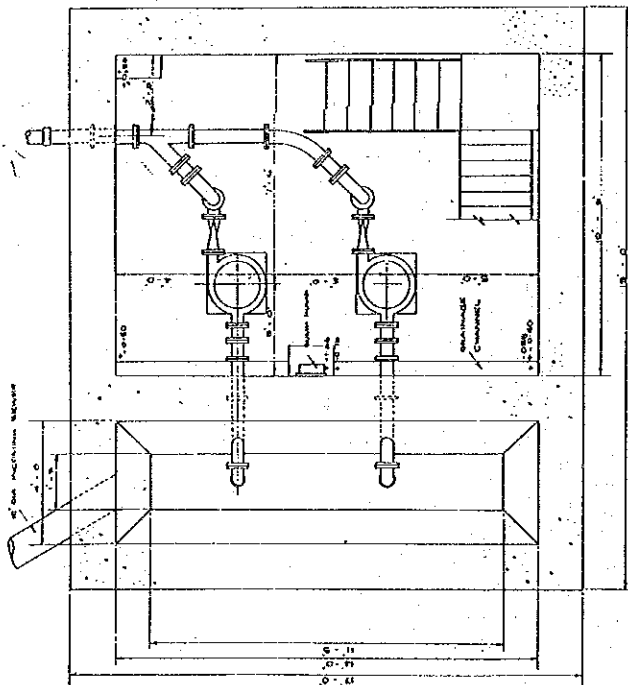
Figure C. 12 Structure of Front Bay Pumping Station

Frequency of Power Failure: 4 times/year, Duration: 4 hrs.			
Overflow of Sewage from Upstream Manholes: Yes			
<u>Structural Damage</u>			
<u>Location of Damage:</u>	<u>Degree of Damage:</u>	<u>Cause of Damage:</u>

1. Motor room	Cracked	Hydrogen sulphide gas	
2. Outside of roof	c.	Wind from sea	
Note: a. corrosion of concrete; b. exposure of steel bar; c. corrosion of steel bar			
<u>Remarks</u>

1. Same machanic takes care of P/S E.			
2. The crack on tje wall of motor room may be tear of mending part by mortar.			
3. Replacement of machinery is necessary.

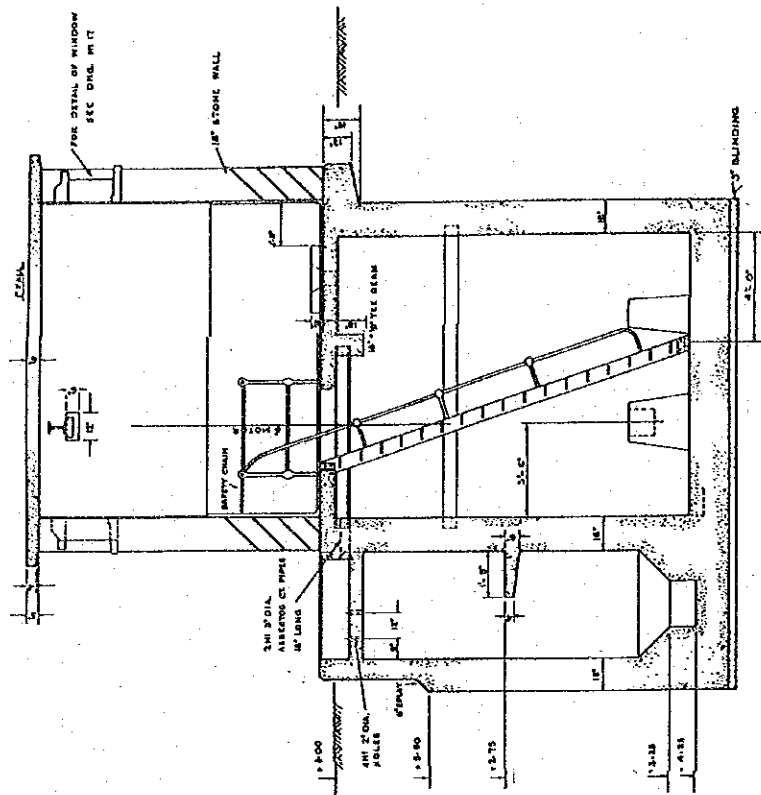
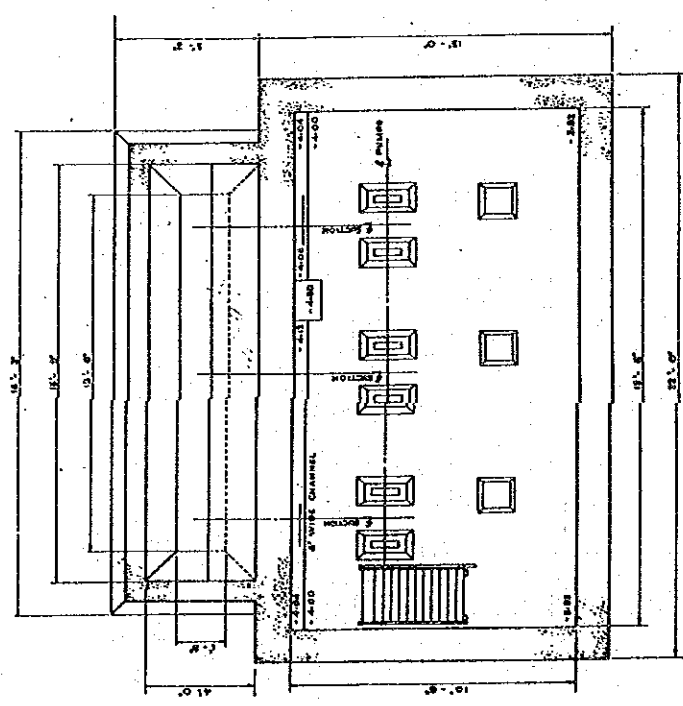
Figure C. 14 Structure of Type 2 Pumping Station

<u>Structural Damage</u>		
<u>Location of Damage:</u>	<u>Degree of Damage:</u>	<u>Cause of Damage:</u>
1. Wall of wet well	c.	Hydrogen sulphide gas
2. Wall of pump room	Cracked	Salinity in concrete
Note: a. corrosion of concrete; b. exposure of steel bar; c. corrosion of steel bar		
<u>Remarks</u>

1. Shafts and gland sleeves of one pump were repaired by Docyard Co.		
2. Structural damage is serious.		
3. Replacement of machinery is necessary.

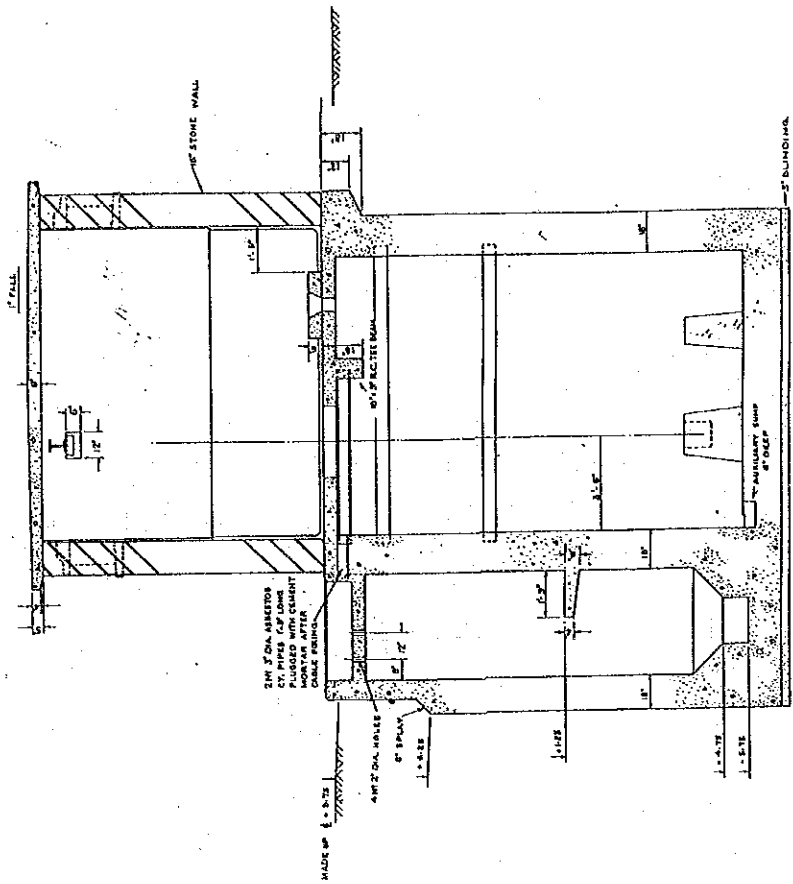
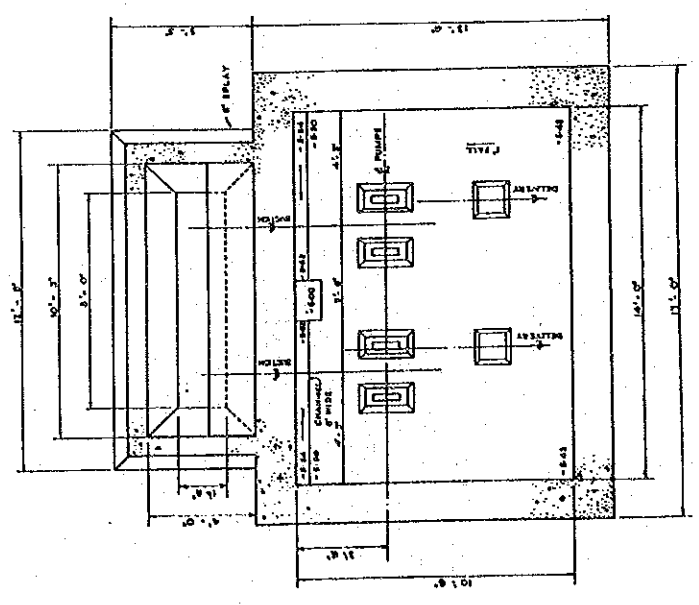
Figure C. 15 Structure of Type 3 Pumping Station

Overflow of Sewage from Upstream Manholes: Yes		
<u>Structural Damage</u>		
<u>Location of Damage:</u> 1. Pit cover (iron)	<u>Degree of Damage:</u> Corroded	<u>Cause of Damage:</u> Wind from sea
Note: a. corrosion of concrete; b. exposure of steel bar; c. corrosion of steel bar		
<u>Remarks</u>

1. Ejectors were replaced by two pumps in 1986. 2. New pumps will be usable for next five years.
