REPUBLIC OF THE PHILIPPINES
DEPARTMENT OF PUBLIC WORKS & HIGHWAYS

Feasibility Study
on
The Rural Road Network Development Project

FINAL REPORT (Volume 3)

APPENDIX

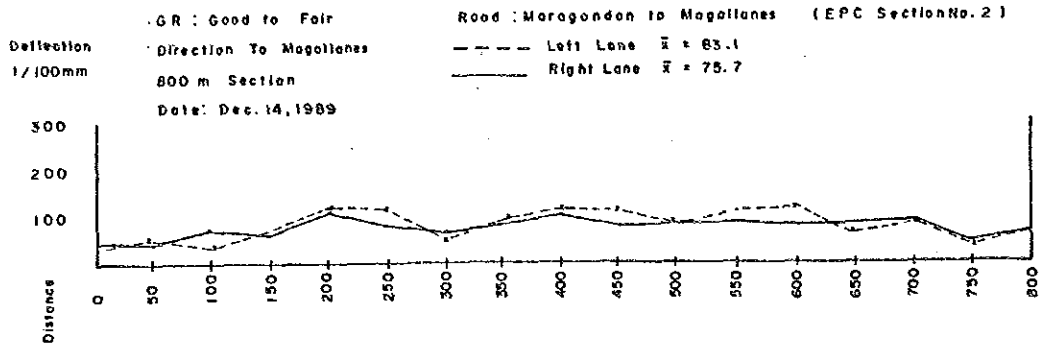
Benkelman Beam Deflection Profile No. 1

Measurement No.	1	2	3
Pavement	Type	GR	GR
	Surface Condition	Good to Fair	Bad
B. B. Deflection Value	Survey length	50 m.	50 m.
	n	12	24
	Max. 0.01 mm	138	218
	Min. 0.01 mm	56	76
	\bar{x} 0.01 mm	86.0	131.5
	σ 0.01 mm	21.6	36.2
	v %	25.2	27.5
Pavement survey Road Section	Provincial Road	Provincial Road	Provincial Road
	Hagallanes to Maragondon (Experimental Pavement Construction Section No. 2)	Hagallanes to Maragondon (Experimental Pavement Construction Section No. 1)	Afonso to Magallanes (Experimental Pavement Construction Section No. 1)
10 m. interval at IHP and OHP on both direction	0-300 to 0-350	0-350 to 0-400	0-400 to 0-450

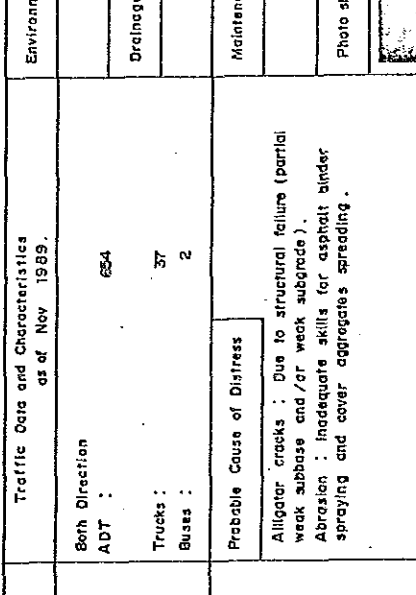
Pavement Material Properties Surface : In some portion, under size and contaminated cover aggregates were used. Base : Well graded aggregates Material W(n) % Max size mm 2.0mm, pass % 32 0.075mm pass %, PI, CBR 8 NP 75		Surface Condition Roughness \bar{x} mm : 5.4 6.0 σ mm : 2.8 2.8 Crack % : 12.0 25.4 Patching % : - - Pothole % : - - Abrasion % : 31.3 9.3 Depression % : - -		Benkelman Beam Deflection (mm) : 24 Range : 118-60 x : 83.8 s : 13.8 v(%) : 16.6		Photo showing representative condition

Subgrade Soil Properties SM and ML W(n) % : 17.9 Max. size mm : 4.75 0.074 mm pass % : 23 LL : NP PL : NP PI : NP CBR : 9		Subbase Crushed stone, sand and silt Silty sand with pea gravel Silty fine sand		Evolution 1. Serviceability Performance 2. Design Adequacy 3. Materials Quality 4. Construction Skills 5. Necessary Measures for Maintenance		Evaluation 1. Fair : Not severely cracked and ravelled, nor depressed surface comfort to bumpy riding surface. 2. If stage construction strategy was planned in this road improvement program, this design would be adequate. 4. Not well trained skills for asphalt binder spraying and cover aggregate spreading. 5. Partial replacement of pavement, then AC overlay.

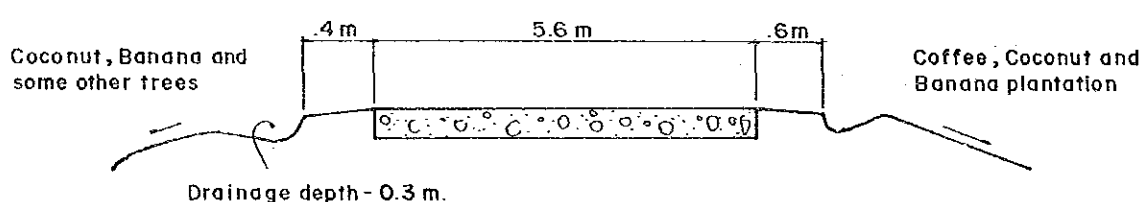
Location : <u>JCT. ALFONSO TO MAGALLANES</u>		Experimental Pavement :	
Province: <u>Cavite</u> Road Classification: <u>Provincial</u>		Section No. <u>1</u> Boring No. <u>2</u>	
Pavement Type <input type="checkbox"/> Earth <input checked="" type="checkbox"/> Gravel <input type="checkbox"/> DBST <input type="checkbox"/> BMP <input type="checkbox"/> AC	Pavement Existing Condition Rating (Visual) <input type="checkbox"/> Very Good Gravel surface condition bad due to some deformation and irregularities of surfacing <input type="checkbox"/> Good <input type="checkbox"/> Fair <input checked="" type="checkbox"/> Bad <input type="checkbox"/> Very Bad		
Traffic Data and Characteristics as of <u>November 1989</u> AADT 106 Trucks 7 Buses 0	Construction Year Maintenance History / Operation Once a year grading operation		
Road Cross-Section

<p style="text-align: center;">Drainage depth - 0.3 m.</p>

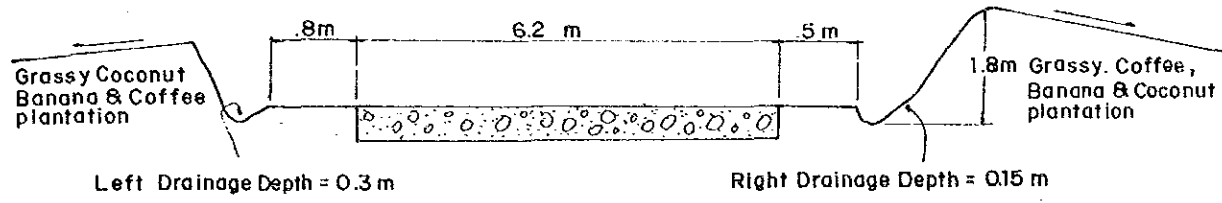
Location : <u>JCT. ALFONSO TO MAGALLANES</u>		Experimental Pavement :	
Province: <u>Cavite</u> Road Classification: <u>Provincial</u>		Section No. <u>1</u> Boring No. <u>3</u>	
Pavement Type <input type="checkbox"/> Earth <input checked="" type="checkbox"/> Gravel <input type="checkbox"/> DBST <input type="checkbox"/> BMP <input type="checkbox"/> AC	Pavement Existing Condition Rating (Visual) <input type="checkbox"/> Very Good Surface generally deformed & irregularities of surfacing <input type="checkbox"/> Good <input type="checkbox"/> Fair <input checked="" type="checkbox"/> Bad <input type="checkbox"/> Very Bad		
Traffic Data and Characteristics as of <u>November 1989</u> AADT 106 Trucks 7 Buses 0	Construction Year Maintenance History / Operation Once a year grading operation		
Road Cross-Section

<p style="text-align: center;">Left Drainage Depth = 0.3 m Right Drainage Depth = 0.15 m</p>

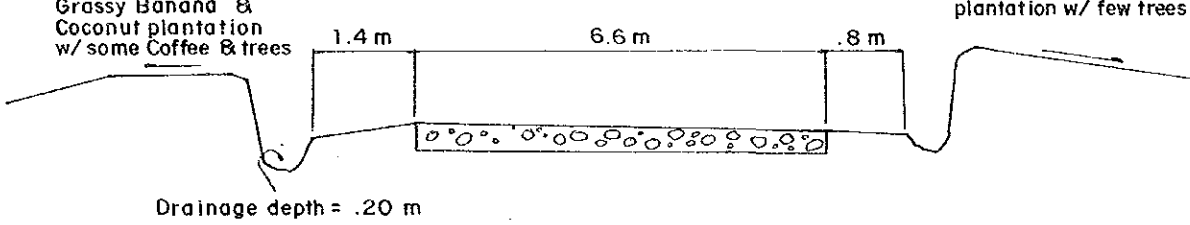
Location : <u>JCT. ALFONSO TO MAGALLANES</u>		Experimental Pavement :	
Province: <u>Cavite</u> Road Classification: <u>Provincial</u>		Section No. <u>1</u> Boring No. <u>5</u>	
Pavement Type <input type="checkbox"/> Earth <input checked="" type="checkbox"/> Gravel <input type="checkbox"/> DBST <input type="checkbox"/> BMP <input type="checkbox"/> AC	Pavement Existing Condition Rating (Visual) <input type="checkbox"/> Very Good Surface condition generally deformed & irregularities of surfacing <input type="checkbox"/> Good <input type="checkbox"/> Fair <input checked="" type="checkbox"/> Bad <input type="checkbox"/> Very Bad		
Traffic Data and Characteristics as of <u>November 1989</u> AADT 106 Trucks 7 Buses 0		Construction Year Maintenance History / Operation Once a year grading operation	
Road Cross-Section Grassy Banana & Coconut plantation w/ some Coffee & trees 1.4 m 6.6 m .8 m Grassy Banana & Coconut plantation w/ few trees

Drainage depth = .20 m

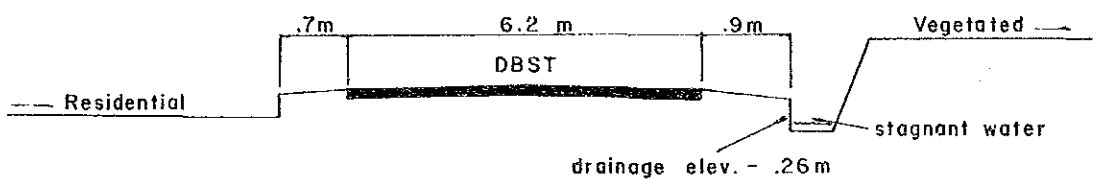
Location : <u>GEN. TRIAS TO AMADEO</u>		Experimental Pavement :																						
Province : <u>Cavite</u> Road Classification : <u>Provincial</u>		Section No. <u>3</u> Boring No. <u>8</u>																						
Pavement Type <input type="checkbox"/> Earth <input type="checkbox"/> Gravel <input checked="" type="checkbox"/> DBST <input type="checkbox"/> BMP <input type="checkbox"/> AC	Pavement Existing Condition Rating (Visual) <input type="checkbox"/> Very Good Surface condition has some <input type="checkbox"/> Good alligator cracks <input checked="" type="checkbox"/> Fair <input checked="" type="checkbox"/> Bad <input type="checkbox"/> Very Bad																							
Traffic Data and Characteristics as of <u>November 1989</u> AADT 654 Trucks 37 Buses 2	Construction Year Maintenance History / Operation																							
Road Cross-Section

<p style="text-align: center;"> .7m 6.2 m .9m Vegetated </p> <p style="text-align: center;"> Residential DBST stagnant water </p> <p style="text-align: center;">drainage elev. - .26m</p>

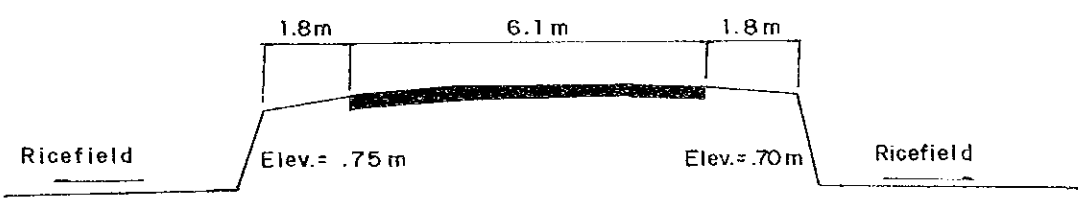
Location : <u>GEN. TRIAS TO AMADEO</u>		Experimental Pavement :																																	
Province : <u>Cavite</u> Road Classification : <u>Provincial</u>		Section No. <u>4</u> Boring No. <u>5</u>																																	
Pavement Type <input type="checkbox"/> Earth <input type="checkbox"/> Gravel <input checked="" type="checkbox"/> DBST <input type="checkbox"/> BMP <input type="checkbox"/> AC	Pavement Existing Condition Rating (Visual) <input type="checkbox"/> Very Good <input type="checkbox"/> Good <input checked="" type="checkbox"/> Fair <input checked="" type="checkbox"/> Bad <input type="checkbox"/> Very Bad Surface condition has some alligator cracks and deformation due to structural failure ; Deflection are observed when trucks and loaded jeepneys are passes by.																																		
Traffic Data and Characteristics as of <u>November 1989</u> AADT 654 Trucks 37 Buses 2		Construction Year Maintenance History / Operation Pothole patching of crushed aggregate

Pavement Cross -Section <table style="width: 100%; border-collapse: collapse;"> <tr> <td style="border-bottom: 1px solid black; width: 150px;">Surface</td> <td style="width: 100px;">DBST</td> </tr> <tr> <td style="border-bottom: 1px solid black;">Base</td> <td>16 mm</td> </tr> <tr> <td style="border-bottom: 1px solid black;">Subgrade</td> <td>20 cm</td> </tr> </table>		Surface	DBST	Base	16 mm	Subgrade	20 cm	Environmental Condition Both side ricefield Flat terrain ; Fill section																											
Surface	DBST																																		
Base	16 mm																																		
Subgrade	20 cm																																		
Subgrade Soil Soil Classification <table style="width: 100%; border-collapse: collapse;"> <tr> <td colspan="4">W (n)</td> </tr> <tr> <td>Max. size</td> <td>mm</td> <td>=</td> <td>19</td> </tr> <tr> <td>0.075 mm pass</td> <td>%</td> <td>=</td> <td>36</td> </tr> <tr> <td></td> <td>LL</td> <td>=</td> <td>NP</td> </tr> <tr> <td></td> <td>PL</td> <td>=</td> <td>-</td> </tr> <tr> <td></td> <td>PI</td> <td>=</td> <td>NP</td> </tr> <tr> <td colspan="2">Soaked CBR</td> <td>=</td> <td>3</td> </tr> </table>		W (n)				Max. size	mm	=	19	0.075 mm pass	%	=	36		LL	=	NP		PL	=	-		PI	=	NP	Soaked CBR		=	3	Drainage Condition Bad due to grassy side ditch is no longer effective
