**REPORT OF JAPAN DISASTER RELIEF TEAM
ON
EARTHQUAKE AT SPITAK, ARMENIA, USSR**

FEBRUARY 1990

**JAPAN INTERNATIONAL COOPERATION AGENCY
(JICA)**

JICA (Japan International Cooperation Agency), on behalf of the Japanese Government, dispatched a JDR (Japan Disaster Relief Team) from 18th to 28th December, 1988, to conduct a survey of the damage of Spitak Earthquake and to advise engineer and officials of Armenia SSR and USSR the technical know-how for the rehabilitation and restoration measures to be taken in the damaged area.

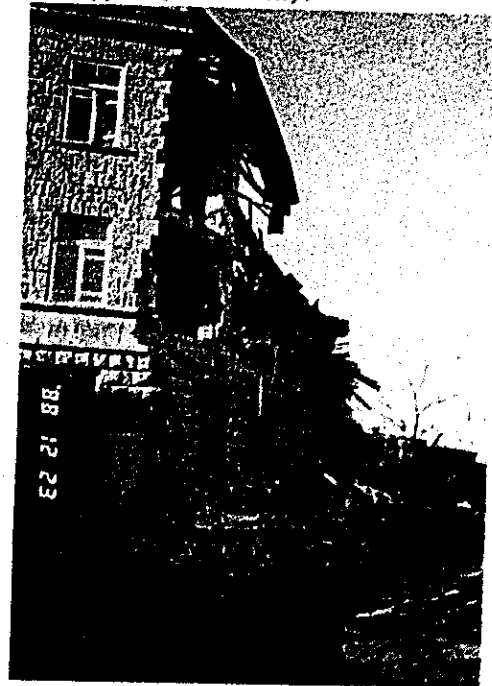
Photograph 3.1.35
Wall material has dropped from the gable at the front porch provided in the longer side of a building. The top of the wall was not reinforced and appeared to have been peeled off by an external force. Similar damages seen in many other buildings. The walls are of filled type and have suffered little damage (Leninakan). The shape of stone material can be seen from the photograph.

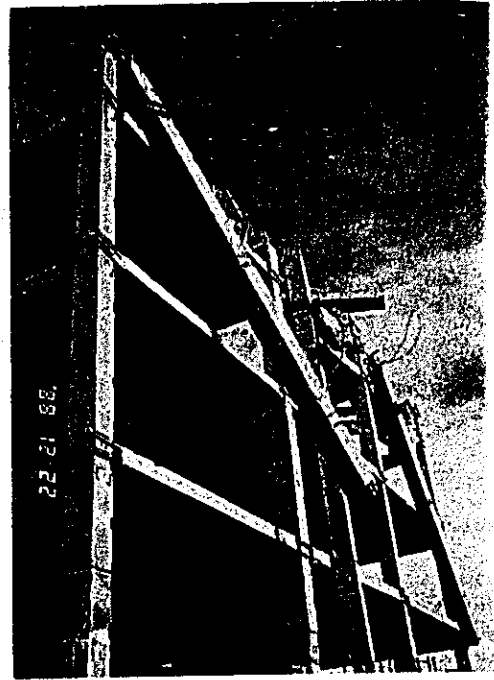
Photograph 3.1.54

An apartment house destroyed during construction. Some precast pillar members have fallen down in the same direction. Precast exterior material is attached to the outer faces of structural members. The building is estimated to have been a nine-storied one, but the cross-sectional dimensions of the pillar members are 40cm x 40cm even in the first story (Leninakan).

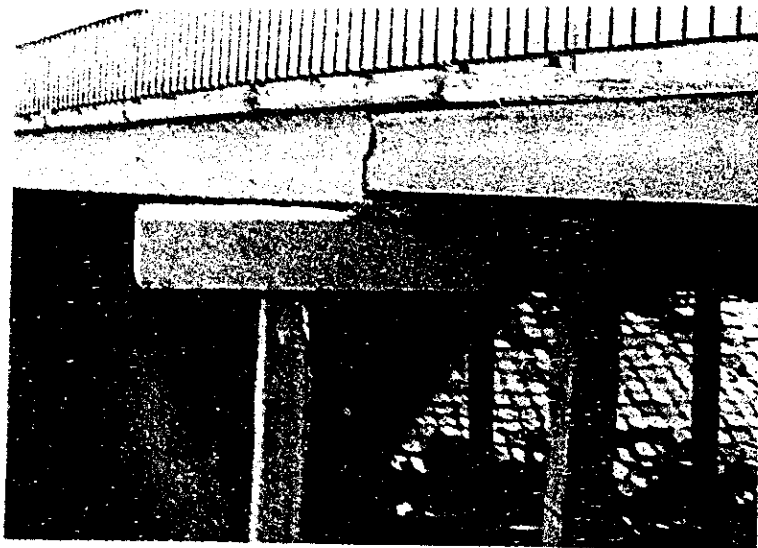
Photograph 3.2.1: Elevated Bridge under Construction (Spitak)
 Cross beams are installed on precast piers to form a frame, on which pretensioned girders are laid. Some of the piers on the left are inclined irregularly. Of the bridges surveyed, this one had the smallest cross section.

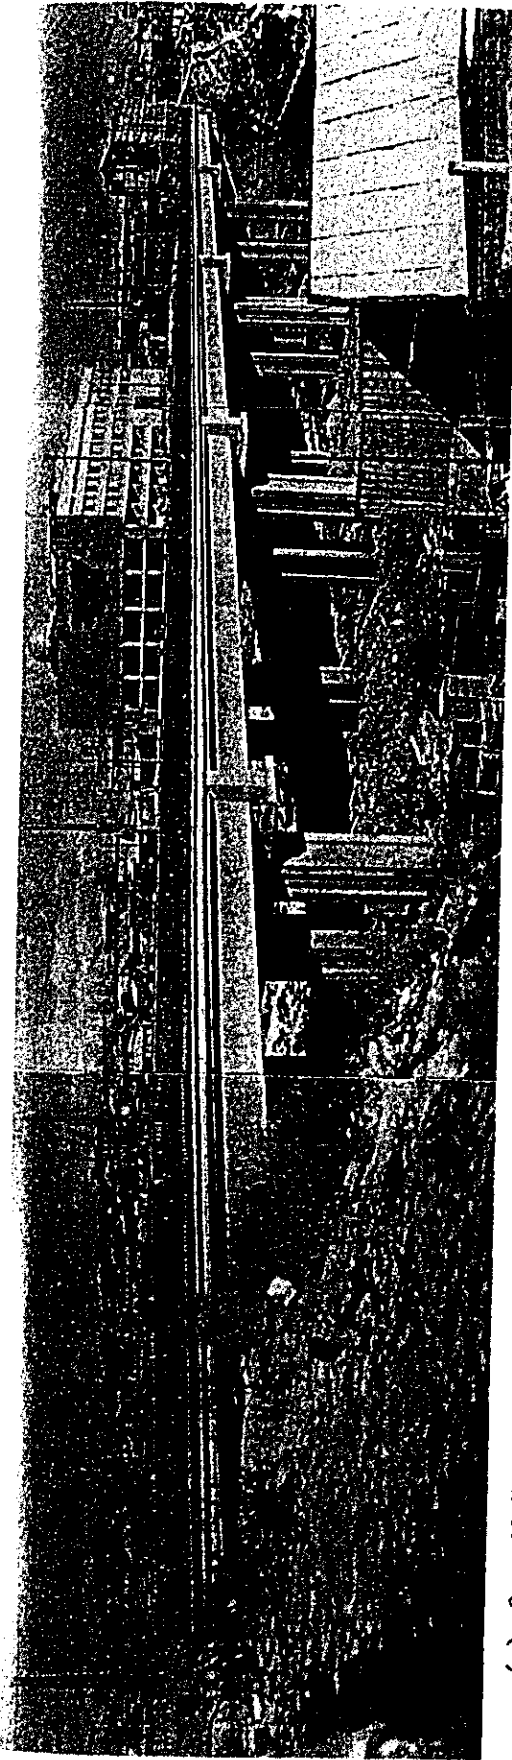
Photograph 3.2.3: Bridge across River (undamaged, Leninakan)

(a) Overall View

The five-span simple bridge is almost free of damage except for displacement of about 7cm perpendicular to the bridge axis.

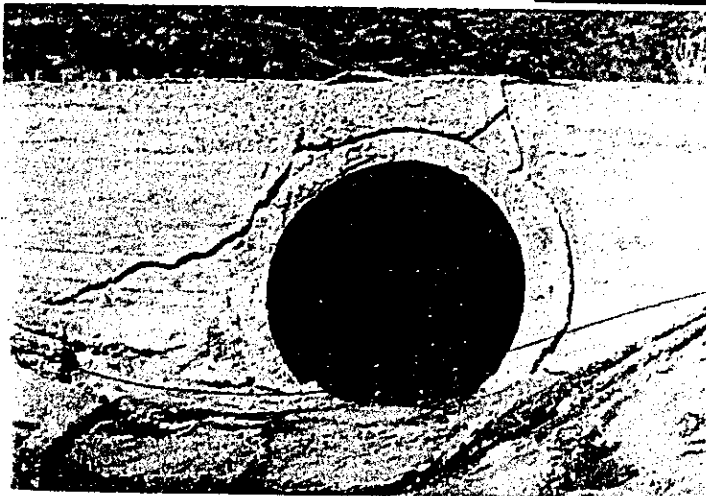
(a) Mouth

Photograph 3.2.8: Damaged Culvert under Road (Spitak)
 This culvert was installed through the banking of the road under construction cited in Photograph 3.2.6. The slippage in the banking caused a gap between the culvert and the breast-wall.

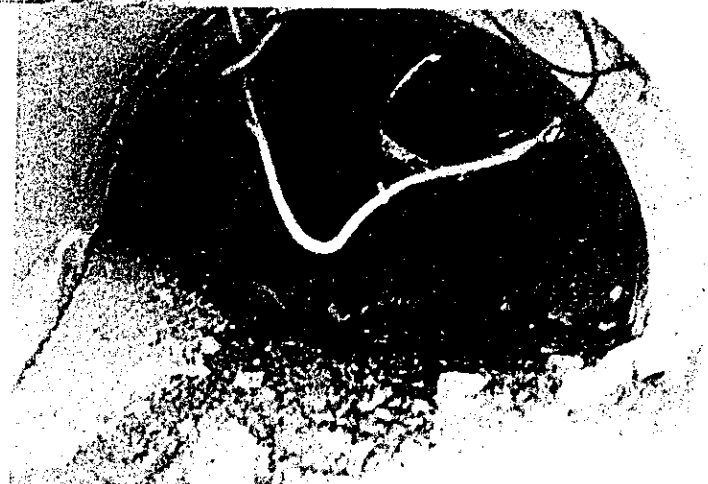
(b) Inside

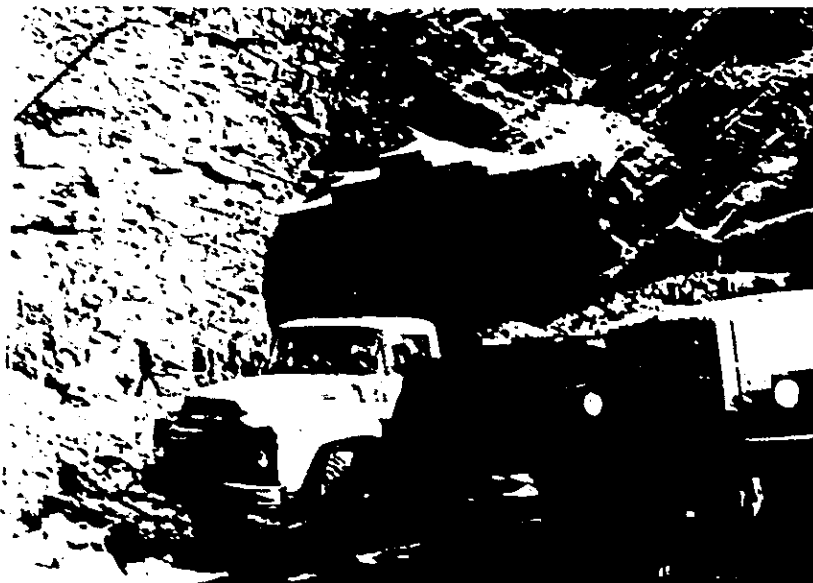
Photograph 3.2.16 Crack at Mouth of Railroad Tunnel (suburban Spitak)
 Restoration work is under way. Damage seemed to have occurred inside the tunnel though railroad service had reopened.

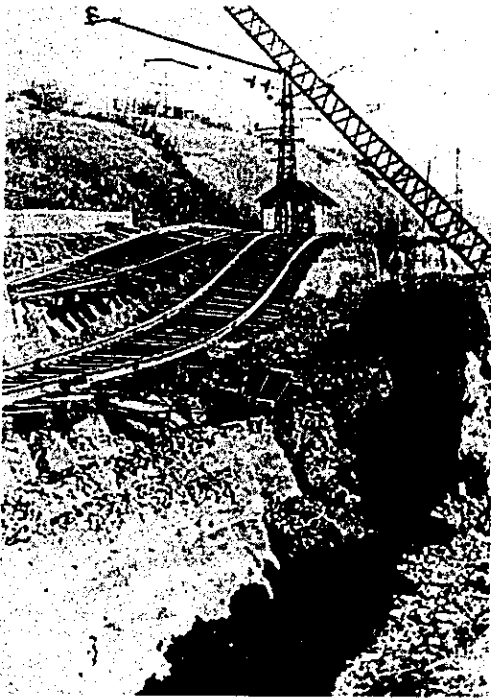
Photograph 3.2.17: Damaged Railroad (photographed by Soviet expert immediately after the earthquake)

(a) The hill in the left appears to be a river terrace. The bank in the low area slipped to destroy the track.

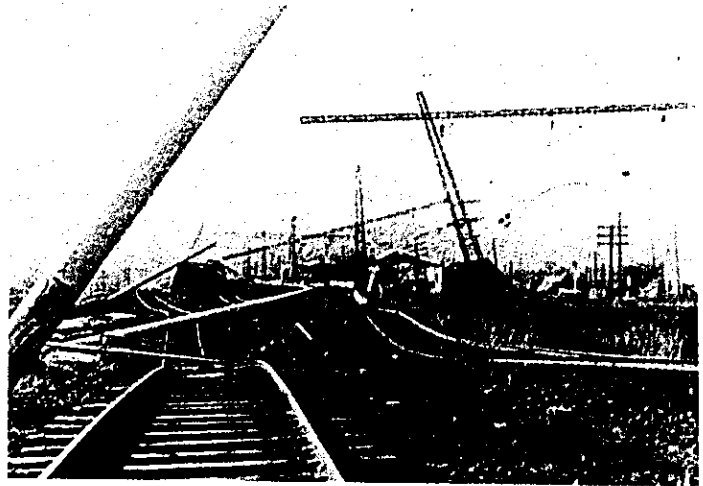
(b) The track is heavily damaged and rails are largely deformed. A train (probably freight train) is also largely inclined. All poles for aerial line and signs have fallen down, reflecting the serious disaster immediately after the earthquake.

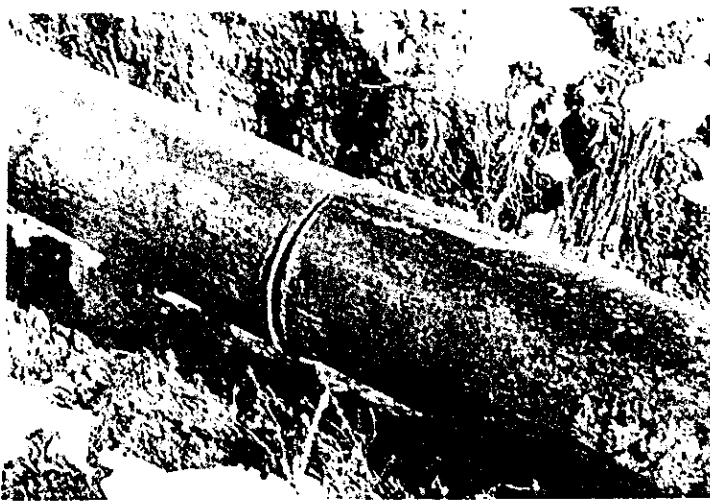
(a) Damaged Weld (approximately 25cm in diameter).
