**BASIC DESIGN STUDY REPORT
ON
THE PROJECT
FOR
REHABILITATION OF CYCLONE-DAMAGED PORTS
AND
CONSTRUCTION OF QUARRY PLANT
IN
WESTERN SAMOA**

November, 1990

JAPAN INTERNATIONAL COOPERATION AGENCY

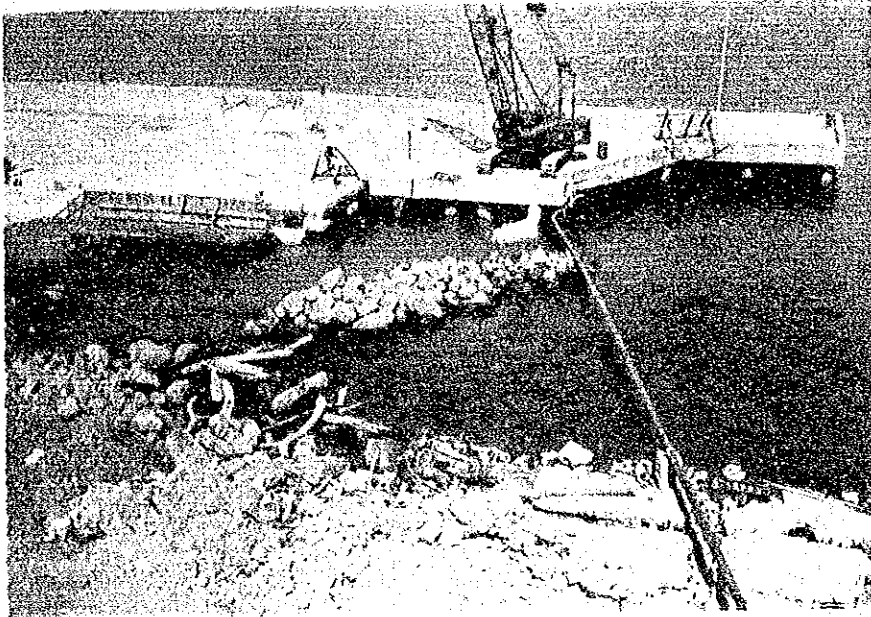
Cyclone-damages
in Apia Port

The causeway has
been washed away
and access to the
main wharf is lost.

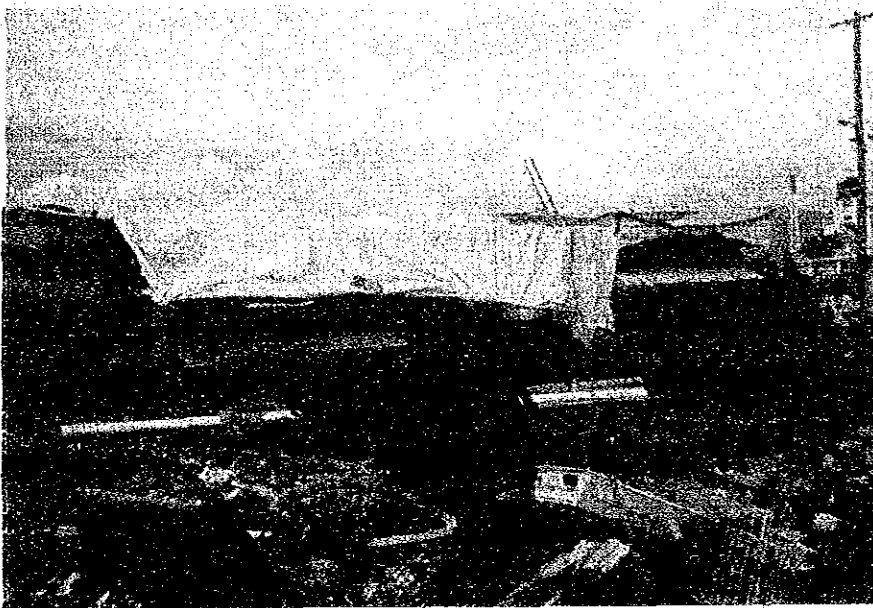
The Marine Office
has been damaged
beyond repair.

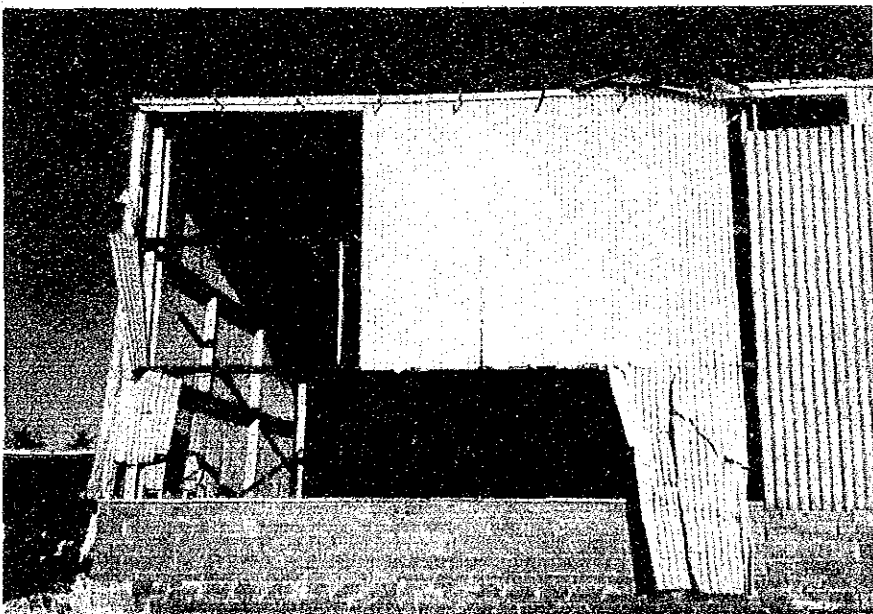
The Shed No.3 has
been damaged on
its roof and wall
and is partly
unserviceable

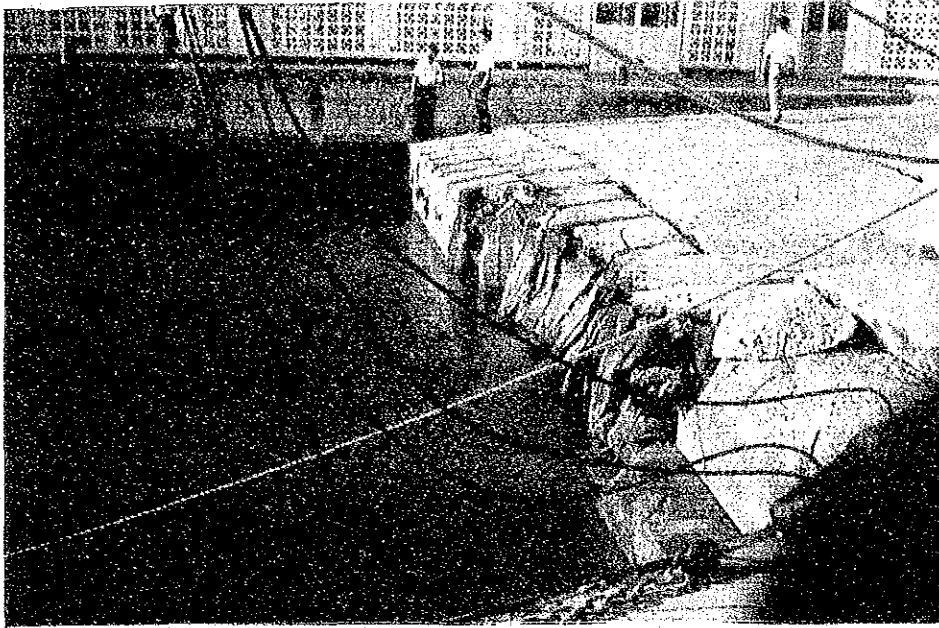
Cyclone-Damages
in Mulifanua Port.

The ferry ramp
has been damaged
on its concrete
coping and apron.

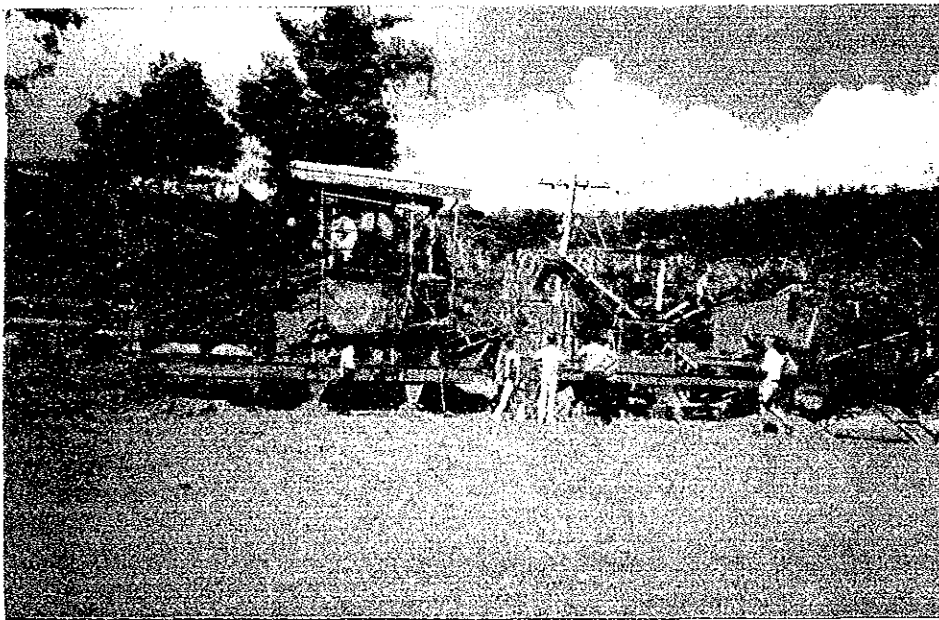
The Existing
crusher in Alafua
is out of operation
due to serious
deterioration.

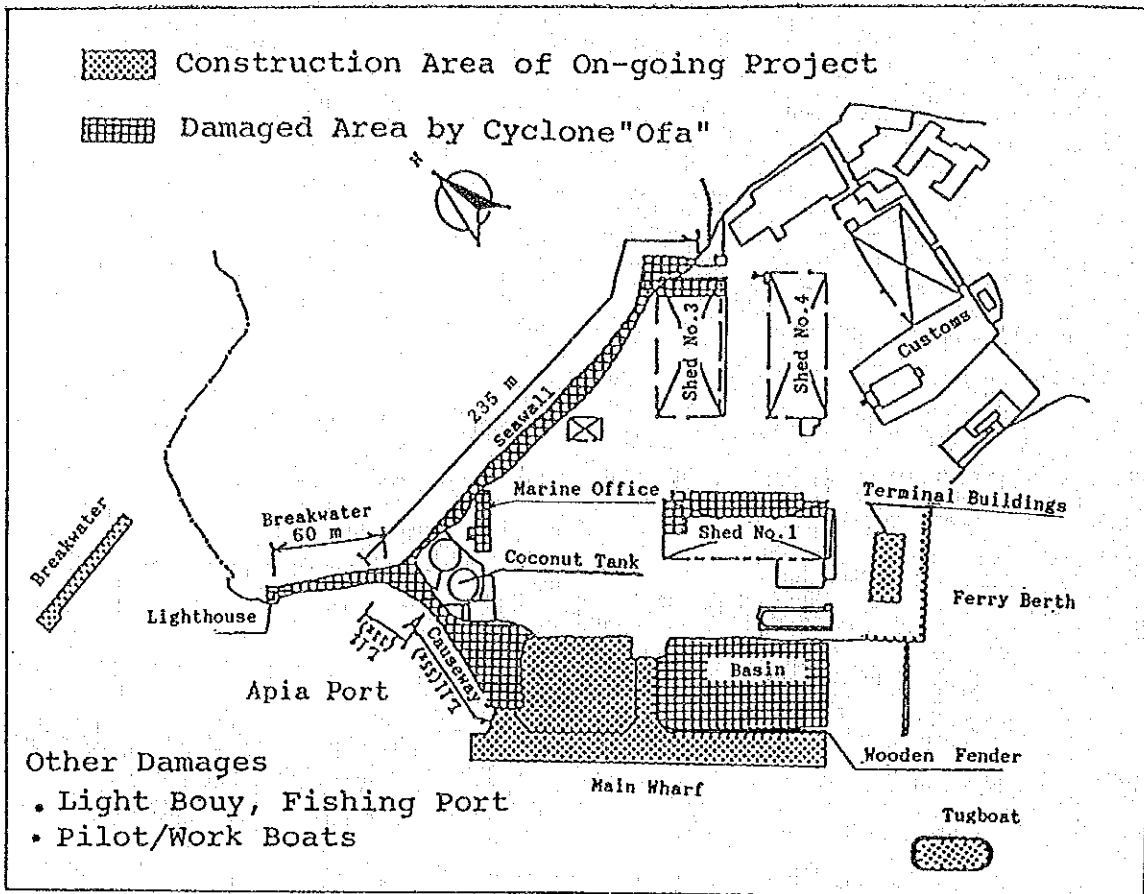
Fig. 2-12 Cyclone Damages, Apia Port

Back-filling material along the entire length of the causeway connecting the main wharf and the container yard was completely lost due to waves at the time of the cyclone. Armour stone weighing 1 ton covering the slope of the causeway were pushed inwards up to 20 m. Part of the back fill material in the reclamation area has been moved to and deposited in the small boat basin at the back of the main wharf. The causeway was scoured about 1 m below sea level and completely lost its function as a connecting road.

The overflow of waves during the cyclone washed away the back-filling material of the revetment, destroyed the slope and moved armour stones weighing between 500 kg and 1 ton inwards by a maximum of 10 m. The copra shed located near the causeway has been demolished, as the foundation was scoured and the shed was seriously damaged beyond repair.

The entire breakwater was washed away by the waves caused by the cyclone and armour stones of 500 kg - 1 ton were moved scattering on the toe of the slope of the causeway.

Of the 3 sheds, the sheds No. 1 and No. 3 directly subjected to the strong wind were seriously damaged. In the case of the shed No. 1, the roofing materials on the north and west sides were blown off. The north wall and roof of the No. 3 shed were also blown off. In addition, containers stored in the shed No. 3 were moved and damaged the pillars of the shed. The damage to the northernmost part of the shed No. 3 was serious and this part is no longer in use for cargo storage. In those places where the damage is not so serious, vinyl sheets are being used to cover cargoes. As the doors to the sheds were also damaged, security against pilferage becomes serious.

The wooden fender installed along the back of the eastern side of the main wharf to moor such small boats as tug boats consists of wooden piles of 30 cm in diameter placed at intervals of 3 m, connected by wooden beams at the top and fixed to the concrete apron by bolts. The fender shows signs of deterioration due to natural aging and is damaged by the cyclone. Two wooden piles were broken and about one third of the beams on the east side were either lost or deformed, requiring urgent repair.

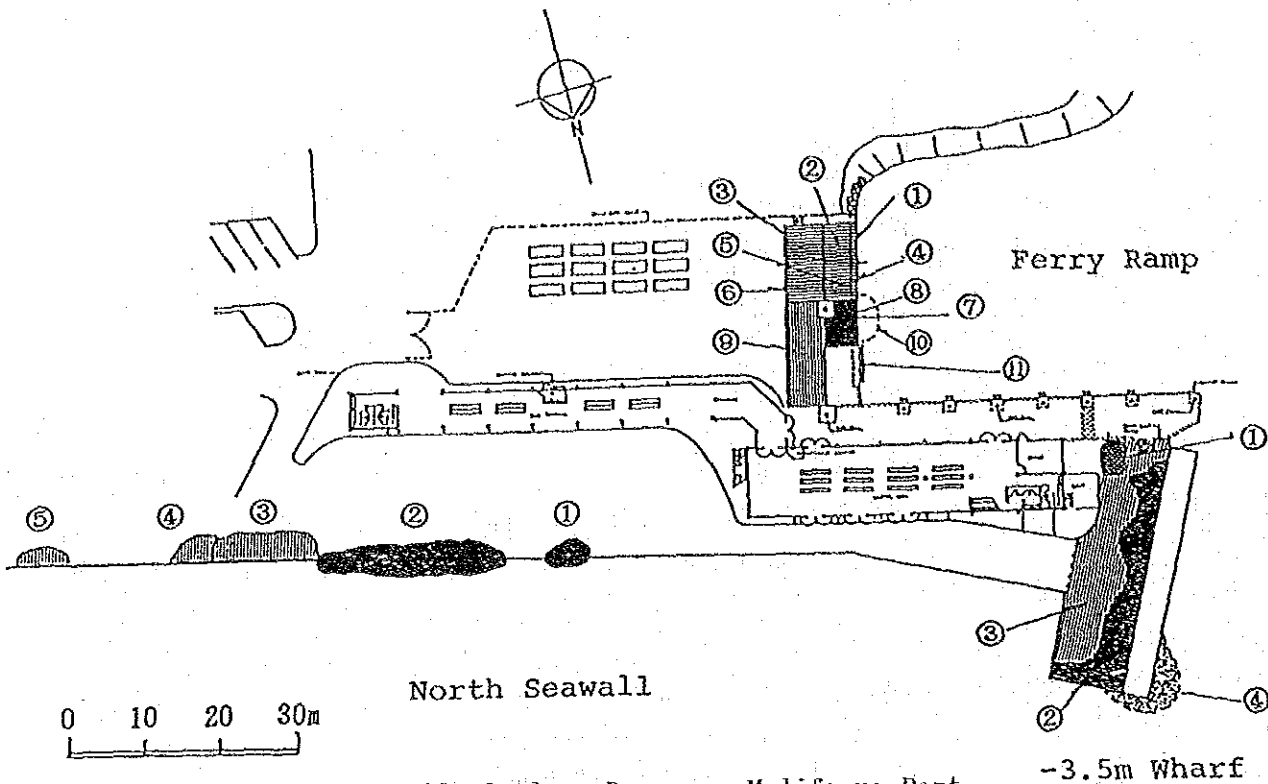
Fig. 2-13 Cyclone Damages, Mulifanua Port

The ferry ramp was damaged in the upper section of the sheet pile structure and the concrete apron behind it due to grounding of the ferry boat, the Lady Samoa II which mooring ropes were cut by the strong wind at the time of the cyclone. The concrete coping was lost for the section of about 5 m, exposing top of the sheet piles and the back-filling material of the ferry ramp was washed away.

The sheet piles were pushed inland by a maximum of 1 m and were buckled. The slabs were broken by the ship load and subsided by a maximum of 50 cm. The space under the slab, including the section of a gravity type, becomes hollow.

Ferry Ramp		Damage
Section 1	Concrete block	Small displacement, not serious
2,3	Concrete apron	Subsidence of 10-20 cm, cavity underneath
4	Concrete block	Displacement of 40-50 cm
5,6	Concrete apron	Displacement of 40-50 cm, subsidence of 10-20 cm
7	Concrete coping	Buckling of pile head, displacement of 50 cm
8	Concrete apron	Subsidence of 50 cm for 5 m section
9	Concrete apron	Cavity of 10-20 cm
10	Backfill sand	Washed away and deposited in front of ramp
11	Rubber fender	Suspending with fixing bolts broken
-3.5 m Wharf		Damage
Section 1	Oil tank	Unserviceable with foundation damaged
2	Concrete apron	Broken into pieces and subsided about 1.0 m
3	Concrete apron	Broken with many cracks
4	Backfill scoria	Scoured and deposited in front of wharf
Seawall		Damage
Section 1		Damaged and subsided about 1.0 m
2		Concrete pavement broken 5 m in width
3		Concrete pavement broken 5 m in width
4		Concrete pavement cracked

All 8 concrete piles have cracked at the joints with the upper concrete deck.

While no cracks are observed on the concrete deck, uneven subsidence has taken place resulting in disjoints of up to 5 cm. The central part of the deck has subsided and the deck generally tilts towards the sea.

A 3 m concrete pavement immediately behind the deck was broken into pieces by the lifting force of the waves. The pavement further behind it suffered only minor damage but shows many cracks. The wharf is much damaged at the seaward end and the concrete slabs have fallen into the sea.

The concrete beams retaining backfill were damaged by waves and some fell down onto the front rubble slope. A 3 m section immediately behind the deck and at the end of the wharf were seriously damaged with most of them broken.

The concrete foundation for the oil tank located at the back of the wharf and used by ferry boats was damaged and caused the tank unserviceable. The revetment next to the -3.5 m wharf was seriously damaged as it was directly subject to the waves. The wooden office built on the slope of the revetment was completely washed away. One lane of a 50 m section of the concrete paved road behind the revetment was broken.

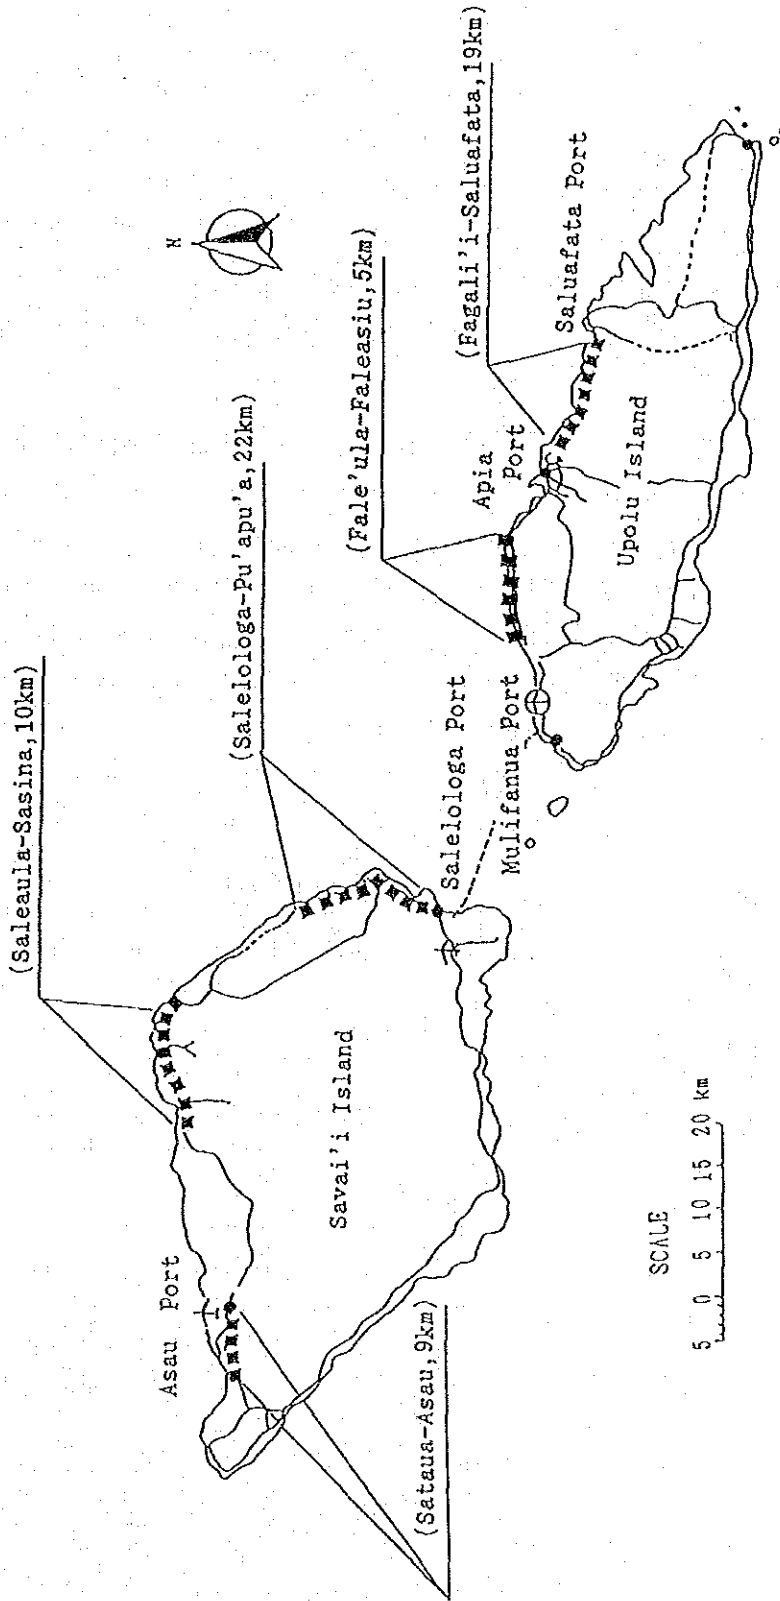
Fig. 2-14 Damaged Road Section

The 19 km section between Moataa at the eastern end of Apia city and Saluafata was seriously damaged because of its proximity to the coast and low ground level. Both seawall and road were washed away, leaving boulders, coral and gravel scattered. All the 6 bridges located in this section are in a dangerous situation with their piers scoured.

The ground elevation of this section is less than 1 m above sea level and the damage was severe in the section between Faleasiu and Fasitoouta in the Mulifanua side where no seawall was provided. The road and land at the back in this section were scoured by about 10 m in width and 1.5 m in depth. Construction of new road is necessary for a 2 km section while seawall and road shoulder should be reconstructed for a 3 km section.

The road along the north coast of Savaii Island suffered from extensive damage for a total length of 35 km consisting of a 10 km section between Tuasivi and Puapua, a 15 km section between Saleaula and Sasina, a 15 km section between Saleaula and Sasina, a 9 km section between Sataua and Asau and a 1 km section of the south coast road.

Of the 35 km of damaged road, construction of a new road is required for 15 km and a major repair work is required for 12 km. Complete repavement is also required for the remaining 8 km. At some points, the coastline has retreated up to 100 m inland and, therefore, a new road has to be constructed several hundred meters back from the present coastline to avoid damages by cyclone waves in future. The damages of road in Savaii Island are summarized below.
