*THE STUDY ON
LANDSLIDE PROTECTION PROJECT
IN PORT LOUIS*

*FINAL REPORT
EXECUTIVE SUMMARY*

NOVEMBER 1990

JAPAN INTERNATIONAL COOPERATION AGENCY

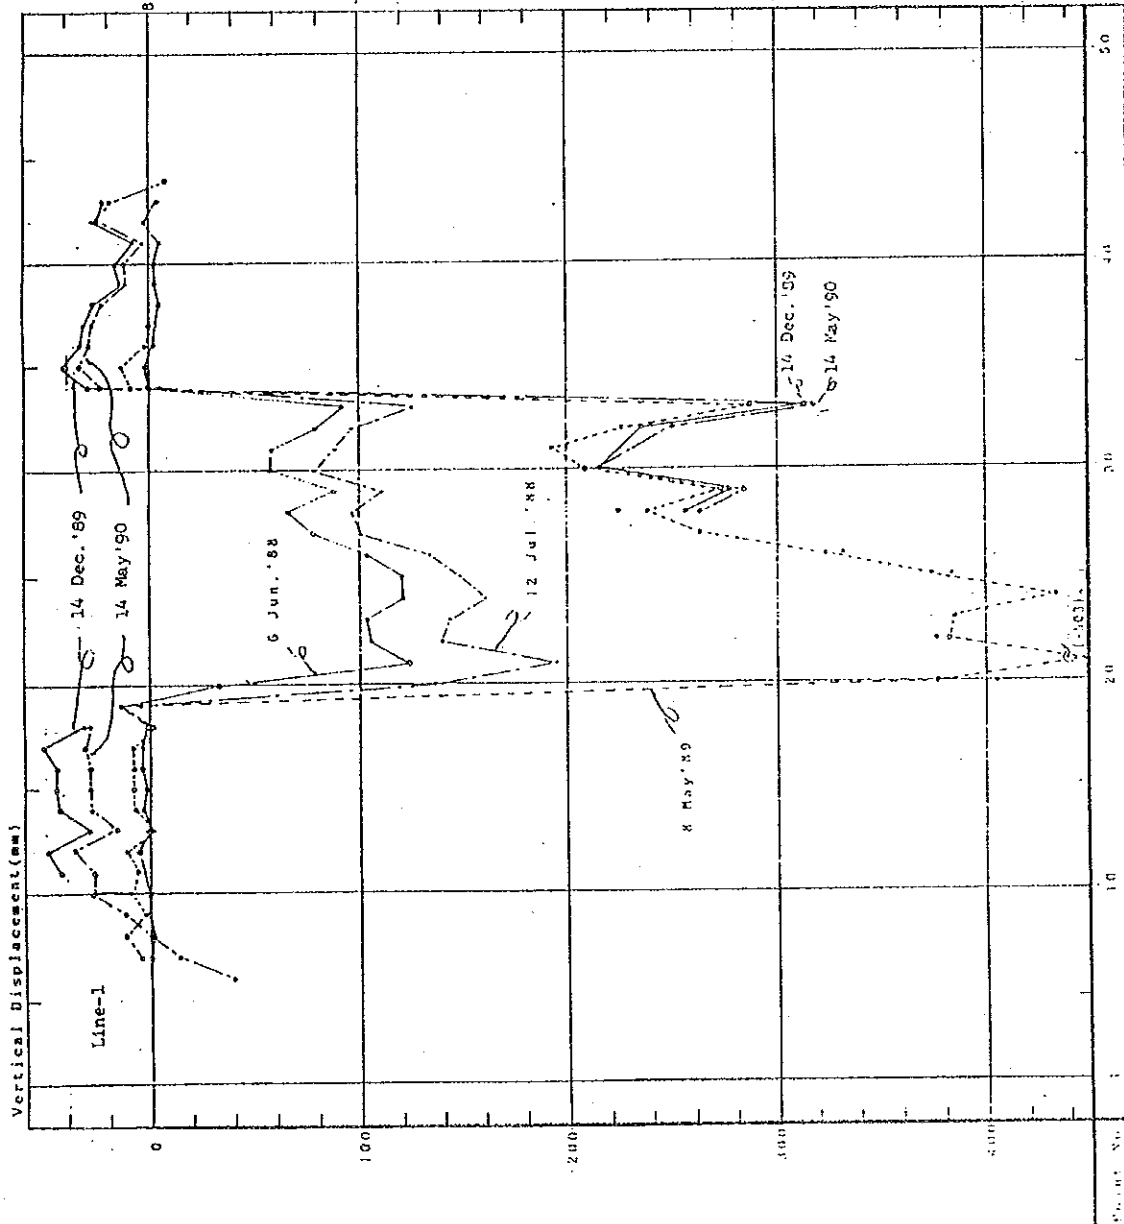
Fig. 2.3

More than 400 mm of subsidence of ground surface was measured along the leveling survey line-1 in the southwestern part of the landslide in May 1989. However, no further subsidence was measured in the following period which decreased rainfall. The location of leveling survey lines is indicated in Fig.2.2 and graphs of the subsidence is shown in Fig.2.3. Diminishing subsidence was believed to be due not only to decreasing rainfall but also to the effect of soil removal which was carried out as an urgent protective measure at the end of 1989.

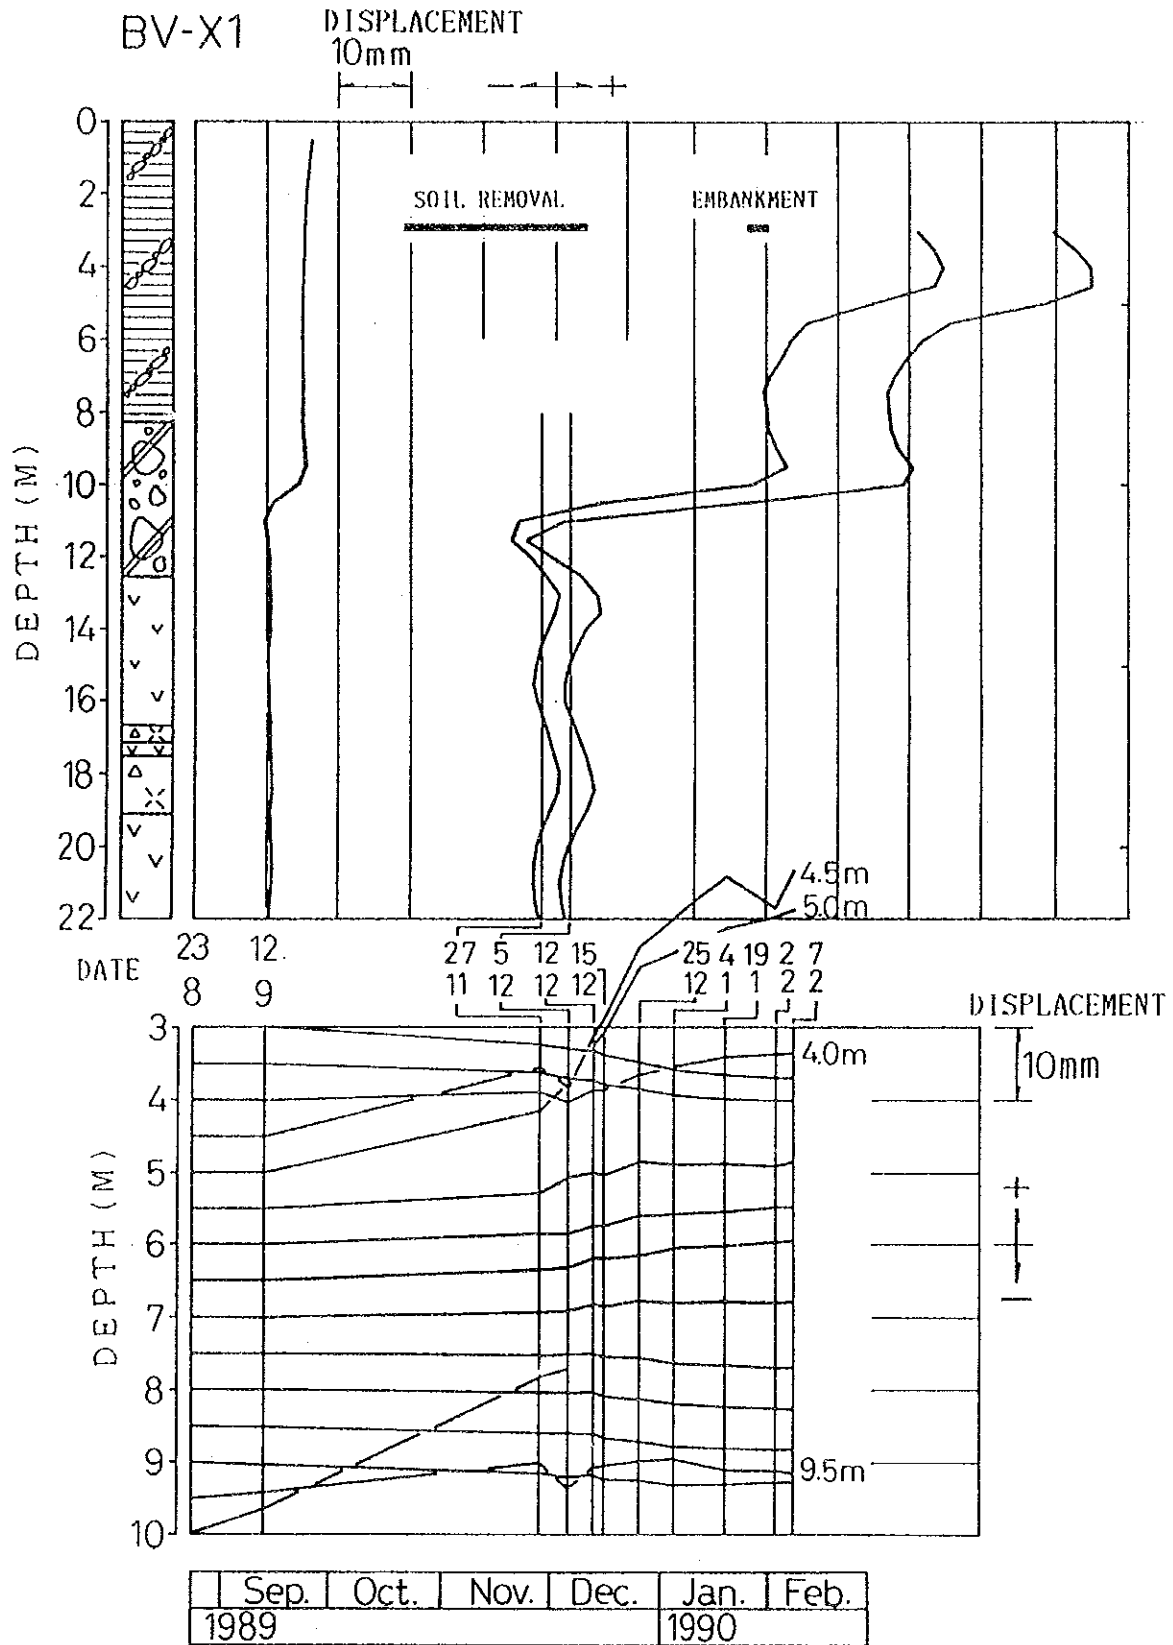
As for landslide monitoring data, slight shearing displacements were interpreted in the records from boreholes in the eastern part of landslide but intensive shearing displacements were measured in the records of the borehole BV-X1 in the lower slopes of extensometer E-3. A small landslide, 60 m x 80 m, occurred along a secondarily developed slide surface in the lower slopes below E-3. This small landslide was believed to have been triggered by soil removal work. Records of the borehole inclinometer in borehole BV-X1 are shown in Fig.2.13.

Monitoring records from extensometer E-3 indicated some intensive displacements possibly caused by a small secondary landslide in the slope below E-3. The small landslide was believed to have been triggered by the soil removal conducted in the period between the end of October 1989 and the middle of December 1989. Very large shearing displacements were interpreted by the borehole inclinometer in the borehole BV-X1 at depths of 5.0 m and 10.5 m. The records of borehole inclinometer are shown in Fig.2.13.

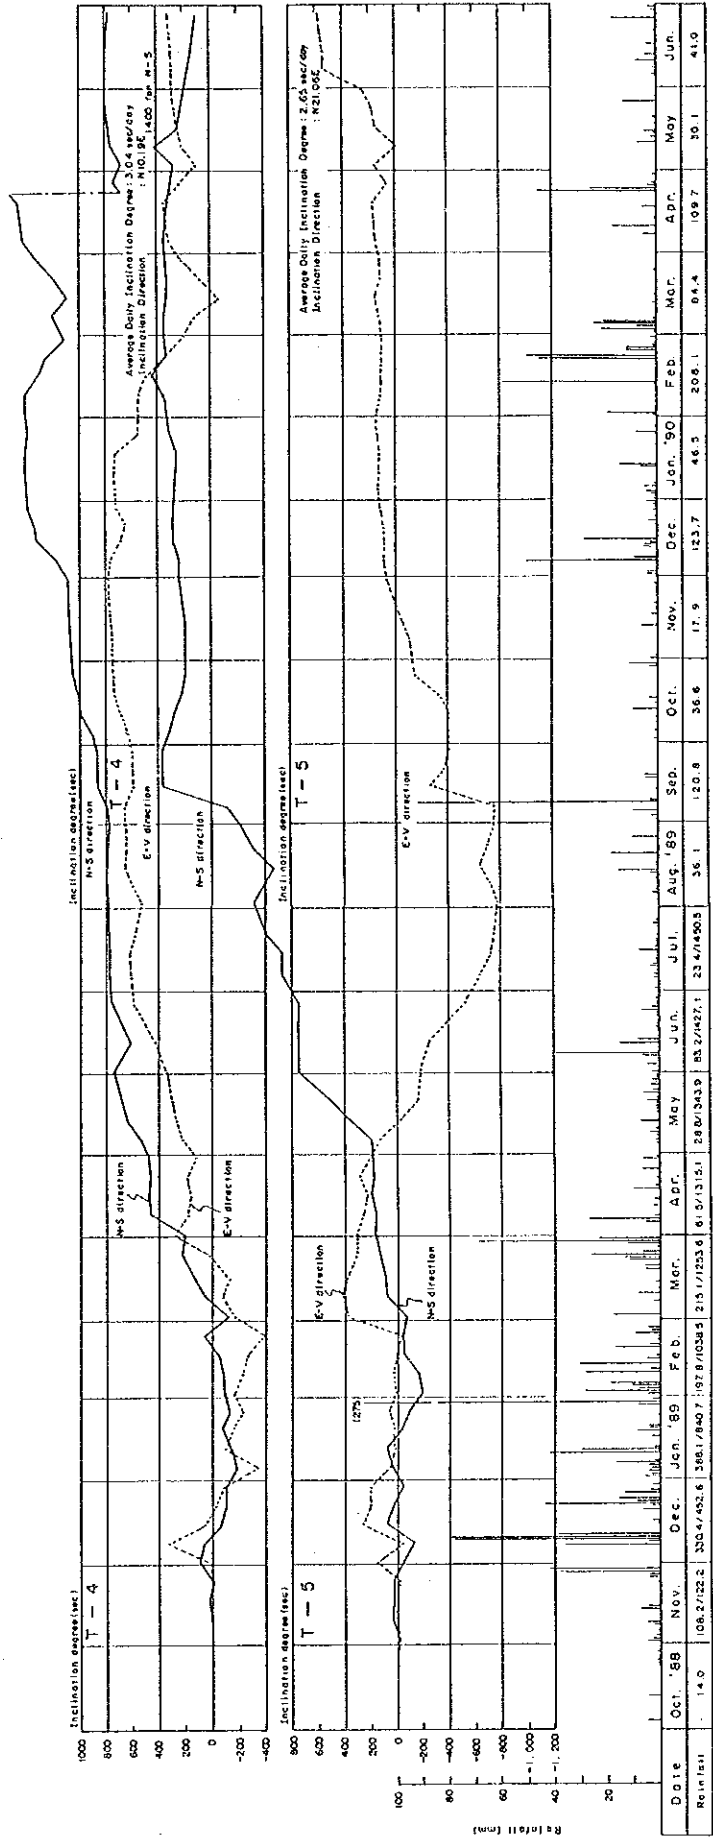
Fig. 2.14

Tilting movements of the ground surface had been measured by the seven tiltmeters installed in and around the landslide area. A relatively clear accumulating tendency to N-S movement was interpreted in the records from the tiltmeters T-4 and T-6 were installed in the eastern part of the landslide. Measurement records of tiltmeters T-4 and T-6 are shown in Figs.2.14 and 2.15.

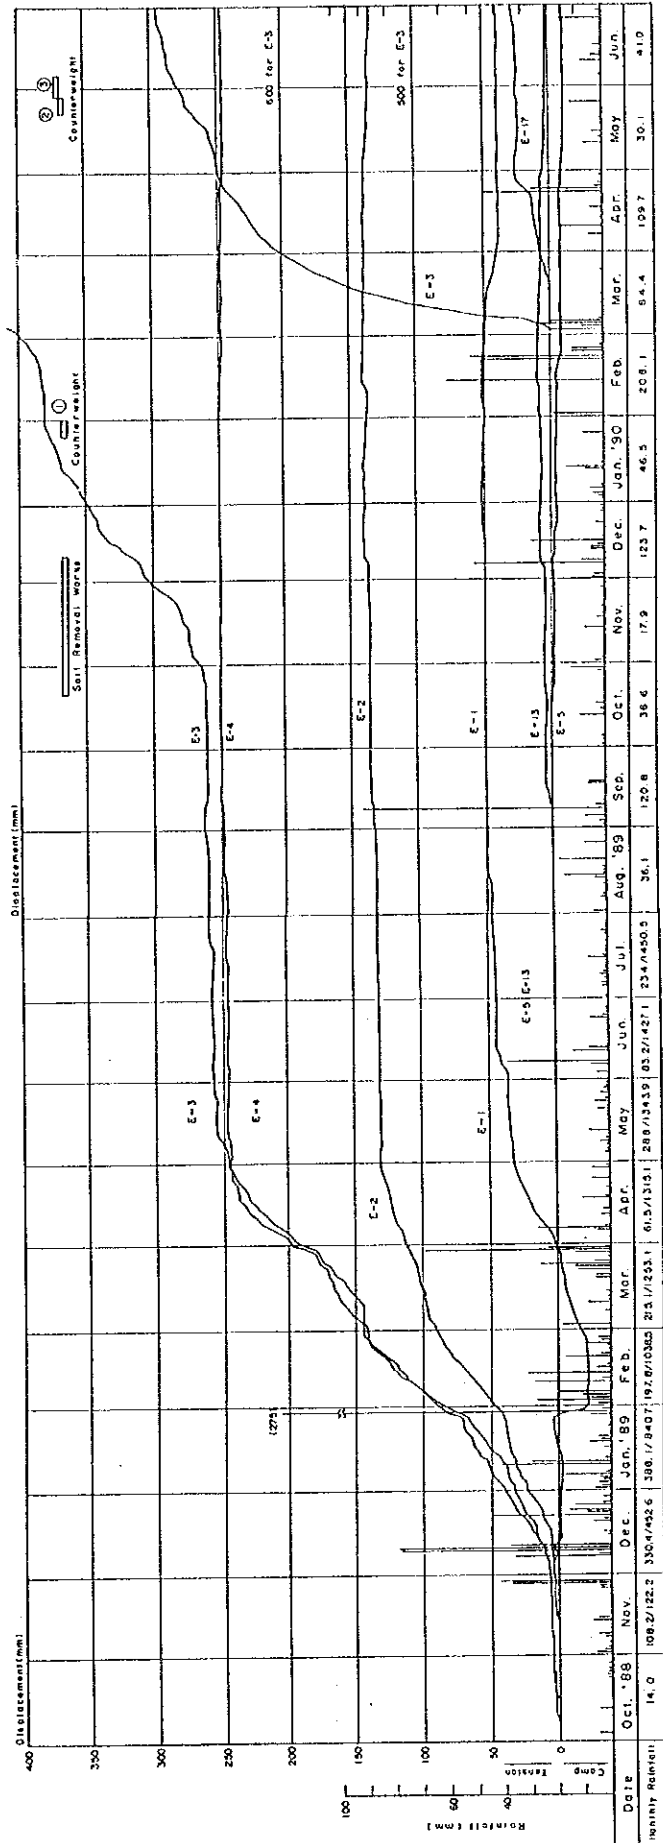
Fig. 2.16

Since recording large displacements in the 1988-9 rainy season, the extensometers have not indicated any significant movement except for records from extensometer E-3. Movements of the small secondary landslide had been recorded by E-3 since October 1989 during soil removal work which was undertaken as an urgent protective measure.

To stop the movement counterweight embankments were constructed both at the end of January 1990 and at the end of May 1990. Intensive displacement amounting to as much as 6.5 mm/day was halted by these counterweight treatments, but further movements expected after heavy continuous rainfall. For protective against future landslide movements, deterrent works composed of steel piling works are planned for long term protective. Displacement records from the extensometers are shown in Figs.2.16.

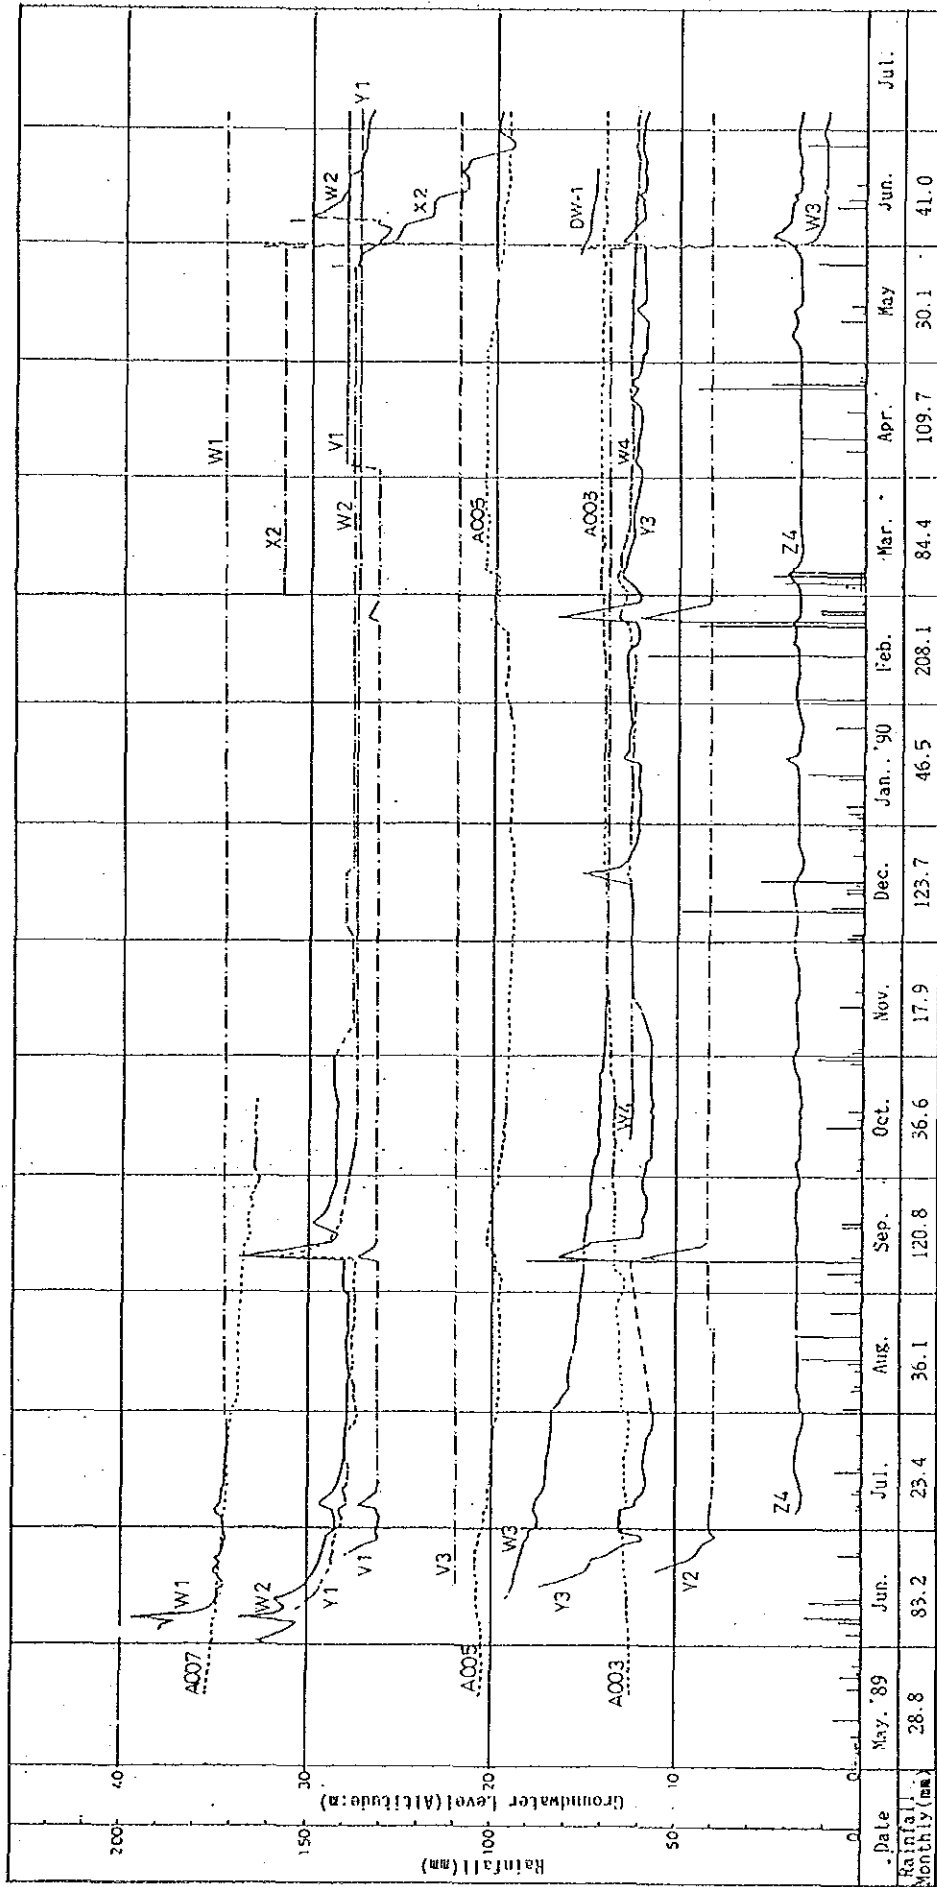
Fig. 2.17

Measurement of groundwater levels in the landslide area has been made in the boreholes drilled in both this study and in the previous studies. Rising of groundwater levels after relatively heavy rainfall was observed mostly in boreholes drilled in the eastern part of the landslide. Therefore, installation of drainage wells, mainly for their peak cut-off function, will be more effective in the eastern part than the western part of the landslide. Results of groundwater level measurement are shown in Fig.2.17.

in the central part of the landslide. A drawdown of about 20 m was measured in the boreholes drilled in the western part, but drawdowns for 5 - 20 m or less were measured in the that eastern part of the landslide. From these facts installation of drainage wells is likely to be more effective in the eastern part than the western part of the landslide.
