GOVERNMENT OF MAURITIUS  
LANDSLIDE PROTECTION PROJECT IN PORT LOUIS

JAPAN INTERNATIONAL COOPERATION AGENCY

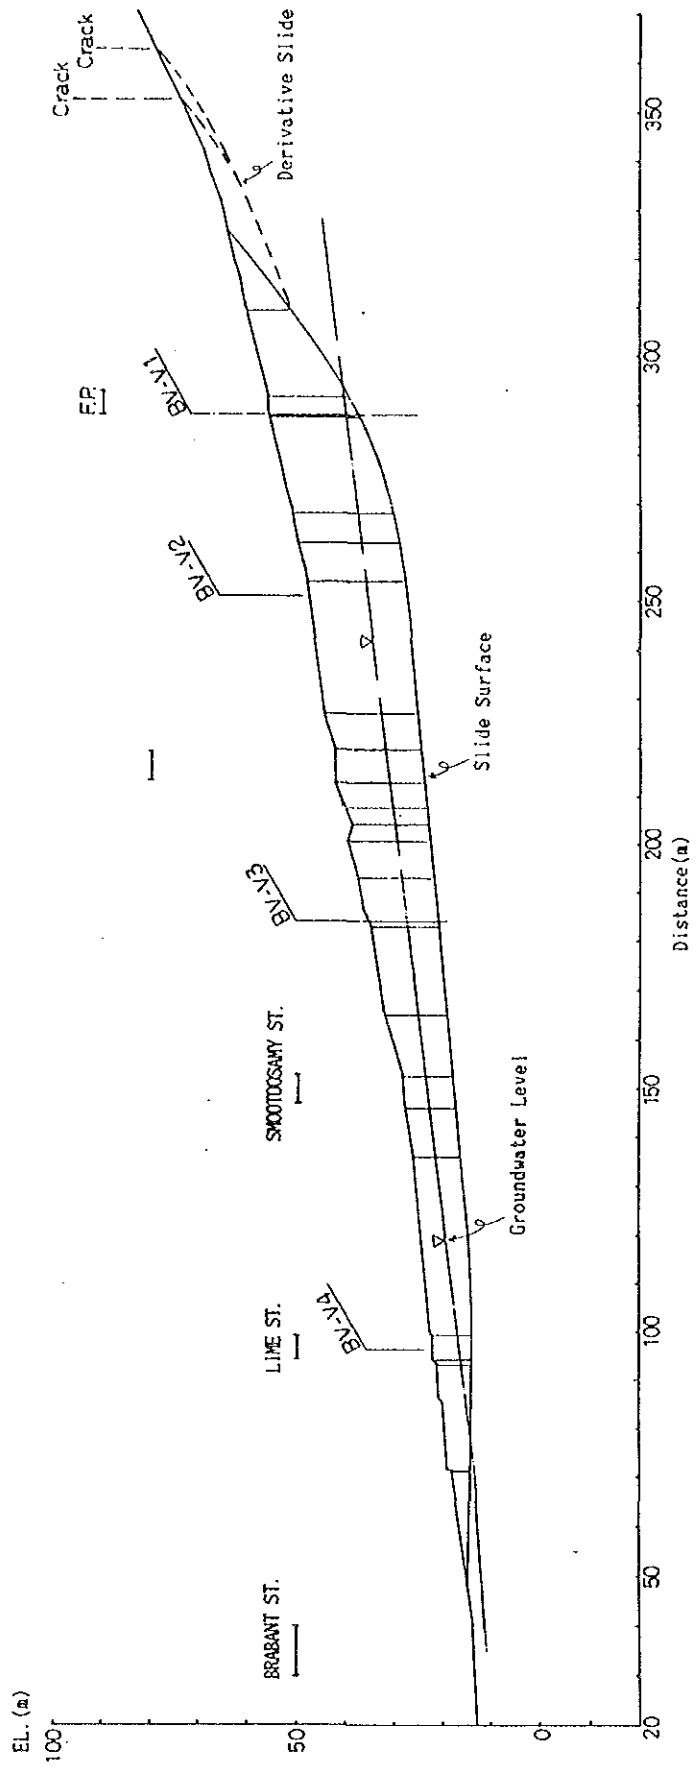
PROFILE OF STABILITY ANALYSIS ALONG V-LINE

Cohesion of Slide Surface  
 Internal Friction Angle of Slide Surface

$c=1.0 \text{ t/m}^2$   
 $\phi=9.4^\circ (\tan \phi=0.16478)$

Safety Factor before Counter Measures  
 Safety Factor after Completion of Drainage Well  
 (Experimental Investigation)

$F_s=1.00$   
 $F_s=1.071$

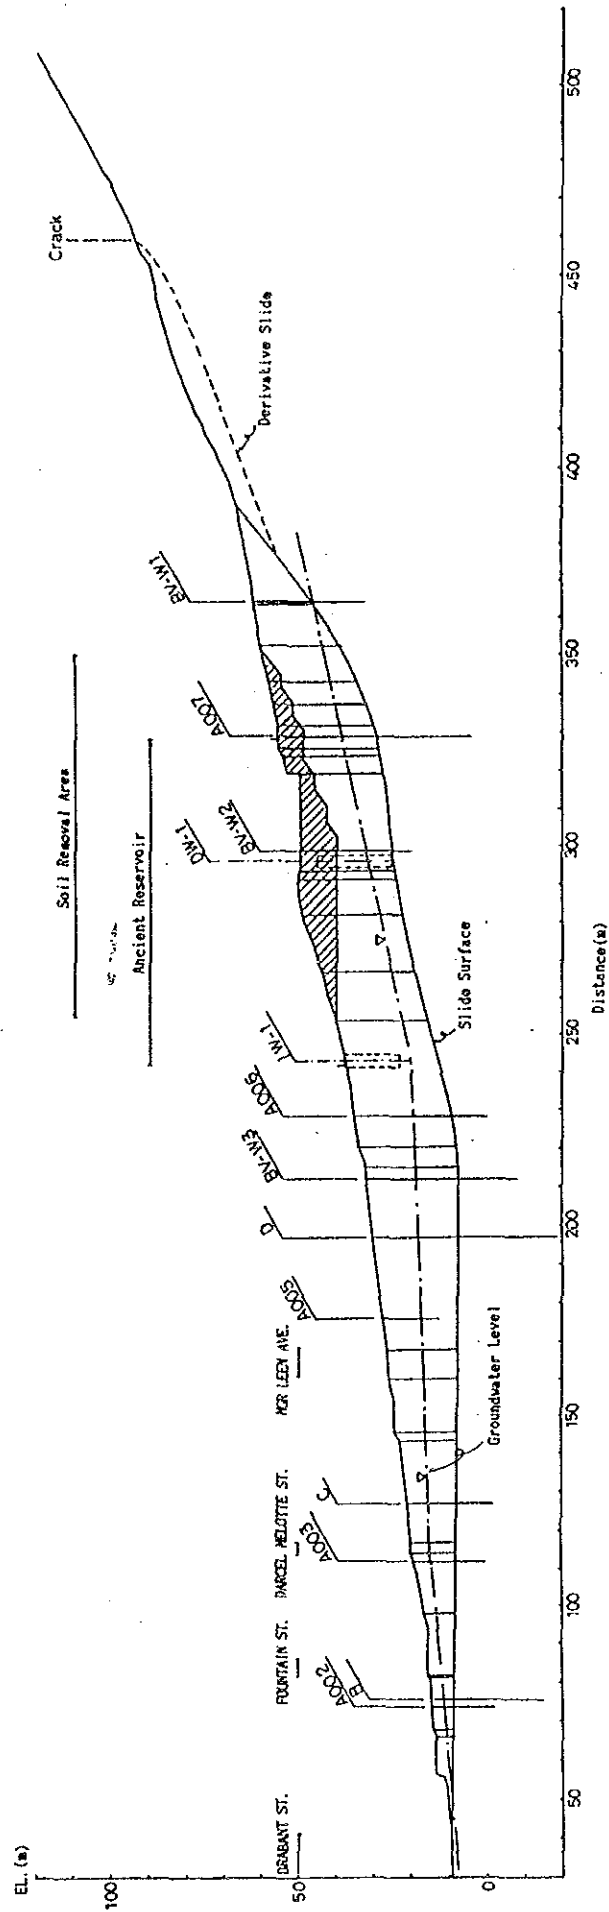
PROFILE OF STABILITY ANALYSIS ALONG W-LINE

Cohesion of Slide Surface  
 $c=1.0 \text{ t/m}^2$   
 Internal Friction Angle of Slide Surface  
 $\phi=9.7^\circ (\tan \phi=0.1708)$   
 Safety Factor before Counter Measures  
 $Fs=1.00$   
 Safety Factor after Completion of Soil Removal Works  
 $Fs=1.031$   
 Safety Factor after Completion of Soil Removal Works  
 and Drainage Well(Experimental Investigation)  
 $Fs=1.092$

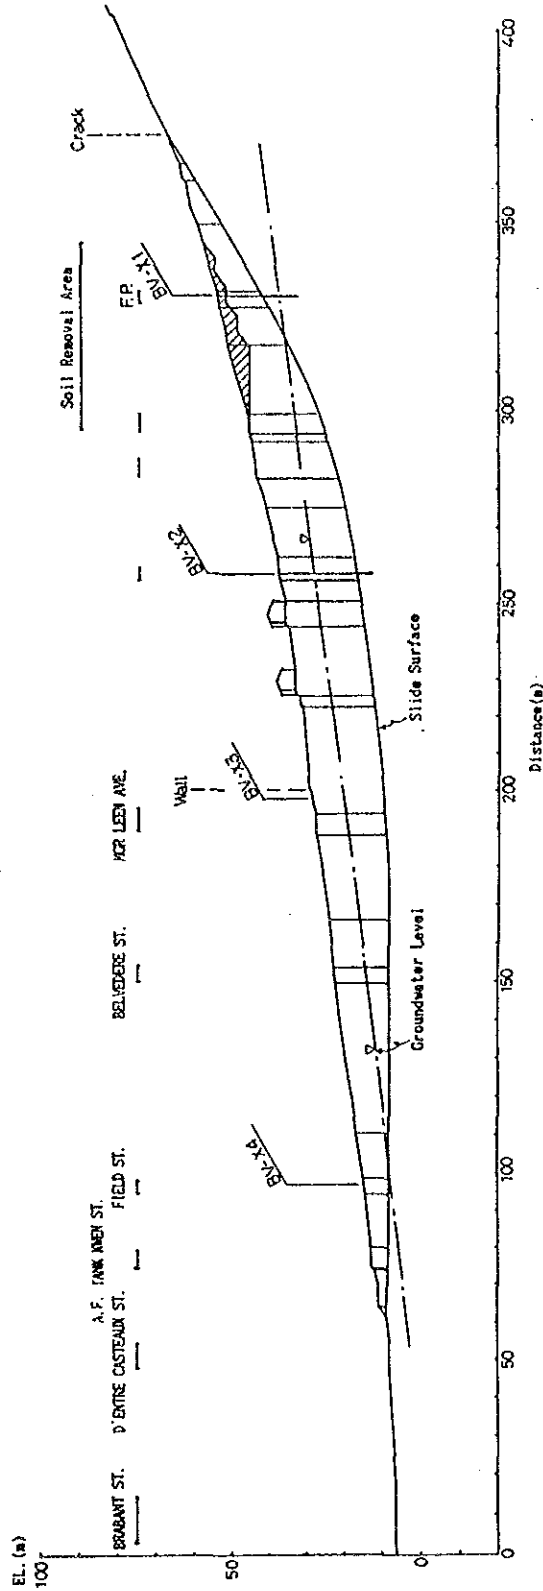
**PROFILE OF STABILITY ANALYSIS ALONG X-LINE**

Cohesion of Slide Surface  $c=1.0 \text{ t/m}^2$   
 Internal Friction Angle of Slide Surface  $\phi=9.9^\circ (\tan\phi=0.1740)$   
 Safety Factor before Counter Measures  $Fs=1.00$   
 Safety Factor after Completion of Soil Removal Works  $Fs=1.070$

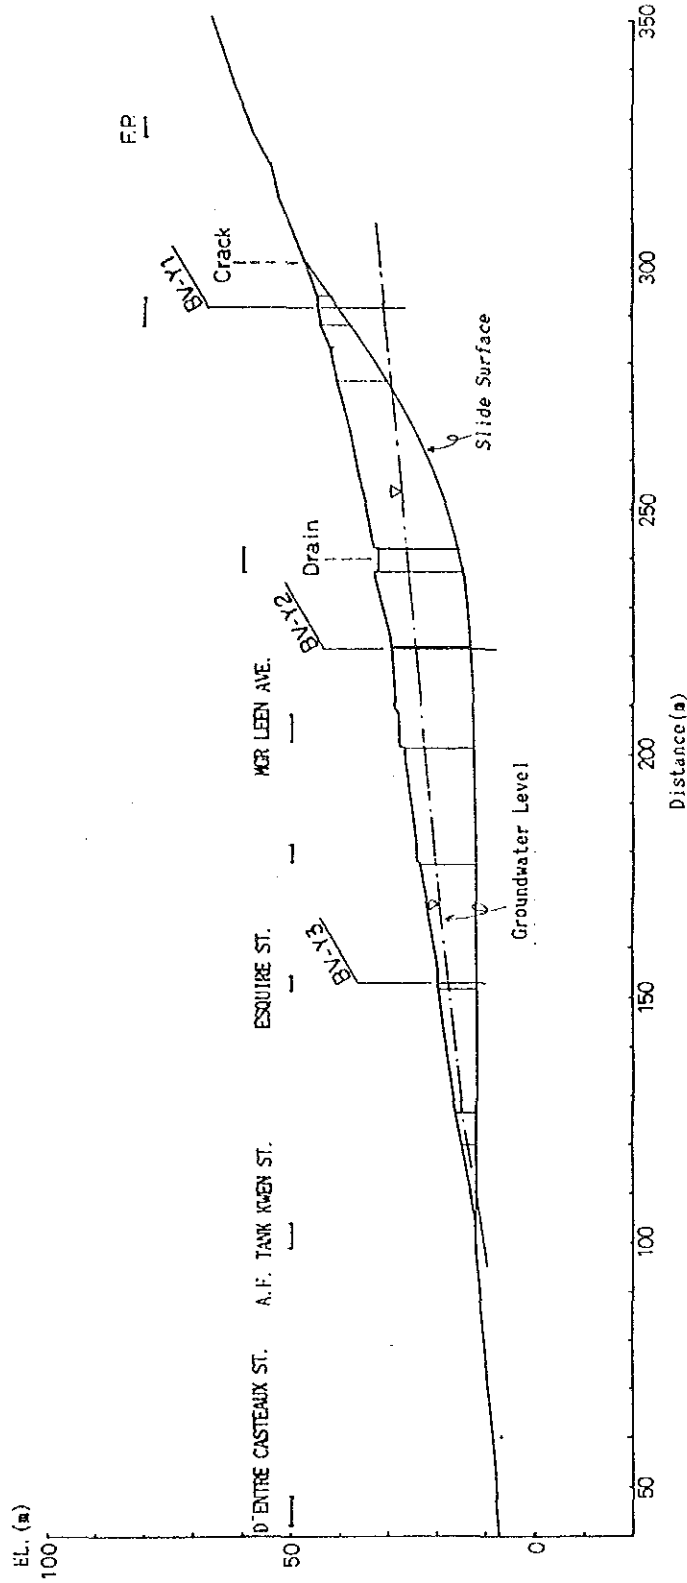
**PROFILE OF STABILITY ANALYSIS ALONG Y-LINE**

Cohesion of Slide Surface  $c=1.0 \text{ t/m}^2$   
 Internal Friction Angle of Slide Surface  $\phi=8.8^\circ (\tan\phi=0.155)$

Safety Factor before Counter Measures  $F_s=1.00$

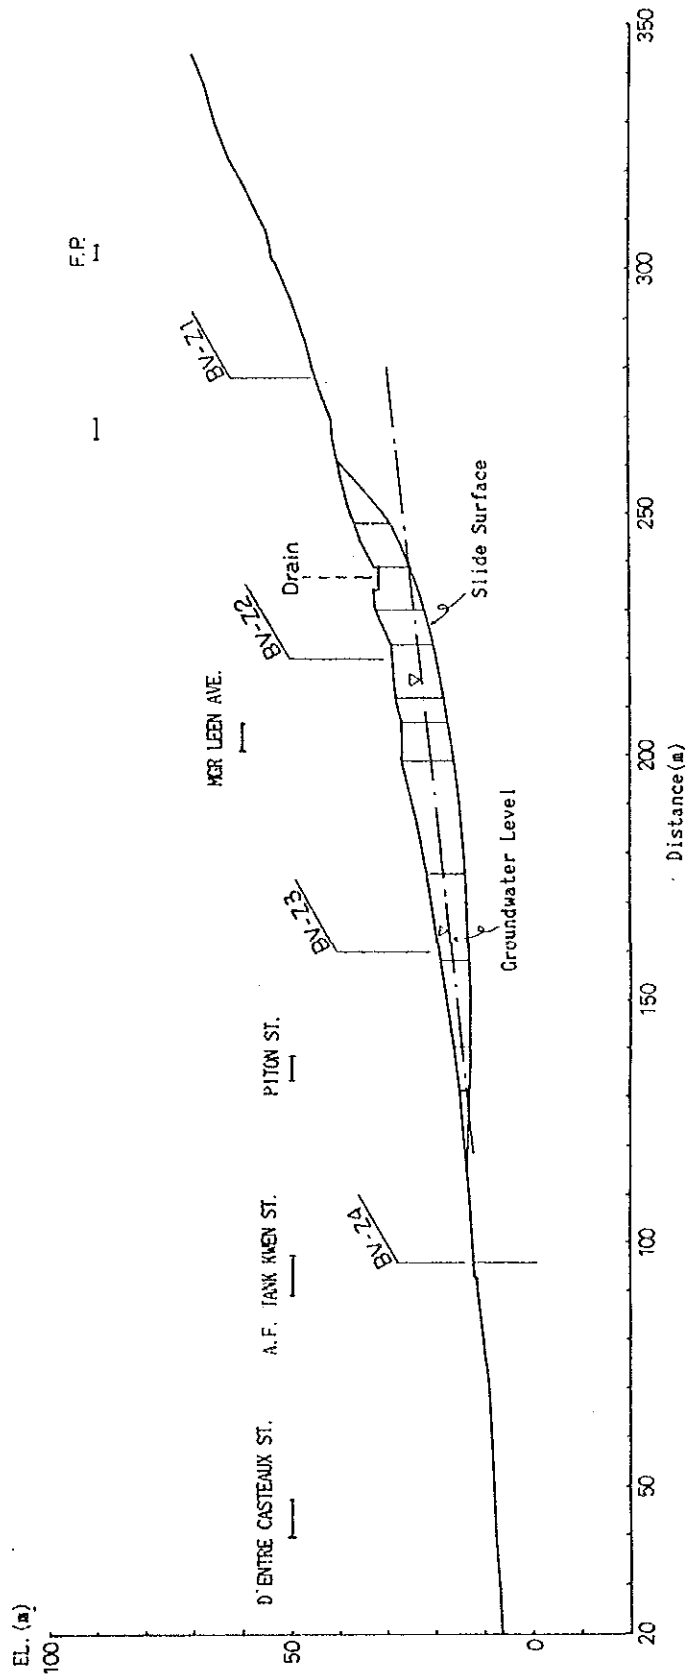
PROFILE OF STABILITY ANALYSIS ALONG Z-LINE

Cohesion of Slide Surface  $c=1.0 \text{ t/m}^2$   
 Internal Friction Angle of Slide Surface  $\phi=6.9^\circ$  ( $\tan\phi=0.121$ )  
 Safety Factor before Counter Measures  $F_s=1.00$

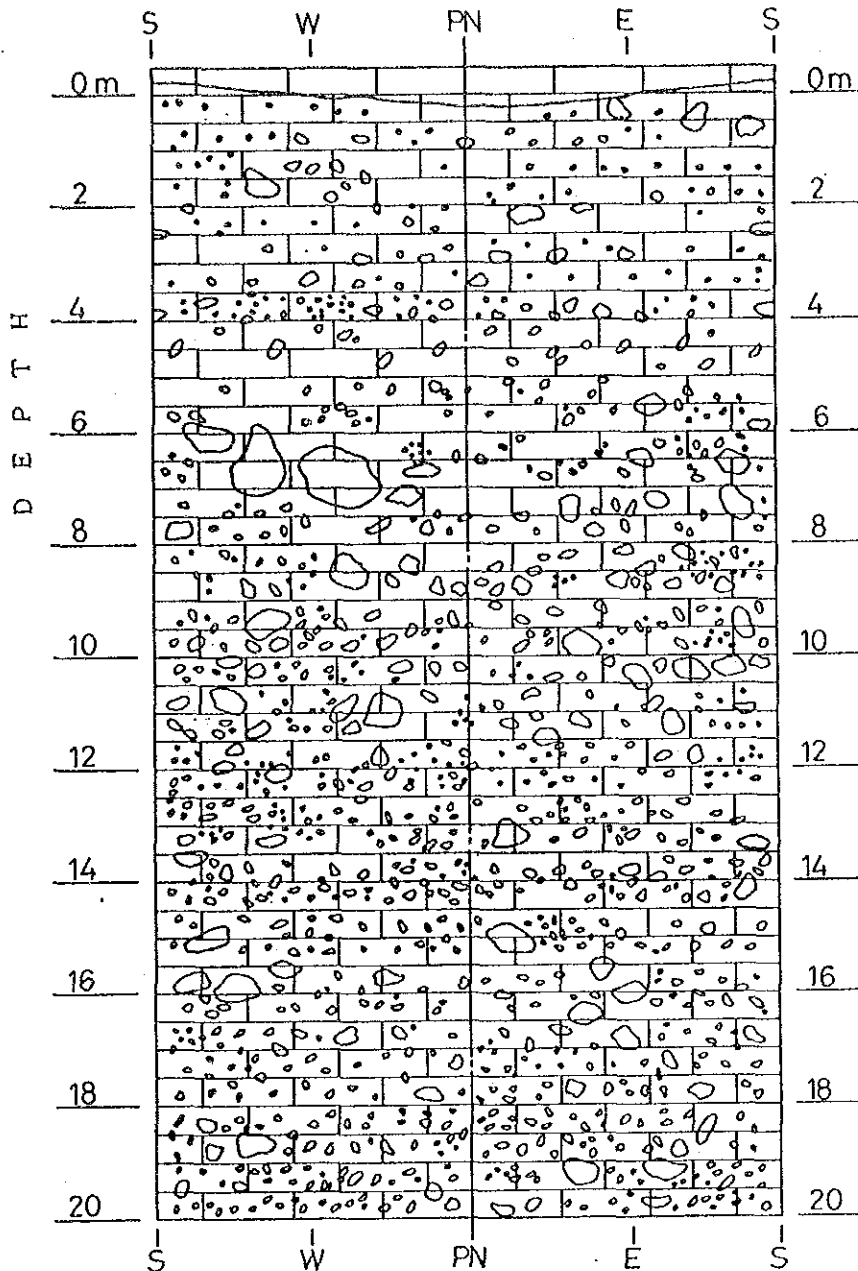
**SUBSURFACE CONDITION SURROUNDING  
DRAINAGE WELL**

Materials (surrounding the drainage well) are composed of basalt gravel and cohesive clayey soil.

No groundwater level is observed.

Clayey soil appears to be reddish brown.

Frequent slickensides are developed in clayey soil.

Clayey soil is slightly sandy below 13m.

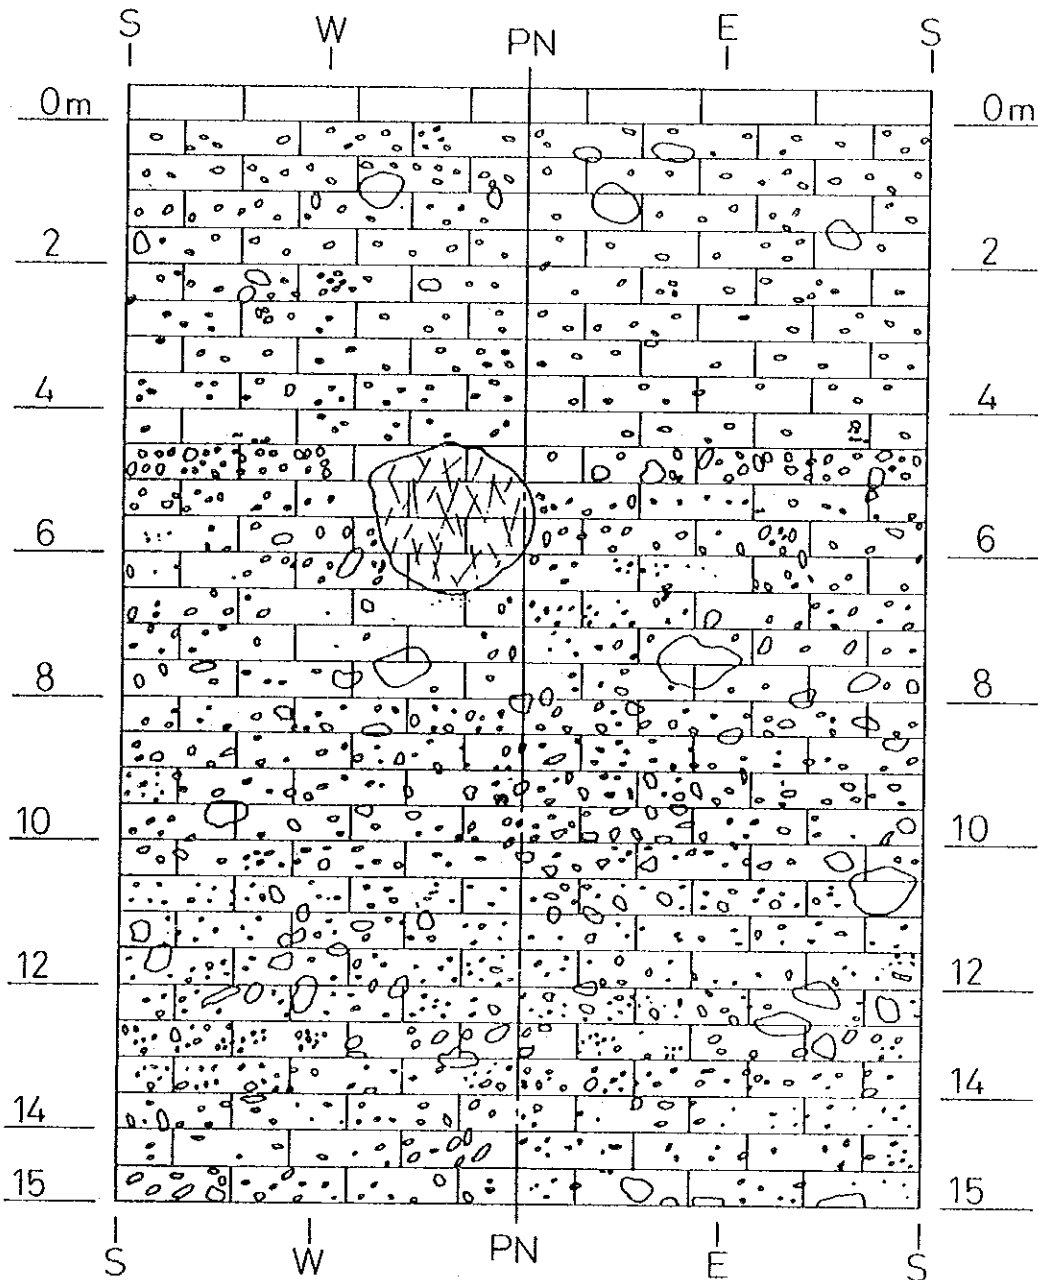
**SUBSURFACE CONDITION SURROUNDING  
INTERMEDIATE WELL**

Materials(surrounding the intermediate well) are composed of basalt, gravel and cohesive clayey soil.

No groundwater level is observed.

Clayey soil appears to be reddish brown.

Frequent slickensides are developed in clayey soil.
