THE GOVERNMENT OF MAURITIUS

*THE STUDY ON
LANDSLIDE PROTECTION PROJECT
IN PORT LOUIS*

*FINAL REPORT
SUPPORTING REPORT
(I)(II)(III)*

JAPAN INTERNATIONAL COOPERATION AGENCY

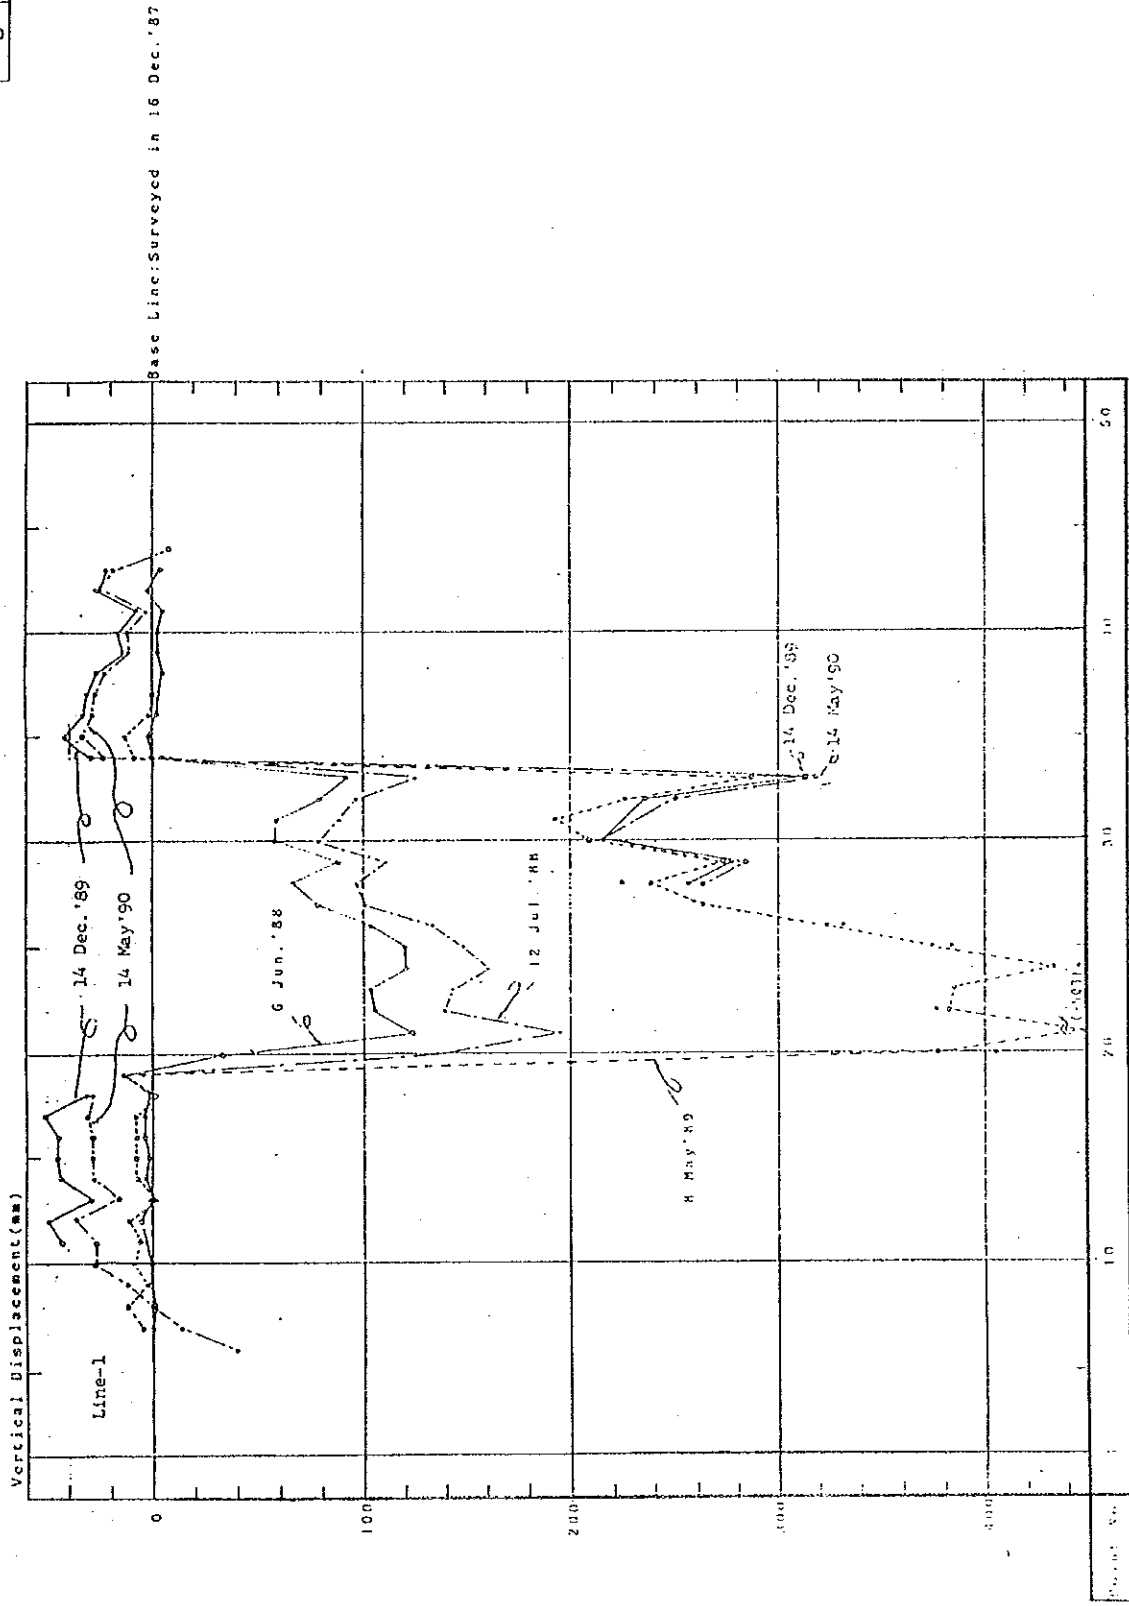
PROFILE OF THE LEVELING SURVEY
ALONG LINE-1

Significant ground subsidence was observed along Line-1. The maximum amount of subsidence was about 50 cm at observation point, 1/21. Observation results are shown in Fig.I.2.3-2. Along observation Line-2 subsidence of about 2.5 cm was observed in the section between 2/9 and 2/21, and upheaval of about 12 cm was observed in the section between 2/30 and 2/39, which is shown in Fig.I.2.3-3. Along observation Line-3 upheaval of 10 cm was observed in the section between 3/13 and 3/26, and upheaval of about 3 cm was observed in the section between 3/28 and 3/33, which is shown in Fig.I.2.3-4. Large movements were observed along Line-4; however, these seem to be caused by other phenomena than displacement caused by landslide movement, and could not be interpreted, in any definite way.

As for the four survey lines, Line-1, Line-2, Line-3 and Line-4, covering the whole landslide area, significant subsidence had been surveyed in the section between 1/20 and 1/33 along Line-1, which is aligned at the head portion of the landslide area as mentioned in the Interim Report. The maximum amount of subsidence, exceeding 53 cm, was observed at survey point, 1/21, on Line-1 in September 1989.

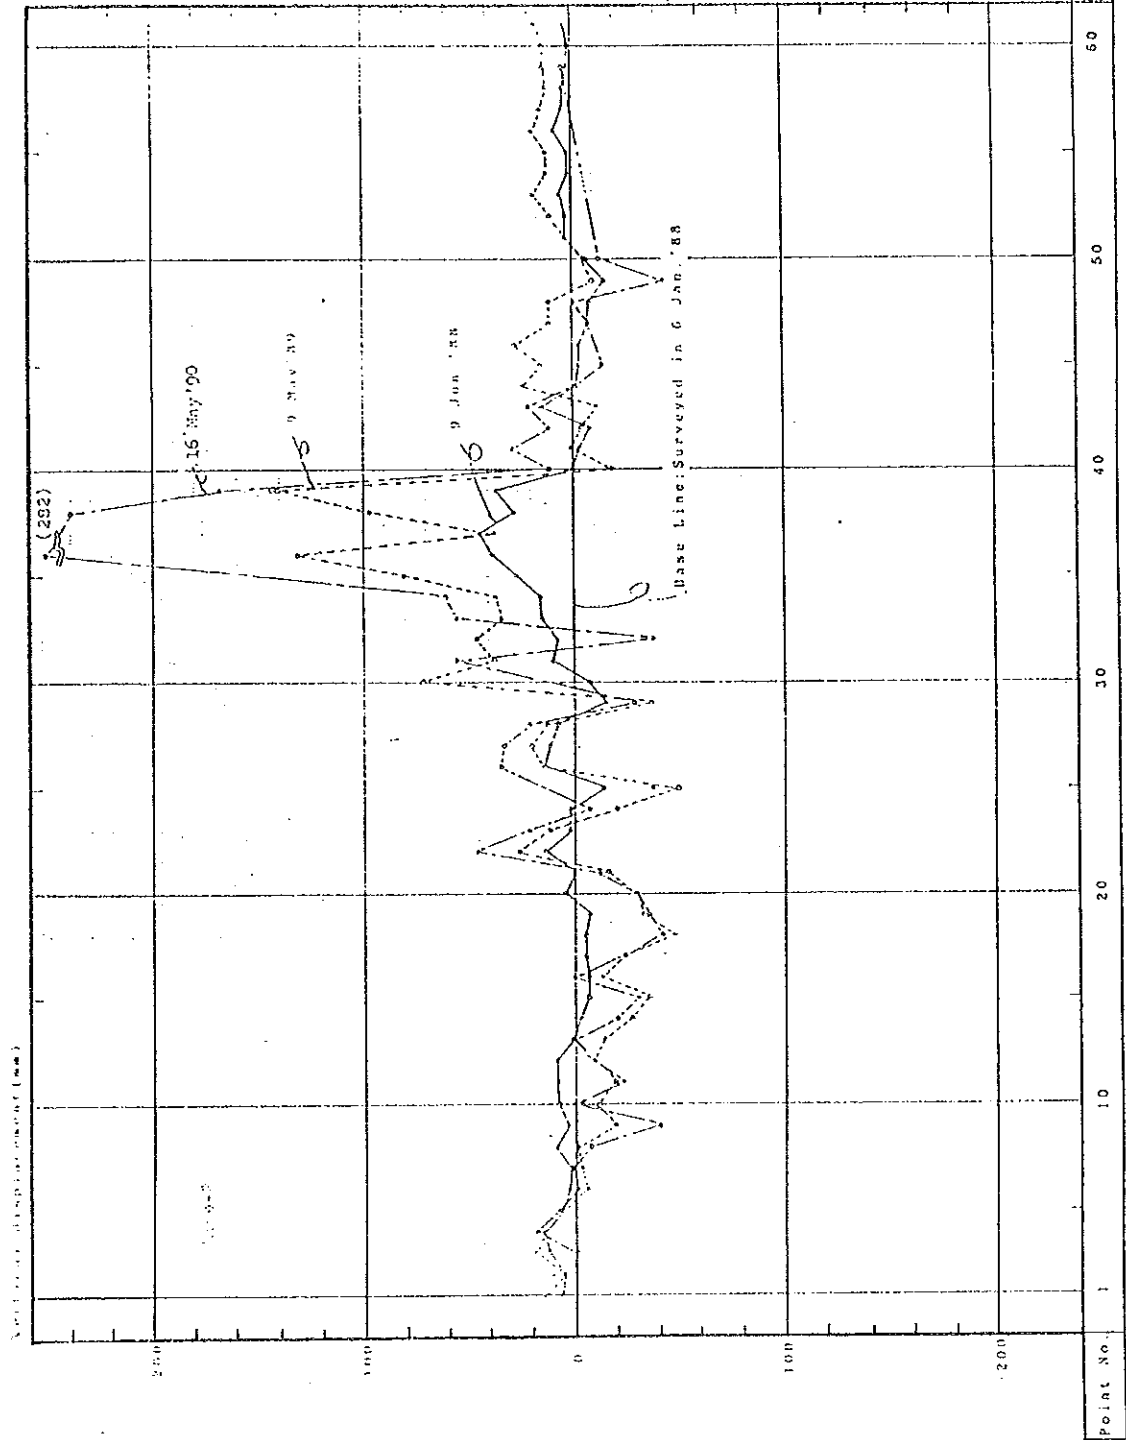
PROFILE OF THE LEVELING SURVEY
ALONG LINE-2

by the leveling survey along Line-2, Line-3 and Line-4. Upheaval movements of about 30 cm were seen in the section between 2/36 and 2/39 along Line-2. These survey points are aligned along Lime Street. The concerned section along this street was damaged intensively by dumping trucks during the soil removal works. Therefore, the movements in this section may have been caused by the soil removal works.

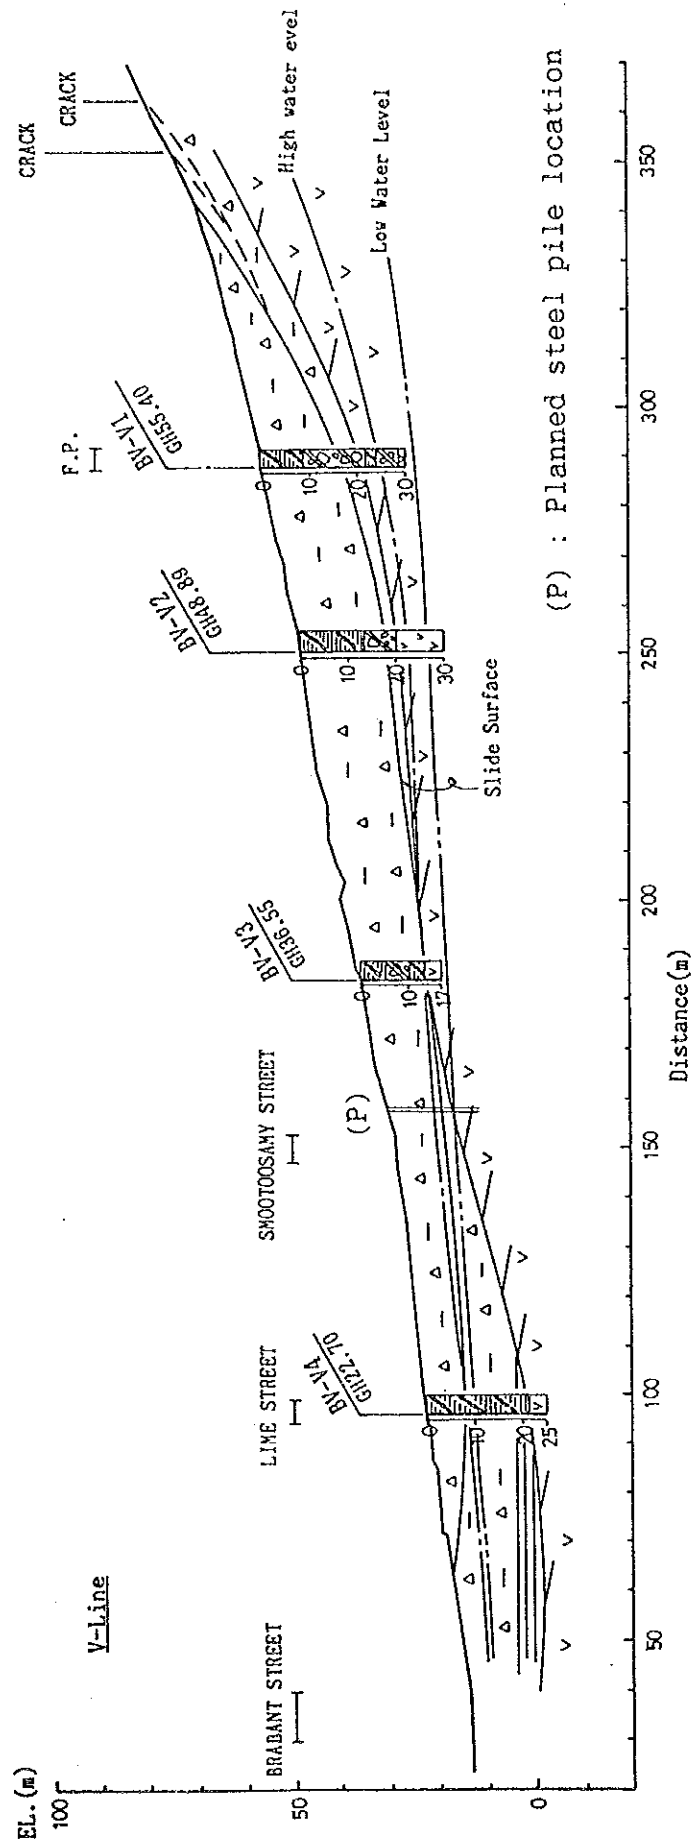
GEOLOGICAL PROFILE ALONG V-LINE

V-line : There are smoothly curved two steps of the bedrock surface. The upper step declines from the part near open cracks at the upper part of the landslide to the borehole, BV-V3. The elevation of the bedrock surface is about 20 m in the boreholes, BV-V3. The lower step declines again from the borehole, BV-V3, to the borehole, BV-V4 at the lower part of the landslide. The elevation of bedrock surface is about 0 m at this part. The bedrock surfaces are overlain by dark grayish clayey layers at the lower part of the landslide. The maximum depth to the bedrock surface is about 25 m near the borehole, BV-V1, drilled at the upper part of the landslide.

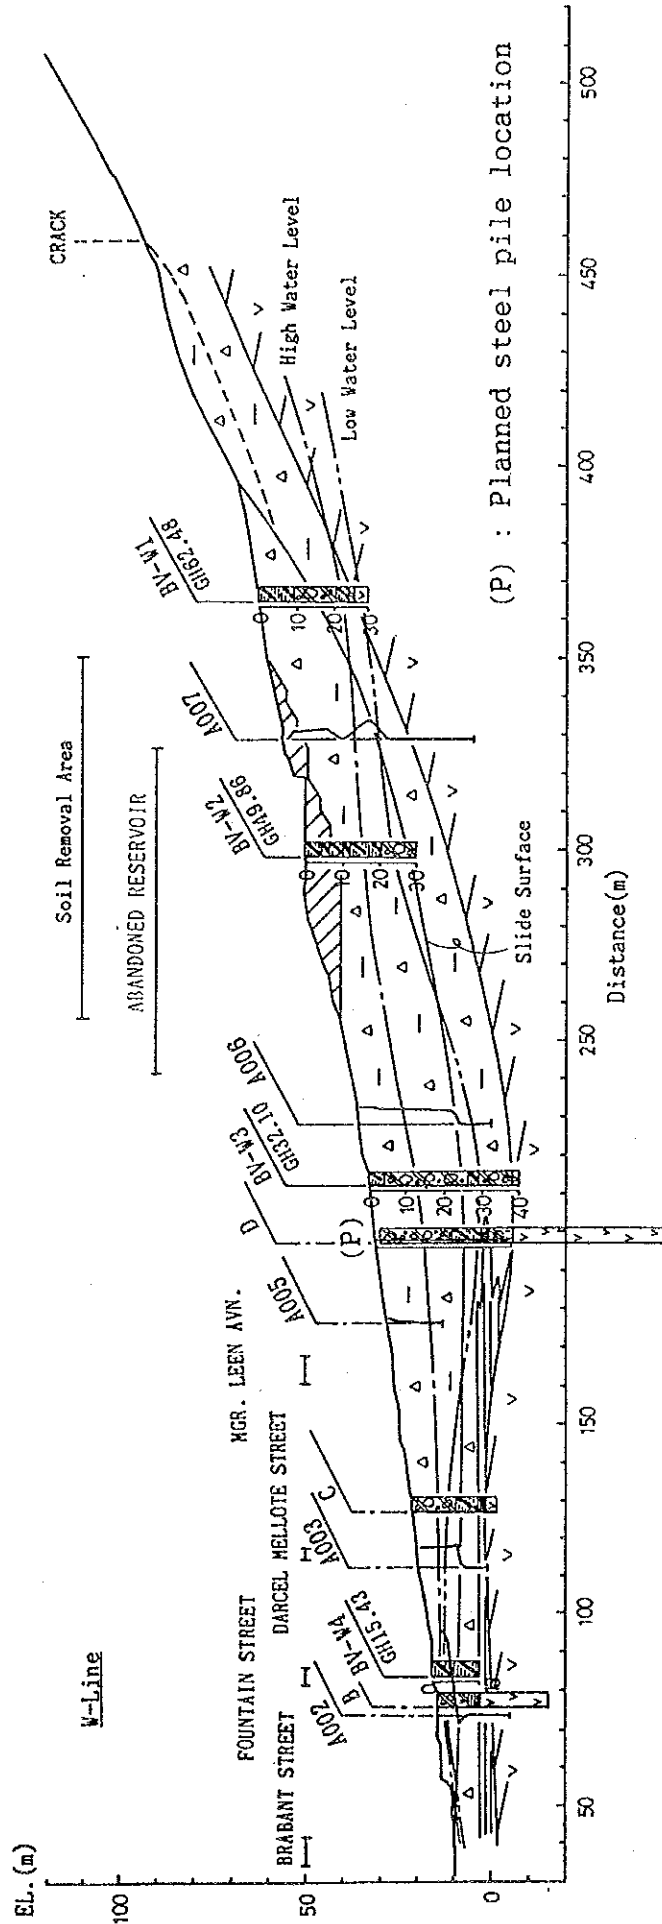
GEOLOGICAL PROFILE ALONG W-LINE

W-line (refer to Fig.I.2.4-6): There is a concaved shape of slide surface at the central part of the landslide along this line. The slide surface declines from the open-cracks at the upper part of the landslide to the borehole, BV-W3. From the borehole, BV-W3, the slide

W-line : There are smoothly curved two steps: one is from the open-cracks to the borehole, BV-W2: the other one is from the borehole, BV-W2, to the lower part of the landslide. A concaved shape of bedrock surface is assumed in the central part of the landslide. The maximum depth to the bedrock surface is assumed to be about 40 m in the central part of the landslide. Clayey layer overlies the bedrock surfaces for about 5 m in the lower part of the landslide.

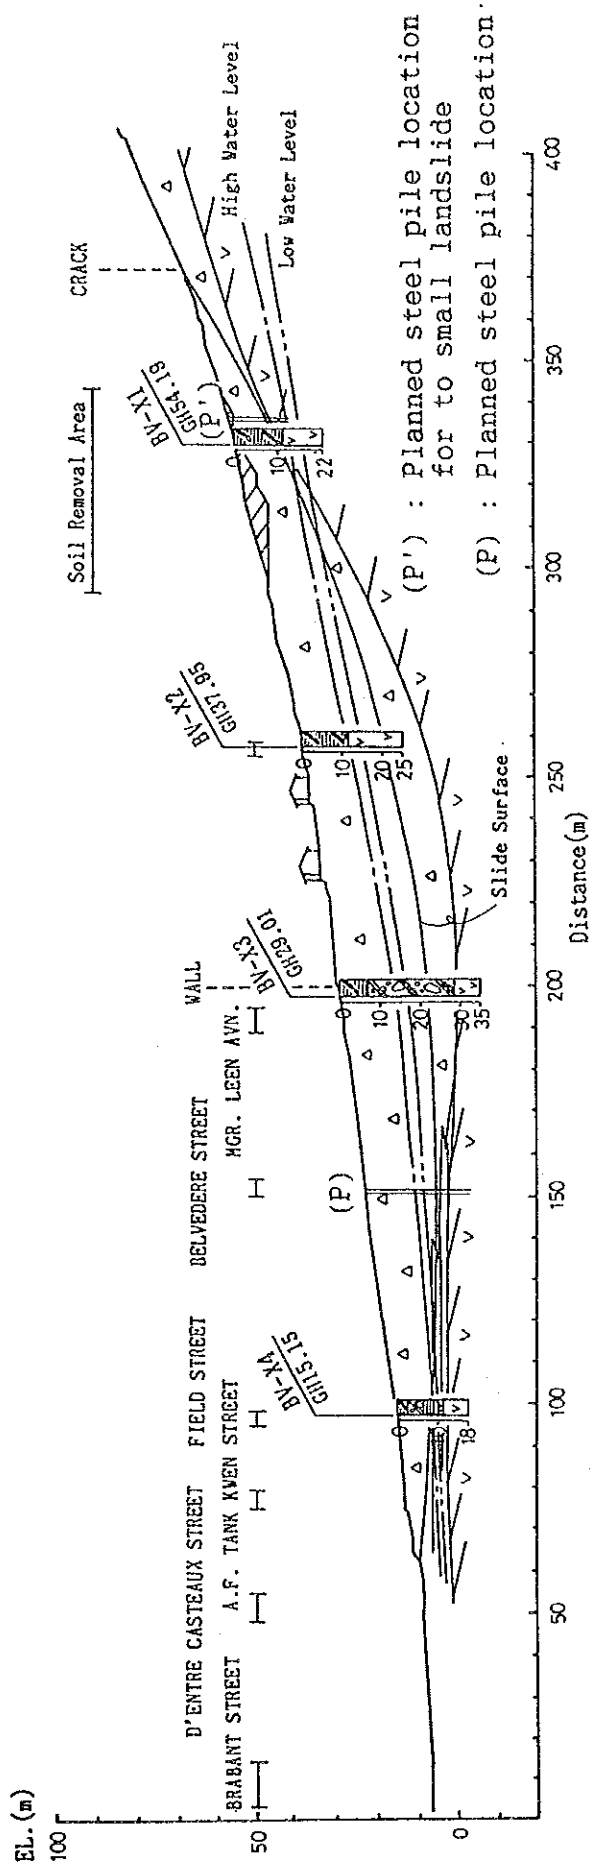
GEOLOGICAL PROFILE ALONG X-LINE

Along X-line displacements which seem to indicate the slide surface are estimated at the depth between 21 m and 22 m in the borehole, BV-X3, and between 6.5 m and 8 m in the borehole, BV-X4. Along Z-line displacements are observed at the depth between 9.5 m and 11 m in the borehole, BV-Z2, and between 12.5 m and 13.5 m in the borehole BV-Z3. In the remaining three (3) boreholes, BV-V2, BV-V3 and BV-Z1, no remarkable displacement was observed since September 1989, although slight deformation was seen on the measurement records from these borehole.

X-line (refer to Fig.I.2.4-7) : The slide surface declines gently and smoothly from the open-cracks at the upper part to the lower part of the landslide. The maximum depth to the slide surface is about 20 m at the central part. The slide surface seems to shear dark grayish clayey layers at the lower part of the landslide at and around the borehole, BV-X4.

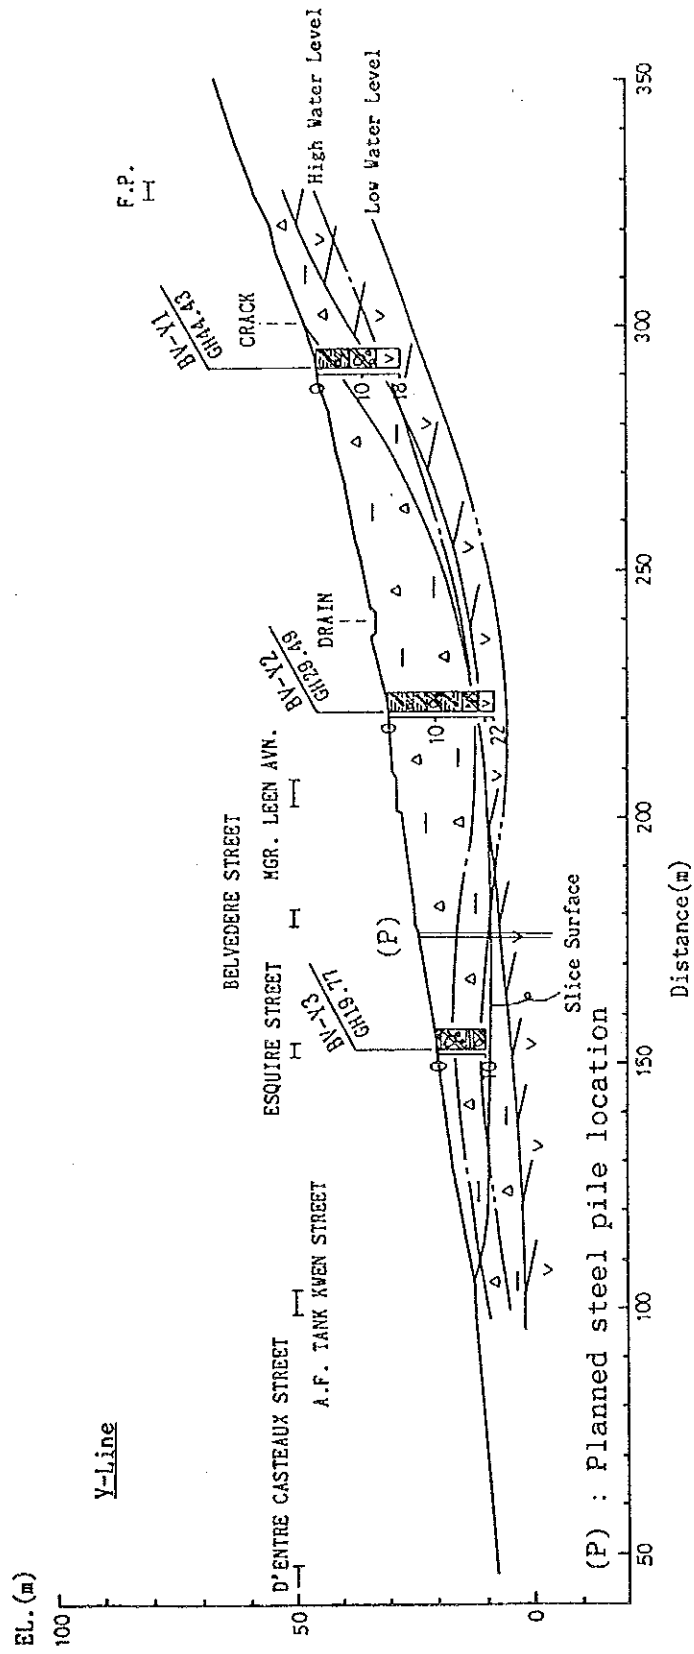
GEOLOGICAL PROFILE ALONG Y-LINE

Y-line (refer to Fig.I.2.4-8): The slide surface declines from the open-cracks at the upper part to the central part of the landslide. The slide surface is almost horizontal in the central to the lower parts. The slide surface turns upward slightly to the ground surface at the compression zone. The slide surface is estimated to lie on bedrock surface at the central part of the landslide. The maximum depth to the slide surface is about 17 m near the borehole, BV-Y2.

Y-line : The bedrock surface declines from the open-cracks at the upper part of the landslide to the central part, forming a smooth curve. The bedrock surface declines again slightly from the central part to the lower part (from about E1.10 m to about E1.0 m). The maximum depth to the bedrock surface is about 12 m in the central

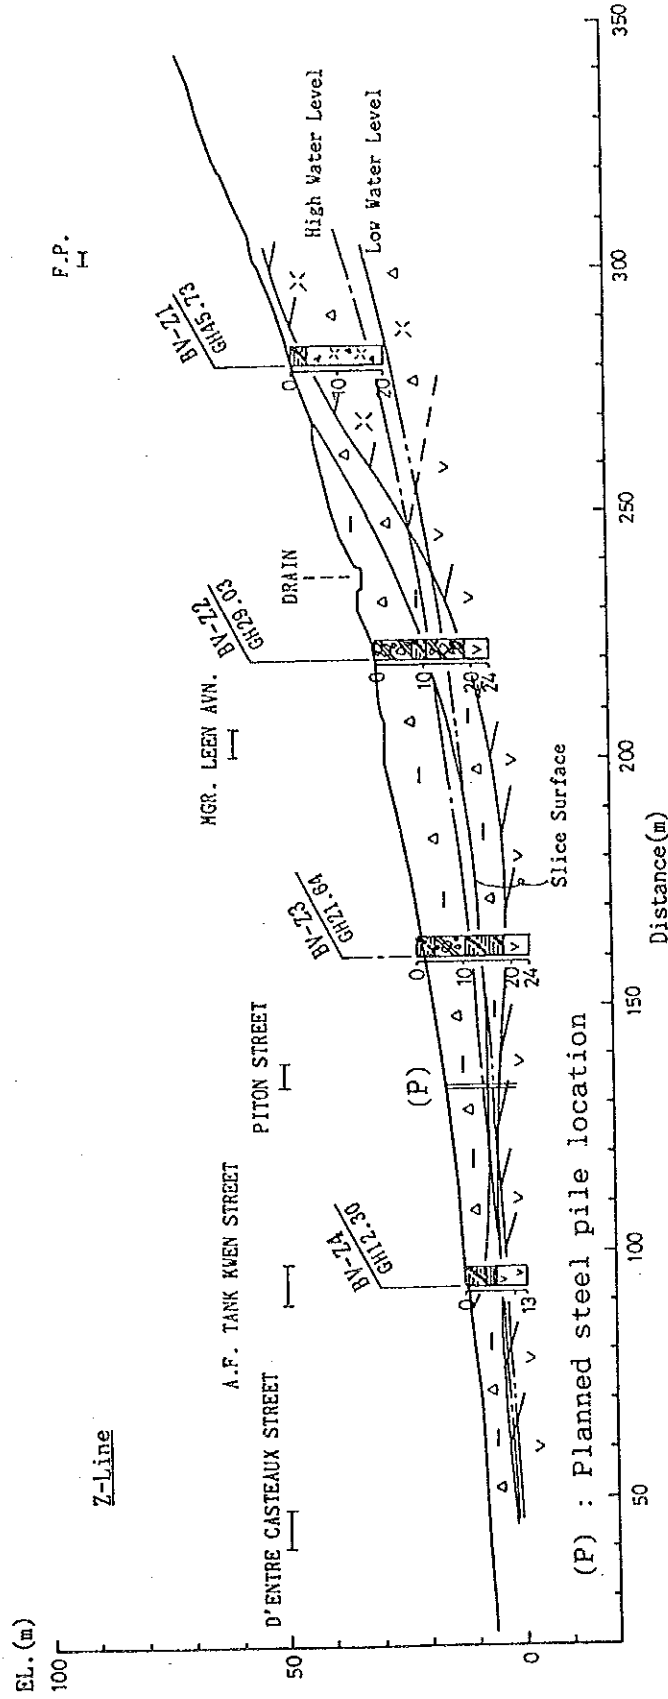
GEOLOGICAL PROFILE ALONG Z-LINE

Z-line (refer to Fig.I.2.4-9): Gently curved line is estimated as the slide surface along this line. The depth to shearing zones are confirmed by measurement of the borehole inclinometer. The slide surface is assumed to shear through loose scree deposits. The maximum depth to the slide surface is about 15 m.
