**REPORT ON EXPERT TEAM OF JAPAN DISASTER
RELIEF TEAM (JDR) ON THE EARTHQUAKE
IN PHILIPPINES OF JULY 16, 1990**

AUGUST 1990

**JAPAN INTERNATIONAL COOPERATION AGENCY
(JICA)**

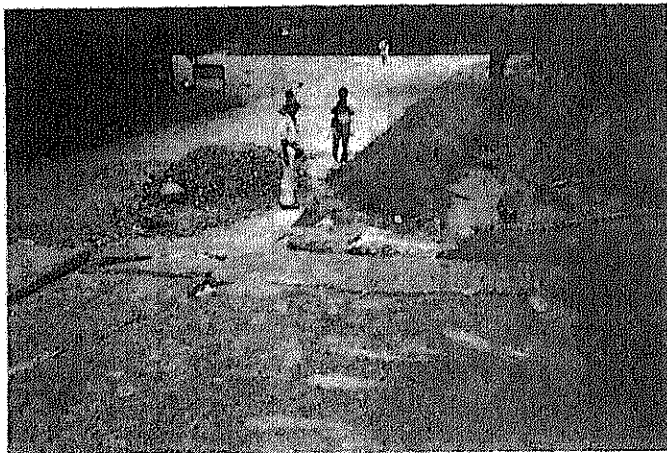
Photo 7.1.1 Earthquake Fault at Digdig. Left-lateral offset at this location is about 5m.

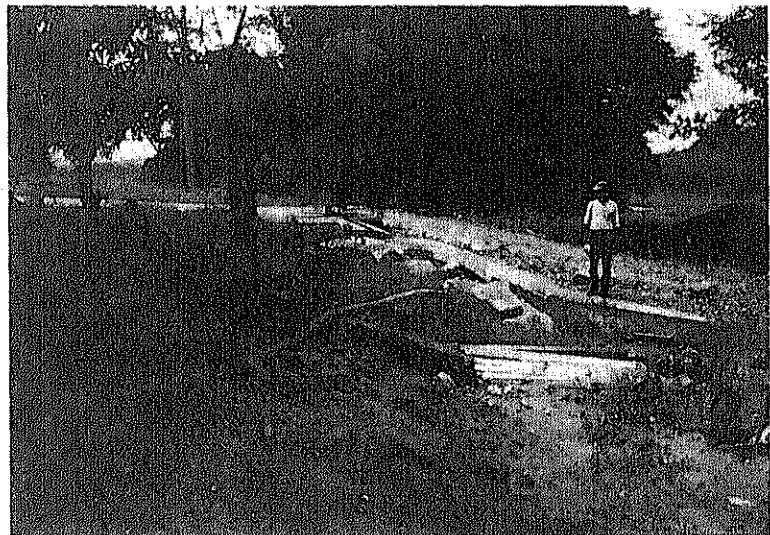
Photo 7.1.2 Earthquake Fault at Digdig. Vertical offset of east side up-thrown is about 1.3m.

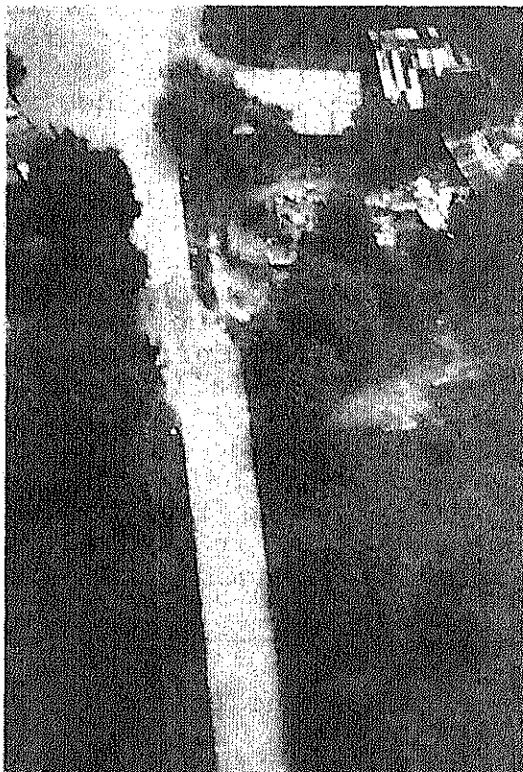
Photo 7.1.3 Earthquake Fault at Digdig, from helicopter. Fault is visible from upper right corner to middle of the left side of the photo.

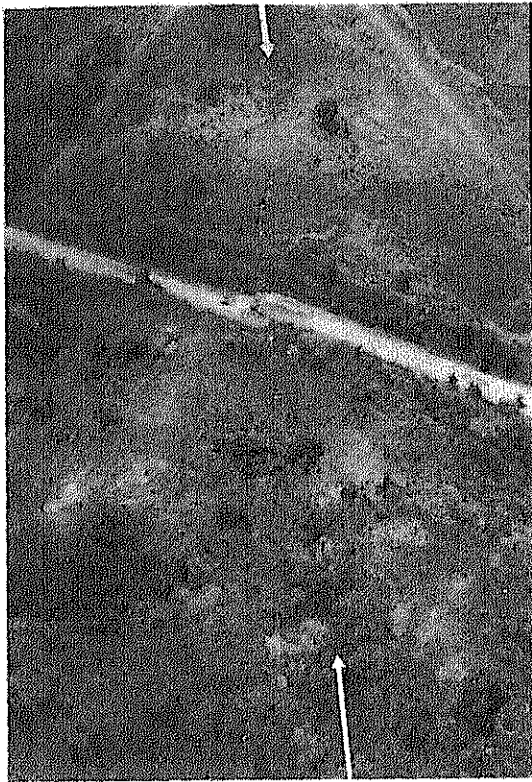
Photo 7.1.4 Earthquake fault crossing the Pan Philippine High Way at KM181 shown by arrows.

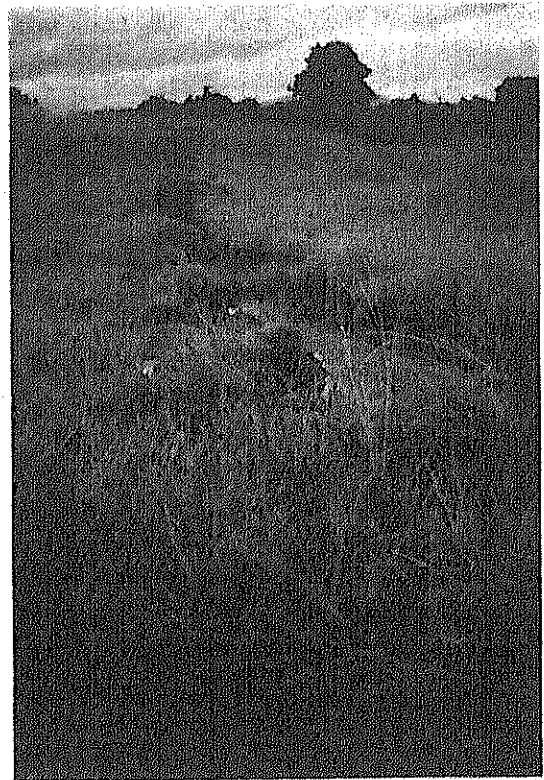
Photo 7.1.5 Earthquake fault crossing the Pan Philippine High Way at KM181. Fault is recognized as an echelon cracks on the grass land.

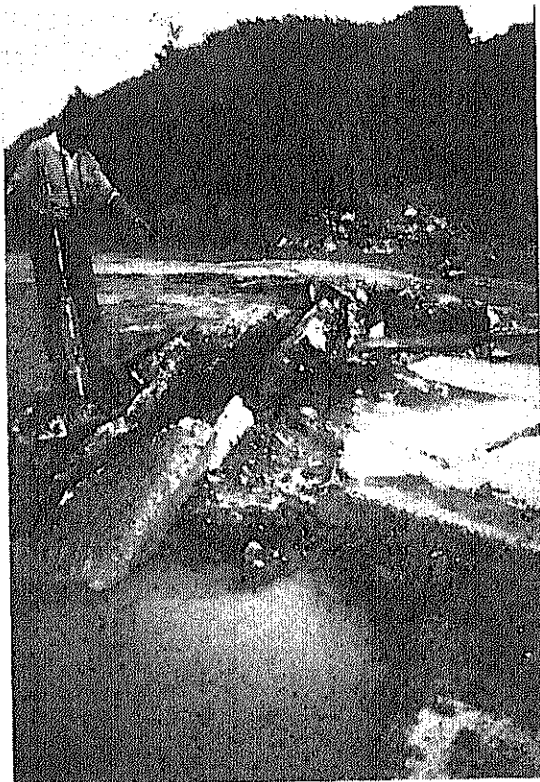
Photo 7.1.7 Earthquake fault crossing the Pan Philippine High Way at KM181. Cracks on the road surface are evident on the fault.

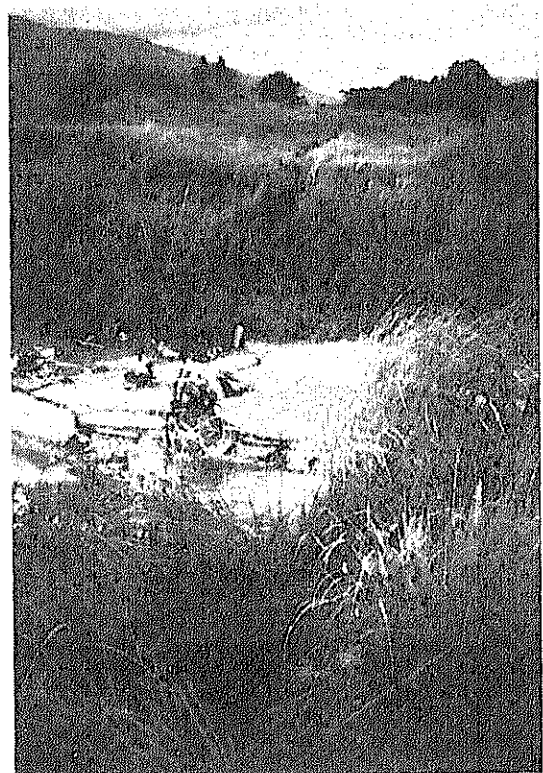
Photo 7.1.6 Earthquake fault crossing the Pan Philippine High Way at KM181. An echelon cracks across the road showing left-lateral movement.

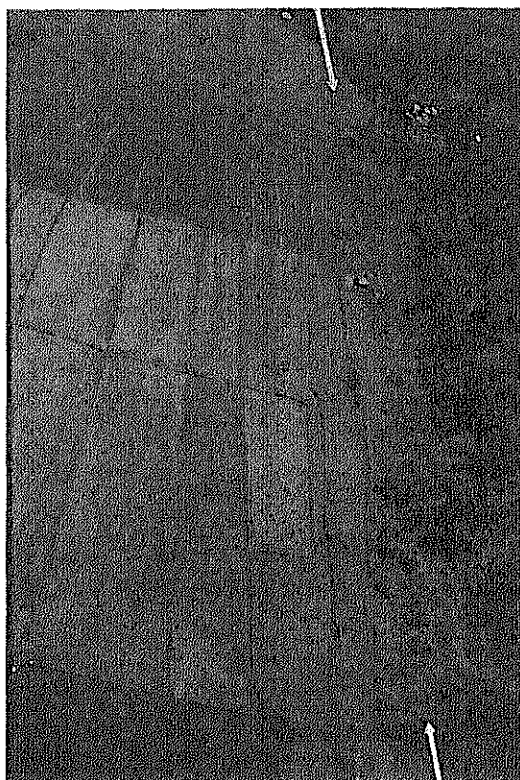
Photo 7.1.8 Fault in the south of Puncan, indicated by arrows.

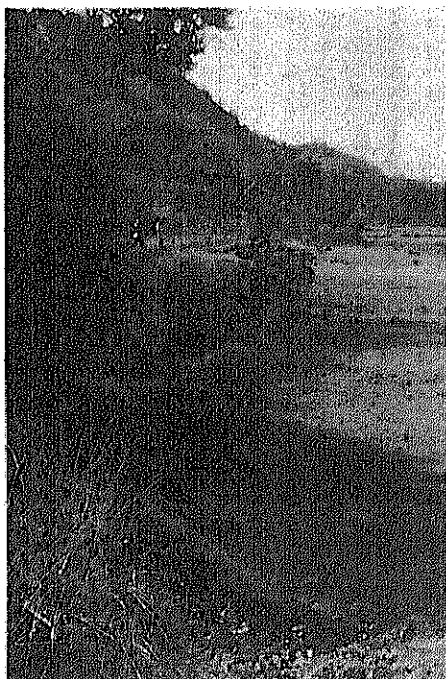
Photo 7.1.9 Fault in the south of Puncan. Mole track shaped cracks are characteristic at this point.

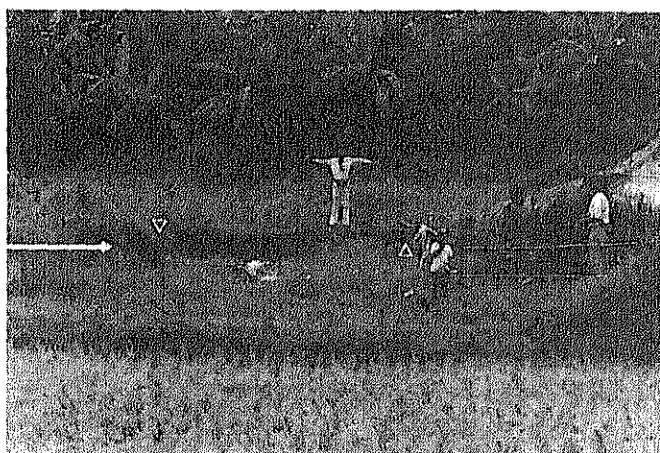
Photo 7.1.10 Fault in the south of Puncan. Lateral offset is shown by two triangles.

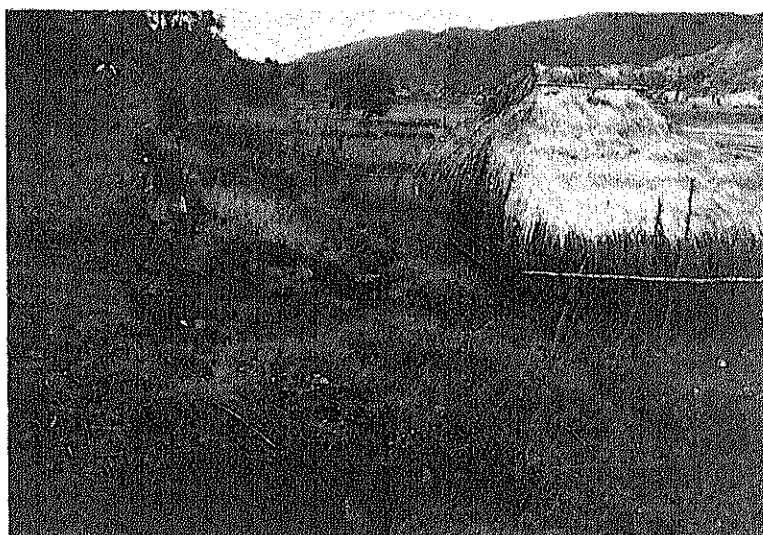
Photo 7.1.11 Fault in the south of Puncan. The scarp in the middle shows the vertical displacement. No damages to the cottage are visible.

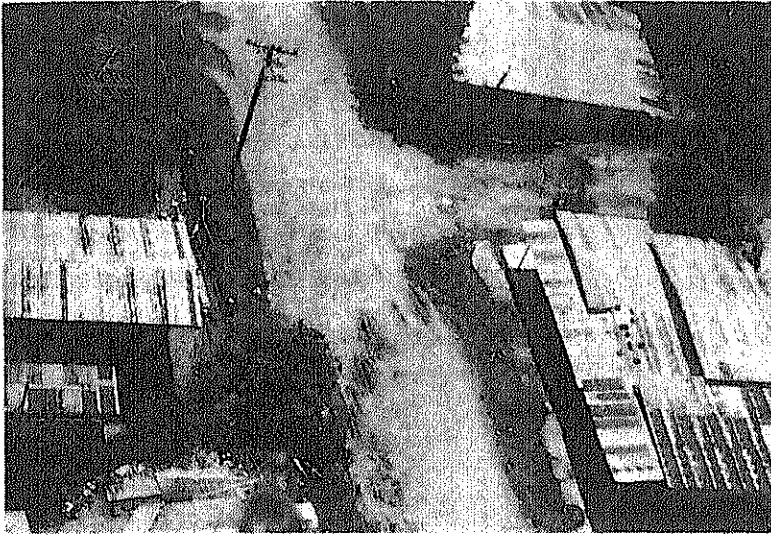
Photo 7.1.13 Fault passing through Rizar.
Left-lateral offset of the road.

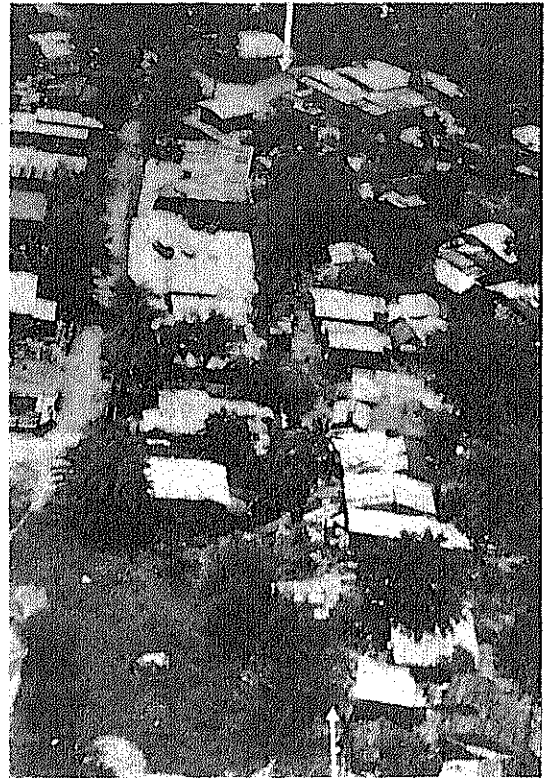
Photo 7.1.12 Fault passing through Rizar,
indicated by arrows.

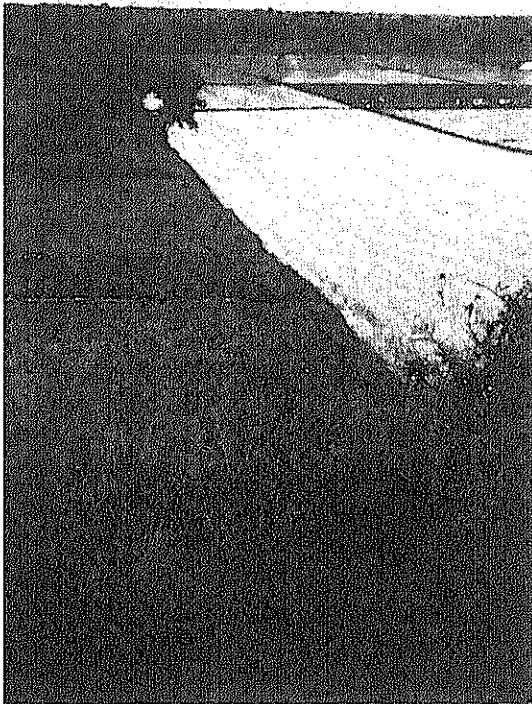
Photo 7.1.14 Fault passing through Rizar.
Passing through paddy field.

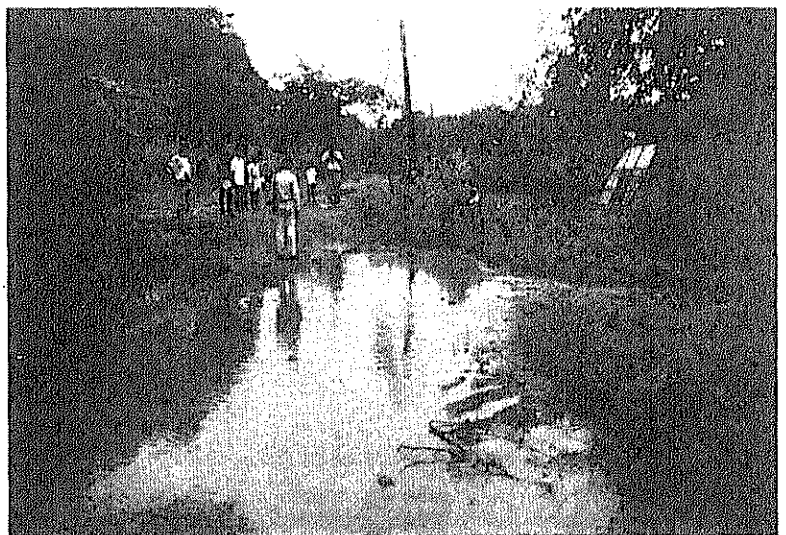
Photo 7.1.15 Fault passing through Rizar. Lateral
and vertical offsets are visible.

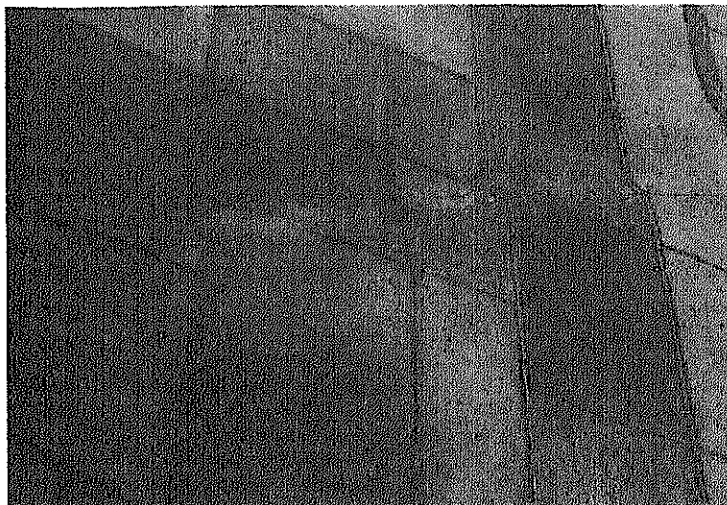
Photo 7.1.16 Fault passing through paddy field in the vicinity of Rizar. Lateral offset is visible clearly as the displacements of levees.

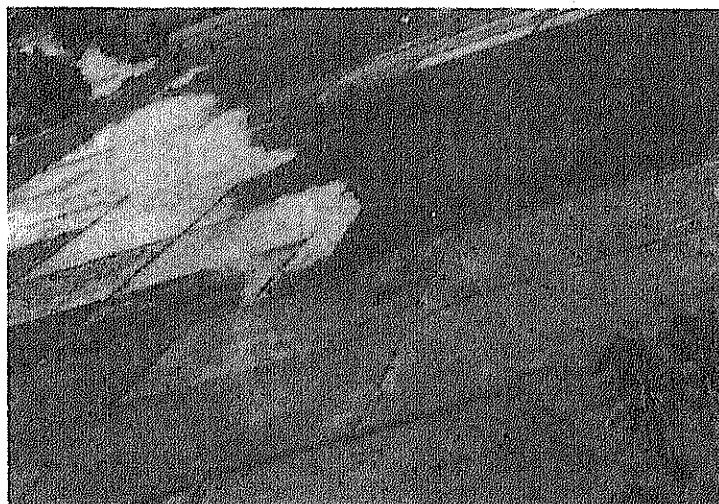
Photo 7.1.17 Fault passing through paddy field in the vicinity of Rizar. Down thrown side of the fault is submerged.

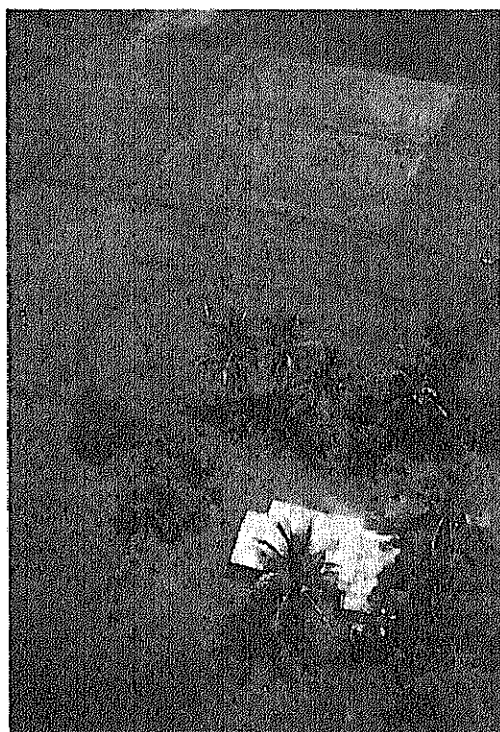
Photo 7.1.18 Fault passing through paddy field in the vicinity of Rizar. Right stepping an echelon cracks, characteristics to the left-lateral displacement, are evident.

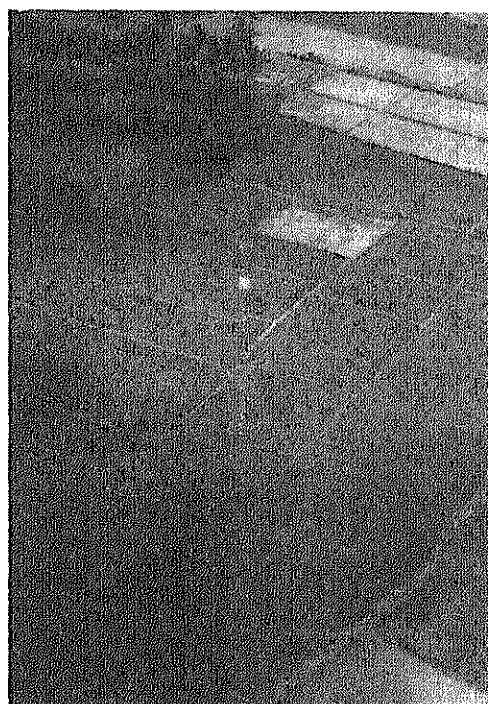
Photo 7.1.19 Fault passing through paddy field in the vicinity of Rizar. Water or sand blows are recognized along the fault trace.
