7.2 Japan Philippine Friendship Highway (Road 1 group)

7.2.1 Japan Philippine Friendship Highway

7.2.2 Conditions of Damage

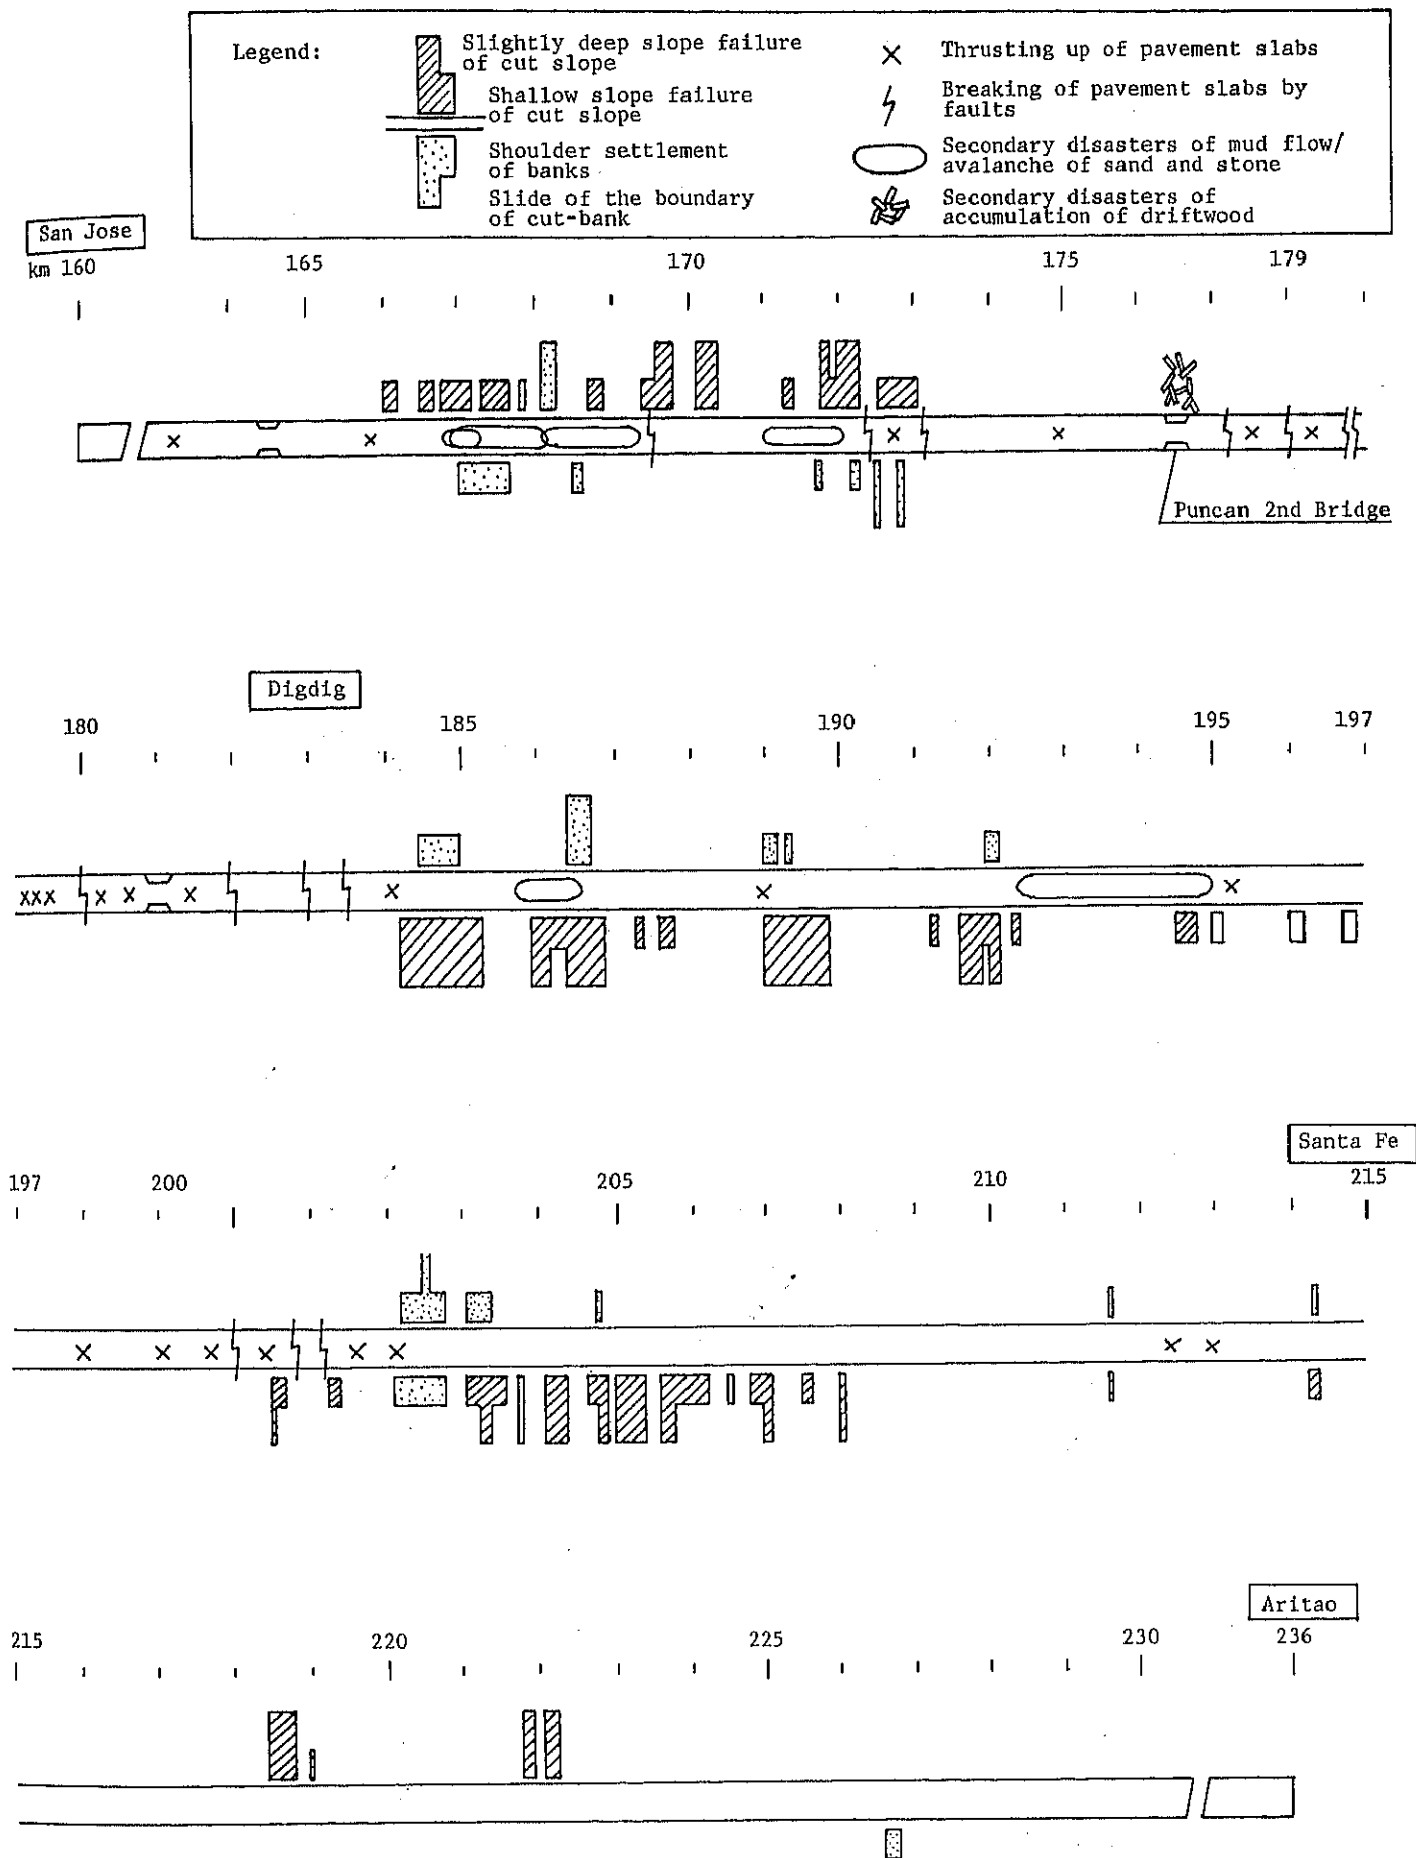
Figure 7.2.5 Distribution of the damages along the highway

Table 7.2.2 shows the kinds of and the distribution of the damage along the Pan Philippine Highway according to visual observation, and Figure 7.2.5 shows the distribution along the kilometer markers. Table 7.2.3 is a list of the places which had slope failures. The number of the places with slope failure reached more than 200 and totaled about 12 km. Most of the slope failures occurred continuously along the direction of the road.

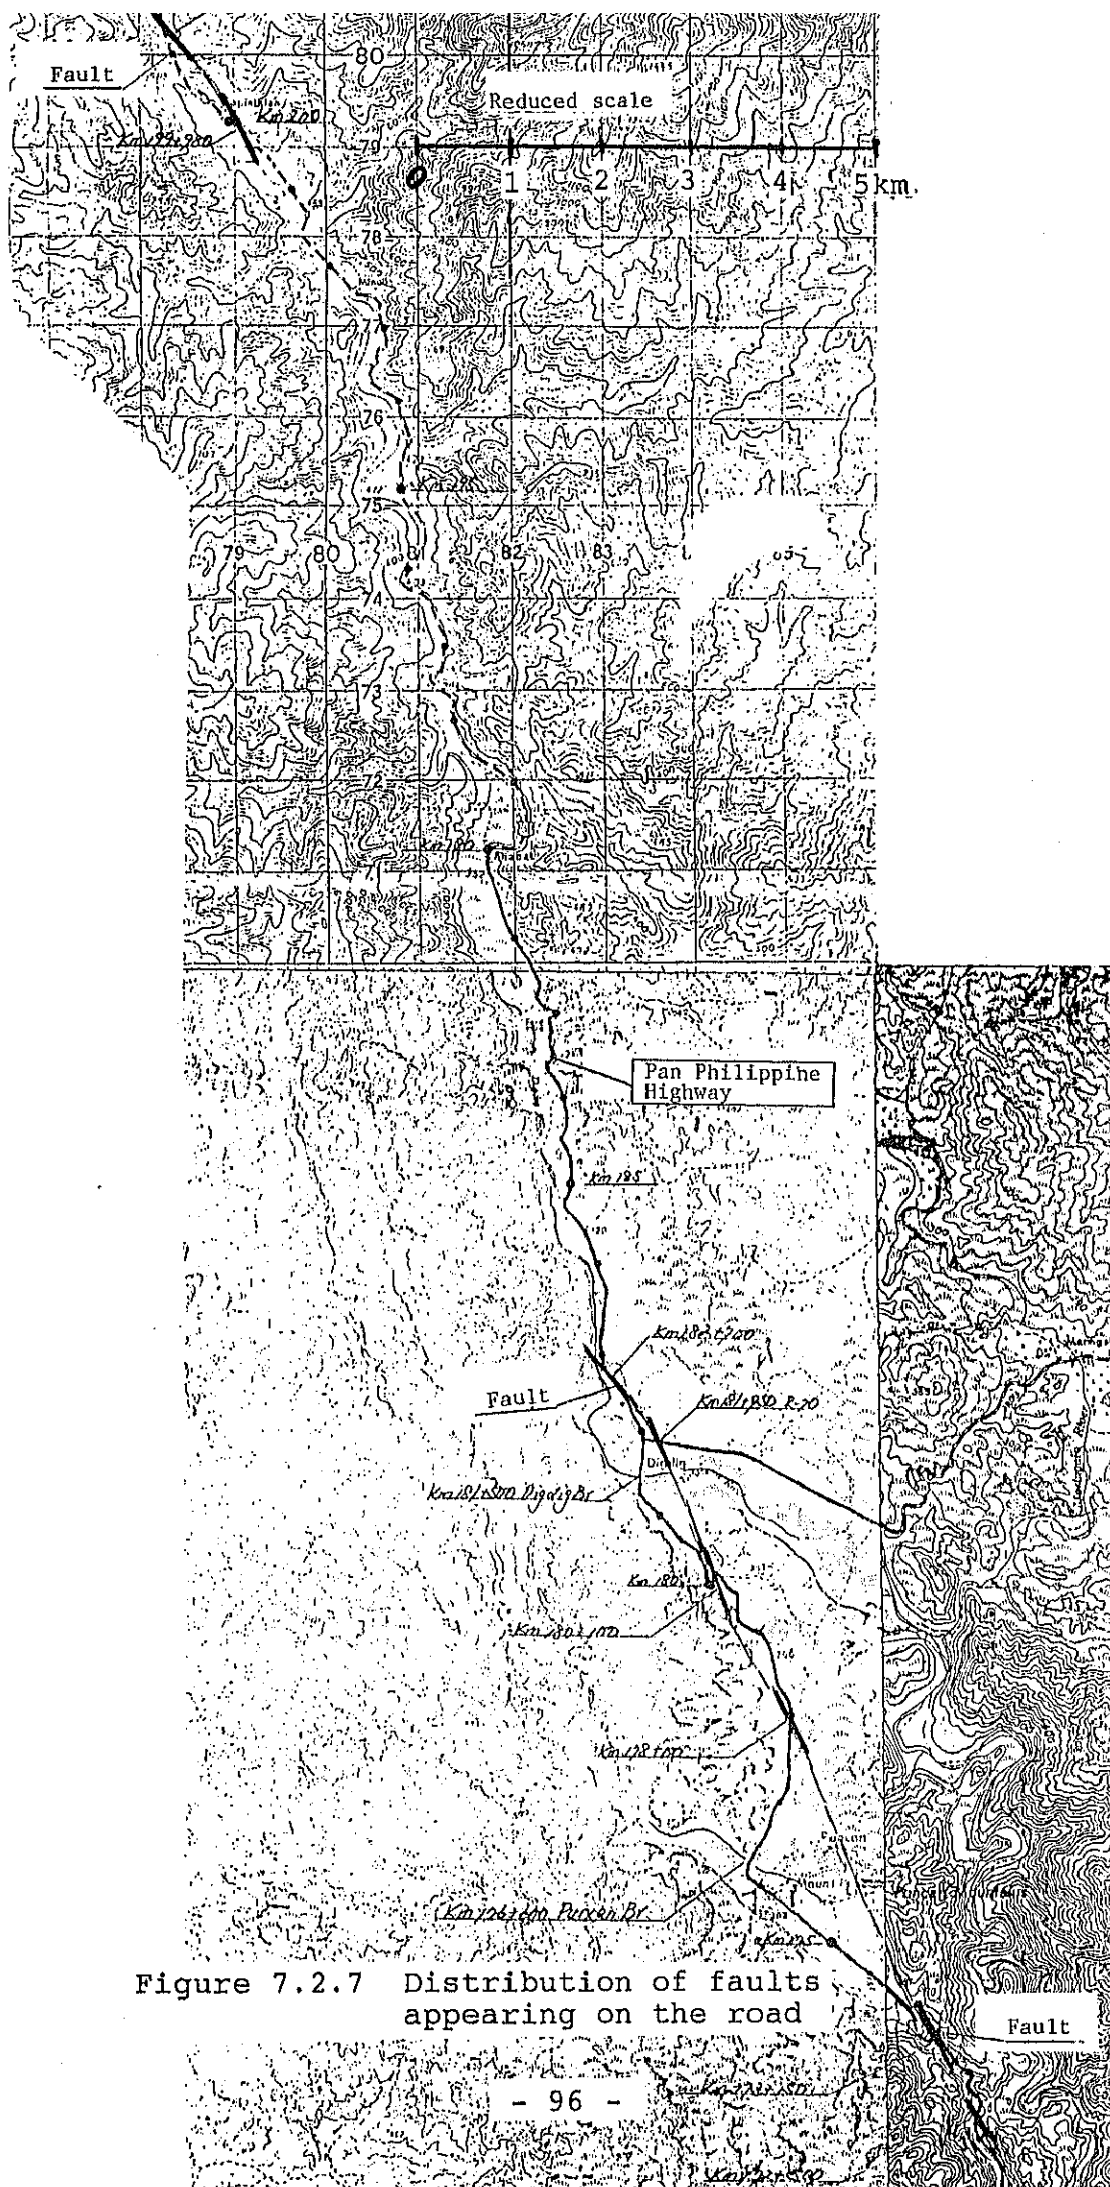
Figure 7.2.7 Distribution of faults appearing on the road

Based on the lateral slippage damage produced on the road surfaces, the positions of the faults are shown in Figure 7.2.7. The direction of roall the faults crossing the road was about N20°W. If the condition of the accuracy of the drawings is considered, they are not strictly accurate, but the faults are distributed nearly along the same line. The slippages on the roads were laterally 1.5 to 2 m to the left. Slippages in an up and down direction were not remarkable.

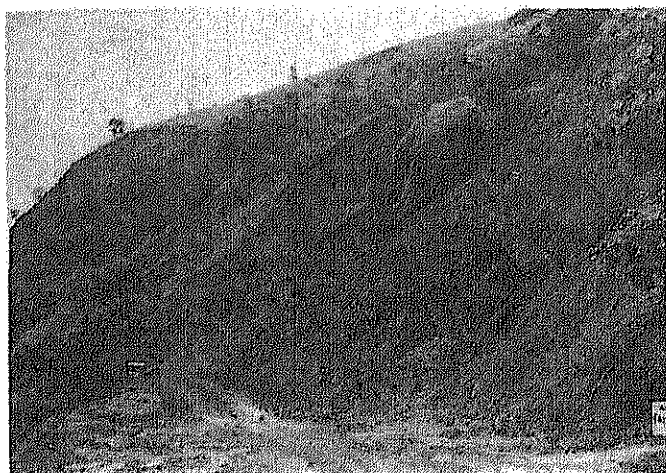
Photo 7.2.1 Surface failure.
(185 km position)

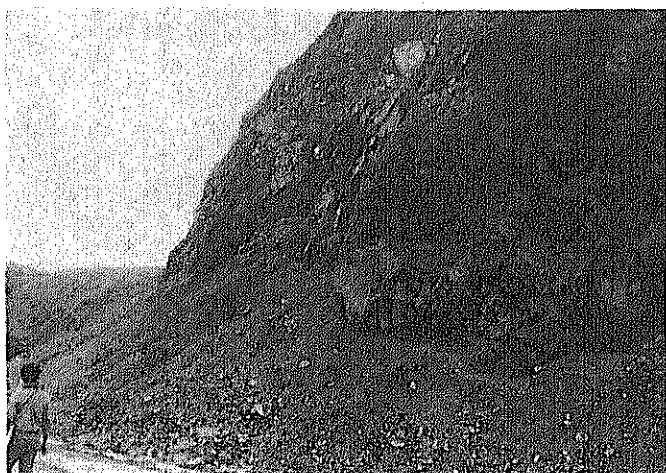
Photo 7.2.2 Surface failure.
(188 km position)

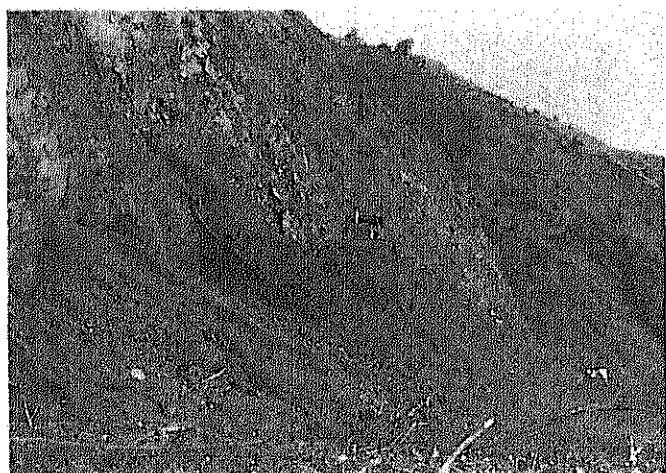
Photo 7.2.3 Road clearing work.
(170 km position)

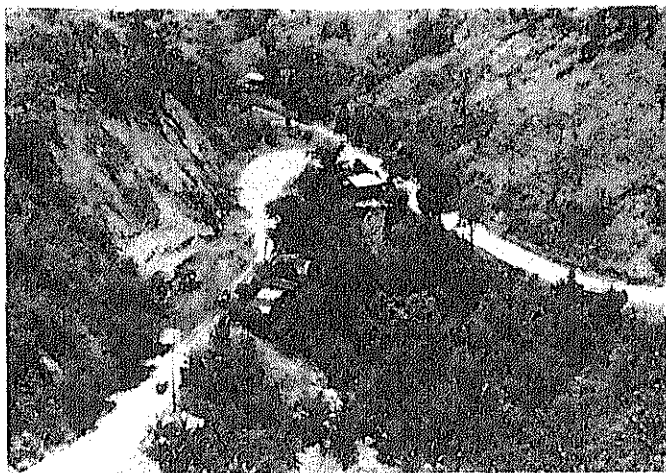
Photo 7.2.4 Road clearing work.
(207 km position)

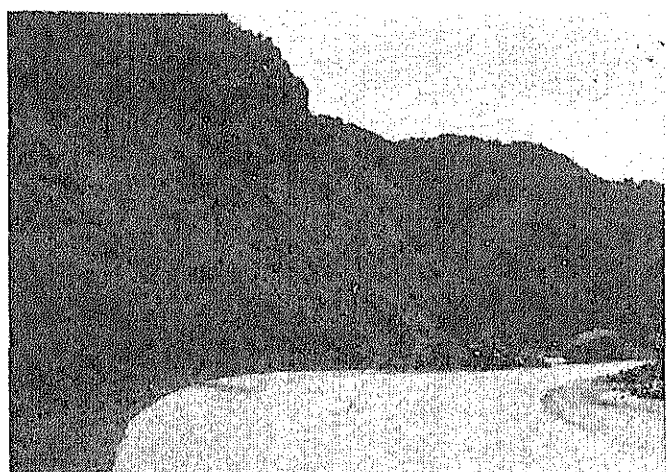
Photo 7.2.5 Huge fallen stone left
as they are, closing one-lane.
There are many stones just about
to fall at the upper part of the
slope-face. (208km position)

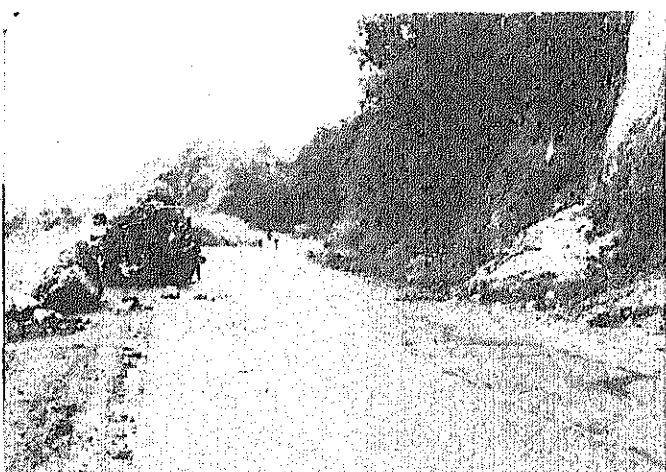
Photo 7.2.6 Fallen stones of
limestone.
(213 km position)

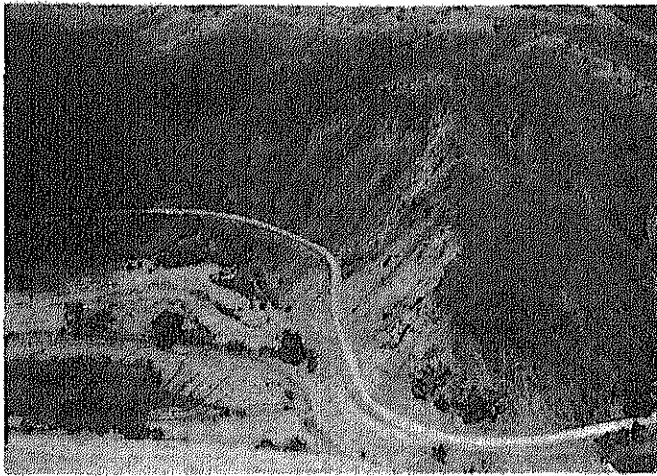
Photo 7.2.7 Road after finishing up clearing work after a huge slope and failure. There is a possibility of secondary disasters. We saw the marks of sand inflows to inflows to the lowlands. (203 km position)

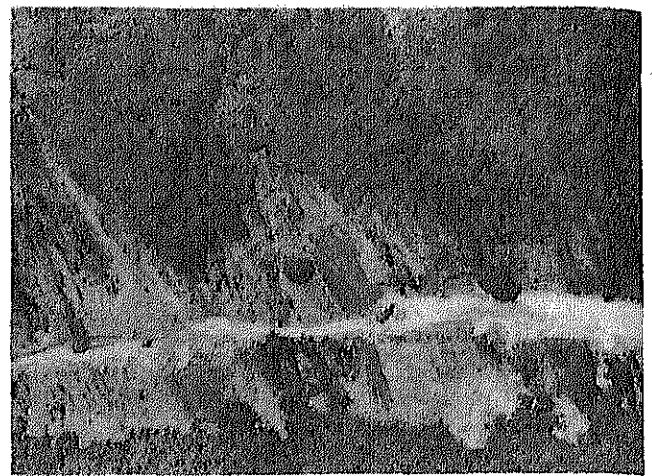
Photo 7.2.8 Slope face with huge fragmented rocks, clearing work by heavy machinery. (185 km position)

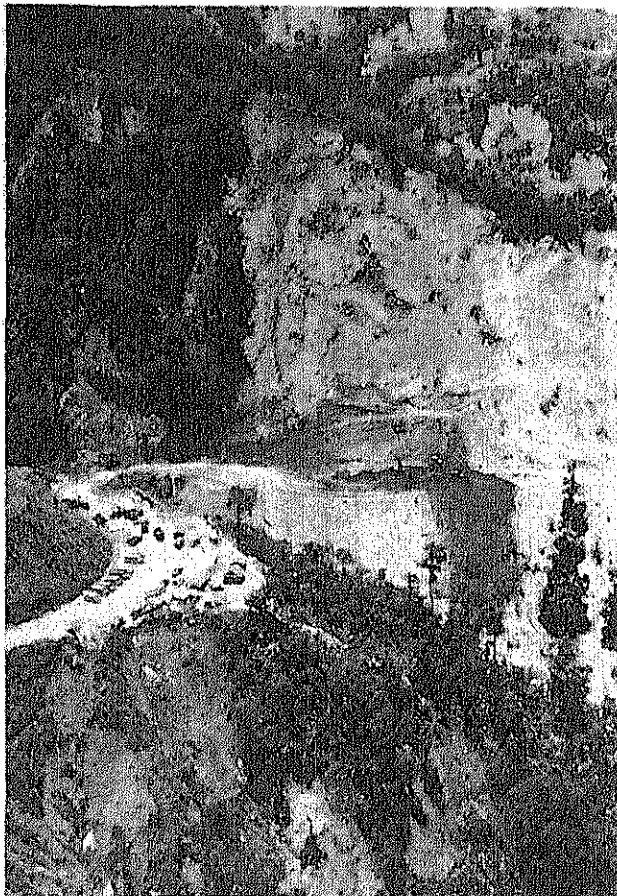
Photo 7.2.9 Huge slope failure at Dalton Pass: both height of the cut face and depth of the valley are 100 m class. At the left side, we saw the waiting shuttle trucks. (206 km position)

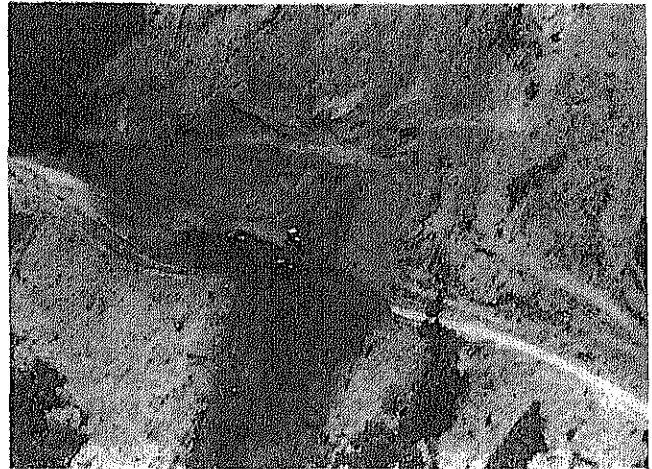
Photo 7.2.10 Clearing work by the heavy machinery at Dalton Pass when three weeks had passed after the earthquake. (206 km position)

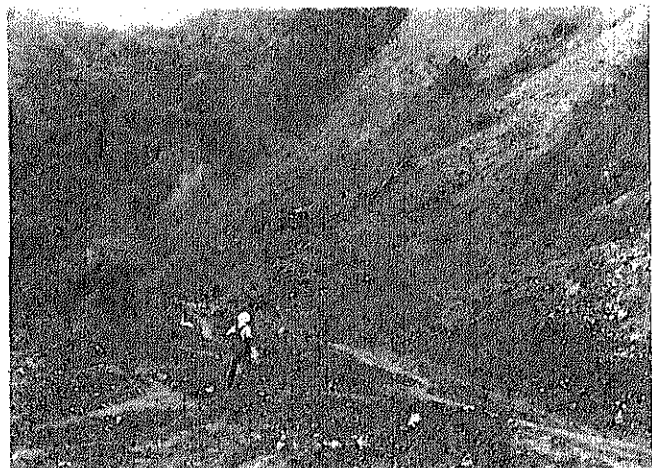
Photo 7.2.11 The same position as above.

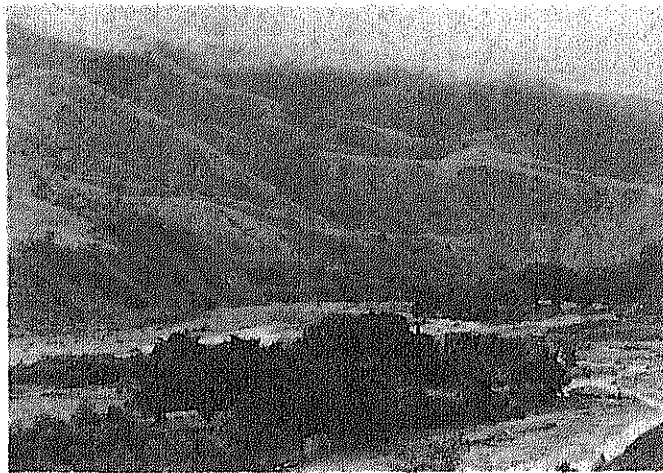
Photo 7.2.12 Environment surrounding the roads where there are large scale landslides and drifting wood. (187 km position)

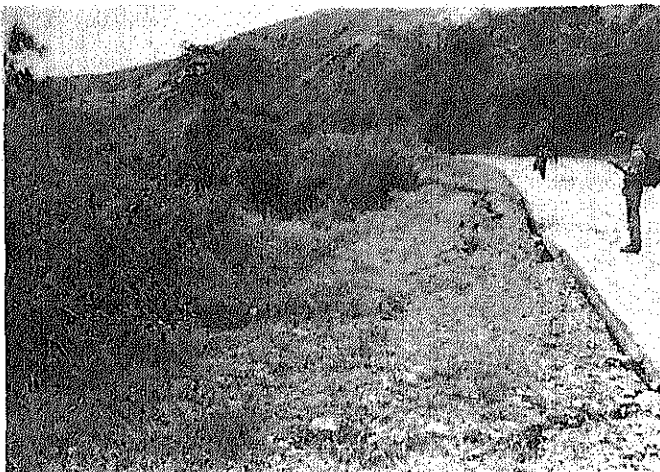
Photo 7.2.13 Settlement of the shoulders. (193 km position)

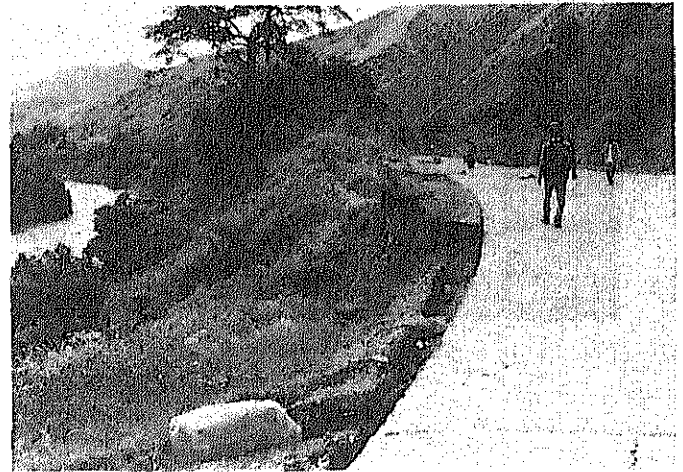
Photo 7.2.14 Collapse of the shoulders. (193 km position)

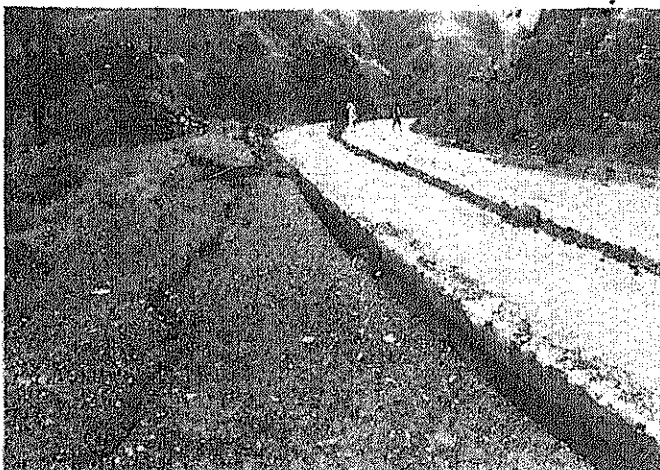
Photo 7.2.15 Opening of the shoulders by the sliding of the banks. (203 km position)

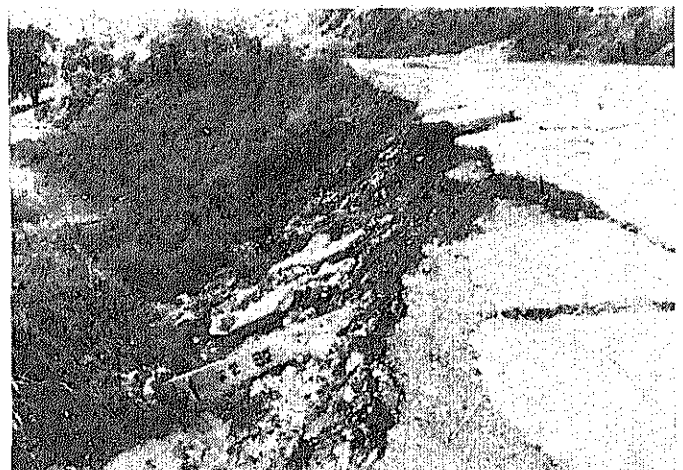
Photo 7.2.16 Collapse of banks. (173 km position)

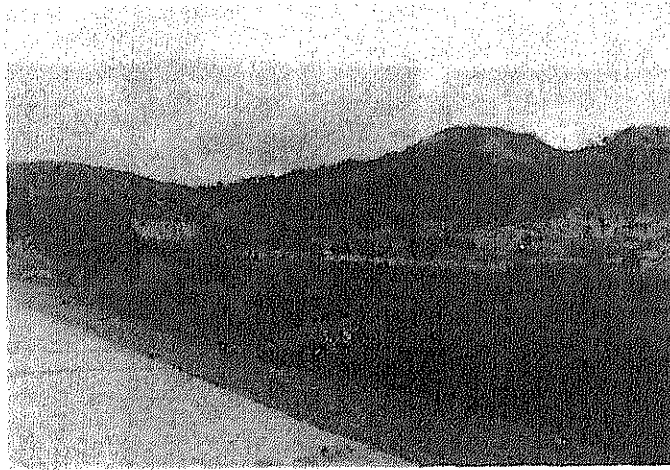
Photo 7.2.17 No damage at gently sloping mountains. (200 km position)

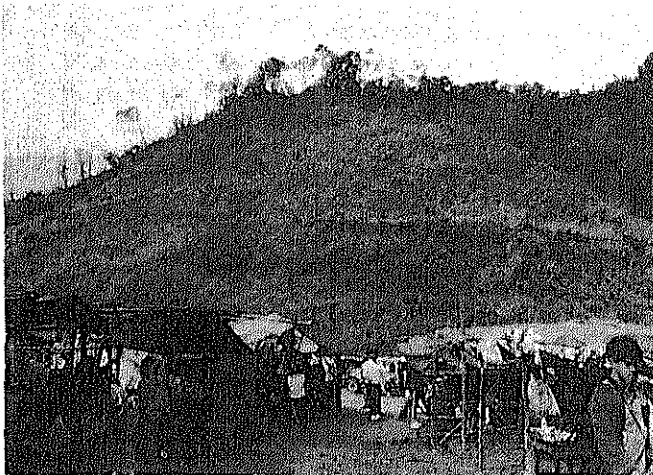
Photo 7.2.18 No damage at a slope face where vegetation was performed seed spraying) as pilot construction. (206 km position)

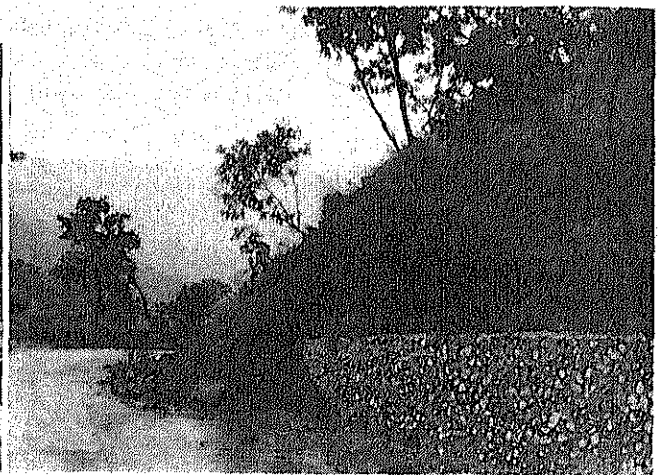
Photo 7.2.19 Small damage at a stone masonry retaining wall (wet masonry with cobbles) as protection of the toe of the cut slope. (201 km position)

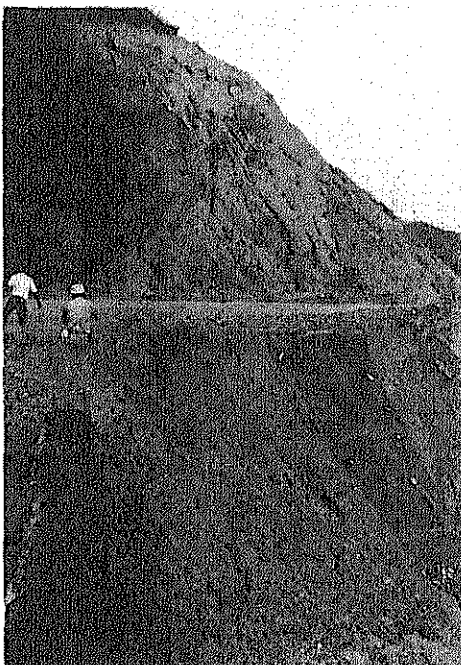
Photo 7.2.20 Stone pitching of the frame type protecting the slope face of a bank has little damage. (212 km position)

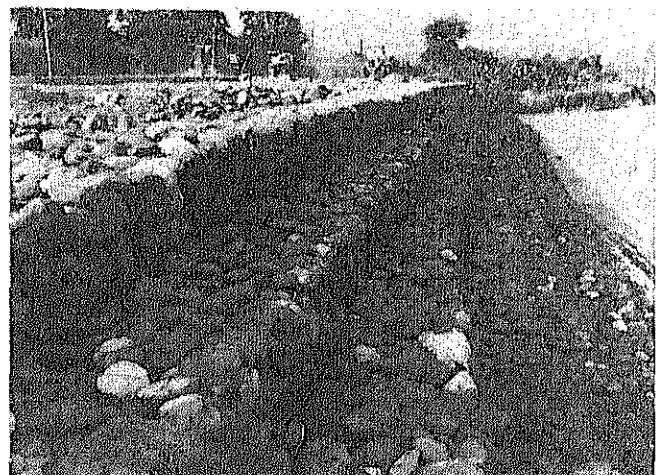
Photo 7.2.21 Wire mats (Gabion) and wire cylinders for scour protection of banking has little damage. (251 km position)

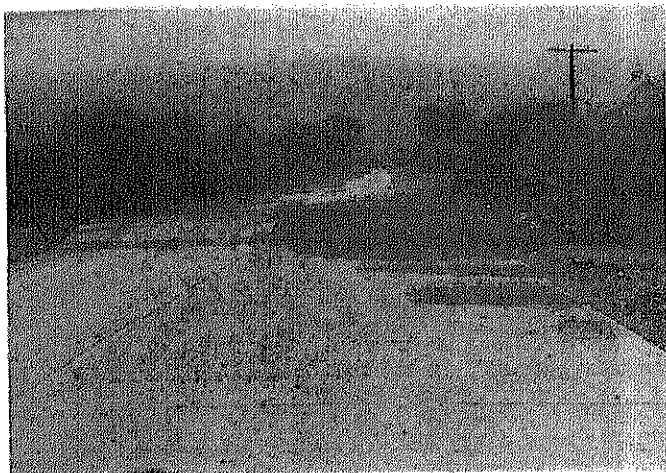
Photo 7.2.22 Thrusting up of pavement
slabs at a low bank section.
(164 km position)

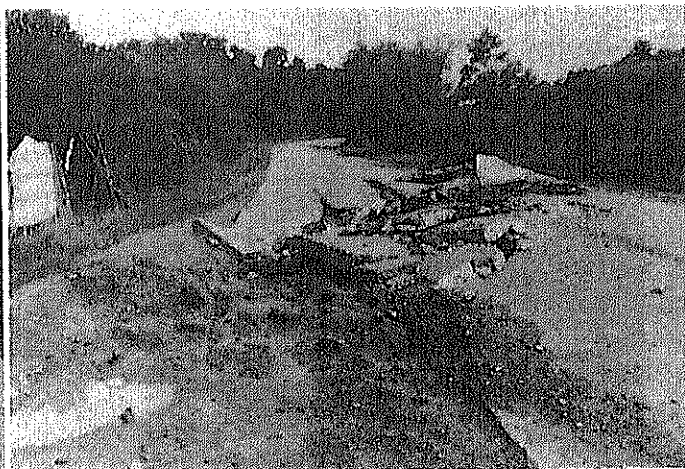
Photo 7.2.23 Road surface destroyed by
a fault crossing the road.
(183 km position)

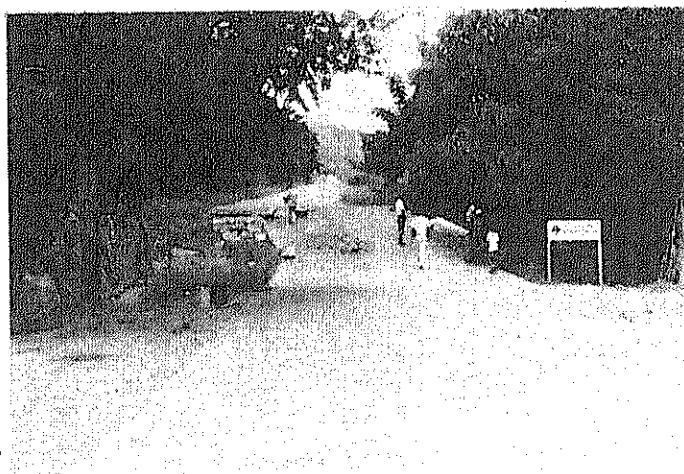
Photo 7.2.24 Road surface destroyed by a fault
crossing the road. (180 km position)

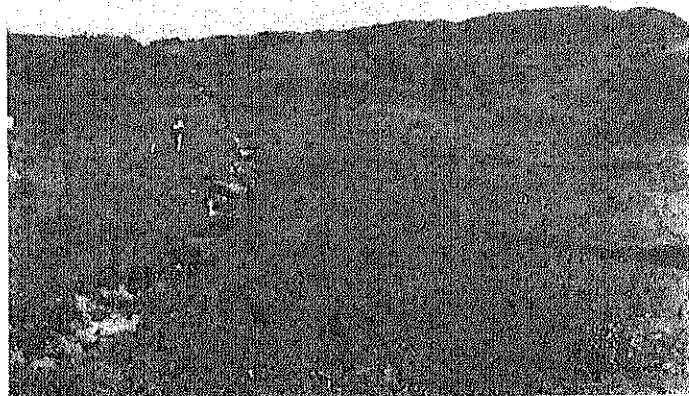
Photo 7.2.25 A fault meandering across the hills
after crossing the road. (180 km position)

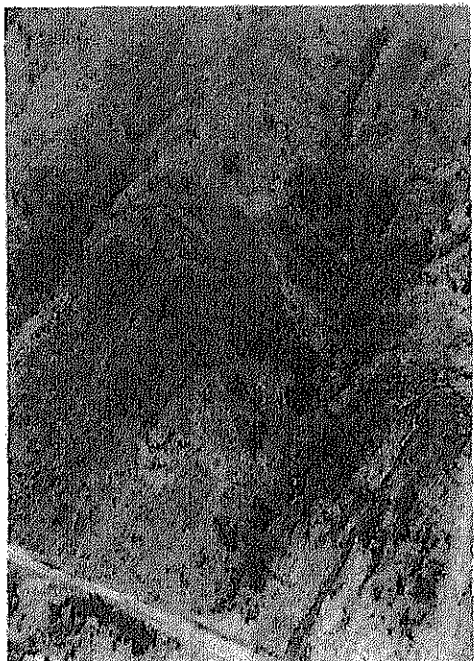
Furthermore, we will now introduce examples of the secondary disasters. Photo 7.2.26 shows open cracks on the upper parts of the face of a slope, observed from a helicopter; this is an example of the danger of shallow slope failure. Thus,

Photo 7.2.26 We saw open cracks from which there is danger of secondary slope failure at the upper parts of the slope.

- To investigate the possibility of dangerous secondary collapses, open cracks at the upper parts of the faces of the slopes should be inspected.
- Avoid the use of a bank as a road.

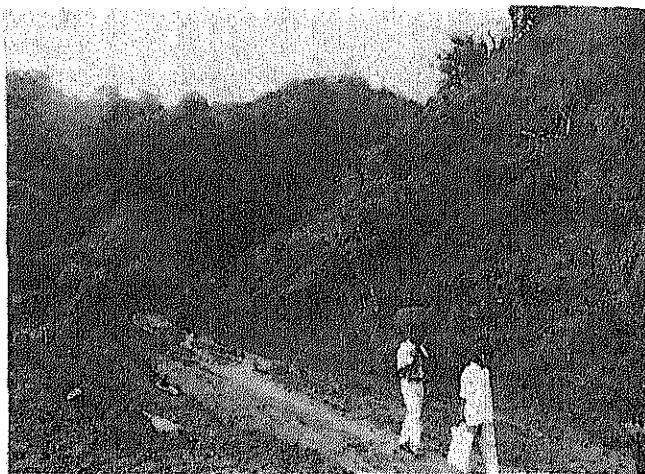
Photo 7.2.27 A slope becomes unstable due to rains. (205 km position)

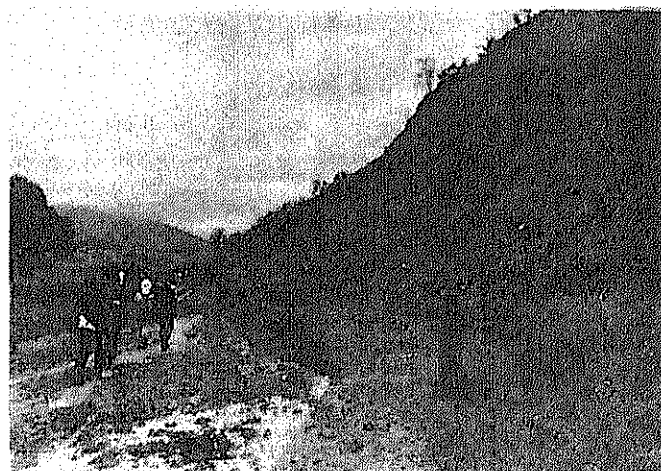
Photo 7.2.28 A slope becomes unstable due to rains. (195 km position)

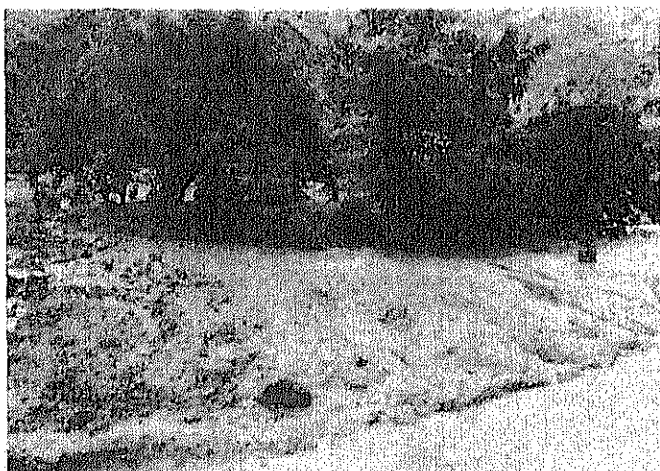
Photo 7.2.29 Outflow of mud from the valley due to rains. (194 km position)

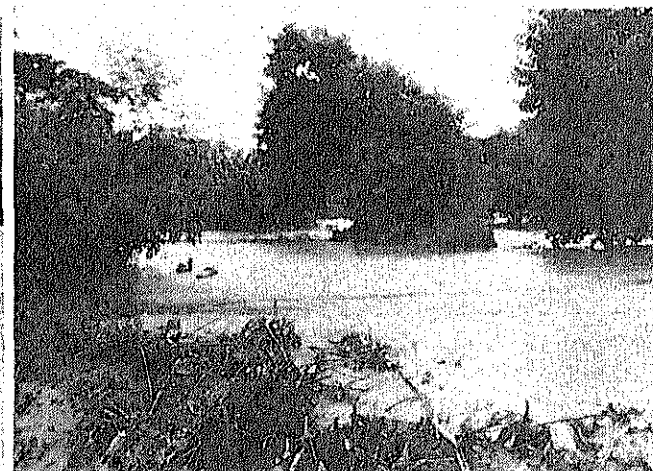
Photo 7.2.30 Outflow of mud from the valleys. (194 km position)

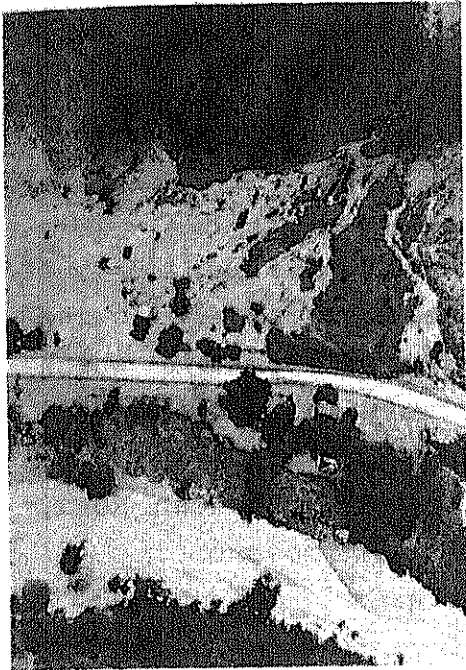
Photo 7.2.31 Conditions of sand outflow, viewed from the sky. (The road had been cleared)

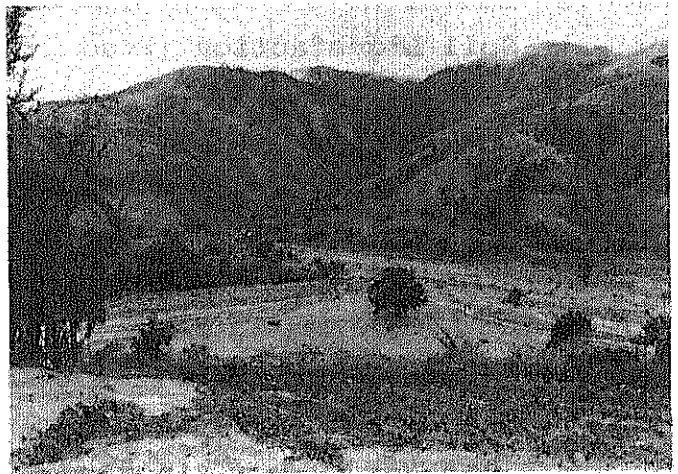
Photo 7.2.32 Conditions of sand outflow in the river. (195 km position)

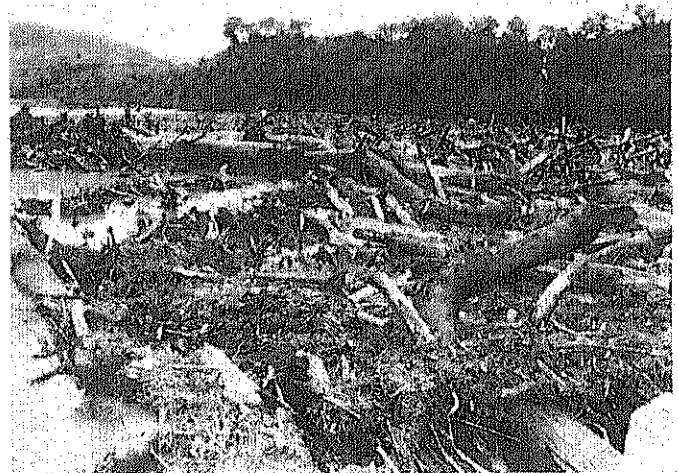
Photo 7.2.33 Drifted wood cast on the riverbank. (192 km position)

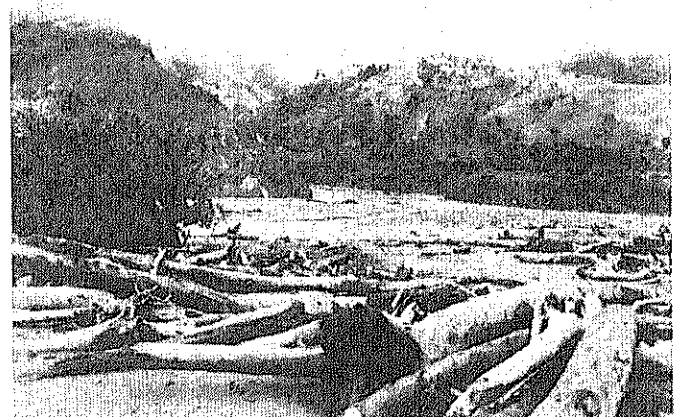
Photo 7.2.34 Accumulated condition of drifted woods at the second Puncan Bridge. (176 km position)
