7.3 Manila North Super Highway, Three Main Routes to Bagio and Soil Liquefaction (Road 2 group)

7.3.1 Role of the Road 2 Group and the Route of its Reconnaissance

7.3.2 Results of the Reconnaissance

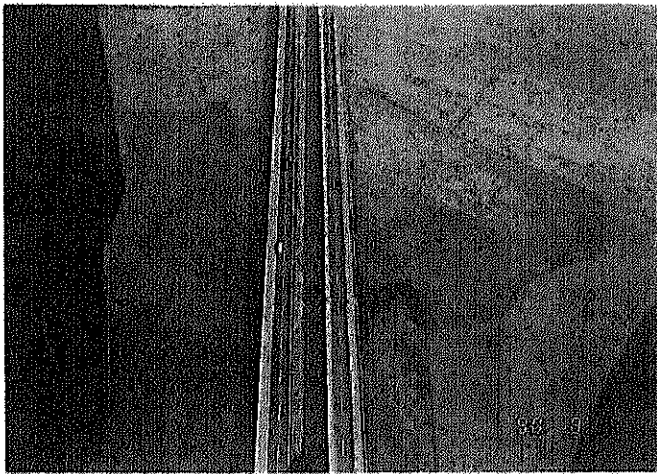
In the roads of this section, the damages thought to have been caused by the earthquake were limited to a part of the viaduct (length: about 5km) of the Manila North Super Highway crossing the Panpanga river. The substructures of the viaduct are pile bent type piers, and the superstructure is a 10-span continuous PC girder bridge. The short span (span: about 1.5m) girders connecting the continuous girders were moved about 0.8m in the transverse direction of the bridge (to the east side). (see Photos 7.3.1 to 3). It is said that this movement was greater in the direction heading away from Manila. At the low-bank section near KM 110 between Capas and Tarlac, 1 to 2cm wide cracks were observed running in a direction parallel to the road, at the joints between the asphalt pavement of the shoulders and the concrete pavement of the near side lane. The surroundings are paddy fields. Whether or not these cracks were caused by the earthquake is underlain.

Photo 7.3.1 Elevated bridge of North Super Highway (lateral slip of floor slab visible)

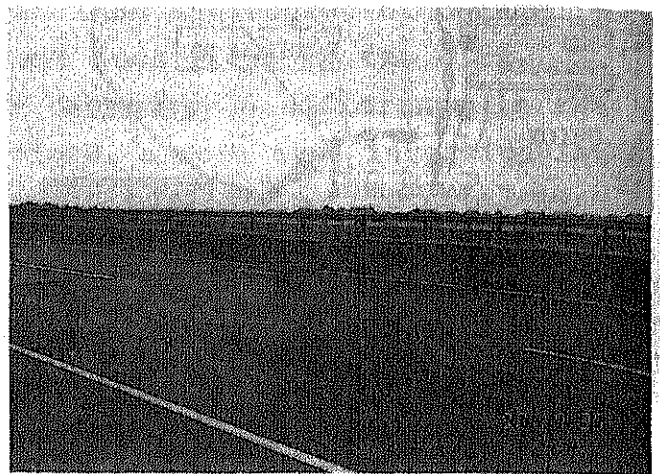
Photo 7.3.2 Lateral slip of floor slab of elevated bridge of North Super Highway

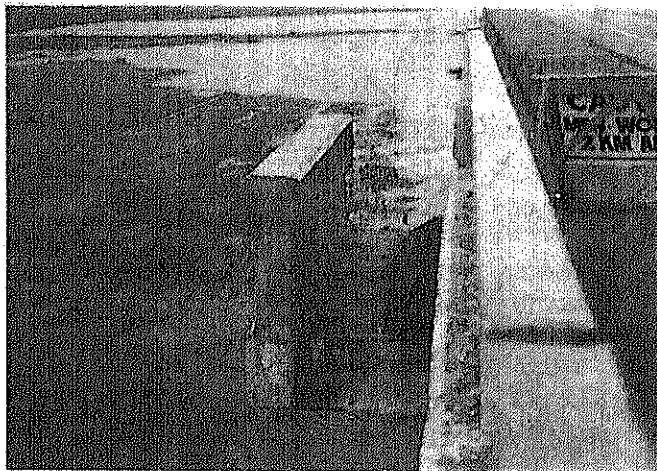
Photo 7.3.3 Lateral slip of floor slab of elevated bridge of North Super Highway; A close up view of the lateral slip

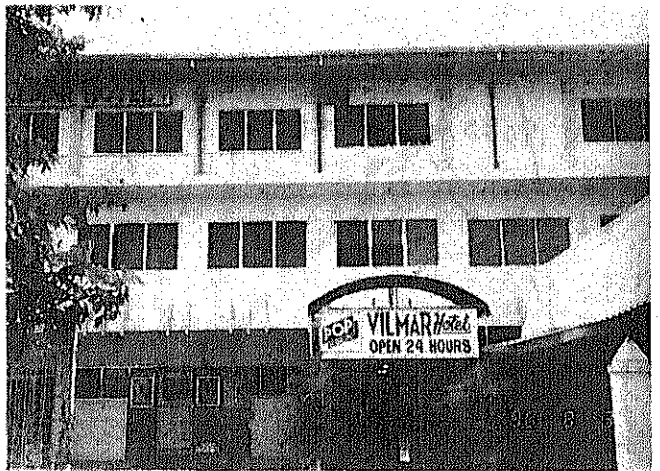
In Tarlac City, cracks obliquely crossing the external wall of the second floor of the Vilmar Hotel (three stories) and broken window glass were observed. (August 3rd evening). (see Photos 7.3.4 to 5). During travel through the section located about 10 to 15km to the north of Tarlac, open cracks about 10cm wide near the center line of the asphalt pavement and cracks at the shoulder parts were observed. Though the length of this is uncertain, it is probably about 500 to 1,000m. (see Photo 7.3.6). From the state of the deformations, it is presumed that liquefaction phenomena occurred in the ground under the road.

Photo 7.3.4 Vilmar Hotel in Talac City (cracks in wall)

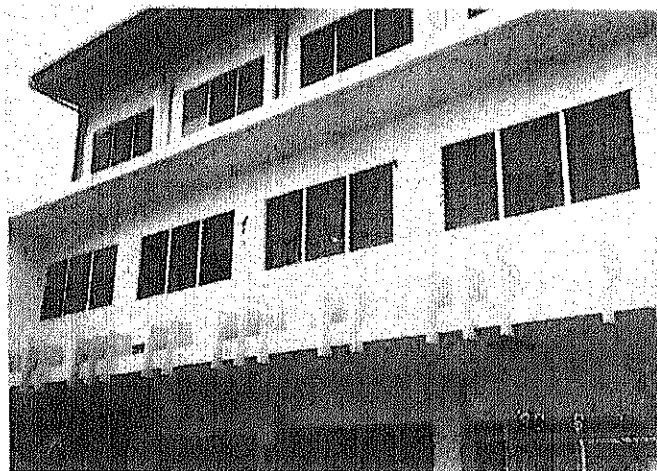
Photo 7.3.5 Cracks in wall of Vilmar Hotel

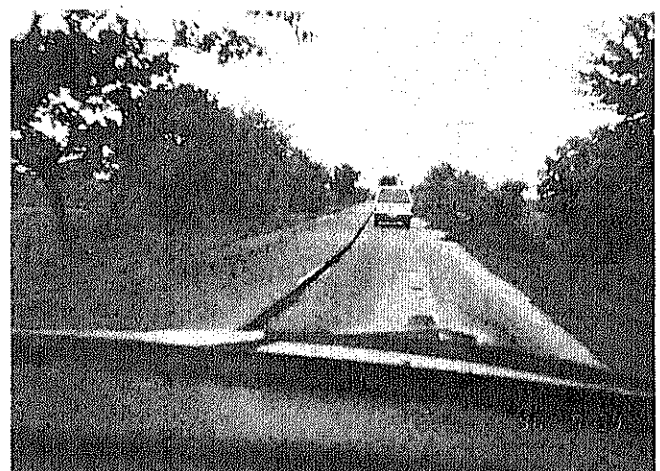
Photo 7.3.6 Cracks along center line near 135km (?) spot on No. 3 Line

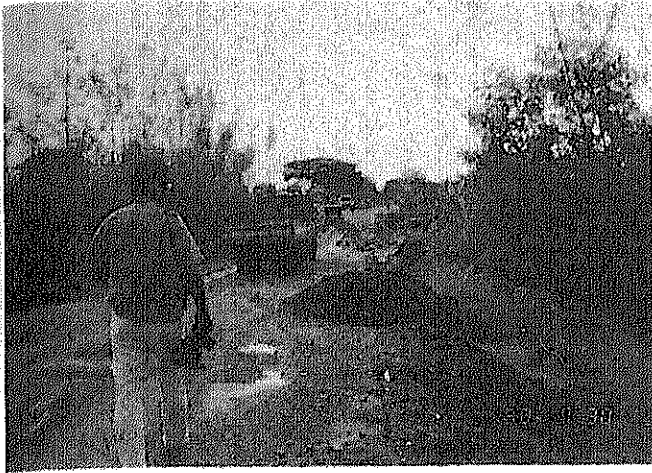
The San Isidro bridge, located at the KP149+511 position near the northern extremity of Pangasinan Province, is a 7-span PC simple girder bridge. Though cracks and spouted out sand were seen on the ground surface near the abutments, the extent of the damage to the bridge seemed to be slight (see 7.4 for details about damage to bridges). At this position, since the approaching fill on the left bank of the bridge (the south side of the bridge on route No.3) has sunk about 1.5 to 2m and the right bank approach has also sunk a fair amount, traffic can pass through only one lane of the two lanes (see Photos 7.3.7 to 7.3.10). Figure 7.3.2 shows a sketch of the area. The settlement of the approaching embankments of the S. Isidro Bridge was definitely caused by soil liquefaction. Not only at the approach banking but also at the left bank side downstream of the bridge, the stone masonry revetments are sunk to the degree that they have sunk below the water surface. Further, both the inland slaughterhouse and the neighboring ground sank to the degree that flooding above the floor boards occurred.

Photo 7.3.7 Sinking of approach to left bank of S. Isidro Bridge

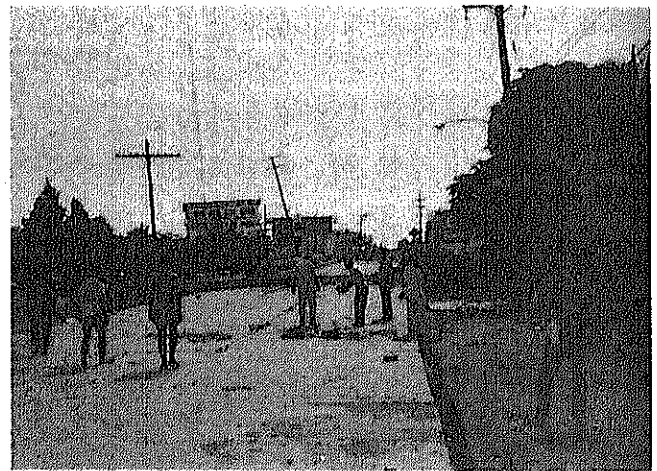
Photo 7.3.16 Approach to left bank of Magsaysay Bridge

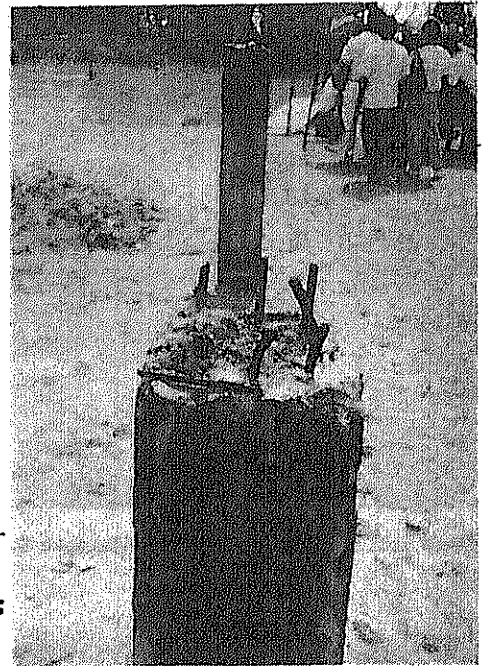
Photo 7.3.20 Substructure for widening of Magsaysay Bridge; Closer view

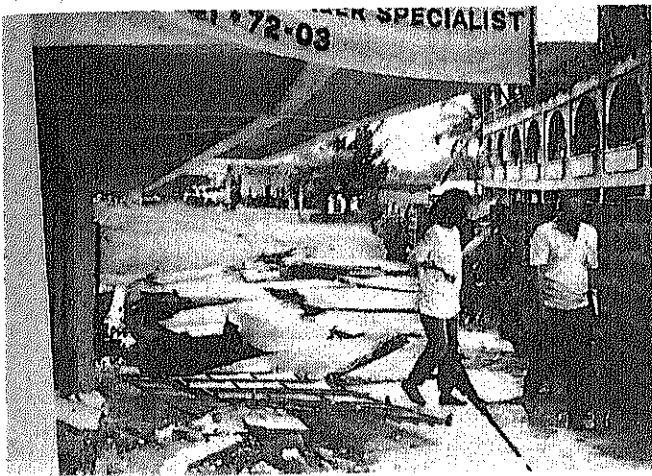
Photo 7.3.21 Damage to building at approach to right bank of Magsaysay Bridge

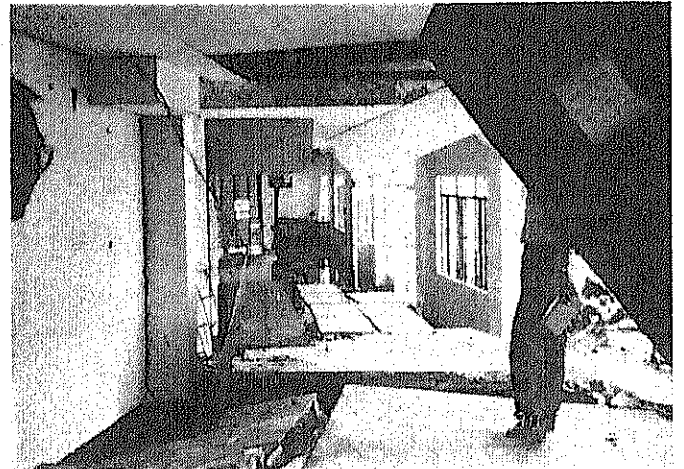
Photo 7.3.22 Damage to building at approach to right bank of Magsaysay Bridge; Inside the building

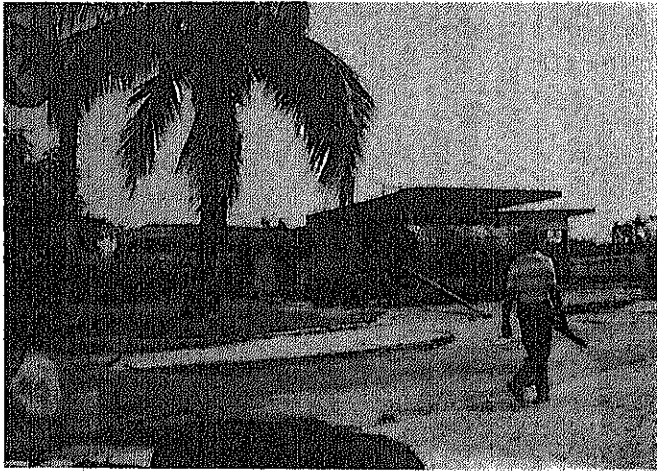
trapezoid shaped part surrounded by Fernandez Blvd., Perez Blvd., Rizal St. and Urdaneta Junction Dagupan Lingayen Rd. In this area, Fernandez Blvd. sank 1.5 to 2m (the amount of the settlement was not measured; this is informed from DPWH local engineers) and the road surfaces were covered with water. Therefore, to raise up the road, earth and sand mixed with cobbles was temporarily spread. Since Perez Blvd. was closed to traffic due to a falling bridge, midtown traffic became one-way in a counter-clockwise direction. For buildings along the four streets described previously, not only damages, such as inclination, settlement and breakdown occurred; they were also flooded above floor level due to the land subsidence after the earthquake. Further, since the gutters lost drainage functions due to settlement of the whole neighborhood, many things went wrong with drainage as well. Underground tanks dug out of the ground are placed at all the gas stations facing the street; this shows that the tanks came to the surface.

Photo 7.3.25 Gasoline stand in Dagupan City

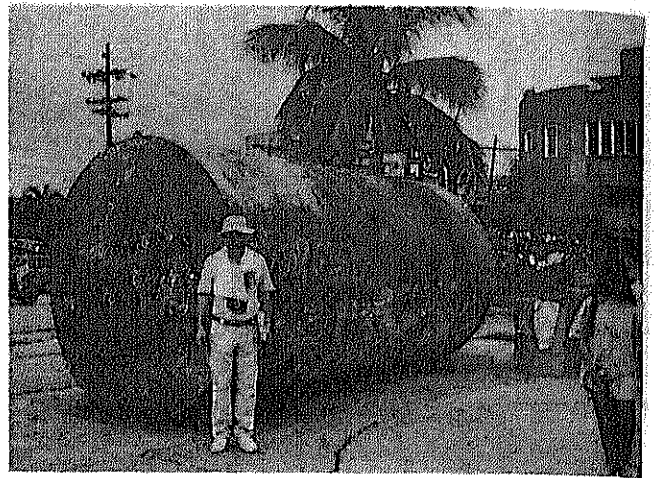
Photo 7.3.26 Excavated tank

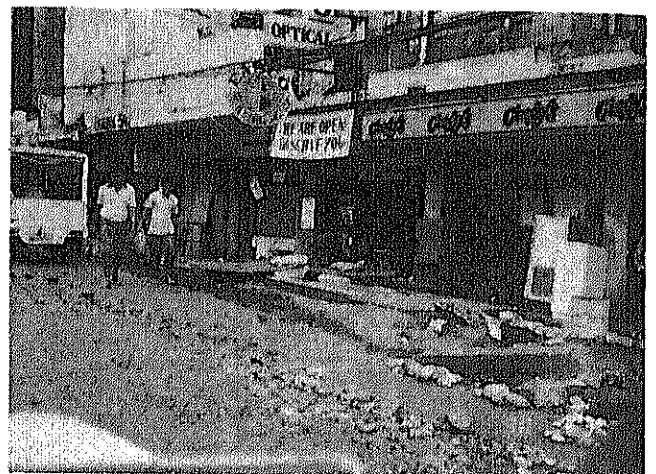
Photo 7.3.28 In Dagupan City (cobble stones on the surface are materials used for emergency repairing.)

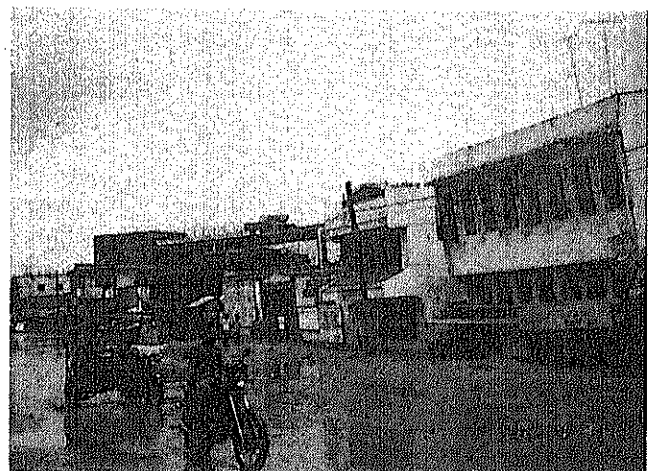
Photo 7.3.30 In Dagupan City (there are some sections where puddles were left.)

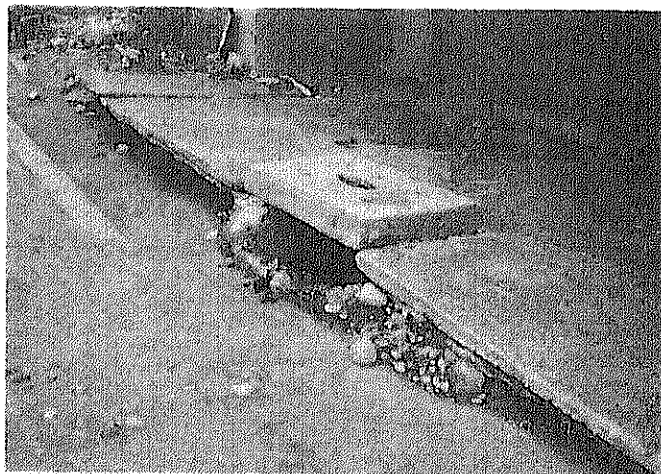
Photo 7.3.32 Damage to drain-ditch in Dagupan City

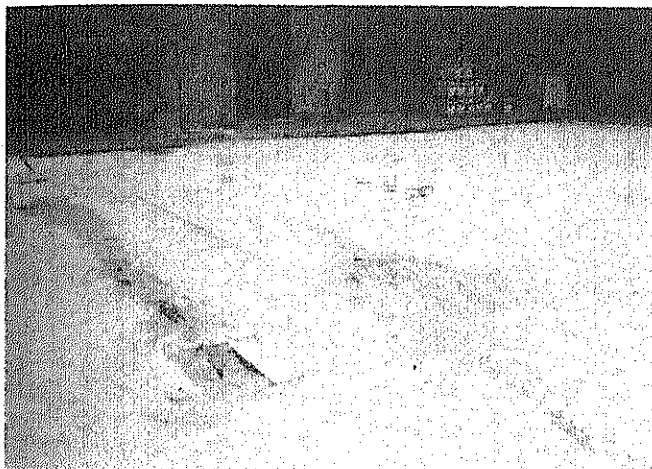
Photo 7.3.33 Sand gust marks on a factory on the right bank (spots 1 - 7) of the Pantar River

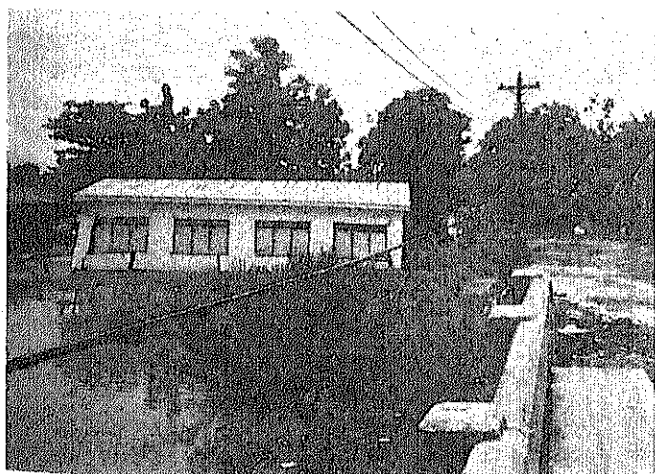
Photo 7.3.35 Road in Barangay Pugo (brought down to a level lower than the water level of the river due to ground sinking.)

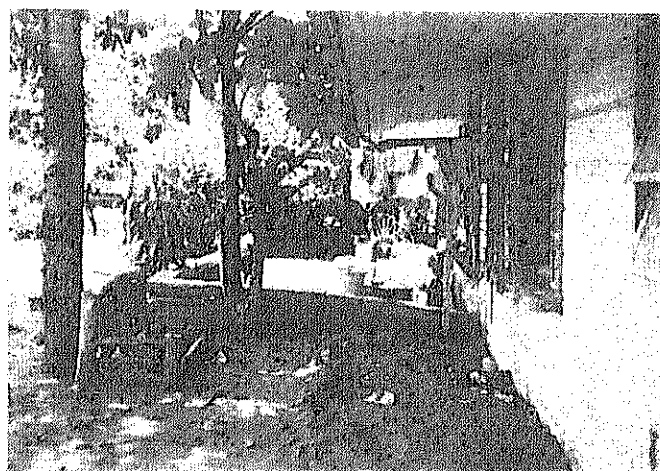
Photo 7.3.36 Damaged private houses in Barangay Pugo

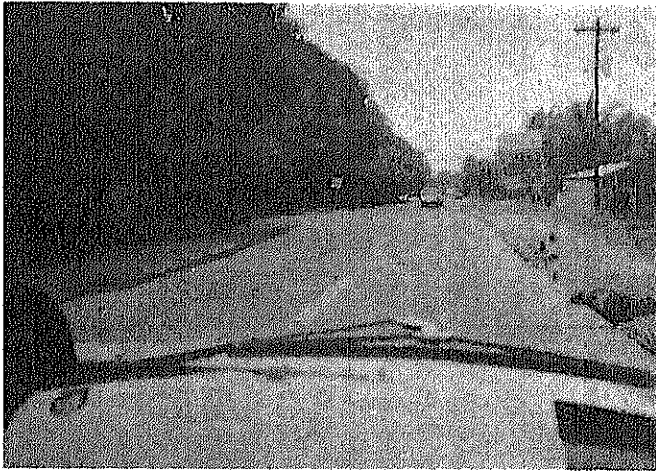
On the way to S. Barbara, branching off from Calasiao, crosswise cracks, differences in level of the pavement surface, and settlement at the shoulders were observed (see Photo 7.3.37 to 39). The section is located in a swampy area and the structure of the road is low embankment of 1 to 2m high. The cause of this portion was considered to be liquefaction.

Photo 7.3.37 Depression of road from Calasiao - S. Barbara

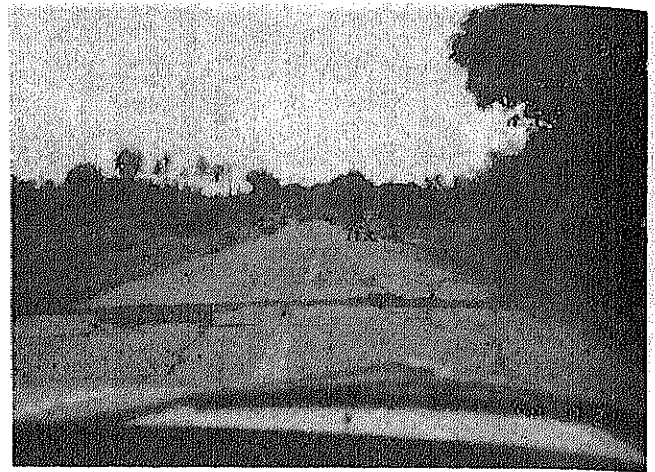
Photo 7.3.38 Depression of road from Calasiao - S. Barbara; Cross-cracking of pavement

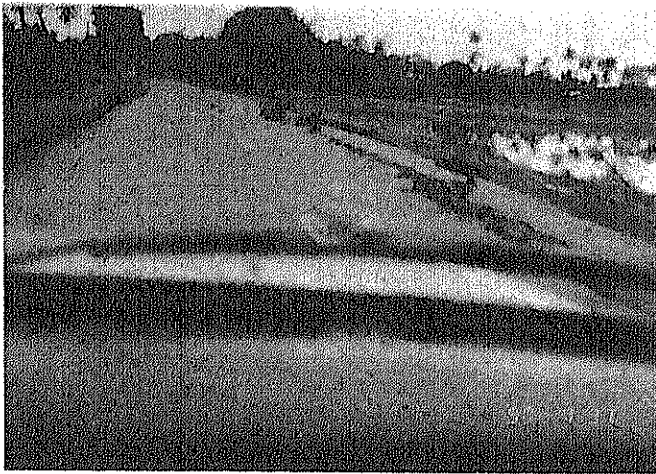
Photo 7.3.39 Depression of road from Calasiao - S. Barbara; Sinking of roadside

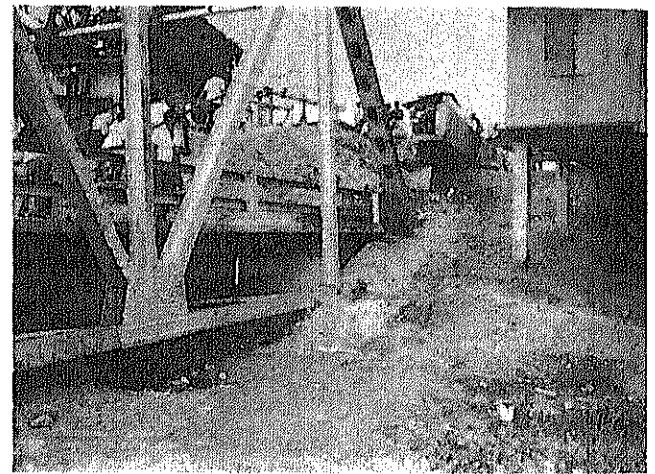
Photo 7.3.40 Left bank abutment of Carmen Bridge

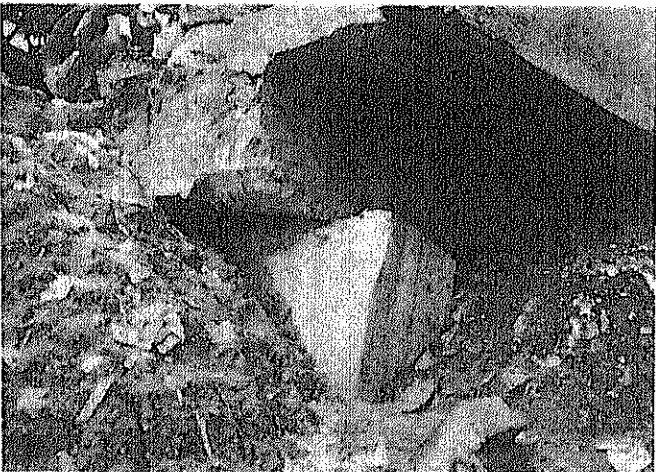
Photo 7.3.41 Left bank abutment of Carmen Bridge; Closer view; side span is pushed out.

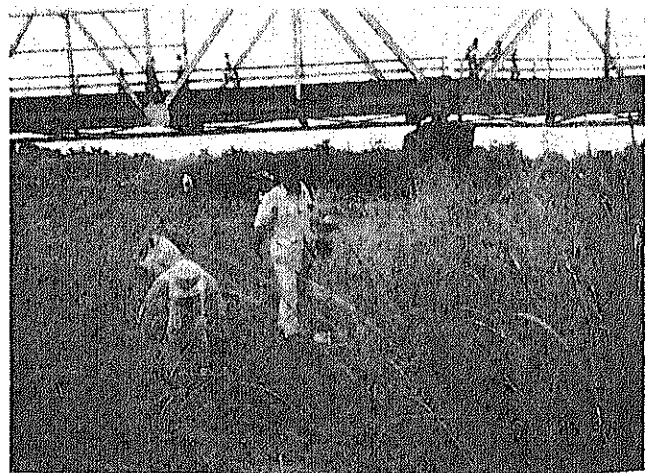
Photo 7.3.42 60cm wide crack seen on left bank side high riverbed

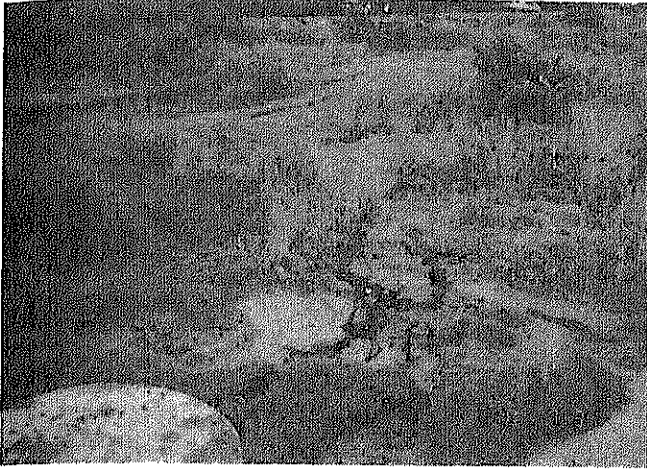
Photo 7.3.43 Crack seen on right bank side high riverbed

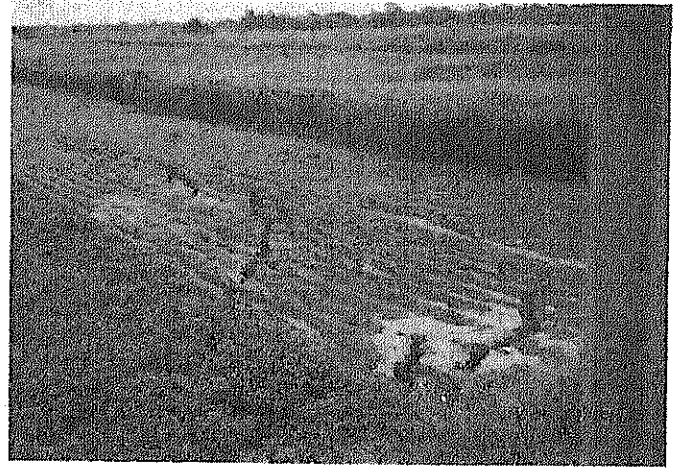
Photo 7.3.44 Crack on left bank down-stream side high riverbed

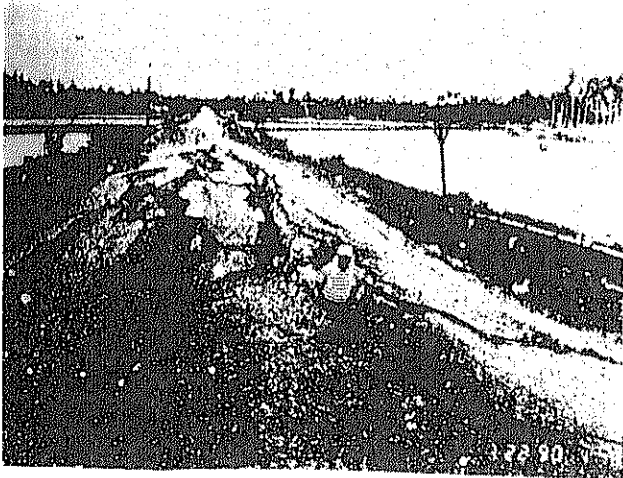
Photo 7.3.45 Crack in bank along No. 313 Line (Courtesy DPHH)

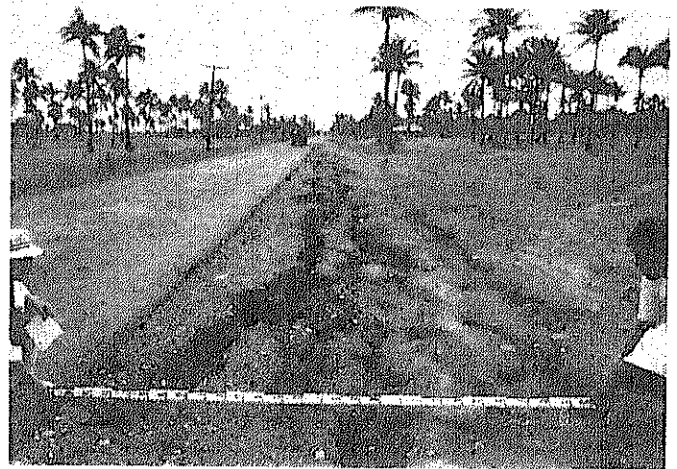
There is a route, one of the roads from Dagupan to San Fabian of route No.3, along the Lingayen Gulf going northward from Dagupan city, although the route is not laid out in old topographical maps. At the outskirts of the urban districts of Dagupan city, there is a continuous 3-4m-high banked section where fish ponds on each side of the road can be seen. It is reported that the damage as shown in Photo 7.3.45 occurred in a part of that section (according to DPWH materials). Since the damaged positions had been temporarily filled up by soils when we passed, the conditions shown in the photograph had disappeared. In part of the section by the Lingayen Golf course near KM217+500, cracks were observed at the shoulders and beside the road (Photo 7.3.46). However, the road surface was not damaged.

Photo 7.3.46 No. 313 Line, Crack at the side of the Lingayen Golf Link

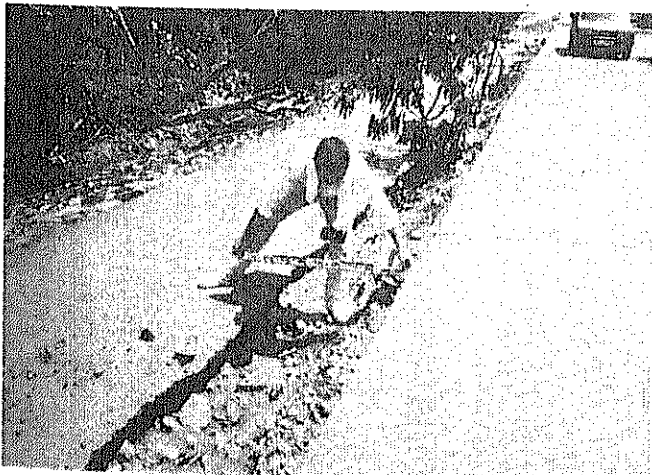
Bridge is a bank of 1 to 2m high. In this section, cracks in the shoulders, differences in level, and damages to parts of the pavement were observed (Photos 7.3.47 - 7.3.49).

Photo 7.3.47 Damage to the low bank section of Longas Junction

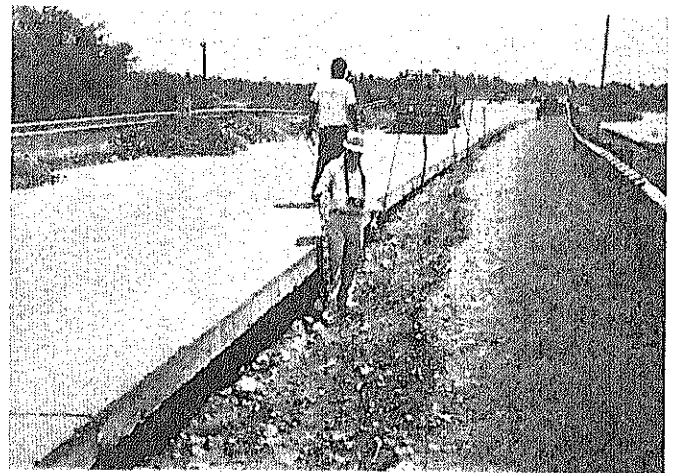
Photo 7.3.48 Damage to the low bank section of Longas Junction

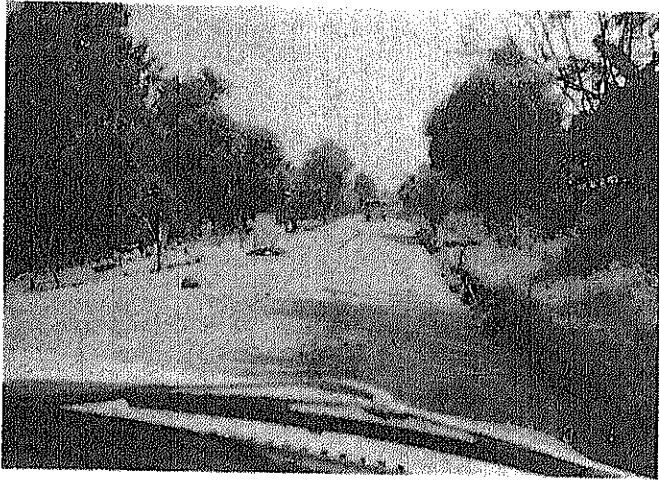
Photo 7.3.49 Damage to the low bank section of Longas Junction ; swelling of surface

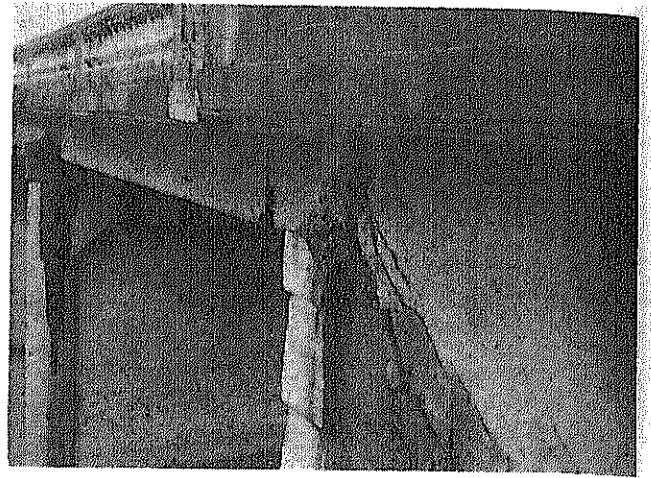
Photo 7.3.50 Damage to left bank abutment of S. Rita Bridge

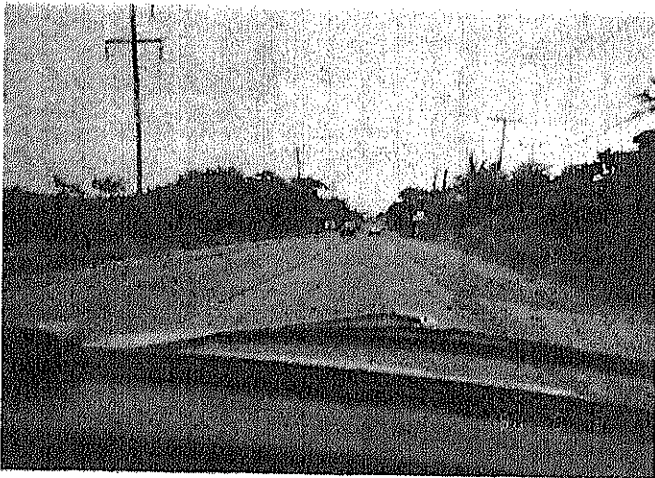
Photo 7.3.51 Stepped part at center of surface from Bauang - S. Fernando

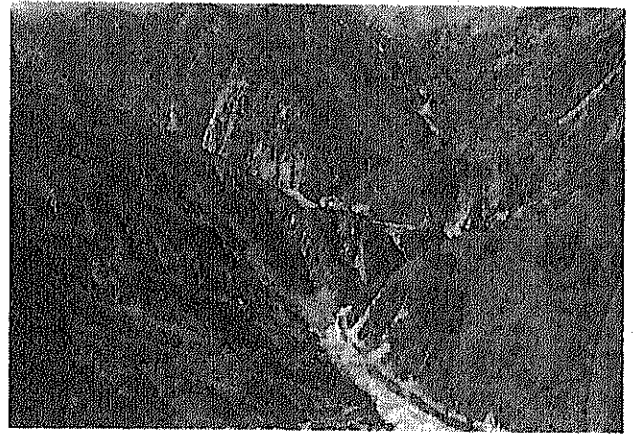
Slope failures occurred on the hillside slopes along the Kennon road and also on the hillsides of Baguio city and its outskirts. Collapsed earth and sand caused riverbeds to rise up along with the accumulation in the valleys; in some places, the rivers are blocked in the form of small-scale natural dams. (Photo 7.3.52 to 53)

Photo 7.3.52 Shallow failures of hillside slopes along the Kennon Road

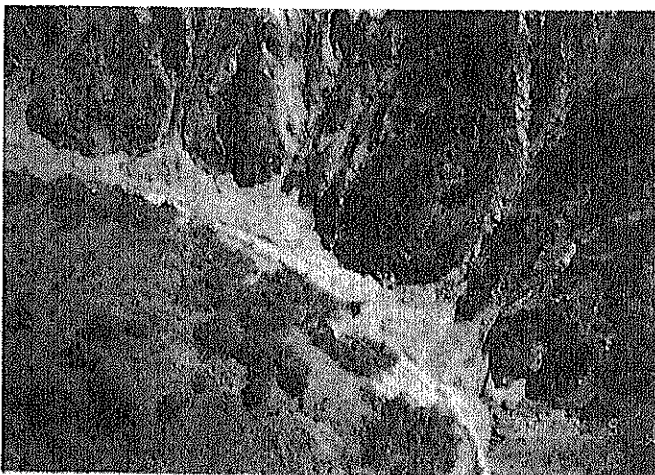
Photo 7.3.53 A large amount of collapsed and fallen sediment flowed out into the Buedo River.

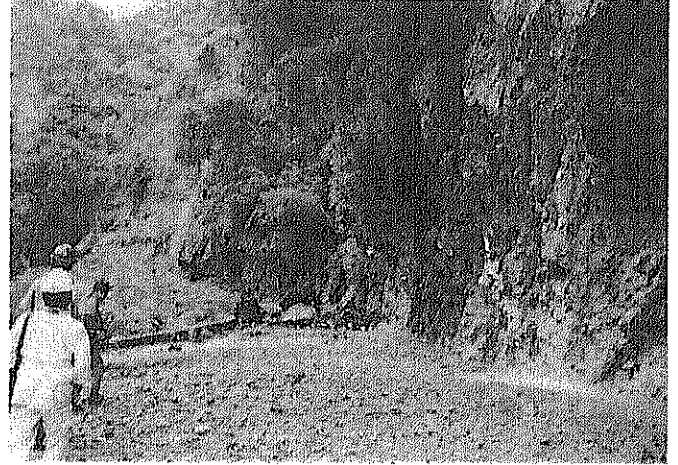
Photo 7.3.56 Around 224km on Kennon Road

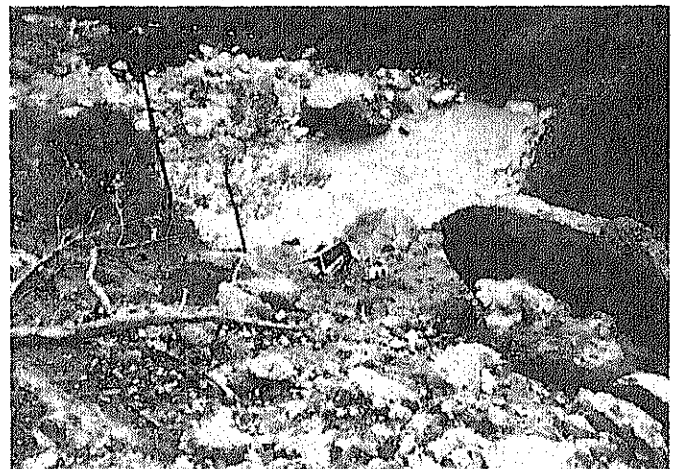
In the KM224+500 neighborhood, the last area which can be reached from the Rosario side, a large-sized bus which fell into the ravine remains. Damage from this position to the upstream end of the impassable section (KM238), are shown in Photos 7.3.52 to 53.

Photo 7.3.58 Around 224km on Kennon Road; a bus which fell into the valley bottom

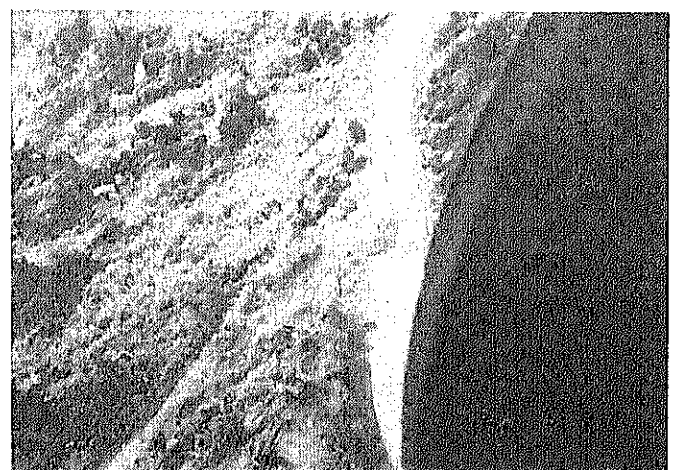
Photo 7.3.60 Settlement of the Marcos Highway

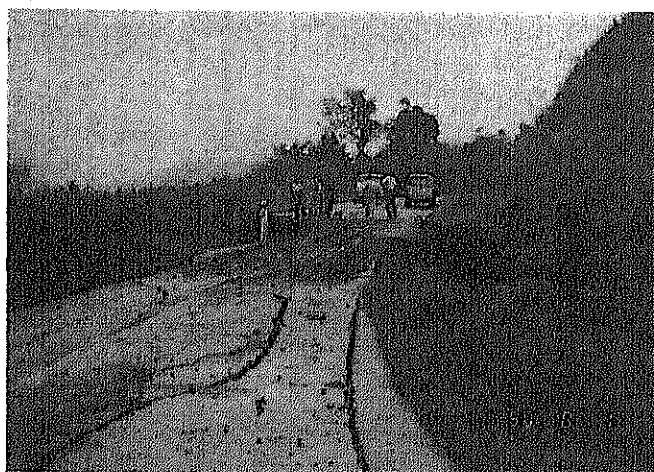
Photo 7.3.61 Collapse around 265km of Marcos Road

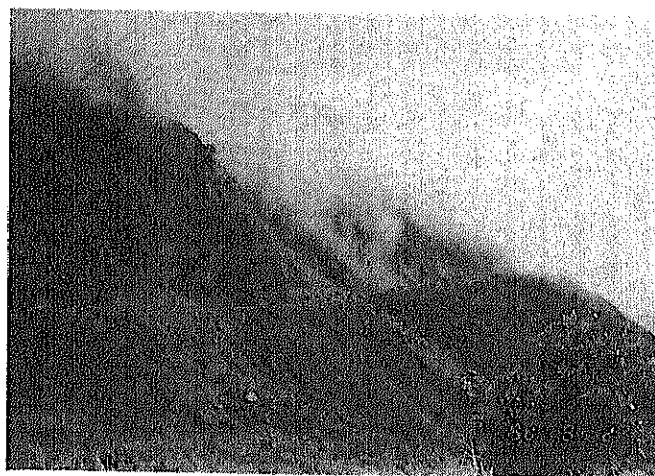
Photo 7.3.63 Collapse around 265km of Marcos Road; Collapse near 277 + 500km (a distant view)

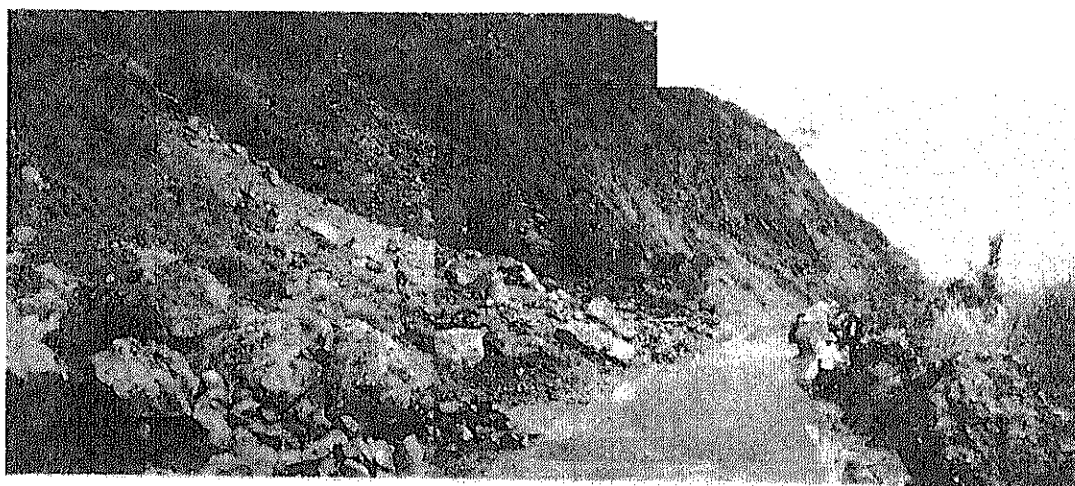
Photo 7.3.65 Collapse around 265km of Marcos Road; Collapse near 277 + 500km (a close range view)

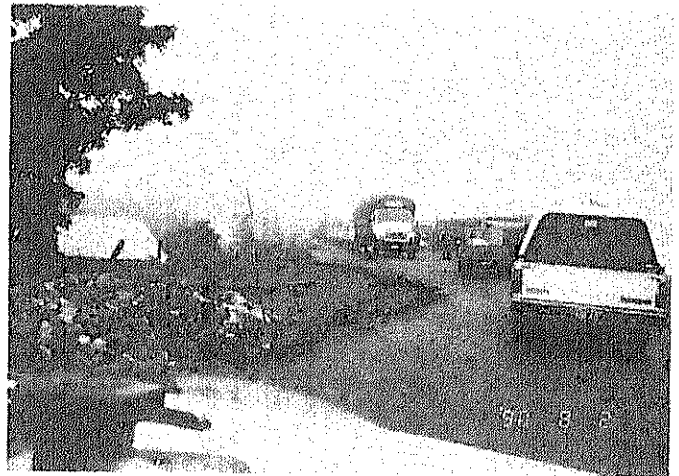
Photo 7.3.69 Entrance to Naguilian Road;
Shoulder collapse

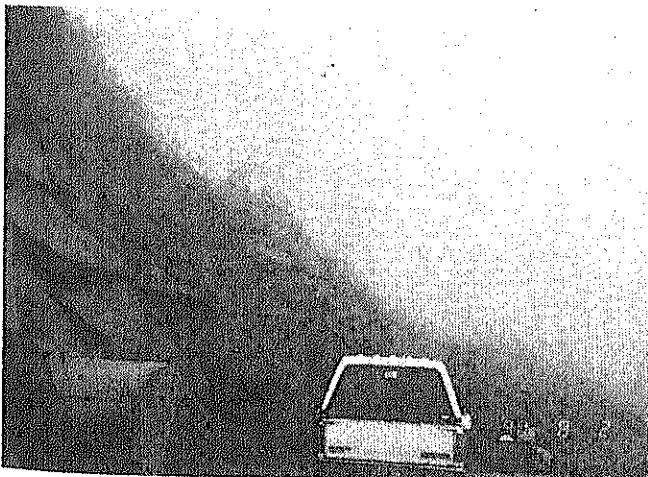
Photo 7.3.70 Entrance to Naguilian Road;
Rock slope collapse and fall

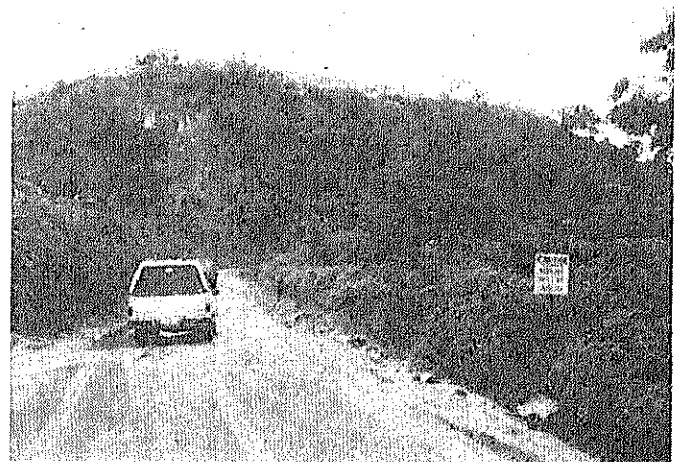
Photo 7.3.71 Entrance to Naguilian Road;
Sediment slope collapse and fall

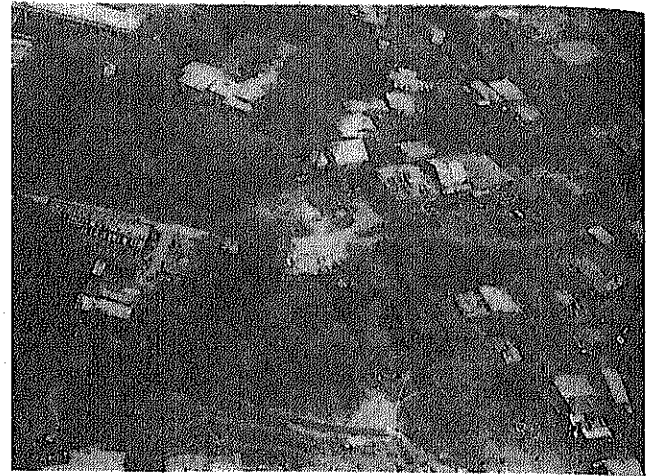
Photo 7.3.73 Colony at Baguio City;
Slope collapse, even though of
small scale, is distinctive.

- (5) Monitoring of the slope failure positions in Baguio city
- 1) In Baguio city, slope failures occurred even within residential areas.
 - 2) To guard against secondary progress of slope failures due to rainfall, monitoring the changes in the slopes is necessary for making judgments about residential evacuation.

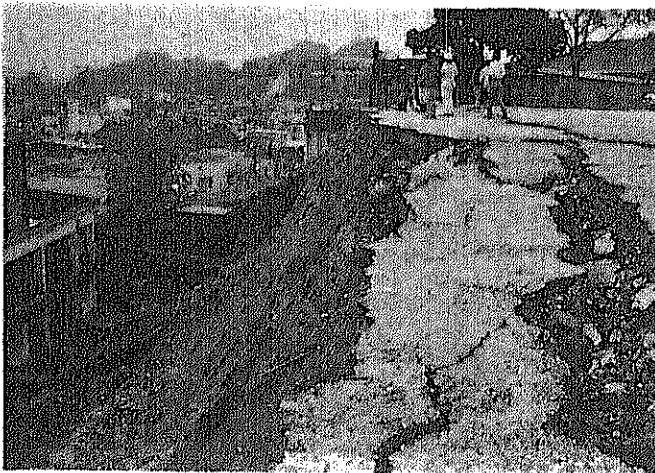
Photo 7.3.74 Collapse of site end of S. Mary Church

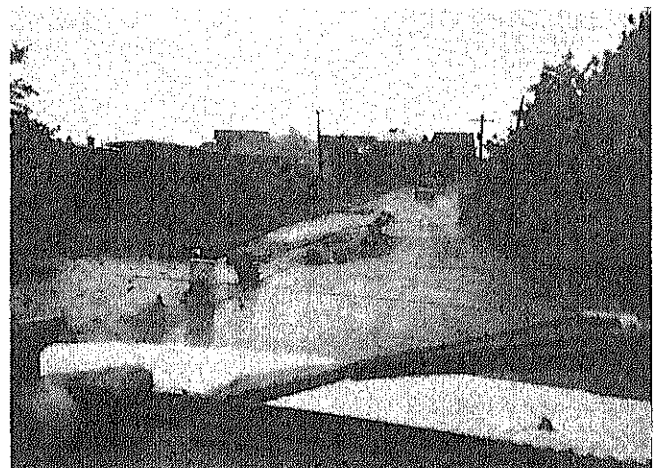
Photo 7.3.77 Depression of roads in
Baguio City

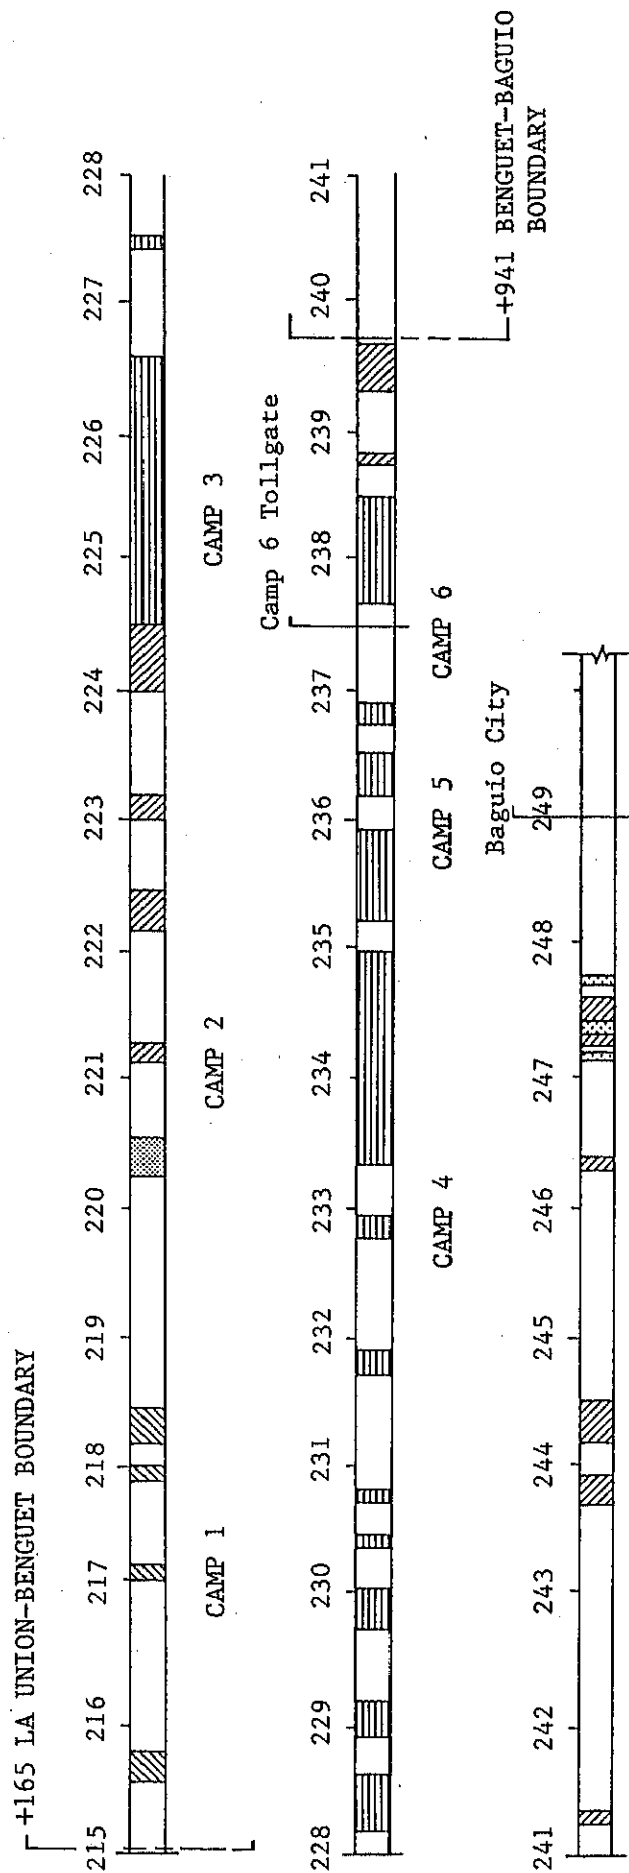
Figure 7.3.8 Damage to the Kennon Road

The damage state in the KM238 neighborhood which can be reached from the Baguio side are the same as the above conditions. Examples of these damage are shown in Photos 7.3.54 to 59. Also, a straight line diagram compiled by the DPWH Baguio office, is shown in Figure 7.3.8. However, quantitative data, such as the volume of collapsed earth, is not available.

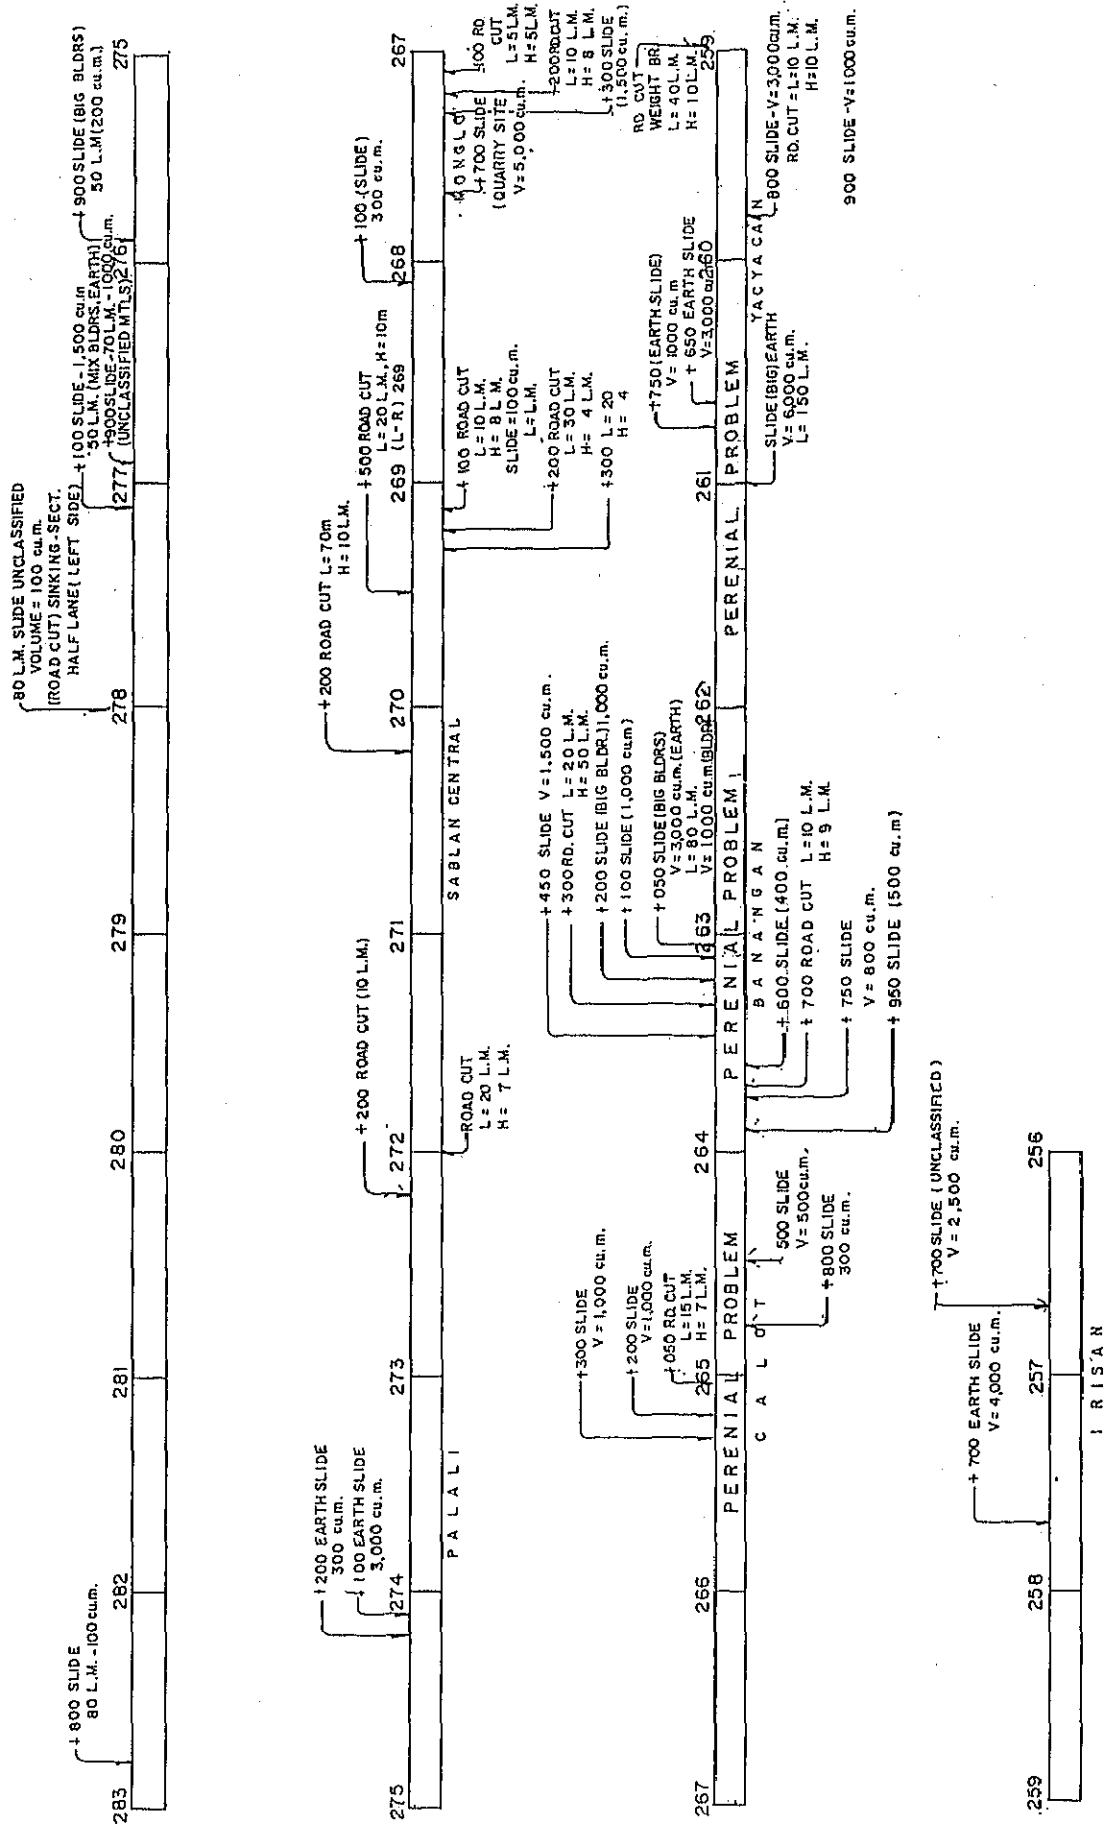
Figure 7.3.10 Damage to the Naguilian Road

Table 7.3.5 and Figure 7.3.10 show the conditions of damage along the road compiled by the local office.
