7.4 Bridges

7.4.1 Status of Damage to Bridges

Photo 7.4.1 Fallen Carmen Bridge (P-1) (1/2)

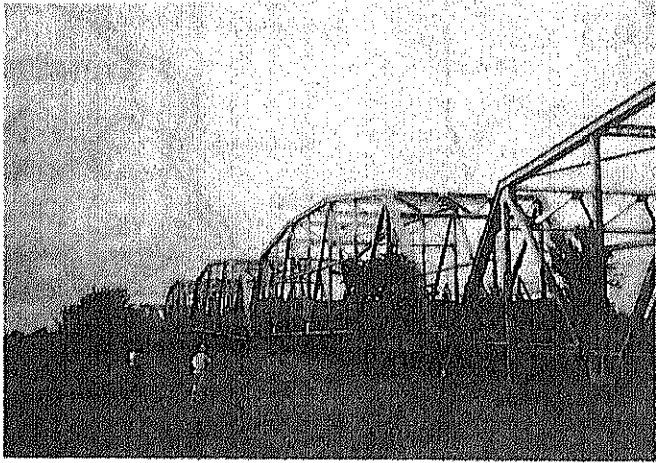
This bridge is 655 m long and six of its spans fell and its six piers were greatly inclined because of liquefaction. Also, a bearing is missing from one span. It is the largest bridge on the Manila-North Road and the effect of its rehabilitation is probably the greatest from the aspect of road traffic. However, to rehabilitate it properly, its tilted piers must be reconstructed. Since this will take considerable time, it is believed that constructing an emergency detour is positively necessary. A temporary wooden bridge using wooden piles is now being constructed about 200 m upstream but when the regular typhoon season comes, it may well become unusable or washed away. It is, therefore, deemed necessary to construct an emergency bridge that can be used in all seasons. In this case, it will be economical if the emergency bridge and the usable parts of the existing bridge section can be linked together.

(1-a) Six spans fell.

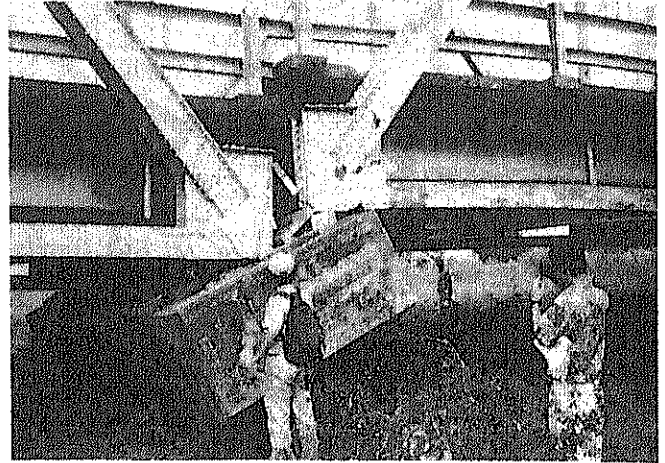
(1-b) Pier tilted and settled by liquefaction

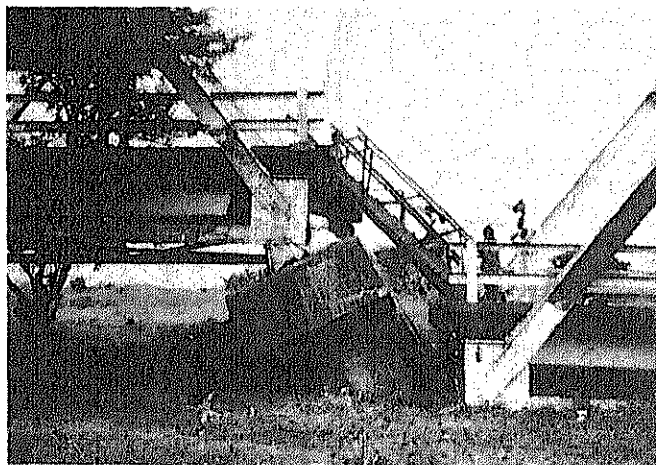
(1-c) Pier tilted and settled by liquefaction

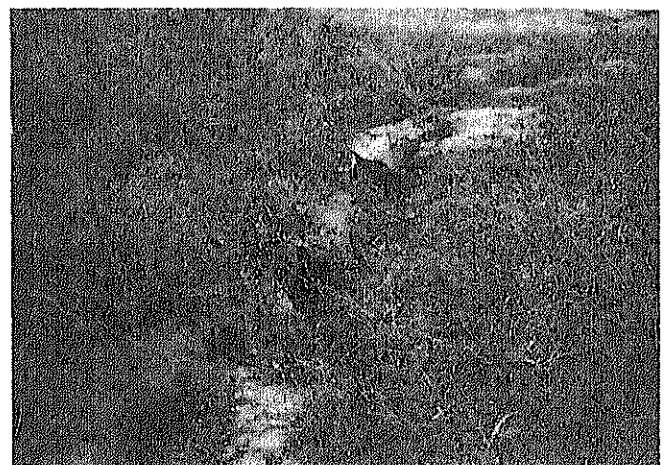
(1-d) Hole caused by sand jetting

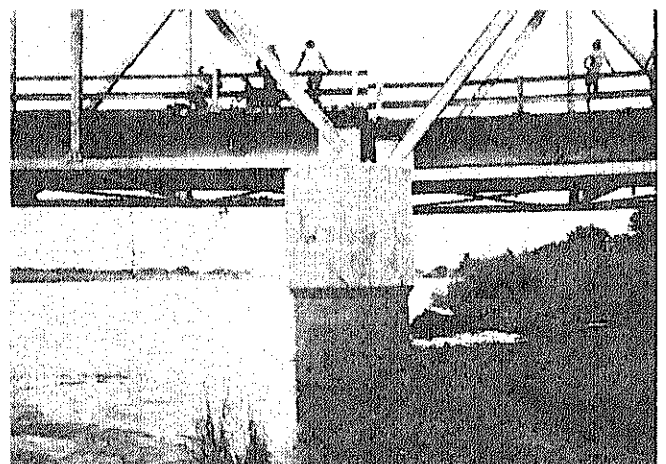
(1-f) Pier (P11) newly constructed due to scour damage - Span on right hand fell from shoe.

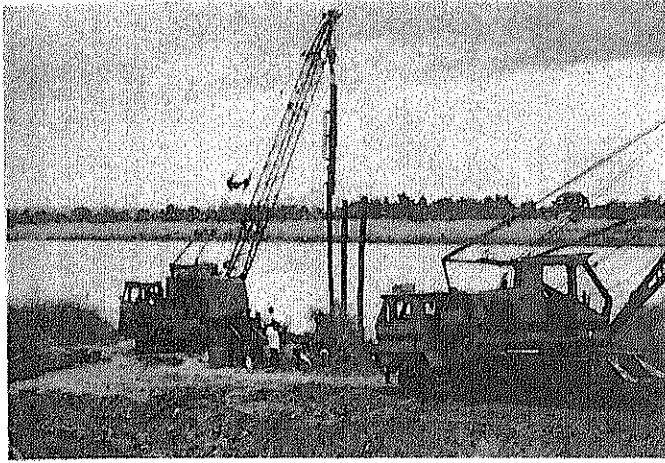
(1-g) Temporary bridge being constructed (about 200m on upstream side)

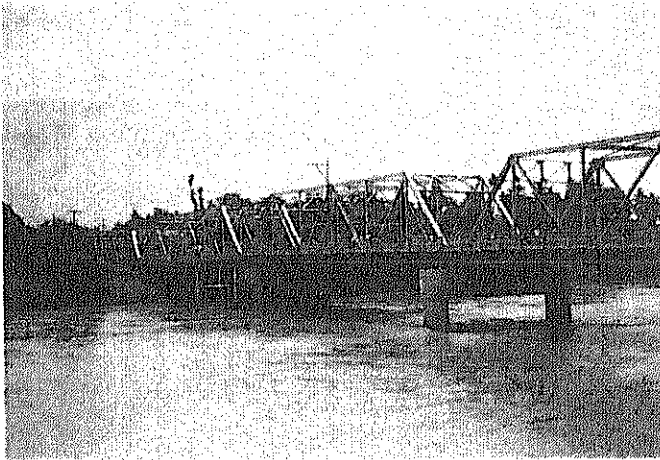
This is a rather large bridge with a length of 200 m although it is situated off the trunk line of the Manila-North Road. So, its rehabilitation priority is felt to be high. Its pier greatly tilted through liquefaction and presumably cannot be reused but the superstructures of the two fallen spans can probably be used again if they are repaired. In this case, checking for the

(2-a) Two spans fell. (Pier on this side was newly constructed but leans slightly.)

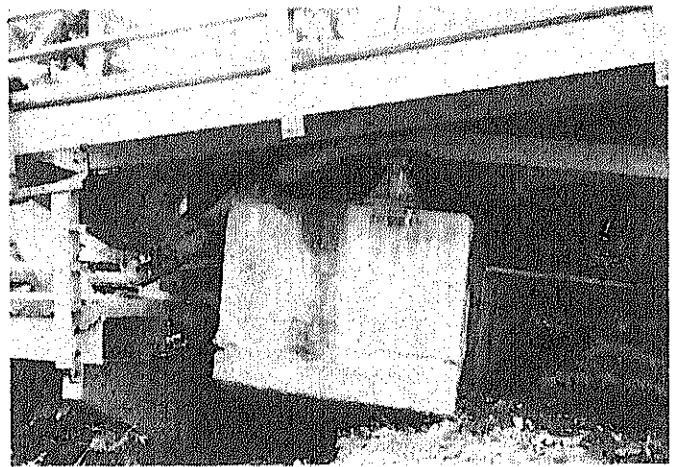
(2-b) Pier tilted and moved by liquefaction

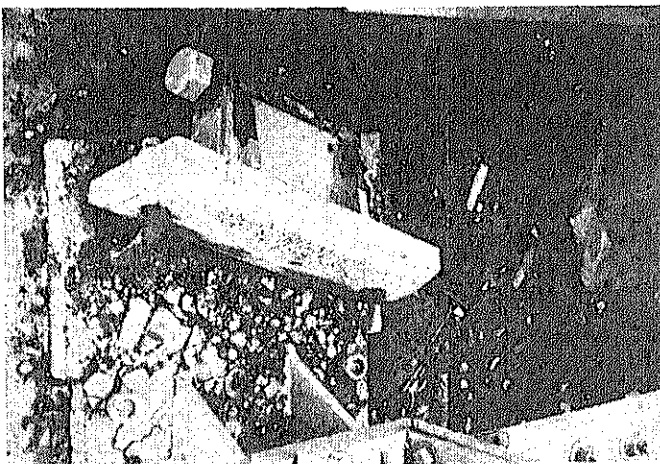
(2-c) Destroyed movable bearing

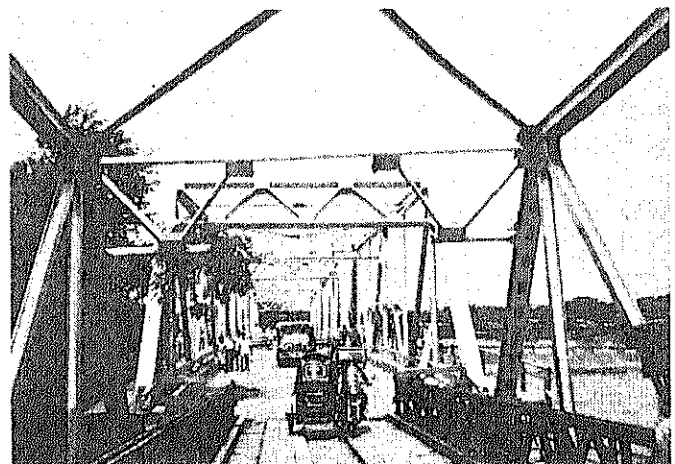
(2-d) Temporary bridge constructed on fallen spans

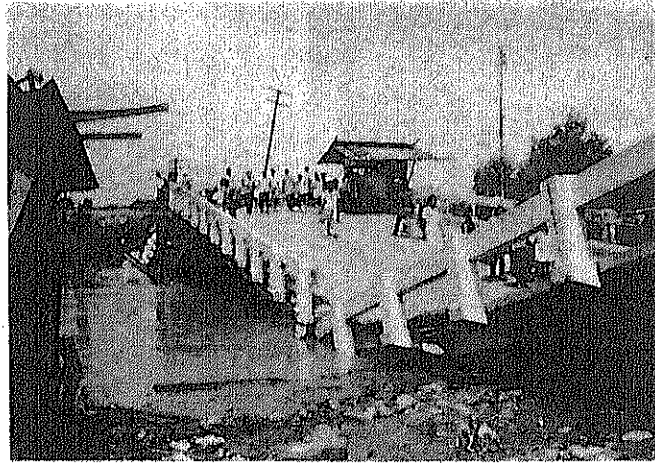
The emergency rehabilitation of this bridge must be rushed because it is on a Dagupan main street. Its super- and sub-structures cannot probably be reused. A possible alternative is to construct an emergency bridge by the side of the fallen bridge. (A plan to construct an emergency bridge is ready.)

(3-a) Four spans fell

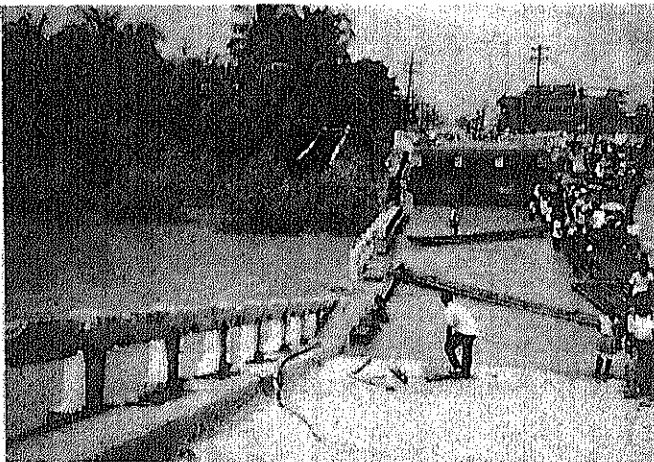
(3-b) Emergency bridge formed by linking boats

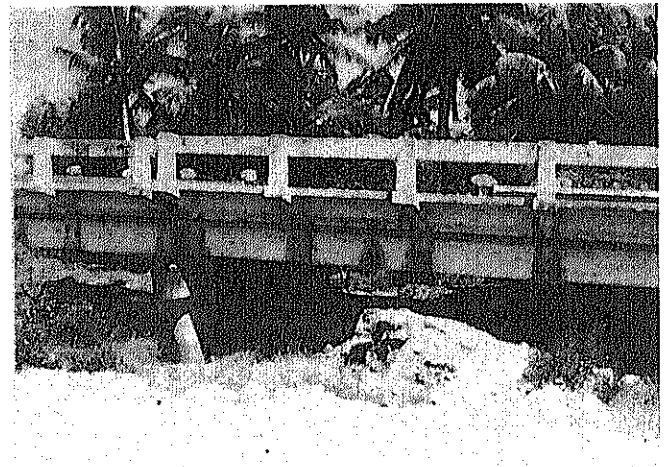
(3-c) Pier tilted by liquefaction

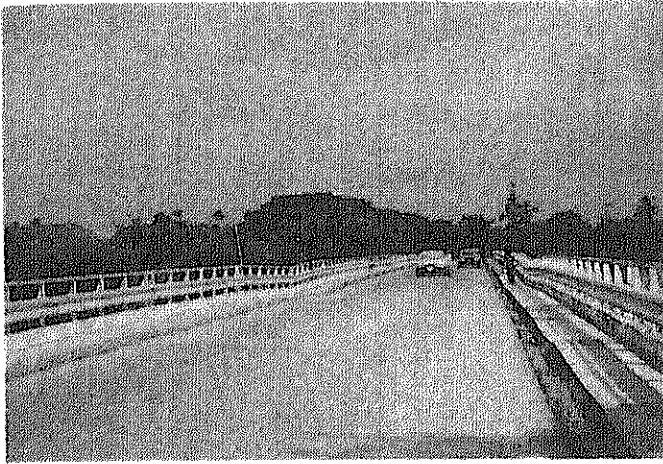
(4-a) Road surface settled by about 30cm

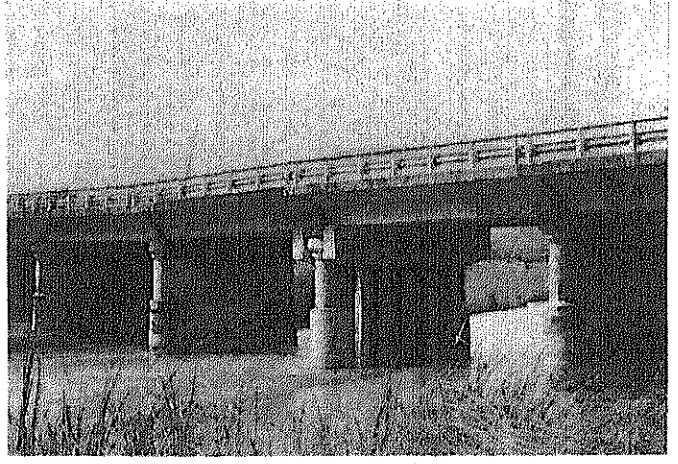
(4-b) Settled pier (Pier on right side was formerly reinforced after scour damage.)

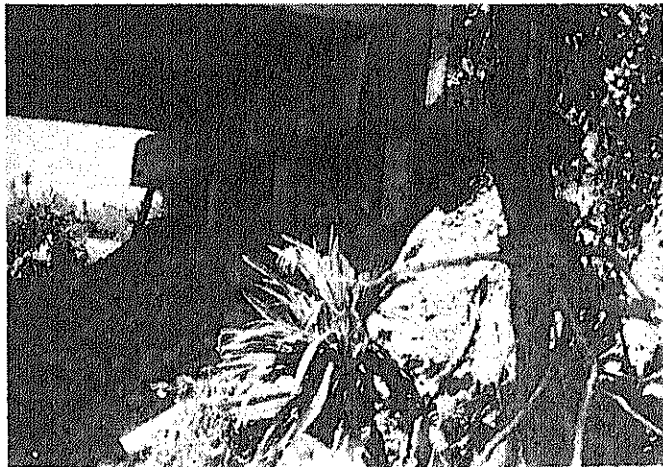
Its abutment piles and bridge seats on pier tops are damaged and the bridge is in danger of falling. Preventing the fall of the bridge and undertaking traffic regulation seem to be necessary as urgent emergency measures. Renewal should be included among the proposals of regular rehabilitation because the present bridge is old.

(5-a) Abutment pile damaged by rupture in bending

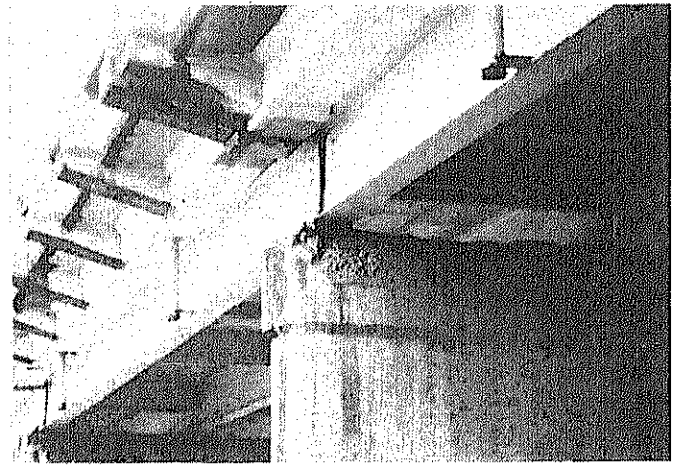
(5-b) Bearing edge damaged by shear fracture

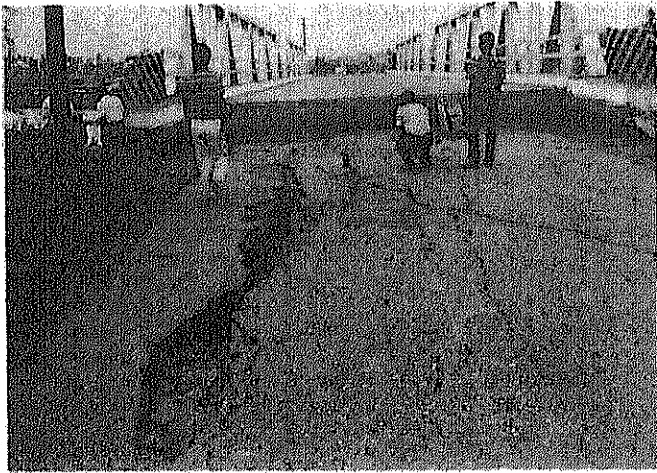
(6-a) Settled approach

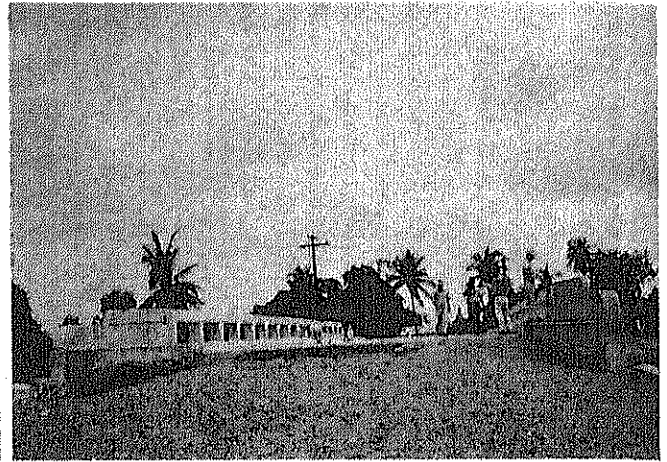
(7-a) Settled approach

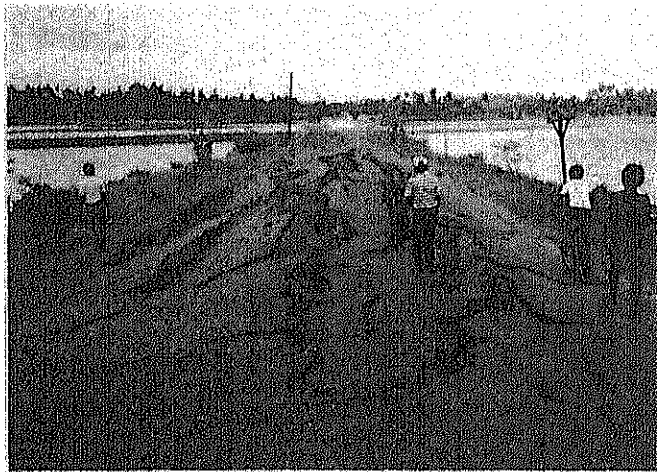
(6-b) Banking in approach settled and moved sideways

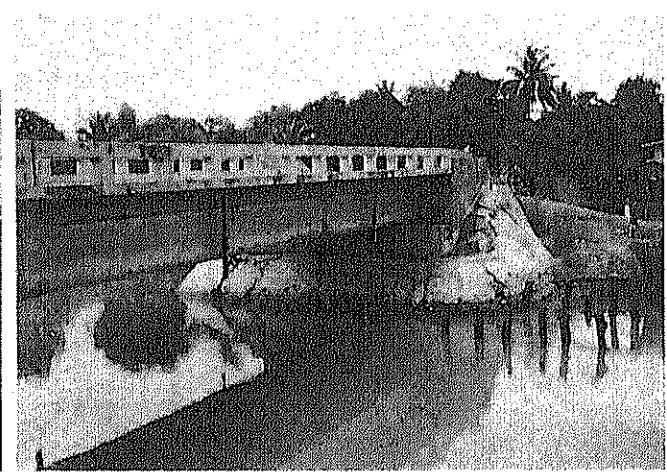
(7-b) Settled abutment banking

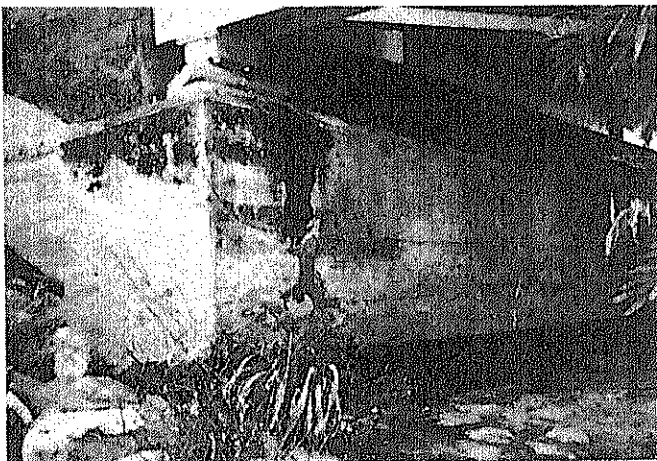
(6-c) Cracks in abutment footing and pile

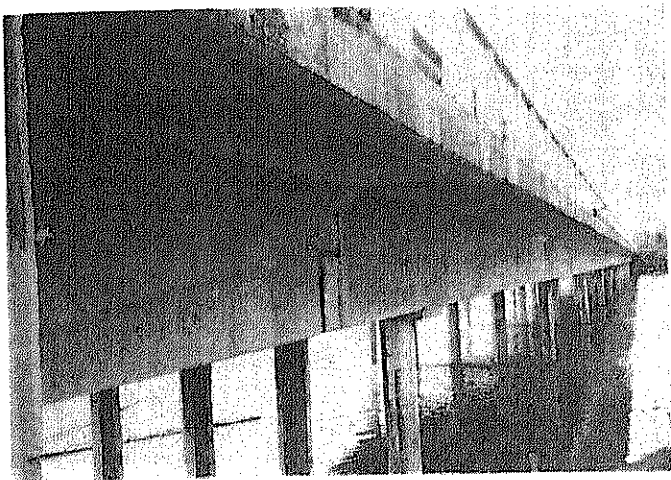
(8-a) Pile bent pier

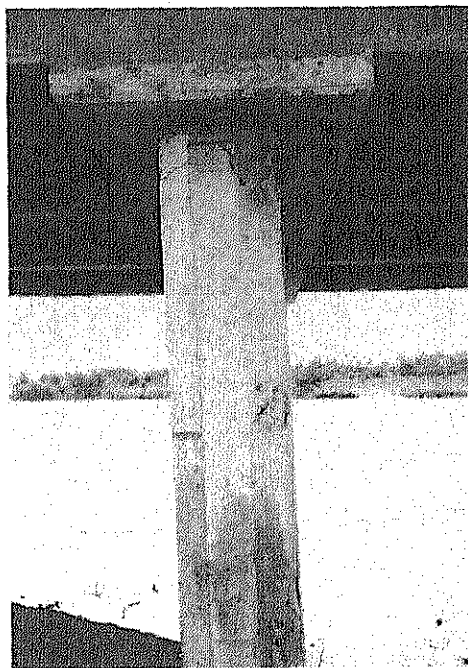
(8-c) Pile tilted and reinforcing bars at pile top became exposed

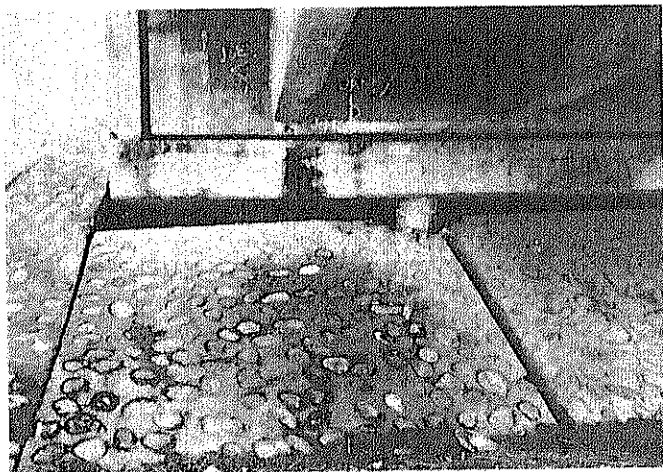
(8-b) Settled abutment banking (settled approach)

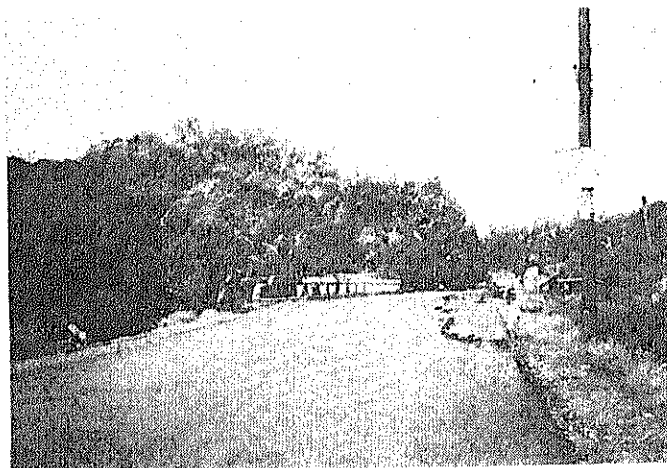
(9-a) Collapsed abutment banking

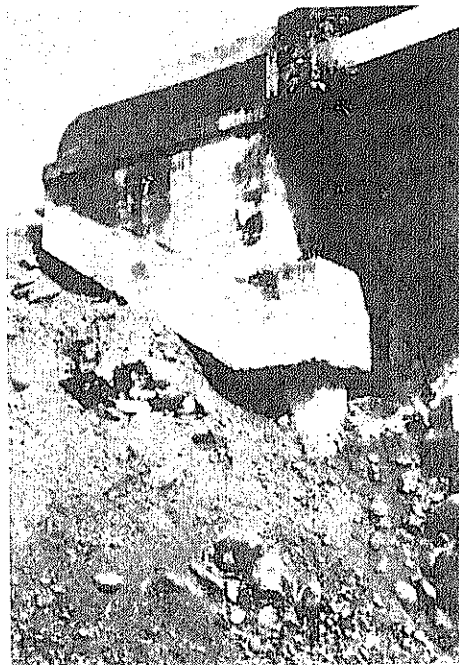
(9-b) Collapsed abutment banking

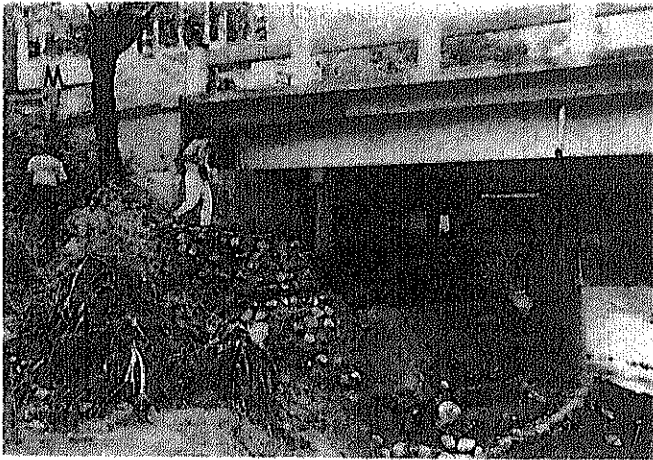
This is a rather small bridge (length: 30 m) on the Manila-North Road. The piles of an abutment were destroyed on one side but temporary supports have already been installed and the bridge is available for traffic.

(10-a) Pier tilted to front and temporary support was installed. (Bridge behind is an old bridge.)

This is sufficient for some time as an emergency measure but, when effecting regular rehabilitation, the abutments must be reconstructed. In this case, the use of pile bent piers will have to be avoided.

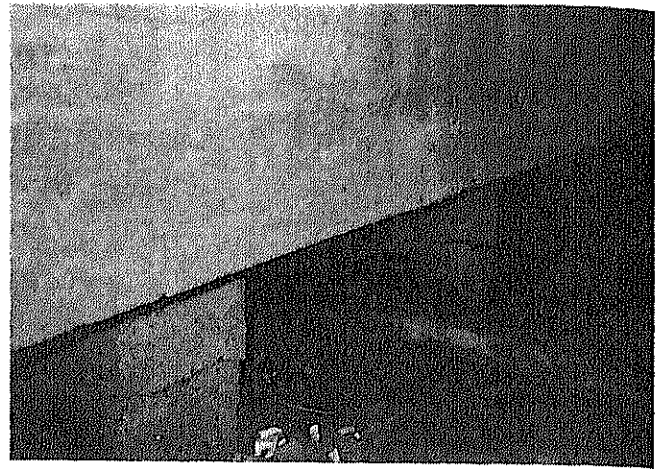
(10-b) Destroyed pile

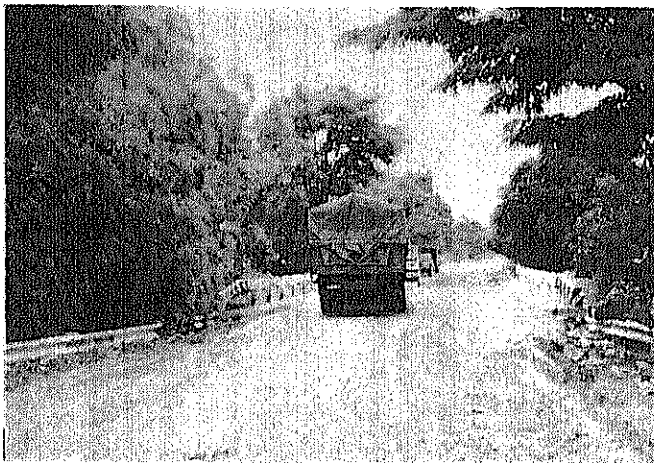
(11-a) Settled approach

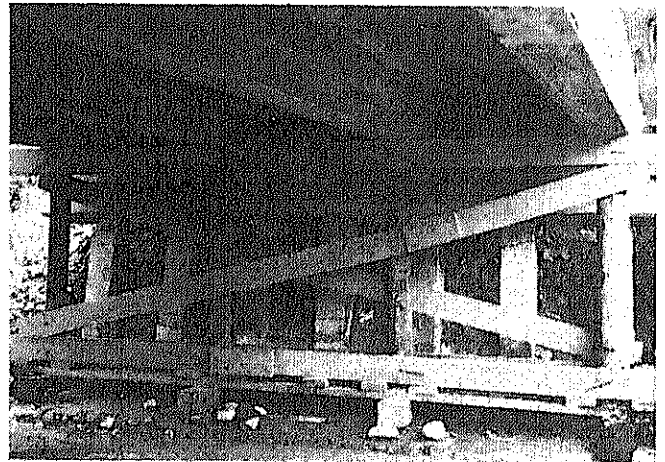
Two pile bent piers were destroyed and, as an emergency measure, temporary supports have already been installed. In making

(11-b) Abutment pile was destroyed and temporary support was installed.

regular rehabilitation, it is probably advisable to avoid the use of pile bent piers and use more rigid substructures instead.

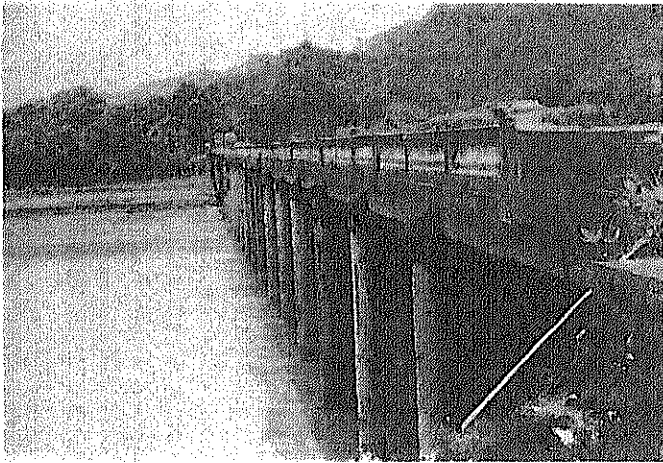
(12-a) It is an old RC bridge

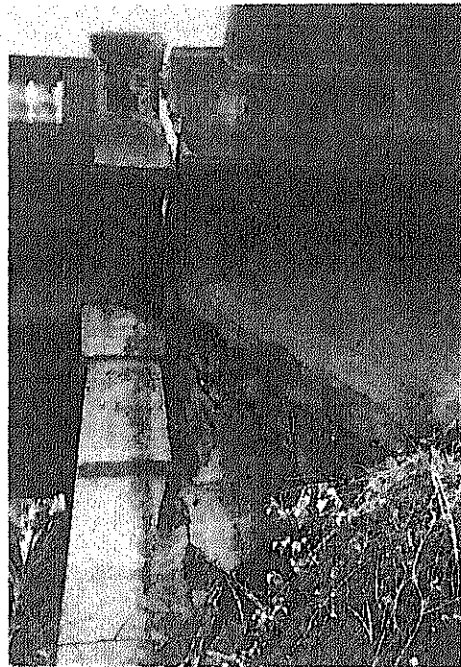
There are signs of violent hits between girder and abutment, between girder and pier and between girder and girder, thus causing heavy damage to the abutments, girder ends and substructures. In view of the possibilities of a future bridge fall, something must be hurriedly done to prevent a bridge fall. Renewal should be included among the proposals of regular rehabilitation because the present bridge is old.

(12-c) Destroyed abutment body

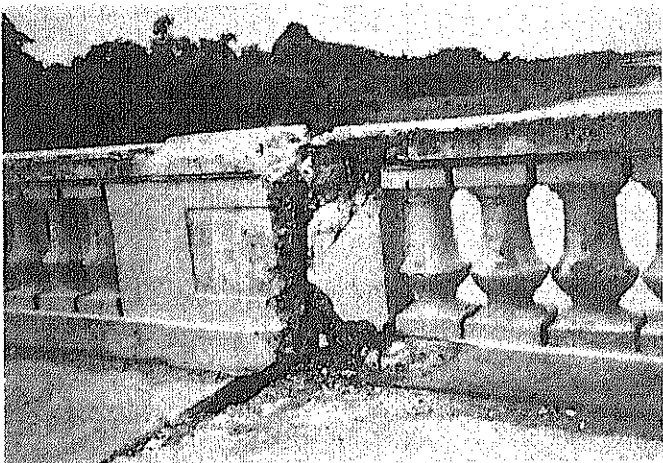
(12-b) Handrail was damaged by violent collision between girders

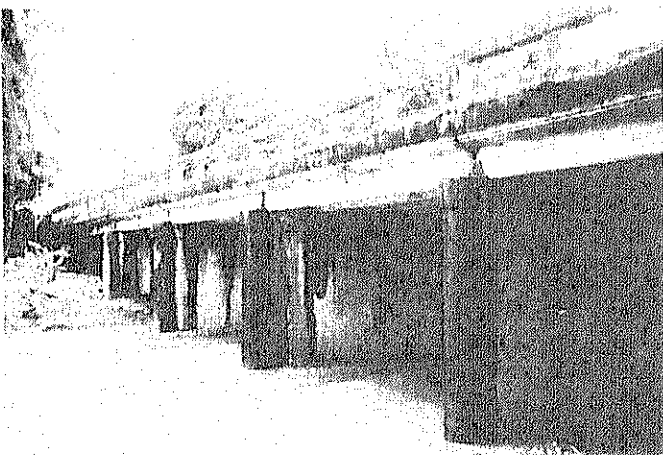
The damage to this bridge is similar to that of the Aringay Bridge (as concerns girders and substructures) and something must be done to prevent its fall. Renewal should be included among the proposals of regular rehabilitation because the present bridge is old.

(13-a) Break-off of concrete in bearing edge

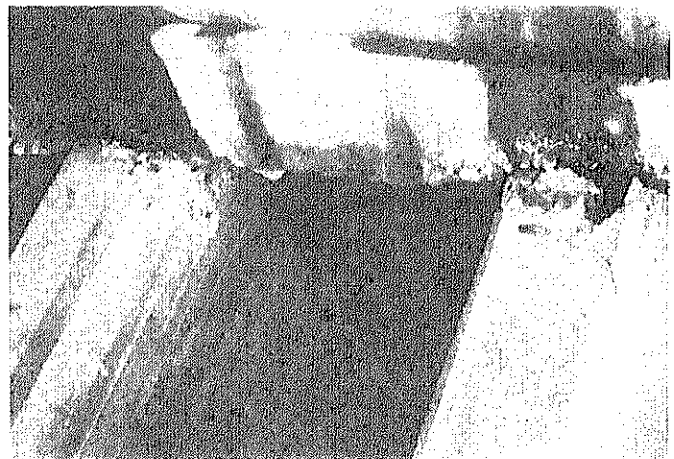
(13-b) Heavily damaged girder and substructure

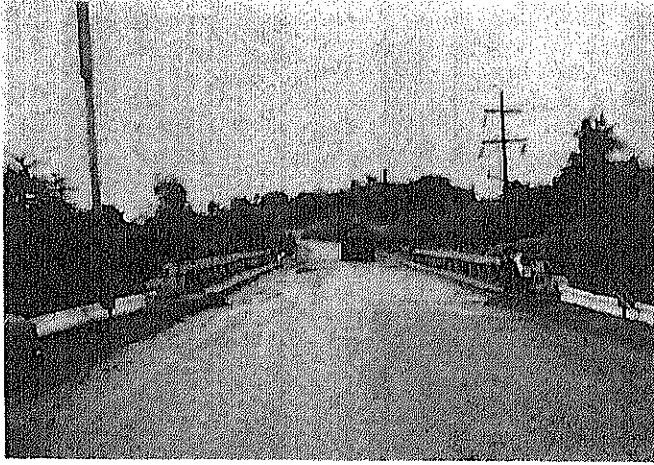
(14-a) Settled approach

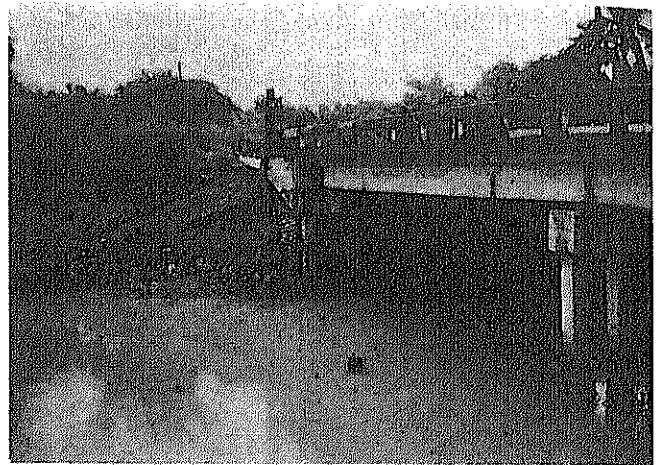
(14-b) Collapsed abutment back-fill
(It underwent emergency repair.)

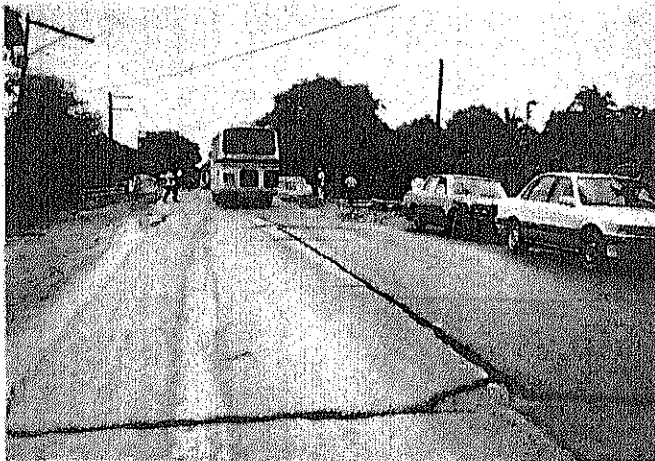
(15-a) Settled approach

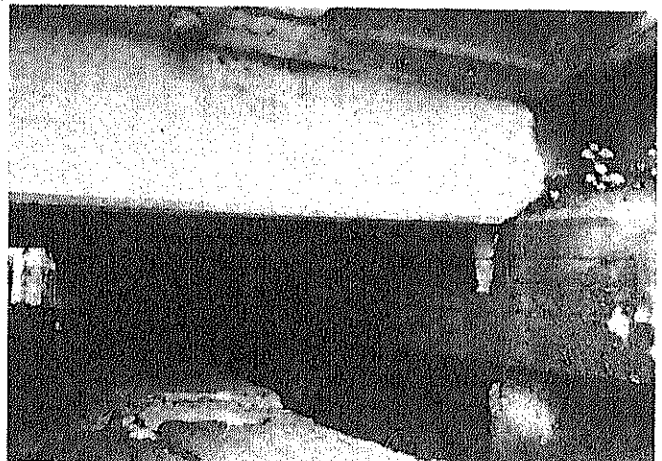
(15-b) Damaged pile

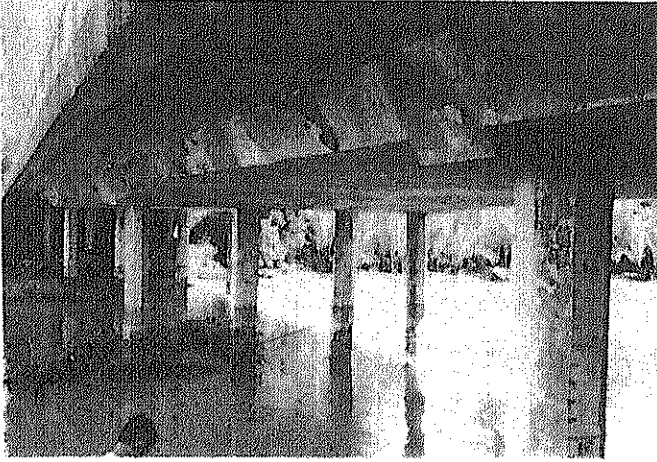
(16-a) Pile bent pier

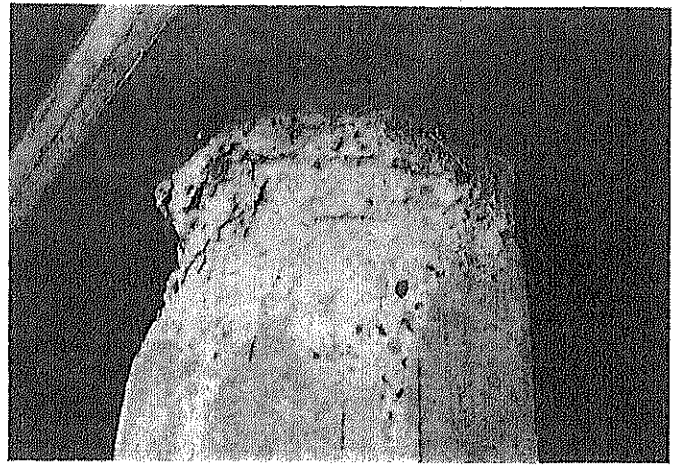
It has four pile bent piers and the piles were greatly deformed horizontally (estimated ± 10 cm or so on the ground plane) in the earthquake. There are signs that the superstructure hit the abutment hard and the concrete at the heads of all piles were damaged. Furthermore, considering the fact that the superstructure shakes violently when a large truck passes, it seems that the bearing force of the substructure must be increased during regular rehabilitation.

(16-b) All pile tops were damaged

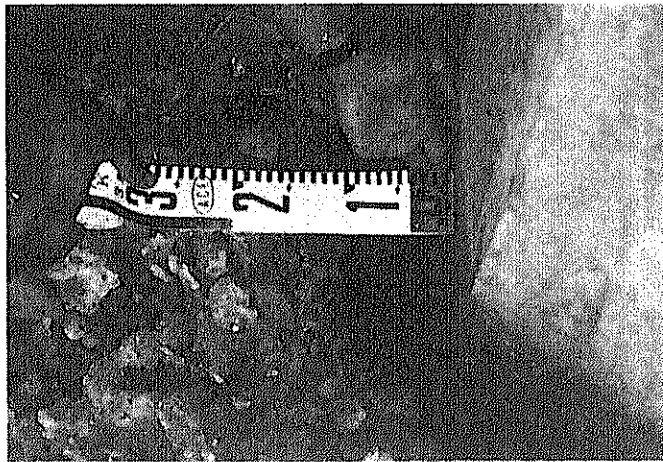
(16-c) Pile shock violently in horizontal direction

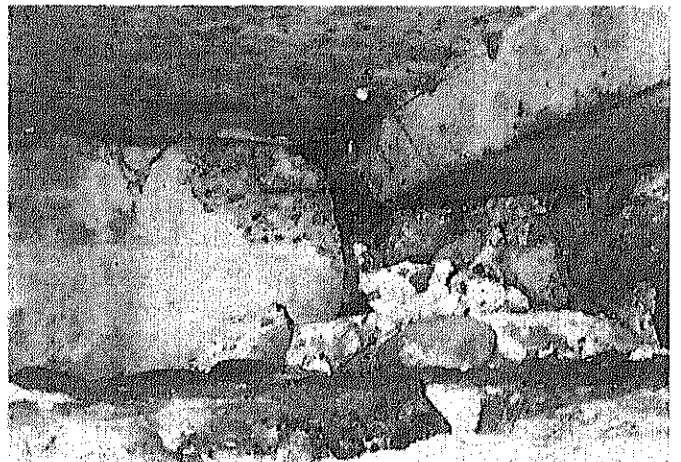
(16-d) Girder hit abutment

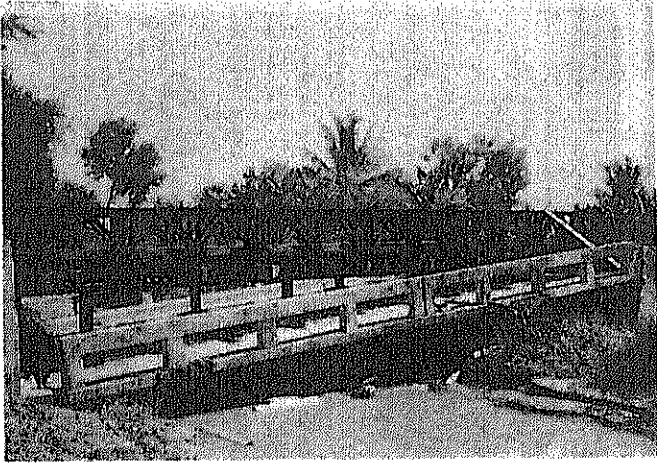
This is a small one-span bridge on the Filipino-Japanese Friendship Highway. The fallen superstructure may be reusable but the abutments will have to be renewed.

(17-a) Temporary bridge was constructed on fallen spans

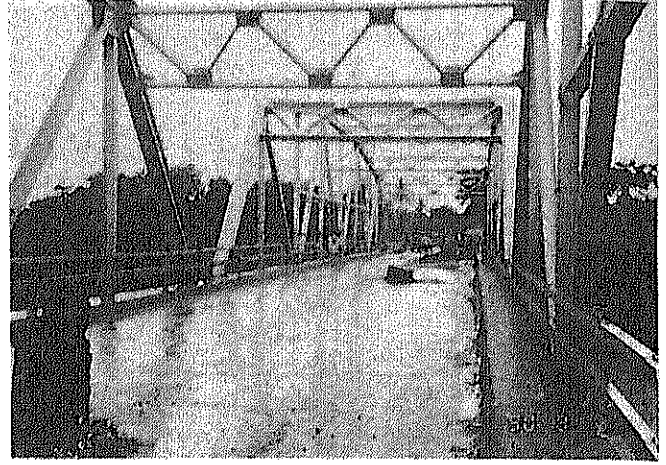
(18-a) Slabs being repaired

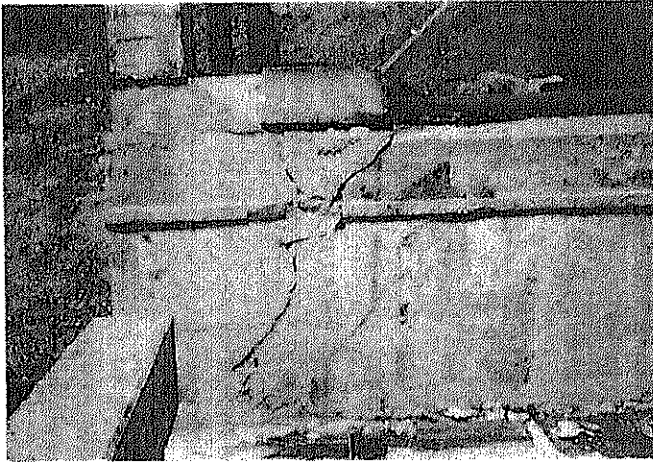
(17-b) Destroyed abutment body

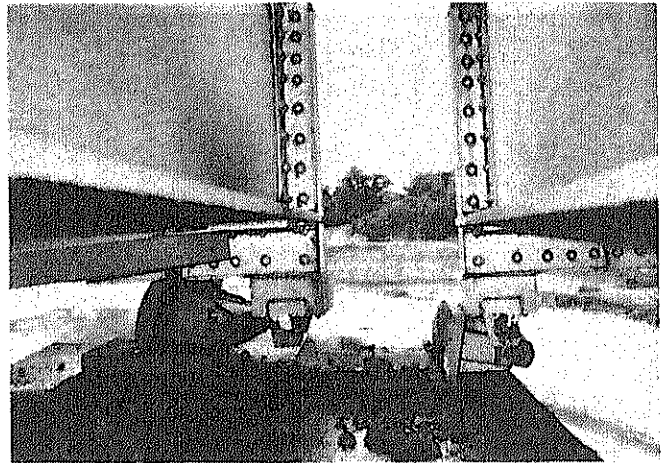
This is one of the important bridges on the Filipino-Japanese Friendship Highway. No earthquake damage, such as destruction of superstructure members, could be found but the shoe in the middle span was out of place and the girder barely stayed on the tip of the pier head. Also, the pier is slightly inclined. Closure to traffic and immediate measures to prevent bridge fall (girder connecting, for example) are necessary. In regular rehabilitation, measures including the widening of bridge seats are necessary.

(18-b) Movable shoe slipped out and is threatening to fall

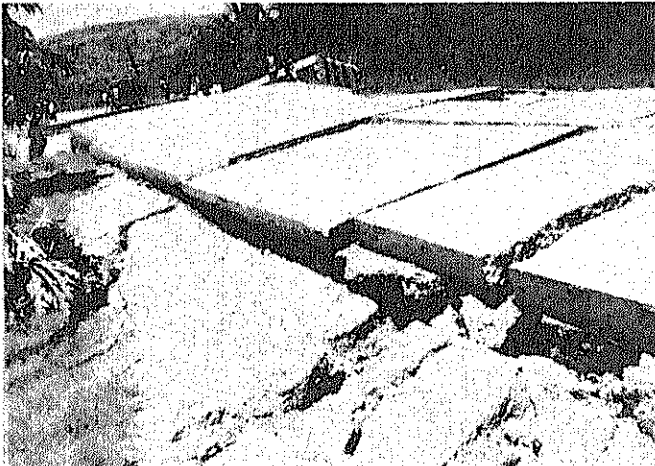
(17-c) Destroyed approach pavement

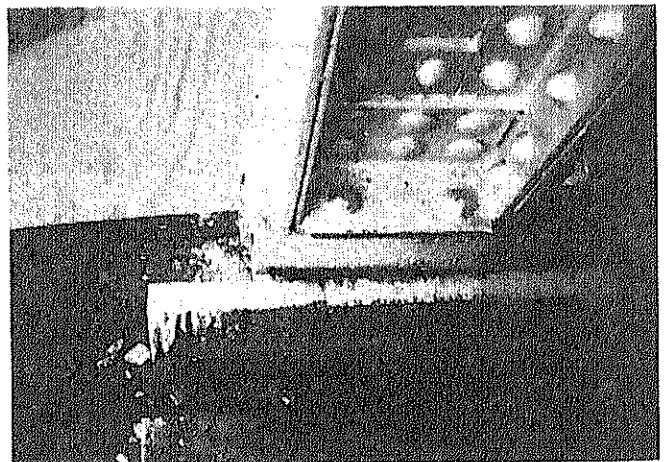
(18-c) Another movable shoe in the same condition

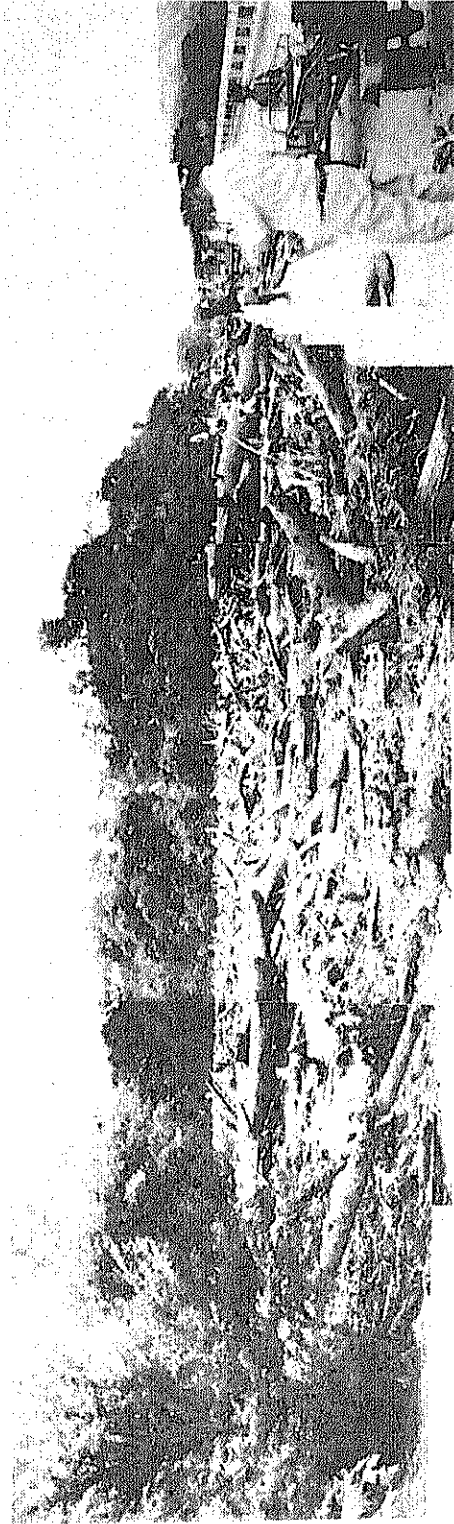
Photo 7.4.19 Puncan Bridge #2 with Large Quantities of Driftwood and Sediments (N-6)

This is a bridge on the Filipino-Japanese Friendship Highway. Large quantities of sediments and driftwood crowded toward it. There is still no damage to the bridge proper but, in a heavy rainfall, these deposits may begin to move. Therefore, measures such as removing driftwood, are urgently necessary.

No.	Name of bridge	Temporary restoration	Permanent restoration	Sketch of damaged bridge	Remarks
N-6	Puncan II Bridge, (Nueva Ecija)	It is urgently necessary to remove driftwood and sediments.

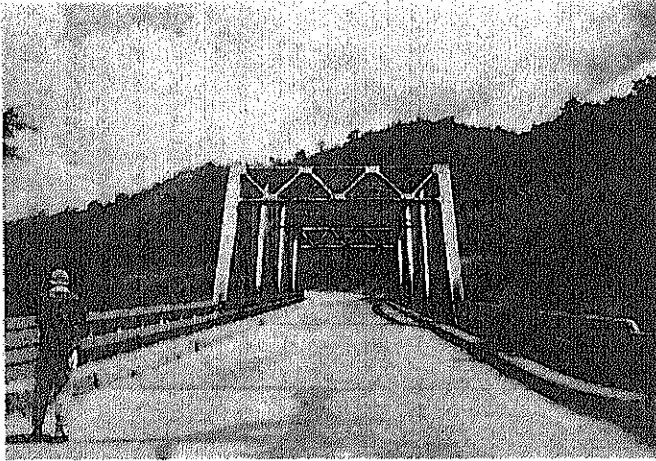
(20-a) Scarcely any damage to superstructure

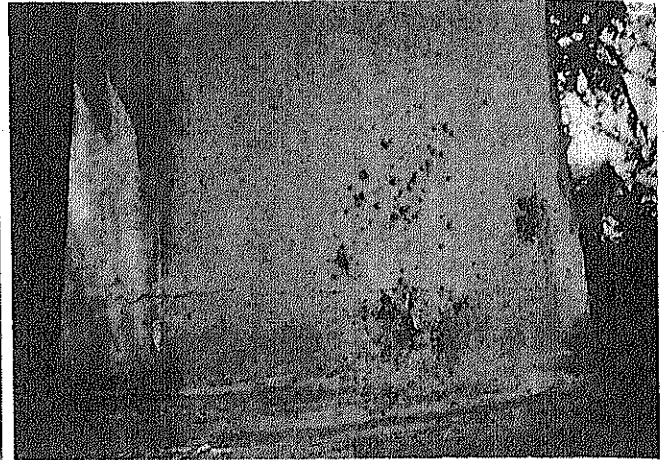
(20-b) Large cracks in pier

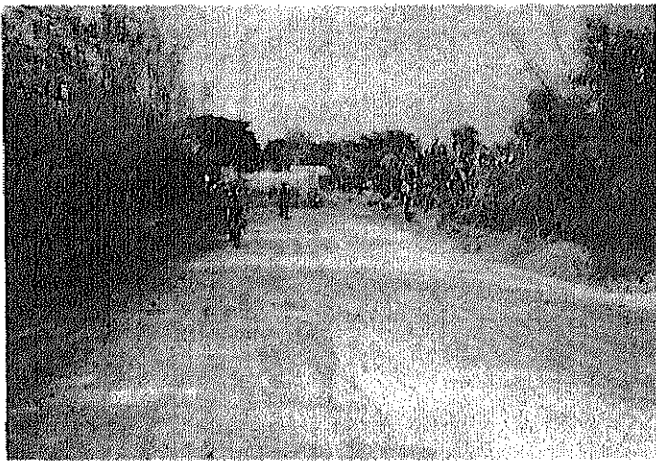
(21-a) Approach settled by about 2m

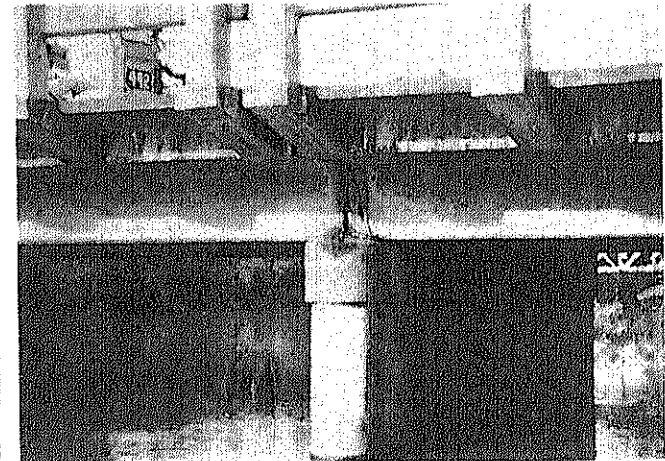
(21-b) Shear cracks at girder end

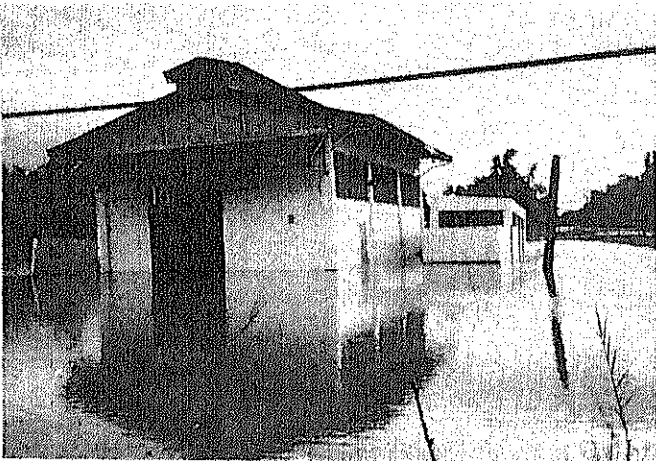
(21-c) Nearby buildings settled

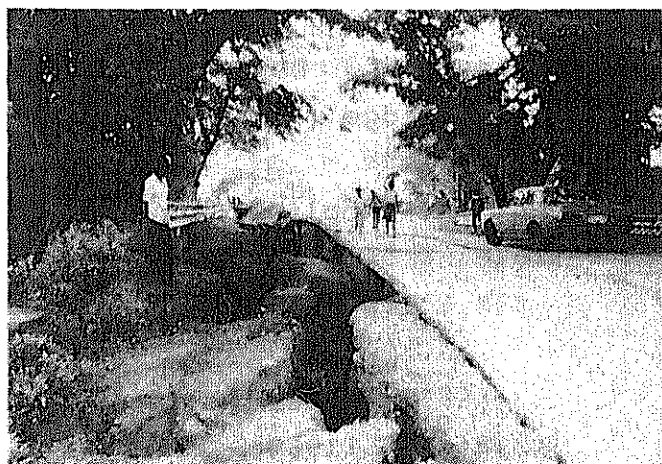
(22-b) Collapse of approach banking (both sides)

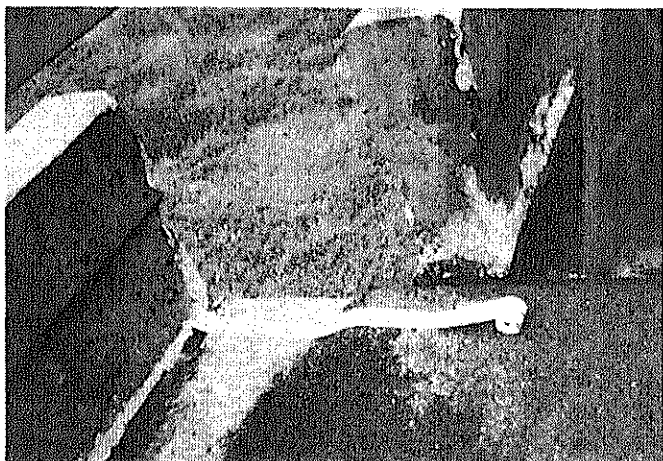
(23-a) Expansion joint slipped out of place by 90cm in direction of bridge axis.

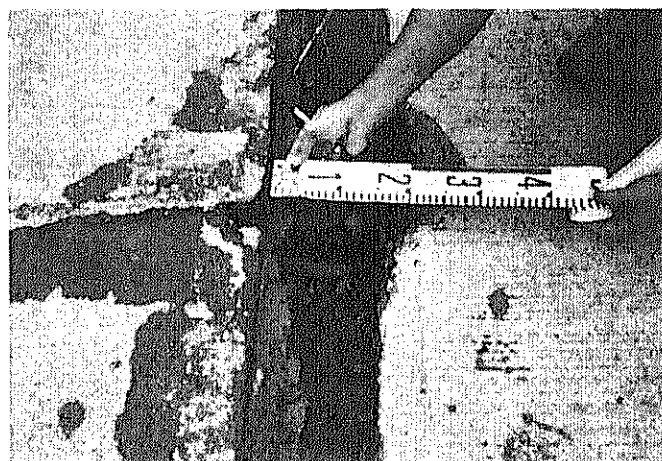
(23-b) Expansion joint opened by 20cm
