7.5 Rivers and Dams

7.5.1 Disaster Damage Conditions

7.5.2 Damage to Rivers

7.5.3 Damage to Dams

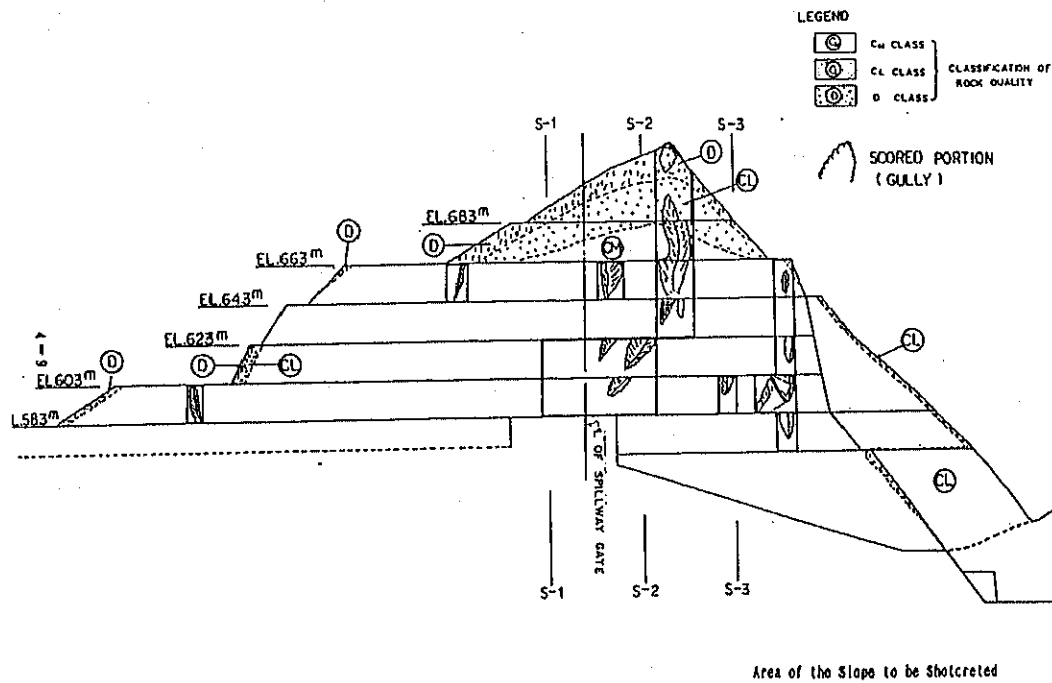
Figure 7.5.9 Cut slope of the left bank of Binga Dam

- 6) No damages were observed in the spillway, except that the No.2 gate which was not operational.
 - 7) Many landslides were observed on the circumference of the reservoir, mainly around the left and right abutments of the dam. However, the cut slope on the left bank of the spillway had been damaged before 1988, the year previous to the earthquake, as shown in Figure 7.5.9. (Photo 7.5.32, 7.5.33)

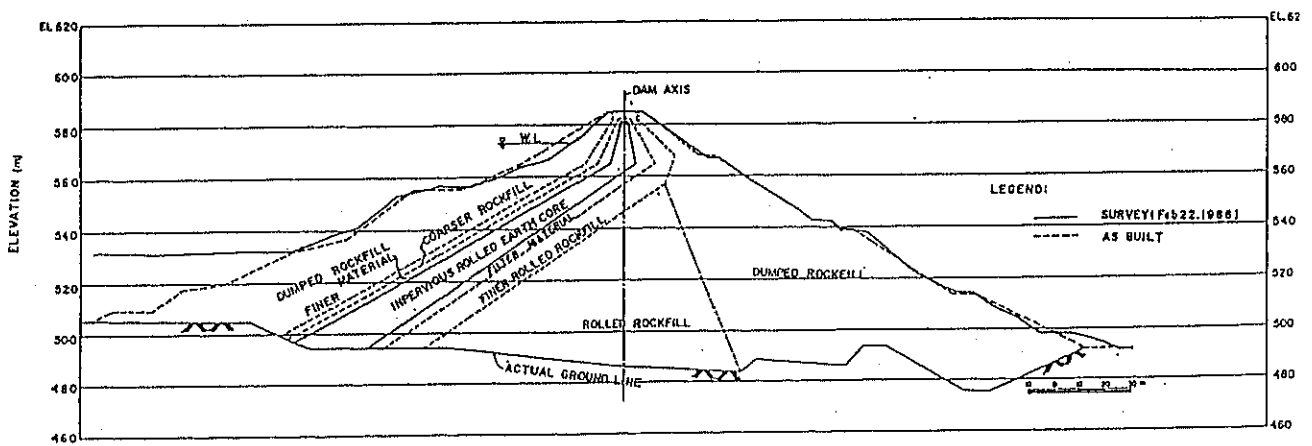
Figure 7.5.10 Profile of Binga Dam

- 10) Figure 7.5.10 shows the results of a survey of a section of the dam on February 1988, the year previous to the earthquake; considerable settlement is observed in the Figure.

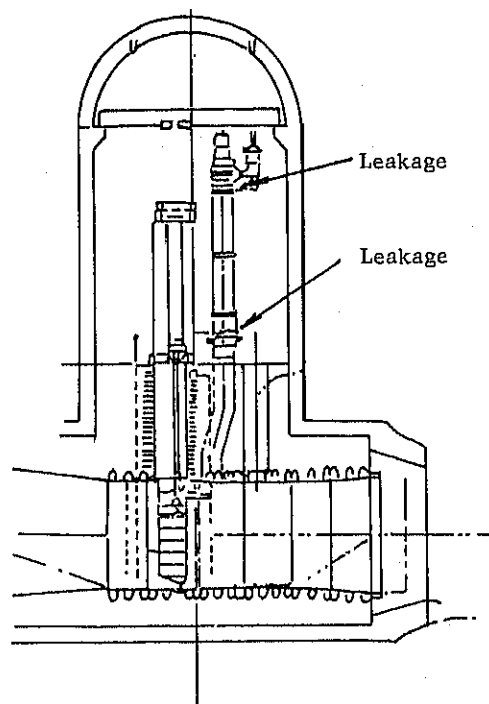
- 4) The pressurized water from the intake tower was leaking out from the vacuum relief valves and flange joints of vacuum relief pipes in the gate chamber; the volume of leakage was estimated to be 2m^3 per minute. (Photo 7.5.38, 7.5.39)

Figure 7.5.15 Leakage from vacuum relief valve and pipe

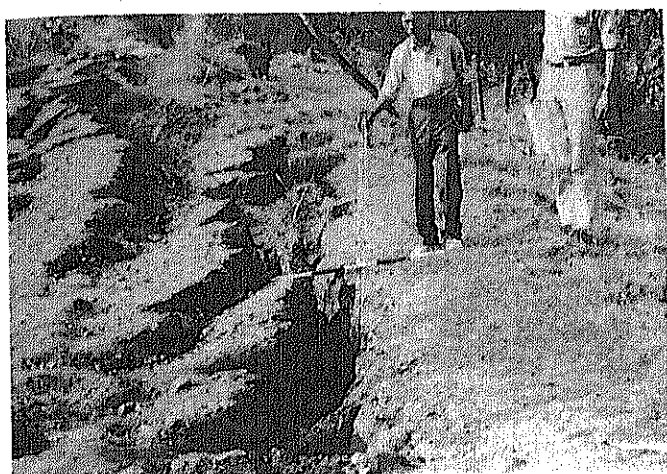
Large cracks occurred at the crowns of earth dikes of 5 - 6m in height, and sliding collapses occurred. The materials of the earth dike were mainly composed of fine sands. Some places were temporarily rehabilitated with sand-bag piling.

Photo 7.5.1 Damage to a levee of the Tarlac river

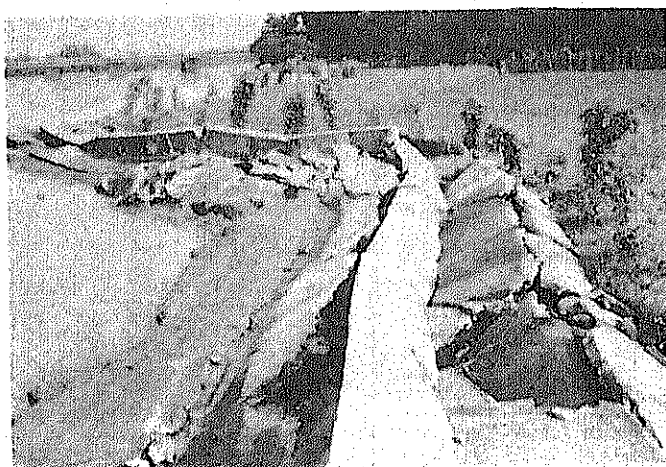
The parapet revetments, made of plain concrete using boulders, were such that the foundations were laid directly on the natural ground; though these revetments were badly damaged, the revetments in which foot protection on the river frontage had been conducted by the placing of boulders suffered little or no damage.

Photo 7.5.2 Damage to a parapet revetment of the Tarlac river

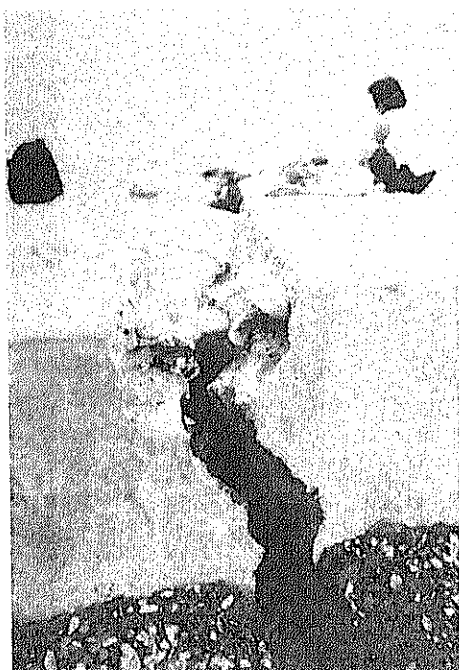
Photo 7.5.3 Damage to a parapet revetment of the Tarlac river

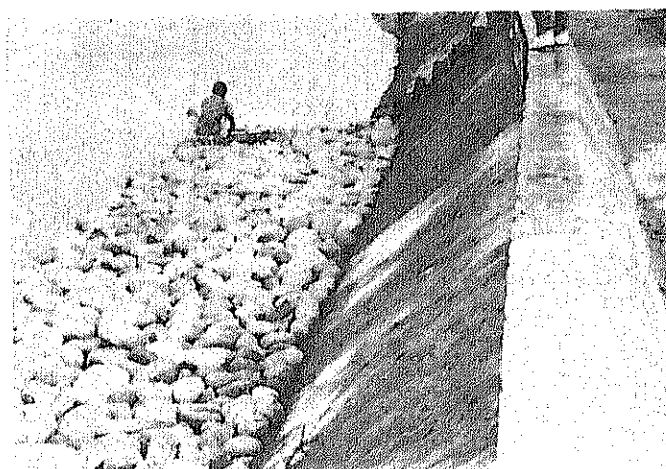
Photo 7.5.4 Parapet revetment with foot protection (no damage)

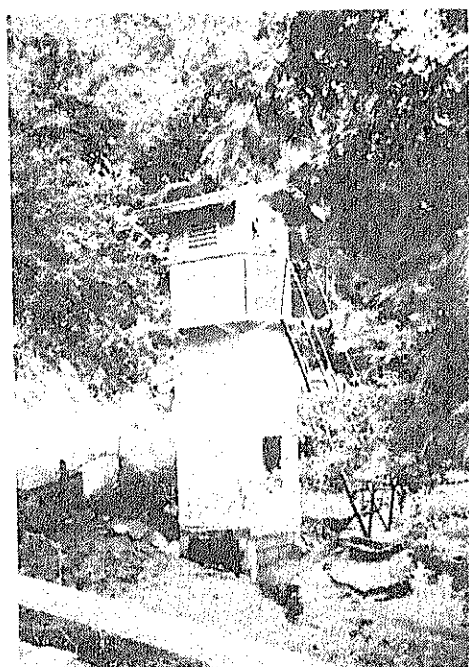
Furthermore, the No.6 water level gauging station on the river bank was inclined, and the conduit pipes were broken. (Figure 7.5.2, Photo. 7.5.1 to 7.5.5)

Photo 7.5.5 Damage to the No.6 water level gauging station

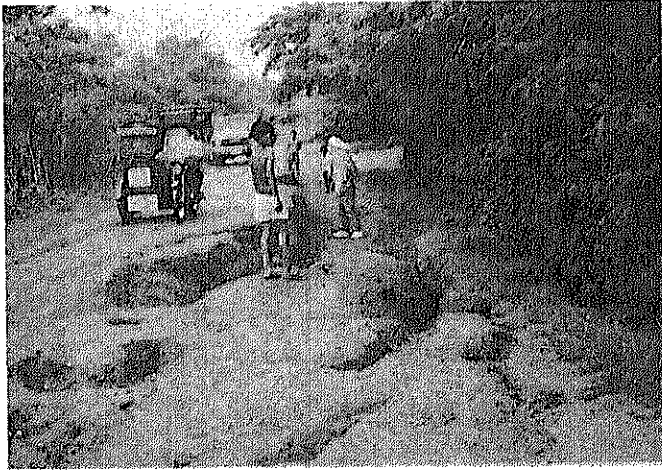
Many cracks were observed at the crowns of earth dikes of 5 to 6m in height; some earth dikes sank about 1m as a whole, or, some of the earth dikes slid and collapsed. Sliding occurred in the direction in which the ground height, inside or outside of the dike, was relatively lower. The main materials of the earth dikes seemed to be silt.

Photo 7.5.6 Damage to a levee of the Agno river

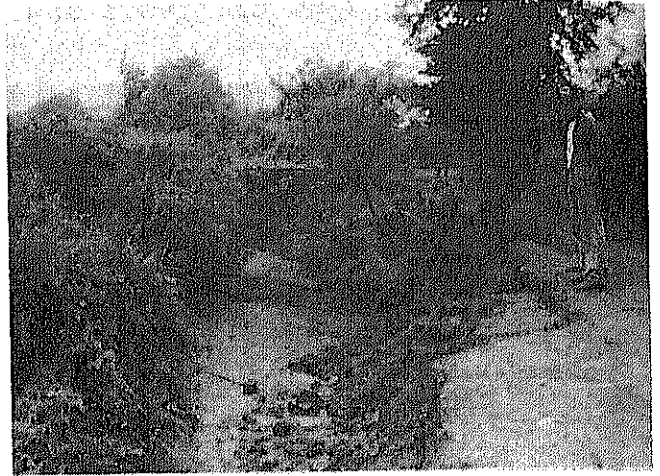
Photo 7.5.7 Damage to a levee of the Agno river

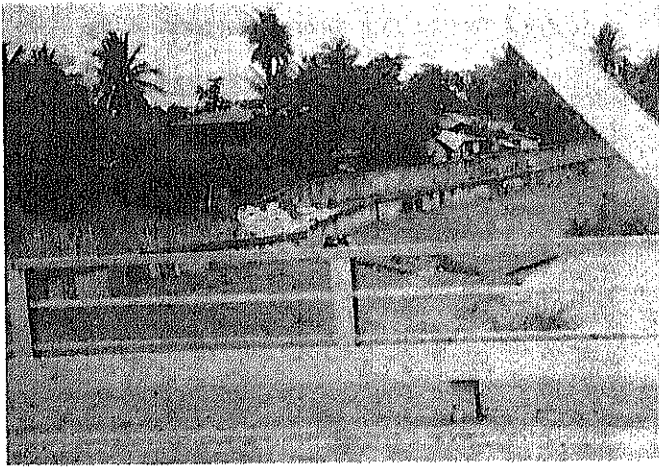
Furthermore, the neighboring Calvo Bridge had collapsed on the left bank, and big shearing cracks occurred at the abutments on the right bank. Also, damage of cracks and settlement was observed on the parapet levees stretching up to the bridge. (Figure 7.5.3, Photo. 7.5.6 to 7.5.8)

Photo 7.5.8 Damage to a parapet levee of the Agno river

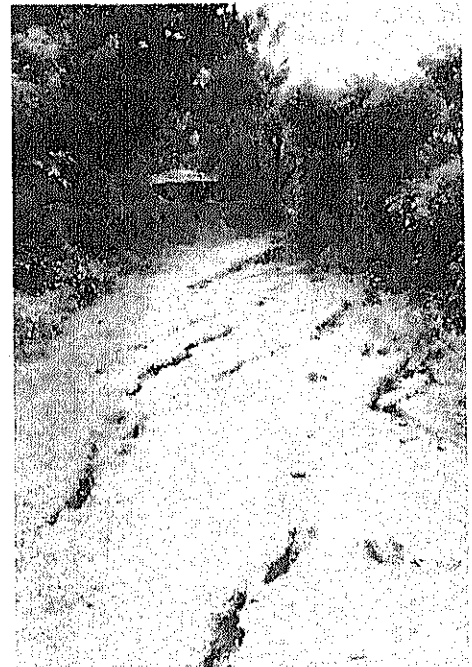
Several oblique cracks on the crowns of earth dikes of about 5m in height, and big collapses caused by sliding were observed.

Photo 7.5.9 Damage to a levee of the Agno river

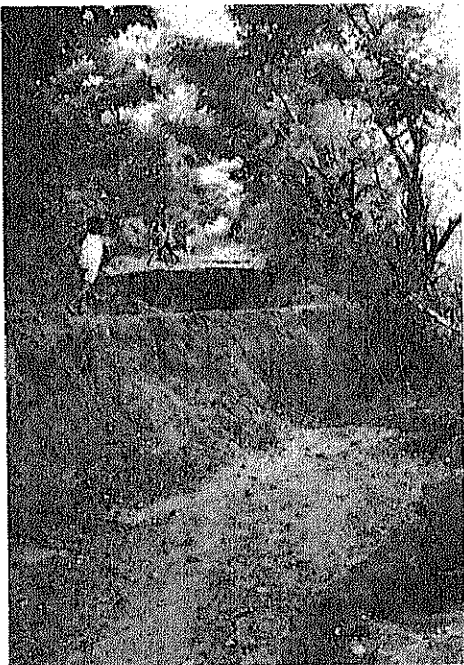
Photo 7.5.10 Damage to a levee of the Agno river

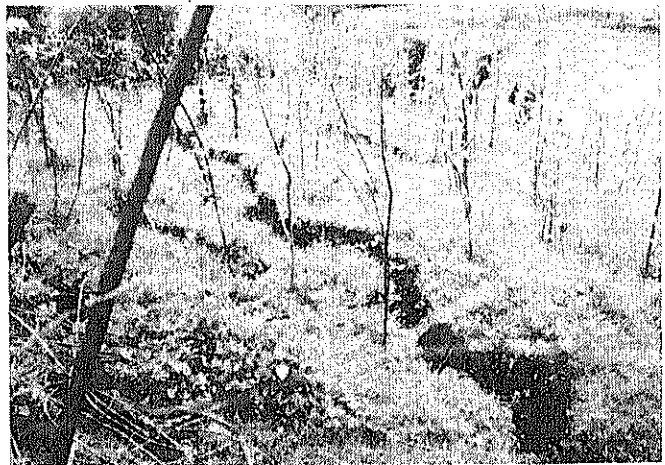
Photo 7.5.11 Damage to the slope-face of a levee of the Agno river

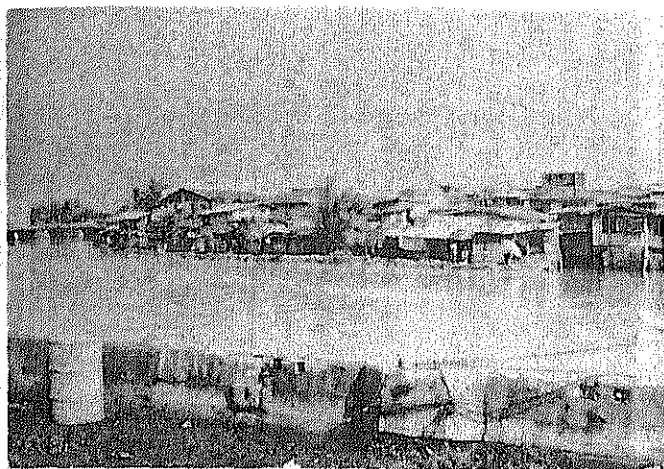
At Dagupan, where serious liquefaction occurred, the parapet revetments in the city were badly damaged; some revetments sank under the water surface (the opposite bank in Photo 7.5.12); the parapet revetments which had the concrete foundation piles of 30-foot in length anchored by concrete blocks were damaged by liquefaction. (Photo 7.5.12, 7.5.13)

Photo 7.5.12 Damage to a parapet revetment in Dagupan city (on the opposite bank)

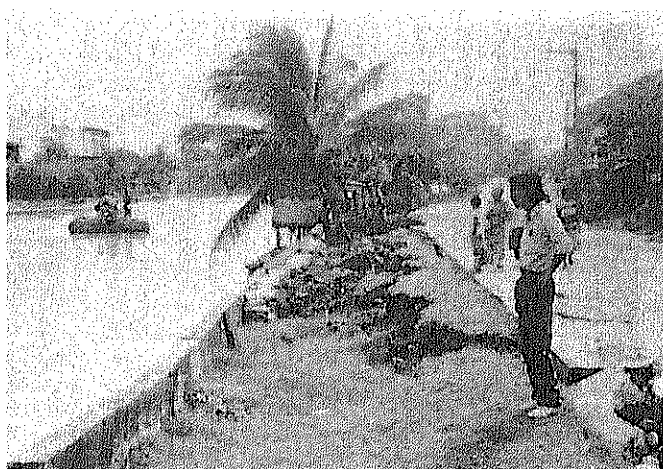
Photo 7.5.13 Damage to a parapet revetment in Dagupan city

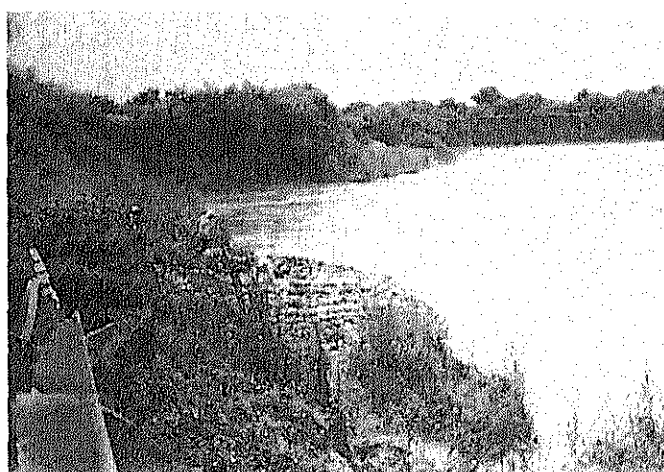
At the position where the water rushes against the banks of the Pampanga river near the foot of Mt. Arayat, cracking and collapsing of the earth dikes occurred; as to the earth dike damaged most severely, one-third of its body remained and was just before the complete collapse. At the upstream side close to the damaged site, emergency groyne work was being conducted; four groynes, including the one under construction, were expected in all.

Photo 7.5.14 Damage to a levee of the Pampanga river

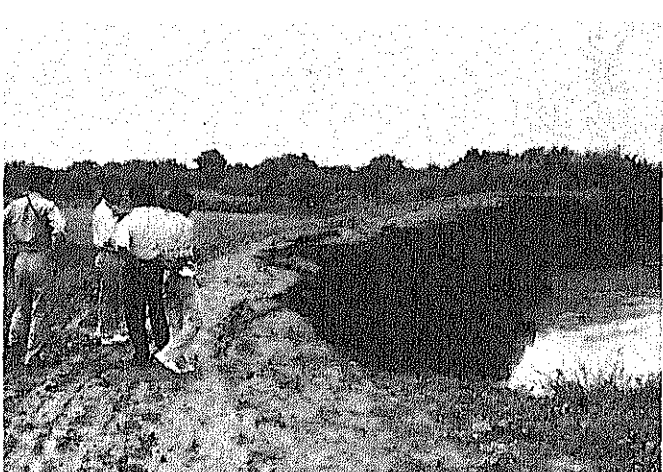
Photo 7.5.15 Damage to a levee of the Pampanga river

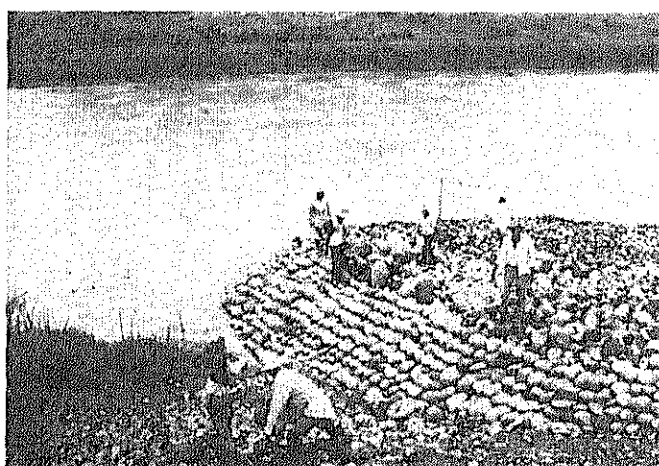
Photo 7.5.16 Groyne work on the Pampanga river (emergency rehabilitation)

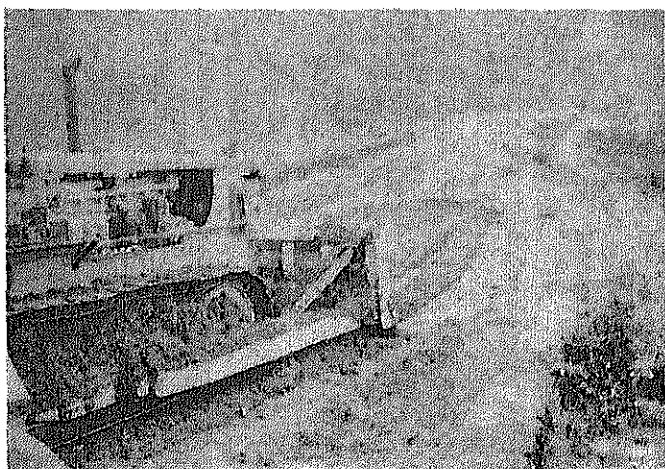
- 1) Though cracks had occurred at the crest of the dam. However, we could not confirmed this, since the rehabilitation of the crest by a bulldozer had been done (Photo 7.5.17).

Photo 7.5.17 Repair of the crest of the Ambuklao Dam (temporary rehabilitation)

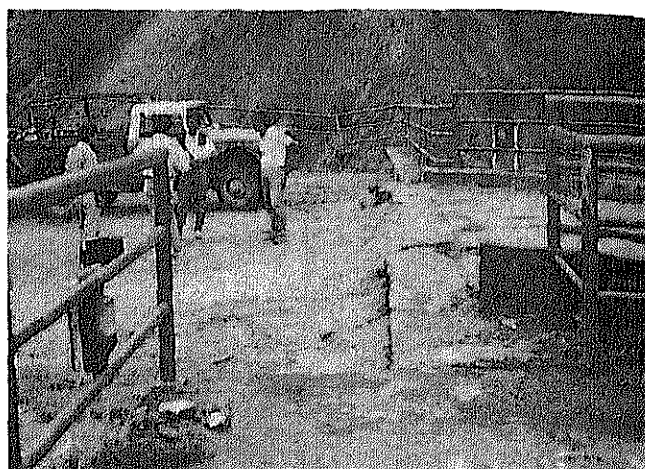
- 2) Settlement of the crest of the dam was about 50cm, and undulation of the crest caused by uneven settlement was observed. (Photo 7.5.18, 7.5.19)
 - 3) Some longitudinal cracks were observed on the upstream slope, and shallow sliding had occurred. (Photo 7.5.20 to 7.5.22)

Photo 7.5.18 Settlement of the crest of the Ambuklao Dam (connecting part with the spillway)

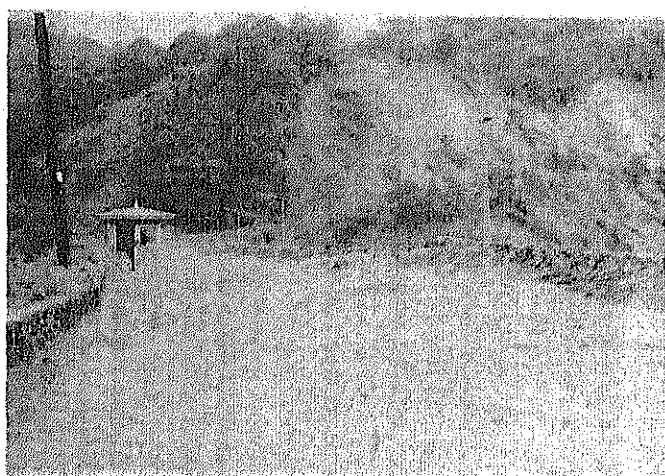
Photo 7.5.19 Differential settlement of the crest of the Ambuklao Dam

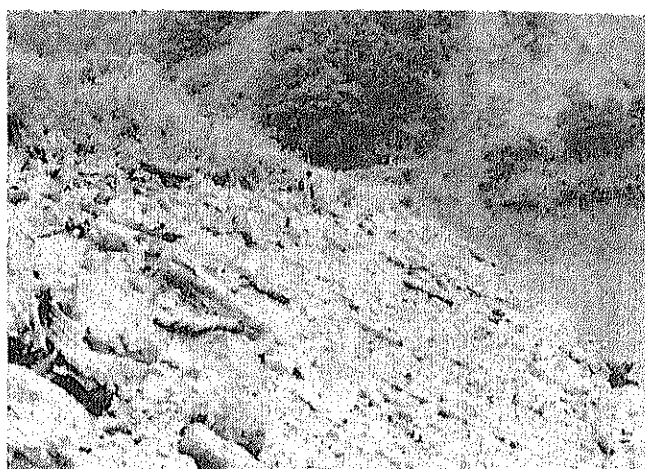
Photo 7.5.20 Conditions of the upstream slope-face of the Ambuklao Dam

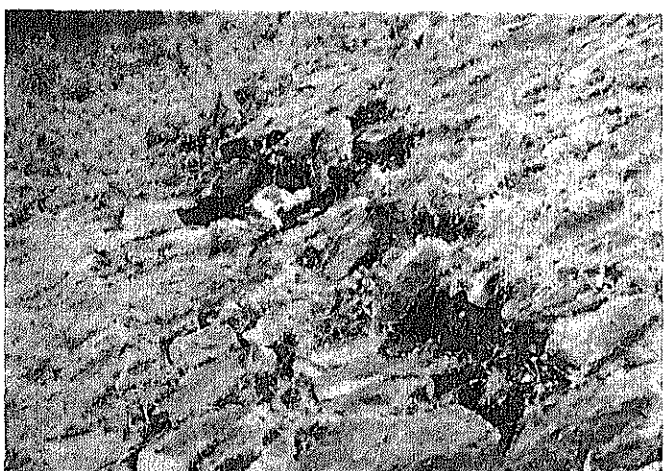
Photo 7.5.21 Sliding of the riprap on the upstream slope-face of the Ambuklao Dam

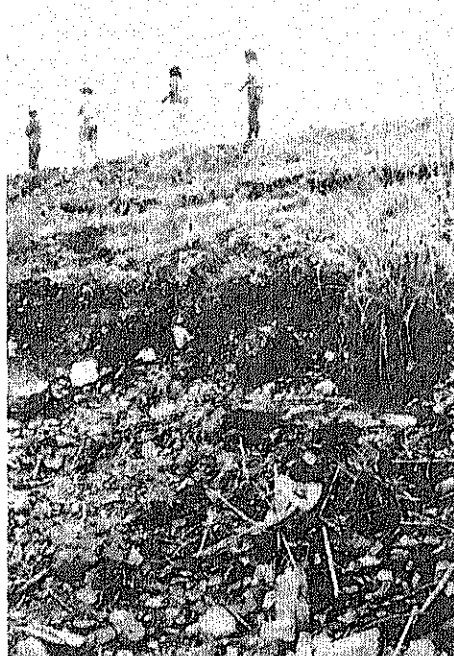
Photo 7.5.22 Sliding of the upstream slope-face of the Ambuklao Dam

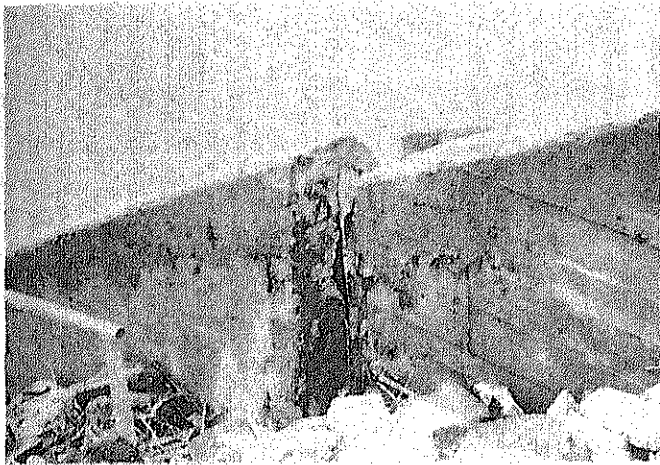
- 4) Openings in the expansion joints were observed on parts of the separate walls between the fill dam and the spillway. (Photo 7.5.23)
 - 5) The downstream slope of the dam seemed to be stable. (Photo 7.5.24)

Photo 7.5.23 Damage to the retaining wall of the Ambuklao Dam

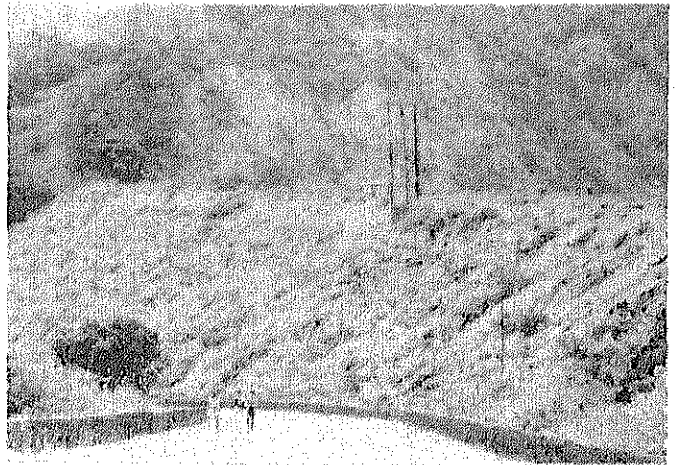
Photo 7.5.24 Conditions of the downstream slope-face of the Ambuklao Dam

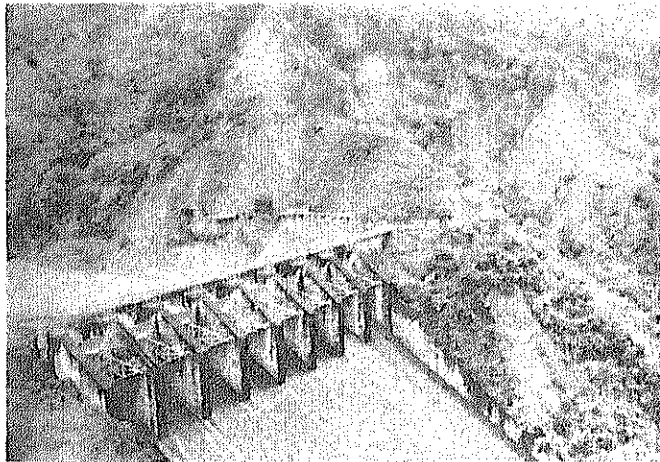
- 6) The spillway was not damaged.
 - 7) Many landslides had occurred on both the cutting faces of the left bank of the spillway and on the slopes on the circumference of the dam. (Photo 7.5.25)

Photo 7.5.25 Sliding of the cutting slope on the spillway of the Ambuklao Dam

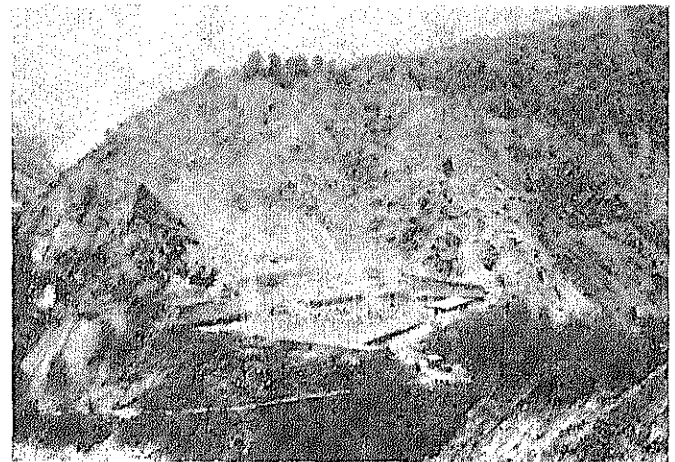
- 8) The transmission yard just under the dam was damaged by sliding the slope behind. (Photo 7.5.26)
 - 9) The change in seepage from the dam could not be determined, since analysis was not completed.

Photo 7.5.26 Sliding near the transmission yard of the Ambuklao Dam

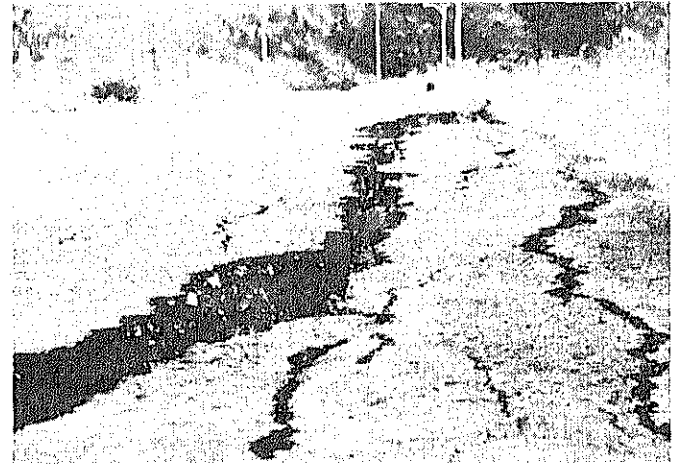
- (2) The Binga Dam (Figure 7.5.7 to 7.5.8)
(No.1 to 7 in Table 7.5.1-IV)
- 1) Many deep longitudinal cracks, 10 to 20cm wide, occurred at the crest. In particular, large cracks occurred from the center to the left, mainly at the upstream side of the crest. And, at the top of the upstream and the downstream slopes, longitudinal cracks occurred throughout the whole length of the crest. (Photo 7.5.27 to 7.5.29)

Photo 7.5.28 Cracks on the crest of the Binga Dam

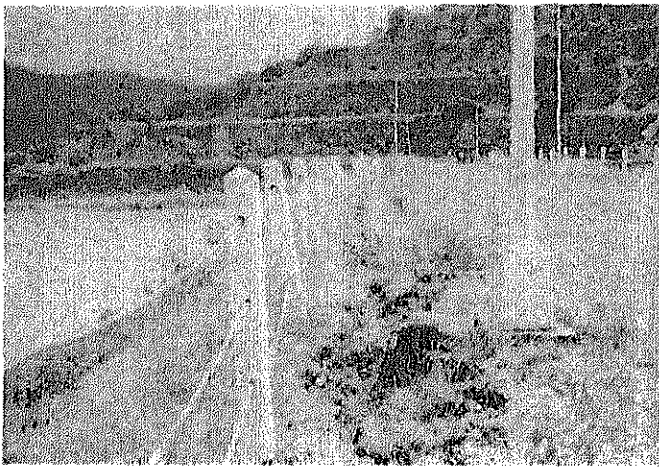
Photo 7.5.29 Cracks on the slope-top of the crest of the Binga Dam

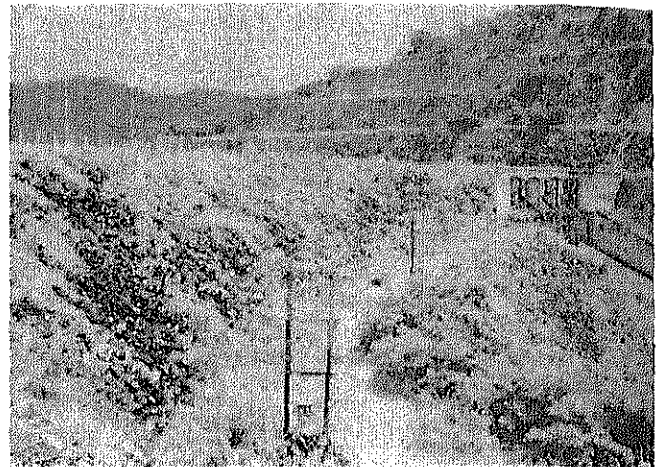
- 4) No damages were observed on the downstream slopes, except for the small landslides around the ex-construction road on the slope. (Photo 7.5.30)
 - 5) The riprap of the upstream slope of the dam seemed to be stable. (Photo 7.5.31)

Photo 7.5.30 Conditions of the downstream slope-face of the Binga Dam

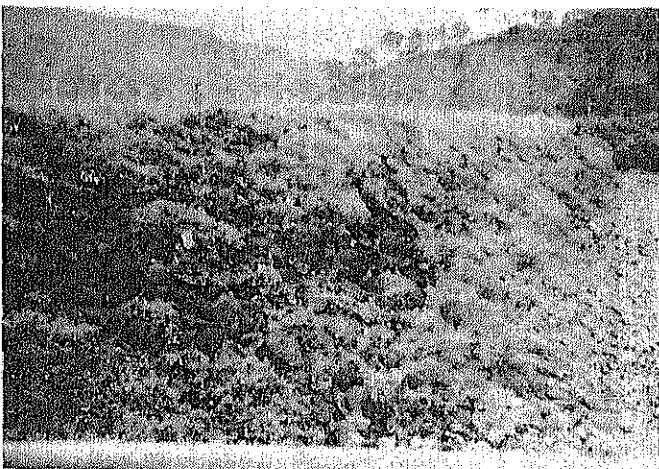
Photo 7.5.31 Conditions of the upstream slope-face of the Binga Dam

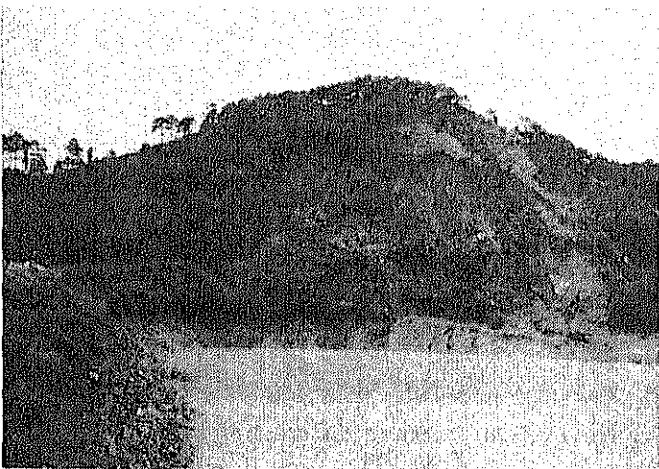
Photo 7.5.33 Sliding of the right bank abutment of the Binga Dam

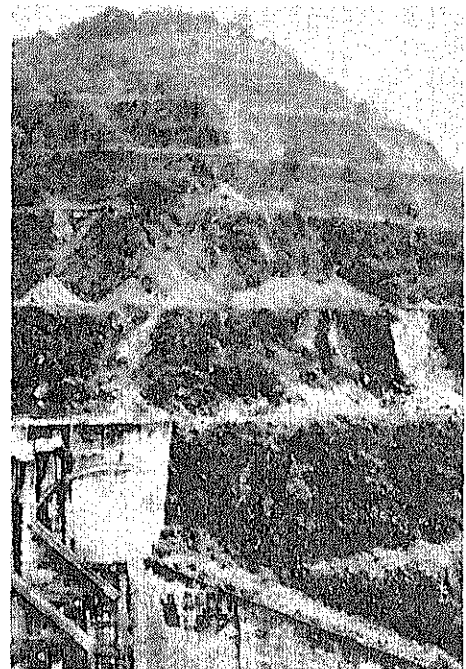
Photo 7.5.32 Collapse of the cutting slope on the spillway of the Binga Dam

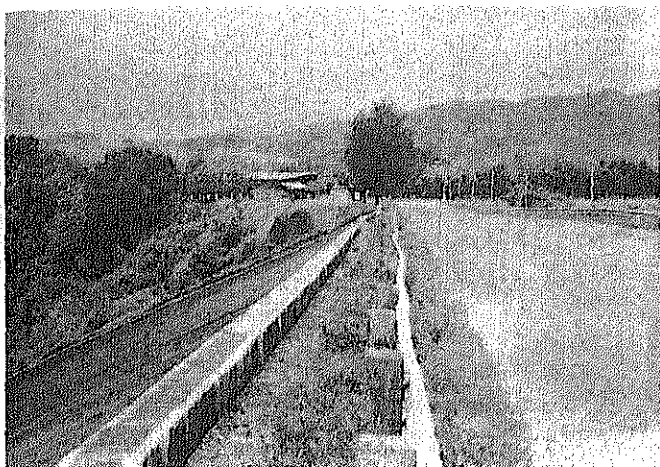
Photo 7.5.34 Settlement of the crest of the Pantabangan Dam

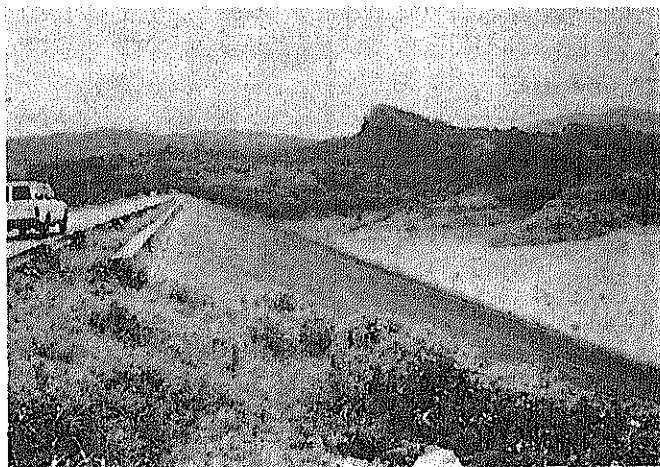
- 2) The upstream and downstream slopes of the Pantabangan Dam were stable. (Photo 7.5.35, 7.5.36)
- 3) Landslides occurred on the road to the Pantabangan Dam, and the damaged portions were rehabilitated with wire mats. (Photo 7.5.37)

Photo 7.5.35 Conditions of the upstream slope-face of the Pantabangan Dam

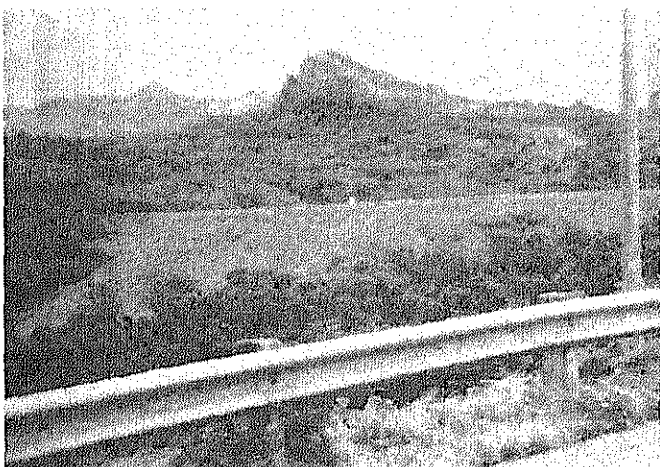
Photo 7.5.36 Conditions of the downstream slope-face of the Pantabangan Dam

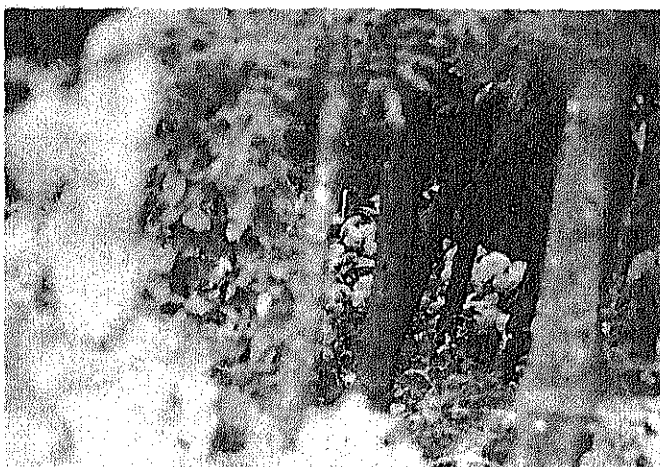
Photo 7.5.37 Temporary countermeasure work on the sliding on a road to Pantabangan Dam

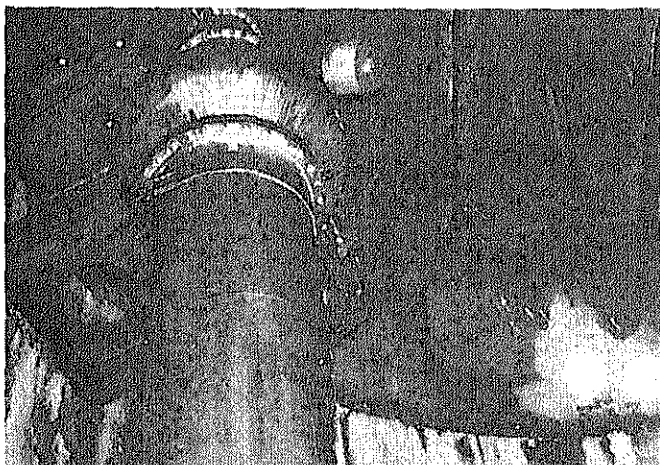
Photo 7.5.38 Leakage from the vacuum relief valves

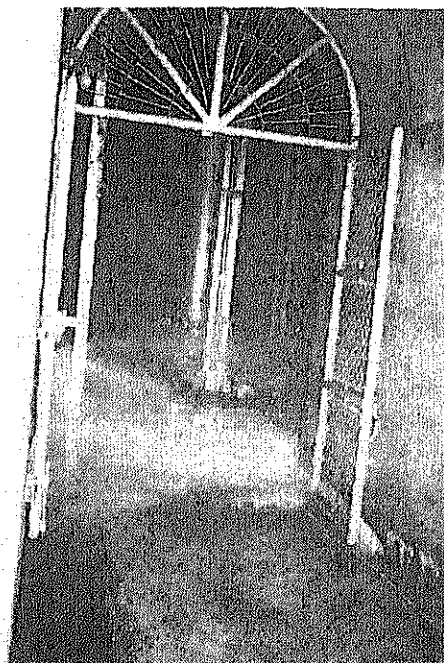
Photo 7.5.39 Leakage from the flange joints of vacuum relief pipes

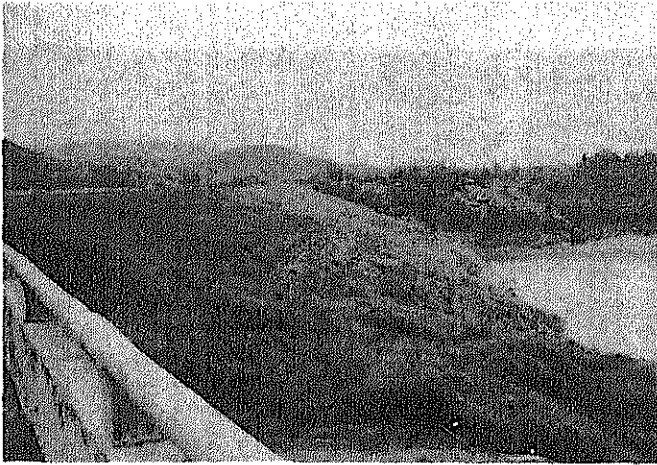
- 5) No apparent damages were observed at the Aya Dam, including the spillway. (Photo 7.5.40)
- 6) The Masiway Dam, which is the reregulating dam for the Pantabangan Dam, was badly damaged, even though the dam height is as low as 24m.

Photo 7.5.40 Conditions of the upstream slope-face of the Aya Dam

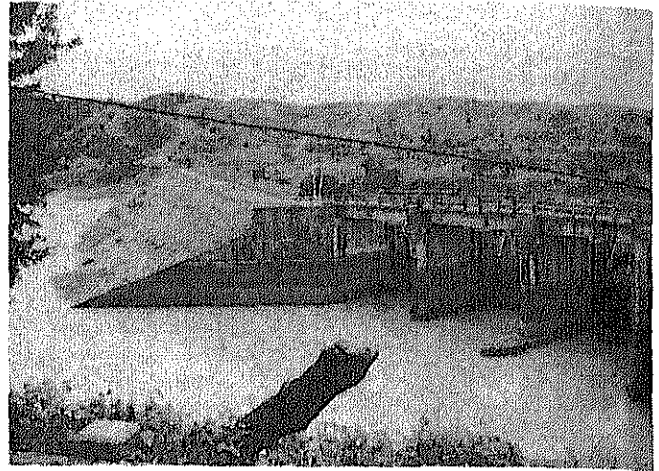
- 7) Longitudinal cracks of a maximum of 2.5m deep occurred at the crest of Masiway Dam, and some cracks had been observed by digging the pits. (Photo 7.5.41, 7.5.42)

Photo 7.5.41 Conditions of the crest of the Masiway Dam

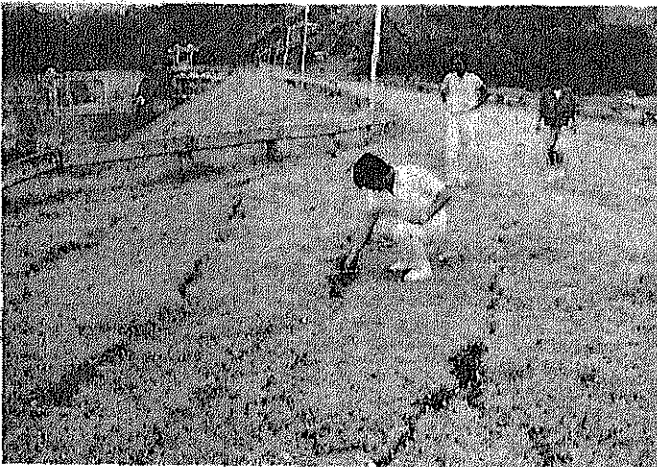
Photo 7.5.42 Cracks on the crest of the Masiway Dam

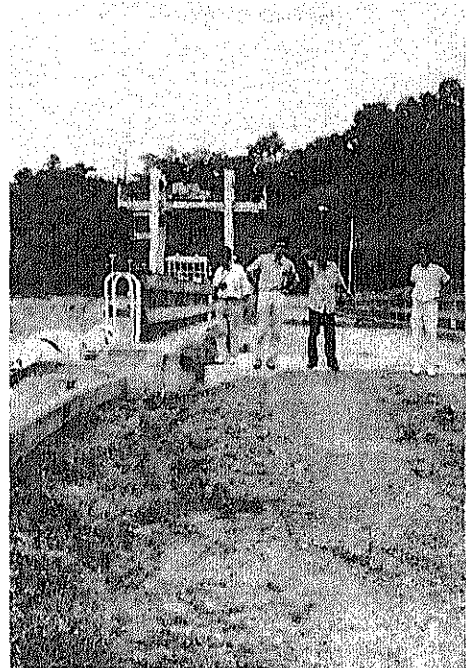
- 8) The crest of Masiway Dam sank about 0.5 to 1m. (Photo 7.5.43)
- 9) Some landslides occurred on the upstream and the downstream slopes of the Masiway Dam, and the swelling of the slope was observed. (Photo 7.5.44, 7.5.45)

Photo 7.5.43 Settlement of the crest of the Masiway Dam (connecting parts with the spillway)

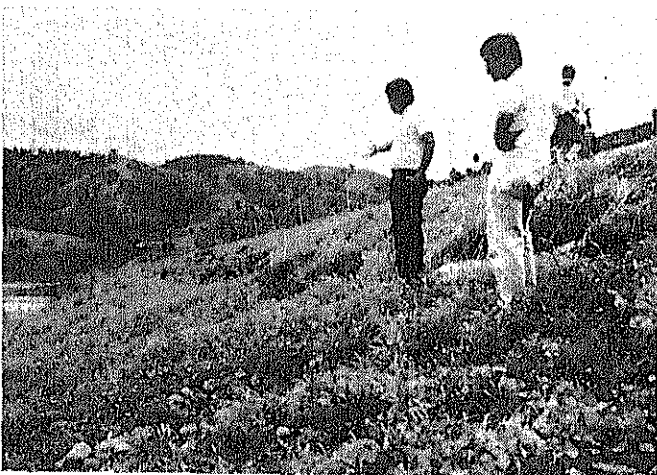
Photo 7.5.44 Sliding of the upstream slope-face of the Masiway Dam

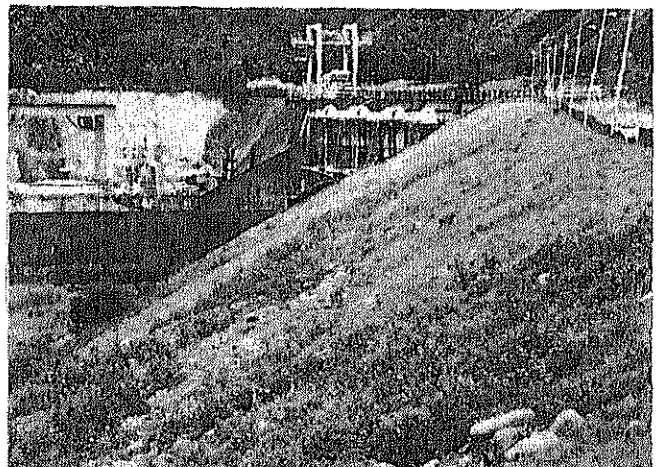
Photo 7.5.45 Conditions of the downstream slope-face of the Masiway Dam

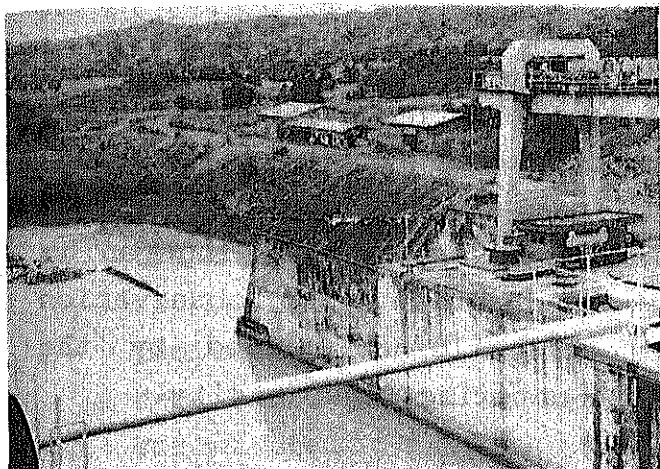
- 10) The spillway of the Masiway Dam was not damaged.
- 11) Some cracks were observed on the revetments on the right side of the spillway. (Photo 7.5.46)

Photo 7.5.46 Cracks on the revetment of the Masiway Dam

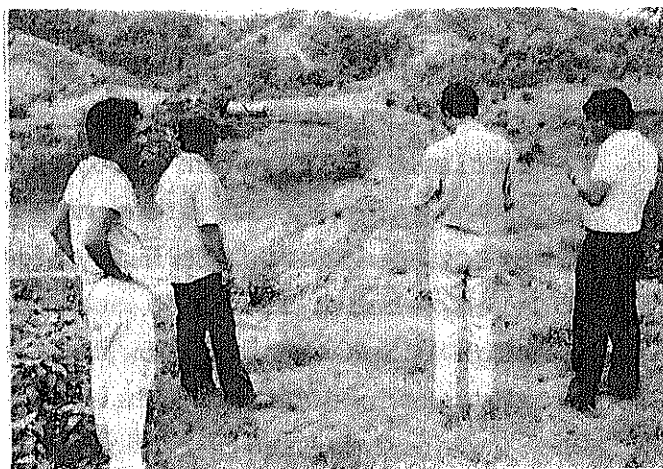
- 12) At the Masiway Dam, in addition to a concrete spillway with gates, a spillway of earth dike, called Fuse Dike, with a 5m lowered crest is installed on the left bank side; longitudinal cracks and settlement were observed on the crest of the Fuse Dike, and landslides were observed on the upstream slope of the Fuse Dike. (Photo 7.5.47)

Photo 7.5.47 Damage to the Fuse Dike of the Masiway Dam

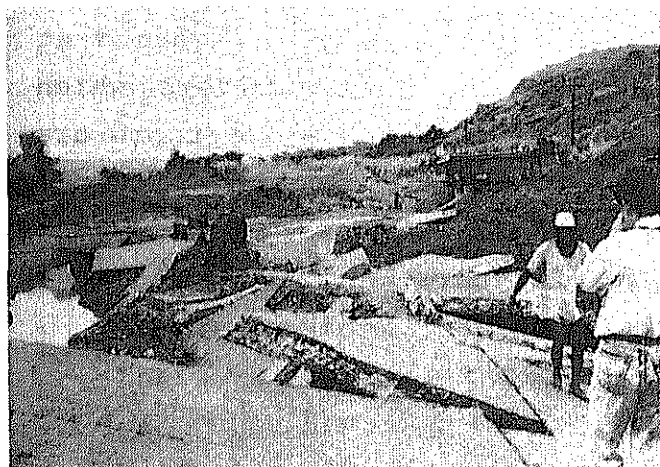
- 13) The No.1 diversion canal (near Rizal), which is an irrigation canal downstream from the Pantabangan Dam, the bridge across the canal, and the pavements on the both sides of the bridge were badly damaged. (Figure 7.5.16, Photo 7.5.48, 7.5.49)

Photo 7.5.48 Damage to the No.1 diversion canal

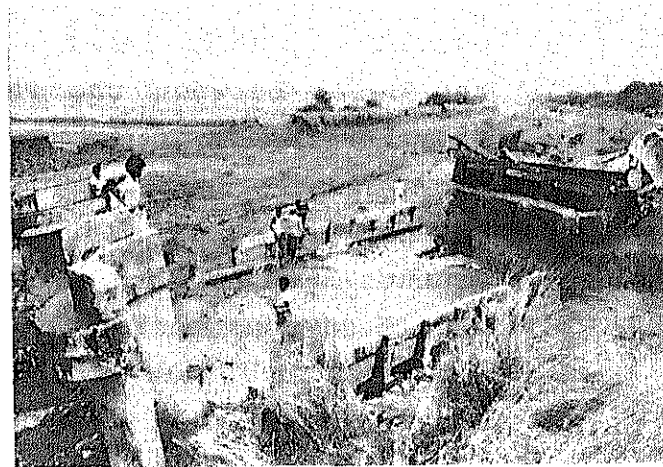
Photo 7.5.49 Damage to the No.1 diversion canal

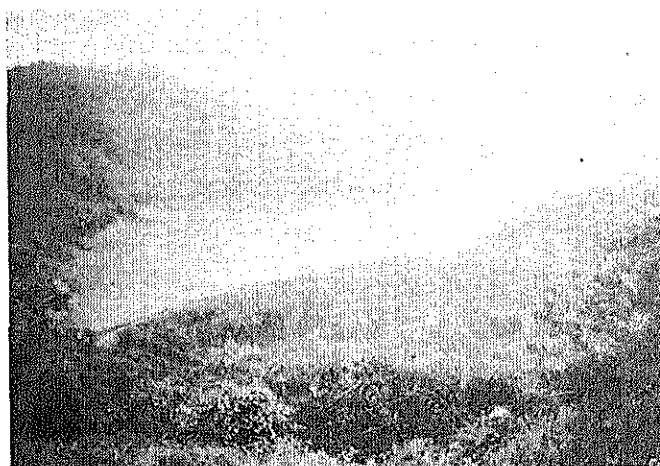
- (4) Angat Dam (Figure 7.5.17, 7.5.18)
(No.1 to 4 in Table 7.5.1-VI)
- 1) Settlement and cracks were not observed on the crest of the dam. (Photo 7.5.50)

Photo 7.5.50 A general view of the Angat Dam

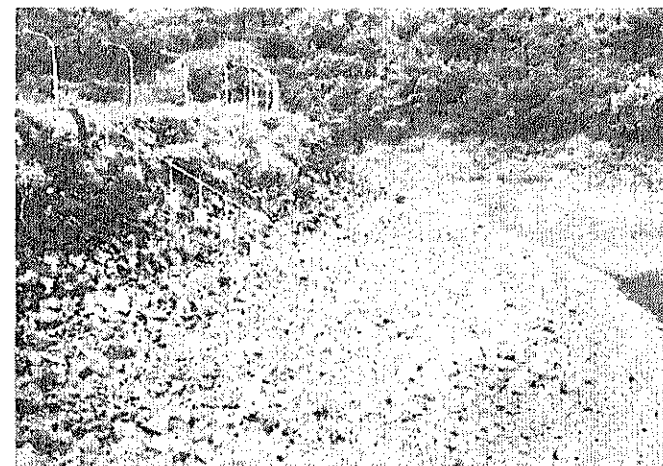
- 2) The upstream and downstream slopes of the dam were not damaged. (Photo 7.5.51)
 - 3) Landslides were observed at the slope on the way to the ex-batcher plant.

Photo 7.5.51 Conditions of the upstream slope-face of the Angat Dam
