7.6 Buildings

7.6.1 Damage in Dagupan City

7.6.2 Damage in Baguio City

7.6.3 Damage to the Metro-Manila

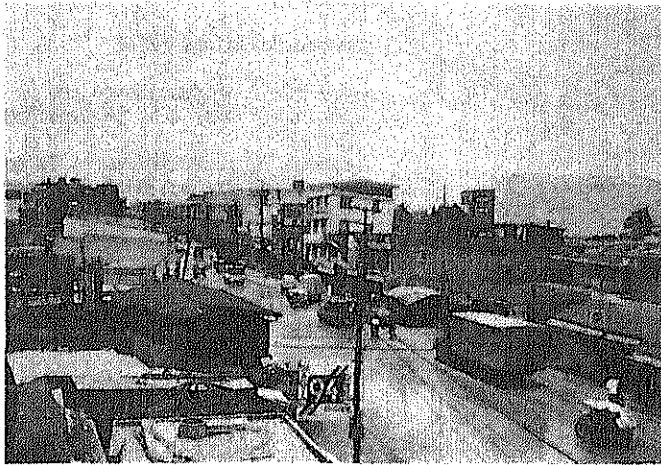
Photo 7.6.1

The row stores and houses on Perez street

- . The view of the Perez street from the roof of a 3-story building beside Ruzon College.
- . On both sides of the street, the 2F to 4F-buildings stand in line; subsidence and the inclination of buildings are shown.

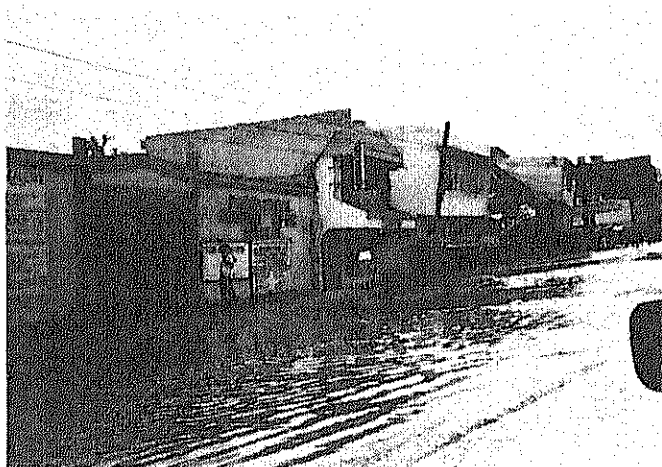
Photo 7.6.2

Damaged Buildings (1)-1

- . The damage conditions of the subsidence and the inclination of the RC 3-story buildings on Perez street.
- . The neighboring 1FL and 2FL buildings subsided; the damage of inclination was slight.
- . The water on the street was caused by the breakdown of drain pipes.

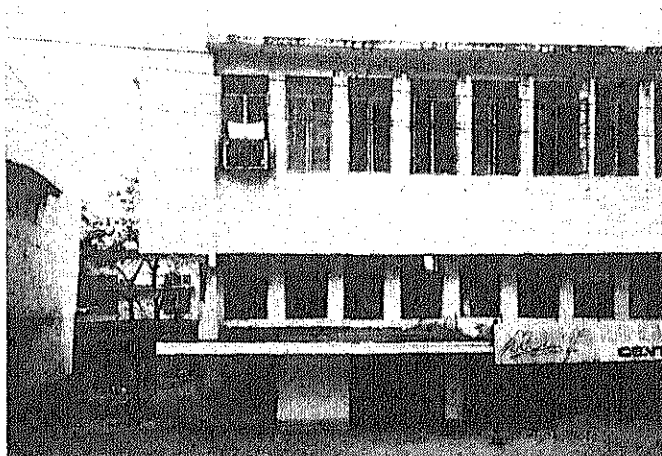
Photo 7.6.3

Damaged Houses (1)-2

- . Close-up of subsided-inclined building.
- . Damage to superstructures was hardly observed.
- . The 1F-part subsides about 1m from the road surface, and is inclined to the road side.

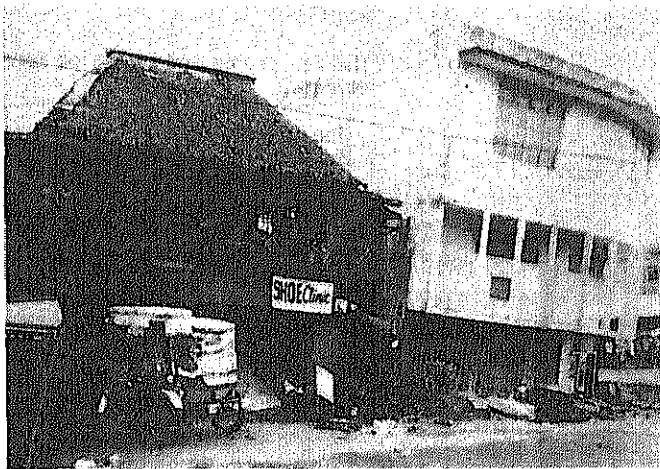
Photo 7.6.4

Damaged Buildings (2)-1

- . The state of subsidence and inclination of a RC 3F building.
- . Damage to superstructures is not observed; the building inclines to the road side remarkably.

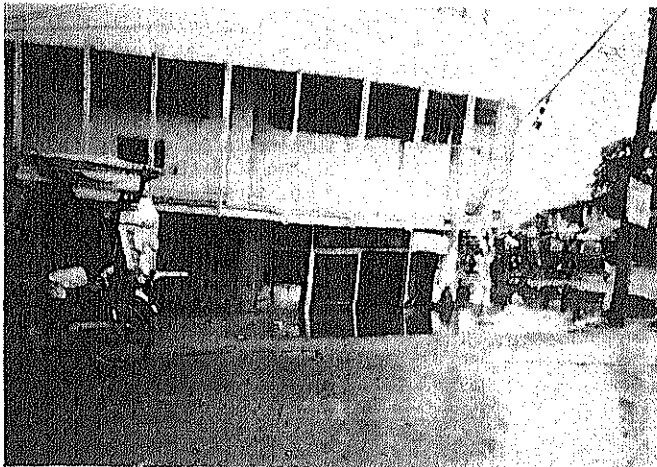
Photo 7.6.5

Damaged Buildings (2)-2

- . The 1F-part sank under water.
- . Spout-out sand is observed around the building.

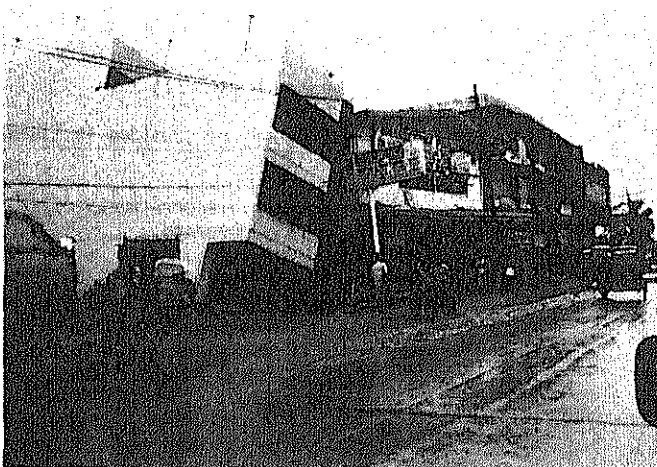
Photo 7.6.6

Damaged Houses (3)

- . The building is inclined at 19 degrees to the right side, and neighboring building is damaged due to this inclination.
- . The superstructures are not damaged.

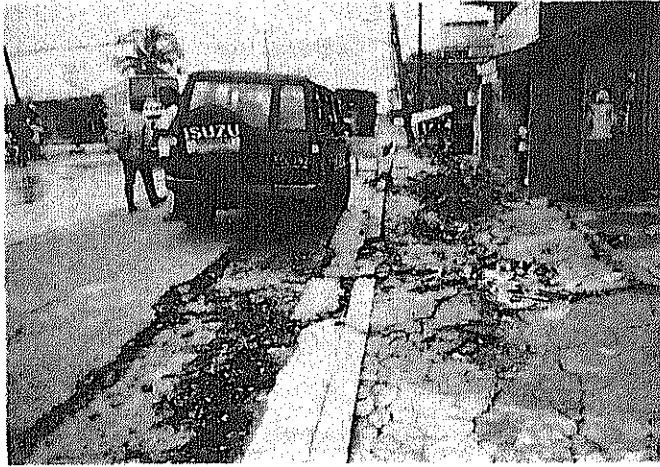
Photo 7.6.7

Conditions of the road on Perez street

- . The side of the buildings subside about 30cm relatively from the road face.
- . Since the side of the building was higher by about 30cm than the road before the earthquake, a subsidence of about 60cm occurs relatively.

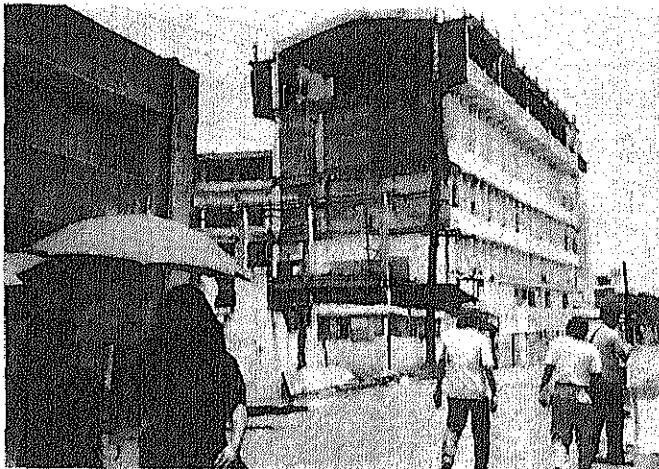
Photo 7.6.10

Luzon College - 2

- . The state of the damaged RC 5F building.
- . The building subsides more than 60cm from the ground surface.
- . The 5FL block wall of the gable end of the new extension built on the old school is destroyed, and the blocks are being demolished.

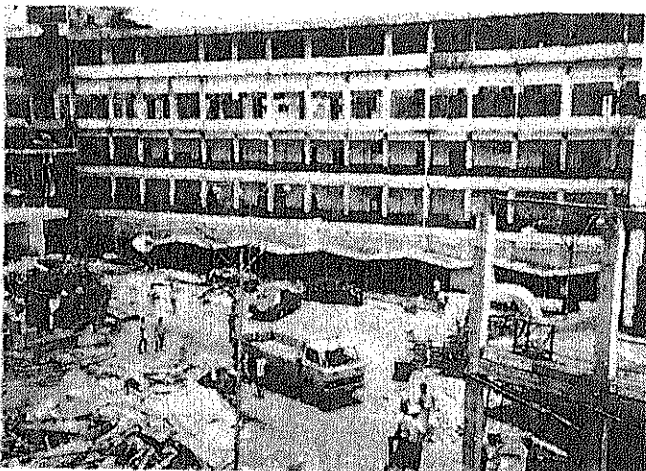
Photo 7.6.11

Luzon College - 3

- . Though subsidence of the whole building is observed, the damage to the superstructure is not observed.
- . The building is level in the bay direction, while it is inclined at two degrees in the span direction.

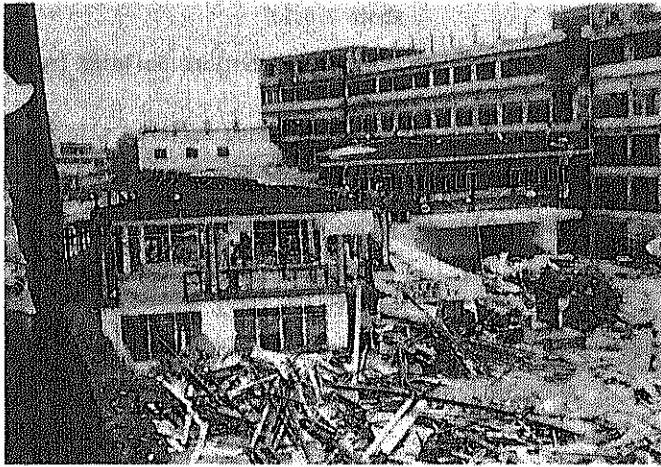
Photo 7.6.12

Luzon College - 4

- . A complete view of the buildings.
- . One or two story buildings are badly damaged, and they are being demolished.

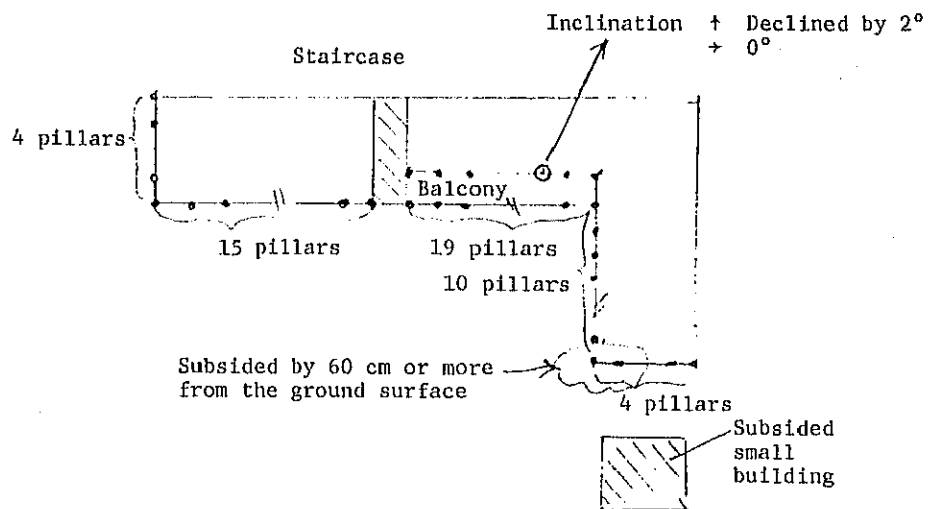
o Luzon College

- . RC 5-story, penthouse 1-story
- . A part: Pilotis
- . Constructed 20 years ago, later 5th floor was extended.

o Subsided buildings

- . There was a fish pond 30 years ago, the pond had been reclaimed for city area 20 years ago.
- . For rehabilitation, the base is used as it is, the first floor is leveled, and the stories more than 2nd floor will be repaired.

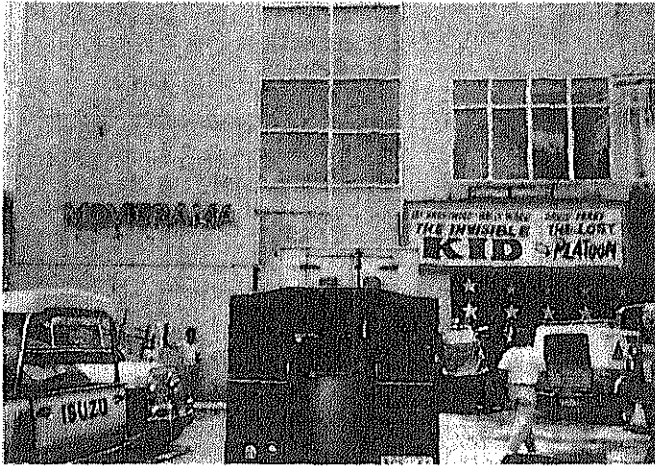
Photo 7.6.13

Modestar Sabeniano Building (movie house)

- . The building suffered slightly; cracks are observed on the exterior walls; subsidence hardly is observed in the neighborhood.
- . The building was not damaged, but the panic caused casualties.

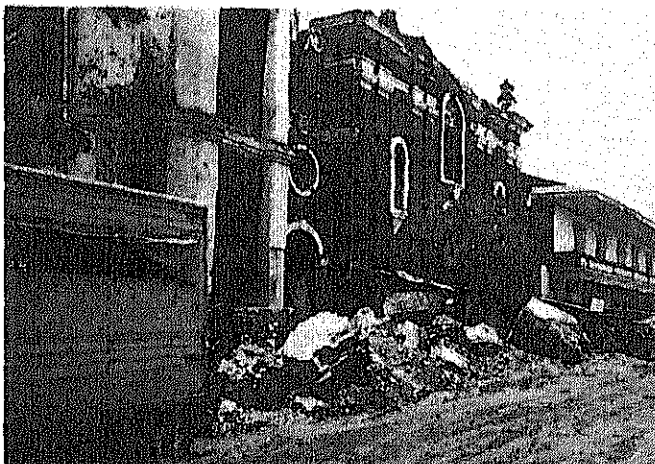
Photo 7.6.14

(7)	Macadore Hotel	Cracks on a part of the exterior walls were observed. However, subsidence in the surrounding grounds were not observed, no unequal settlement existed.	Photos 7.6.13 7.6.14

Macadore Hotel

- . The old penthouse made of bricks is damaged.

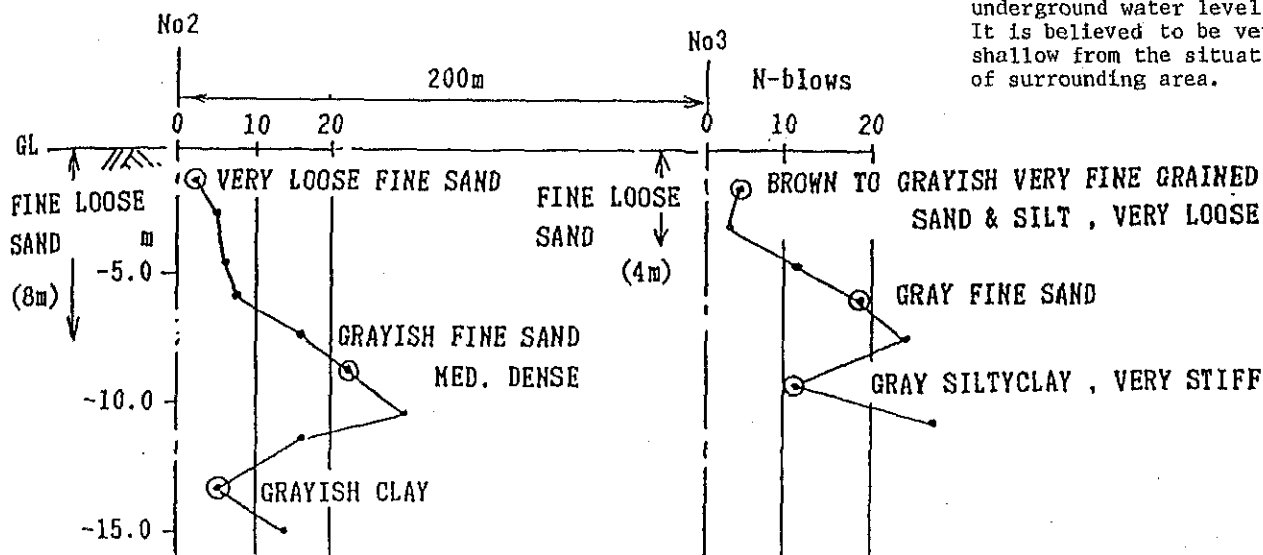
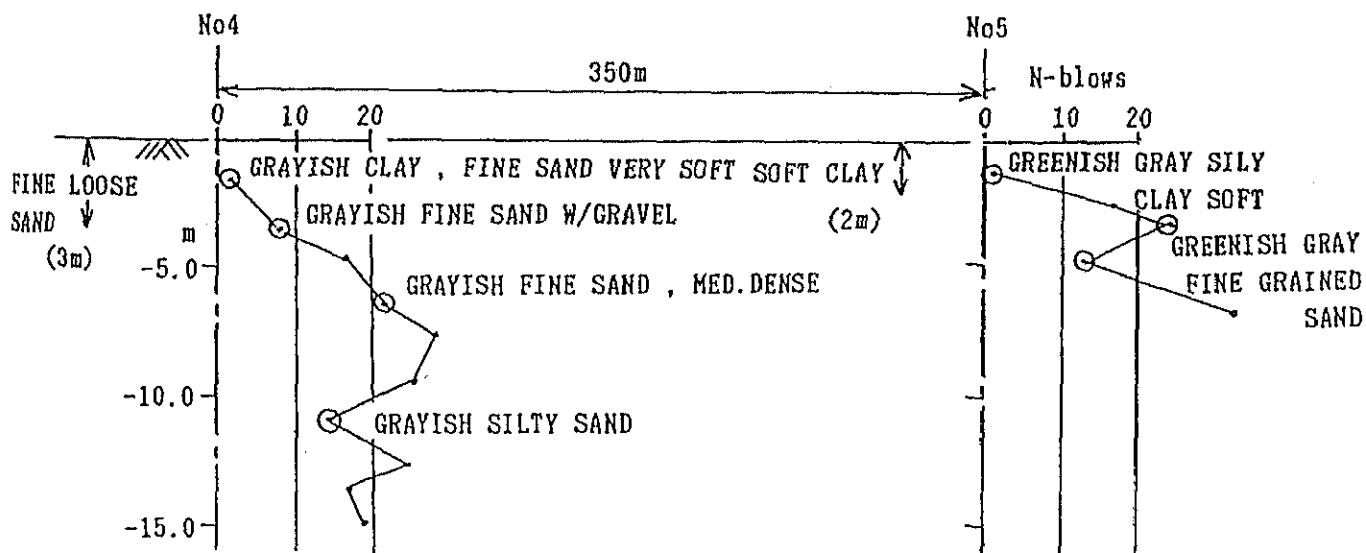
Figure 7.6.2 Ground of Dagupan City

The very loose sand layer (N-value: less than five) is obtained at about the 3m-depth in the No.2 boring position. In the other boring positions this loose sand layer is shallower than that of the No.2 boring position. Further, the medium-degree sand layer with N-value of more than 15 is obtained at the 5m-depth in the No.4 boring position. For these boring data, it will be necessary to do energy correction to extract accuracies from this circumstantial judgment.

. As shown in the No.2 boring, N=5 loose sand at GL-3m may be liquefied even in the level of 100 gal input.

. As shown in the No.3 boring, N=15 medium degree compacted gray fine sand at GL-5m may be liquefied even in 200 gal input.

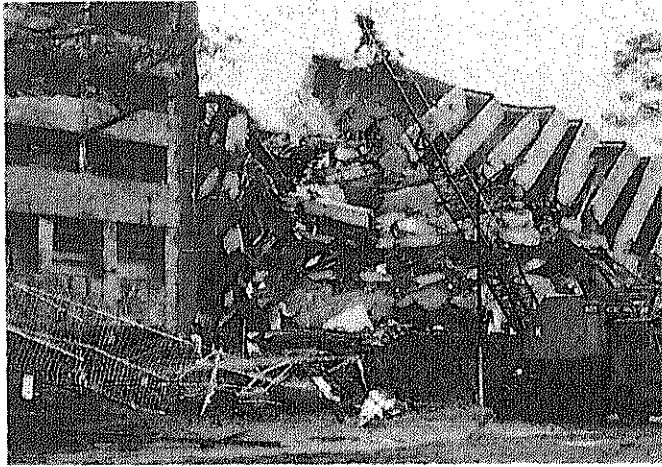
Photo 7.6.18

Name of the building:
Hyatt Terrace Hotel

Condition of the building:
Collapse

Collapsed condition of the tower parts.

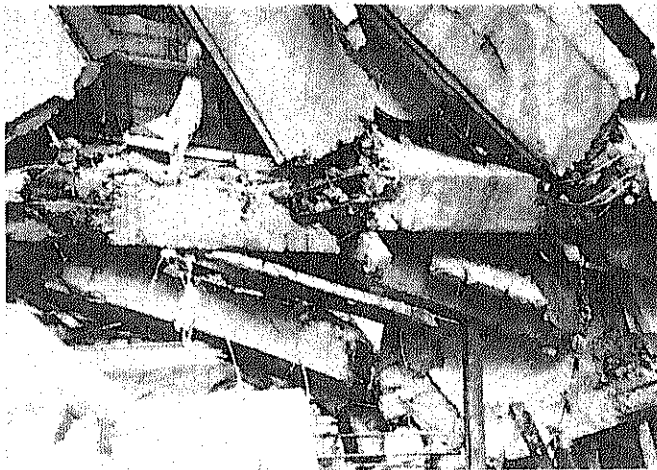
Photo 7.6.19

Damage of the column-beam joints:
The columns are seen horizontally.
The dimension of the column is smaller than that of the beams.
The section of the 1F columns: 60 x 75cm, main reinforcement: 10-D38, hoop: D16-200@
The interval of the column: 4.0m

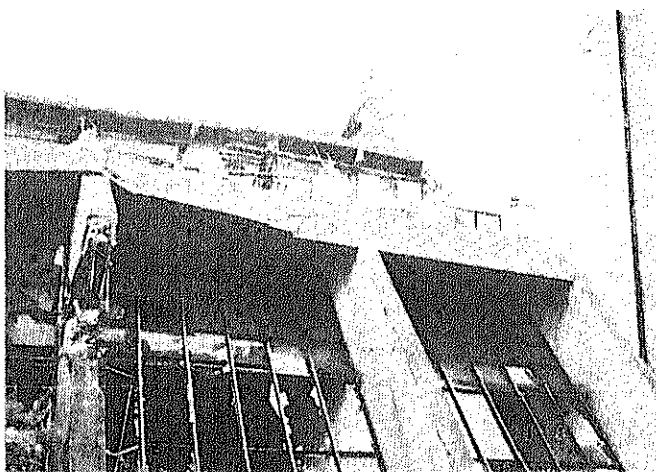
Photo 7.6.20

The damage condition of the entrance side of the terrace:
The structural joint with the right side building is not observed; the section of the oblique column: 850 x 55cm, main reinforcement: 8-D32 hoop: D10-300@

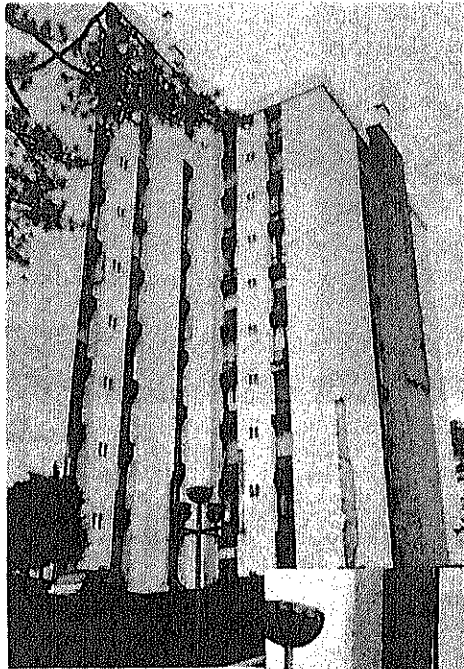
Photo 7.6.22

The east end of the north face:
Serious damage of the short column
parts, serious damage of the
secondary walls made of blocks.

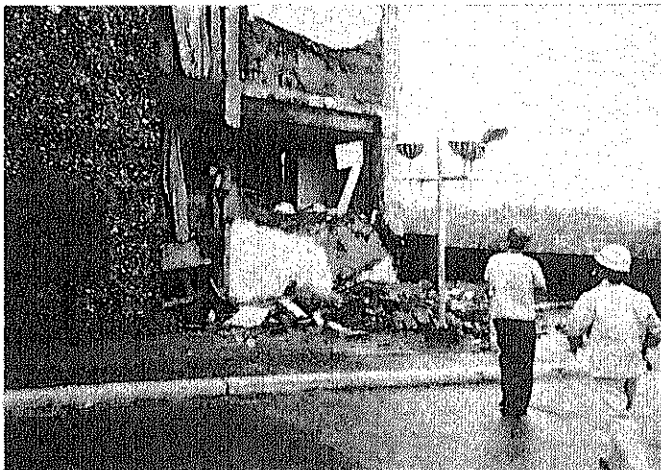
Photo 7.6.23

The end part of the west side of
the north face: Serious damage of
the 1F column-wall parts (Buckling
of the main reinforcement,
collapse of the secondary walls).

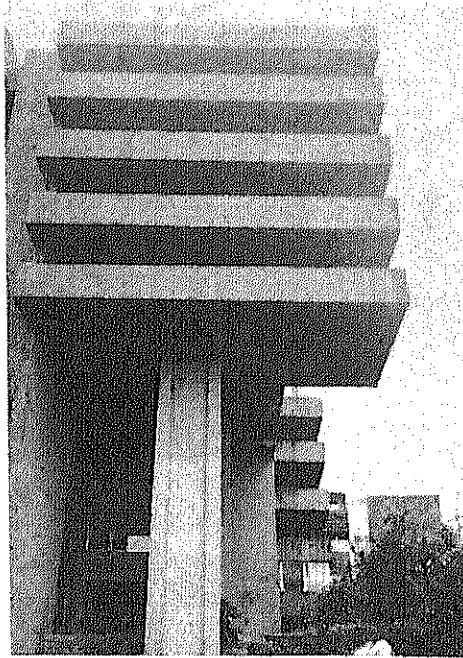
Photo 7.6.24

Name of the building: The Tower

Condition of the building:
Non-damage

The wall area and the column section are larger than those of the other buildings.

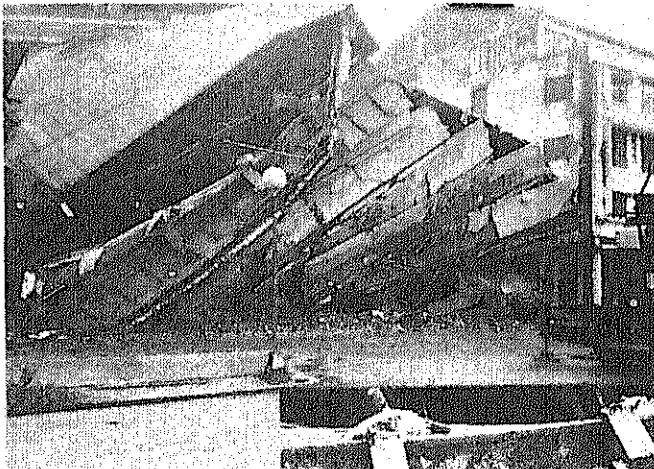
Photo 7.6.25

Name of the building:
Baguio Park Hotel

Condition of the building:
Collapse

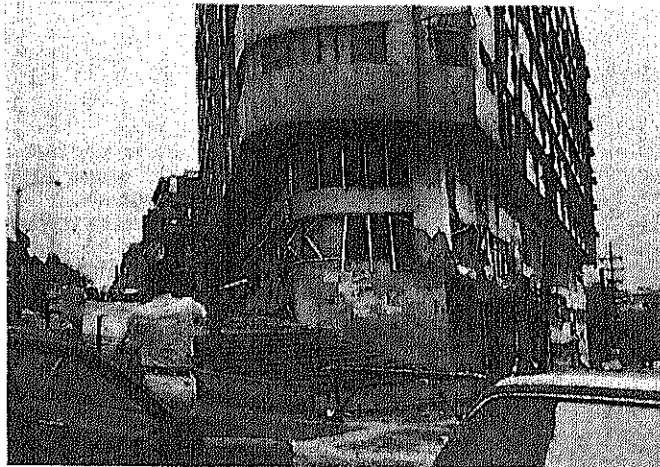
Photo 7.6.28

The 30 to 50cm floor height at 1F descends.

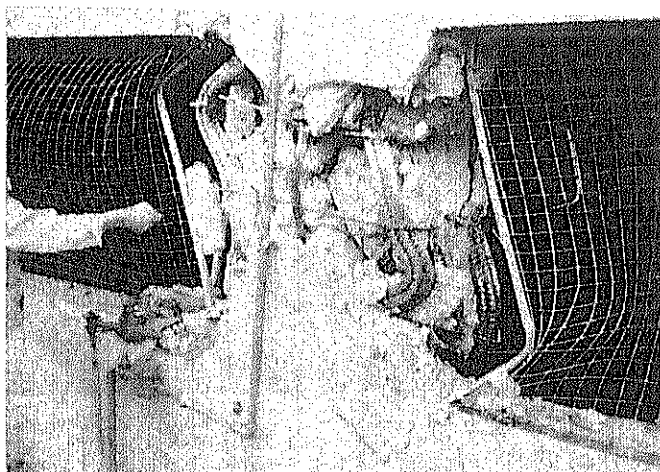
Photo 7.6.29

The condition of the damage of the short columns: The 4-main reinforcing bars (D29) are bundled at the corners; amount of hoop (D10) is few.

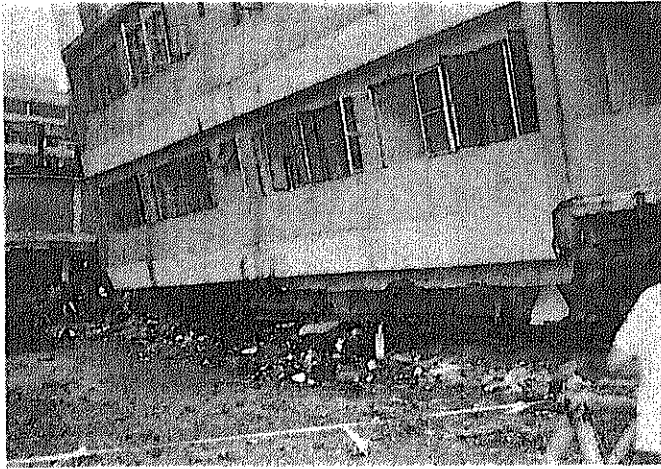
Photo 7.6.30

Name of the building: Royal Inn

Condition of the building:
Collapse of 1F parts

Post tension PC cables are used
in the beams.

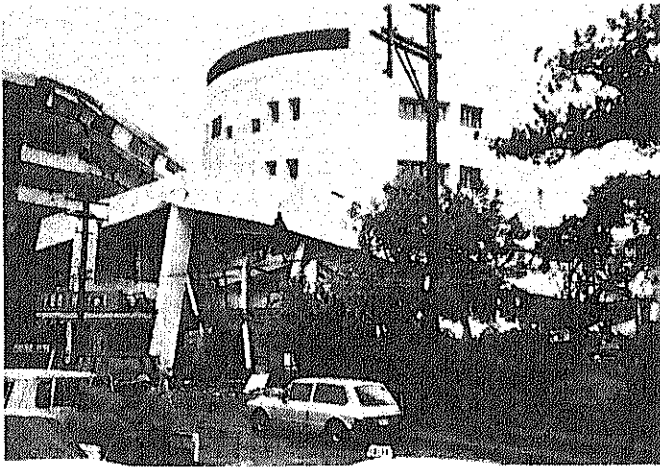
Photo 7.6.31

Name of the building: FRB Hotel

Condition of the building:
Collapse of the 1-2F parts

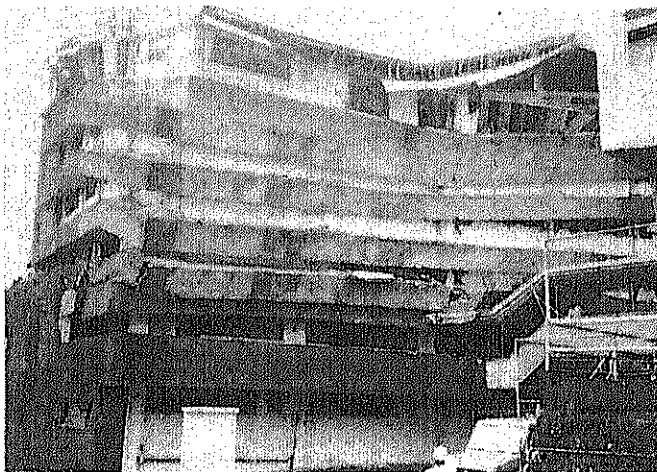
Photo 7.6.34

Name of the building:
Baguio University

Condition of the building:
Collapse above 3F

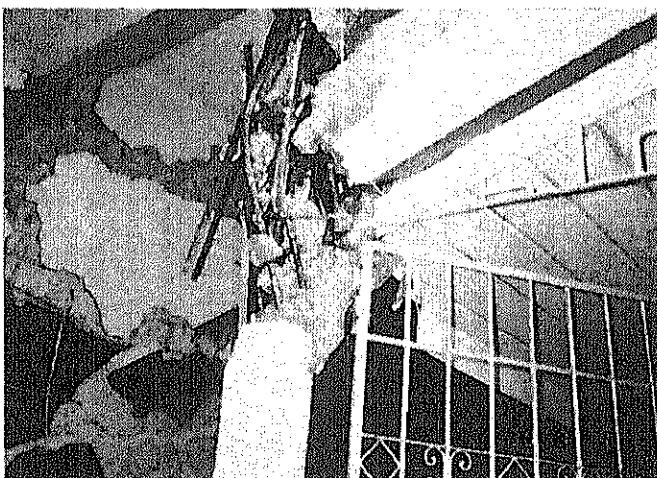
Photo 7.6.35

The joints of the columns and the
beams in the neighboring building

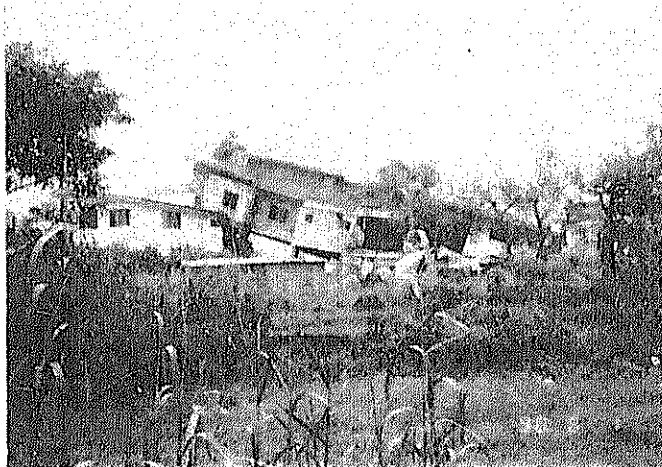
Photo 7.6.37

Name of the building:
Mixed residence

Condition of the building:
Collapse 1F and 2F parts

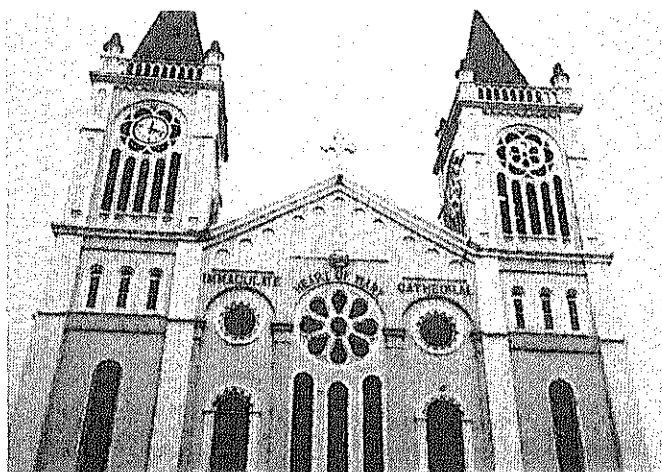
Photo 7.6.38

Name of the building:
Baguio Cathedral

Condition of the building:
Collapse in parts of the columns
and walls.

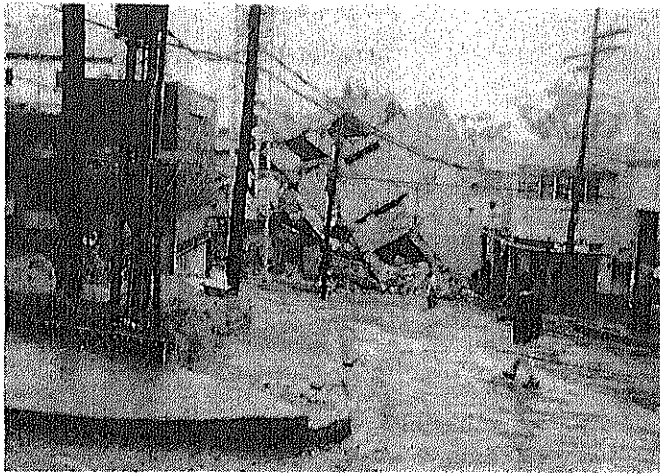
Photo 7.6.39

Name of the building: Unknown

Condition of the building:
Collapse

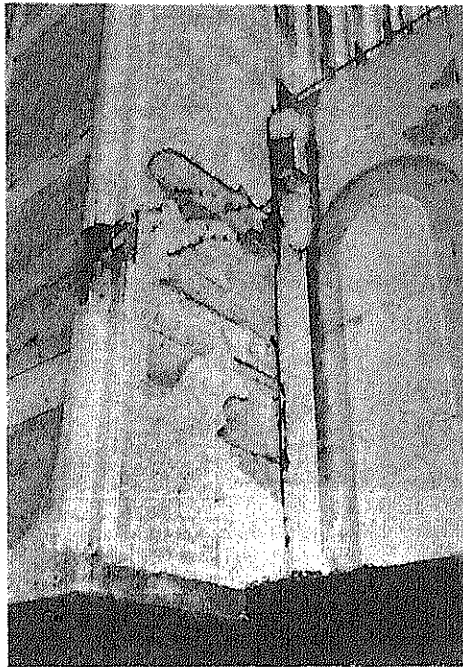
Photo 7.6.50

Name of the building:
Veteyans Bank

Condition of the building:
The buckling of bottom of the
column at the south side of 3F.

Shear cracking of the walls,
peeling of the bricks.

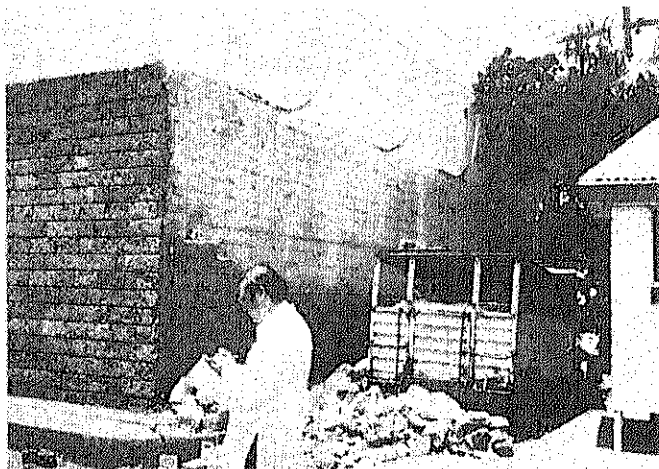
Photo 7.6.51

Peeling of the finishing wall
surface at 1F.

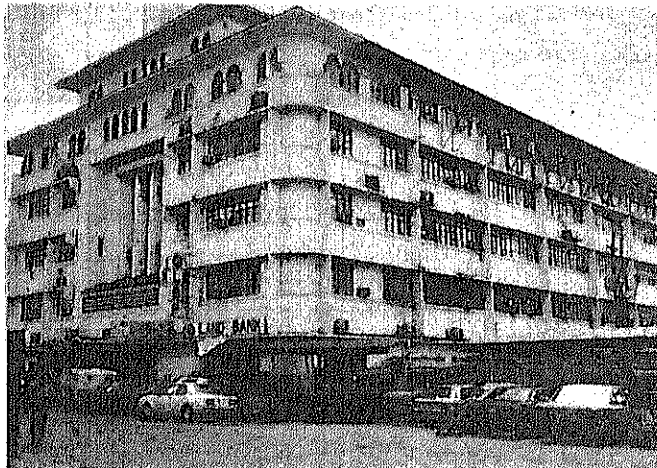
Photo 7.6.53

Name of the building: P.P.A.

Damage conditions:
Cracks at the block walls and
the head of the columns.

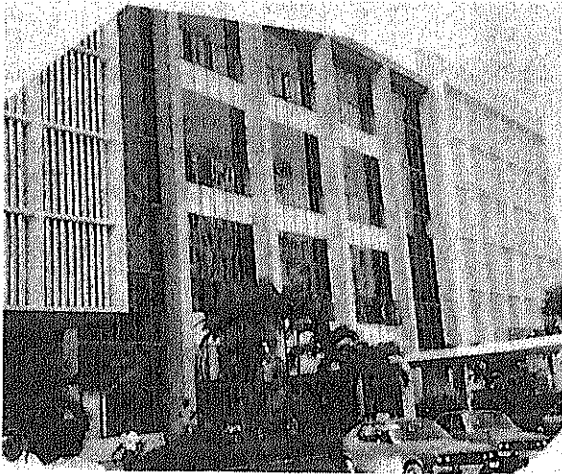
Photo 7.6.54

Name of the building:
National Library

Damage conditions:
Cracks at the
earthquake-resisting wall.

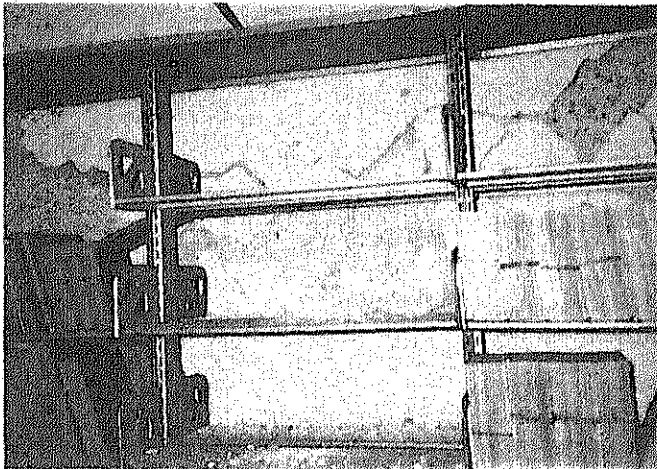
Photo 7.6.55

After the earthquakes in 1968 and 1984, the block walls were reinforced, and further the block walls were changed into RC walls; however, shear cracks occurred there.

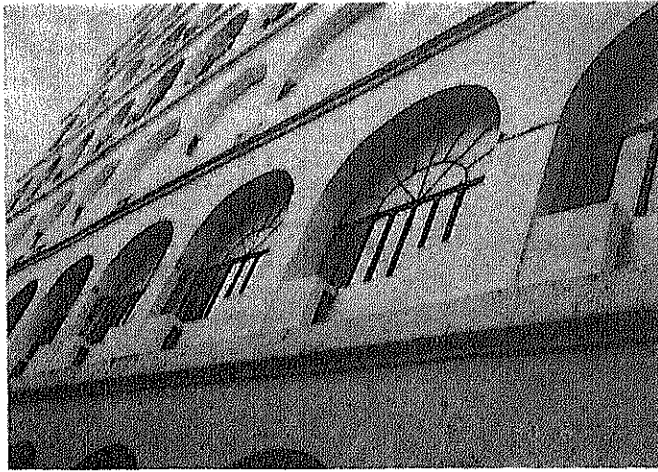
Photo 7.6.56

Name of the building:
Philippine General Hospital

Damage conditions:
Damage at the expansion joints
and peeling of the mortar of the
decorated column at the low-rise
parts.

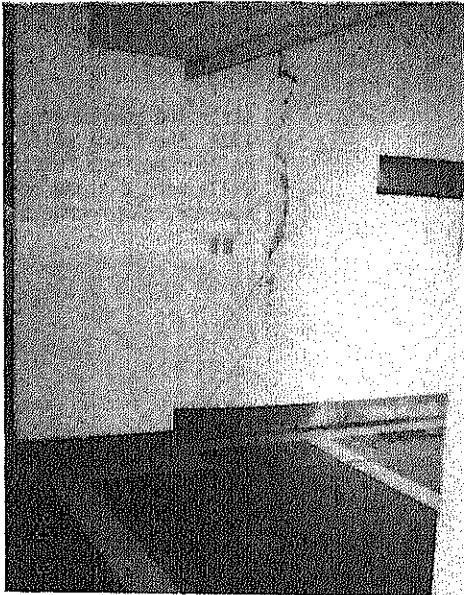
Photo 7.6.57

Cracks at the simplified expansion
joint.

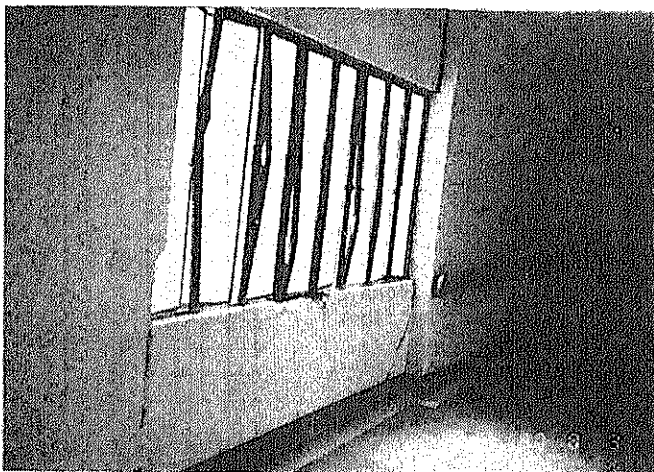
Photo 7.6.58

Damage of the window in the
expansion areas.

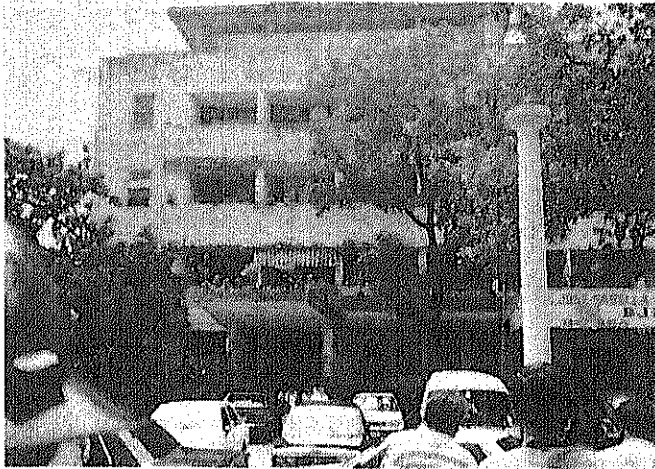
Photo 7.6.59

Name of the building:
Dr. Jose Fabella
Memorial Hospital Nurse
Dormitory

Damage conditions:
Cracks at the secondary block
wall.

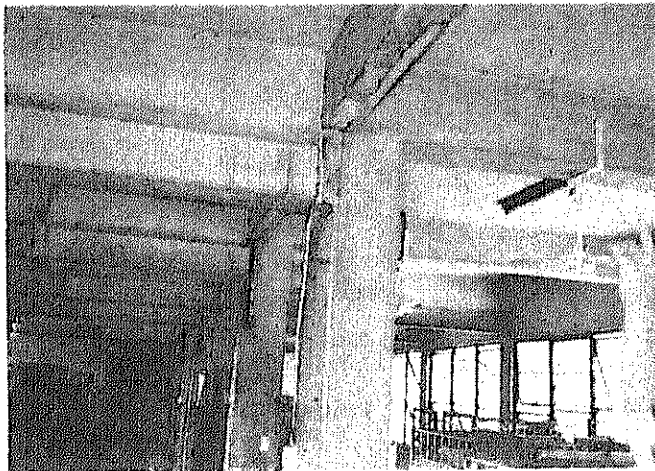
Photo 7.6.60

After the earthquake in 1968,
reinforcement by steel frames.

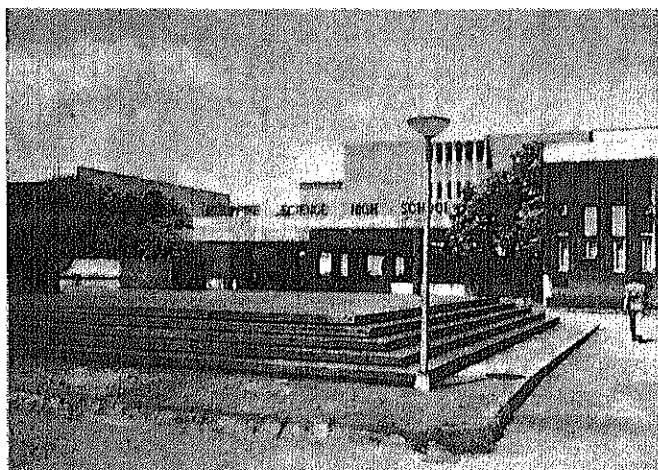
Photo 7.6.62

Name of the building:
Phil. Science High School

Damage conditions:
Cracks at the block walls.

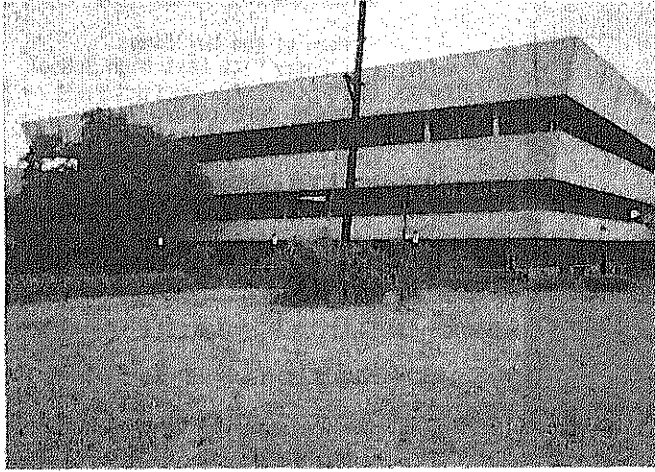
Photo 7.6.63

Name of the building:
State Accounting & Auditing Center

Damage conditions:
Cracks at the columns and walls in
the top story.

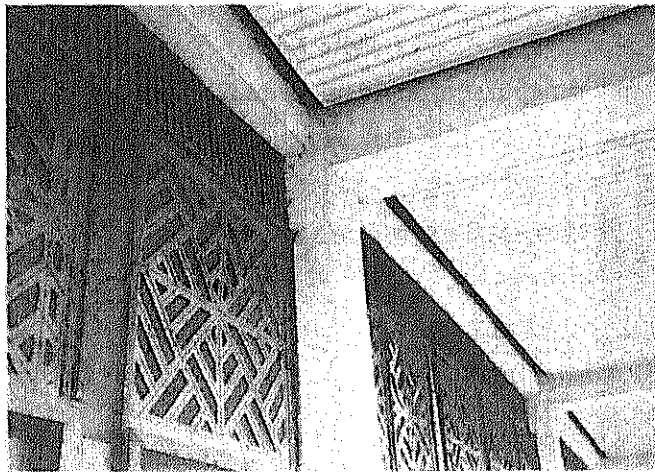
Photo 7.6.64

Bendings and cracks at the head of
the column of 2F.

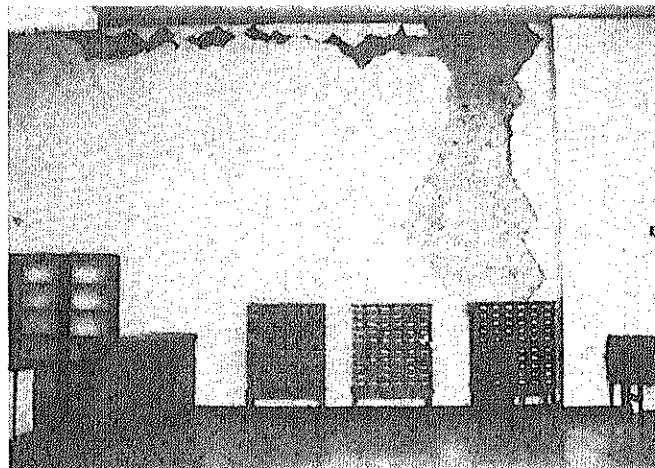
Photo 7.6.65

Name of the building:
Ministry of Energy

Damage conditions:
Cracks at the head parts and the
block walls of 4F.

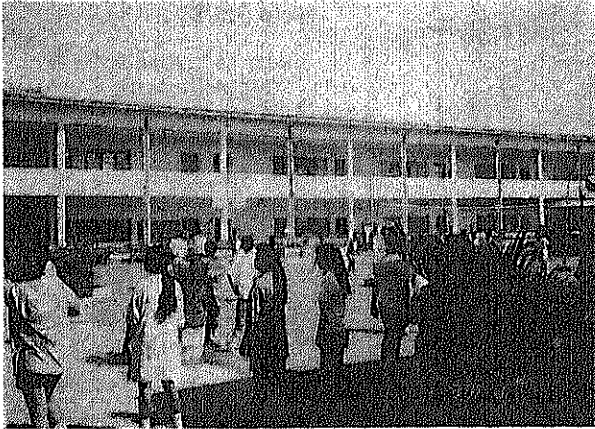
Photo 7.6.66

Name of the building:
Pasay City East High School

Damage conditions:
Cracks at the block walls.

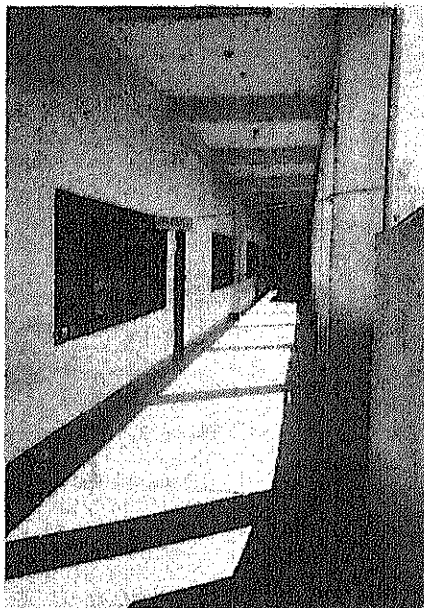
Photo 7.6.67

The RC columns for strengthening
after the earthquake in 1974 are
projected from the wall surface.
