3.4 Present Condition of Coyolar Dam

3.4.3 Present Condition of Coyolar Dam

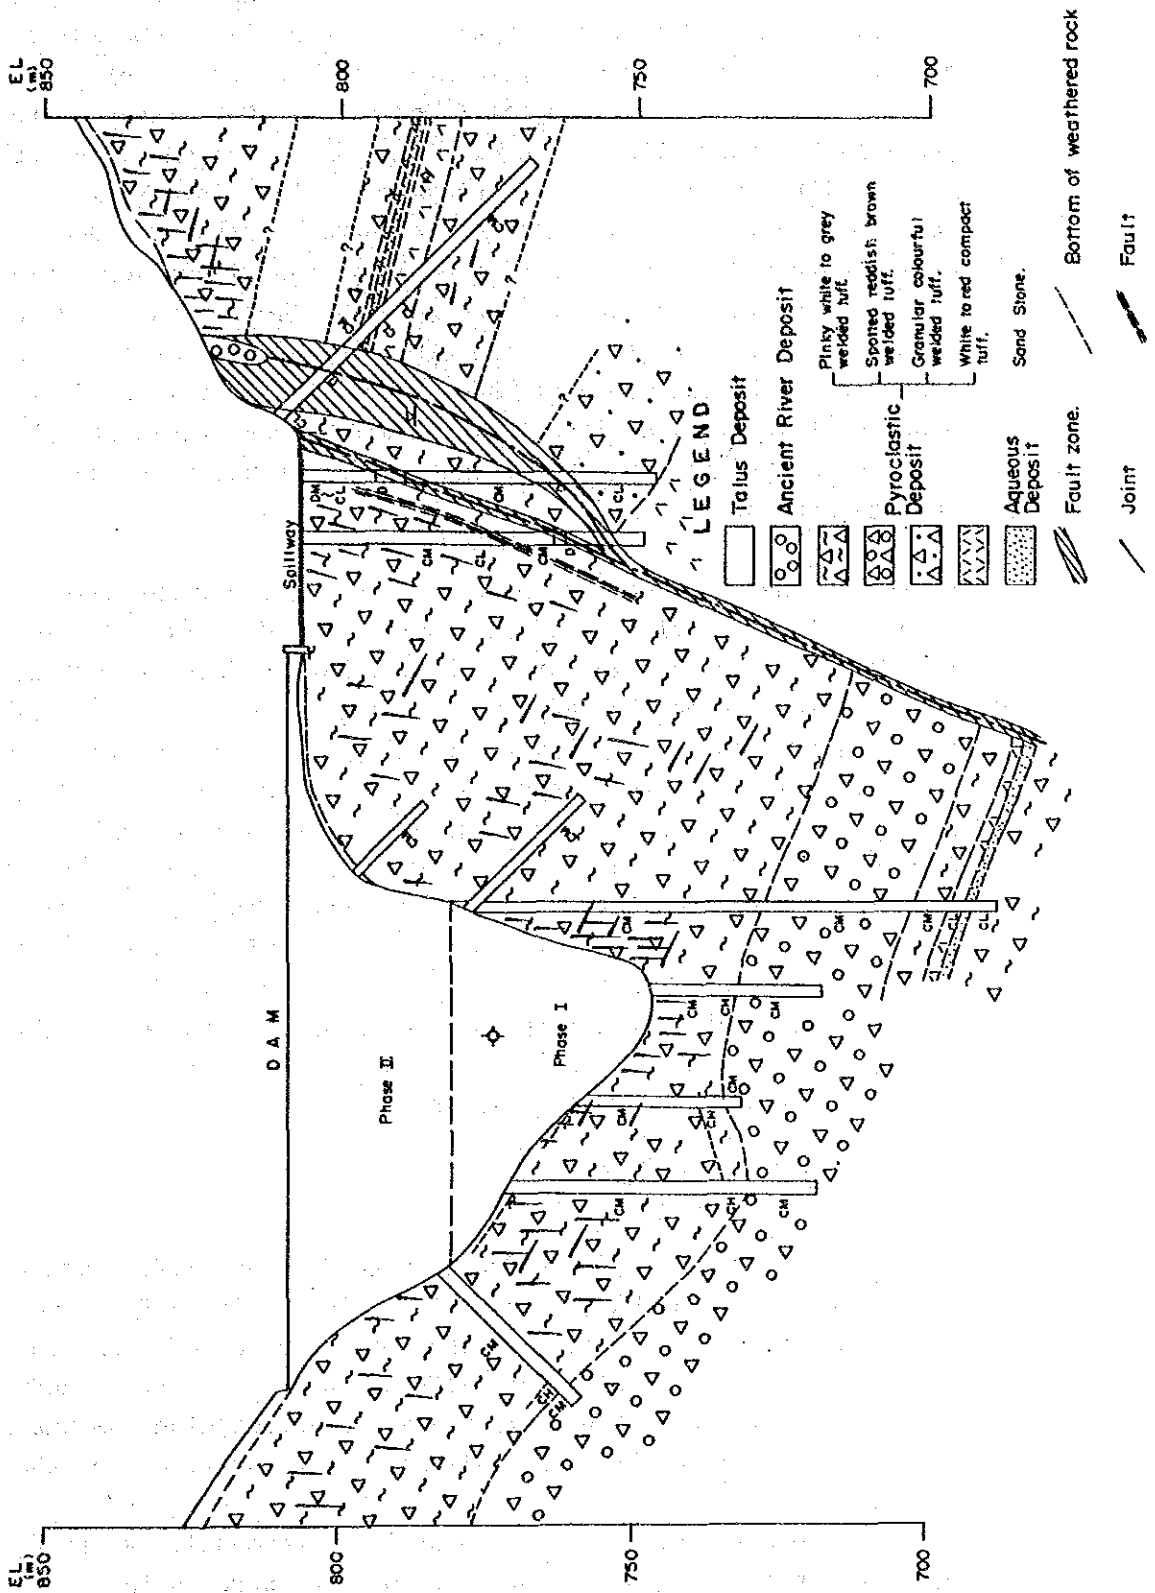
Fig.3.4-4 Geological Profile along Dam Axis

Fractures are found abundantly, consisting in two types: fractures formed as a by-product of a cooling process and tectonic joints. The first type is generally composed of welded tuff, specially columnar joint in the walls of both margins composed of welded tuff of class CH. They have varying characteristics: some of them show 10 cm openings filled with clayish tuff or secondary minerals. They run east-west, northeast-southeast, north-south, northwest-southeast according to the order of apparition and with a vertical-semivertical inclination. The second type corresponds to a fracture running parallel to the direction of the fault with a scaled distribution. Some of them show a lineal cove 1-2 mm wide sometimes filled with clayish stuff. These cracks may be closely related to the water leakage at the foundation and can be the cause of landslides.

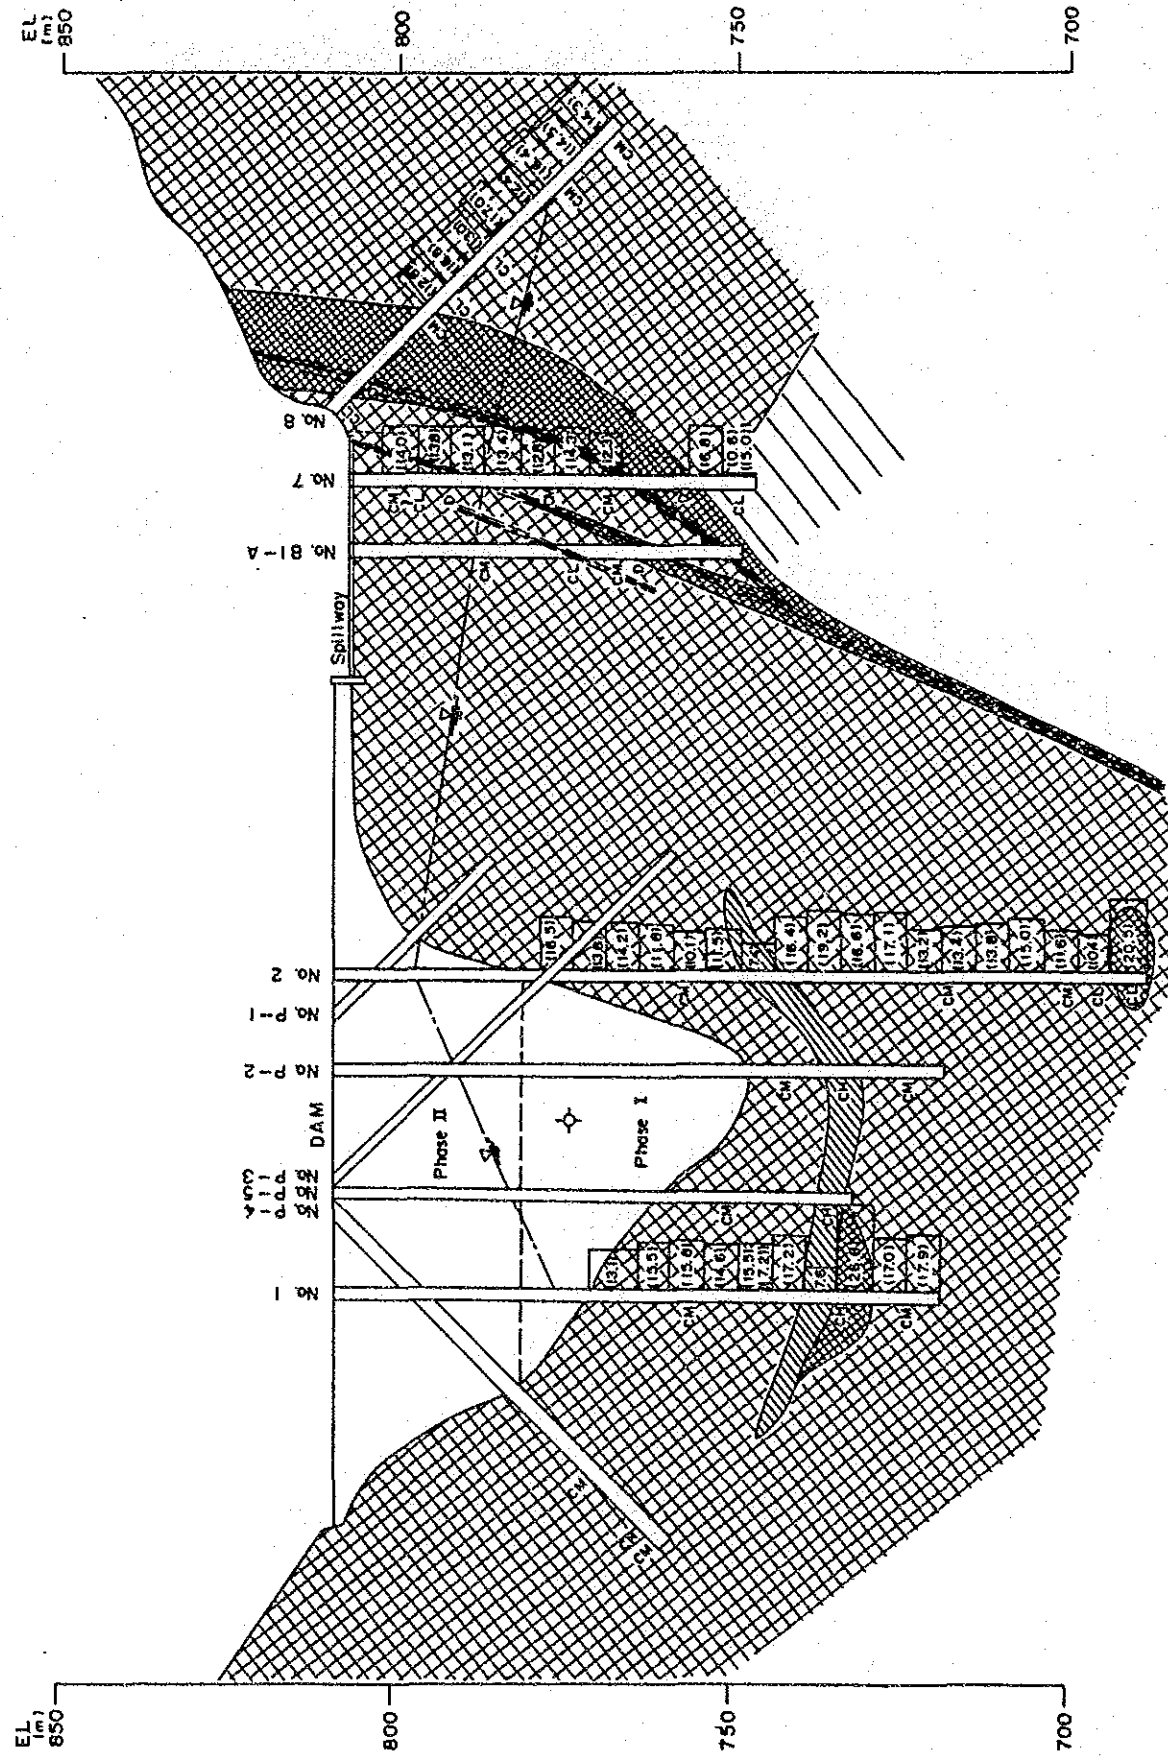
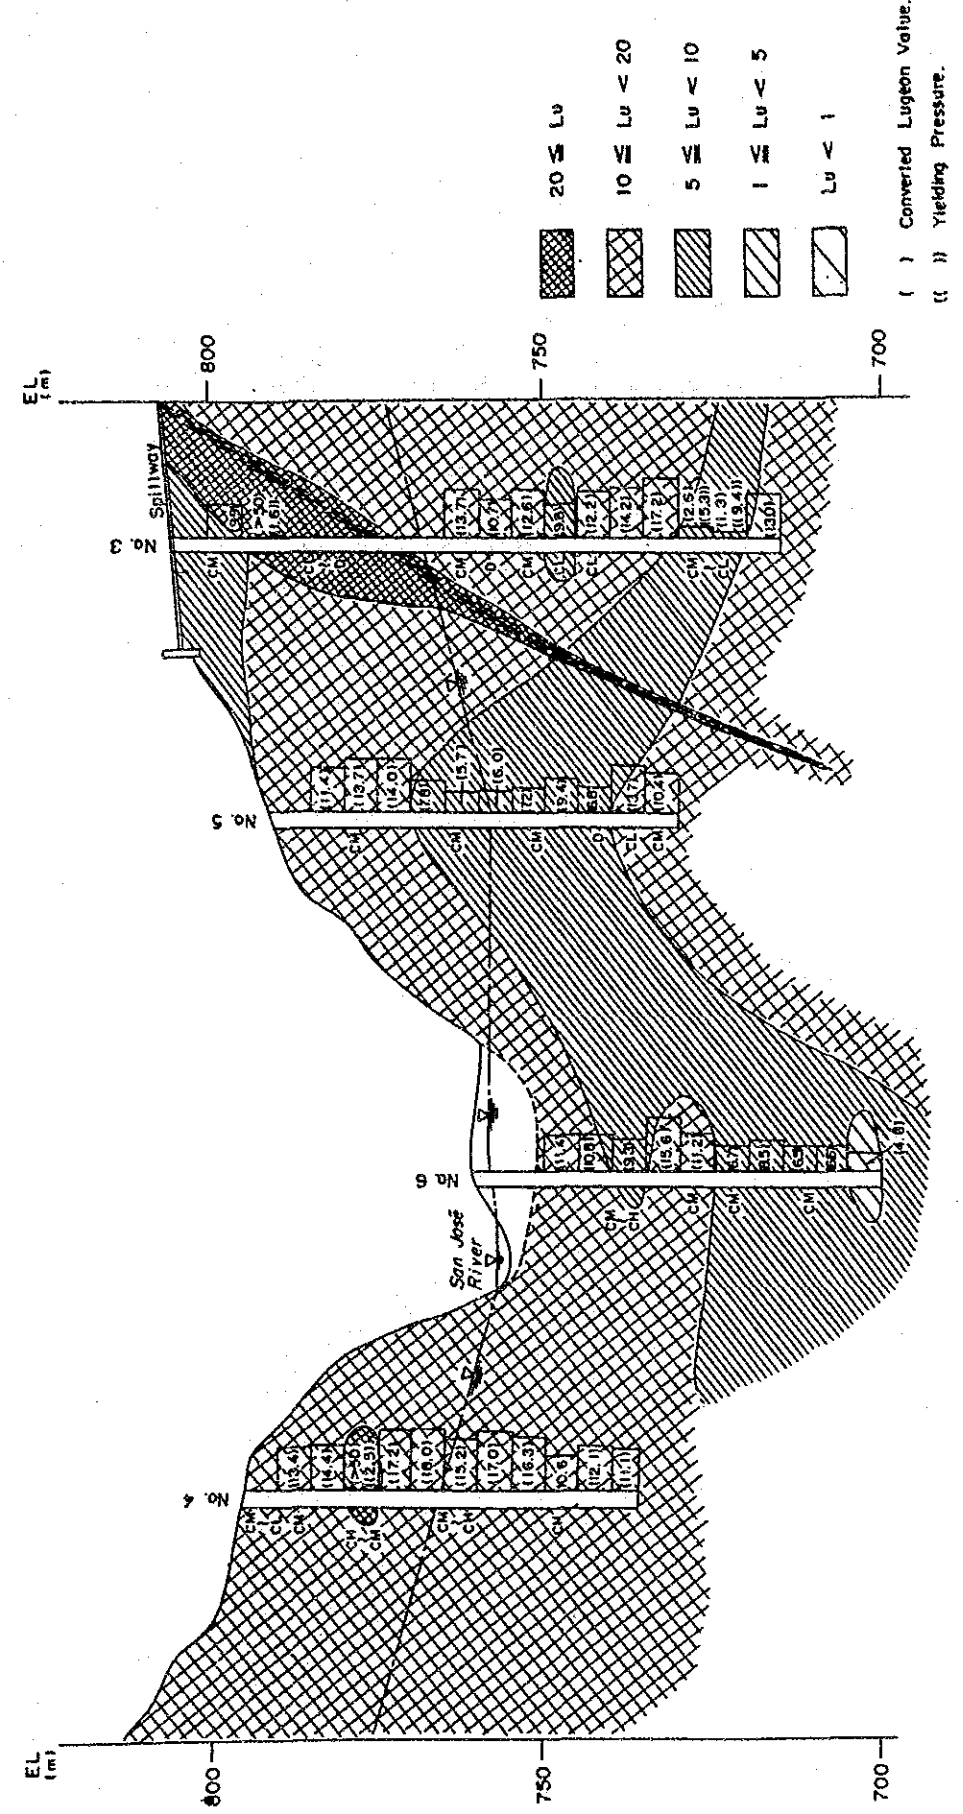
Fig. 3.4-5 Lugeon Map

The Lugeon values for the foundation vary between 10 and 20 which make it classifiable as a semi-permeable foundation. These values come from diaclasses or fractures presented at the foundation. There is not variation by depth.

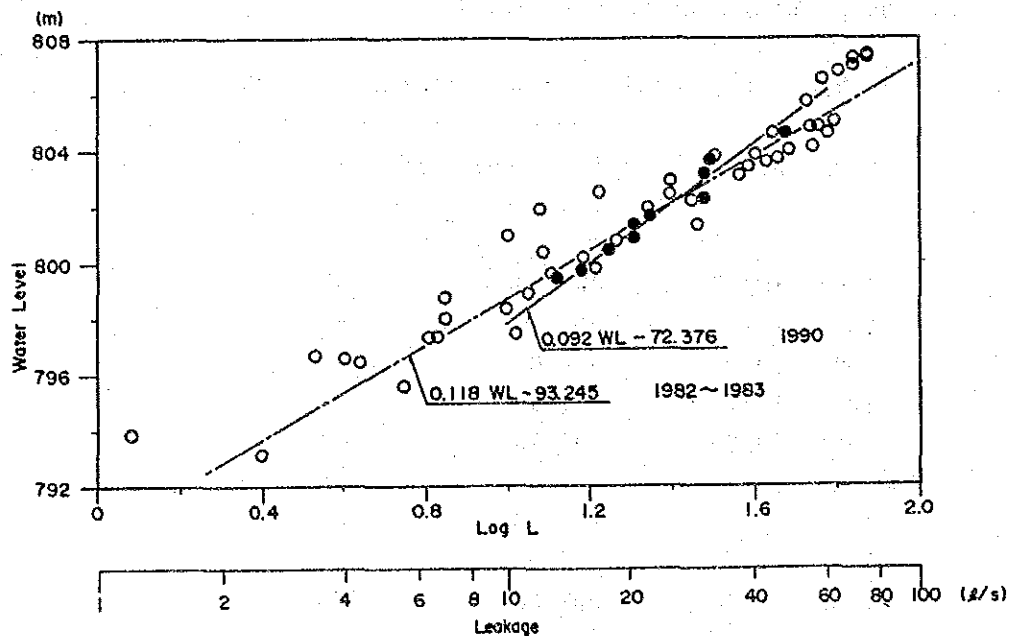
Fig.3.4-9 Relationship between the Water Leakage and Water Level of the Reservoir

The leakage from the crack of foundation rock and joins is one of the serious problems which the Coyolar Dam involves. Four leakage points are located near the contact part with Dam and rock between 30 m and 40 m from the left edge of the Dam. One of them is through a continuous crack about 1 cm wide, however leakage is weak. The largest

leakage is located about 37 m from left edge of the dam (El.794.0 m: below 15 m of the crest). This leakage might be from rock mass deeper than the contact line. These leakage water flow into the canal which was constructed as bypass canal during the construction and measured by notch (it is around 80 l/sec). Fig. 3.4-9 shows the measurement of leakage for 8 months in 1982 and in 1990. The figure shows good correlation between leakage and water level of the reservoir. Comparing the measurement in 1982 and this year, no change of leakage behavior is noticed.

The other type of leakage is found at the border limit of the Phases I and II. As in the former case, the leakage flow lowers when the water level of the reservoir is also reduced.

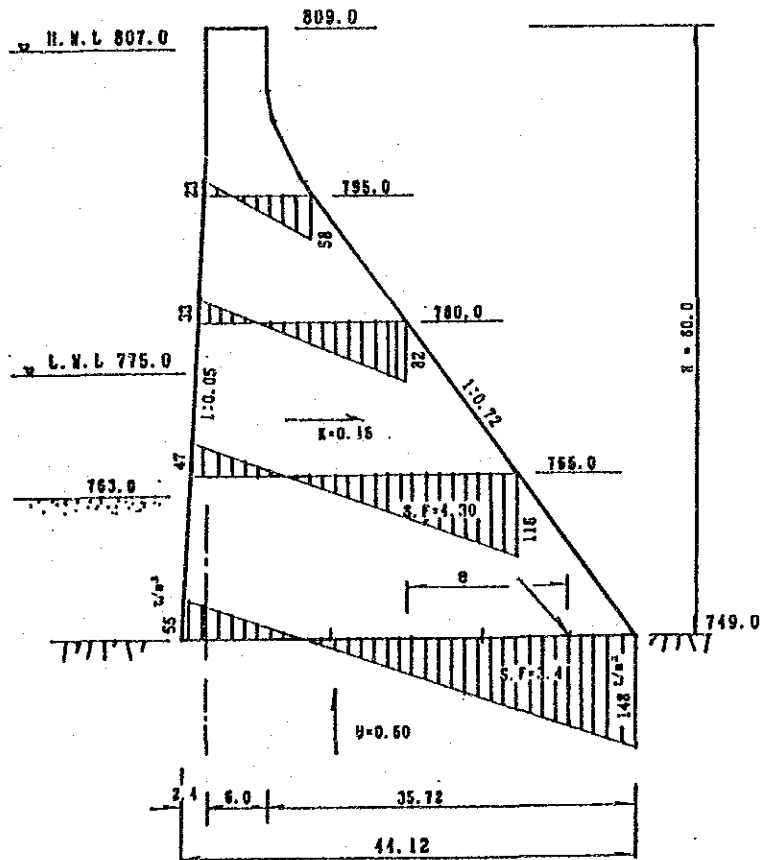
Fig.3.4-10 Calculation of the Present Dam Stability

It is important to take into account the seismic factor for the construction of a dam. The uplifting coefficient can be a value above to the one shown above. Based on the condition of the foundation and the available results of the grouting tests. The unitary weight of the Dam body is of 2 ton/m³ according to the results of the Dam body mechanics test.

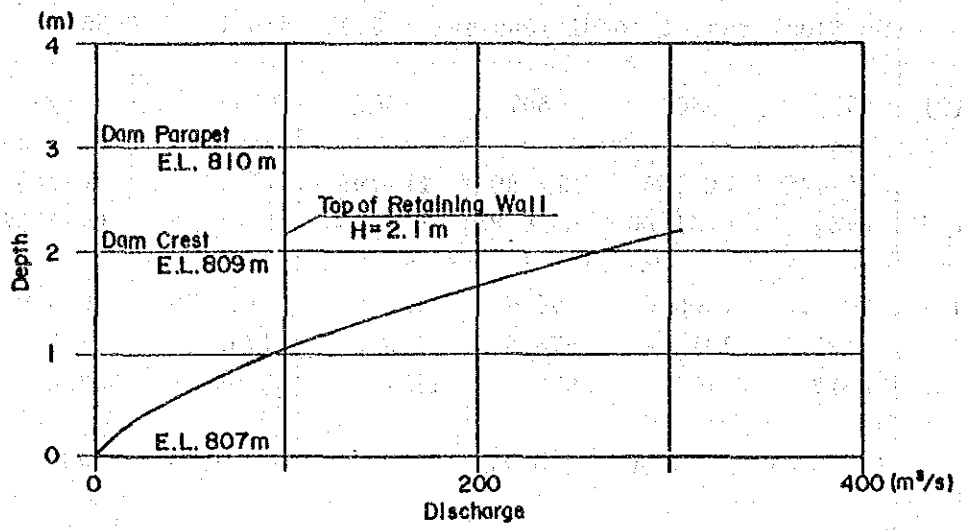
Fig.3.4-11 Discharge Capacity of the Spillway

The present spillway has a design flow capacity of 288m³/sec and specific discharge of 1.5m³/sec/km². According to the tentative calculation of the cross section of spillway, it is possible to flow this discharge (Fig.3.4-11). However, there are a noise as a product of the negative force due to a small flood and possibility of overflow beyond the guide wall. Judging from these facts and foundation condition, the structure can not be guaranteed even the case of flood of design flood discharge.
