## 7.5 Mechanical/Electrical Facilities and Instrumentation

### 7.5.1 Mechanical Facilities

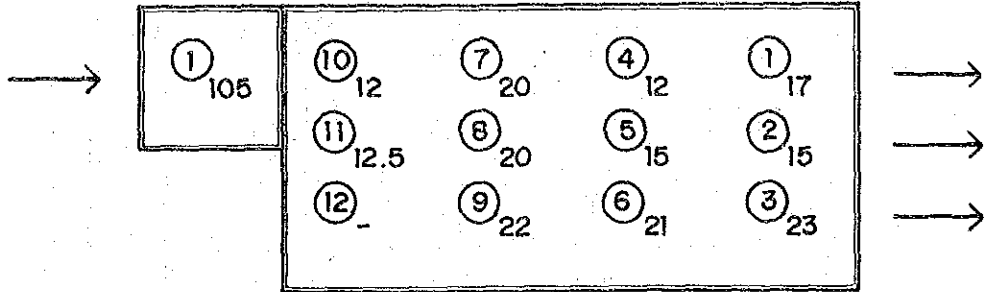
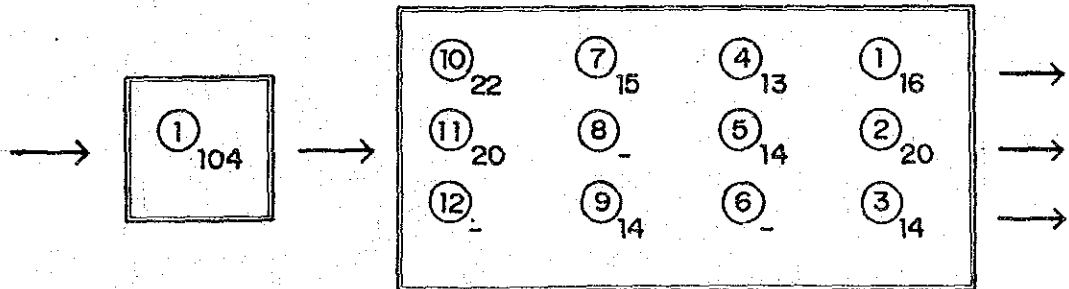
Fig. 7.5.1

The rapid mixers and twelve flocculators in Sedimentation Basin No. 1 & No. 2 were installed respectively in 1981, however at present, they are deteriorated. The shafts of the rapid mixer has been revolving eccentrically due to the length of shaft and the rapid stream flowing in the channel. Four flocculators out of the twenty four units have

no motor due to burn-out as a result of voltage fluctuations. Actual operating conditions are shown in Fig. 7.5.1. Although flocculators have variable speed gears, they are not properly adjusted to make good flocculation by reducing mixing speed gradually.

RAPID MIXER - 1	FLOCCULATOR - 12
DESIGN :	104	13.2 - 34.2
ACTUAL :

DESIGN :	4.5	0.6 - 1.5
ACTUAL :	4.5	0.53 - 1.0

RAPID MIXER - 1	FLOCCULATOR - 12
DESIGN :	104	13.7 - 34.2
ACTUAL :

DESIGN :	45	0.6 - 1.5
ACTUAL :	4.5	0.57 - 0.97

OPERATING CONDITION OF  
FLOCCULATORS IN PLANT NO.1

It is recommended to arrange the rotation speeds of flocculators as follows:

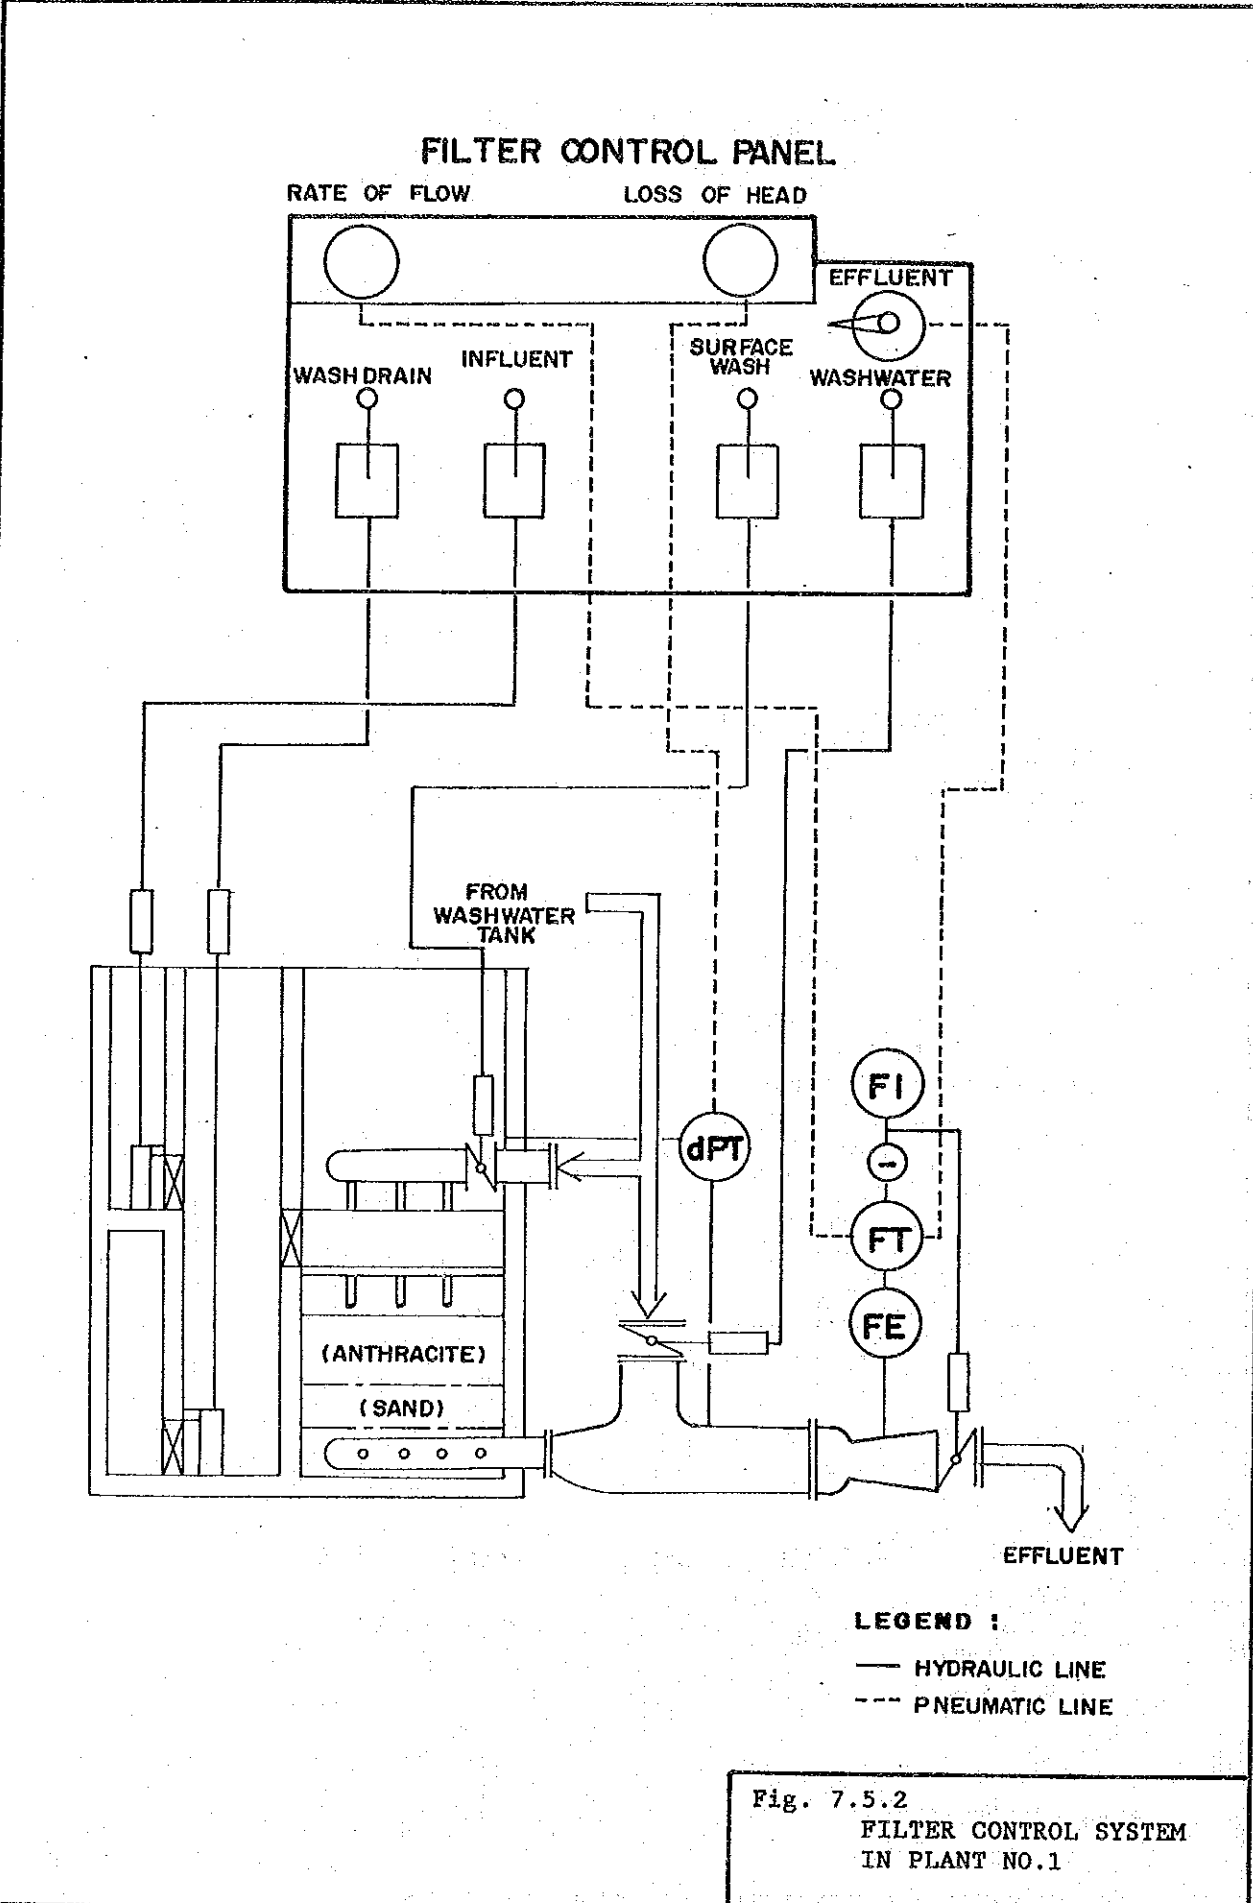
Fig. 7.5.2  
 FILTER CONTROL SYSTEM  
 IN PLANT NO.1

The flow control equipment, as shown in Fig. 7.5.2, which is comparatively fragile and complicated, is located at the basement of the Filter Building where the atmosphere is very humid. Because of these conditions the said equipment had easily deteriorated as well as the air compressors and hydraulic control equipment.

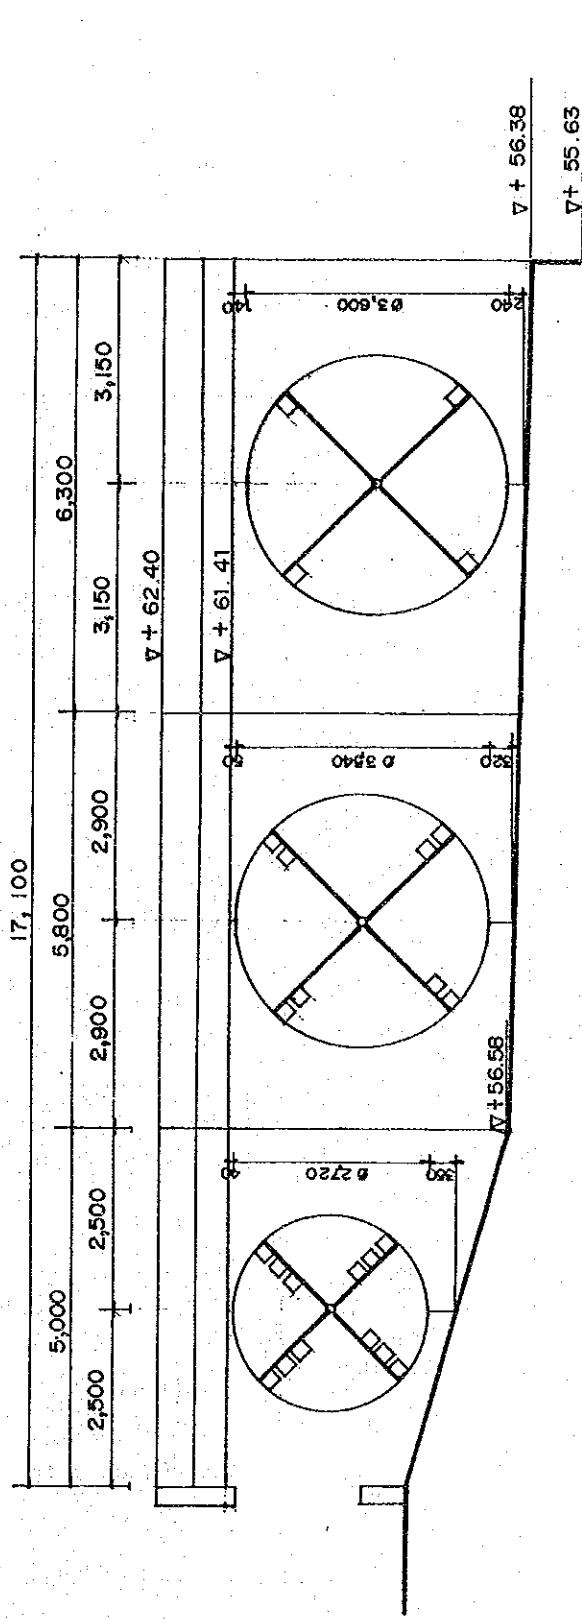
Fig. 7.5.3  
ACTUAL OPERATING CONDITION OF  
FLOCCULATOR IN PLANT NO.2

Flocculators' parts have been replaced (sprocket wheels, chains, paddles, etc.) since their construction in 1965/67. The entire flocculators are now deteriorated, particularly the driving units and bearings (gland packings) which have excessive leakages. Actual operating conditions of flocculators are shown in Fig. 7.5.3.

ACTUAL	1ST	2ND	3RD
REVOLUTION (RPM)	283	212	212
PERIPHERAL VELOCITY (M/SEC)	0.4	0.39	0.4

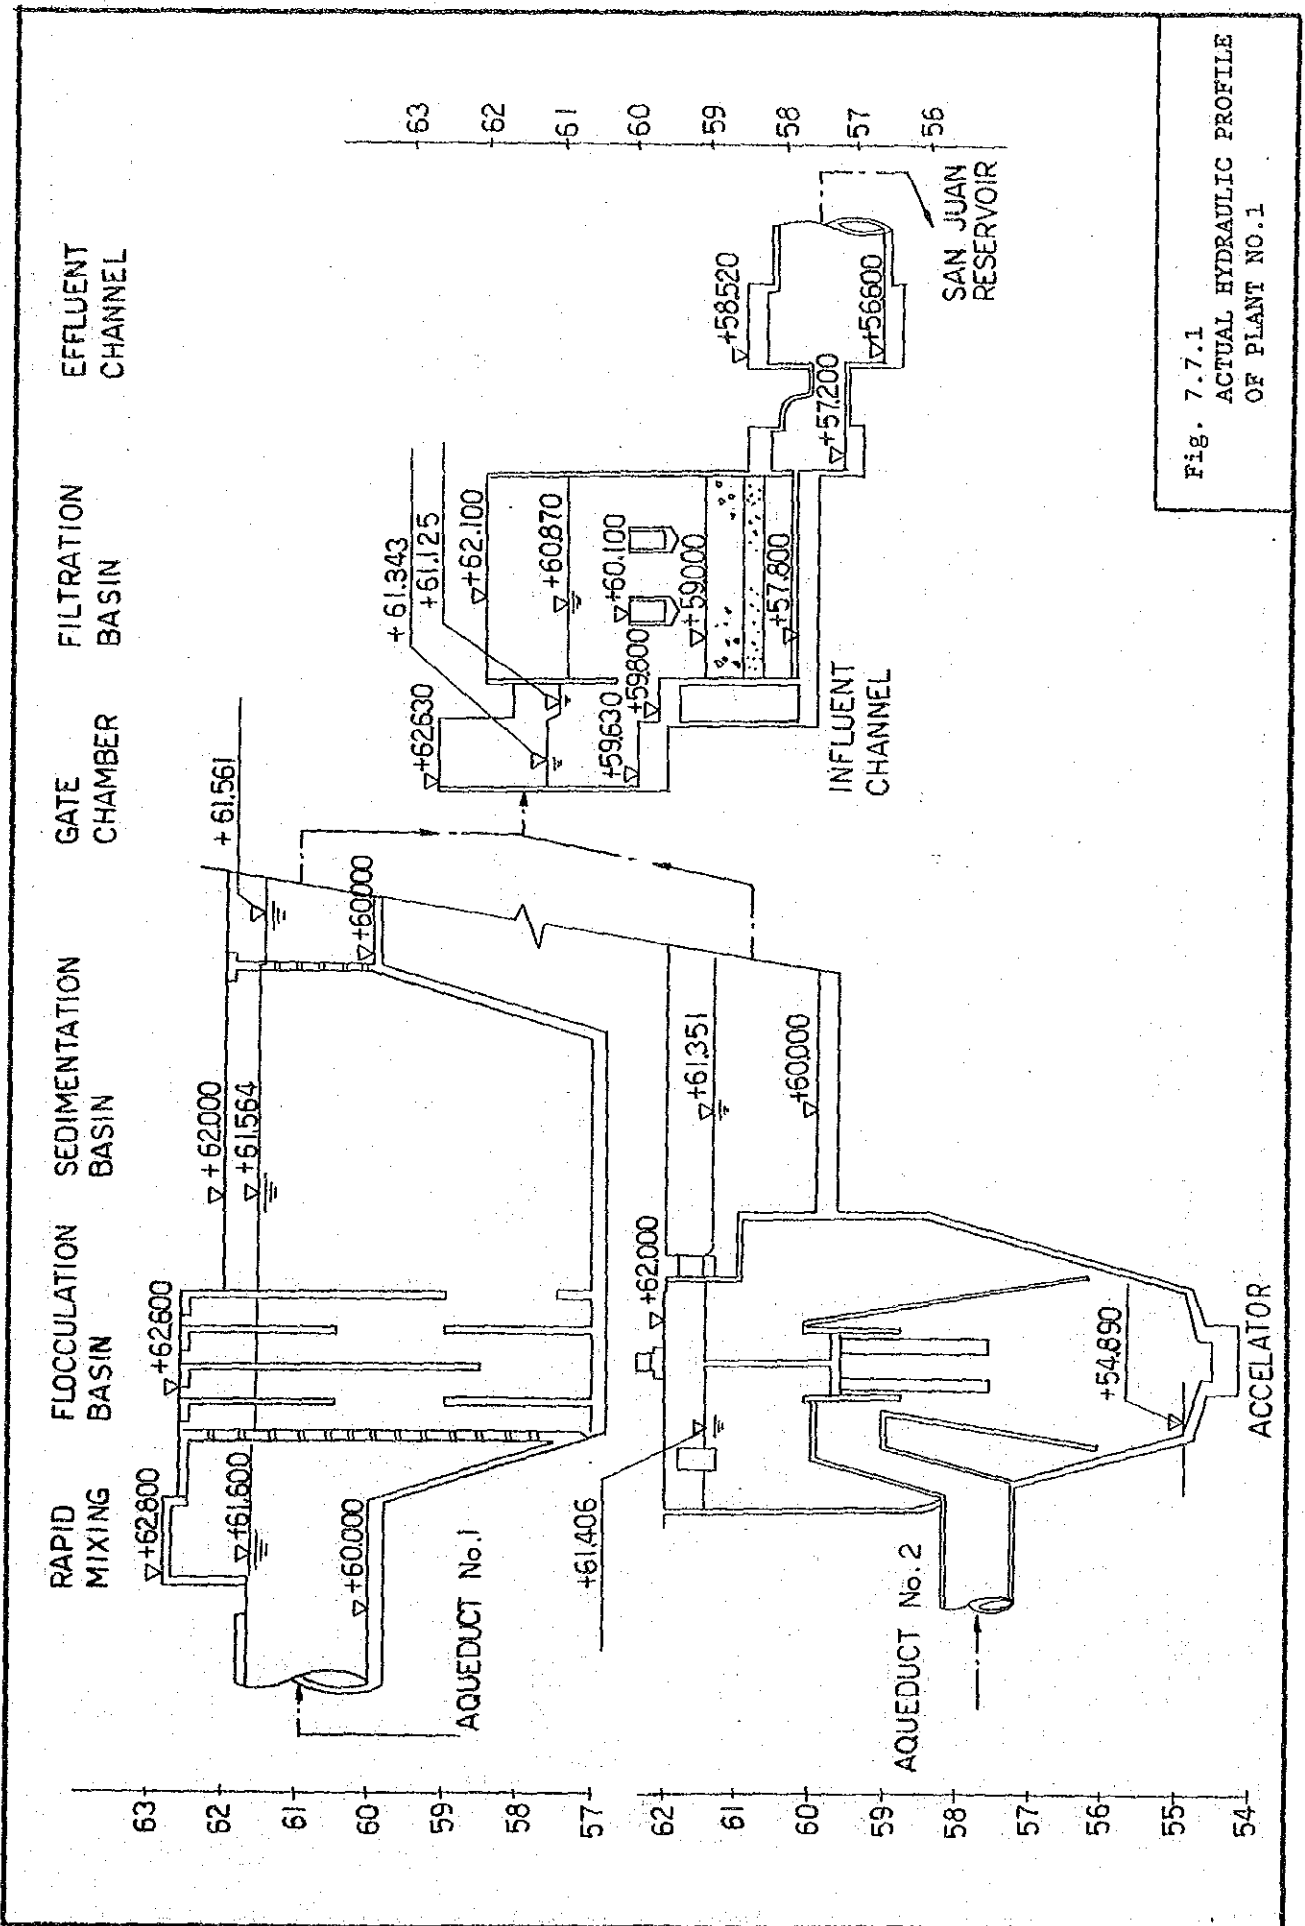
Fig. 7.7.1  
ACTUAL HYDRAULIC PROFILE  
OF PLANT NO.1

The designed filtration process is a system of constant-rate filtration using a rate-controller installed at the effluent line. At present, due to superannuation of rate controllers, filter beds are operated as declining-rate filtration system. Washwater drains through washwater trough, washwater gullet, washwater drain sluice gate, and washwater drainage channel. Hydraulic capacity of a series of washwater drain system of Plant No. 2 is observed to be insufficient so that washwater troughs are submerged and not functional during backwash.

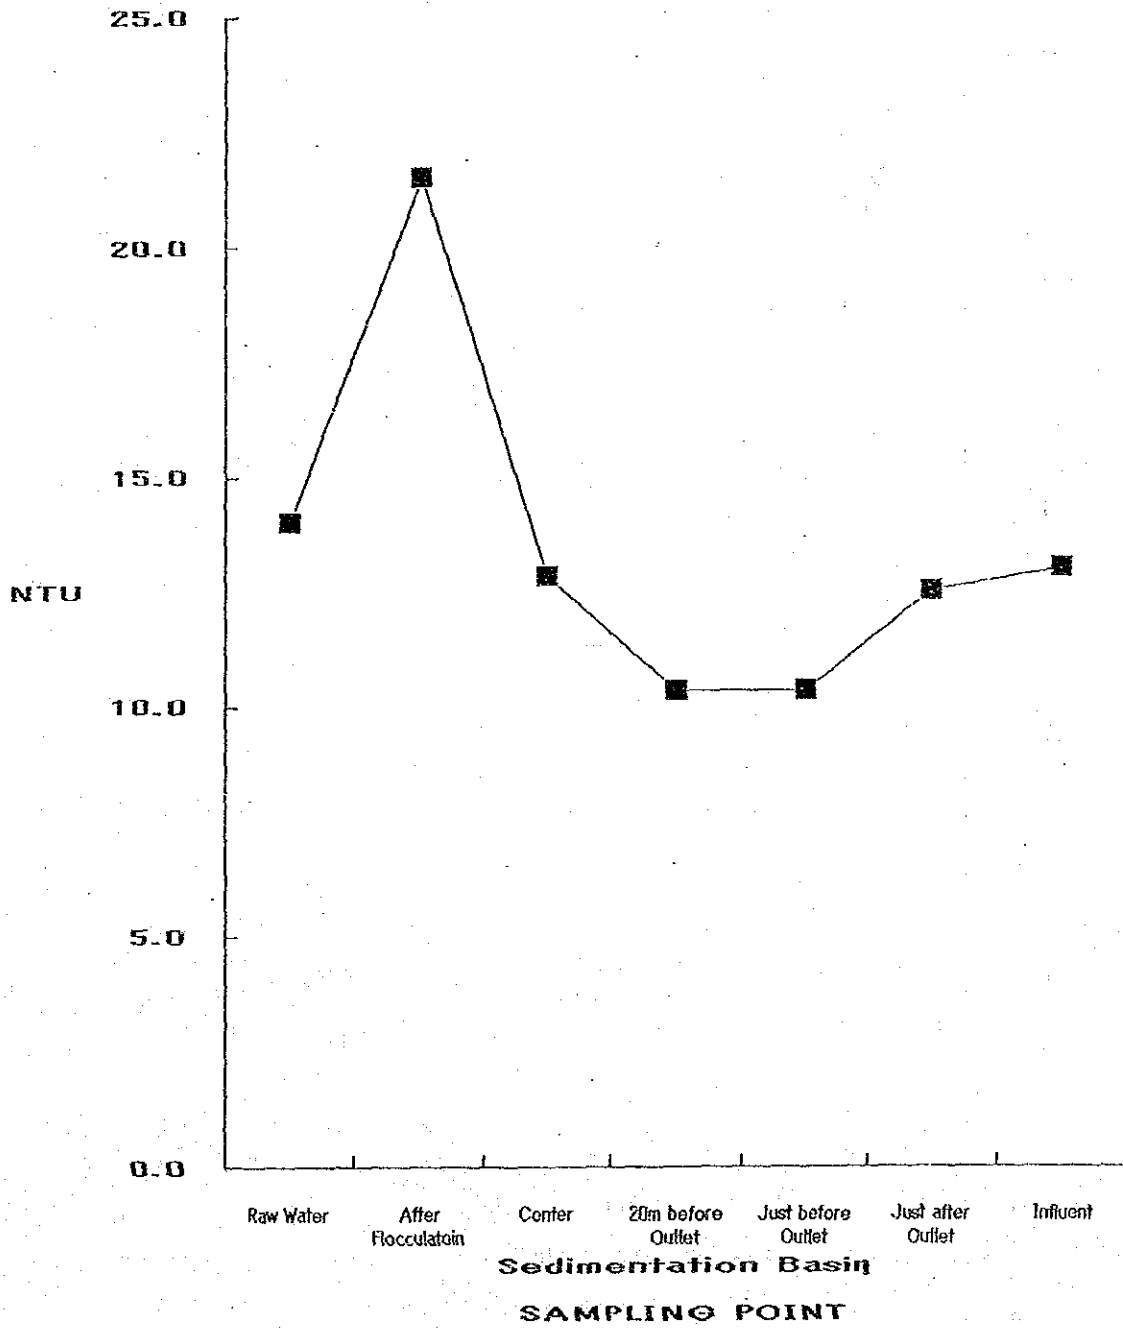
Fig.7.8.1  
TURBIDITY IN SEDIMENTATION  
BASIN IN PLANT NO.1

Turbidity removal  
in sedimentation  
basin of plant No.1  
Basin 1 Process Water  
DATE 10/08/1991

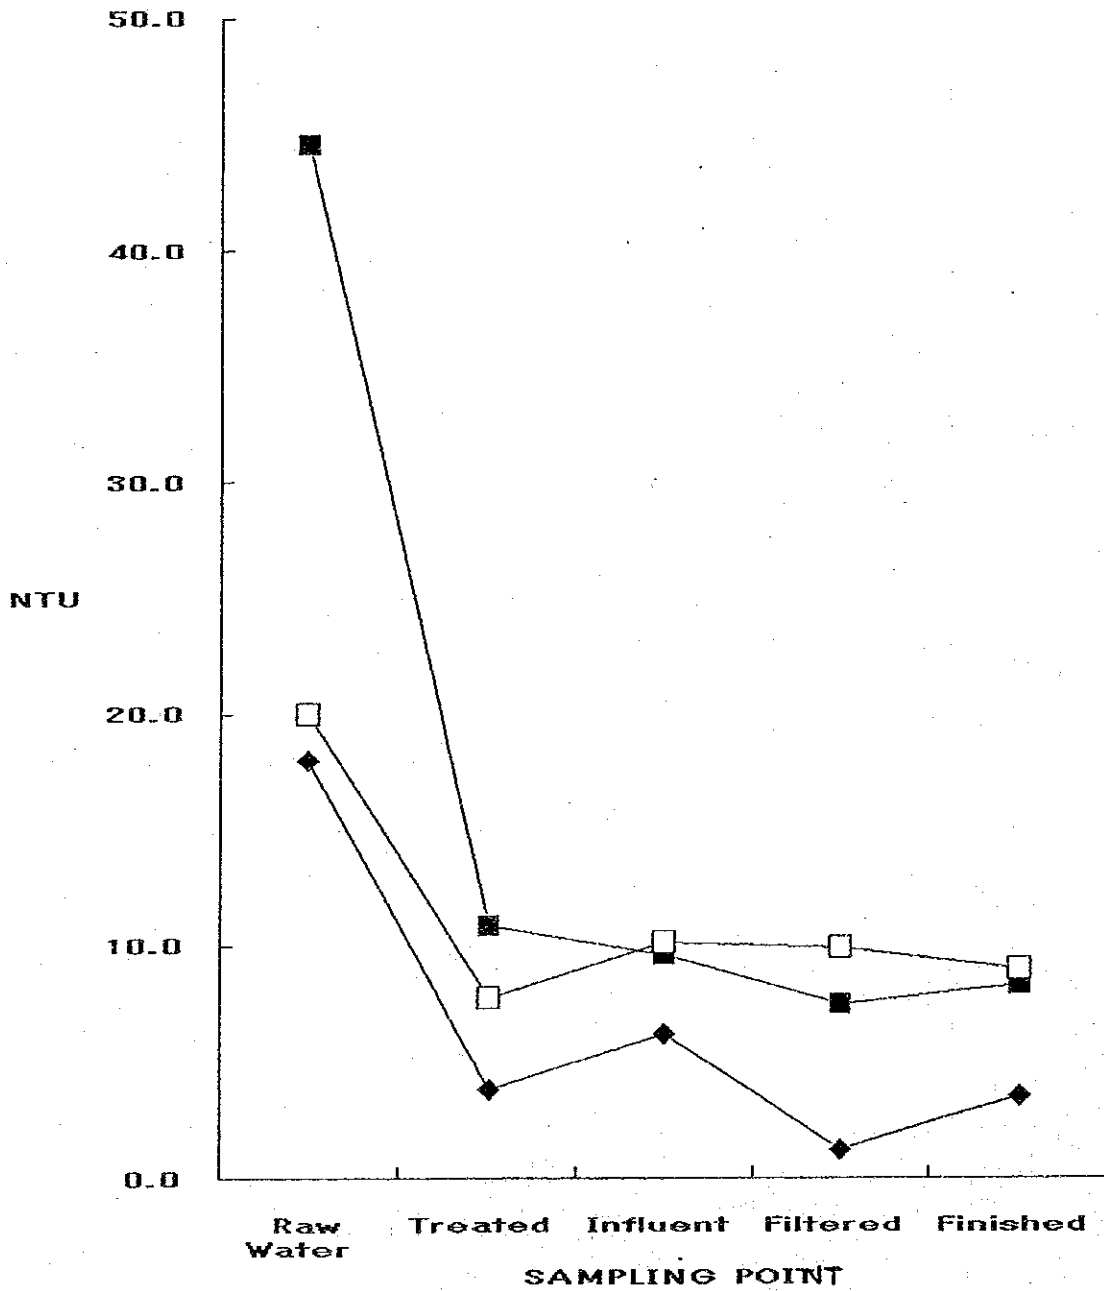
Fig.7.8.2  
TURBIDITY IN SEDIMENTATION  
BASIN IN PLANT NO.2

Turbidity removal  
in sedi mentation  
basin of plant No.2  
Process Water
