4.1.2 Geotechnical Investigation

4.1.4 Study on the Present Condition of Tunnel Deterioration

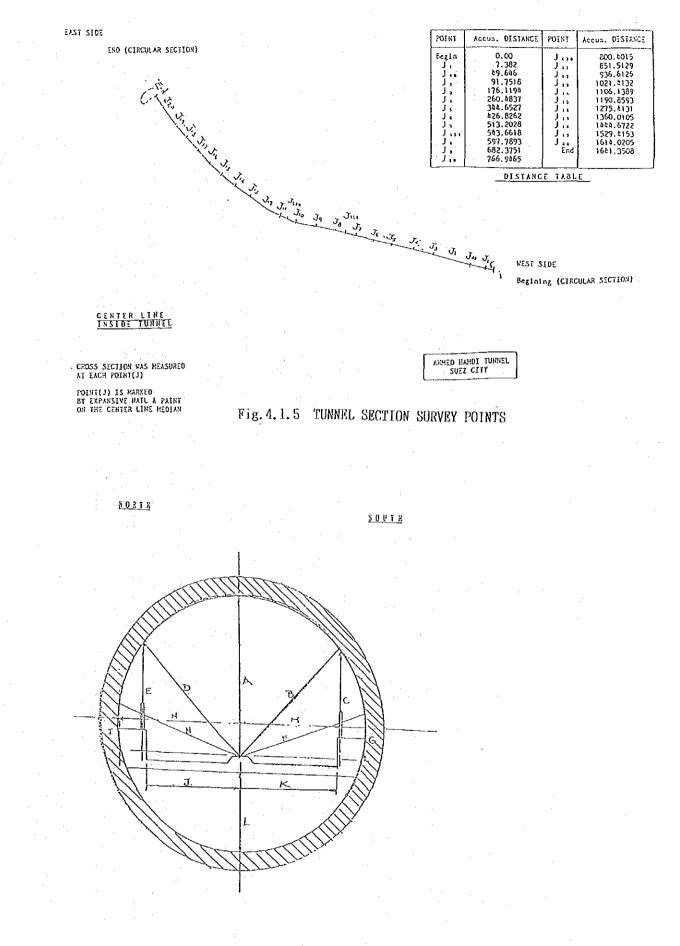
Fig. 4.1.6 DISTANCE MEASURE LINES A-N

Survey results of each section are shown in Table 4.1.5. The difference compared with the segment ring radius of 5.200m was considered to be the deflection of the Tunnel, and the survey results of B,D,F and H were converted to the lengths from the ring center which is shown in the Table 4.1.6.

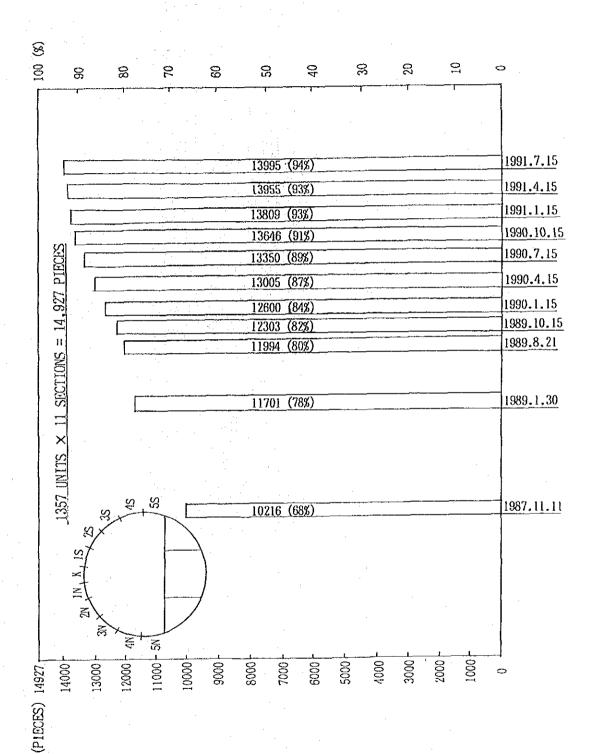
Crown Observed by S.C.A. Tunnel the Segment with Cracks in чч О Fig.4.1.7 Number

- The deterioration of the concrete segment such as carbonation of concrete, and cracking and chipping of concrete, and cracking and chipping of concrete slice due to corrosion and expansion of the steel bar of the element are still going on in the same way as it was observed/recognized in February/March 1990 (ref. in Final Report of May 1990).
- a. According to the previous 4 years records by S.C.A., cracking and chipping of concrete slice were found for approximately 94 percent of the concrete segments of the tunnel crown, which is much higher than that of the deck (in total 14927) as shown in Fig. 4.1.7. So, it is no longer practical to repair the Tunnel partially.

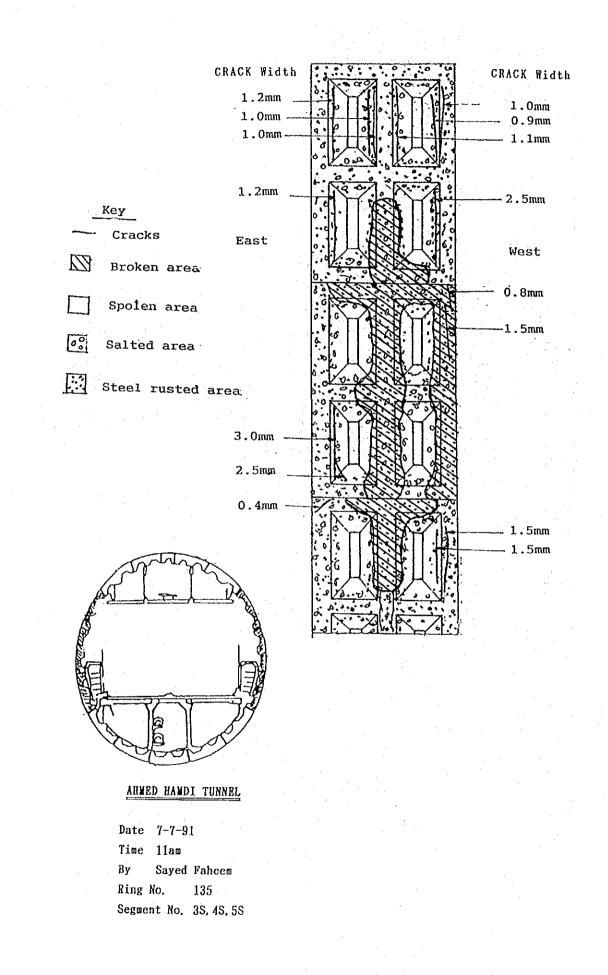
Fig. 4.1.8 Deteriorated Typical Sample on the Segment

Furthermore, further deterioration of the concrete segments located approximately 200m from both end of the tunnel entrances were observed in this field survey.

For instance, in Fig. 4.1.8, the surface concrete of the segment No.1232(4S) at the Tunnel's south side 200m from the east entrance, has been spalled with concrete with a maximum of 5cm in thickness at the rib and disappeared the reinforcing steel bar already at the same place.

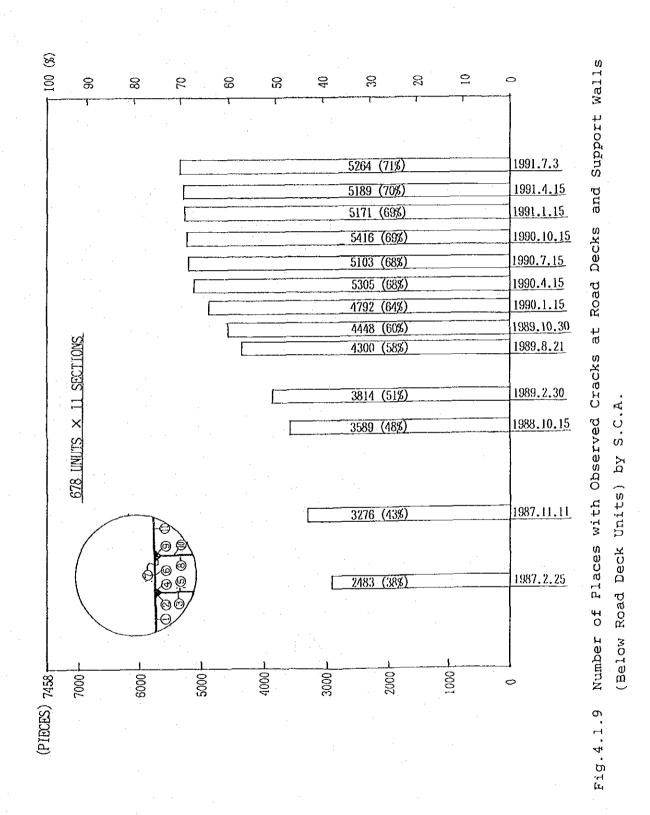
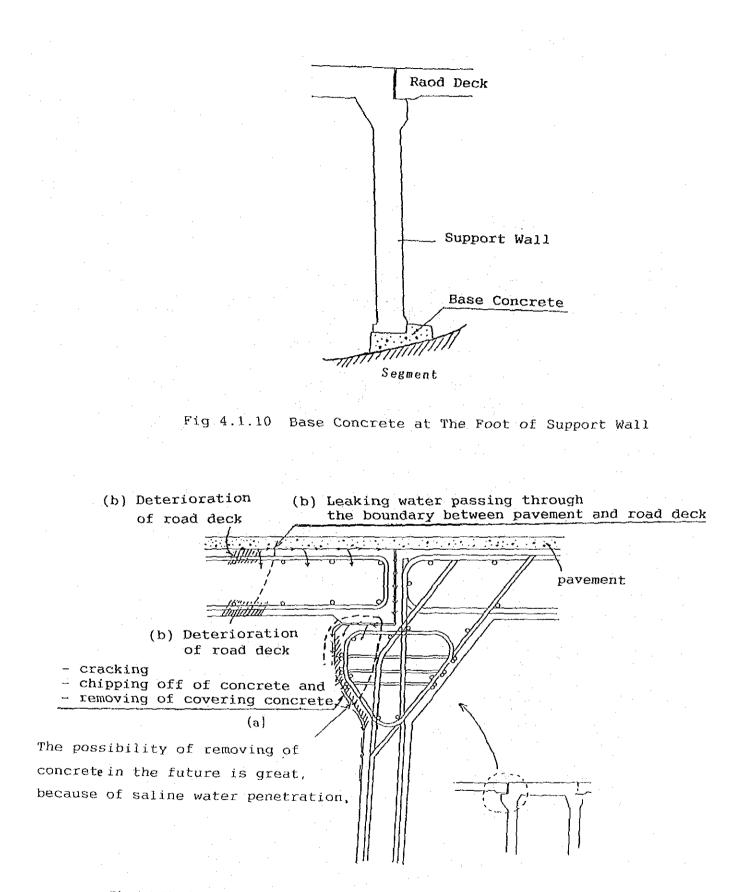
Fig. 4.1.11 Covering Concrete Damage at Road Deck and Support Wall

- The road deck and the support wall which are all precasted concrete have been damaged by the carbonation and deterioration, and this damage is still going on daily. According to the previous 4 years records by S.C.A., the deterioration is in the form of cracking and chipping of concrete slice with approximately 71 percents of the total 7,458 units (=678 units x 11 sections) as shown in Fig 4.1.9.
- Reduction of section area of some the reinforcing steel bar at the road deck by the deterioration/rusting has been found.

4) The support walls have been damaged approximately 70 percents the carbonation and salty water penetration especially in the Fresh Air Duct areas resulting in cracking, chipping off/spalling off and removing of covering concrete. Even though many partial repairs have been made for the damages, the phenomenon is still going on and it can be possible that the Road Deck supporting condition may be further deteriorated (ref. Fig.4. 1.11(a)).

The Safety for the Road Deck and the Support Wall is going down also for the following reasons. Therefore, it is recommended to all the related parties that the Rehabilitation Works should start as soon as possible.
