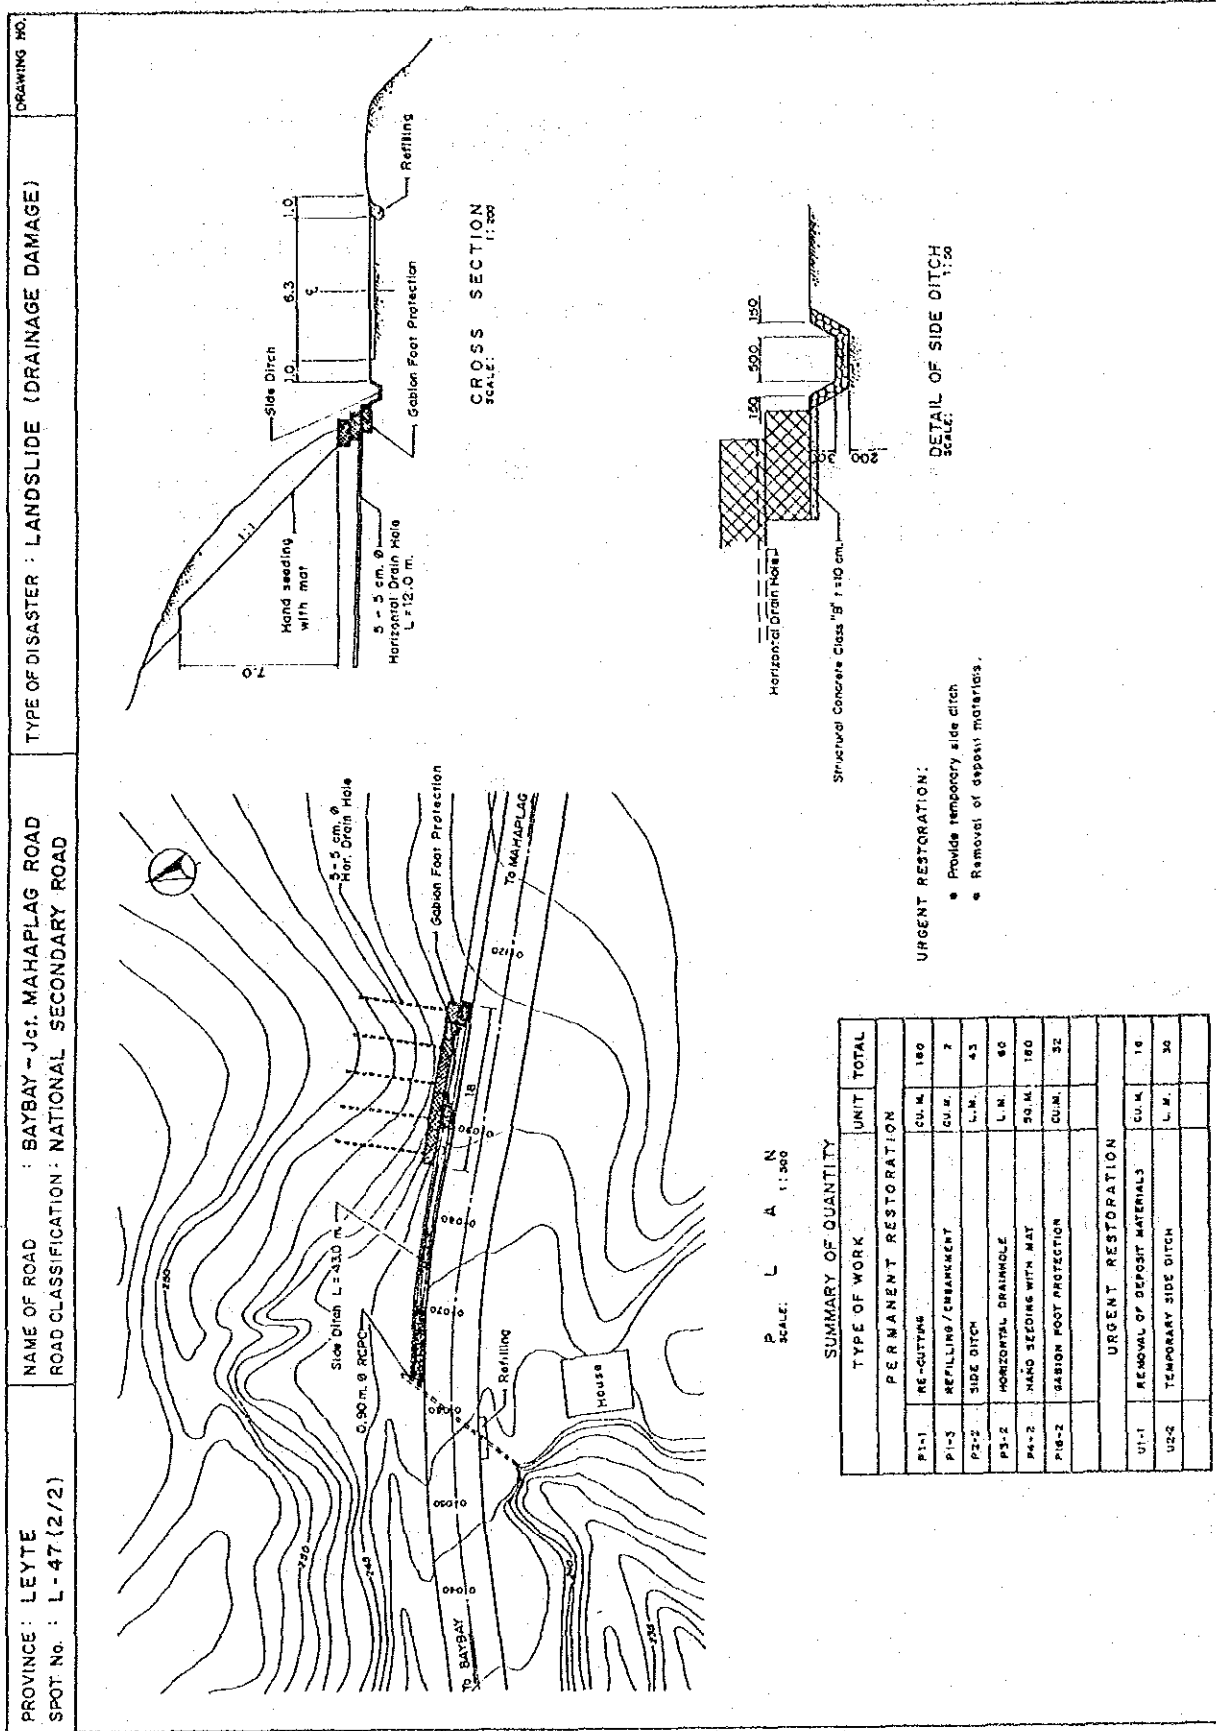
FIGURE 4-1 PROPOSED RESTORATION MEASURES (L-47)

Location	:	0.9 km from Km. Post 993
Road Name	:	Baybay - Jct. Mahaplag Road
Road Classification	:	National Secondary Road
Geological Condition	:	Soft Clay
Water Condition	:	Surface and seepage water from hinterland

On mountain side of the road, the evidence of landslide was found in 0.5 - 1.0 m high scarps along the sliding surface extending over about 40 m in length and 10 m in height. The side ditch on mountain side was displaced, damaged and clogged with soil about 40 m in length.

Potential cause is on hillside cutting in road construction, injuring a stability of the slope. Landslide was induced by decrease in shear strength of the earth due to rise of groundwater level during heavy rain.

Measures for stabilizing the slope by means of partial removal of sliding mass, groundwater drainage and foot protection to resist the sliding force were proposed as permanent measures for this spot. No alternative measures were proposed. The proposed measures include the following works (See Figure 4-1):

Proposed Measures		P u r p o s e
P1-1	Recutting	To remove partially sliding mass
P1-3	Refilling/Embankment	To repair shoulder along valley side
P2-2	Side Ditch	To prevent water from running on road surface
P3-2	Horizontal Drain Hole	To drain groundwater and thus lower its level
P4-2	Hand Seeding w/Mat	To protect slope from erosion
P16-2	Gabion Foot Protection	To increase resisting force against sliding movement

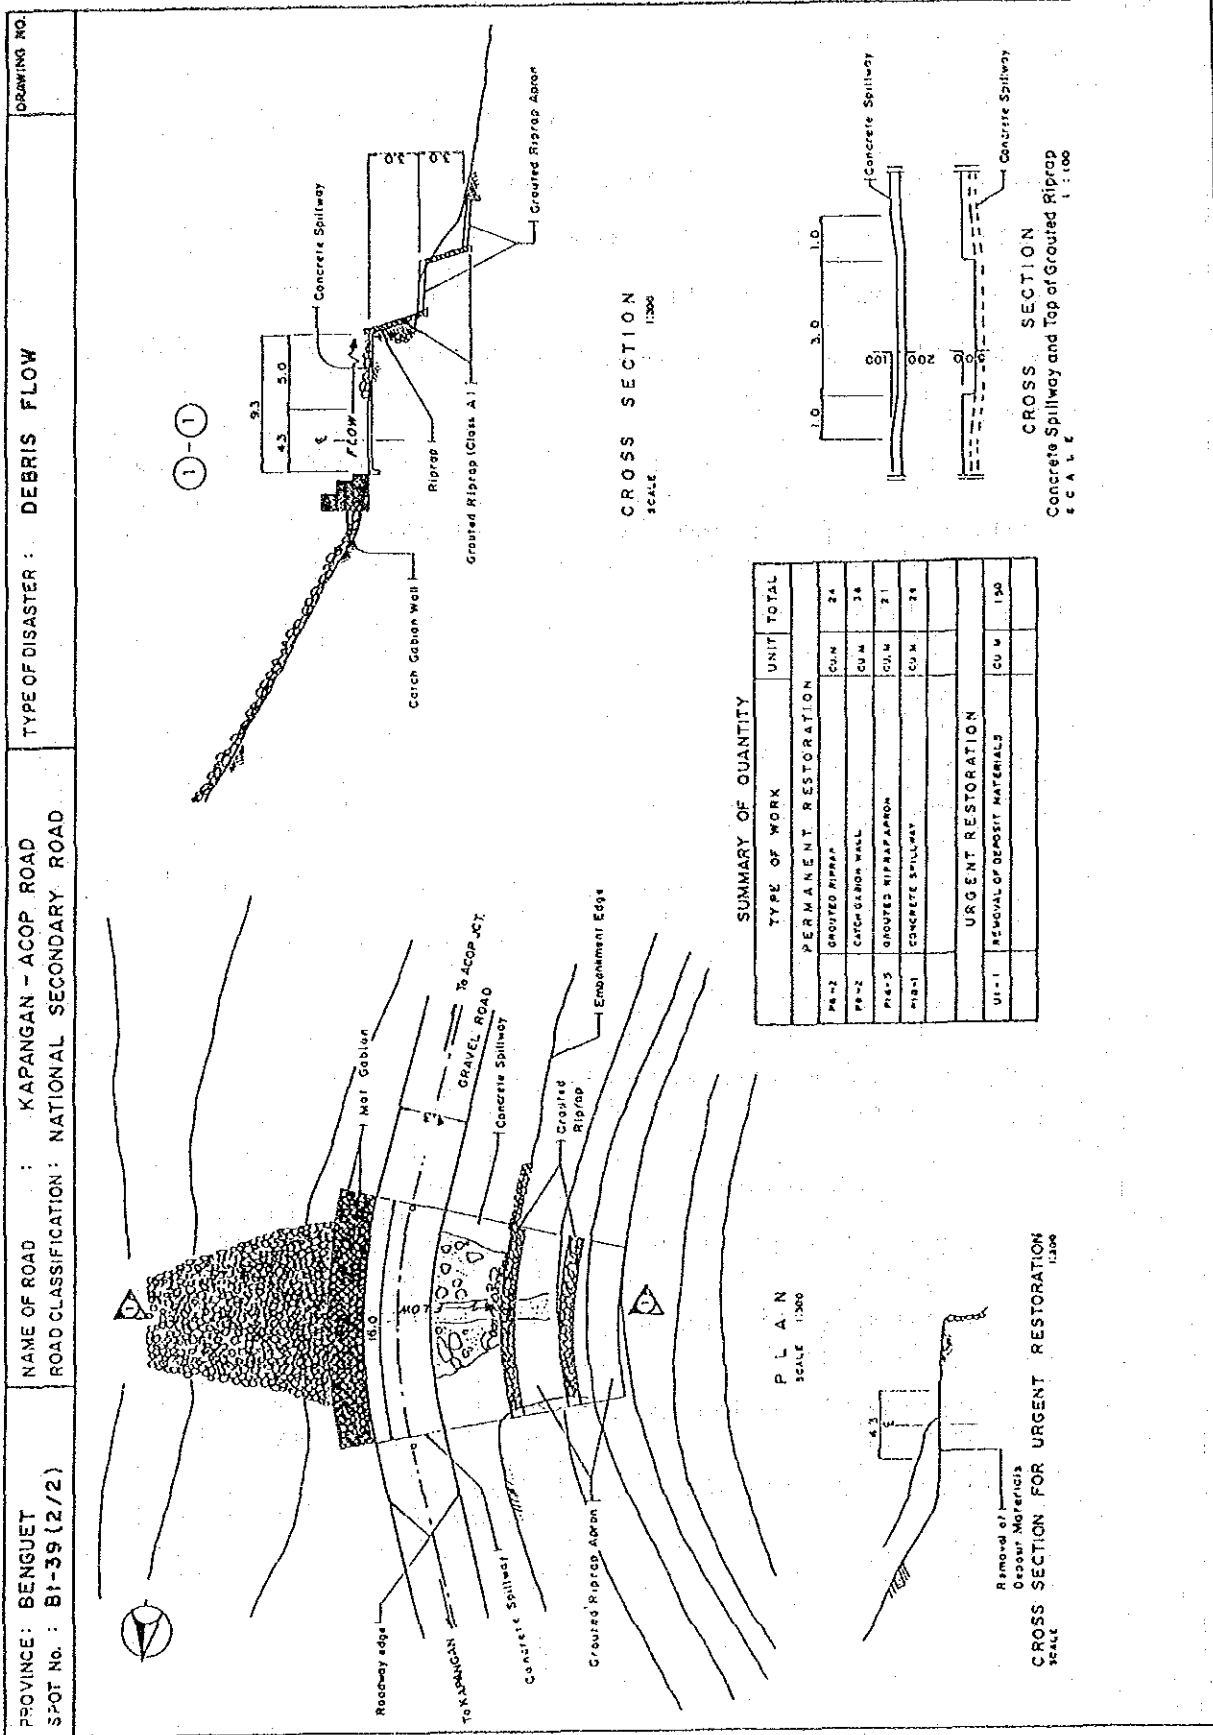
FIGURE 5-1 PROPOSED RESTORATION MEASURES (B1-39)

- Location : 15.2 km from Kapangan Municipal Hall
- Road Name : Kapangan-Acop Road
- Road Classification : National Secondary Road
- Geological Condition : Diorite
- Water Condition : Concentrated water from mountain

Rocks carried by the flow of water from upstream accumulate on the bed of ravine about 40 meters in length and 16 meters in width at the roadside. The deposit rocks often flow over the road during heavy rain. The riprap protecting the slope on valley side of the road is eroded by the water directly running thereon.

Debris flow was induced by the force of flow during heavy rain.

Catch work against debris flow, drainage work for surface water and protection work for valley side slope were proposed for this spot. No alternative was proposed. The proposed restoration measures are as follows (See Figure 5-1):

Proposed Measures		Purpose
P6-2	Grouted Riprap	To protect the slope on valley side of the road
P8-2	Catch Gabion Wall	To catch debris and to control flow of debris
P16-3	Grouted Riprap Apron	To protect the foundation of grouted riprap from scour
P18-1	Concrete Spillway	To regulate the flow of surface water and to protect road surface

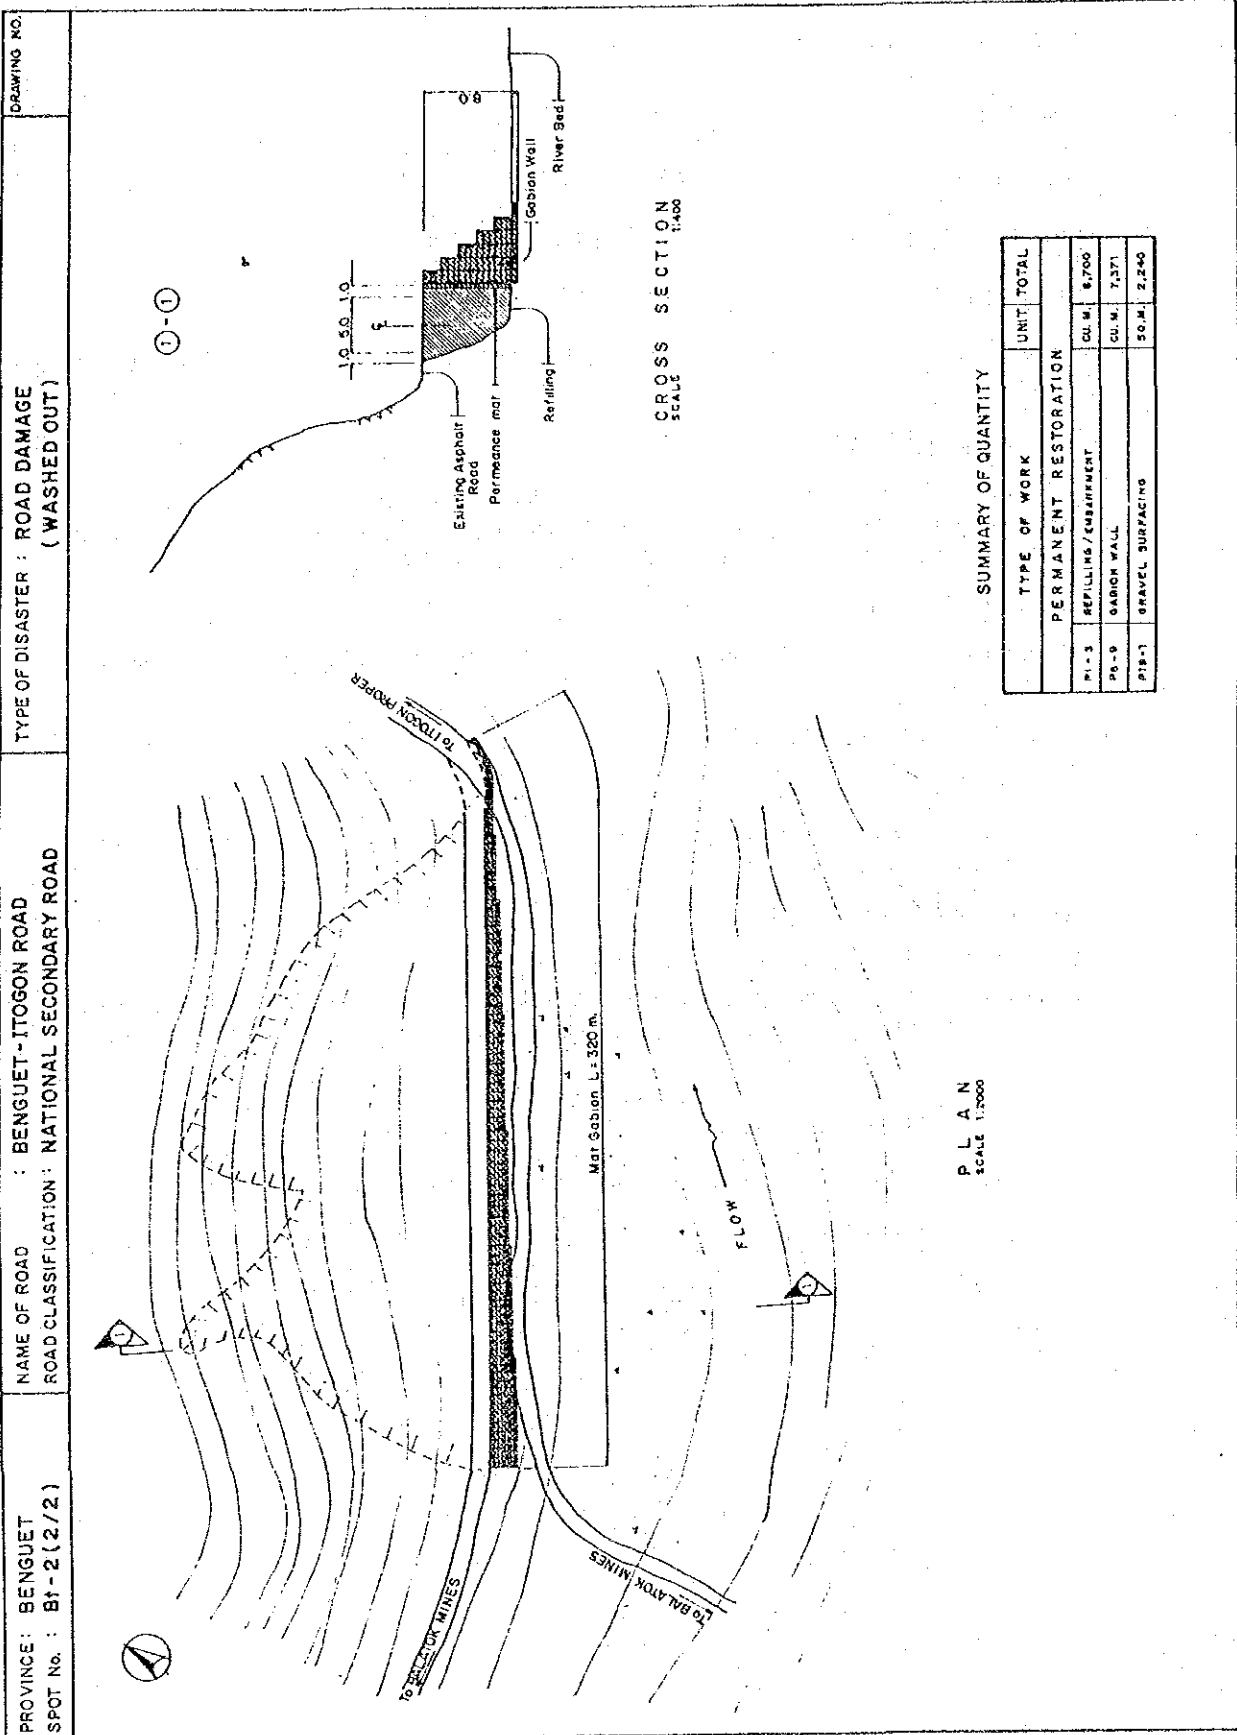
FIGURE 6-1 PROPOSED RESTORATION MEASURES (B1-2)

Location	:	0.3 km from Itogon
Road Name	:	Itogon - Balatok Road
Road Classification	:	National Secondary Road
Geological Condition	:	Dacite
Water Condition	:	Embankment is located along river, thus, subject to erosion.

The roadbed was totally washed out in the section with a total length of about 300 m caused by the July 1990 earthquake and succeeding floods due to typhoons. The road is totally cut and the flood plain is used as detour during dry season.

Damage on slope due to earthquake and scouring action of flowing water are the causes of washout.

Gabion wall was selected to support and retain the embankment taking advantage of its strength against erosion by water, availability of stores on the river bed, and lower cost than concrete wall. The proposed measures consist of the following (See Figure 6-1):

Proposed Measures		P u r p o s e
P1-3	Refilling/Embankment	To fill washed-out section
P6-9	Gabion Wall	To retain embankment
P19-1	Gravel Surfacing	To surface the road

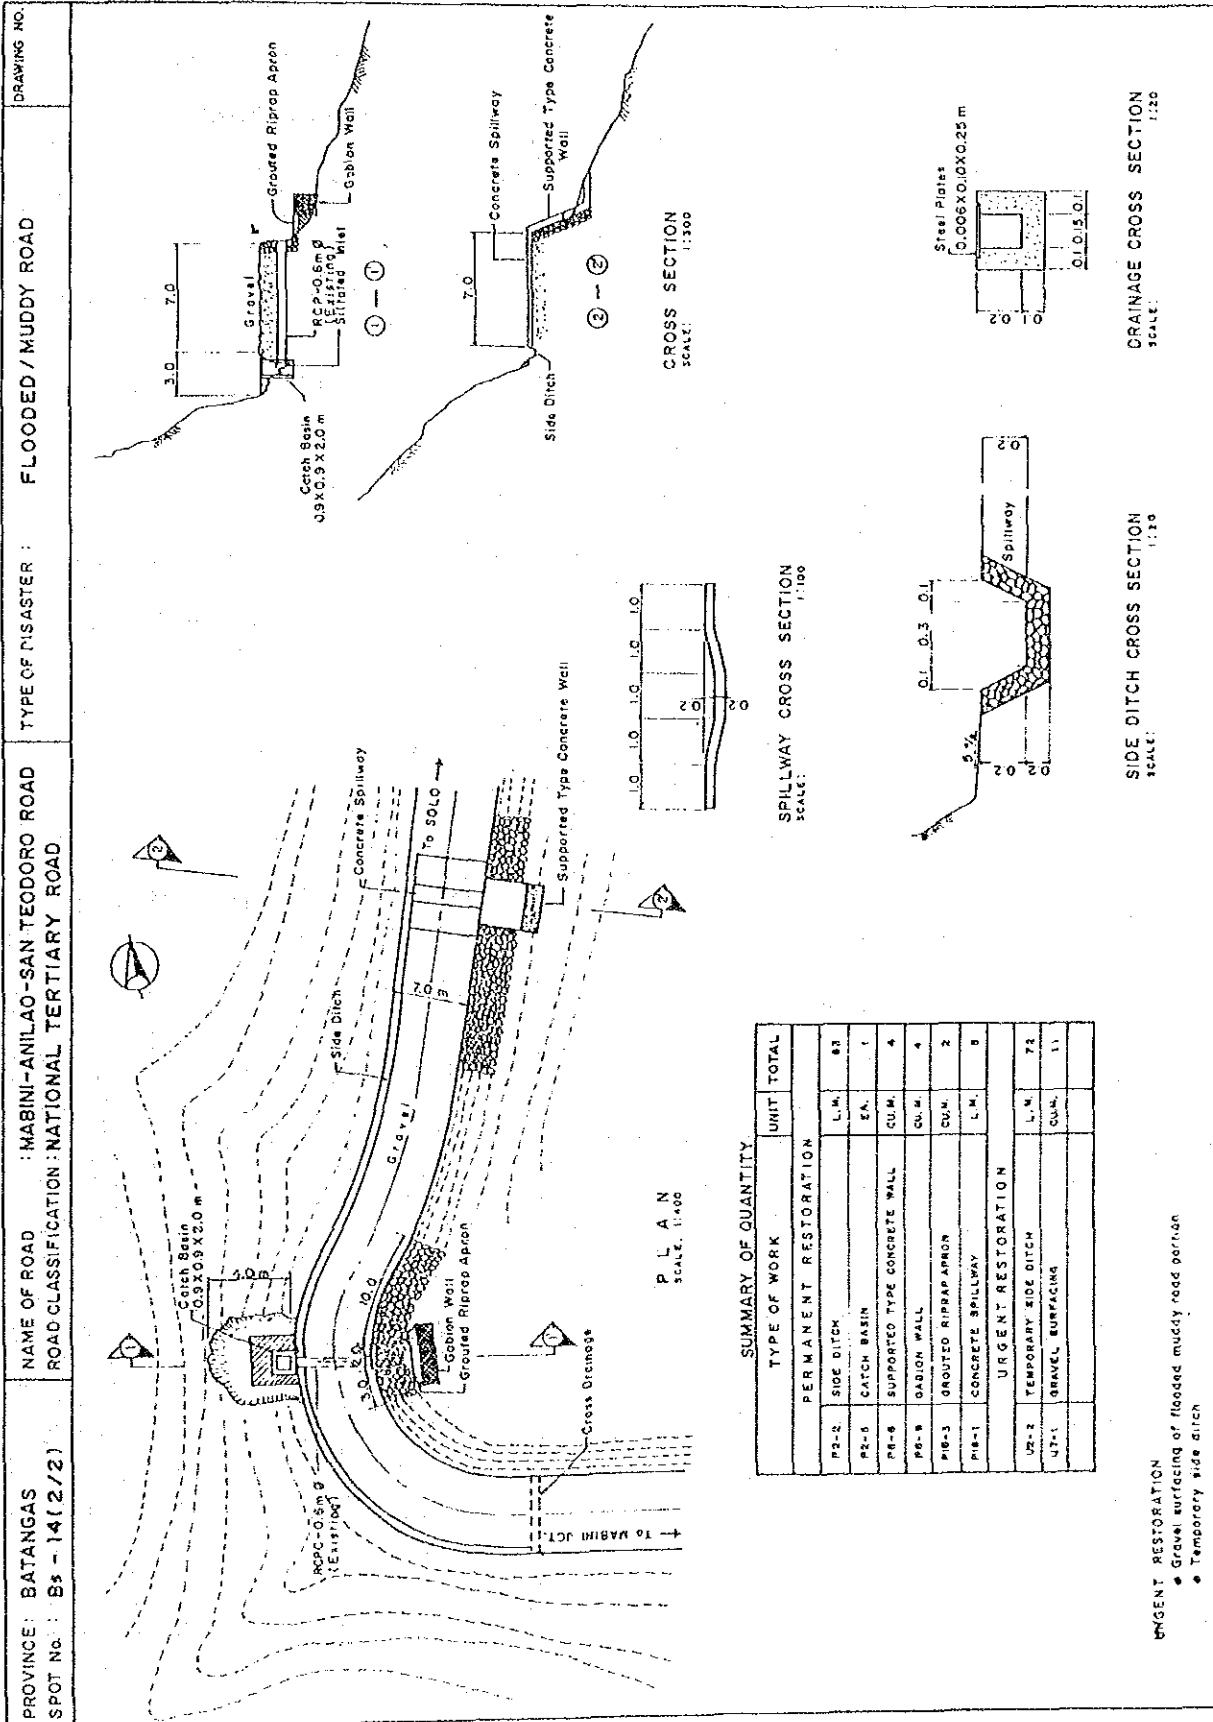
FIGURE 7-1 PROPOSED RESTORATION MEASURES (Bs-14)

Location	:	3.8 km from Mabini Jct. to Malimatok
Road Name	:	Mabini Jct. - Anilao - Solo Road
Road Classification	:	National Secondary Road
Geological Condition	:	Volcanic rocks, predominantly andesite
Water Condition	:	Surface water from hinterland

A pipe culvert of diameter 0.610 m is laid 42 m away from the lowest portion of the road. The entrance of the culvert is partly clogged with rocks and other debris resulting in insufficient capacity of discharging the rain water. No side ditch is provided. Due to surface water flowing directly on the road surface, the road is very muddy during rainy season.

Improper drainage of surface water is the cause of the road surface to be muddy.

Proposed measures consist of the following (See Figure 7-1):

Proposed Measures		P u r p o s e
P2-2	Side Ditch	To prevent water from running on road surface
P2-5	Catch Basin	To prevent the entrance of culvert from clogging
P6-6	Supported Type Concrete Wall	To protect the existing riprap from erosion
P6-9	Gabion Wall	To protect outlet portion of culvert
P16-3	Grouted Riprap Apron	To protect outlet portion of culvert
P18-1	Concrete Spillway	To regulate the flow of surface water and to protect road surface

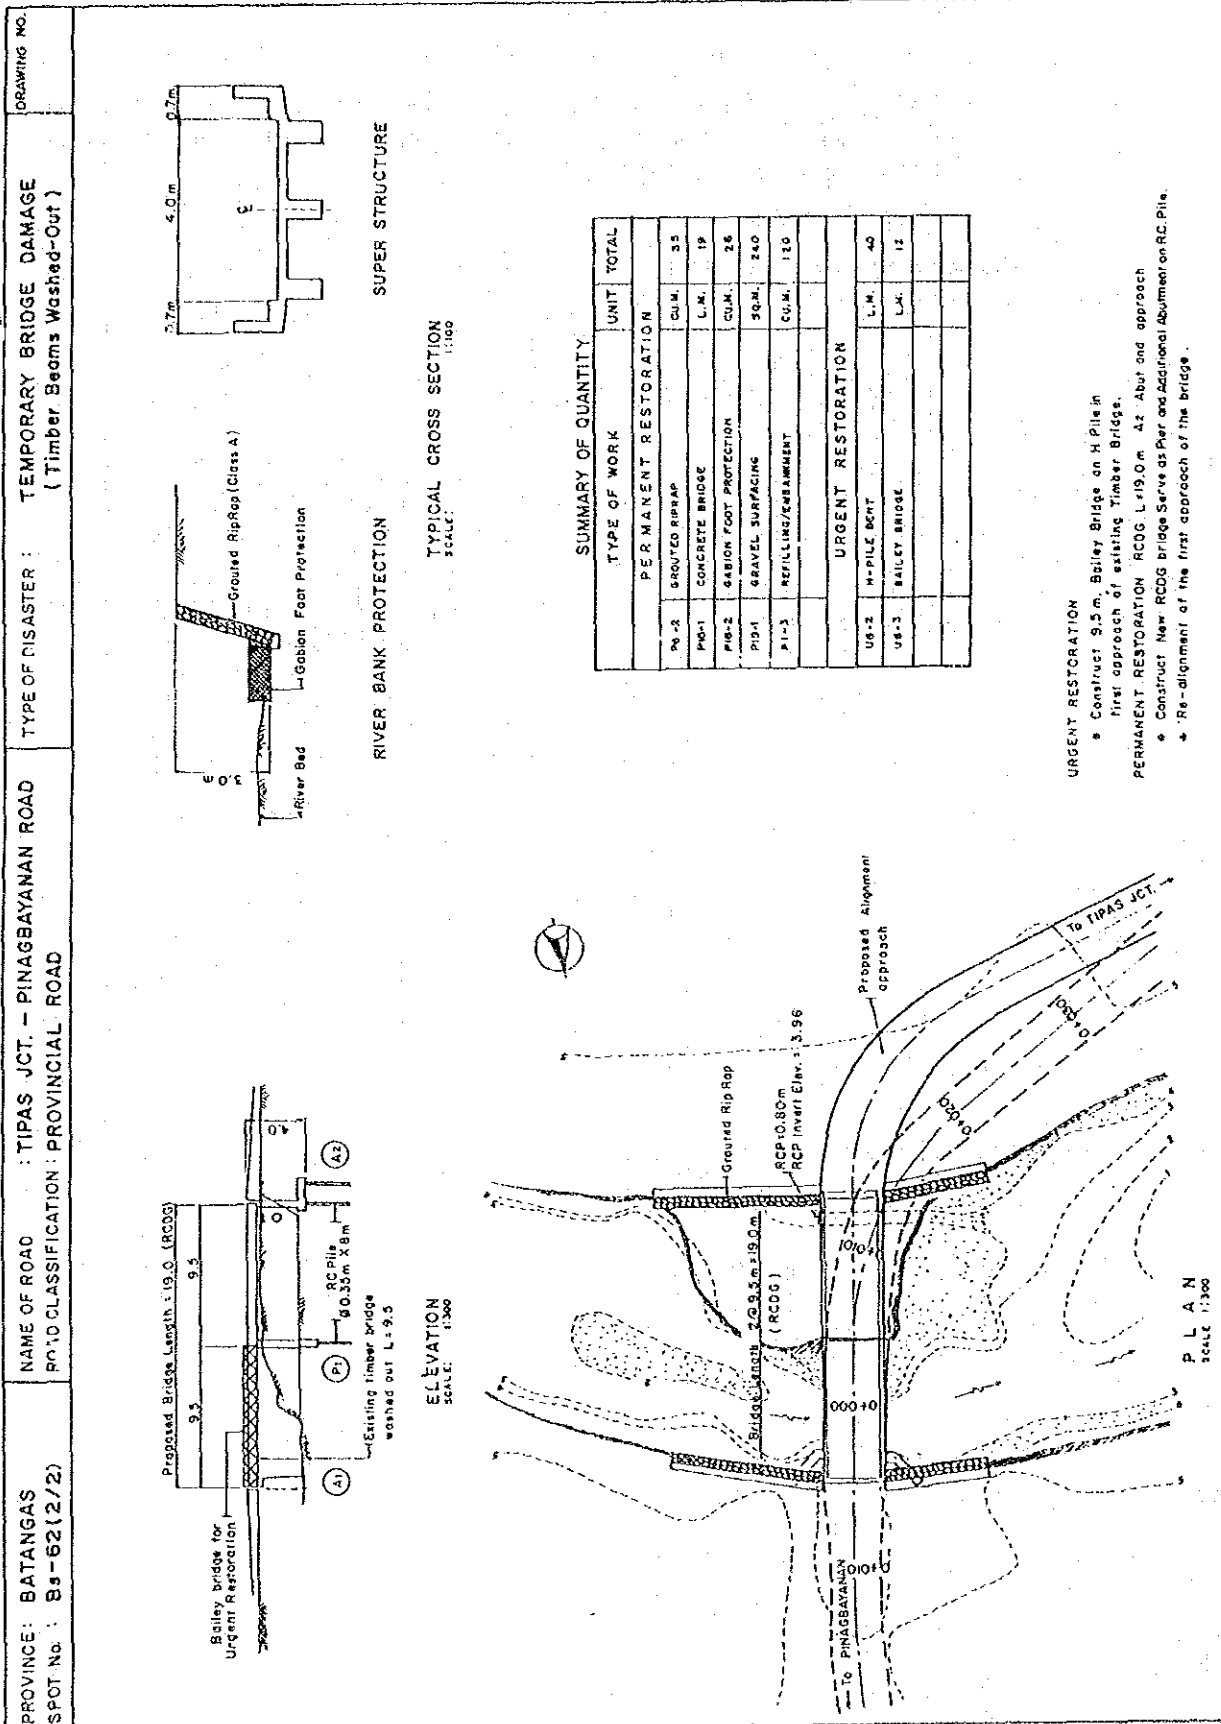
FIGURE 8-1 PROPOSED RESTORATION MEASURES (Bs-62)

Location	:	2.8 km from Tipas Jct. to Candelaria, Quezon
Road Name	:	Tipas Jct. - Pinagbayanan Road
Road Classification	:	Provincial Road
Geological Condition	:	Alluvial deposit on volcanic tuff and associated rocks particularly tuffaceous shale
Water Condition	:	Alluvial stream with instable channel

The surrounding area of this spot is flat and low, and water from vast catchment area is drained through this area, submerging the area during heavy rain. Highest flood level reaches 1.50 m above the road surface. A bailey bridge 9.0 m long, together with Tipas side abutment, was washed out in 1990 by overflowing water. The riverbed was widened toward Tipas side both upstream and downstream of the bridge location. Thus, the approach portion is in danger of being washed-out.

Overflow of the river submerging the bridge is the cause of this disaster.

- To raise bridge elevation to prevent the bridge from submergence.
- To add one more span not to encroach on the river stream, otherwise contracted river width may cause a rise of water level upstream and high velocity of flow bringing on severe erosion problem to approach portion.
- To protect river bank.

The permanent restoration measures were proposed as follows (See Figure 8-1):

Proposed Measures		P u r p o s e
P1-3	Refilling/Embankment	To elevate approaches of the bridge
P6-2	Grouted Riprap	To protect river bank
P15-1	Concrete Bridge	To provide permanent river crossing structure
P16-2	Gabion Foot Protection	To protect foot of grouted riprap from scour
P19-1	Gravel Surfacing	To surface the approaches of the bridge

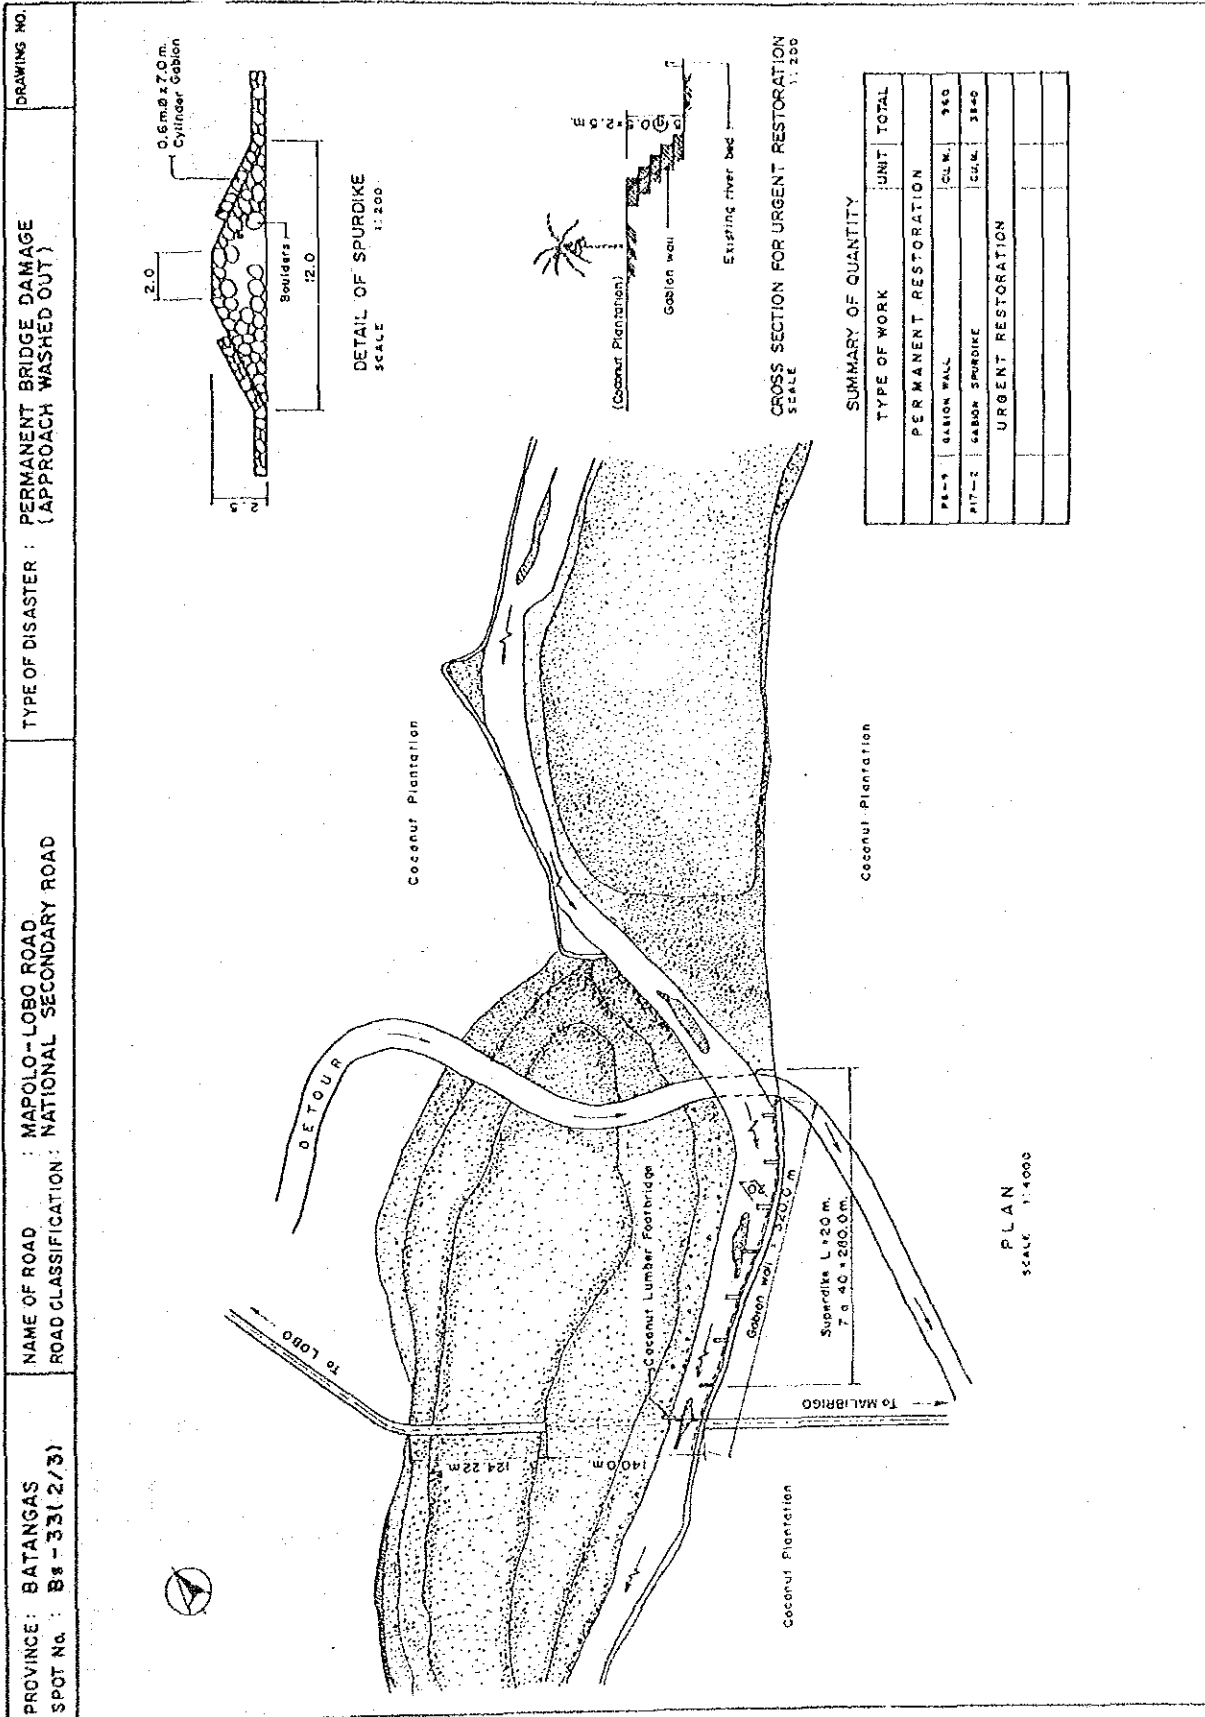
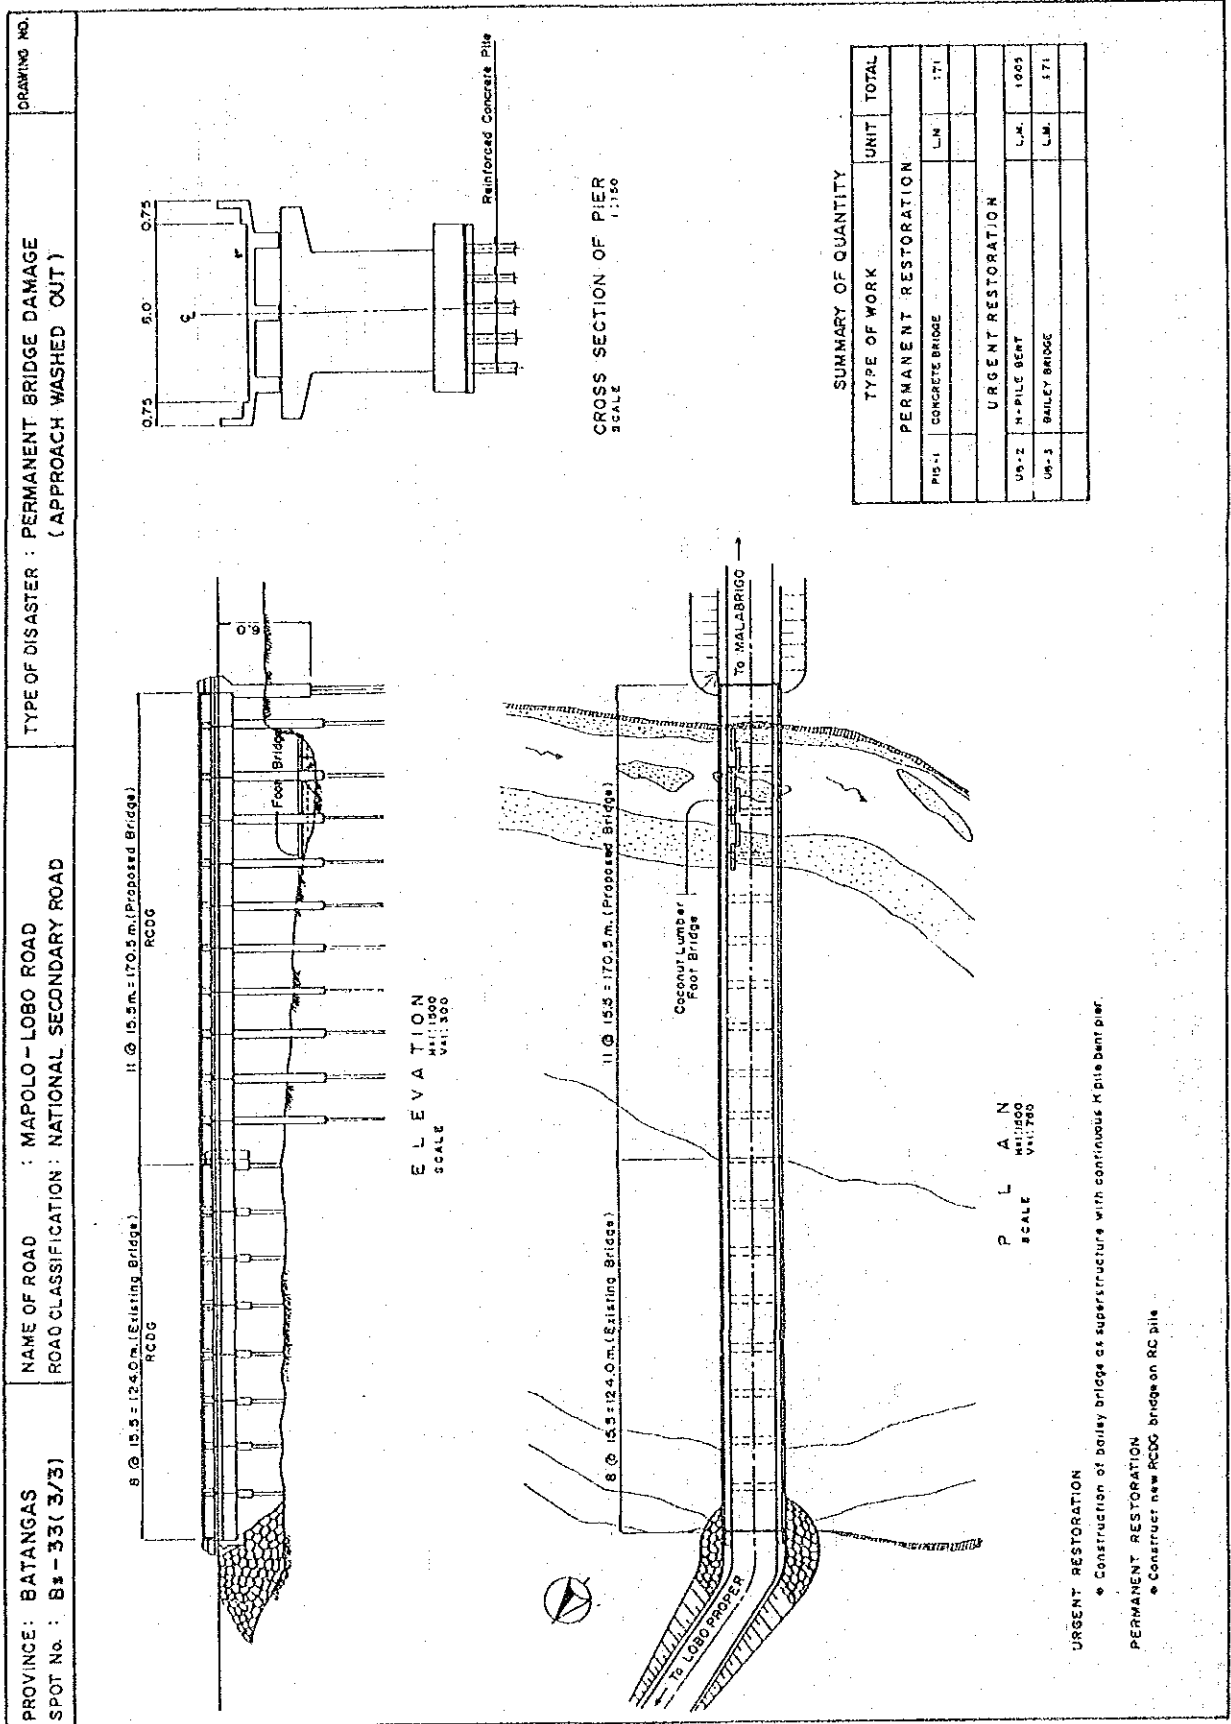
FIGURE 9-1 (1) PROPOSED RESTORATION MEASURES (B9-33)

- Location : 18.5 km from Dagatan Jct. to Taysan
- Road Name : Dagatan Jct. - Lobo Road
- Road Classification : National Secondary Road
- Geological Condition : Alluvial deposit, particularly sand fills the whole river.
- Water Condition : Alluvial stream with instable channel

Lobo bridge, 8-span RCDG bridge with a total length of 124 m, was constructed in 1984. Due to meandering of Lobo river, Malabrigo side bank started to be eroded in about 1986, and washed out about 160 m in width at the bridge location on the occasion of typhoon "Sisang" in January 1988. The bridge itself is sound. A few vehicles cross the stream by fording during dry season.

Shift of the main channel in meandering stream resulted in the disaster.

The river bank on Malabrigo side is still in danger of being further eroded. Preventive measures against bank erosion must be incorporated with extension of bridge to cross the shifted main channel. Thus, the permanent restoration measures for this spot were proposed as follows (See Figure 9-1):

Proposed Measures		P u r p o s e
P6-9	Gabion Wall	To protect bank from erosion
P15-1	Concrete Bridge	To cross the shifted main channel
P17-2	Gabion Spurdike	To control movement of stream

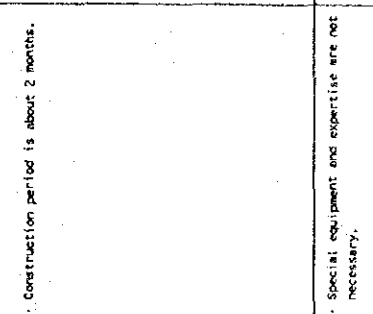
(2) Concrete foot Protection with Gabion

There is possibility of submerge of Gabion Foot Protection due to scouring of the river bed.	Conc. Foot Protection $65 m^3 \times 2,942 = 191$ Gabion Foot Protection $208m^3 \times 1,425 = 294$ P485	Special equipment and expertise are not necessary. Construction period is about 3 months.		- Applicable.

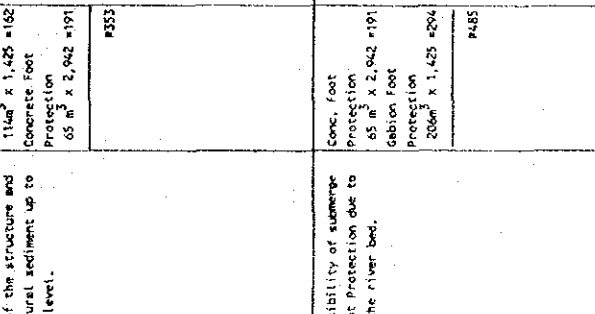
(3) Concrete Foot Protection with Steel Sheet Pile

Even if the riverbed is further scoured, the sheet pile affords stability.	Concrete Foot Protection $108m^3 \times 2,942 = 294$ Steel Sheet Pile $181 \times 34,200 = 616$ P910	Sheet piles must be driven from above the bridge because of short height of the bridge, causing traffic disturbance. Automatic pile hammer is necessary. Construction period is about 6 months.		- Not recommendable because of high cost and difficulty in construction.

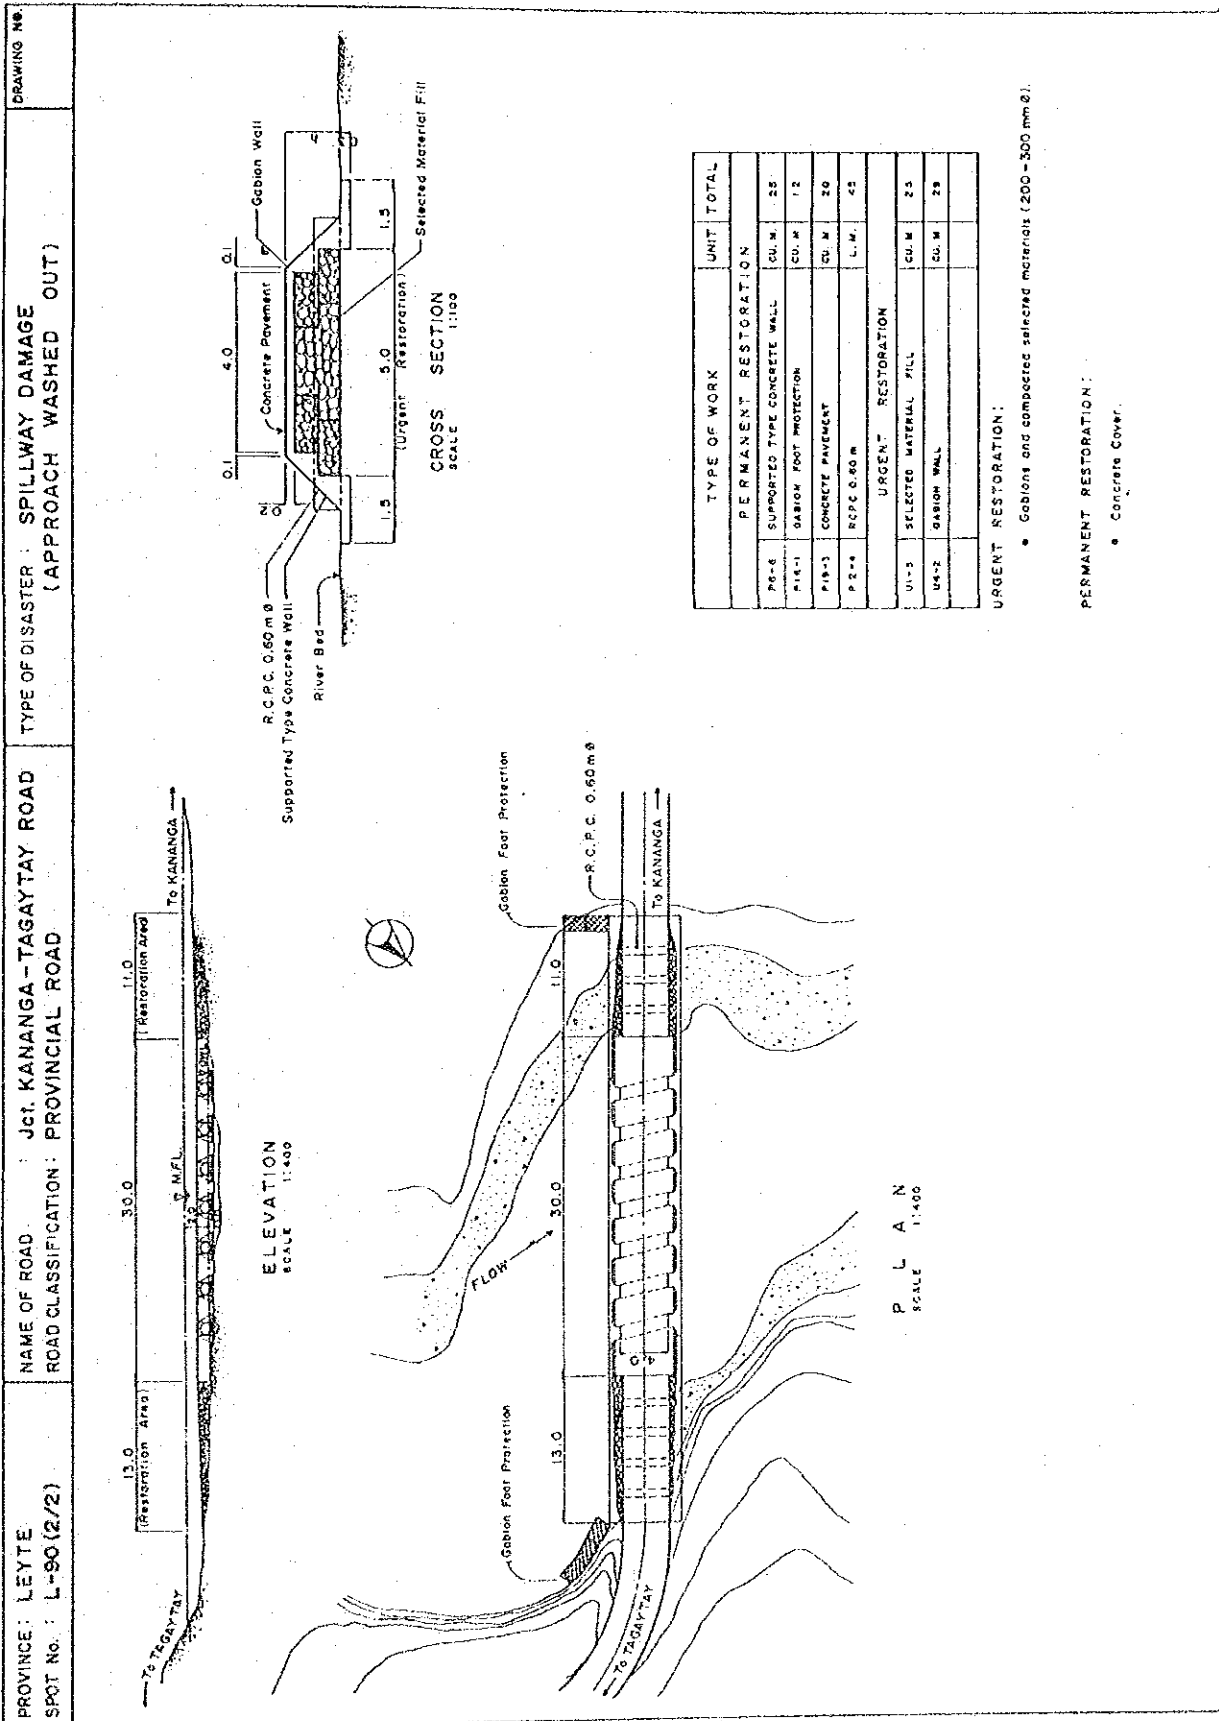
FIGURE 11-1 PROPOSED RESTORATION MEASURES (L-90)

Location	:	1.5 km from Kananga proper
Road Name	:	Jct. Kananga - Tagaytay Road
Road Classification	:	Provincial Road
Geological Condition	:	Sand and gravel
Water Condition	:	Main channel 30 m wide, alluvial flow with instable channel

30 m long and 4 m wide spillway with 7 pieces of reinforced concrete pipe culverts crosses a meandering stream at about 20 m downstream of a bend. Approaches were washed out about 10-15 m in length on each side of the spillway during typhoon "Ruping" in November 1990. At that time, flood level reached about 1.0 m above the spillway. The spillway itself was still sound but traffic was totally interrupted.

Erosion of bank by flood water is a cause of approach washout.

Proposed permanent measures are to protect the approaches constructed as urgent measures, including the following works (See Figure 11-1):

Proposed Measures		P u r p o s e
P2-4	Culvert R.C.P.C. 0.6 m	To provide the smooth water flow during the high flow
P6-6	Supported Type Concrete Wall	To provide permanent protection of the approach road constructed as urgent measures
P16-2	Gabion Foot Protection	To protect the upstream side river bank
P19-3	Concrete Pavement	To provide permanent surfacing

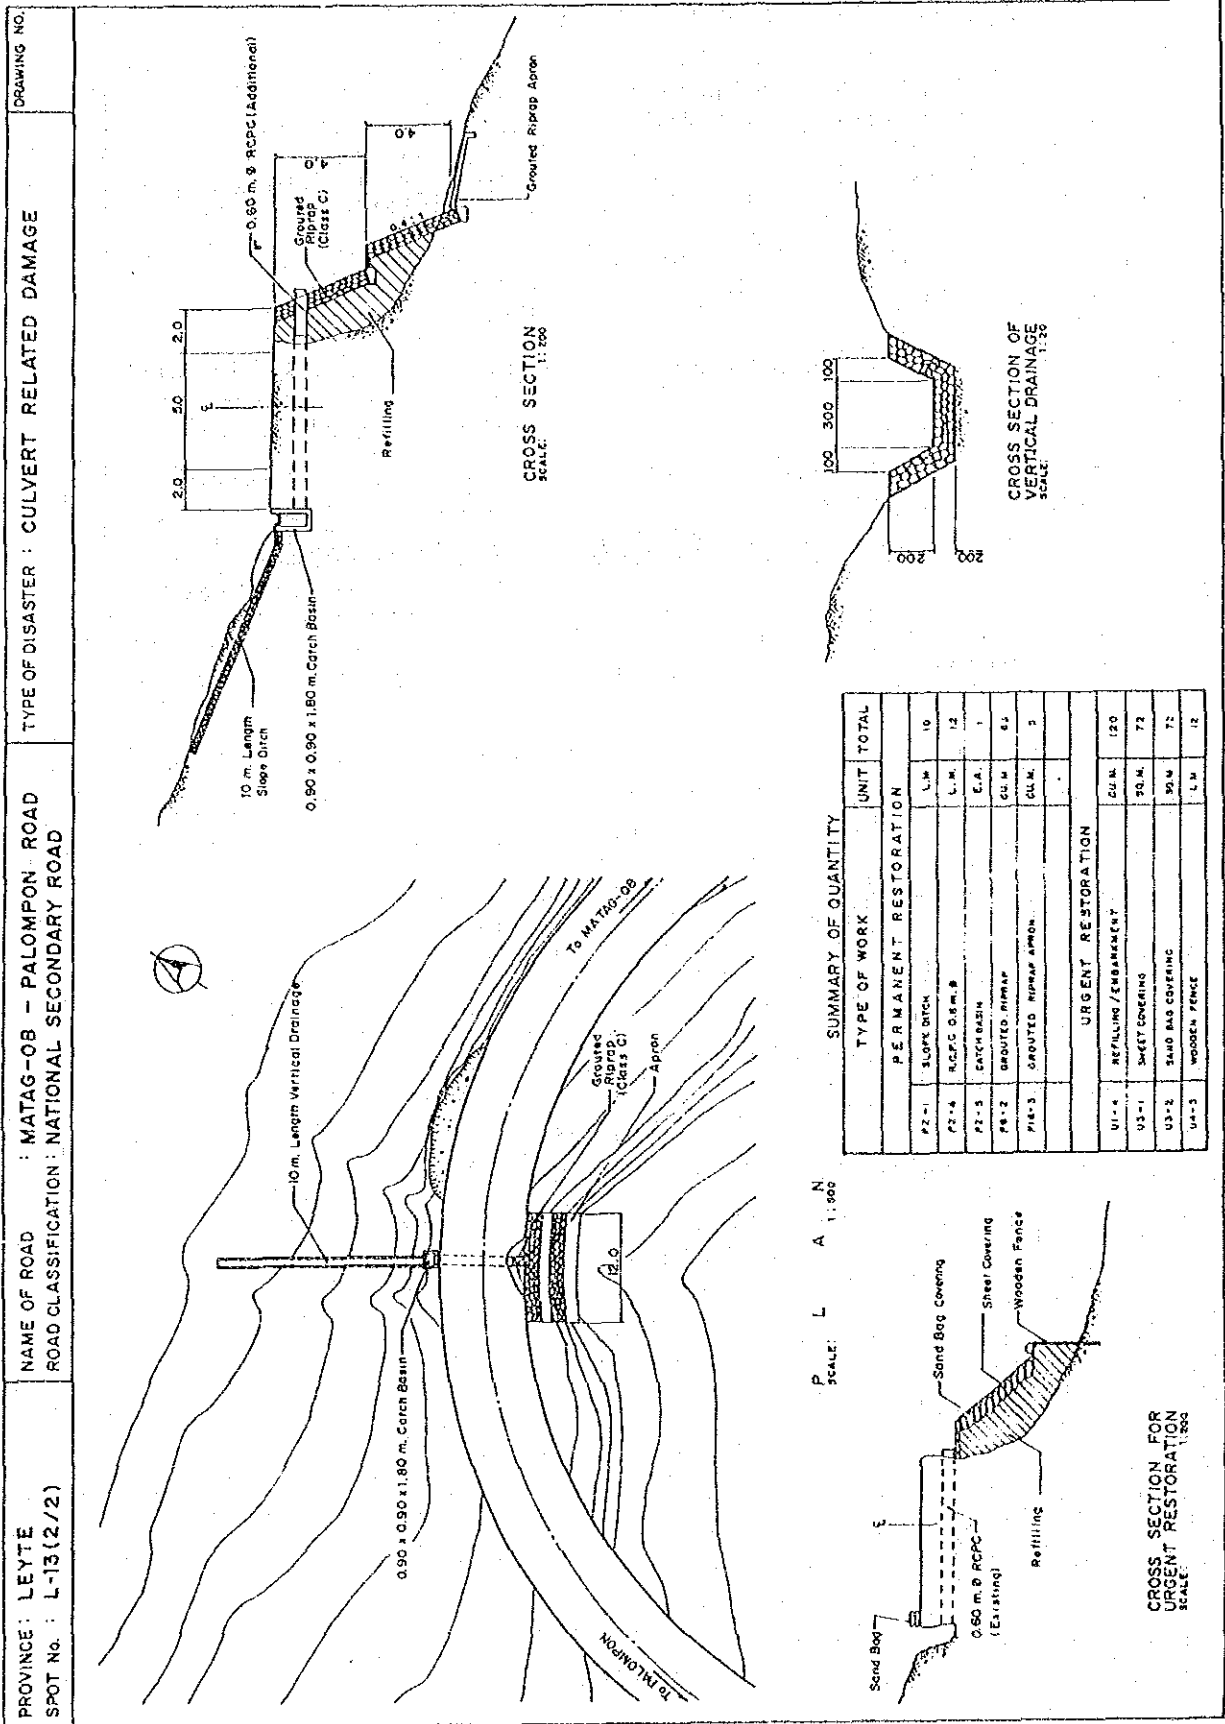
FIGURE 12-1 PROPOSED RESTORATION MEASURES (L-13)

Location : 8.8 km from Matag-ob Proper
Road Name : Matag-ob-Palompon Road
Road Classification : National Secondary Road
Geological Condition : Sandstone, gravelly soil
Water Condition : Concentrated water from hinterland

A pipe culvert of diameter 0.610 m was installed at curved portion of the road in mountainous terrain. Inlet was partially clogged with debris. Unprotected slope on valley side was eroded about 10 m in length and 2 m in width at top of slope.

Insufficient capacity of culvert and accumulation of debris at inlet caused water to overflow on the road surface and run directly on bare slope surface resulting in slope failure.

The following measures were proposed (See Figure 12-1):

Proposed Measures		P u r p o s e
P2-1	Slope Ditch	To provide waterway along mountain slope thus protect slope surface from erosion
P2-4	RCPC, 0.610 m in diameter	To extend the existing pipe culvert beyond the surface of slope
P2-5	Catch Basin	To connect slope ditch with pipe culvert reducing the energy of running water
P6-2	Grouted Riprap	To protect slope on valley side
P16-3	Grouted Riprap Apron	To protect foundation of grouted riprap from scour
