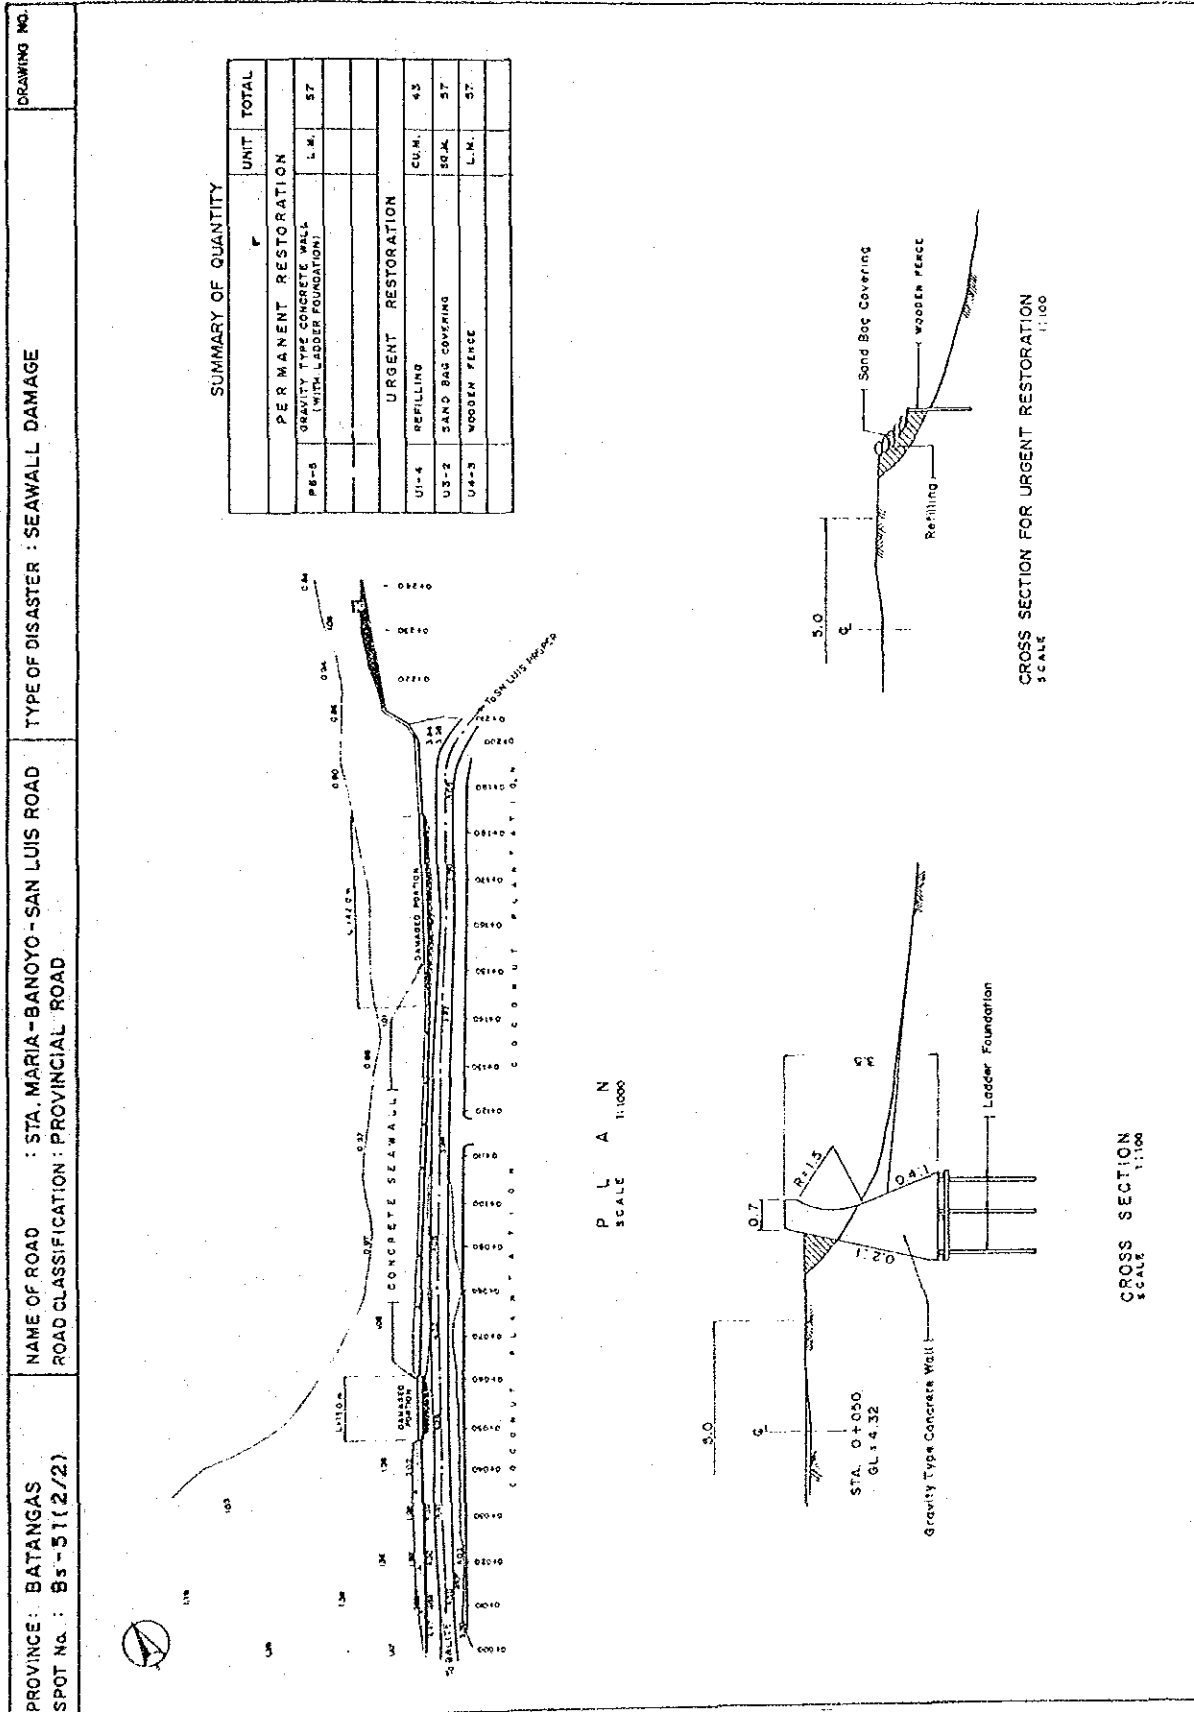
FIGURE 13-1 PROPOSED RESTORATION MEASURES (Bs-51)

- Location : 0.65 km from Banoyo Jct. to Baguilaua
Road Name : Banoyo Jct. - San Luis Jct.
Road Classification : Provincial Road
Geological Condition : Clay, silt, sand, gravel and limestone fragments
Water Condition : Within affected zone of seawave

A seawall of 200 m in length and 2.1 m in height was initially constructed in the early 1970's and reconstructed in 1987 with grouted riprap. During the November 1988 typhoon, 42 m northern portion of the seawall was totally collapsed and 18 m southern portion was partially damaged.

The damage was caused by seawave and backwash actions.

The following measures were proposed (See Figure 13-1):

Proposed Measures		Purpose
P6-5	Gravity Type Concrete Wall (With Ladder Foundation)	To retain embankment protecting it from erosion by seawave
