DESCRIPTION AND DESIGN OF RESTORATION MEASURES
FOR EACH DISASTER SPOT (BENGUET)

PROVINCE: **BENQUET**
SPOT No. : **Bt-1(1/3)**

NAME OF ROAD : **ITOGON-BALATOK ROAD**
ROAD CLASSIFICATION : **NATIONAL SECONDARY ROAD**

TYPE OF DISASTER : **CUT SLOPE FAILURE**

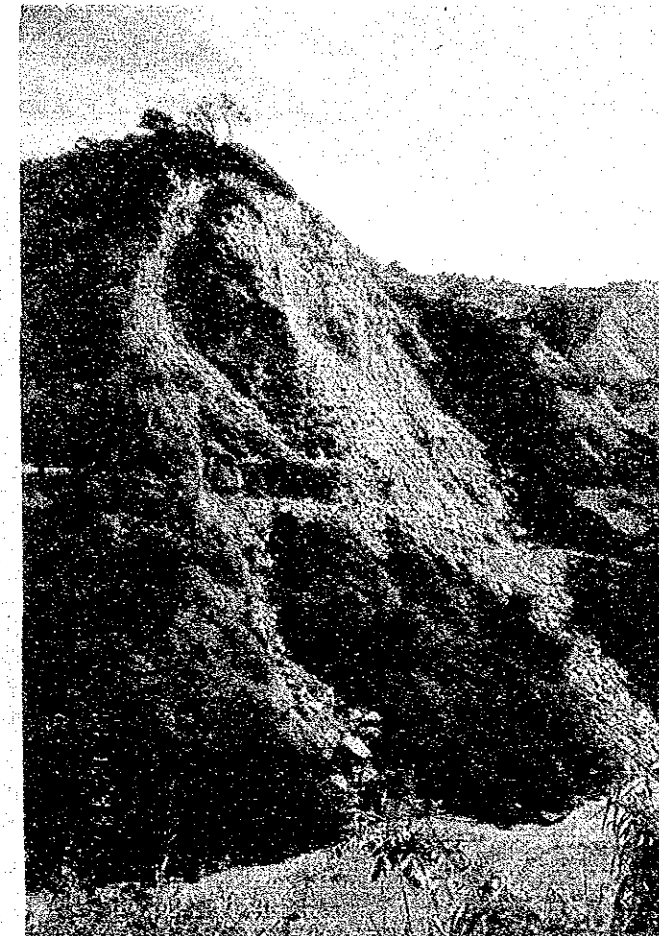
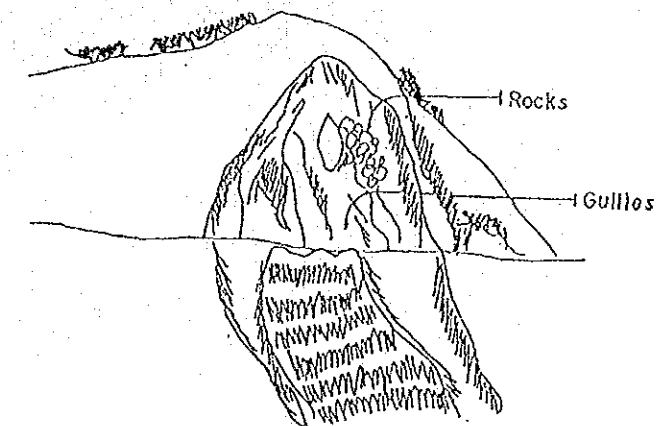
BENQUET SPOT NO. 1 (Bt-1)

- Type of Disaster : Cut Slope Failure
- Magnitude of Damage : 75.0 meters wide x 70.0 meters high
- Date Noticed : July 16, 1990
- Degree/Period of Traffic Interruption : High and totally
not passable to traffic
- Description of Disaster

This disaster occurred during the July 16, 1990 earthquake that hit the Benguet Province. The shape of the slope failure is like an inverted V with its vertex on top and the base lying on the road surface. Existence of some gullies were also noticed on the slope surface. The fallen rocks are deposited and exposed to weathering on the roadway causing the road to close to traffic.

This failure is caused by loose contact of soil on slope surface. Weathering and fracturing of rock joints caused the rock to land into the road surface.

Translational failure which occurs along structural weakness such as faults, bedding planes and border planes between firm bedrock and overlying detritus or soils.

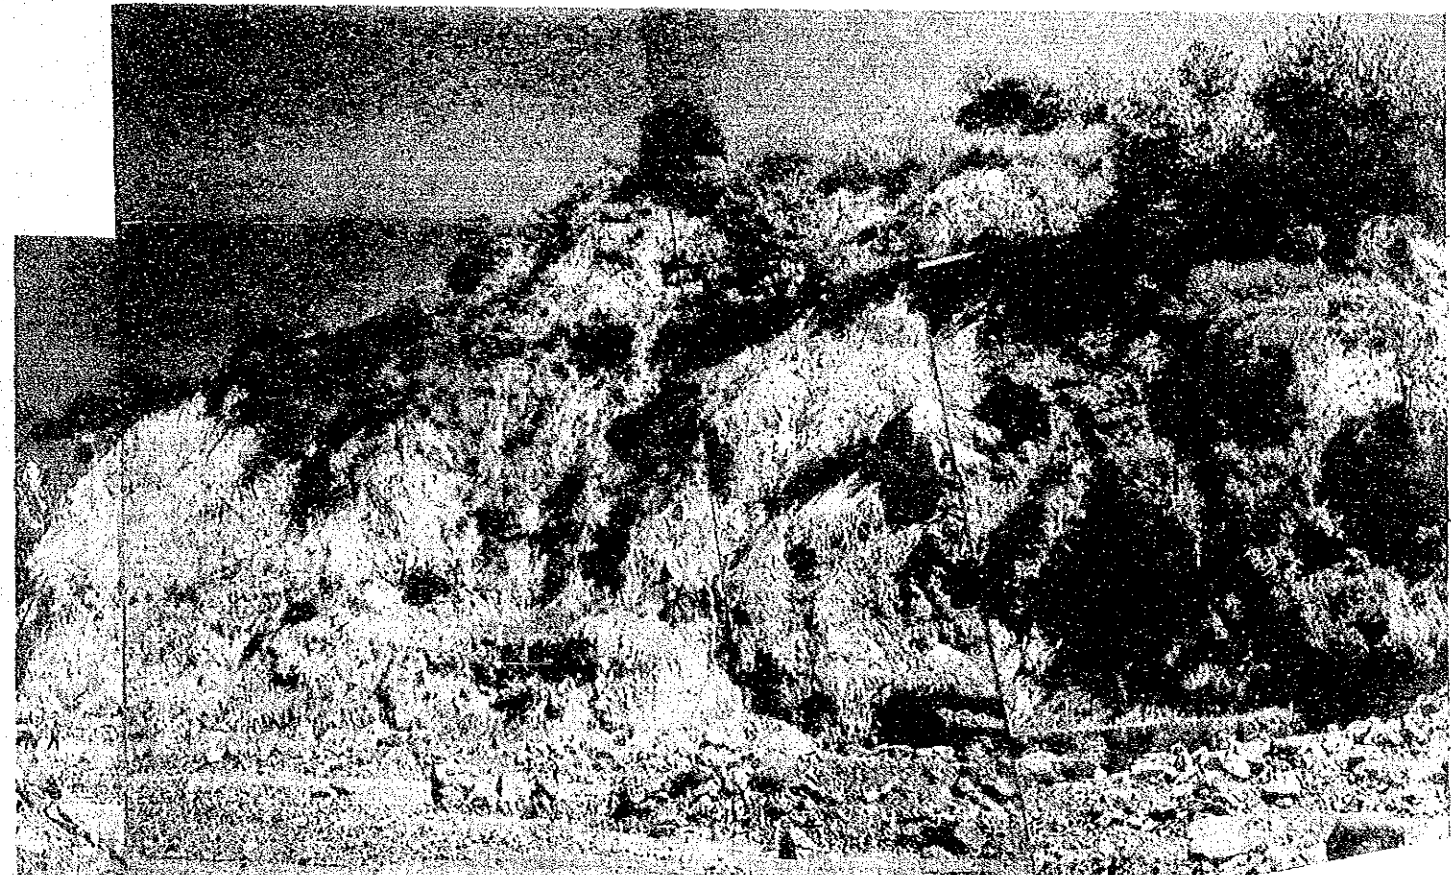
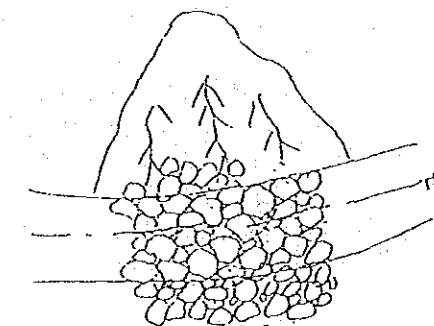
Benguet Spot No. 2

- Type of Disaster : Washed-out pavement
- Magnitude of Damage : 30 meters high by 320 meter wide
- Date Noticed : July 16, 1990
- Degree/Period of Traffic Interruption : Totally collapsed/not passable the all year round.
- Description of Disaster :

The spot is located on cut slope portion, wherein rock joint was inclined towards the road, rockfalls are most likely to occur along these joints during heavy rains. Due to insufficient vegetation control, loosening of soil and rock materials were observed.

The cause of this failure was due to the earthquake and a strong typhoon that hits the Benguet Province last July 16, 1990. The asphalt pavement was totally washed-out due to no provision of slope protection on the slope surface.

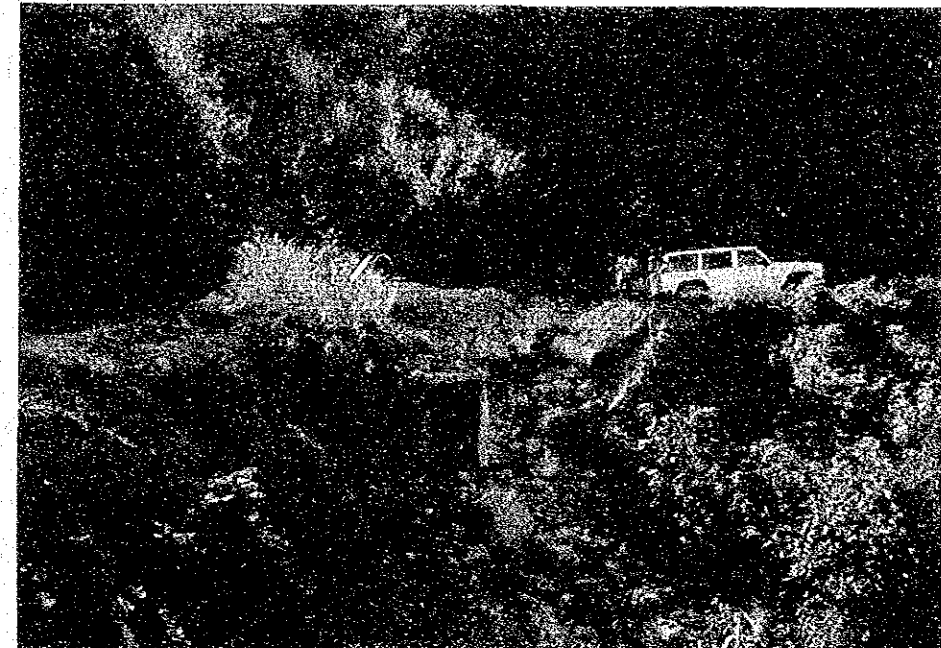
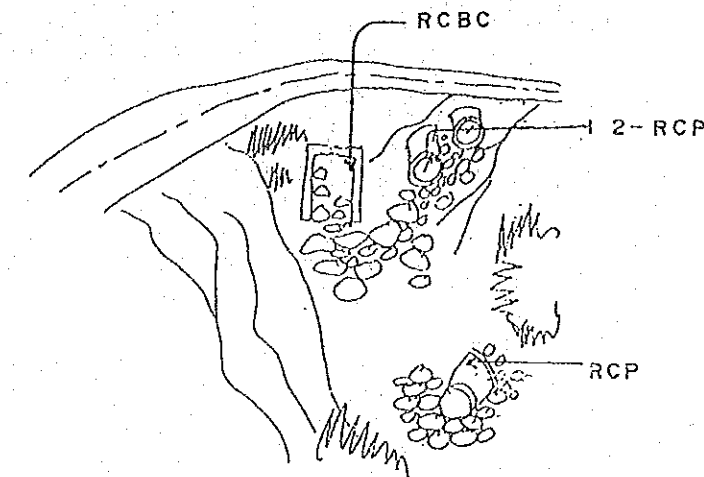
BENGUET SPOT 7 (Bt-7)

- Type of Disaster : Culvert and Its related Damages
- Magnitude of Damage : RCPC - 2 x 0.60 meter diameter
RCBC - 2.4 meter x 1.6 meter
Embankment Slope - 18 meter wide x
5 meter high

Two (2) lines of RCPC (0.6 meter in diameter) and one (1) RCBC (2.4 meter in height x 1.6 meter in width) were placed at this spot. All of them were clogged by debris brought from upstream. Water from upstream overflowed the road surface, then scoured the embankment slope.

RCBC was not the proper structure to cope with debris flow from upstream or road alignment was selected too close to the stream which is always subjected to debris flow.

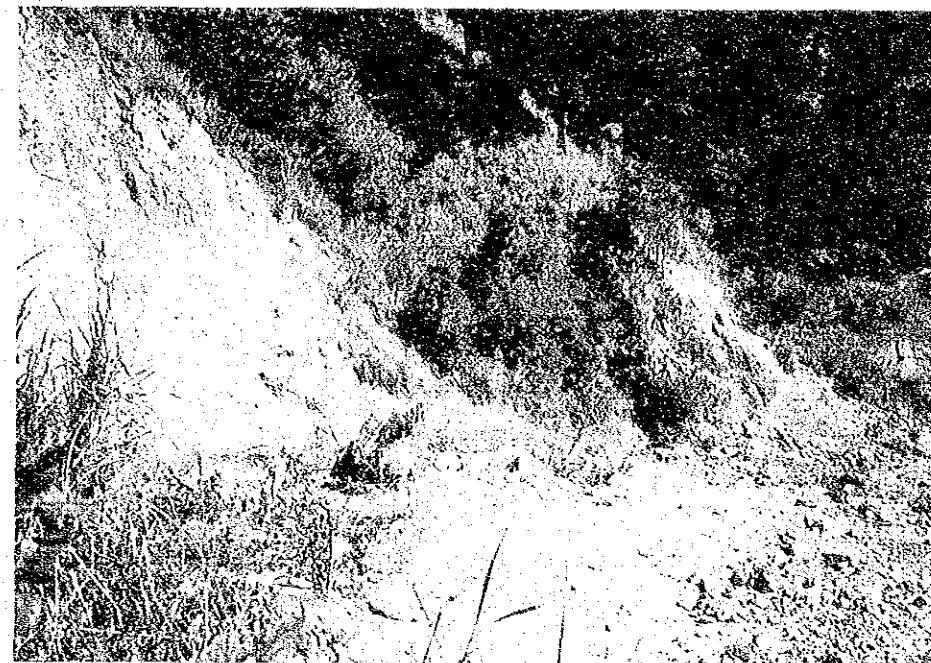
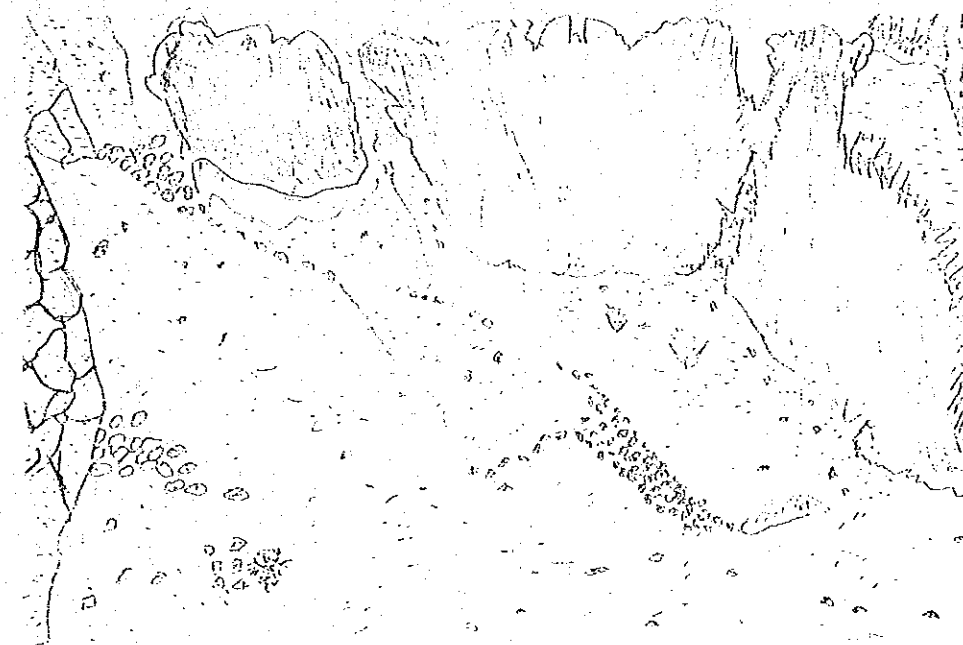
BENGUET SPOT NO. 11 (Bt-11)

- Types of Disaster : Landslide
- Magnitude of Damage : 70 meters in width x 30 meters in height
- Date Noticed : July 16, 1990
- Degree/Period of Traffic Interruption : High / both lane still passable

The road is paved with asphalt in fair condition having a gradient slope that varies from 8-10 percent. This particular section was extensively damaged by earthquake causing a massive landslide eroding the slope surface and partly damaging the residence situated on top of the mountain. The embankment side of this spot was immediately restored by the City Engineers Office to protect the roadway from scouring and it was considered as sinking area.

The soil slide along the slope of the mountain when saturated water caused loss of shear resistance between soils. It is also considered this portion as sinking area on the locality.

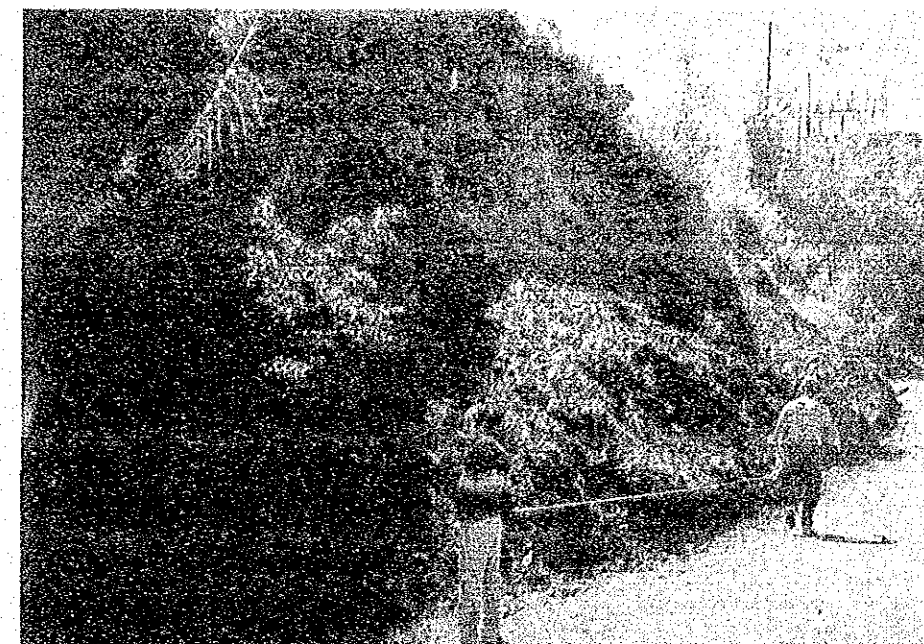
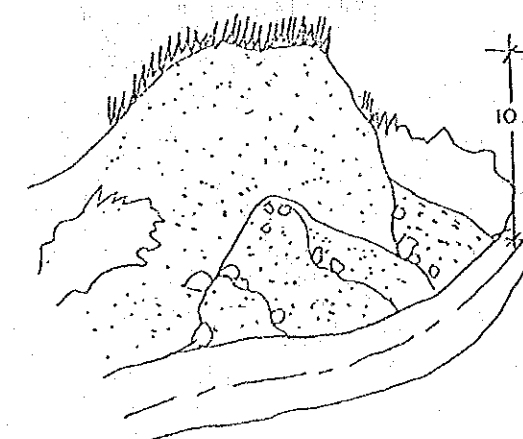
BENGUET SPOT NO. 14 (Bt-14)

- Type of Disaster : Cut Slope Failure
- Magnitude of Damage : 40.0 meter in wide x 10.72 meter in
height
- Date Noticed :
- Degree/Period of Traffic Interruption : Low with one lane
passable

This failure is directly caused by earthquake that hits the Benguet Province last July 16, 1990 and heavy rains poured down in this locality after the earthquake. Slope surface water runs with high velocity along the steep gradient slope of 50 degrees to roadway causing erosion. Existence of gullies were also observed on the slope surface.

A slope has irregular surface and water concentrated at sagged portion causing erosion. Soil material deposits on the slope surface slide due to saturated water in top soils.

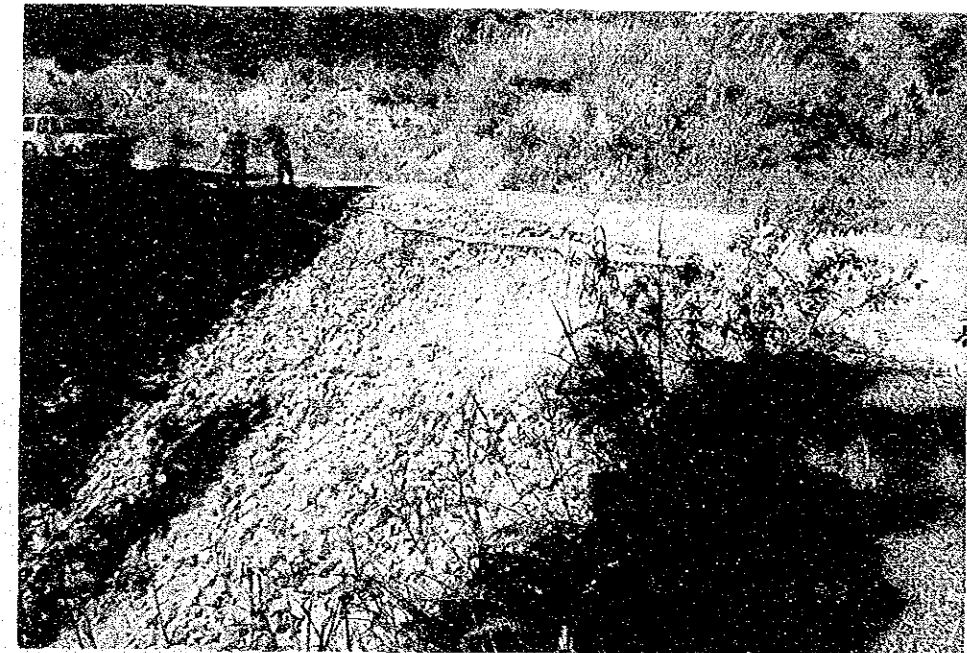
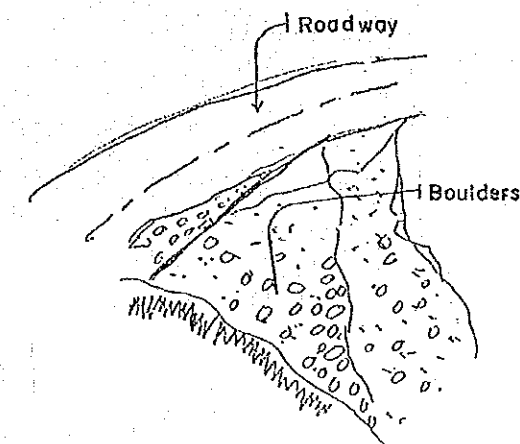
- Type of Disaster : Embankment Failure
- Magnitude of Damage : 20 meters wide x 19.0 meters high
- Date Noticed : Sept. 1990
- Degree/Period of Traffic Interruption : Medium / one lane Passable

This embankment failure is 20.0 meters wide and 19.0 meters high on slope. Previously, the slope was protected by riprap, however, it collapsed. Boulders on the present slope surface were those used for riprap. A triangular side ditch having a depth of 0.20 meter x 0.50 meter wide exists on the mountain side portion of the road. The asphalt pavement has a cut of 14.50 meters in length and 1.50 meter wide near the shoulder of the road where the eroded embankment had occurred.

The spot is located at the sagged section and surface water concentrates. Soil materials on the embankment side were not properly compacted where water saturates causing the drywall riprap to collapse and fall down on the slope.

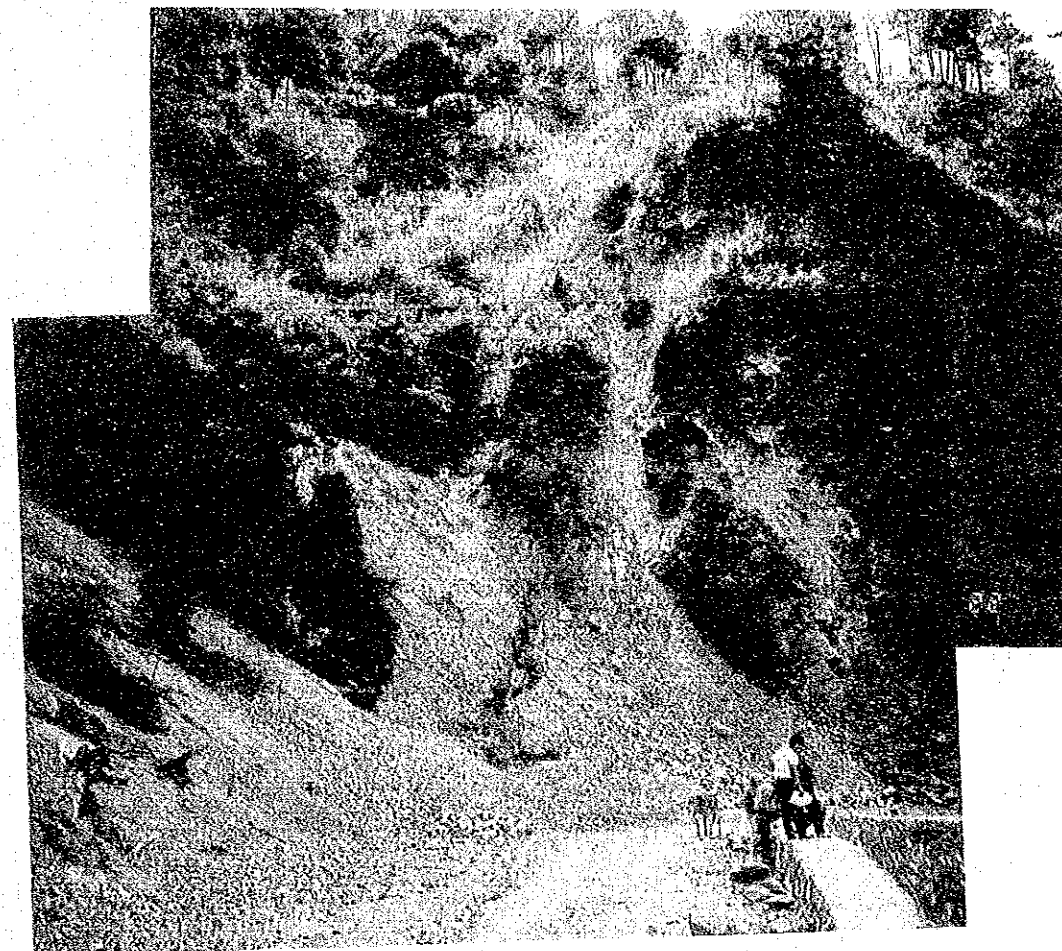
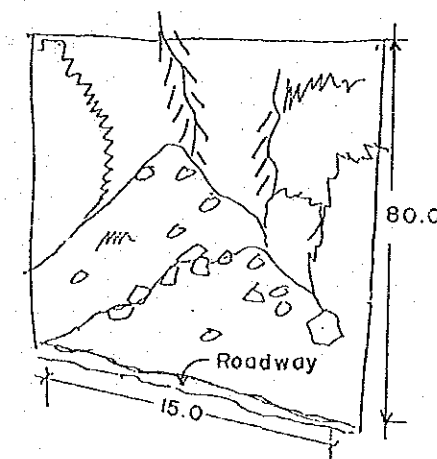
- Type of Disaster : Cut Slope Failure
- Magnitude of Damage : 18.0 meters in width x 40.0 meters in
height
- Date Noticed : July 16, 1990
- Degree/Period of Traffic Interruption : High/Passable

This failure occurred at the area on the slope surface at a height of 40 meters and width of 18 meters. Crop boulders were piled upon the side of the roadway. Existence of vegetation were also observed in this site. The slope surface has a gradient of 50 degrees. No existence of drainage facilities in the locality.

This failure is caused by earthquake and heavy rainfall which loosen the soil condition wherein debris slid on slope surface.

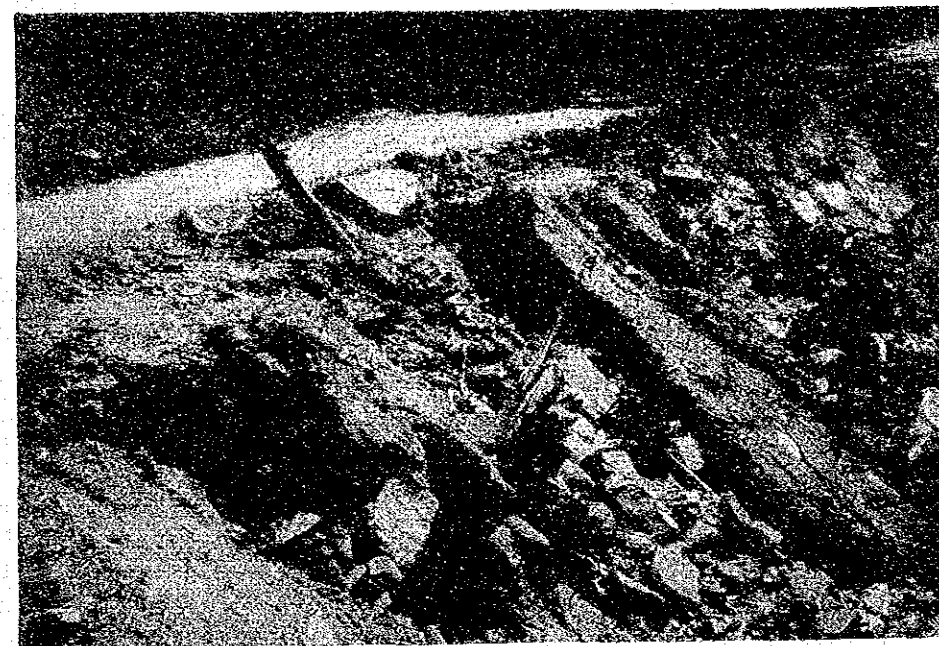
- Type of Disaster : Fall
- Magnitude of Damage : 40 meters in width x 100 meters in
height
- Date Noticed : July 16, 1990
- Degree/Period of Traffic Interruption : High but still
passable

This embankment failure was caused by earthquake that struck the province last July 16, 1990. The magnitude of damage is 40 meters wide and 6 meters high on the slope. No side ditches on both side of the road and no existing of drainage facilities in the locality. The flow of water coming from the mountain slope runs through the roadway causing this damage to occur.

The embankment failure is caused by earthquake and concentration of water surface on the roadway during heavy rains. Failure was aggravated non-provision of drainage facilities and gradual devegetation of the slope surface.

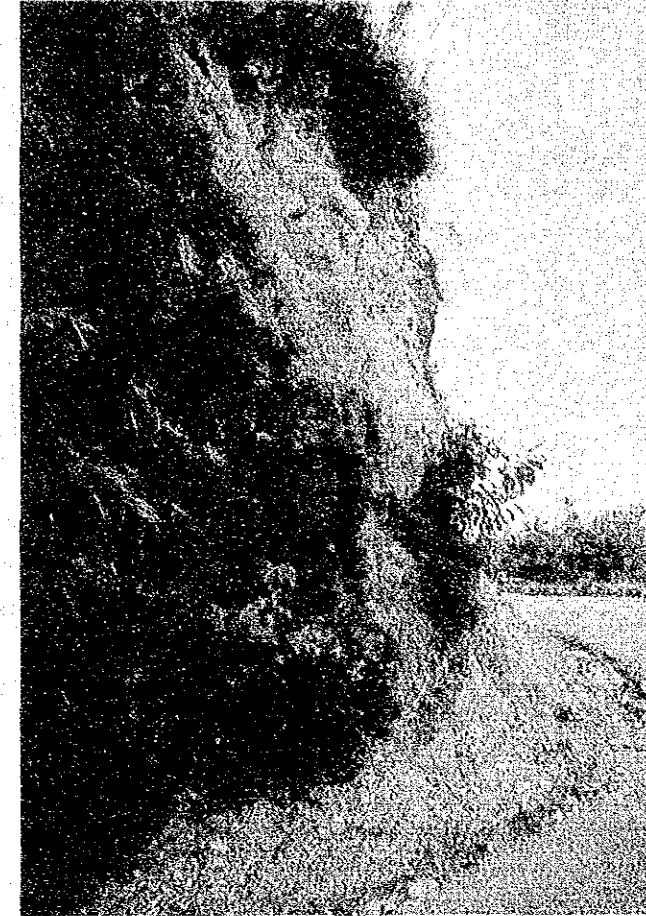
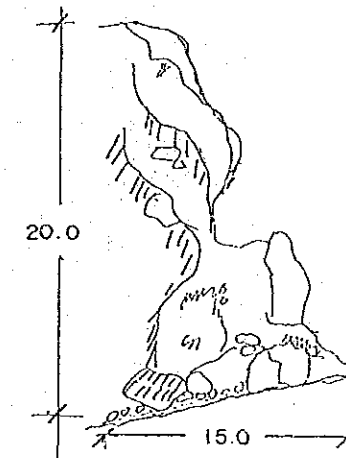
- Type of Disaster : Fall
- Magnitude of Damage : 33 meter wide x 10 meter high
- Date Noticed :
- Degree/Period of Traffic Interruption : Low/Passable

The cause of fall was the earthquake (July 16, 1990) that fractured the rock joints dislocating a portion from the bedrock. The seepage of water into the bedrock softens and causing it to fall. Top soil slides and comes half of the roadway.

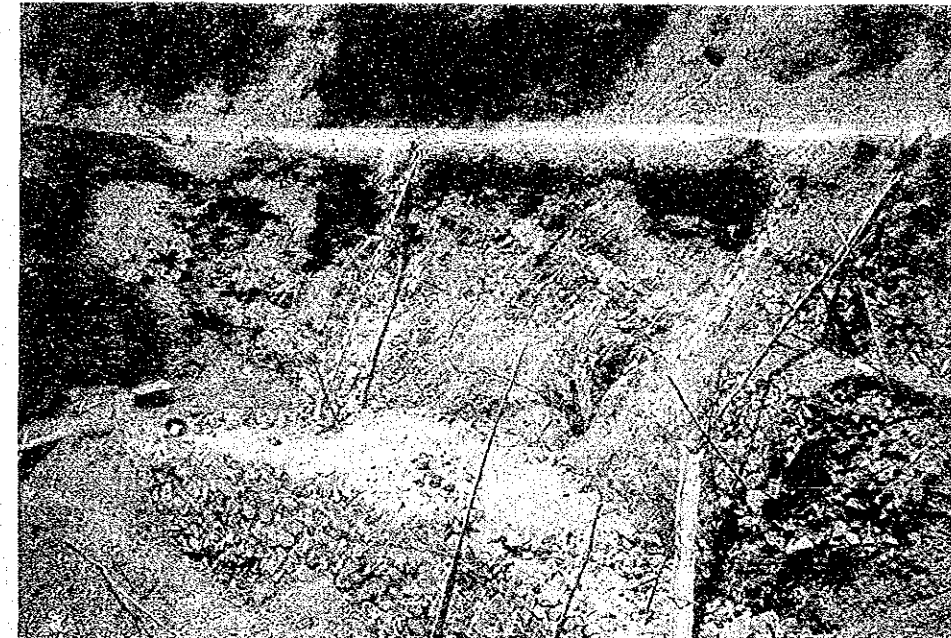
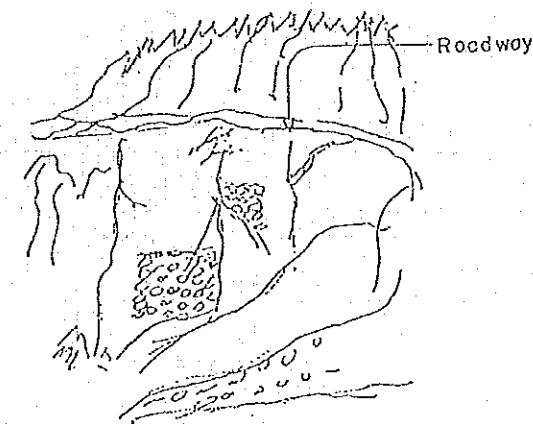
- Type of Disaster : Embankment Slope Failure
- Magnitude of Damage : 35.0 meters in width x 15.0 meters in height
- Date Noticed : July 16, 1990
- Degree/Period of Traffic Interruption : Low with one lane passable

This failure occurs during the July 16, 1990 earthquake. The spot is located at the concaved portion of the road where water converges at this point. Since the composition of the natural grade is purely soil and unconsolidated, erosion is inevitable. A collapsed grouted riprap was observed along the embankment slope which is almost covered with soil materials. The size of the failure is 35.0 meter long and 15.0 meter deep.

It is caused by heavy rains where the rainwater converged on the concaved portion of the road where embankment failure was aggravated by the nonprovision of drainage facilities and the gradual devegetation of the slope surface.

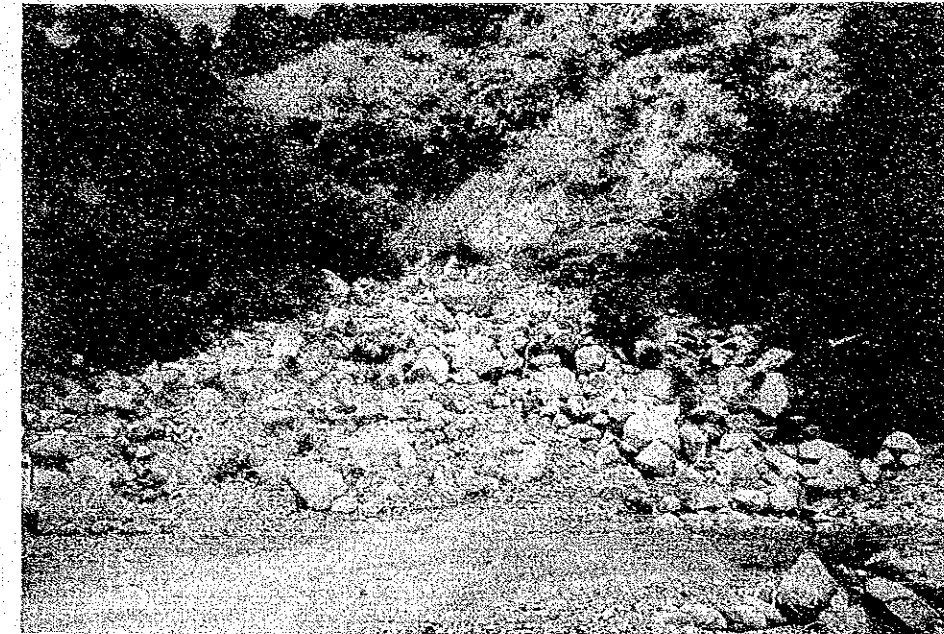
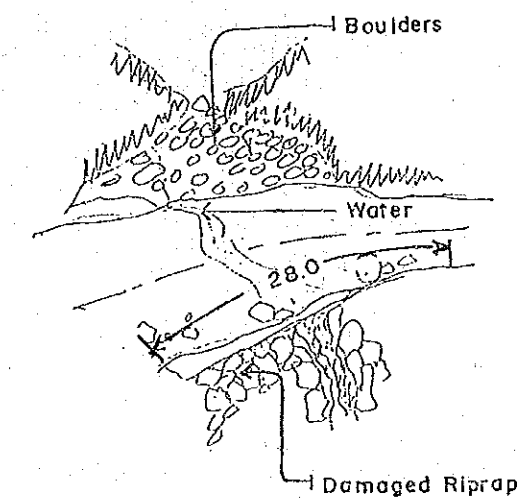
- Type of Disaster : Shoulder erosion, flooded roadway
- Magnitude of Damage : 16.0 meters in length x 8.0 meter in
wide
- Date Noticed :
- Degree/Period of Traffic Interruption : Medium / 2 lane
passable

Rocks and boulders deposited along the ravine flew down with rainwater. Sabo work should have been provided, or spillway should have been constructed.

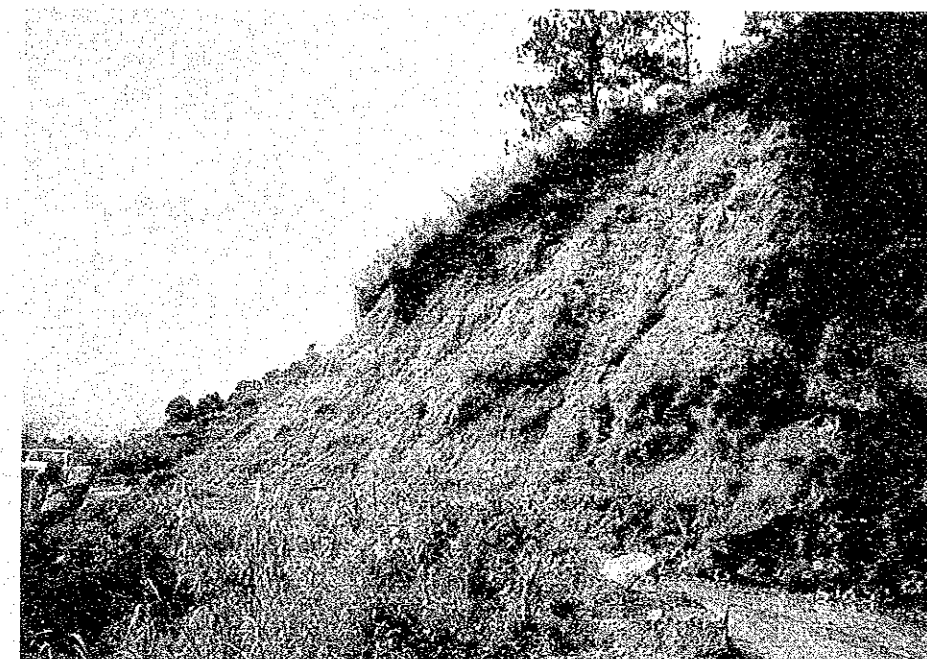
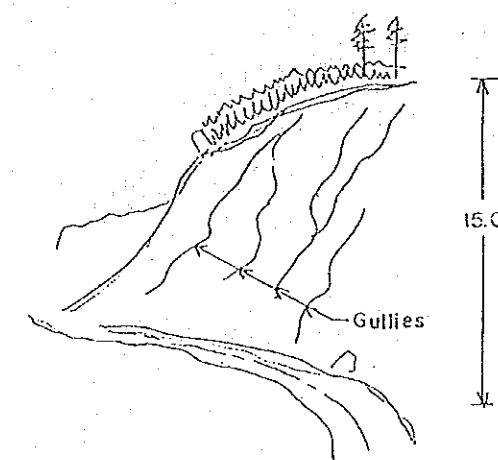
- Type of Disaster : Cut Slope Failure
- Magnitude of Damage : 60 meters in wide x 15 meters in height
- Date Noticed :
- Degree/Period of Traffic Interruption : Medium / Passable

The length of the slope failure is 45 meters and 15 meters high with a slope grade of 35 degrees. The exposed surface is nearly soil with patches of stone. Water freely runs on the slope surface due to its steep and high gradient. The absence of drainage facilities made possible the stagnant water in road surface.

This failure is caused by saturation of water in slope surface due to heavy rainfall and weak sub-surface condition.

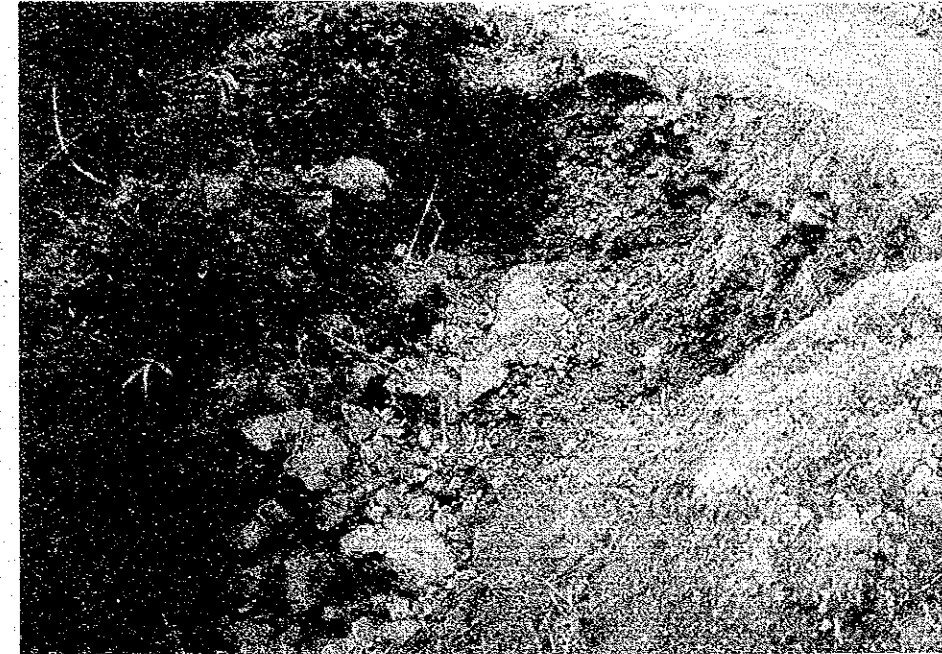
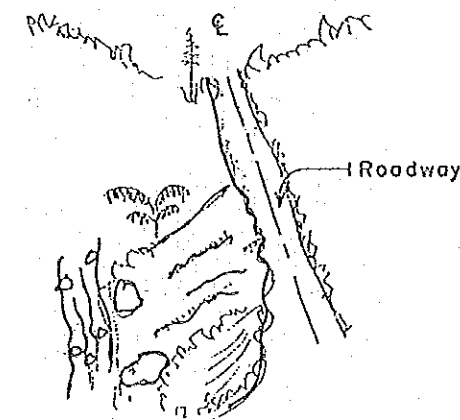
- Type of Disaster : Eroded embankment
- Magnitude of Damage : 16.0 meter in width x 7.0 meters in height
- Date Noticed : July 16, 1990
- Degree/Period of Traffic Interruption : Low with one lane passable

Debris deposits on the river bed narrowed river width at this spot, resulting in raising of water level and high velocity of water which caused erosion of embankment.

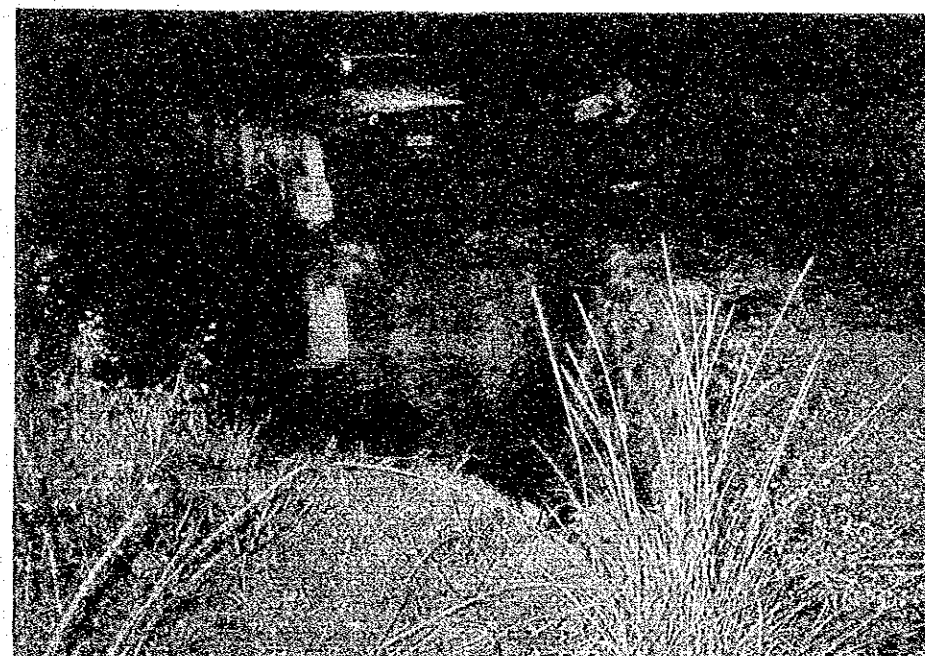
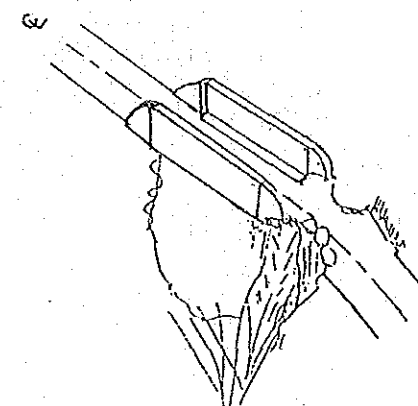
- Type of Disaster : Bridge Approach Washout
- Magnitude of Damage :
 - Baguio City Side Approach
 - Upstream side : 1.5 m x 4.5 m
 - Downstream side : 2.0 m x 9.5 m
 - Kibungan Side Approach
 - Upstream side : 2.0 m x 1.5 m
- Date Noticed : Sept. 1990
- Degree/Period of Traffic Interruption : Medium/ one lane passable

Strong current hit the ripraps with no foundation around the abutments which were scoured and collapsed. The cause of this scoured bridge approach was the strong flow of water from upstream and surface running water coming from upper grade of roadway.
