PROVINCE : **BENGUET**
 SPOT No. : **Bt-55 (2/2)**

NAME OF ROAD : **KIBUNGAN - KAPANGAN ROAD**
 ROAD CLASSIFICATION : **NATIONAL SECONDARY ROAD**

PROVINCE : BENGUET
SPOT No. : Bt -57 (1/2)

NAME OF ROAD : ATOK PROVINCIAL ROAD
ROAD CLASSIFICATION : PROVINCIAL ROAD

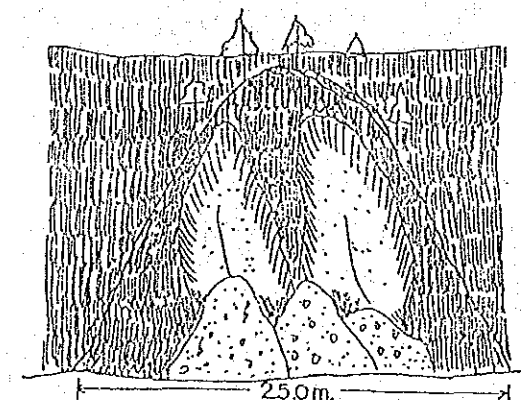
BENGUET SPOT NO. 57 (Bt-57)

- Type of Disaster : Cut Slope Failure
- Magnitude of Damage : 32.0 meter in length, 10.0 meters in height
- Date Noticed :
- Degree/Period of Traffic Interruption : Low and passable

The length of the slope failure is 23.0 meters and a height of 10.0 meters. The surrounding area is vegetated with grasses and sparsely with some stones. The slope gradient is steep and high enabling the water to flow freely into the road surface. The slope gradient is 50 degrees after the cut slope failure occurs. Existence of gullies on slope surface.

Slope was not stable (too high and too steep). Very loose soil strata.

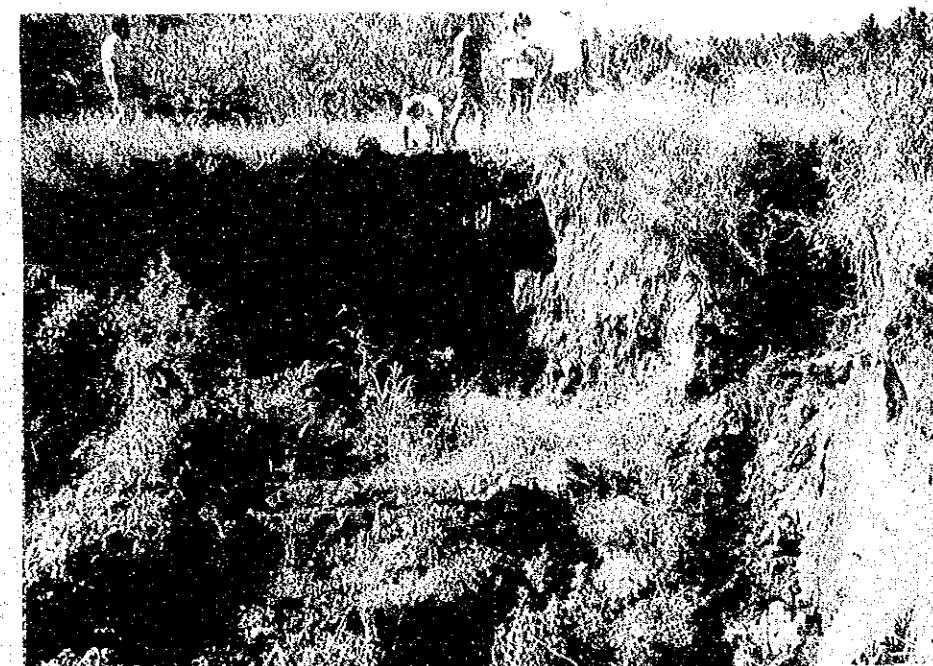
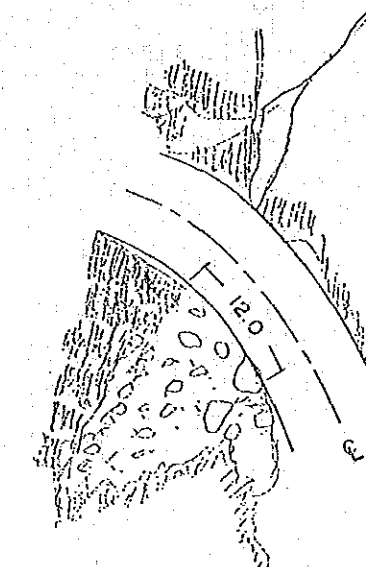
BENGUET SPOT NO. 58 (Bt-58)

- Type of Disaster : Embankment Slope Failure
- Magnitude of Damage : 18 meters wide & 40 meters deep
- Date Noticed : July 16, 1990
- Degree/Period of Traffic Interruption : Low with one lane passable

The failure in this spot was caused by the earthquake last July 16, 1990. The road embankment was eroded at about 12 meters wide and 40 meters deep. The roadway becomes narrow because of this failure making it dangerous for commuters in travelling.

This failure is caused by earthquake and heavy rainwater. The embankment failure was aggravated by the non-provision of embankment protection and the gradual devegetation of the slope surface.

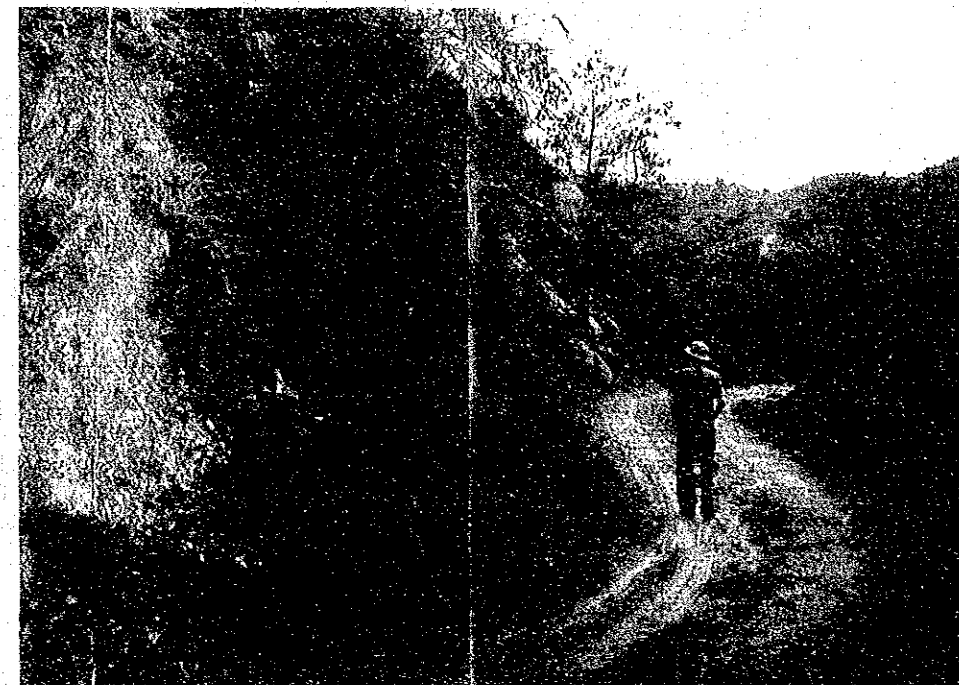
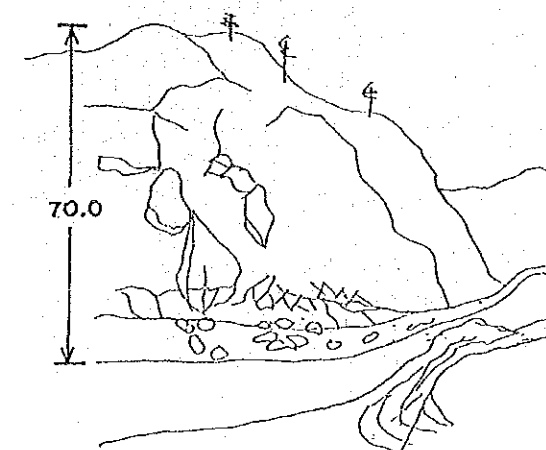
BENGUET SPOT NO. 59 (Bt-59)

- Type of Disaster : Cut Slope Failure
- Magnitude of Damage : 350 meters in wide x 100 meters high
- Date Noticed : July 16, 1990
- Degree/Period of Traffic Interruption : High/still passable

The cause of failure was the July 16, 1990 earthquake which registered a magnitude of 7.3 in the richter scale. It was, however, aggravated by heavy downpour that loosen the soil condition of the surface. A big volume of earth slid into the roadway which thereby made the road temporarily impassable.

The length of the slope failure is 350 meters and a height of approximately 100 meters. It is triangular in shape with its base lying on the road surface. The slope failure is easily identifiable because it is a wide clayey brown earth with gullies, surrounded by vegetation of trees and ferns.

The cause of cut slope failure is due to loosen subsurface condition. As manifested from the photo, the rock condition is highly weathered. During heavy rain, the slope surface is soaked to saturation which causes the slope surface to soften and sliding. The slide plane of the earth surface being eroded was caused not only by earthquake but also heavy rain downpour.

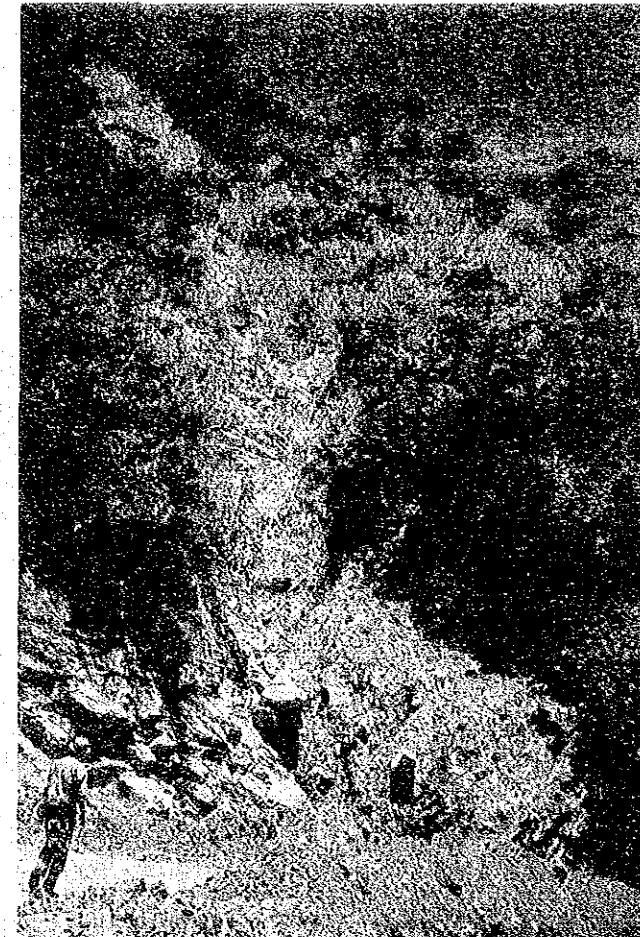
BENGUET SPOT NO. 62 (Bt-62)

- Type of Disaster : Rockfall
- Magnitude of Damage : 32.0 meter long x 30.0 meter high
- Date Noticed :
- Degree/Period of Traffic Interruption : Low with two lane
passable

This disaster spot is located at the valley like shape topography curved out from the mountain side. The surface is like inverted V with its vertex tapering to the top with some vegetations on slope surface. It has a base of 10.0 meters wide and 30.0 meters in high. The average rock size is 1.0 meters with a minimum of 0.20 meter and a maximum of 1.5 meters.

The cause of fall was the earthquake (July 16,1990) that hit the Benguet Province fractured causing rock joints dislocating a portion from the bedrock. The seepage of water from the bedrock softens cracks and joints and causing it to fall.

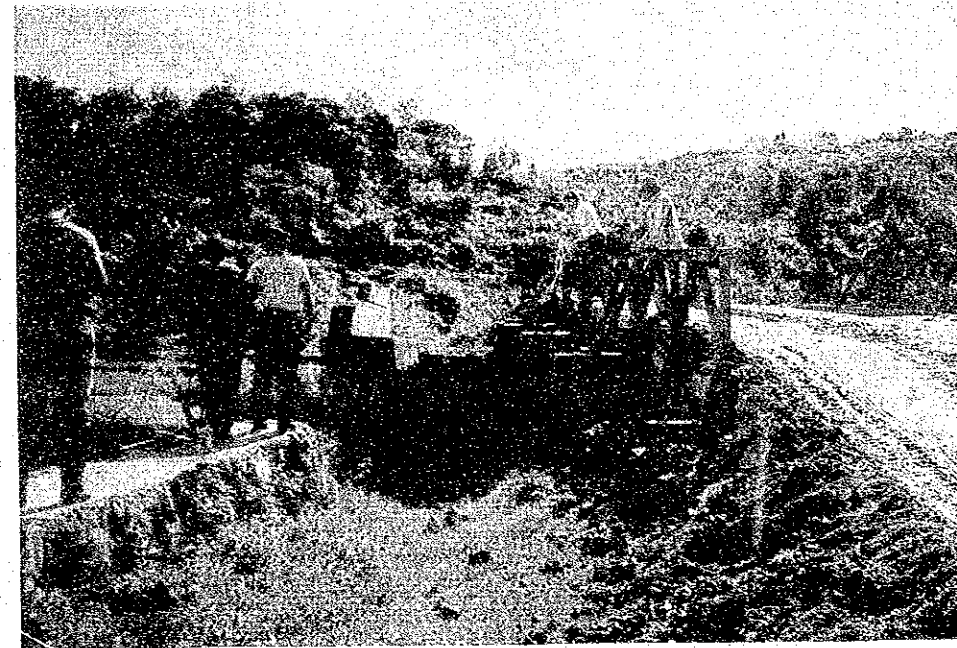
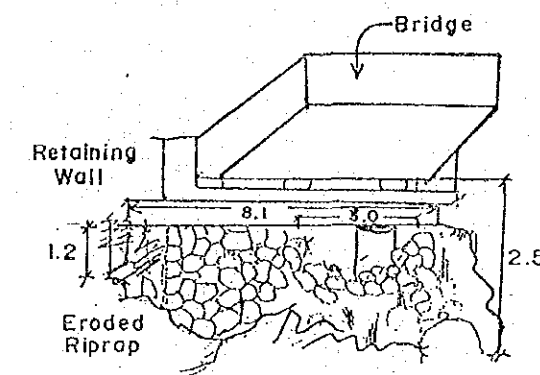
BENGUET SPOT NO. 63 (Bt-63)

- Type of Disaster : Bridge approach washout
- Magnitude of Damage : 9.0 meters in length x 4.0 meters in width x 6.0 meters in height
- Date Noticed :
- Degree/Period of Traffic Interruption : High/ one week

The permanent concrete bridge has length of 23.0 meters and a two (2) lane structure. The flood plain of the river stream has width of 35.0 meters. The bridge approach failure was caused by typhoon which struck the northern part of Luzon Island in 1990. The scoured approach was remedied by adding a temporary 9.0 meter long Bailey Bridge to allow continues flow of traffic.

Bridge length was too short. Meandering of river channel and debris coming from the mining site directly hit and washed out the approach.

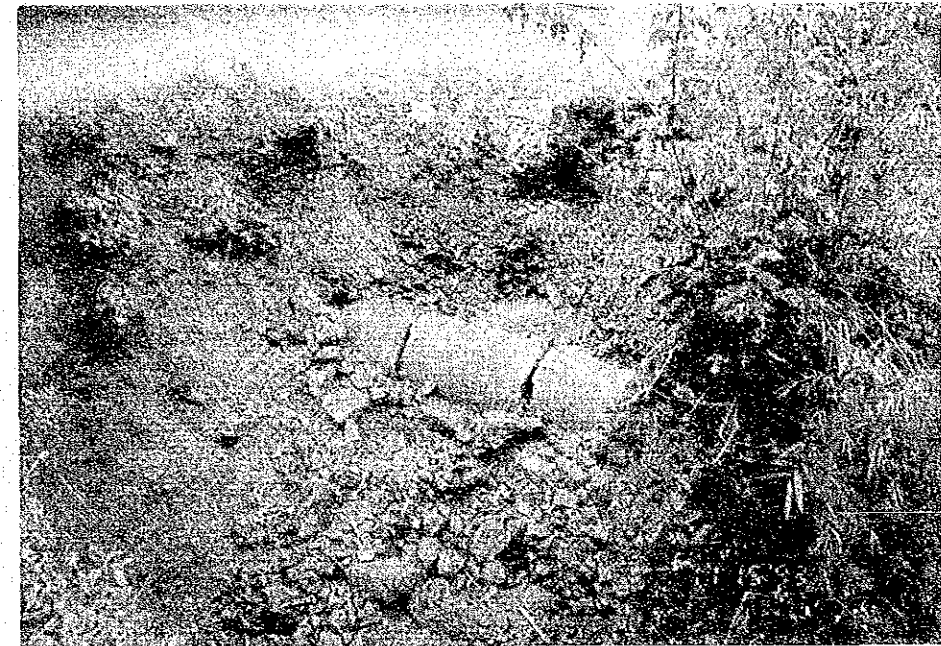
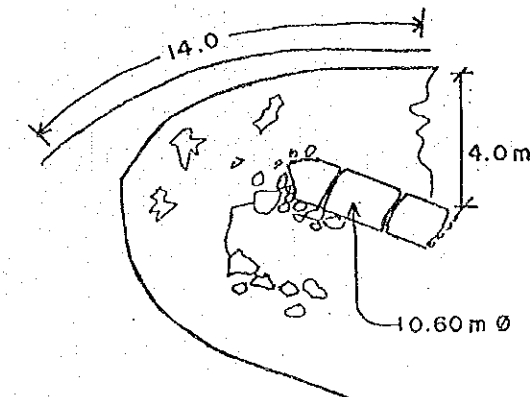
BENGUET SPOT NO. 68 (Bt-68)

- Type of Disaster : Washout Reinforced Concrete Pipe (RCP),
damaged embankment, eroded road surface.
- Magnitude of Damage : Embankment 12.0 meters in length x
4.0 meters in width x 3.6 meters in
height, RCP washout
- Date Noticed : Aug. 1990
- Degree/Period of Traffic Interruption : Low and still
passable

The spot is located at sharp curve . The reinforced concrete pipe culvert (diameter 0.6 meter) mounted on the embankment side slope of the road was silted & clogged. The grouted riprap that protects the roadway from scouring was destroyed due to the concentration of surface running water coming from upstream.

During heavy rains water coming from upstream as well as running on the road surface concentrates at this point and overflow the road surface. The absence of drainage facilities such as side ditches and cross drainage at upper grade of roadway causes the surface water to flow on the roadway. The water on the Mankayan side scoured the inlet of the RCPC. No headwall and collaring was provided on RCPC.

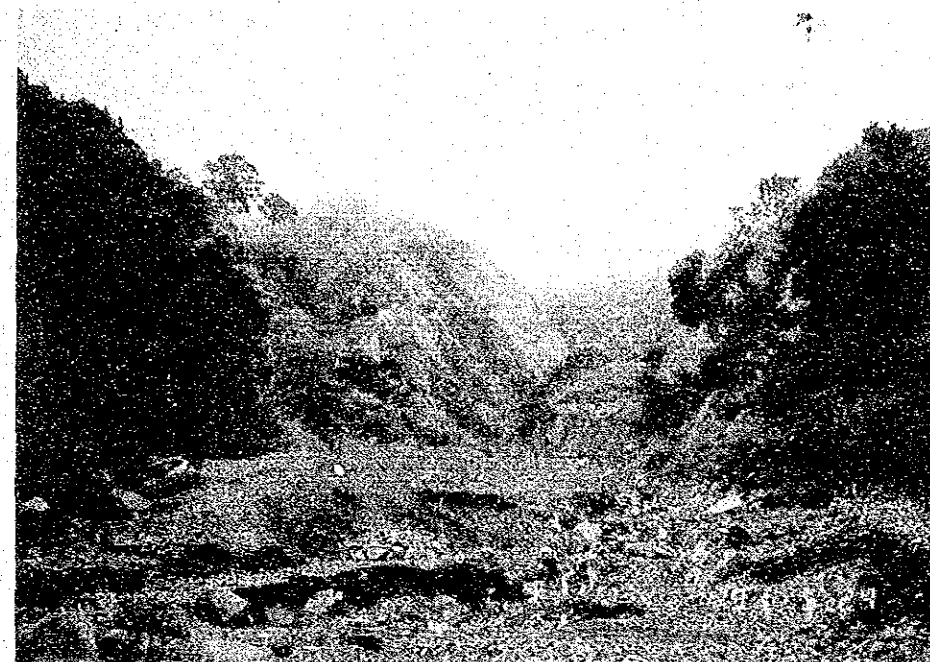
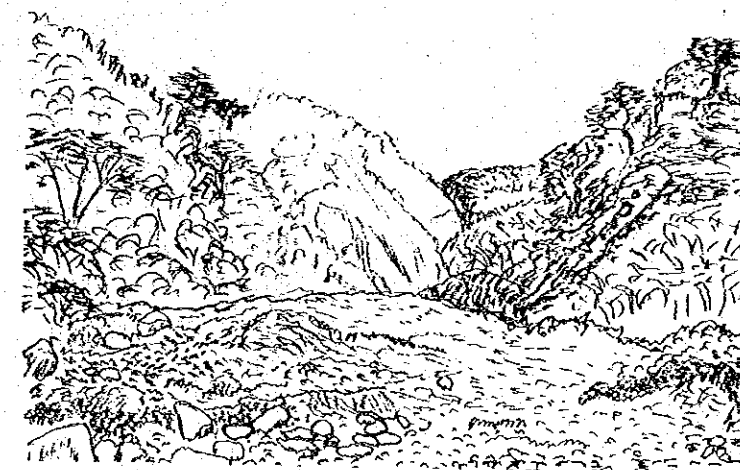
BENGUET SPOT NO. 70 (Bt-70)

- Type of Disaster : Debris Flow
- Magnitude of Damage : 25 m. in length x 5 m. wide
- Date Noticed : every time after heavy rain
- Degree/Period of Traffic
Interruption : 3 days - 1 week not passable

The debris flow on the ravine was brought down the flow of rain water at the far distance from upstream. After heavy rains debris flow already deposited on the bed of ravine.

This failure is caused by concentration of surface water from upstream. Rock and boulders deposited along the ravine flow down with rain water. Sabo work should have been provided on this spot.
