DESCRIPTION AND DESIGN OF RESTORATION MEASURES
FOR EACH DISASTER SPOT (BATANGAS)

PROVINCE: **BATANGAS**
SPOT No. : **Bs-3(1/2)**

NAME OF ROAD : **MAHAYAHAY JCT. - PAYAPA ROAD**
ROAD CLASSIFICATION: **NATIONAL SECONDARY ROAD**

TYPE OF DISASTER : **EMBANKMENT SLOPE FAILURE**

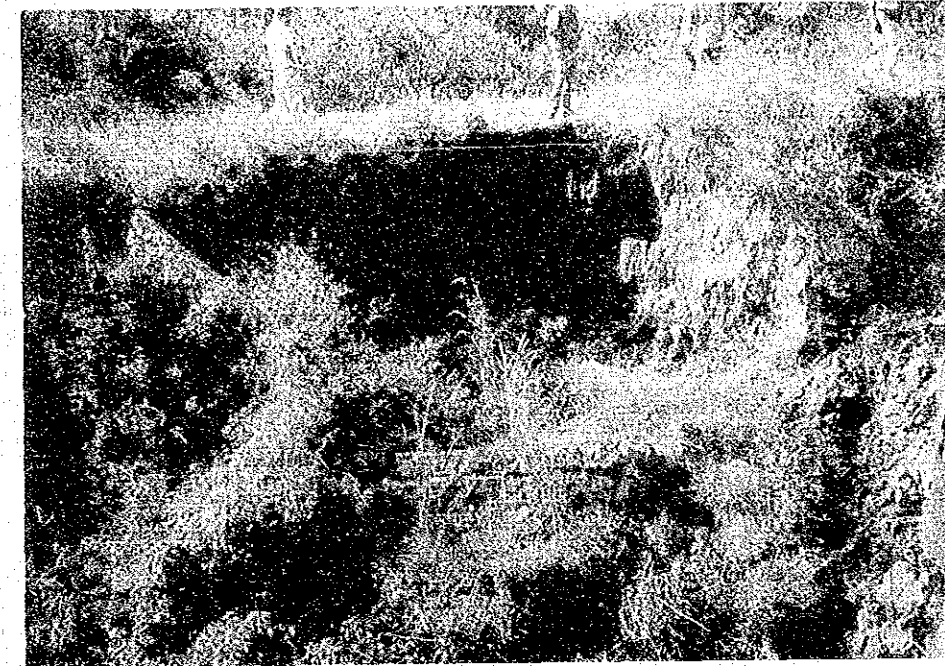
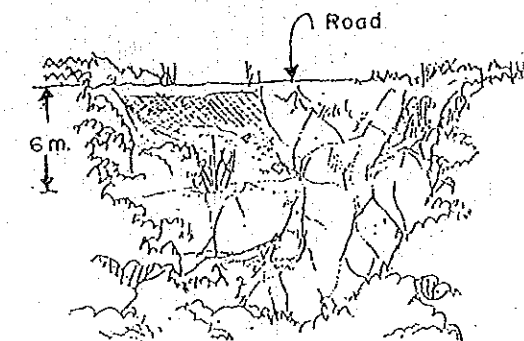
- Type of Disaster: Collapsed Grouted Riprap and Shoulder Erosion
- Magnitude of Damage: 12.0m W. x 2.5m H
- Date Noticed:
- Degree/Period of Traffic Interruption: Medium and One lane still passable
- Description of Disaster:

For this particular spot, the retaining wall was constructed without any foundation to hold the structure firmly. It is laid on a relatively erodable material of unconsolidated volcanic ashes and sands. The top and the toe of the retaining wall have been constantly disturbed by movement of water along the side drain from higher vertical alignment of the road. Direct erosion at the shoulder of the road and at the toe of the retaining wall is then occurring when soil particles are loosened and transported by water. The said phenomena led to the caving-in of the natural slope materials and eventual collapse of the retaining wall. To date continuous scouring has further damaged the road embankment which has already encroached half of the road section making it highly dangerous to traffic.

- Poor drainage system (silted and vegetated).
- The natural slope (valley side) consist of volcanic ashes and sand which is highly erodable materials.
- The caving-in of natural slope materials created a hallow portion behind the structure protecting it.
- The erosion of soil behind the retaining wall had progressed deeper to the toe of the structure thus created a cantilevered condition which eventually collapsed due to its own weight.
- No weep holes and foundation were provided.

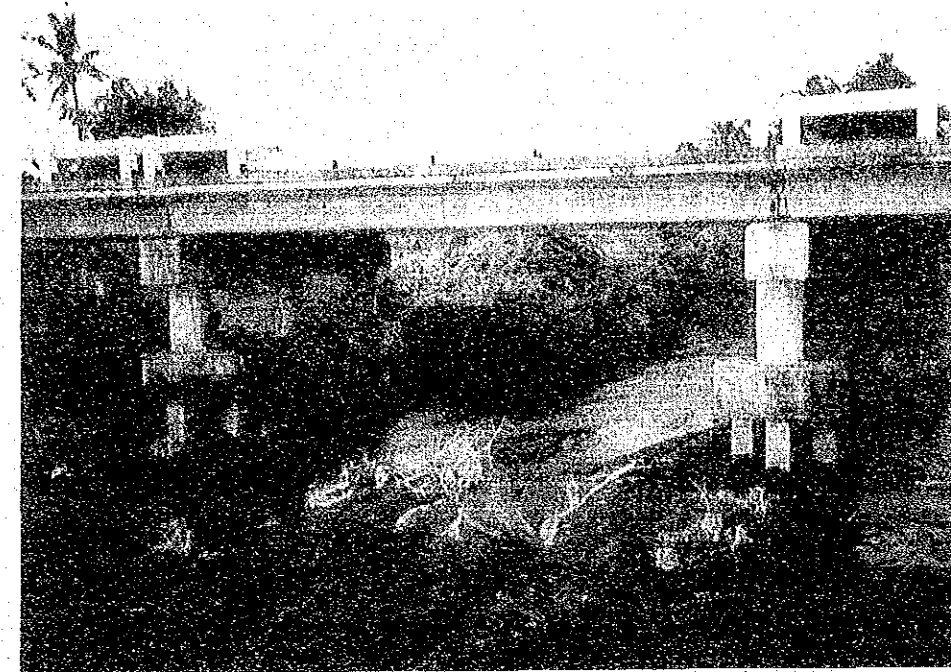
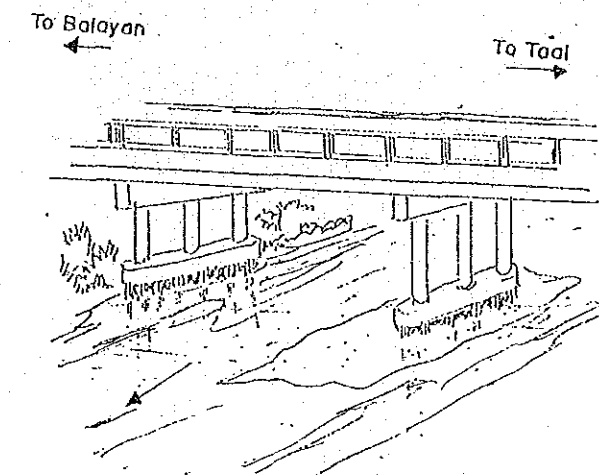
- Type of Disaster: Permanent Bridge Damage (Expose of Pile)
- Magnitude of Damage: Two pier foundations are exposed, scouring depth is 2.0 meters at pier 1 and 1.5 meters at pier 2.
- Date Noticed: 1985
- Degree/Period of Traffic Interruption: Low
- Description of Disaster:

The existing Sirisian Bridge is 3 spans at 12.0m, 2-lane RCDS structure. Scouring of the river bed materials at the footing of the bridge was noticed in 1985. During its construction in 1983, pier footings were placed below the river bed, however, the river bed is presently lowered by 2.0 meters below the bottom of footing at pier 1 and 1.5m at pier 2 which has severely exposed the foundation footings. Gabion mat at the lower portion of the abutment protection was partly sagging due to the lowering of original river bed. Retaining wall was constructed in 1989, adjacent to the structure at the downstream portion, to protect the river bank from scouring and the feeder road and neighboring houses from overflowing.

Generally in this case, scouring occurred primarily due to the continuous quarrying of sand and gravel downstream, 100m away from the structure. The scouring was further aggravated during heavy rains due to strong velocity of water.

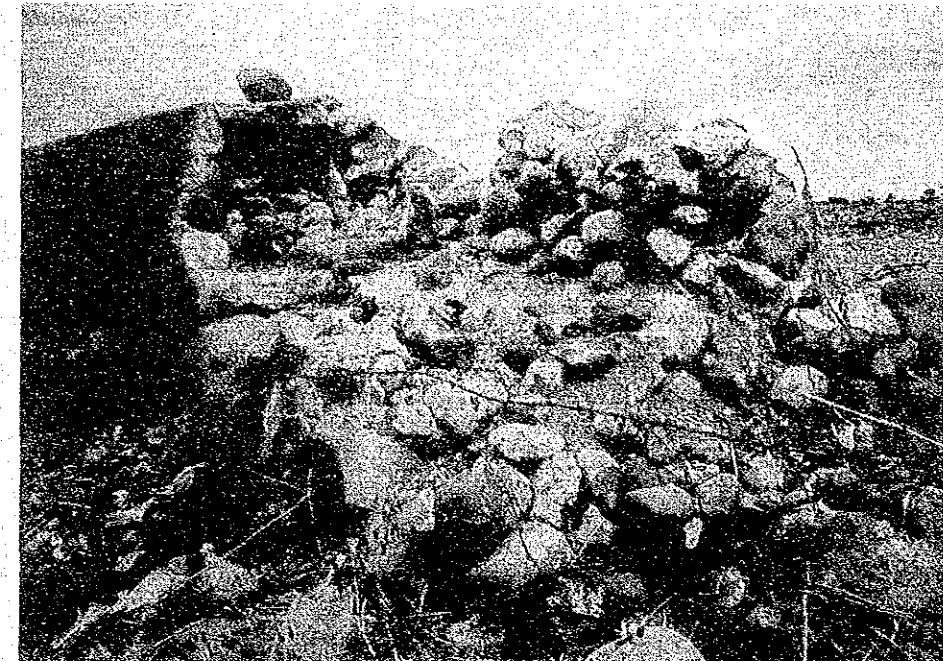
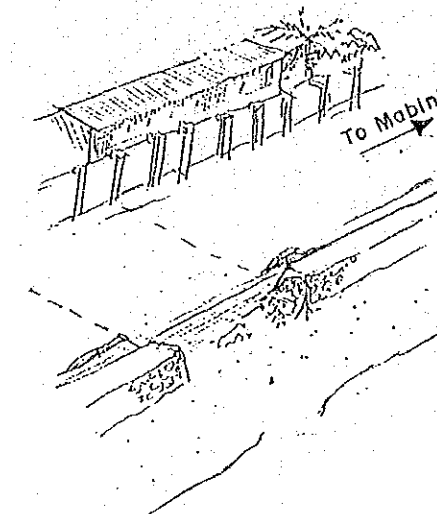
- Type of Disaster: Seawall Damage
- Magnitude of Damage: At one end 3.0m, and other end 1.5m long
- Date Noticed: Occured 1990
- Degree/Period of Traffic Interruption: Low/None
- Description of Disaster:

The original 52.0m length of the seawall was just cut short to the existing length of about 32.0m due to fund constraints. The seawall was constructed with the dimension of 0.8m top width, base width of 1.8m and 1.3m in height. The primary purpose of constructing this seawall was to protect the opposite school building from seawaves. However, damage with an extent of 3.0 meters long at one end adjacent to the spillway and 1.5m long at the other end in front the gate of the school building occurred during the 1990 typhoon.

The damage was caused by the backwash wave action at both ends of the seawall during the typhoon. This could also be attributed to the poor construction method and workmanship wherein insufficient amount and poor quality of mortar was applied only along the side of the structure, and no grout was used inside the structure as shown in the picture above.

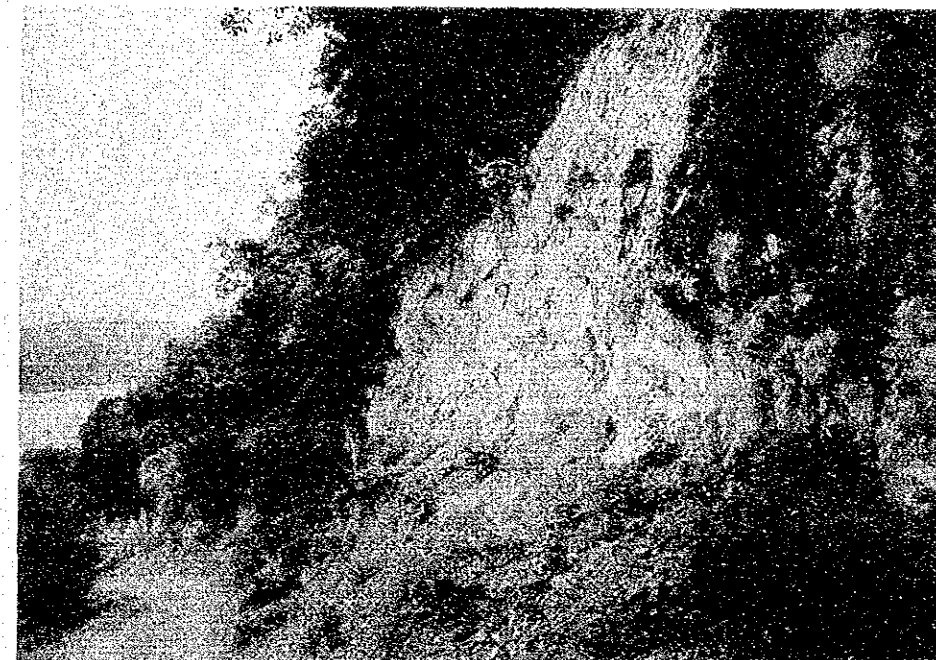
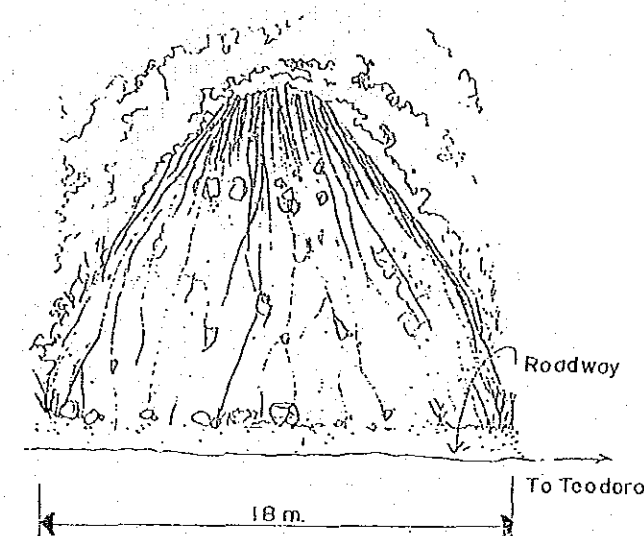
- Type of Disaster: Rockfall
- Magnitude of Damage: 7.0m in height x 70m in length
- Date Noticed: Once a year
- Degree/Period of Traffic Interruption: High/5 days/year
- Description of Disaster:

This failure occurs at least once a year. The height of disaster dimension varies from 3.5 - 7.0m in height and 150m long, but due to continuous rockfall and sliding of top soils damaged area is increasing year by years. The falling rocks and debris block the whole width of the road, resulting in a total closure of traffic for about 5 days, thus impact to the road is very high.

- Major failure occurs along the developed joints.
- Due to orientation of joints which incline towards the road, rockfalls are most likely to occur along these joints during heavy rains.

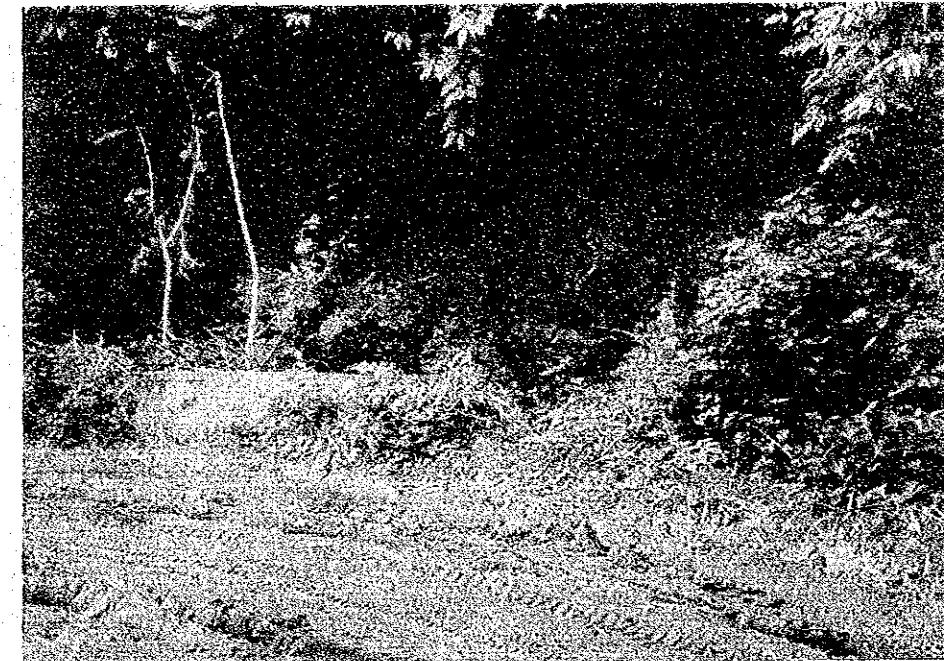
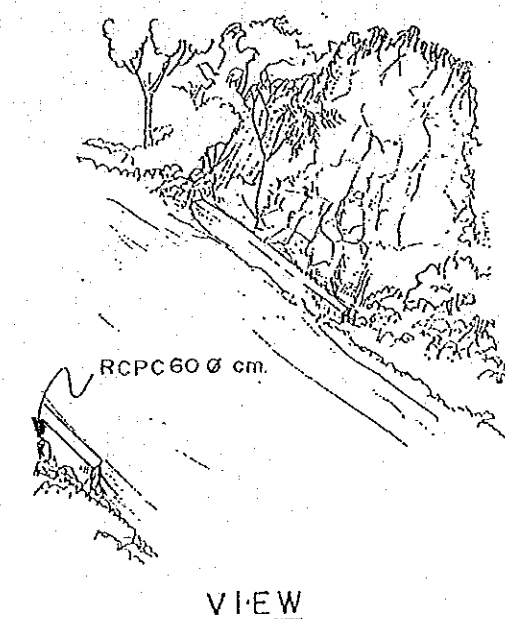
- Type of Disaster: Floody/Muddy Road
- Magnitude of Damage: 42m long along the roadway
- Date Noticed: During rainy season
- Degree/Period of Traffic Interruption: Low
- Description of Disaster:

The existing pipe culvert 0.60m ϕ was laid 42.0m away from the lowest portion of the roadway. It is observed that the pipe culvert entrance is partly clogged with rocks and other debris and has insufficient capacity to discharge the rain water. No side ditches were provided/constructed, so at every heavy rain the water coming from the gullies and spring is rather confined in the roadway therefore road surface resulted to a floody/muddy road.

- Improper location of pipe culvert.
- Culvert pipe diameter incorrect.
- Partial obstruction of culverts by rocks and natural debris and other materials.
- No side drain.

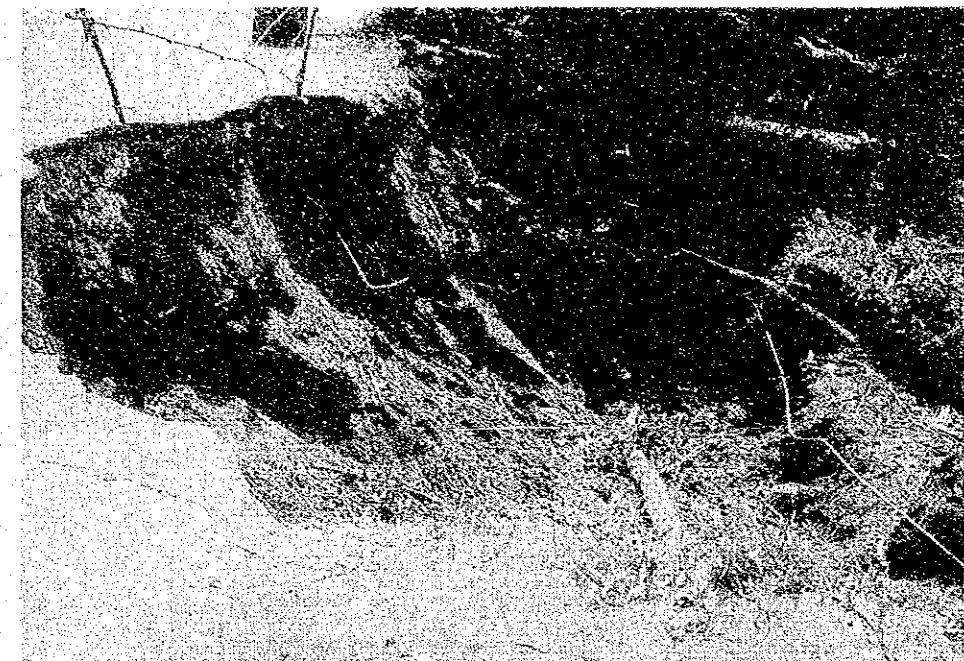
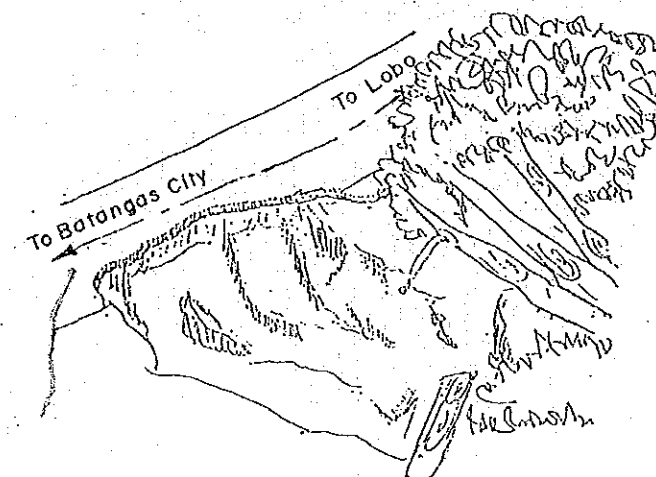
- Type of Disaster: Erosion of embankment protection and almost half of the roadway.
- Magnitude of Damage: 16m. long and 3.0m. in height
- Date Noticed:
- Degree/Period of Traffic Interruption: Medium
- Description of Disaster:

This spot was affected by strong current of water from the adjacent lateral canal during heavy rains. First, the toe of the embankment protection was slowly eroded that led to its eventual collapse. It was also aggravated by the earthquake that happened last July 16, 1970.

The damage was due to the seeping of water at the toe of the embankment protection. It was also caused by absence of base foundation and weepholes. Weak embankment protection was also one of the causes of damage.

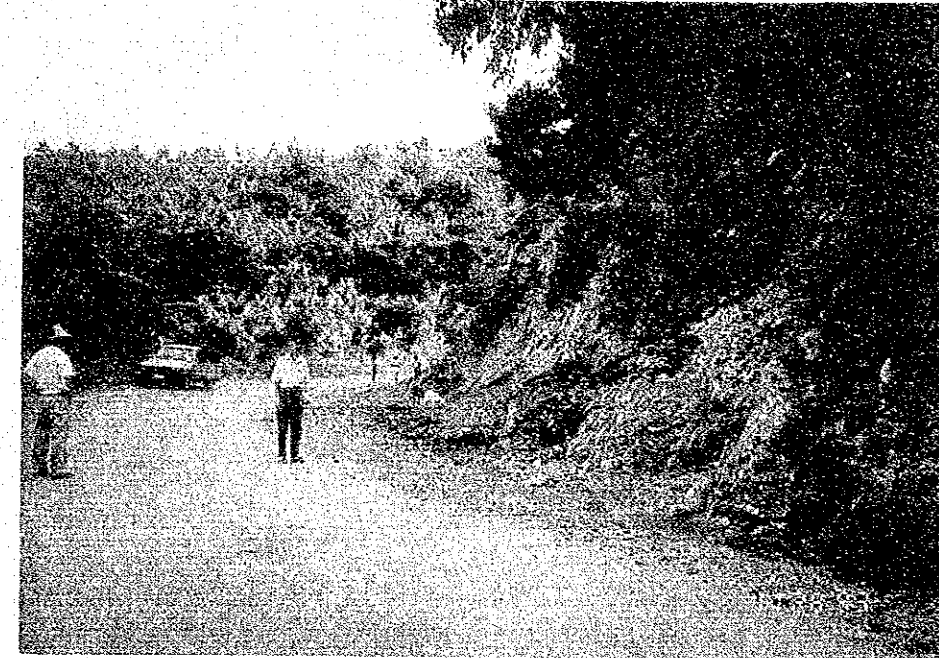
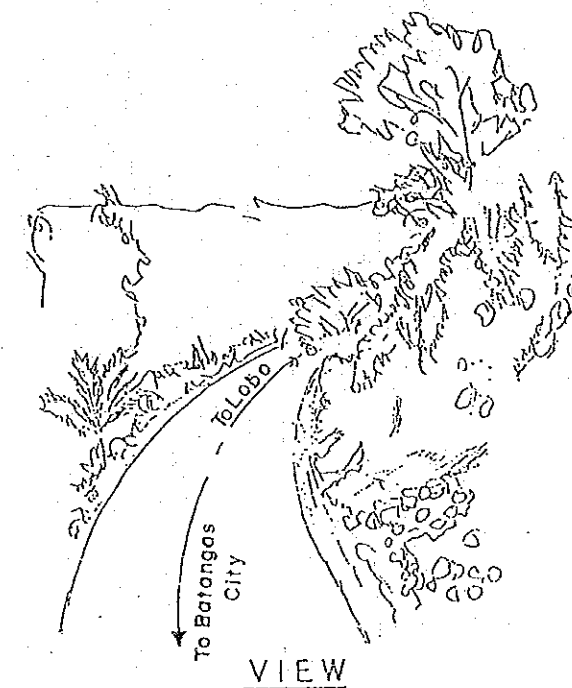
- Type of Disaster: Rock Fall/Debris Fall
- Magnitude of Damages: 42m long x 20m high
- Date Noticed: Rainy Season/dry season/earthquake
- Degree/Period of Traffic Interruption: Low/None
- Description of Disaster:

The spot is located on a sharp curve. Two damaged portions are observed, one is situated at Dagatan side which is composed of highly weathered andesite rocks and the other is located at Lobo side which is also composed of highly weathered tuff. The dimension of damage was about 32.0 meters long and 20.0 meters in height. In the whole area of tuff type, rockfall, fallen debris and sliding of the top soil are expected to occur regardless of weather condition. Effect of rockfall and fallen debris is hazardous to the commuters because of its location.

- the rocks are highly weathered and fractured.
- fall is triggered by water pressure on open joints (andesite).
- intense weathering on the tuff joints which are filled with clay minerals.
- instability of the former slope which is almost vertical.

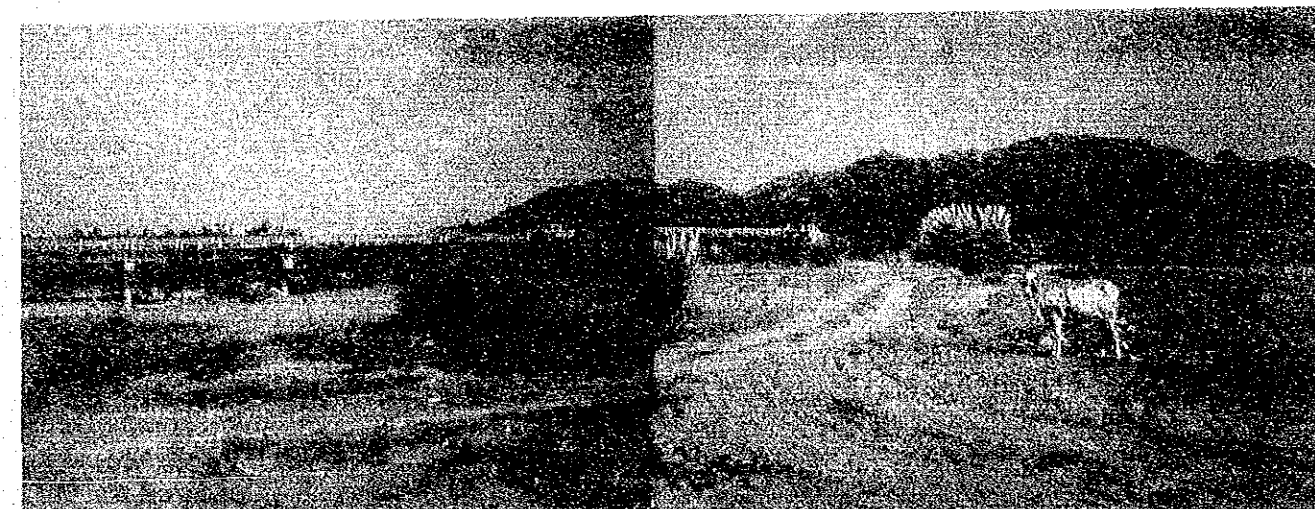
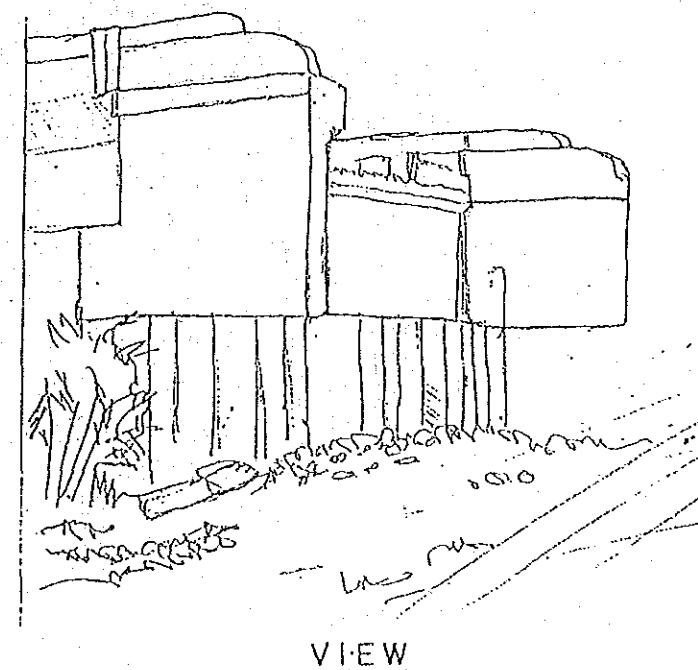
- Type of Disaster: End approach washed-out due to meandering of river
- Magnitude of Damage:
- Date Noticed: 1986
- Degree/Period of Traffic Interruption: High/Abandoned
- Description of Disaster:

The RCDB Lobo Bridge with a total length of 122 meters/8-span (span length = 15.24m) was completed in 1984. In 1986, the Malabrigo side bridge approach started to be scoured due to the meandering of Lobo river. The Bridge was totally closed to traffic in January 16, 1988 due to the damage at the end approach caused by typhoon "Sisang" which directly hit the Province of Batangas. It must be mentioned that water did not overtop the bridge but debris especially coconut tree trunks longer than the 15m length bridge span created serious obstructions that changed/shifted the course of the river at a considerable distance of about 120m.

- River bank control protection was not considered in the design.
- No immediate remedial measure/provisions for river control to prevent further shifting of the course of the river was instituted after the meandering phenomena was noticed in 1986.

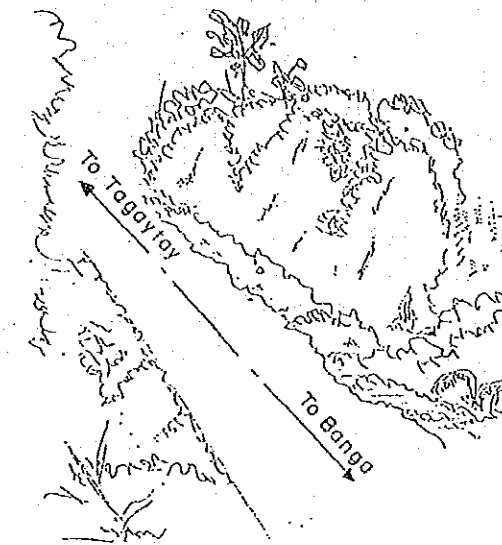
- Type of Disaster: Cut Slope Failure
- Magnitude of Damage: 5.0-8.0m in width x 50m long
- Date Noticed: Every rainy season
- Degree/Period of Traffic Interruption: Low/None
- Description of Disaster:

The spot is located on a cut slope section. Almost horizontal stratification is noticeable on the left side slope towards Tagaytay and the opposite cut slope shows deep weathering almost dry and devoid of vegetation and stratification is hardly visible. The damage dimension varies from 5.0m - 8.0m in height and 50 meters long only at the right side towards Tagaytay Road. Only small scale failure is expected to occur, considering rock joints are not present, thus less possibility of water infiltration.

For this case, the wearing-off of tuff kind of rock due to weathering action, the steep gradient and the absence of vegetation activated the material to fall easily causing small scale of slide.

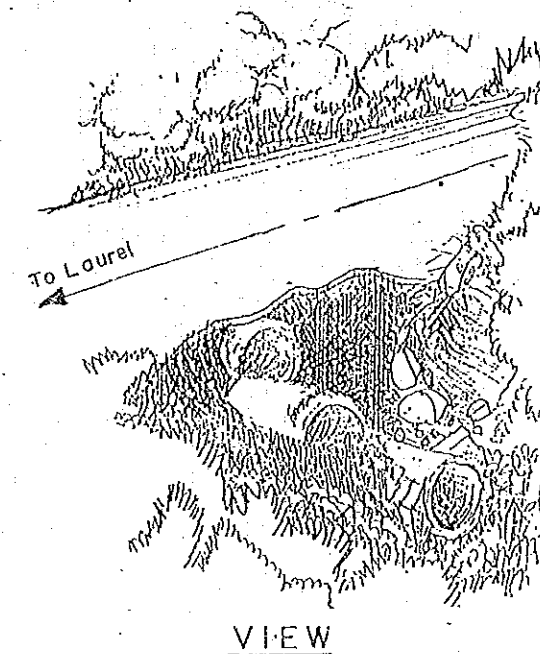
- Type of Disaster: Collapsed pipe culvert at the downstream portion
- Magnitude of Damage: 5.5m long, 4.8m wide and 2.5m height
- Date Noticed: Sudden collapse
- Degree/Period of Traffic Interruption: Medium
- Description of Disaster:

For this particular spot, pipe culvert has a diameter of 0.9m, two adjoining creeks drain into the pipe culvert where the water does not directly flow towards the inlet but is obstructed or bended by the wingwall then finally to the pipe. During heavy rains, large volume of water carrying debris could not be accommodated in the pipe culvert clogging its entrance and the tendency is to overflow on the roadway. Overflowing had caused the gradual erosion at the base of the apron of the outlet until most of the materials at the wingwall had been eaten up, creating a gaping hole. This gaping hole served as the passage of eroded materials and running water.

This continuous process eventually widened the hole, eroding further the materials around the pipes which led to its eventual collapse. Damage had already reached almost half of the roadway and is considered highly dangerous to travelers especially during night traffic.

- Improper location of pipe culvert.
- Diminished bearing capacity of foundation layers and settlement of soils under foundation.
- Erosive action around structure.
- Settlement with subsequent cracking in headwall, wingwall and culvert structure.
- Heavy concentration of whirling water had further encroached the pipes and removed the surrounding soils resulting to its collapse.

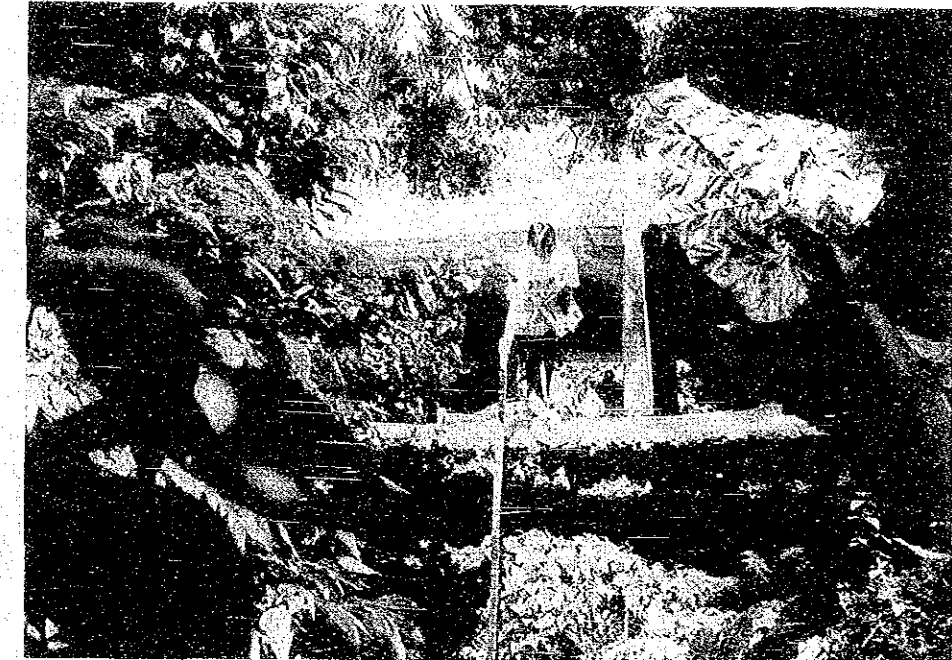
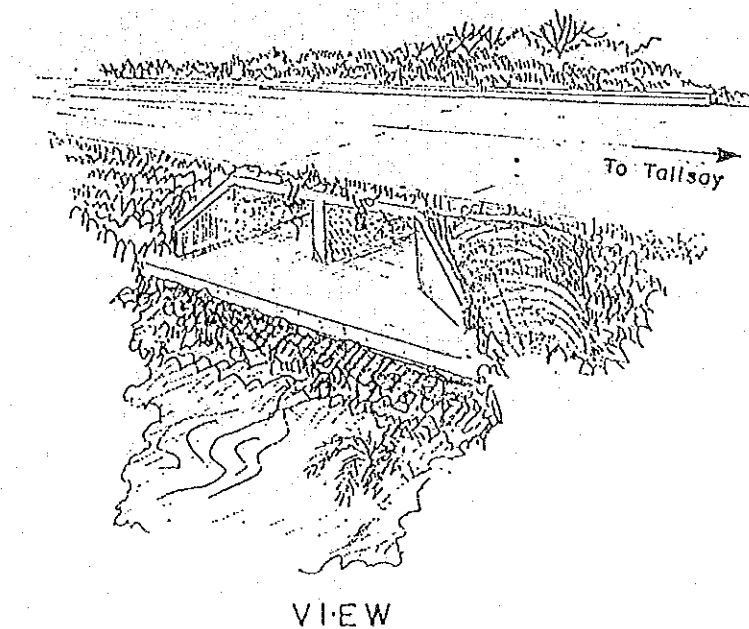
- Type of Disaster: Scoured riverbed at the downstream portion
- Magnitude of Damage: 1.5m height, 8.4m long, 1.0m wide
- Date Noticed:
- Degree/Period of Traffic Interruption: Low/None
- Description of Disaster:

Similarly, it was observed that the creek channel and banks were heavily eroded/scoured due to the cascading action of floodwaters hitting the wingwall before it enters the inlet.

The material for this particular spot is characterized as volcanic sand with gravel easily to accelerate and erode. Due to strong flow of water during heavy rains, the riverbed from the foot of the apron started to scour carrying the deposited sediments and causing the apron to be in its hanging condition which is expected to damage further the main structure if no countermeasure will be taken into consideration immediately.

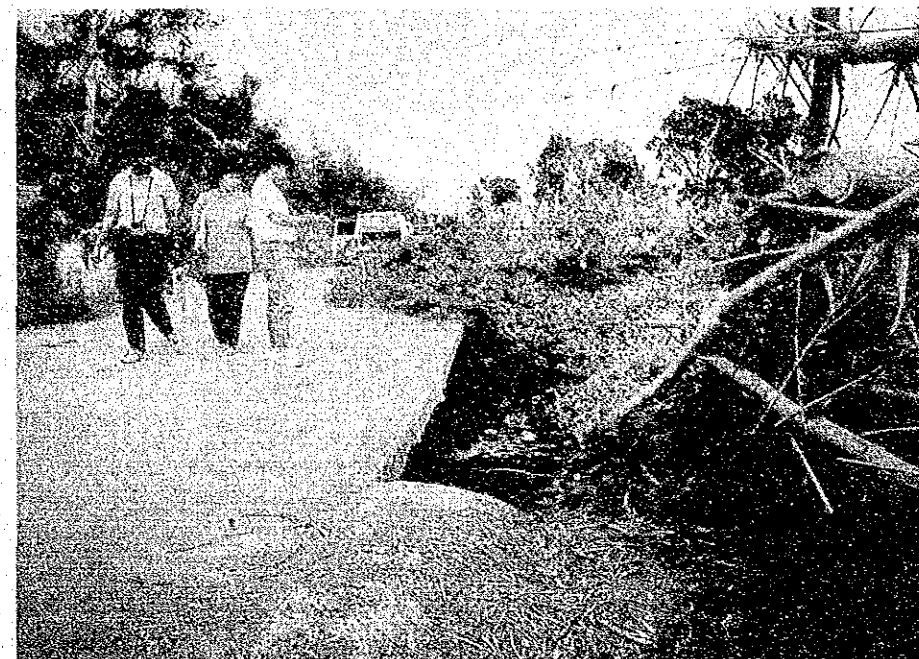
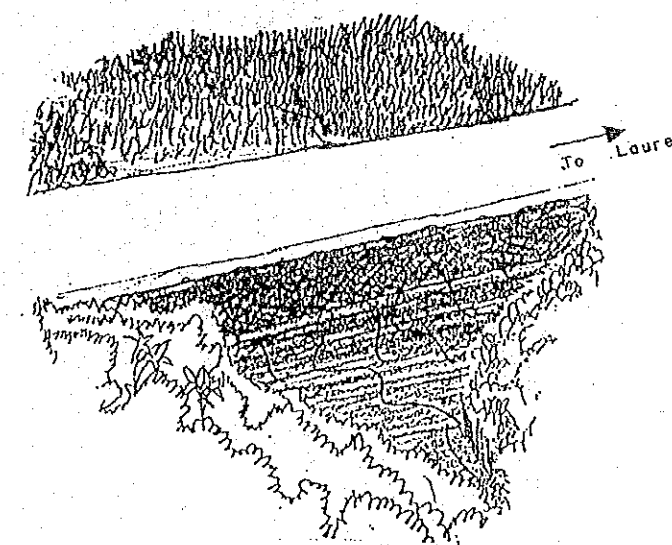
- Type of Disaster: Scouring of Natural Roadbed and shoulder erosion.
- Magnitude of Damage: 12.0m long, 1.5m wide, 1.4m height
- Date Noticed:
- Degree/Period of Traffic Interruption: High/Closed to traffic
- Description of Disaster:

At this particular spot, the road shoulder as well as the natural roadbed materials were totally scoured and has a magnitude of damage of about 12.0m long, 1.5m wide and 1.4m in height, causing the PCC pavement to hang. The scoured portion had already reached a width of 1.5m and a slight sagging on PCC pavement was observed. The hanging pavement is considered dangerous when subjected to heavy load. Immediately beside this failure is a lagoon which is enclosed by deposit of sand dunes which presently acts as a barrier from further scouring of the affected area.

As the embankment protection was not constructed in this particular spot and the road was just about 45m away from the shore line of Taal Lake, this damage was triggered mainly by wave action during high tides that directly hits the embankment/natural road slope. Failure was also aggravated by the flow of big volume of running water coming from the mountain slope which directly drains into this section during heavy rains.
