DRAWING NO.
102

Batangas Spot No. 48 (BS-48)

5. RESTORATION MEASURES FOR SELECTED SPOTS IN LEYTE

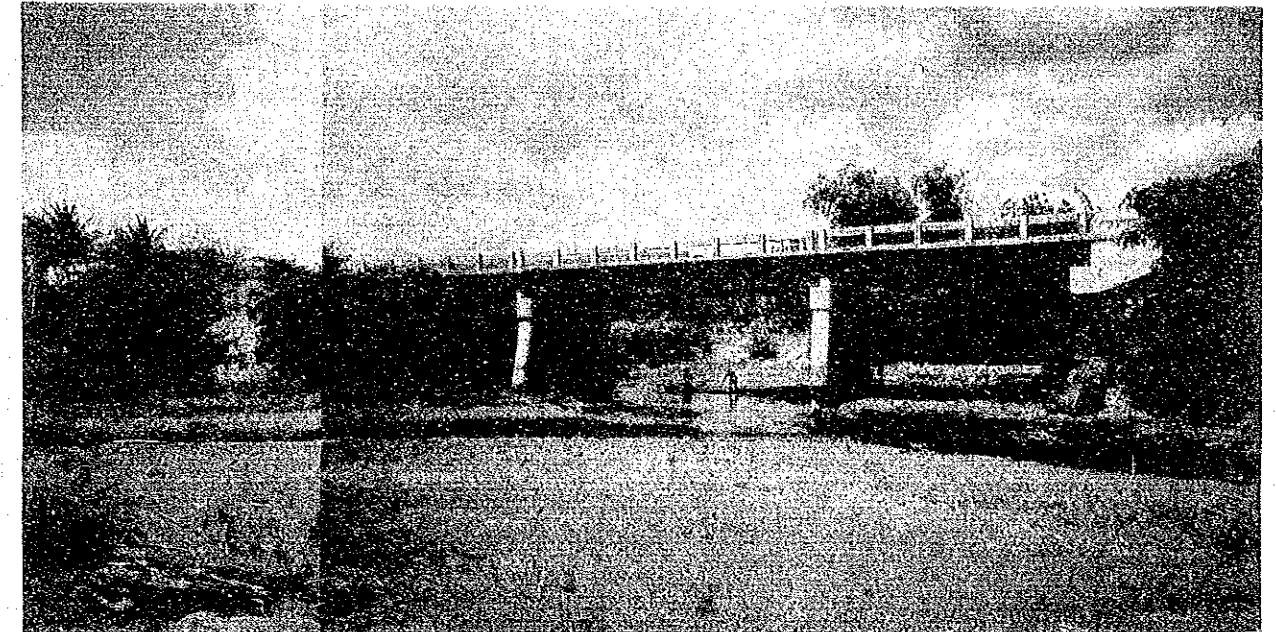
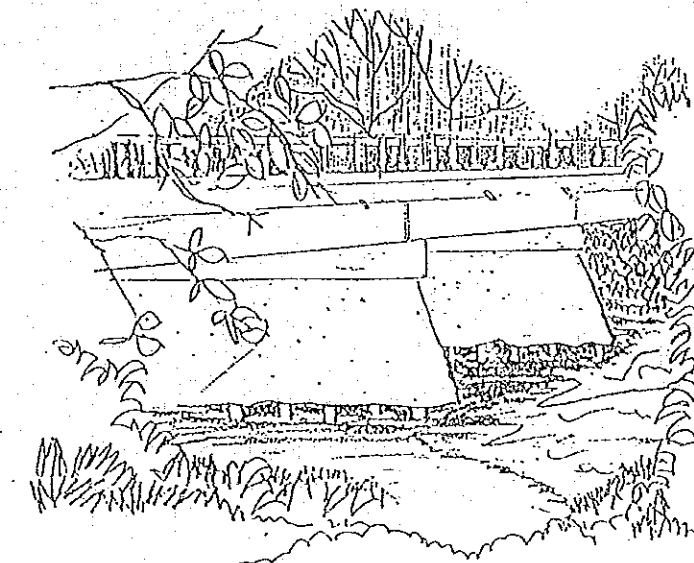
VIEW

- Type of Disaster: Permanent Bridge Damage (Expose of Pile)
- Magnitude of Damage: 1.0 to 1.20 meters
- Date Noticed:
- Degree/Period of Traffic Interruptions: Low/None
- Description of Disaster:

The existing 3 span, 2 lane RCDG Alas-as Bridge with a total length of 34.5m was constructed over two converging rivers, to mention the Alas-as and San Gabriel rivers. The height of the bridge based from the original river bed was 7.9 meters. Continuous scouring of the river bed due to turbulence of water has lowered down the elevation of the river bed thereby exposing the pier footing. To date the height of the bridge based from existing river bed is 9.9 meters. The sheet piles that protect the approach of the bridge were damaged by strong typhoon that hit Batangas Province sometime in 1984. To date absence of embankment protection has caused the scouring of the approach.

- The bridge was constructed on a wrong choice of site.
- Piers/abutments not in line with the flow of water.
- Caused by the turbulence of water due to confluence of two streams.

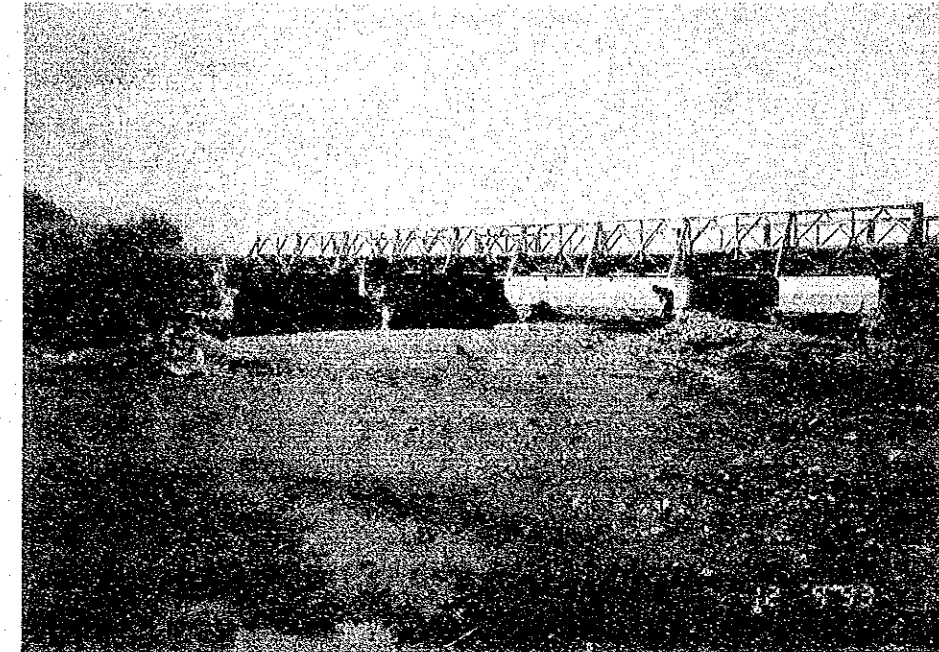
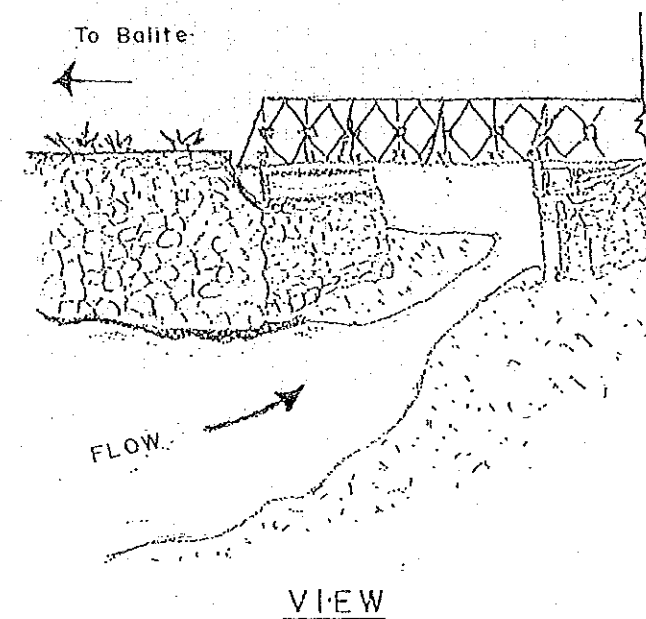
- Type of Disaster: Temporary Bailey Bridge Damage (Approach Scouring)
- Magnitude of Damage: Approach 30 cm; Pier 15 cm
- Date Noticed:
- Degree/Period of Traffic Interruption: Low/None
- Description of Disaster:

A bailey bridge with a total length of 27 meters (3 spans) is presently crossing Banoyo River along Banoyo Jct. - San Luis Jct. Provincial Road, facing Balayan Bay. The bridge was originally constructed as one span in 1969.

After the construction, flood currents continued to scour the left bank which is composed of fluvial deposits on the upstream side of the bridge. Finally the left side approach facing Balayan Bay was completely washed away, so another span was extended in 1977.

To strengthen the bridge, additional pier was constructed in 1985. However, up to the present time, flood currents are threatening to wash away again the left approach.

- Meandering river channel to a moderate degree.
- Accumulations of sandy sediments under the bridge due to strong wave action causing the river channel to change its course.

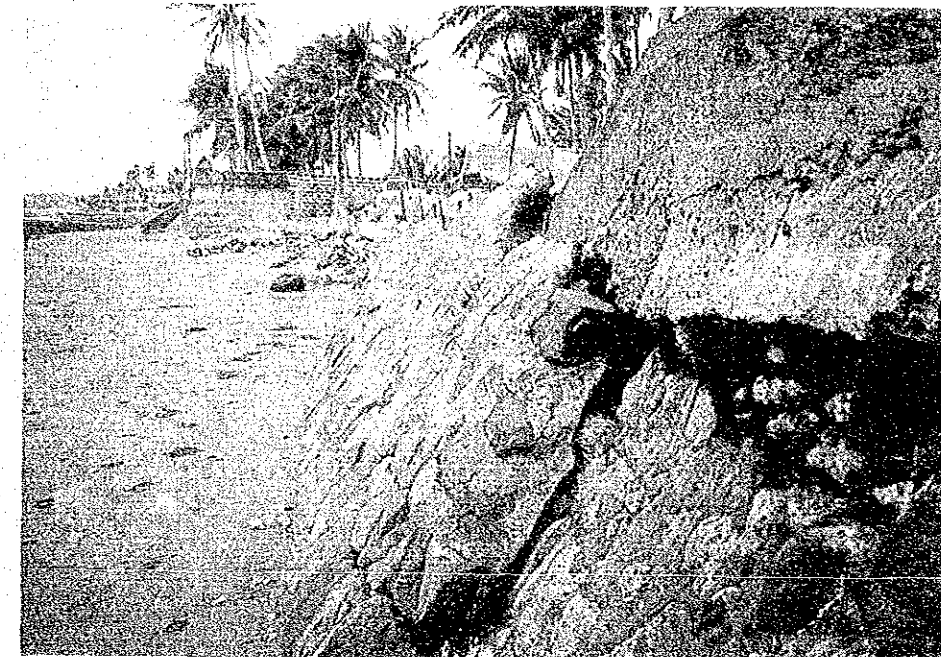
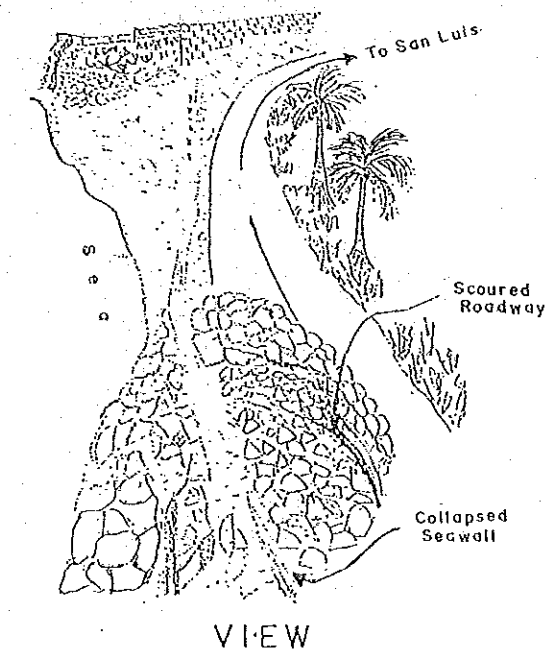
VIEW

- Type of Disaster: Collapsed Seawall
- Magnitude of Damage: 42m totally collapsed adjacent to Private Resort; 18m partly damaged near Banoyo Bailey Bridge
- Date Noticed:
- Degree/Period of Traffic Interruption: Low/None
- Description of Disaster:

This seawall was primarily constructed at the early part of 70's with a total length of 200 meters and with a height of 2.1m from the foundation. Maximum wave height experienced then was about 1.5m. After a few years, the seawave action has gone beyond the height of the existing seawall which has caused the overflowing of the roadway along the coastline. In order to protect the affected areas, additional seawall was proposed and constructed in the last quarter of 1987 with an additional height of 1.5m. During strong typhoon with heavy rains on Nov. 1988, a portion of the seawall of about 42m long adjacent to the private resort has totally collapsed and partly damaged the additional structure of about 18m near the Banoyo Bailey Bridge.

For this particular spot, the damage was basically due to strong seawaves and backwash wave action which was aggravated by poor construction method taking into account that construction joint might not be properly constructed and not enough mortar was applied to the structure.

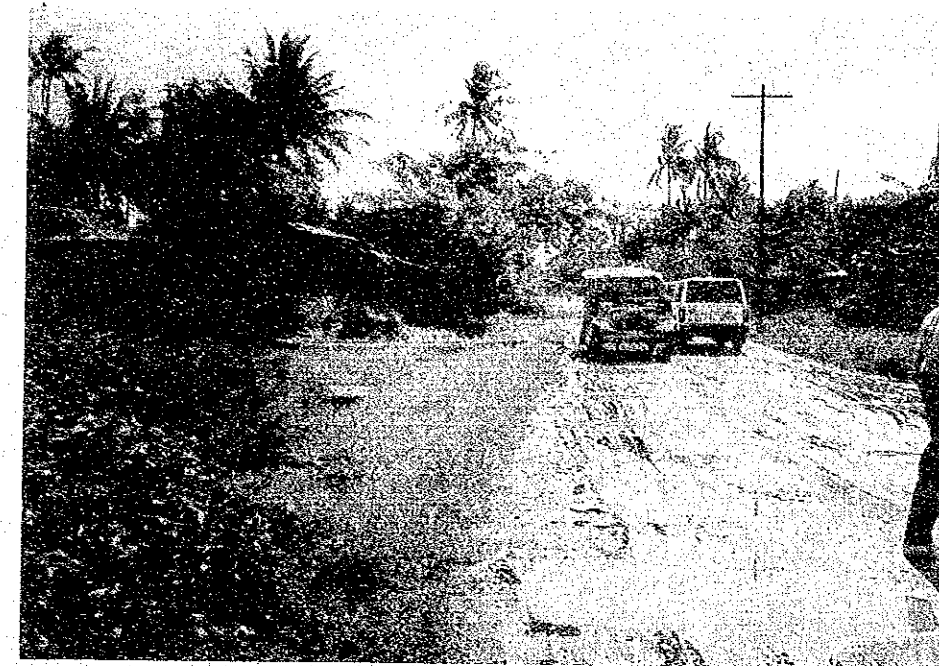
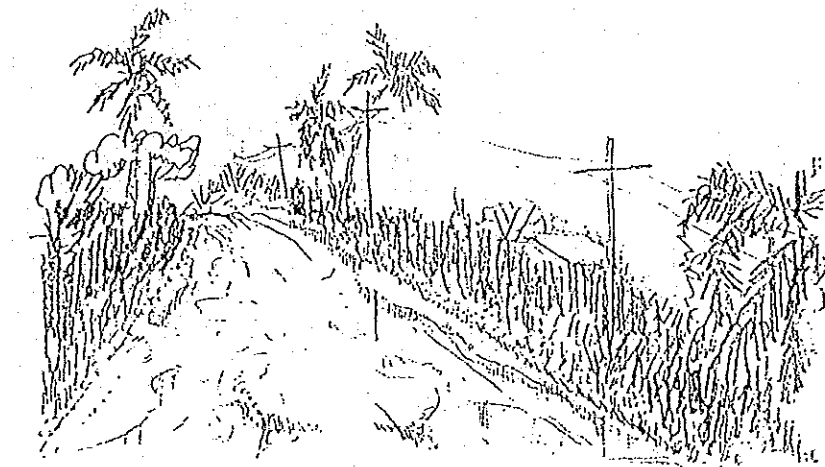
VIEW

- Type of Disaster: Floody/Muddy Road
- Magnitude of Damage: 2.0 kms
- Date Noticed: Every rainy seasons
- Degree/Period of Traffic Interruptions: Low/None
- Description of Disaster:

From Tiquiwan Jct. up to the selected spot of about 2.0 km, the whole length has experienced floody/muddy road in which transportation could hardly traverse during rainy seasons. The drainage by now is ineffective considering side drain is already silted and vegetated.

This damage was caused by higher elevation of abutting lands on both sides compared to that of the road surface and insufficient drainage facilities.

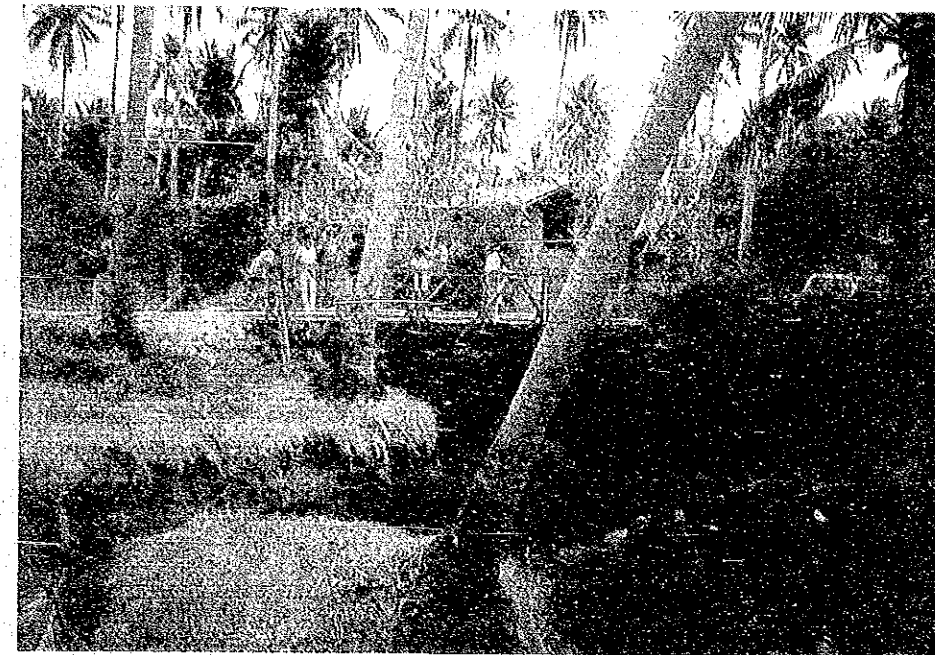
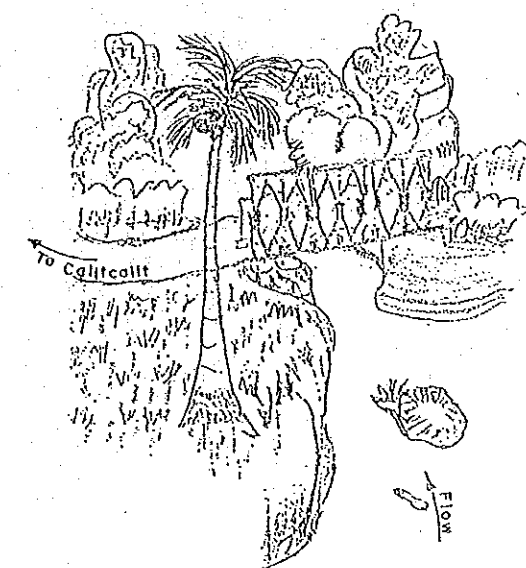
VIEW

- Type of Disaster: Timber beams/flooring and one abutment washed out.
- Magnitude of Damage: Bridge length = 8.0m
- Date Noticed:
- Degree/Period of Traffic Interruption: Road closed, but soon after the damage, bailey bridge constructed.
- Description of Disaster:

A Bailey Bridge with a total length of 9.0 meters, 1-span was located in Barrio Pootol. Considering the topography of this area which is in flat terrain and of low elevation, all the flood waters coming from Rosario, San Juan, Taysan and as far as Laguna and Quezon are drained at this place. Highest flood level during heavy rains reaches a maximum of 1.50m from the road surface. Damage to properties, infrastructures such as school buildings, roads and bridges and agricultural crops are heavily affected.

Timber beams/flooring and Tipas side abutment were washed out in 1990. Provincial Engineering Office (PEO) constructed/erected bailey bridge. Washed-out abutment was not newly constructed, however, the bailey bridge is supported on natural rock.

- Denuded mountains which could not hold rainwater.
- Lack of flood control measures such as dikes and dams.
- Very low and flat terrain condition.

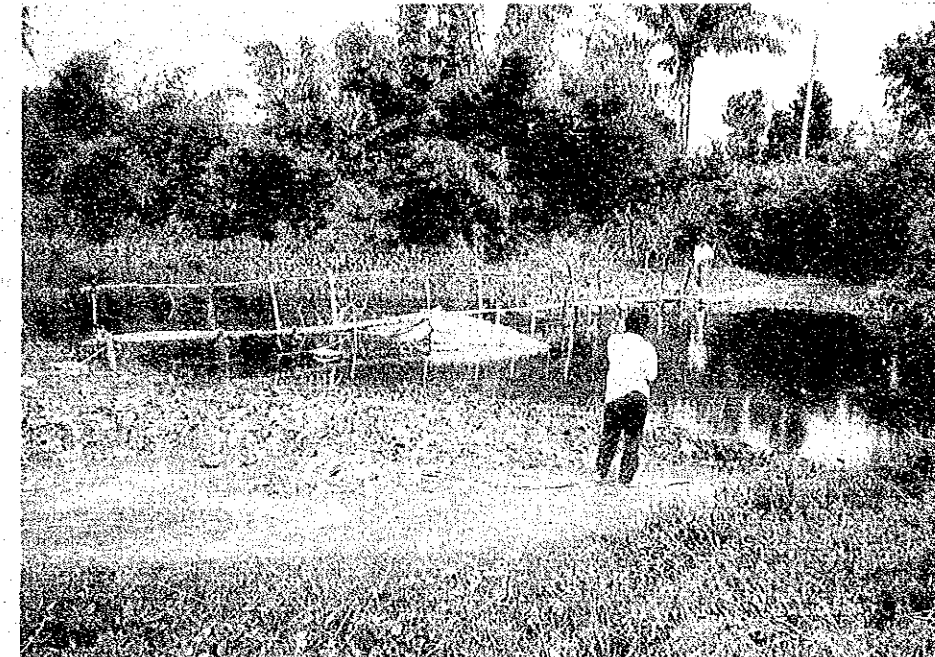
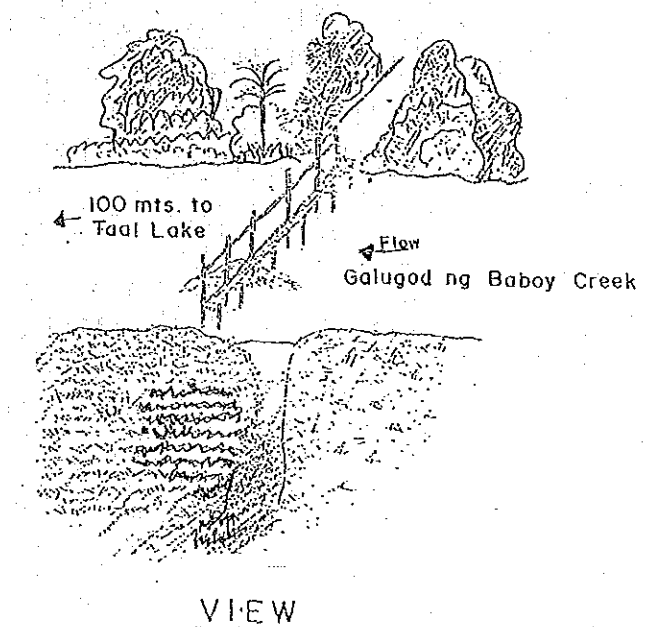
- Type of Disaster: Structure totally washed-out
- Magnitude of Damage: 21.0m
- Date Noticed: Before 1980
- Degree/Period of Traffic Interruption: High/Not passable during rainy season

The spillway was constructed with a total length of 21.0 meters with 10 pcs. of reinforced concrete pipe culvert (0.6m dia) underneath. During rainy season the spillway is under water by about 1.5 meters from the top of the structure. The spillway was totally washed-out in two years from the time of its construction. This has no available detour road but vehicles can traverse by crossing the creek with a water depth of about 0.6m during the season. At present, temporary Bamboo foot bridge was constructed by the local residents, and is being used to cross the waterway.

The immediate cause was due to the scouring of the foundation of the spillway which resulted to its collapse, thereby the structure was washed-out during heavy floods.
