DESCRIPTION AND DESIGN OF RESTORATION MEASURES
FOR EACH DISASTER SPOT (LEYTE)

PROVINCE: LEYTE
SPOT No. : L-4(1/2)

NAME OF ROAD : BARUGO - BABATNGON ROAD
ROAD CLASSIFICATION: NATIONAL SECONDARY ROAD

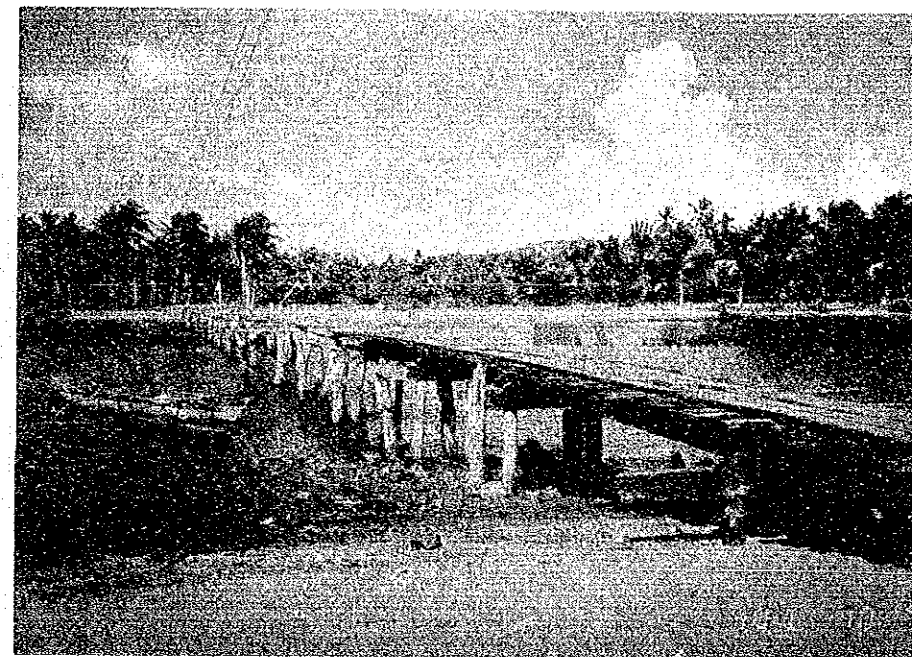
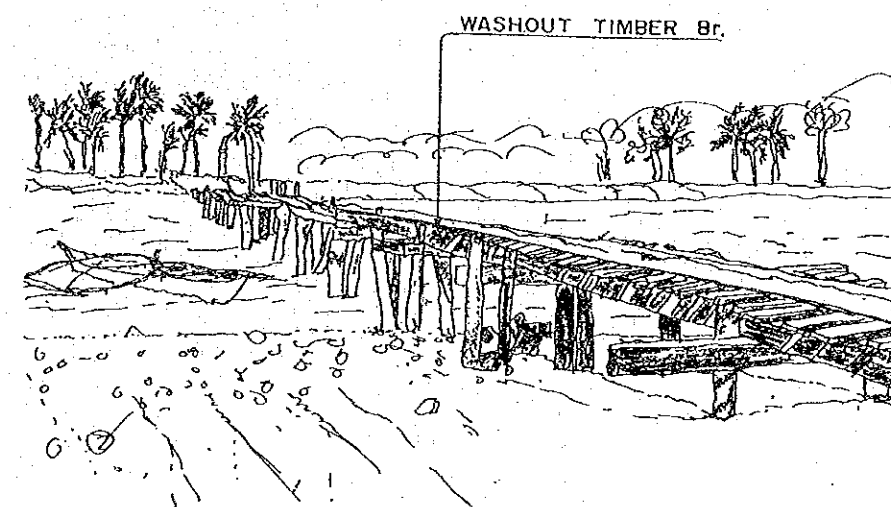
Leyte Spot No. 4 (L-4)

- Type of Disaster: Washed out of superstructure/scouring on abutments
- Magnitude of Damage: 160.0 meters
- Date Noticed: 1988
- Degree/Period of Traffic Interruption: High
- Description of Disaster:

The Cabarasan timber bridge has a total length of 160.0m, composing of 26 spans and a 1-lane bridge with 4.0m width.

The timber bridge was washed out last 1988 during typhoon "Undang". Since that time the bridge was not passable to traffic and temporary foot bridge was made available to crossing pedestrians.

No logs nor debris were coming or flowed from upstream that may cause damaged to the bridge.

- Tidal waves that hit the bridge last 1988 by typhoon "Undang" caused the superstructure to be washed out.

TYPE OF WORK	UNIT	TOTAL
URGENT RESTORATION		
U1-4	REFILLING / EMBANKMENT	CU. M. 360
U6-2	H-PILE BENT	L. M. 288
U6-3	BAILEY BRIDGE	L. M. 168
U7-1	GRAVEL SURFACING	SQ. M. 240

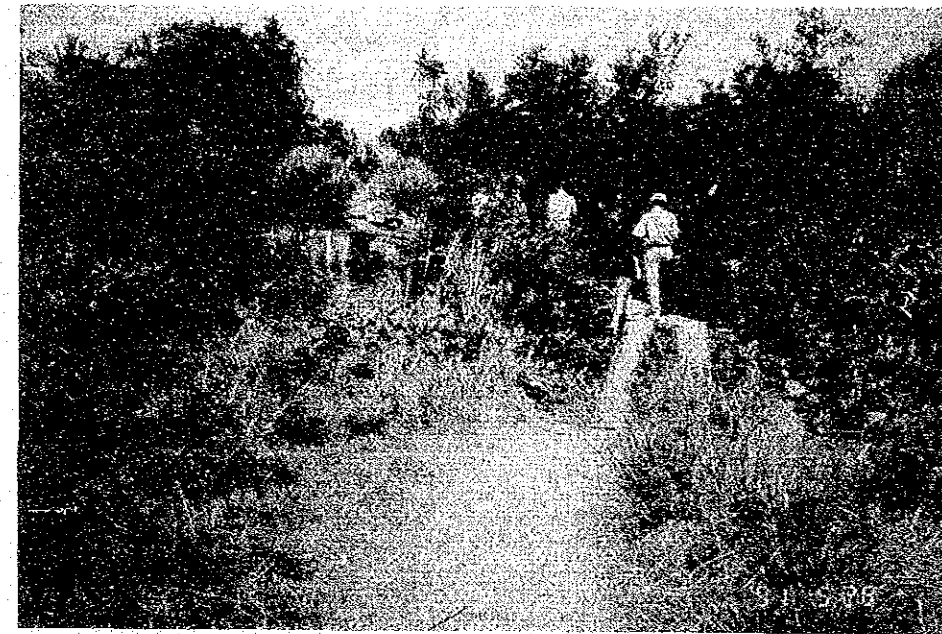
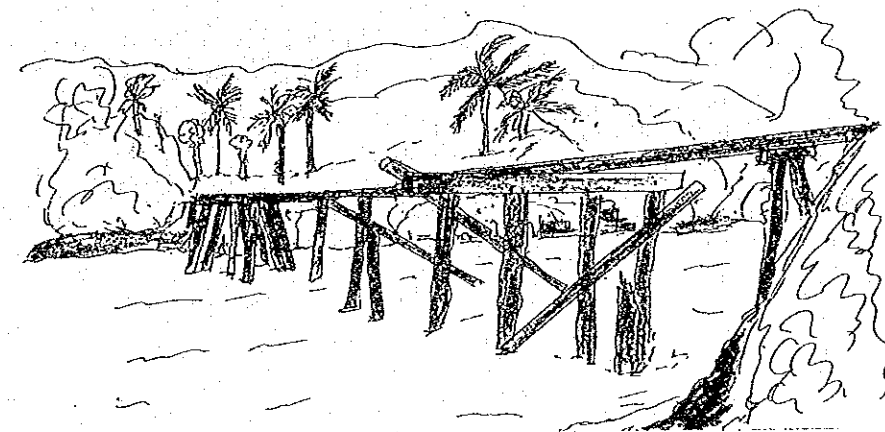
Leyte Spot No. 6 (L-6)

- Type of Disaster: Timber bridge washout
- Magnitude of Damage: 54.0 total length of bridge washout
- Date Noticed: 1986
- Degree/Period of Traffic Interruption: High
- Description of Disaster:

The Bagacay timber bridge has a total length of 54.0m, composing of 9 spans, and a 1-lane bridge with 4.0m width. This bridge was washed out last 1986 and since then it was not passable to vehicles. Temporary foot bridge was made available for pedestrians.

Insufficient free board and too short span length between piers caused accumulation of logs and debris flowed from upstream.

TYPE OF WORK		UNIT	TOTAL
URGENT RESTORATION			
U1-4	REFILLING / EMBANKMENT	CU.M.	360
U6-2	H-PILE BENT	L.M.	108
U6-3	BAILEY BRIDGE	L.M.	60
U7-1	GRAVEL SURFACING	SG.M.	240

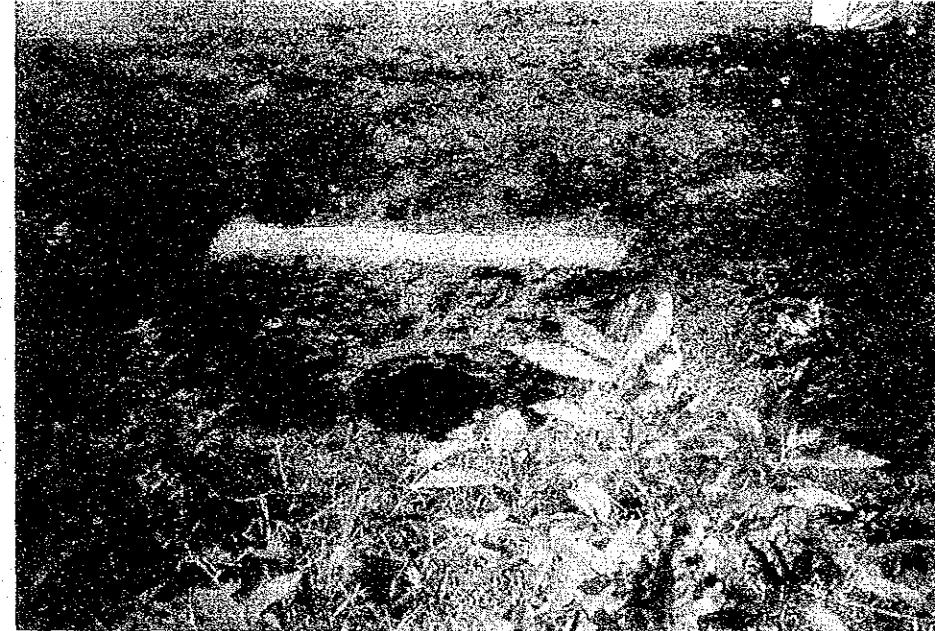
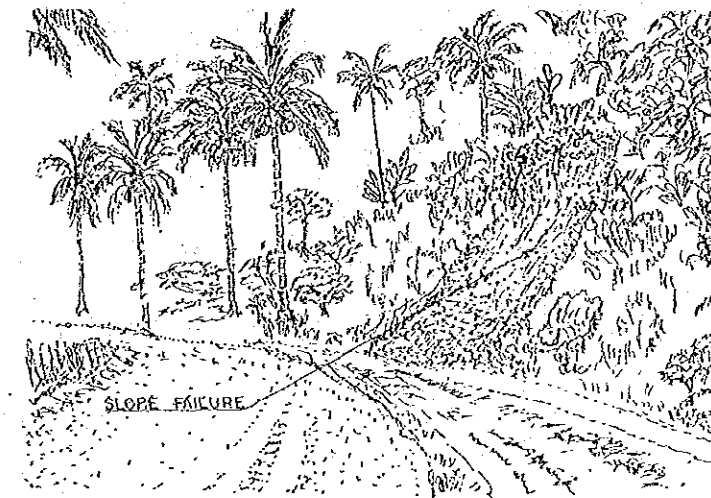
Leyte Spot No. 13 (L-13)

- Type of Disaster: Culvert damaged
- Magnitude of Damage: Inlet and outlet facilities of 0.610m RCP
- Date Noticed: 1988
- Degree/Period of Traffic Interruption: Low
- Description of Disaster:

This culvert damaged is located on a sharp curve at a radius of about 57.0m. Inlet portion was partially clogged.

During heavy rain, water that comes from high elevation cannot be accommodated to the existing drainage pipe of 0.610m ϕ . Also, absence of side ditches and damaged inlet facilities caused water to flow on the roadway and runs directly on embankment slope that causes heavy scouring. No outlet facility is provided.

- Insufficient capacity of culvert, thus causing water to overflow on road surface and damaging embankment slope.
- No outlet drainage facilities, thus water runs directly on a slope, causing deep scouring.

TYPE OF WORK		UNIT	TOTAL
PERMANENT RESTORATION			
P2-1	SLOPE DITCH	L.M	10
P2-4	R.C.P.C 0.6 m. Ø	L.M	1.2
P2-5	CATCH BASIN	E.A.	1
P6-2	GROUTED RIPRAP	CU.M	63
P16-3	GROUTED RIPRAP APRON	CU.M	5
URGENT RESTORATION			
U1-4	REFILLING / EMBANKMENT	CU.M	120
U3-1	SHEET COVERING	SQ.M	72
U3-2	SAND BAG COVERING	SQ.M	72
U4-3	WOODEN FENCE	L.M	12

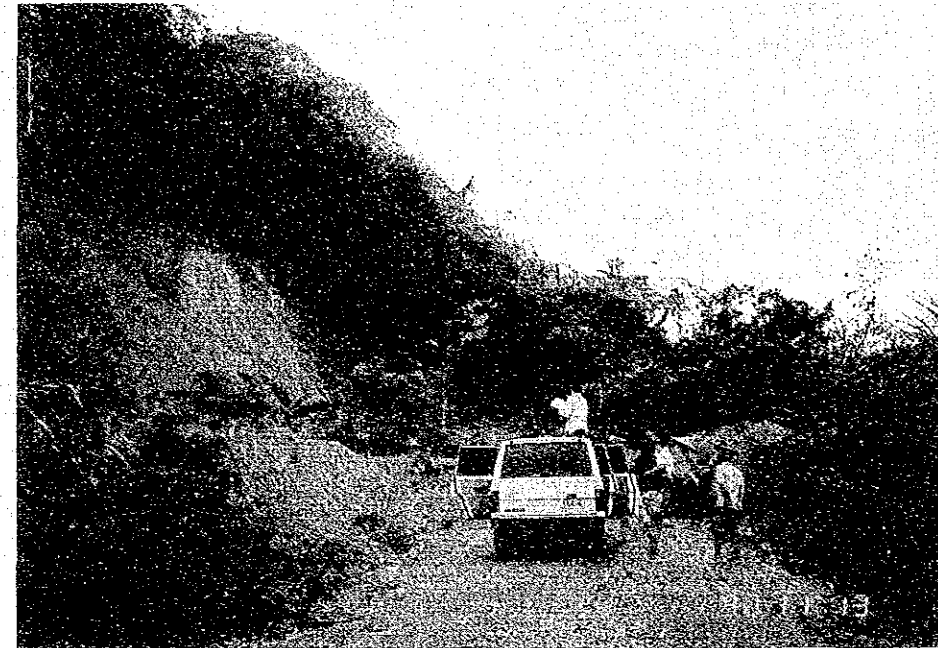
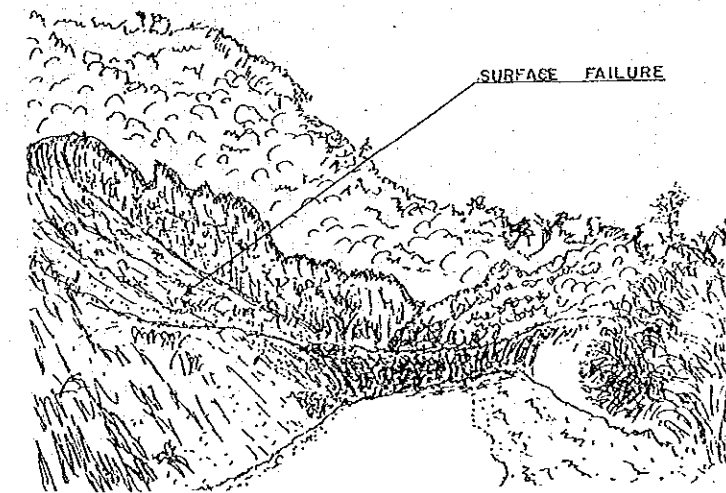
Leyte Spot No. 16 (L-16)

- Type of Disaster: Cut slope failure
- Magnitude of Damage: 60 meters in length; 24.0m in height
- Date Noticed: Nov. 12, 1990 (typhoon "Ruping")
- Degree/Period of Traffic Interruption: Low
- Description of Disaster:

Damaged section is about 60.0m in length and 24.0m in height. Mountain slope is about 34° angle from the roadway.

Right after the typhoon, debris materials were on the roadway that block the flow of traffic. At present, debris materials were just on the roadside with no effect to passing vehicles.

- Unstable slope gradient.
- Weathered rocks slide due to rainfall.

TYPE OF WORK		UNIT	TOTAL
PERMANENT RESTORATION			
P8-2	CATCH GABION WALL	CU. M.	192
URGENT RESTORATION			
UI-1	REMOVAL OF DEPOSIT MATERIALS	CU. M.	90

- Removal of deposit materials

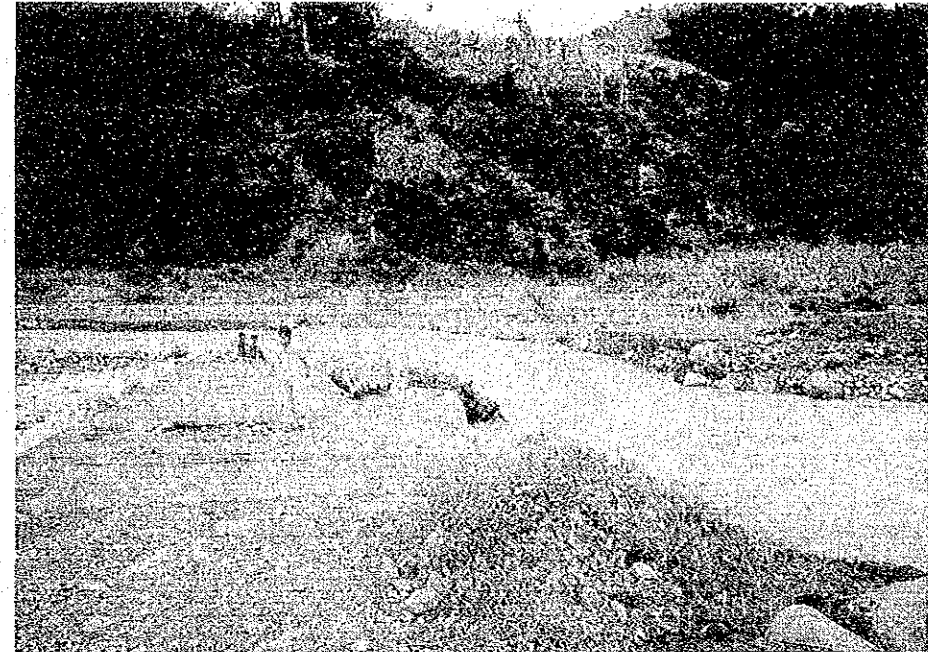
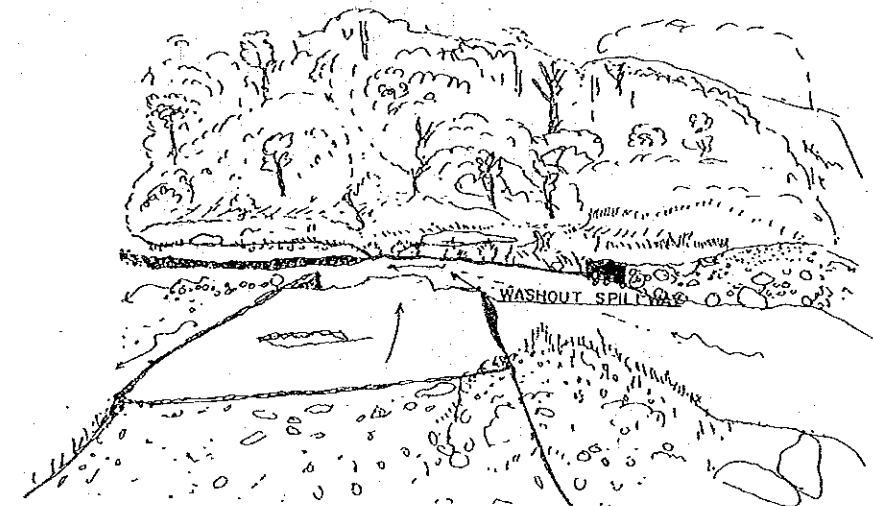
Leyte Spot No. 19 (L-19)

- Type of Disaster: Spillway Damaged
- Magnitude of Damage: 56.0m in length
- Date Noticed: 1988
- Degree/Period of Traffic Interruption: High
- Description of Disaster:

The spillway 56.0m in length and 6.5m width was damaged last 1988. Approach of the spillway is about 12.0m in length was washed out.

- Debris and logs flowed from upstream by flood water usually damaged the structure.

TYPE OF WORK	UNIT	TOTAL
PERMANENT RESTORATION		
P6-6 SUPPORTED TYPE CONCRETE WALL	CU. M.	100
P10-3 CONCRETE PAVEMENT	CU. M.	80
URGENT RESTORATION		
U1-6 SELECTED MATERIAL FILL	CU. M.	286
U4-2 GABION WALL	CU. M.	134

NOTE:
 Urgent restoration - Gabion B inside boulders (Selected materials)
 about 20-30 cm. Ø
 Permanent restoration - Cover Concrete

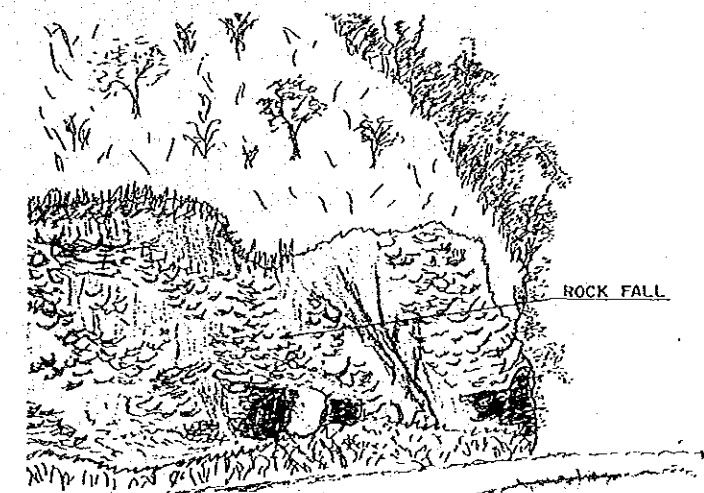
Leyte Spot No. 21 (L-21)

- Type of Disaster: Falling rocks
- Magnitude of Damage: 35m in length; 15.0 m in height
- Date Noticed: Nov. 12, 1990
- Degree/Period of Traffic Interruption: Low
- Description of Disaster:

The spot was located at a very steep slope almost at 90° angle and at about 15.0m high and 35.0m in length. The rock fall is expected due to its overhang situation.

The spot is located at a sharp curve with a radius of 38.0 m.

- Rocks with highly weathered and developed cracks/joints.
