PROVINCE : **LEYTE**
SPOT No. : **L-23 (1/2)**

NAME OF ROAD : **TABANGO - SAN ISIDRO ROAD**
ROAD CLASSIFICATION : **NATIONAL SECONDARY ROAD**

TYPE OF DISASTER : **FLOODED/MUDDY ROAD SURFACE**

Leyte Spot No. 23 (L-23)

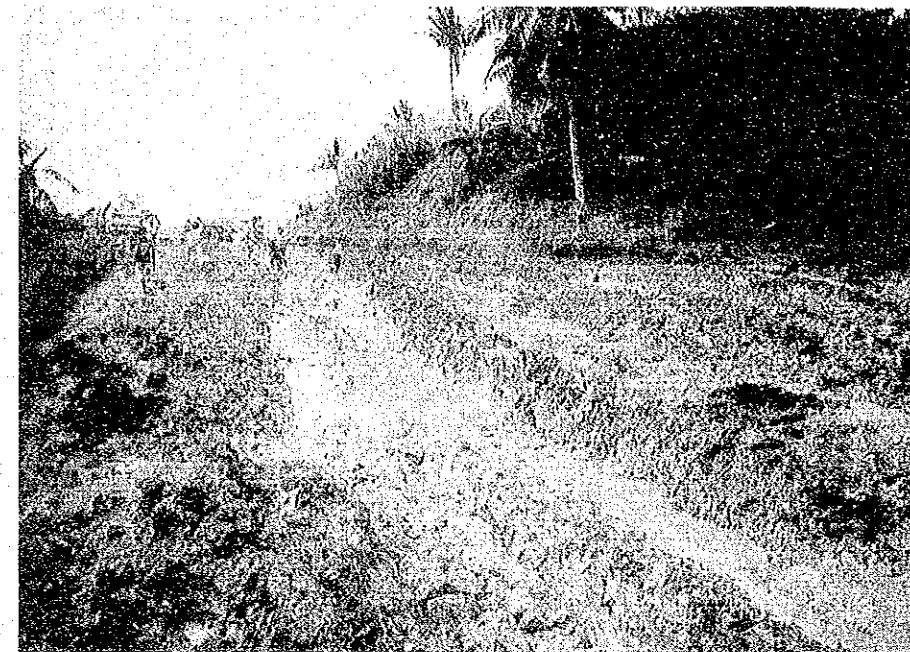
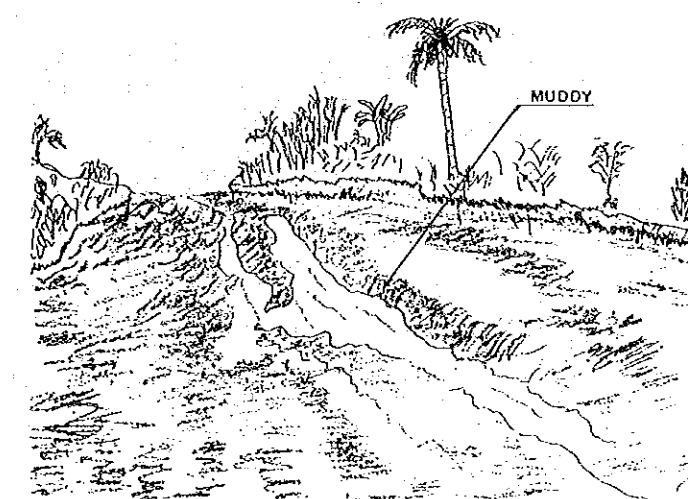
Total length of the flooded section is about 100m. Once flooded, the section remains muddy for 2-3 days and not advisable for vehicles to pass.

During heavy rain this section is flooding and muddy due to absence of cross drainage & side ditches that caused water to concentrate on embankment/surface materials.

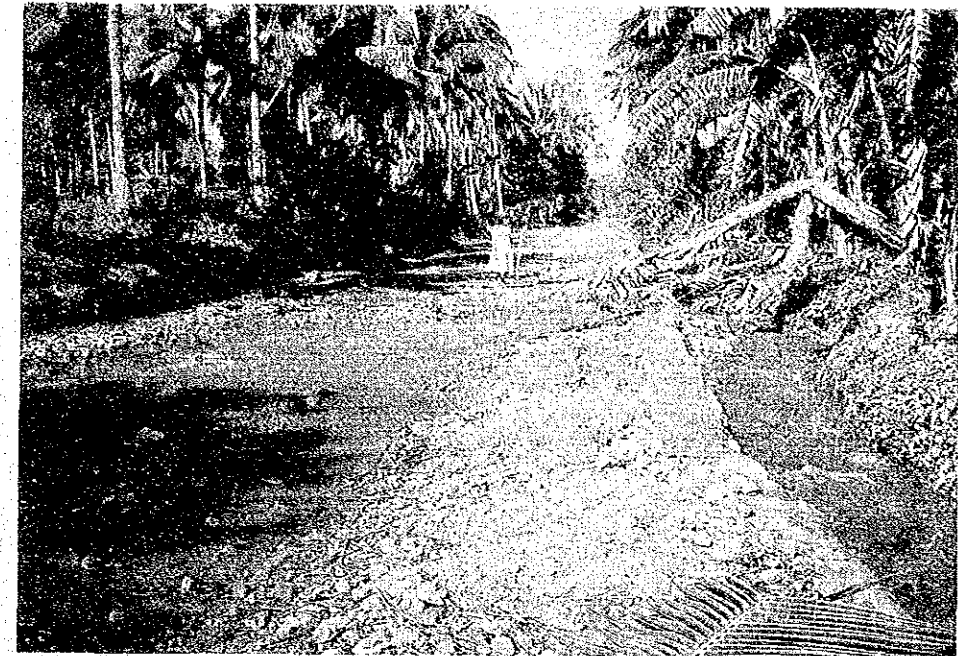
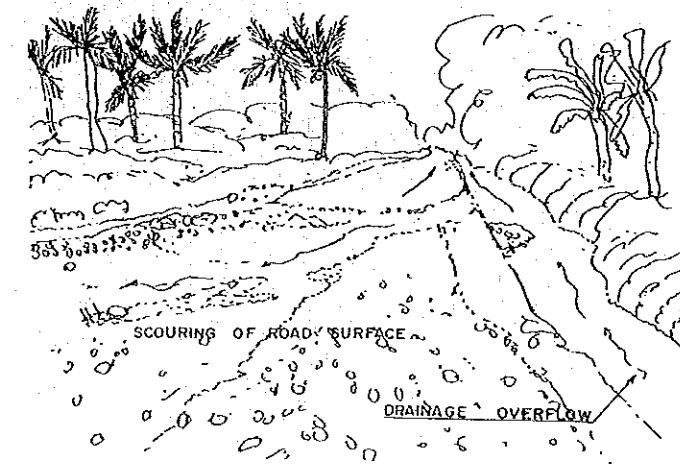
Leyte Spot No. 26 (L-26)

The section is located at a lower elevation than abutting land. Every heavy rain the road is flooded at about 120.0m length and 0.50m depth from the road surface. Existing RCP of .910m² and 0.610m² were not sufficient to accomodate the water that comes from the mountain side.

- Lower elevation of the road than abutting land and insufficient drainage facilities that causes the road to be flooded and muddy during heavy rain.

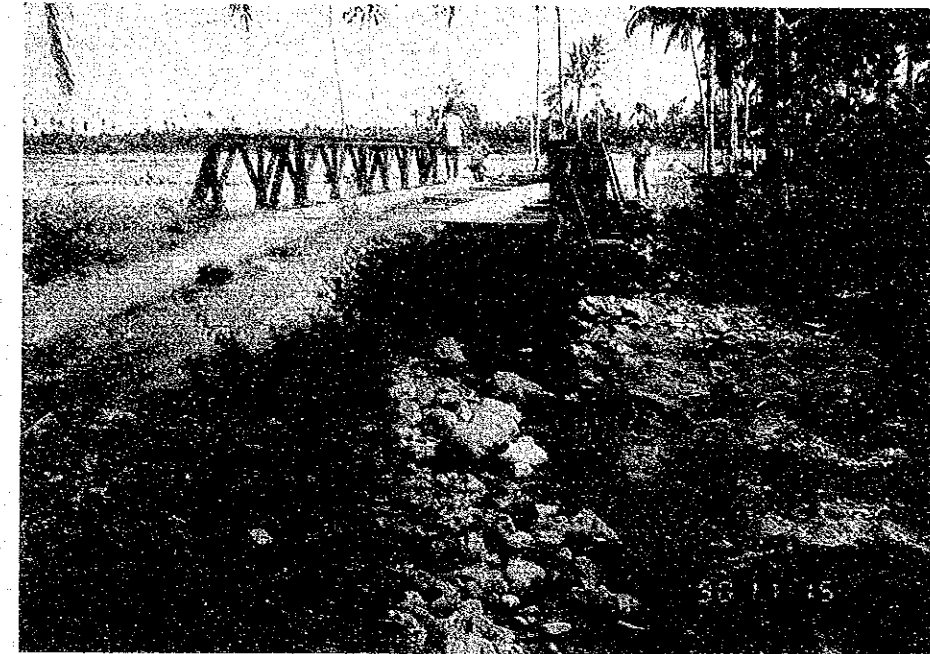
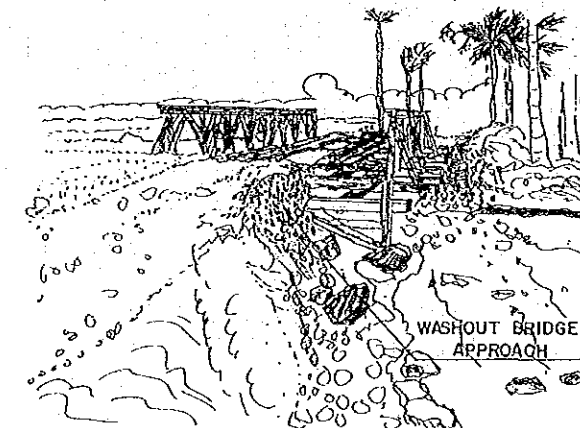
Leyte Spot No. 38 (L-38)

There were two (2) flows of water in the river. One (1) flow which runs parallel to the approach of the bridge site that washed out the bridge approach in 1988 for 2.0m in length and 1.5m in depth.

- Two direction of flow caused by debris from upstream, resulting in deep local scouring of the approach.

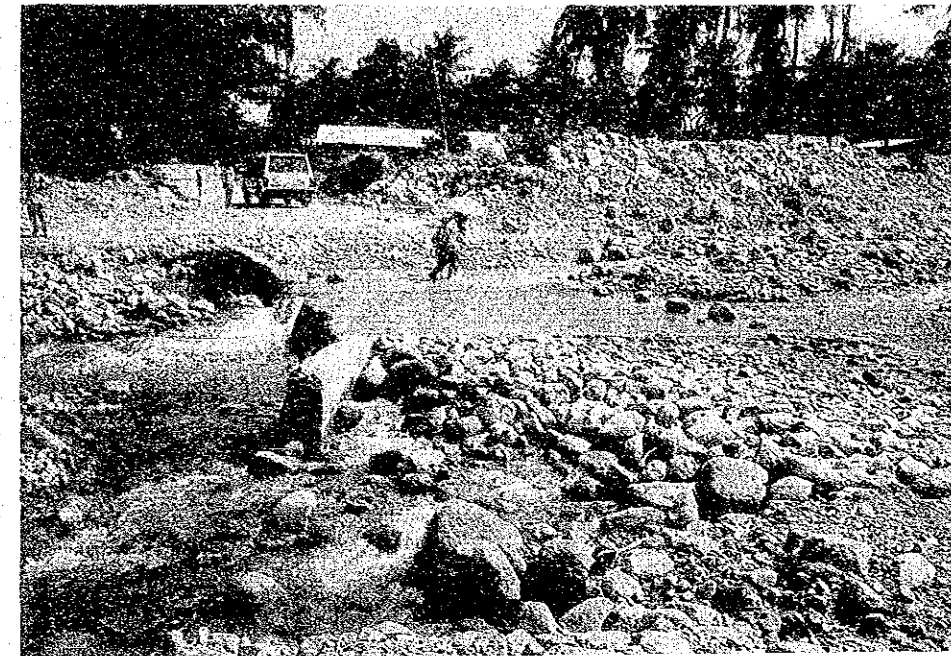
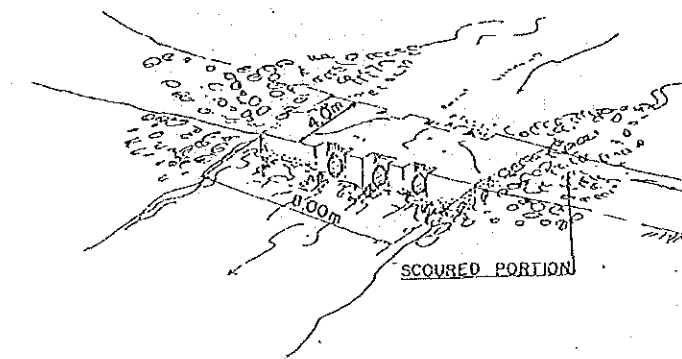
Leyte Spot No. 39 (L-39)

The Tuccdao spillway is 8.5m. in length and 6.0m in width. Both approaches at about 8.0m. each were damaged last 1988. Too short spillway, thus damaged of approach usually occurred everytime there is flood. Shallow river bed caused debris to overflow along the river bank.

- Debris coming from upstream every heavy rain.

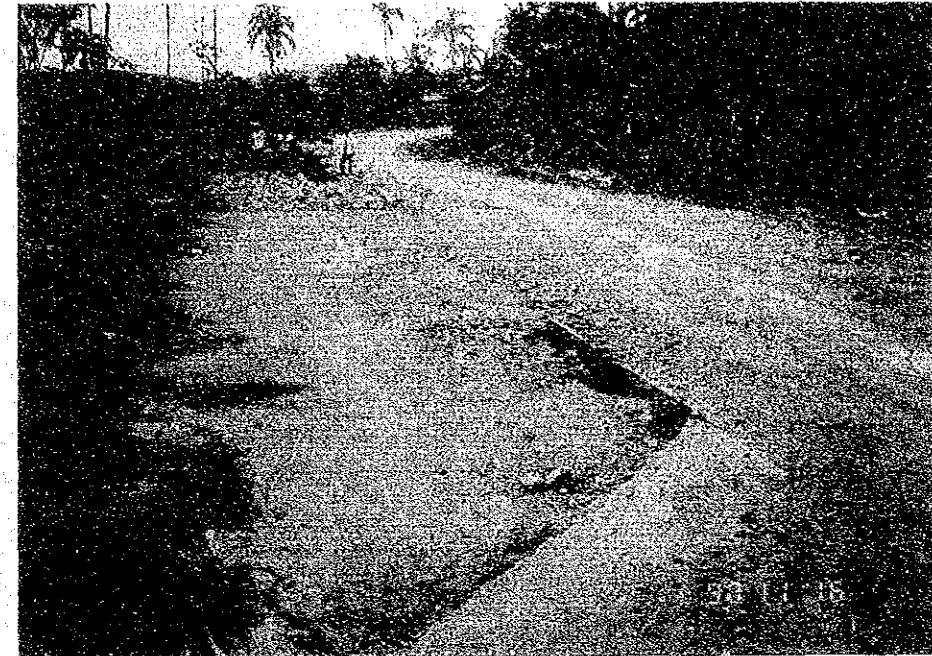
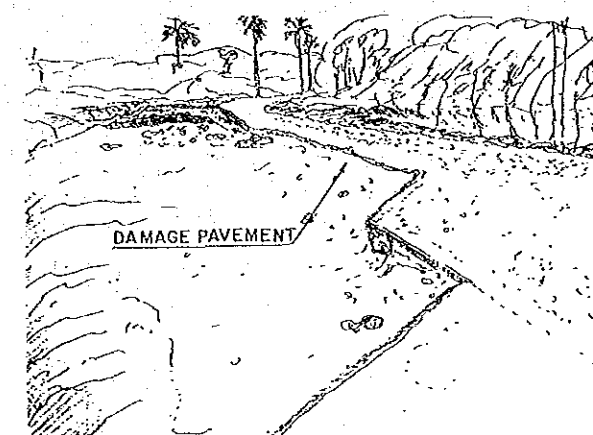
Leyte Spot No. 45 (L-45)

Cracks on concrete pavement occurred last 1988. It was about 45.0m in length.

Saved water on mountain side was permeated to embankment side and embankment soil was loosened.

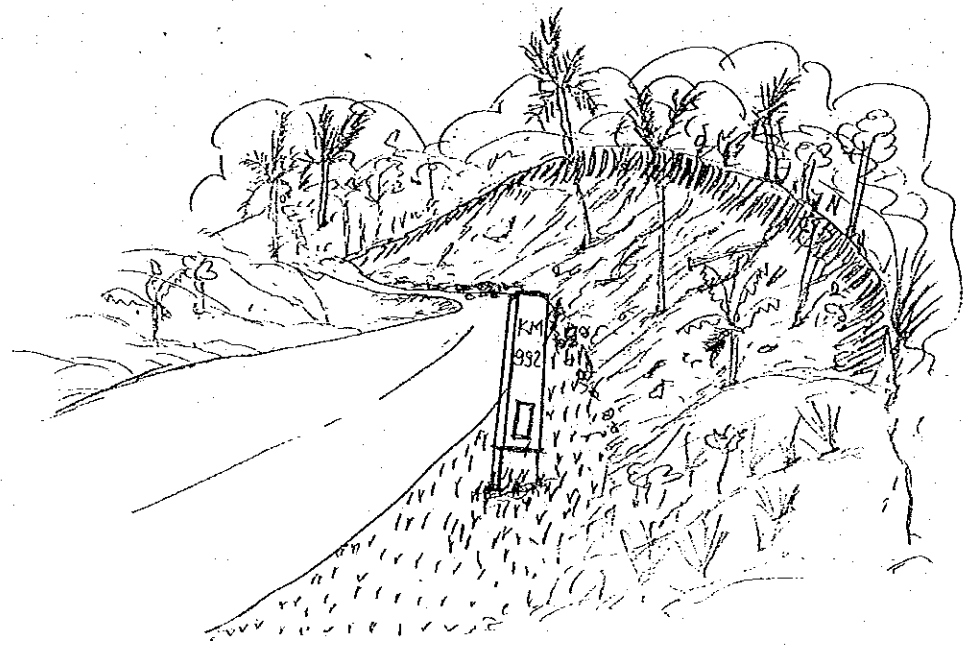
Leyte Spot No. 47 (L-47)

Scouring around the inlet is about 6.0m length; 1.50m width; 2.0m depth.

Embankment failure at outlet is about 5.0m length; 5.0m width; 15.0m depth.

During heavy rain, water from the mountain cannot be accommodated from the existing RCP (0.910m Ø) and flows on the surface of the concrete pavement and runs directly on embankment slope.

Landslide cause damage to the drainage and insufficient drainage facilities caused water to overflow on the surface of the concrete pavement thus causing water to run directly on the embankment slope that caused scouring.

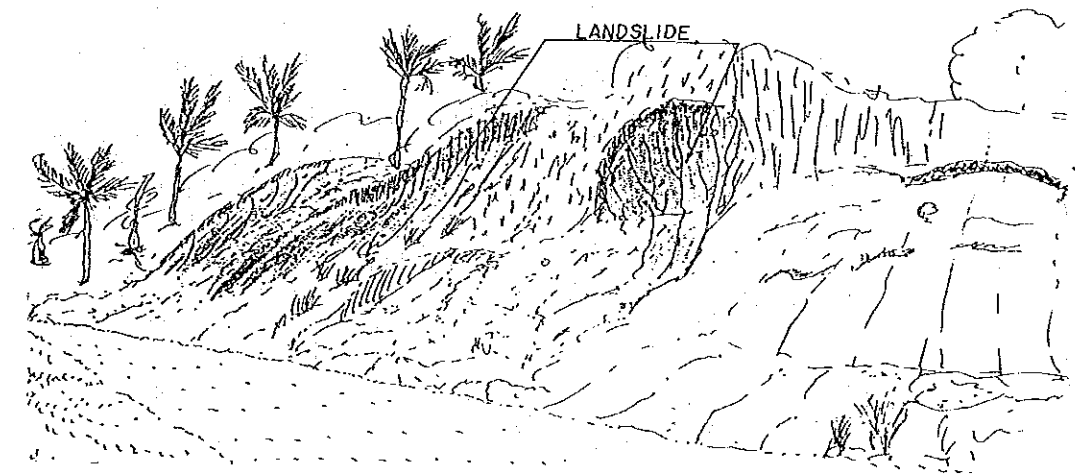
Leyte Spot No. 50 (L-50)

The spot is located at a sharp curve with radius of 37.0m. Landslide portion is about 50.0m in length and 15.0m in height. Mountains slope is about 21° angle.

This landslide occurred last 1988. Mass of soils on irregular mountain slope slid due to heavy rain. Slide plain did not reach to roadway, therefore, the roadway was not affected. Slided materials formed traffic obstruction along the roadway.

Mass of soils slid along the slide plain when saturated water caused loss of shear resistance between soils. At present, the slope seems to be stable.

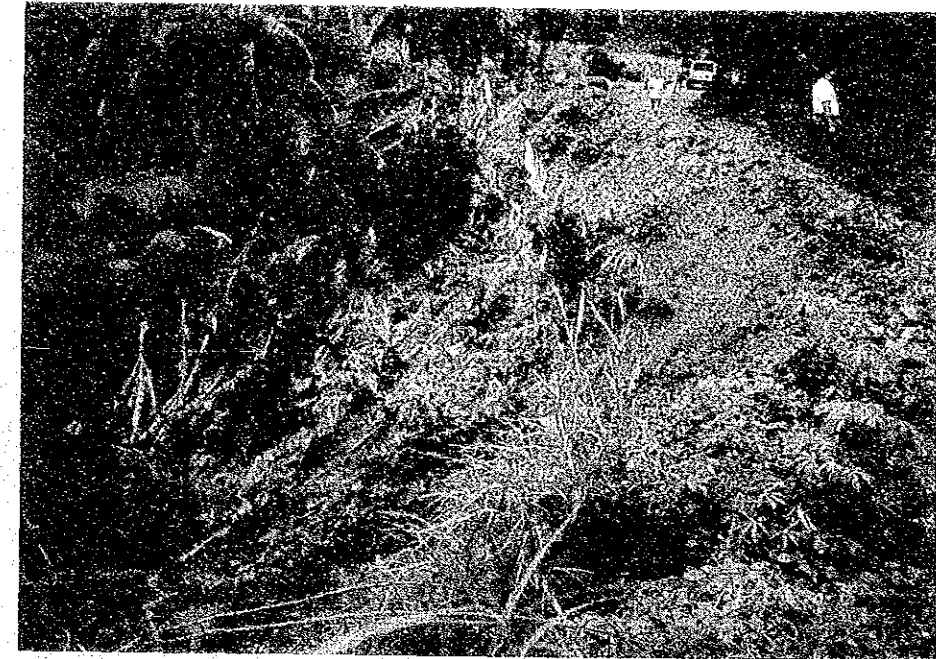
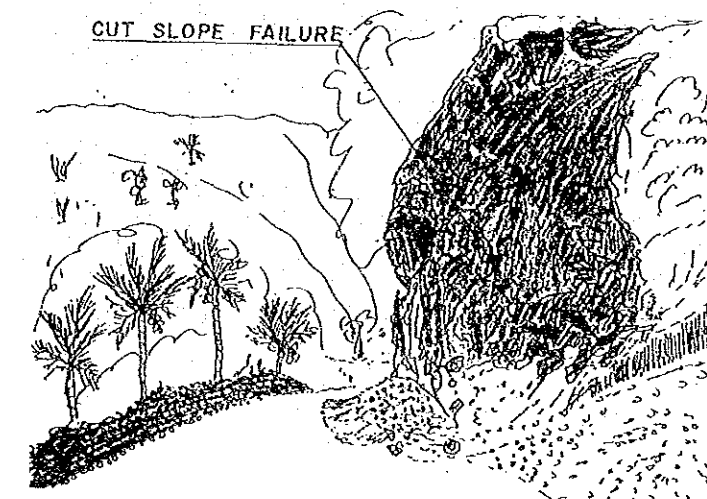
Leyte Spot No. 65 (L-65)

This spot was damaged last Nov. 12, 1990 during typhoon "Rufing". Damaged section is about 34.0m in length and 25.0m in height. Mountain slope is almost 90° with vegetation. Fallen materials were still on the roadside.

Rock fall is expected due to it's overhang situation and highly weathered condition.

- Unstable slope gradient with overhang causes weathered rocks to fall during heavy rain.

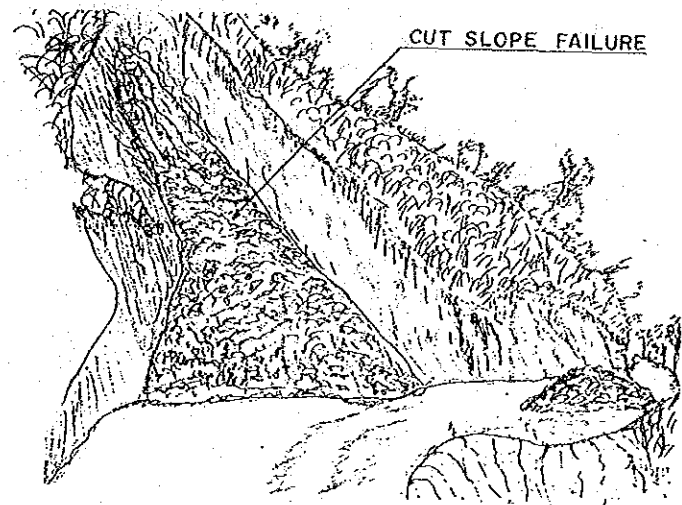
The slope failure occurred last Nov. 12, 1990 during typhoon "Rufing". Damaged portion is about 30.0m in length, 26.0m in height. The mountain has a slope of 45° . The slope failure is located on a narrow road of a curve with a radius of 56.0m.

- * Surface water concentrates on the slope surface and water runs directly to gullies with high velocity thus materials slides.
- * Unstable slope gradient.

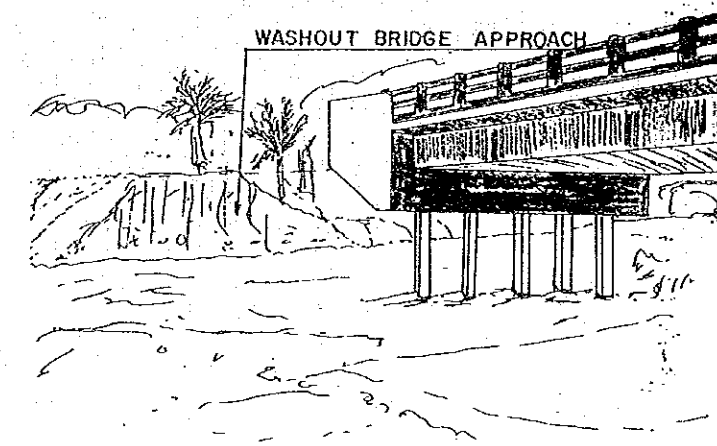
The Marabong River has a width of about 90.0m with no defined river banks. The Marabong bridge (RCDG) has an aggregate length of 60 meters composing of 3-spans, 2-lane with 7.6 width. This was damaged last 1988. Approach 32.0m in length was washed out & rip-rap on the other approach was damaged due to logs and debris flowed from upstream by flood water. Since then, the bridge was not passable. Temporary detour bridge was constructed.

Too short bridge length and insufficient opening at bridge site and flood discharge cannot be accommodated.

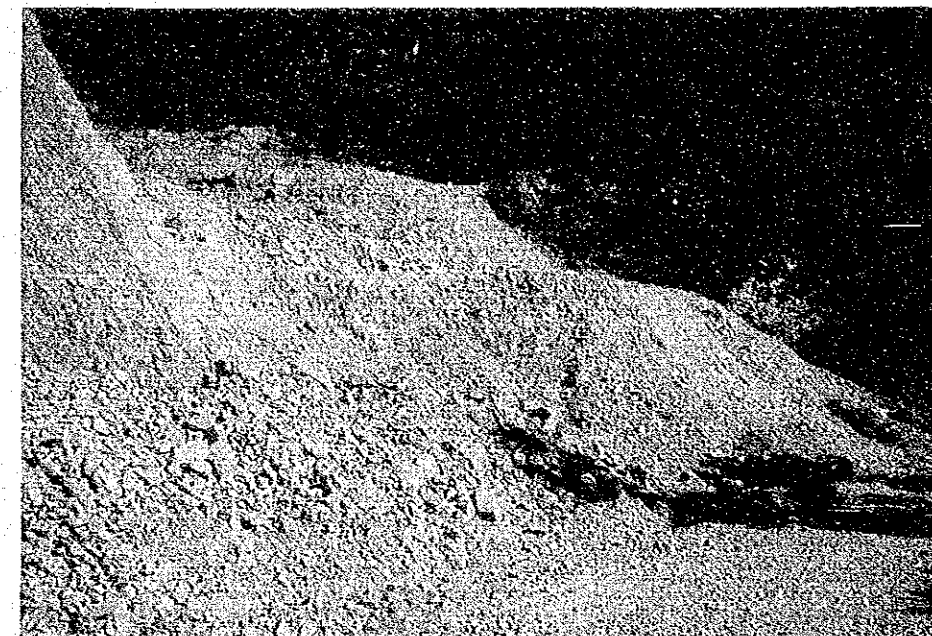
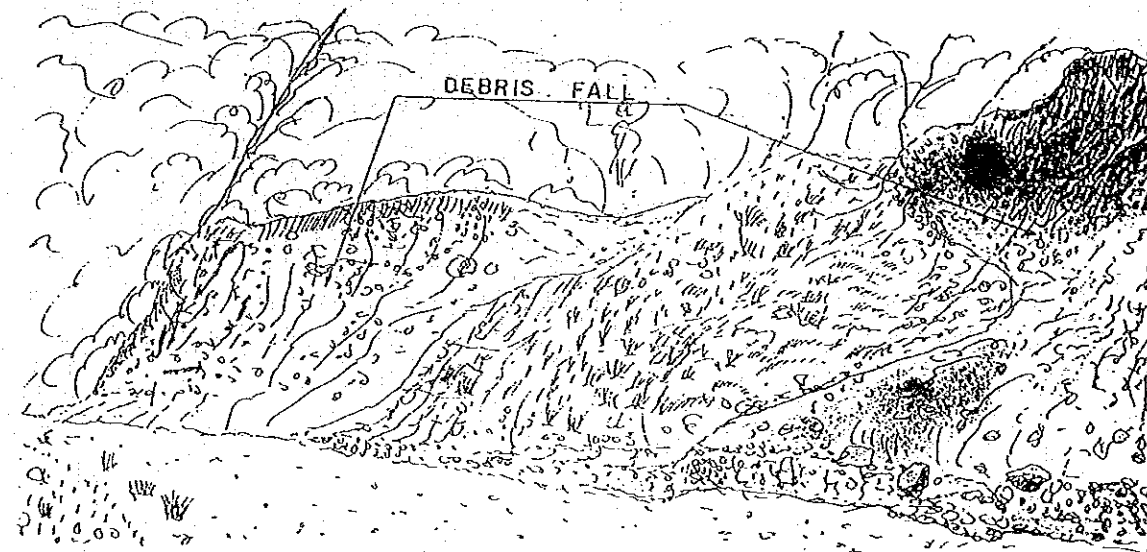
This disaster spot is located between two mountain at about 1560m in length. Height of the 1st slope failure is about 40.0m measured from 54° angle and the other failure is about 50.0m in height at 45° angle. Debris materials from this cut slope failures deposited on the bed of valley and flowed onto the road during heavy rain.

Unstable slope gradient causes debris to fall along valley. Deposited materials along the valley caused debris flow during heavy rain.

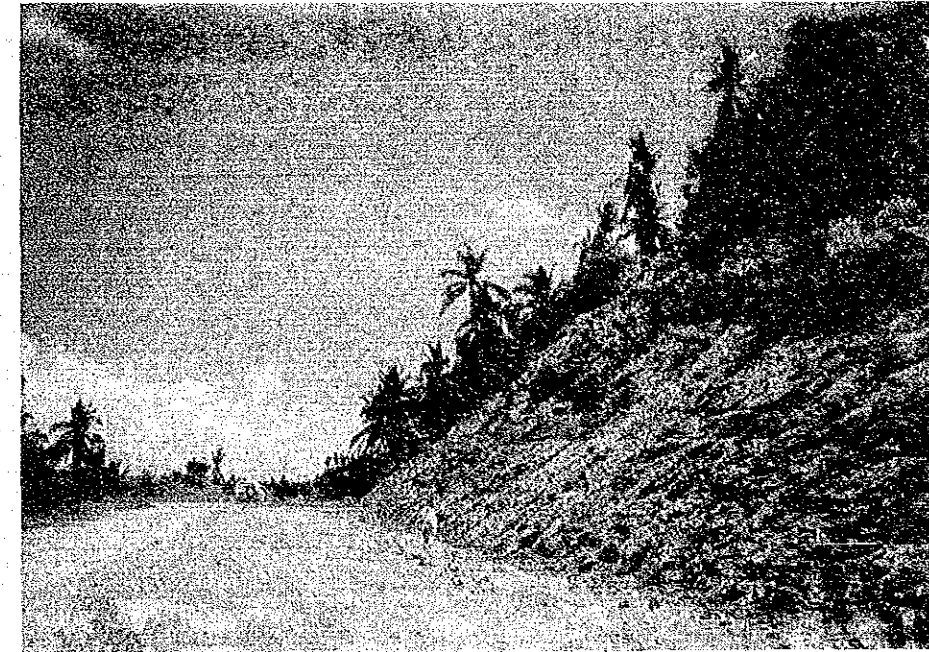
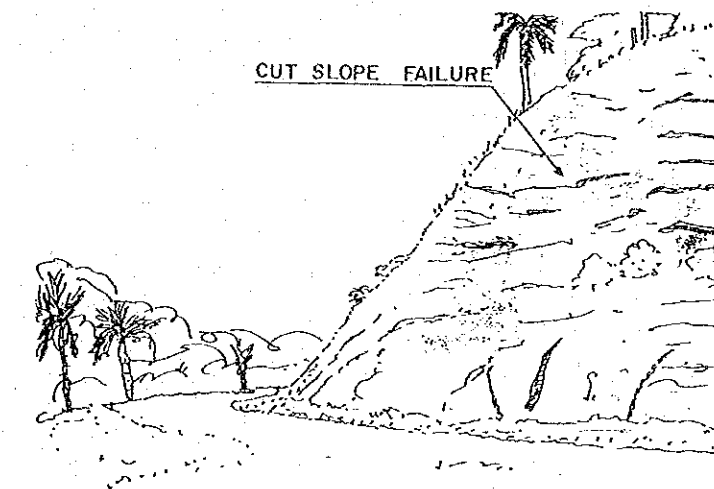
The spot is located along the sharp curve and mountain slope with an angle of 55° . Damaged section is 50 meters in length and 20 meters in height. At present, this slope failure does not affect the roadway. Sliding of soft soil along the bare slope is expected.

The slope gradient is unstable and soft soil slides along bare slope during heavy rain. It has a very weak shear strength.

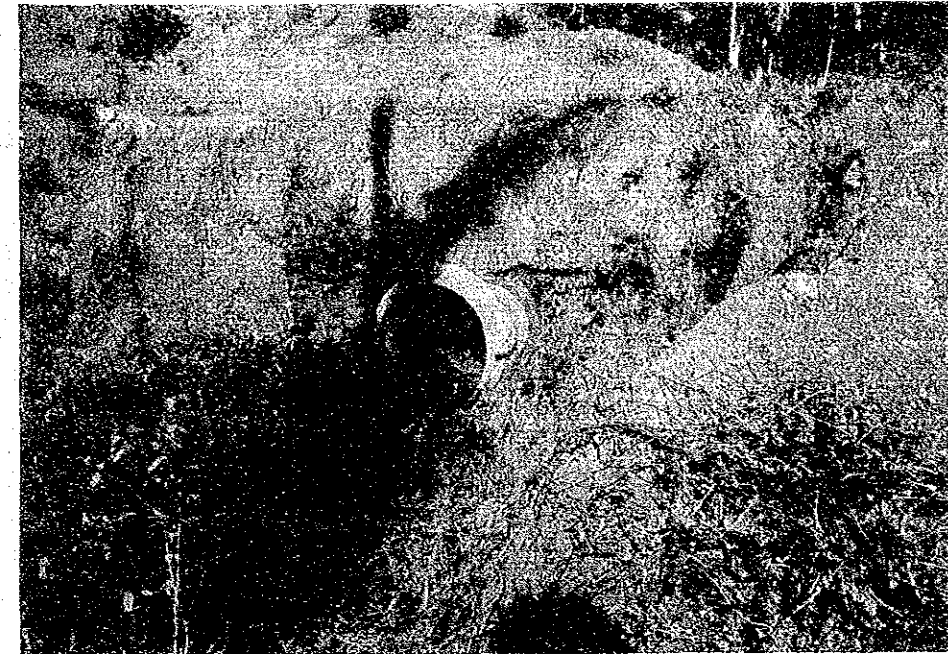
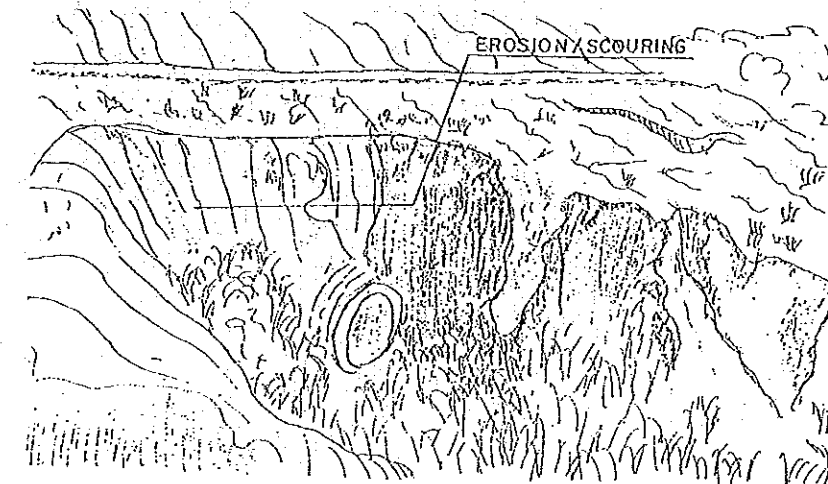
- Type of Disaster: Culvert related damaged/scouring of outlet section
- Magnitude of Damage: 2.5 meters wide and 1.0 meter depth
- Date Noticed: 1990
- Degree/Period of Traffic Interruption: Low
- Description of Disaster:

Insufficient capacity of culvert causes over flow of concentrated surface water over road surface and damaging embankment slopes; and no outlet drainage facilities thus water runs directly on slope causing deep scouring.

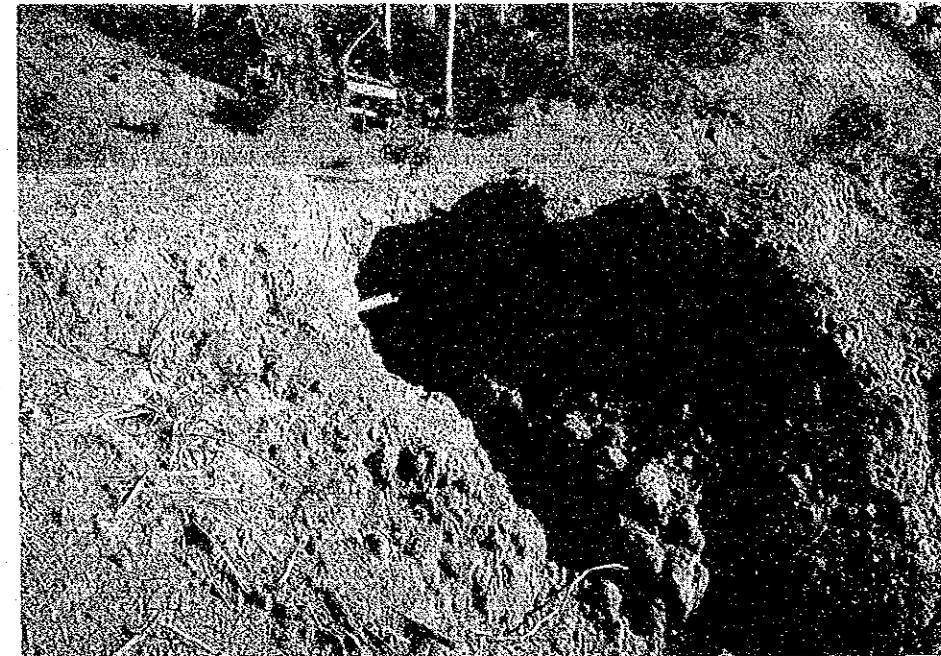
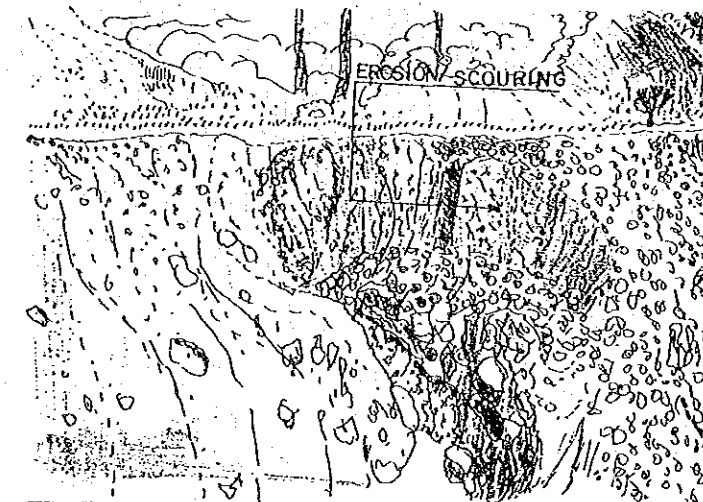
The slope of the mountain is 65° angle and 18.0 meters in height. The vertical alignment of the road is approximately 3% and the horizontal alignment is straight. There is no side ditches all throughout the section. The damage portion is 2.5 meters in length and 2.0 meters in depth. Deep scouring of this section will always occur every heavy rain due to the flow of water that comes from mountain side slope and road surface.

- No drainage facilities were provided that causes water to run directly on the road surface and on embankment slope that causes deep scouring and erosion.
