PROVINCE : LEYTE
 SPOT No. : L-82 (2/2)

NAME OF ROAD : TADOC - SOUTHERN LEYTE ROAD
 ROAD CLASSIFICATION : BARANGAY ROAD

TYPE OF DISASTER : EMBANKMENT SLOPE FAILURE

DRAWING NO.
 164

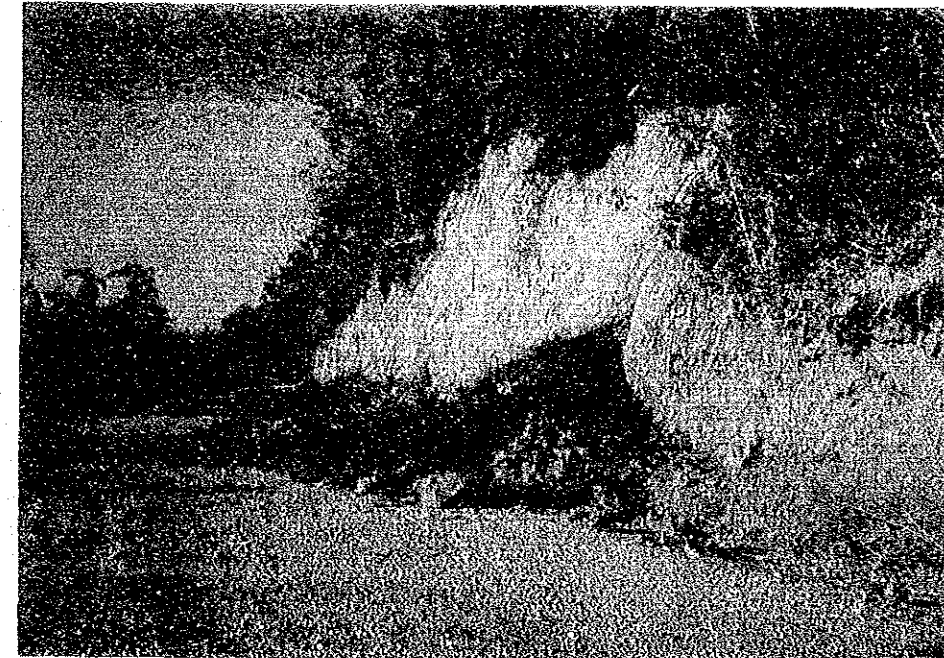
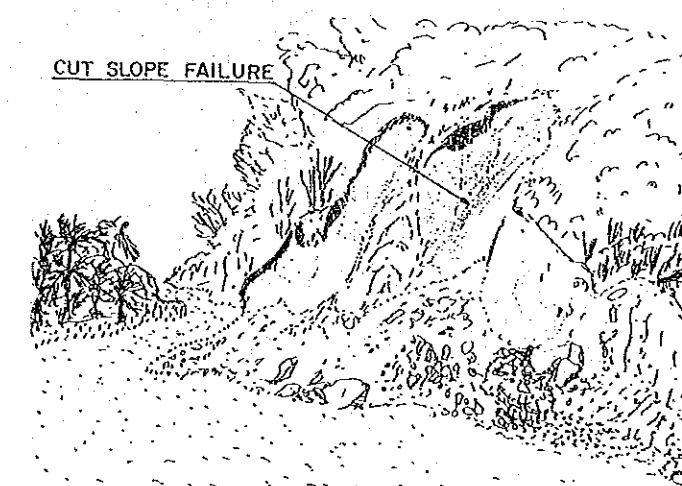
DRAWING NO.
165

- Type of Disaster: Cut slope failure
- Magnitude of Damage: 17 meters in length & 12 meters in height
- Date Noticed: Nov. 12, 1990
- Degree/Period of Traffic Interruption: Low
- Description of Disaster:

It was during the time of construction of the road where cutting of the hillside has been done for the alignment. The section which has been cut remain unstable due to the present condition of top soil of the natural slope. The slide materials on this spot is still existing but with less traffic interruption.

The valley side, deep slope could be noticed which is just near and parallel to the river. This spot is less vegetated that cannot hold firmly that materials from sliding.

Unstable slope gradient, soft soil slides during heavy rain.

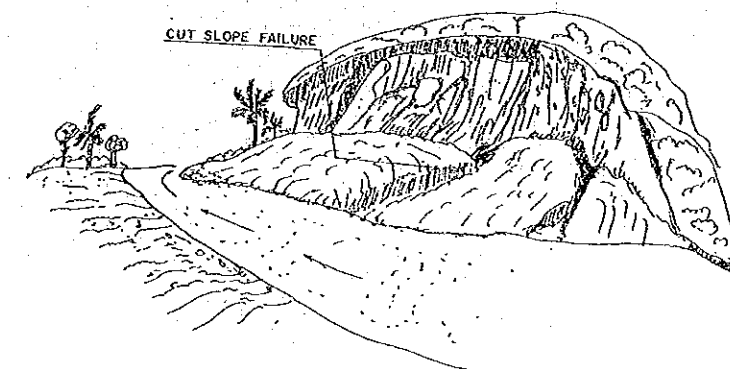
DRAWING NO.
167

- Type of Disaster: Cut slope failure
- Magnitude of Damage: 32m in length and 11m in height
- Date Noticed: Nov. 12, 1990
- Degree/Period of Traffic Interruption: Low
- Description of Disaster:

This particular spot is located 8.2 kms. from Jct. Abuyog - Mahaplag Road and was damaged last Nov. 12, 1990 by typhoon "Ruping". Damaged section is about 32.0m in length and 11.0m in height. The slope of the mountain is about 70° angle with light vegetation. Soft soil slides during heavy rain.

Slide materials were still on the roadside but with less effect on traffic.

- Slope is irregular and unstable, thus water concentrate on sagged portion causing erosion.

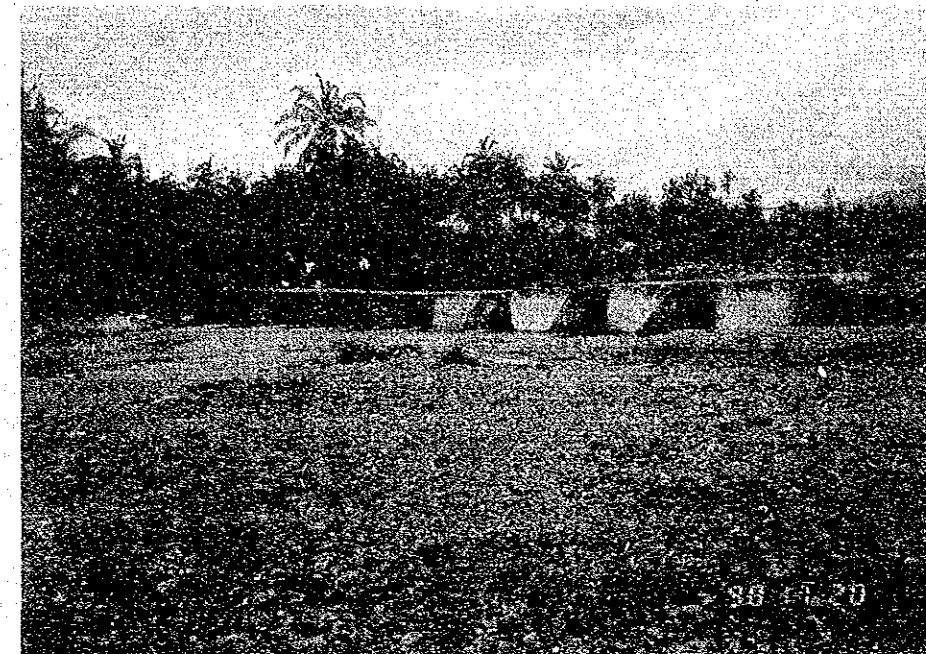
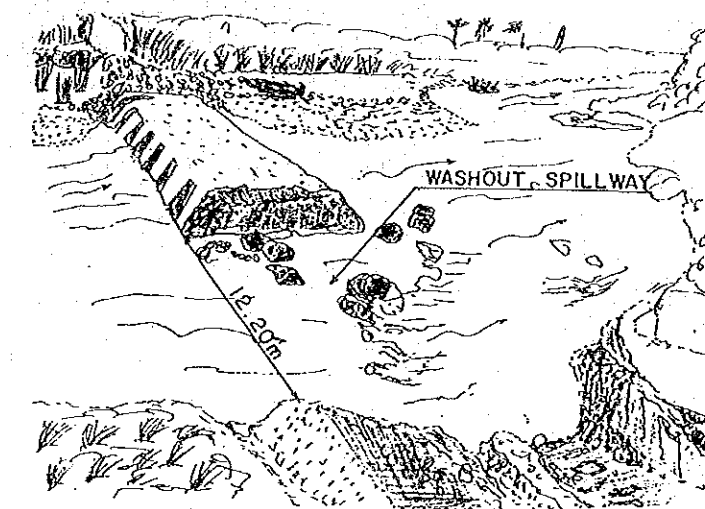
DRAWING NO.
169

- Type of Disaster: Washed out of approach (temporary restored)
- Magnitude of Damage: 24 meters
- Date Noticed: Nov. 12, 1990
- Degree/Period of Traffic Interruption: High
- Description of Disaster:

The spillway was damaged last Nov. 12, 1990 during typhoon "Ruping". Both approaches at 13.0m and 11.0m each were washed out.

- The spillway is too short thus scouring and washout of approach occurred.
