CHAPTER 5

WELL REHABILITATION SURVEY

STUDY FOR THE GROUNDWATER DEVELOPMENT IN METRO MANILA

JAPAN INTERNATIONAL COOPERATION AGENCY

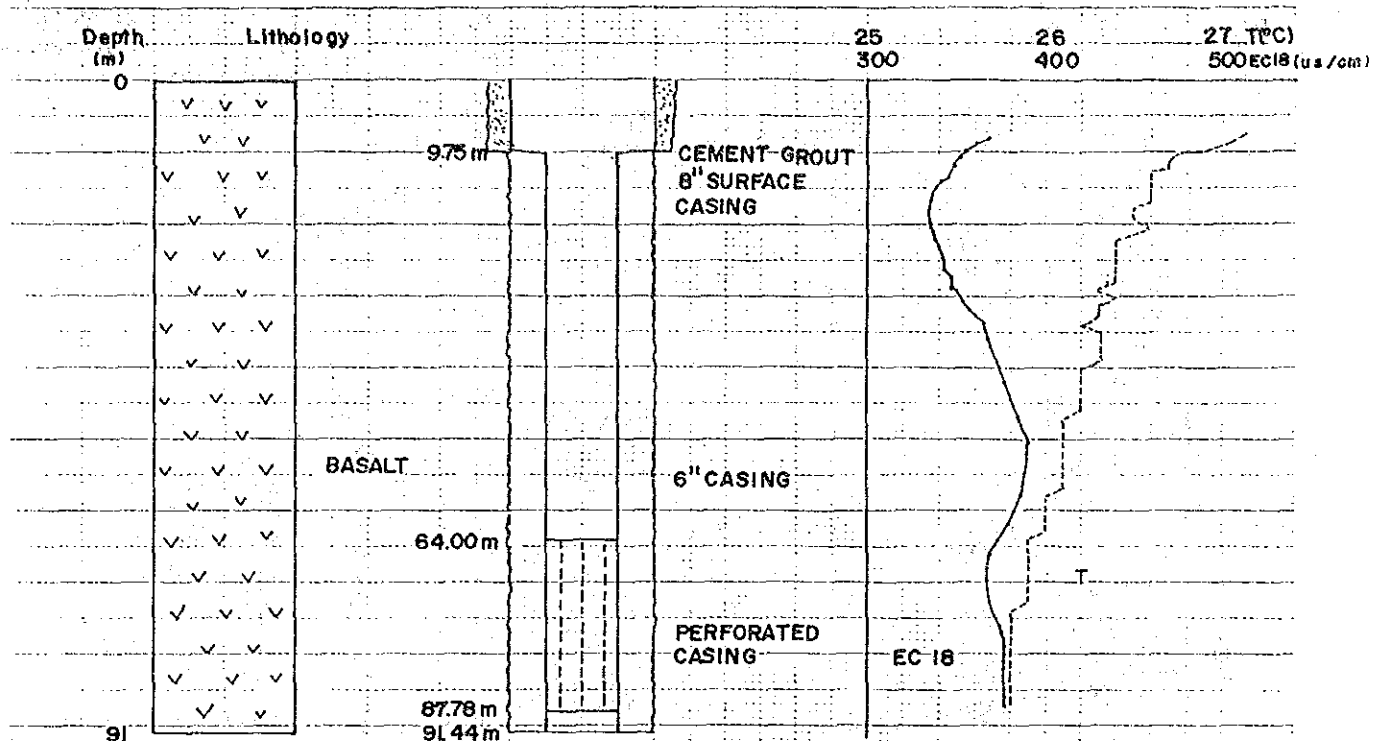
<p>STUDY FOR THE GROUNDWATER DEVELOPMENT IN METRO MANILA</p> <p>JAPAN INTERNATIONAL COOPERATION AGENCY</p>	<p>FIGURE 5.3.3</p> <p>DETAILS OF MWSS WELLS FOR REHABILITATION (COGRO, ANTIPOLO NO. 1)</p>
--	---

It was also observed that the pumping water level declined rapidly and did not become stable at the discharge rate of 198 l/min. This may indicate that the groundwater of this well come from the fissure of basalt and is unconfined. Storage coefficient S values and aquifer loss coefficient values B obtained from the pumping tests also support this idea.
