Fig. 4-2-4 The Percentage of Boiler Troubles of the 4th Thermal Power Station (from start-up date of all boiler to the end of December, 1990)

Fig. 4-2-6 Photographs of Site Conditions

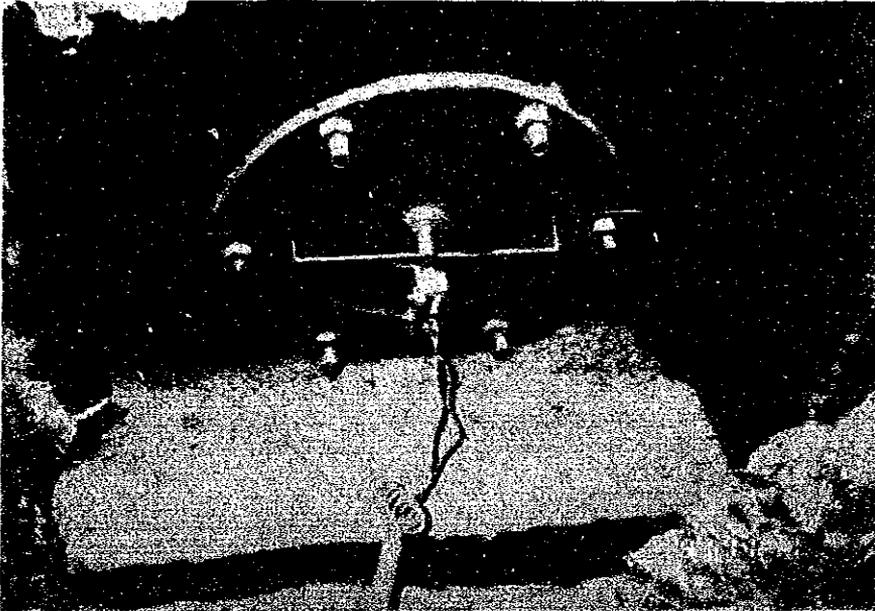
Photo-2 Present Situation of ESP Hopper Ash Level Sensor

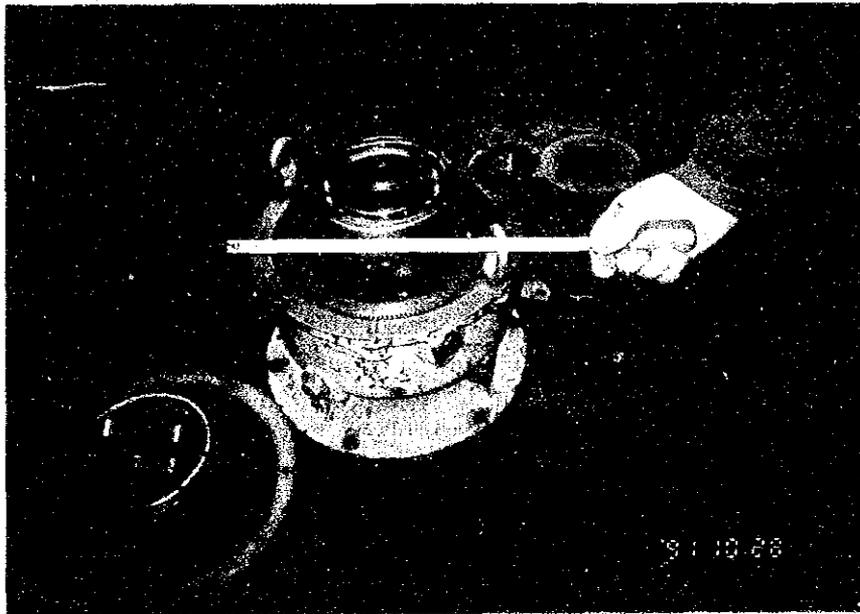
Photo-4 Reducer of ESP Rapping System
(Gear Removed from the Device)

However, since Mongolian-made reduction gears are defective and last about one month only, the number of devices which need to be repaired often (⊙) is 81 or accounts for 60% of all the devices (140 in total) including those for collecting and discharge electrodes.

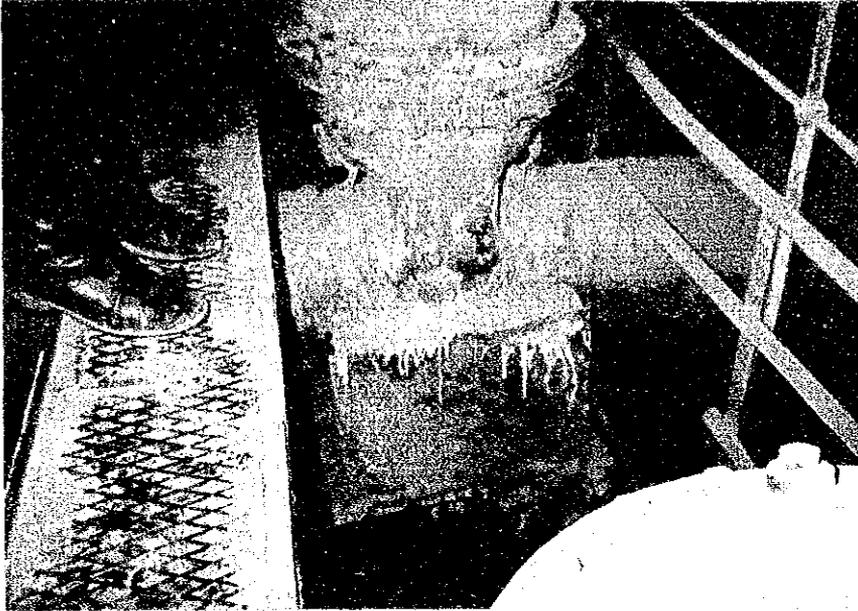
Photo-7 Slurry Valve at Ash Slurry Pump Outlet

Since the water level of slurry pits is control by manual operation of slurry pump outlet valves, the valves are wearing out and it makes long continuous operation difficult.

The outlet valves cannot be closed completely since the lower portion of disk and bottom of seat of valves have been damaged by wear. When the ash slurry pumps are to be repaired, complete isola-

tion cannot be achieved and repair of the pumps is difficult with such damaged valves.

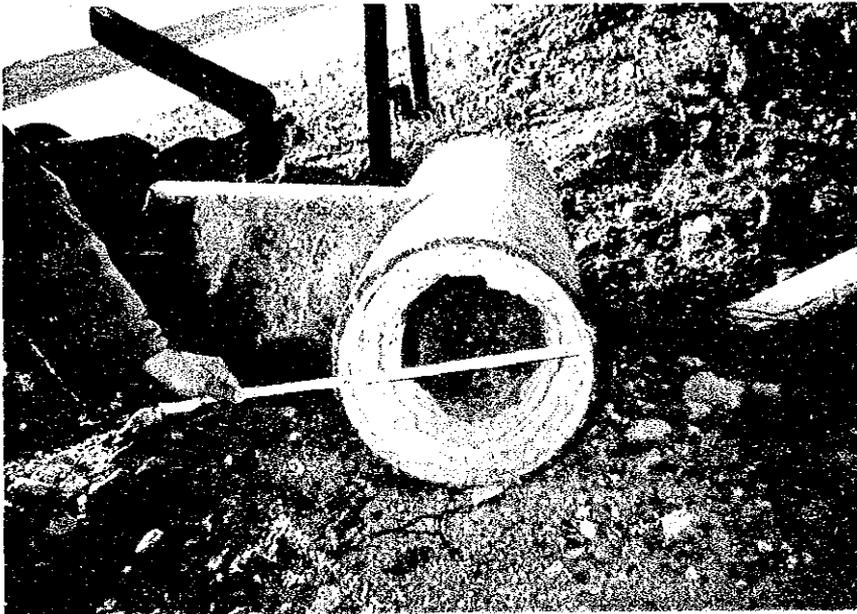
Photo-8 Scaling of Feed Water Pipe

Since the feed water pipes for Units No. 7 and 8 have not been used for a long time since the completion of the pipes, scale adhering to them has not caused any problem yet.

Scale growing inside the feed water booster nozzle pipes has caused slight pluggage.

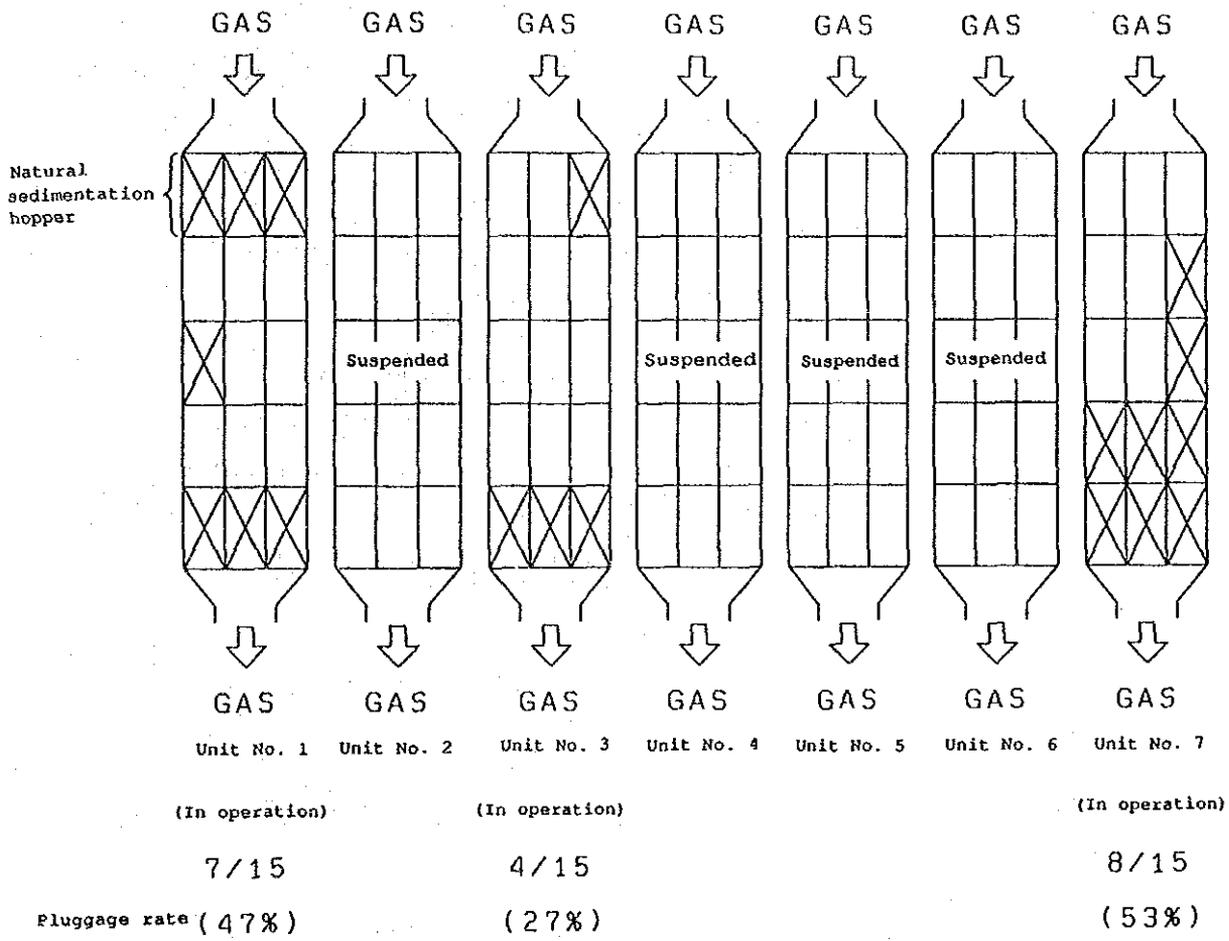
Fig. 4-2-10-(1) Ash Pluggage Condition in Hoppers

It can be said that certain hoppers do not tend to cause ash pluggage.

Since most part of fly ash in flue gas generally drops into hoppers on the gas inlet side of the precipitator, hoppers on the inlet side generally tend to suffer from ash pluggage. However, ash pluggage is imagined to take place also inside the hoppers on the gas outlet side because precipitators in the 4th thermal power station have partially been in service for a long period of time.

If all the precipitators are in normal service, ash pluggage tends to take place inside the hoppers on the gas inlet side.

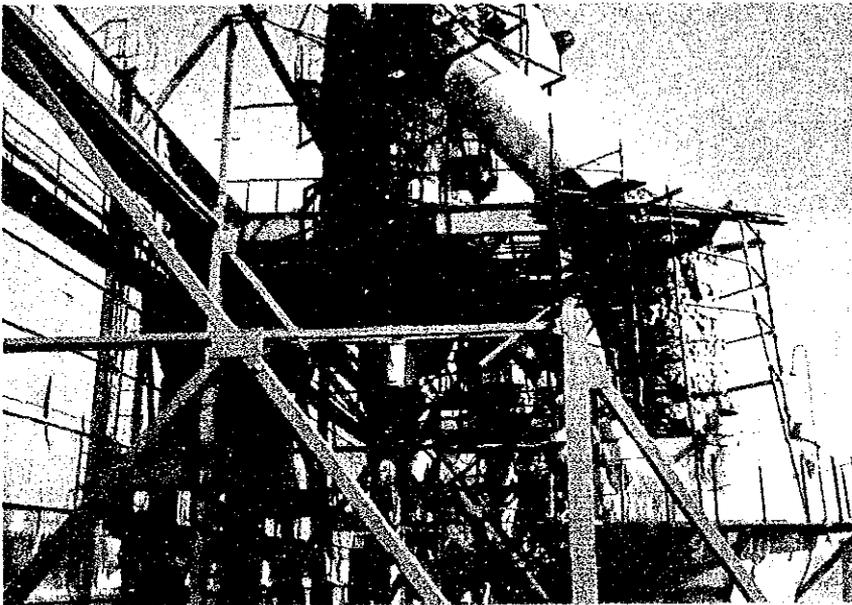
Since this place is severely damaged by wear, its rehabilitation will be conducted in the near future by the power plant side.

Fig. 4-2-15 Photographs of Site Conditions of Outlet
Pipe of Classifier (right side of photo)

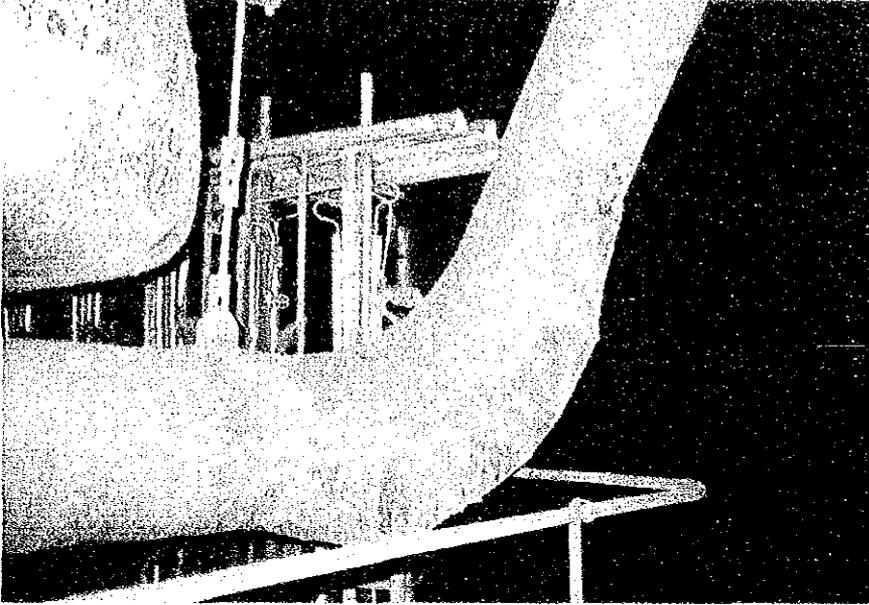
Fig 4-2-16 shows the pictures of pulverized coal pipe bend's site conditions. They mainly show that the plate type bend has been covered with another steel plate for repairs.

Photo-1 Pulverized Pipe Bend (Plate), Part 1

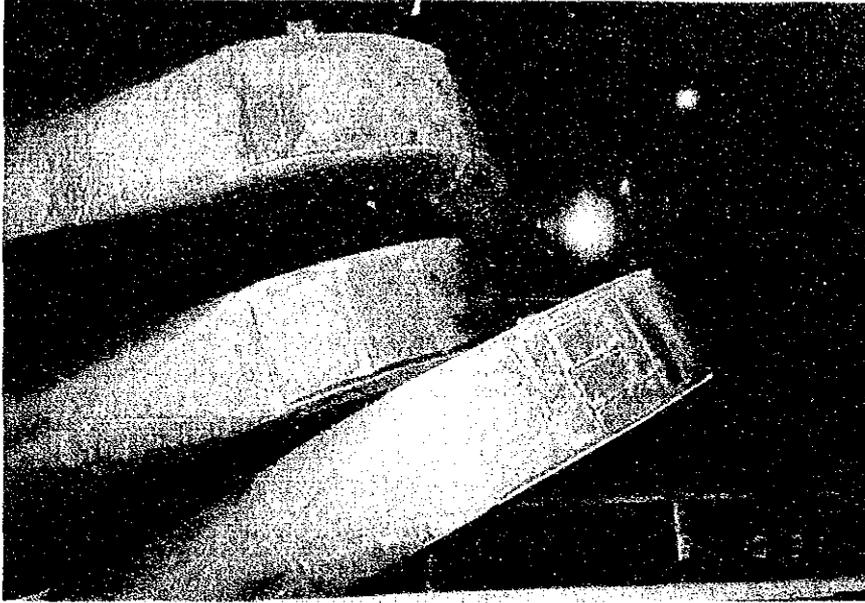
Photo-3 Pulverized Pipe Bend (Plate), Part 3
