3. Survey on Aids to Navigation

Survey on Aids to Navigation had been conducted at 20 stations from May 2 to May 23. Table 3.2 and Figure show the areas covered.

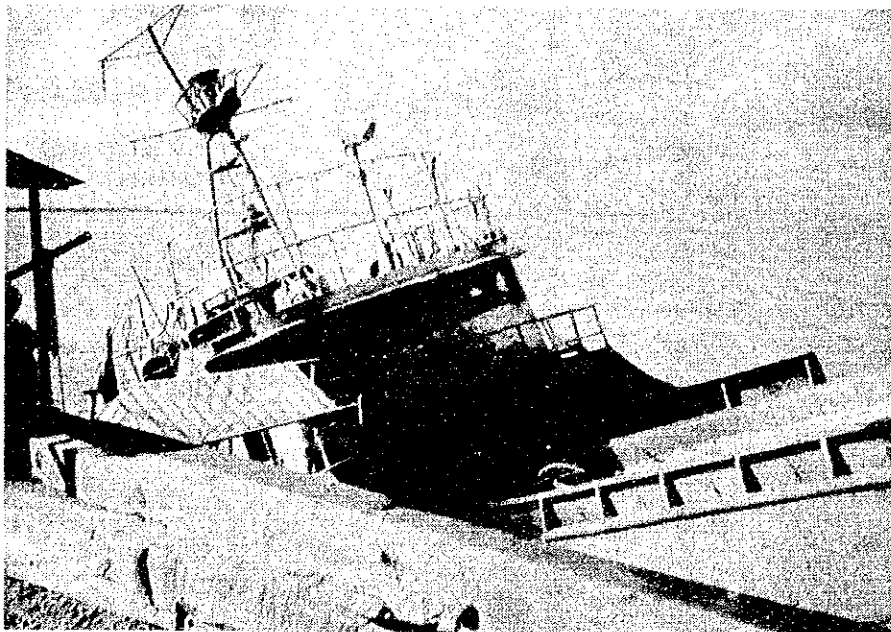
Picture Cebu - 2
Sunken Vessel due to Typhoon Ruping

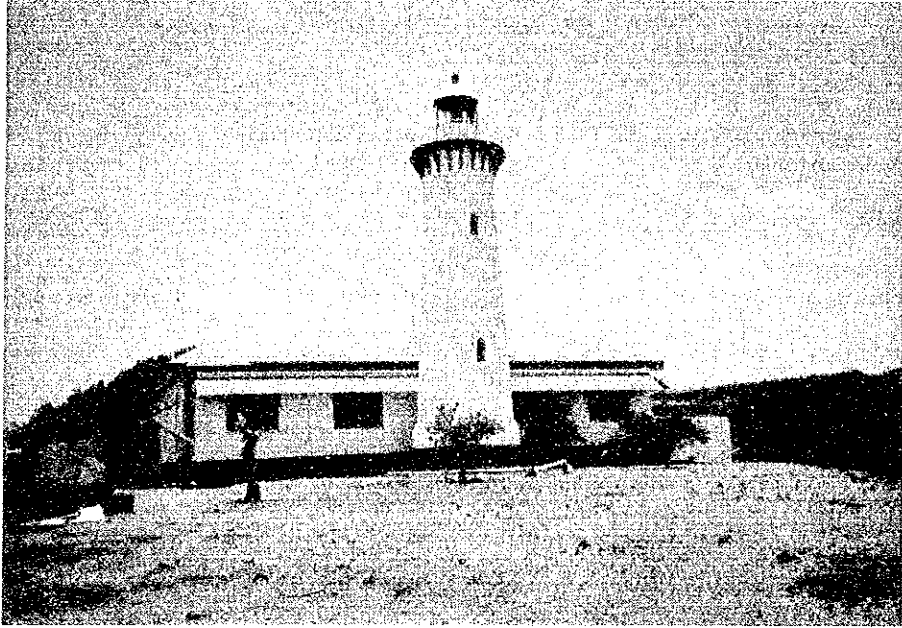
Seq. No.	1	Name	Cape Santiago LH	Survey Date	May 2, 1991	Location	Calapan, Batangas																																				
<p><u>Outline of Facility</u></p> <p>Tower : Built in 1890; structure is good : Window frames broken</p> <p>Lantern : Iron/steel frames, bay covered with heavy rust : Door missing : Many cracks in concrete platform : Lightning rod/wires missing</p> <p>Building : Associated bldgs. for office & dwelling well rehabilitated : Ceiling/walls broken : Some windows inoperable : Rain leakage in many parts</p> <p>Lighting : Very temporary Apparatus : Temporary electric wires temporary : No spare parts/no maint.tools : Dusty lens</p> <p>Power : Engine/generator functioning well : No elec. distribution box : No spare parts/maintenance tools</p> <p>Others : Fence down in many parts : Poor sanitary condition : Broken water storage/tank</p>

Picture 1-1 : Overview of Cape Santiago LH

Excel- lent	Good	Ave- rage	Poor	Very Poor	1. Location	v					2. Building			v			3. Light				v		4. Operation			v			5. Maintenance				v		<p><u>Recommendation for Improvement</u></p> <ul style="list-style-type: none"> - Lantern house/lighting apparatus should be replaced. - Distribution wires should be replaced. - Electrical distribution box should be installed. - Fence/gate should be repaired. - Water supply system should be installed. - All drainage parts of structure should be replaced. 			
	Excel- lent	Good	Ave- rage	Poor	Very Poor																																						
1. Location	v																																										
2. Building			v																																								
3. Light				v																																							
4. Operation			v																																								
5. Maintenance				v

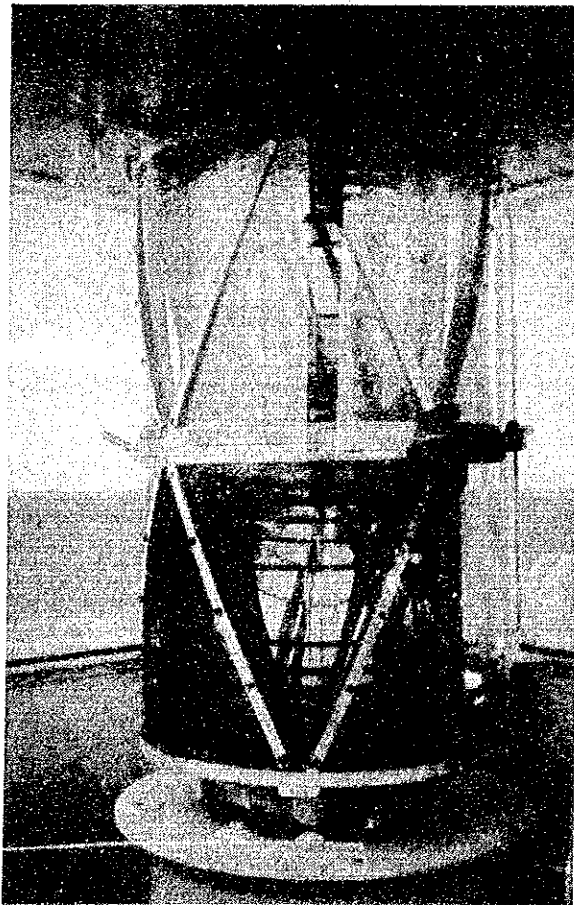
Picture 1-2 : Lighting Apparatus

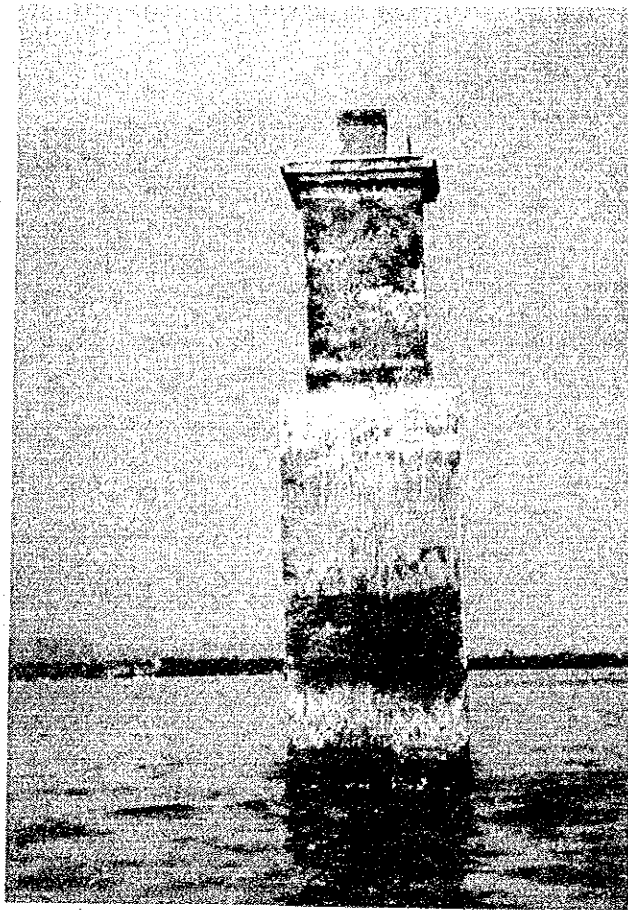
Seq. No.	2	Name	Calatagan Reef	Survey Date	May 2, 1991	Location	Calatagan, Batangas																																				
<p><u>Outline of Facility</u></p> <p>Structure : Beacon tower is good. There is no ladder for climbing; no fender for maintenance.</p> <p>Lantern : There is no lantern light.</p>																																											
<p><u>Maintenance & Operation</u></p>

Picture 2-1 : Overview of Calatagan Reef Beacon

Excel- lent	Good	Ave- rage	Poor	Very Poor	1. Location		v				2. Building		v				3. Light						4. Operation						5. Maintenance				v		<p><u>Recommendation for Improvement</u></p> <ul style="list-style-type: none"> - Tower elevation should be increased by at least 5 meters. - Lighting apparatus should be installed. - Ladder and fender should be installed. 			
	Excel- lent	Good	Ave- rage	Poor	Very Poor																																						
1. Location		v																																									
2. Building		v																																									
3. Light																																											
4. Operation																																											
5. Maintenance				v

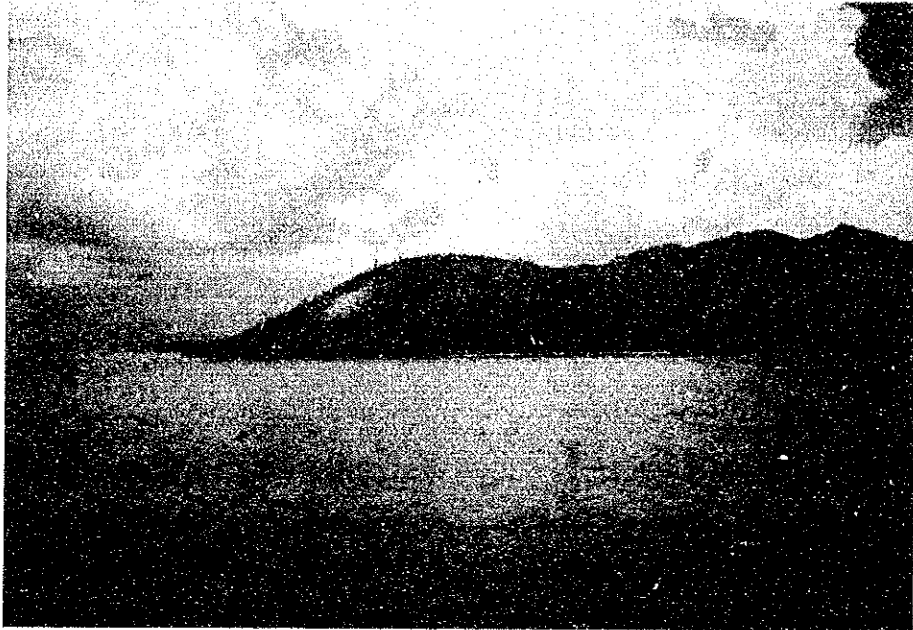
Seq. No.	Name	Verde Island Passage	Survey Date	May 3, 1991	Location	Verde Passage
<p><u>Site Examination</u></p> <ul style="list-style-type: none"> - High level of fishing activities. - Strong tidal current. 						
<p><u>Proposal for Construction</u></p> <ul style="list-style-type: none"> - New lighthouses should be established in West Pt./South Pt. of Verde Island. - Solar panels should be used for power supply. - Access should be provided to the Western Pt. - A jetty in South Pt. should be established. 						
<u>Evaluation</u>	Excel- lent	Good	Ave- rage	Poor	Very Poor	<u>Recommendation for Improvement</u>
1. Location						
2. Building						
3. Light						
4. Operation						
5. Maintenance

Picture 3-1 : Proposed Point

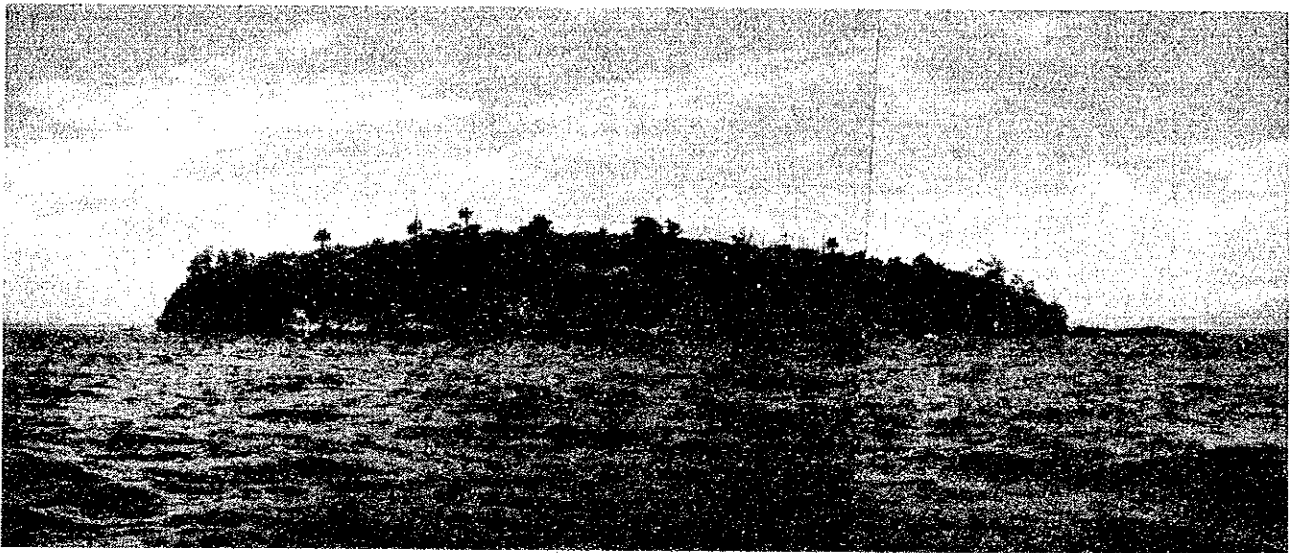
Seq. No.	Name	Baco Chico Island	Survey Date	May 4, 1991	Location	Calapan, Oriental Mindoro
<p><u>Site Examination</u></p> <ul style="list-style-type: none"> - Located at the entrance of Verde Island Passage. 						
<p><u>Proposal for Construction</u></p> <ul style="list-style-type: none"> - A lighthouse should be constructed at the center of the island. - A large size beacon should be installed and a jetty constructed. - Access, passing through the channel, should be provided. 						
<u>Evaluation</u>	Excel- lent	Good	Ave- rage	Poor	Very Poor	<u>Recommendation for Improvement</u>
1. Location						
2. Building						
3. Light						
4. Operation						
5. Maintenance

Picture 4-1
Overview of Baco Chico Island

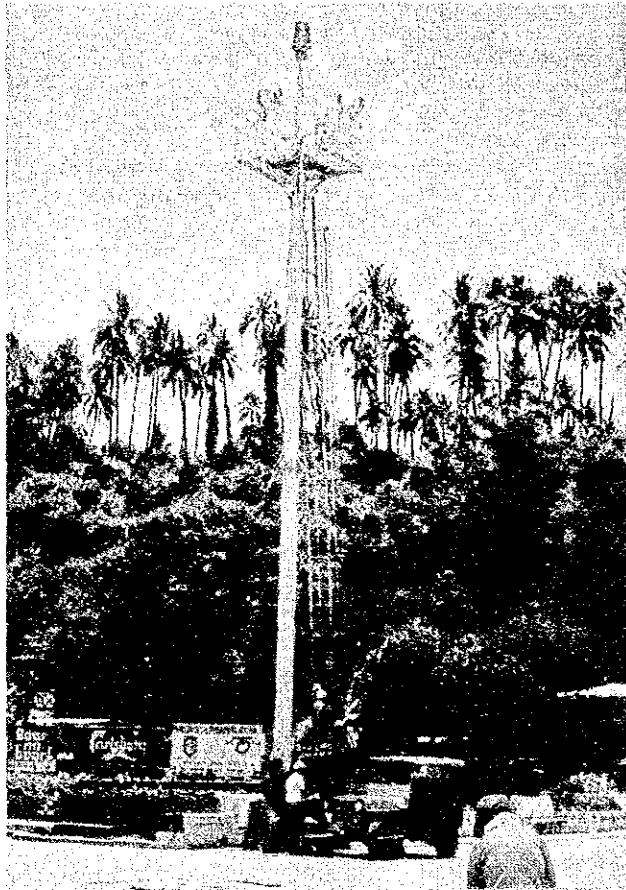
Seq. No.	Name	Calapan LB	Survey Date	May 4, 1991	Location	Calapan, Oriental Mindoro
<u>Outline of Facility</u> Structure : The light installed is located at the wharf. The tower is too slender and is not visible.						
<u>Maintenance & Operation</u> - Maintenance is at a very good level.						
<u>Evaluation</u>		Excel- lent	Good Ave- rage	Poor Very Poor	<u>Recommendation for Improvement</u>	
1) Location				v	- Power supply should be changed to solar panel.	
2) Building				v	- Tower should be built into a single one or a day mark board should be installed at the upper part of the existing lighting pole.	
3) Light		v				
4) Operation			v			
5) Maintenance		v

Picture 5-1
Overview of Calapan
Lightbeacon

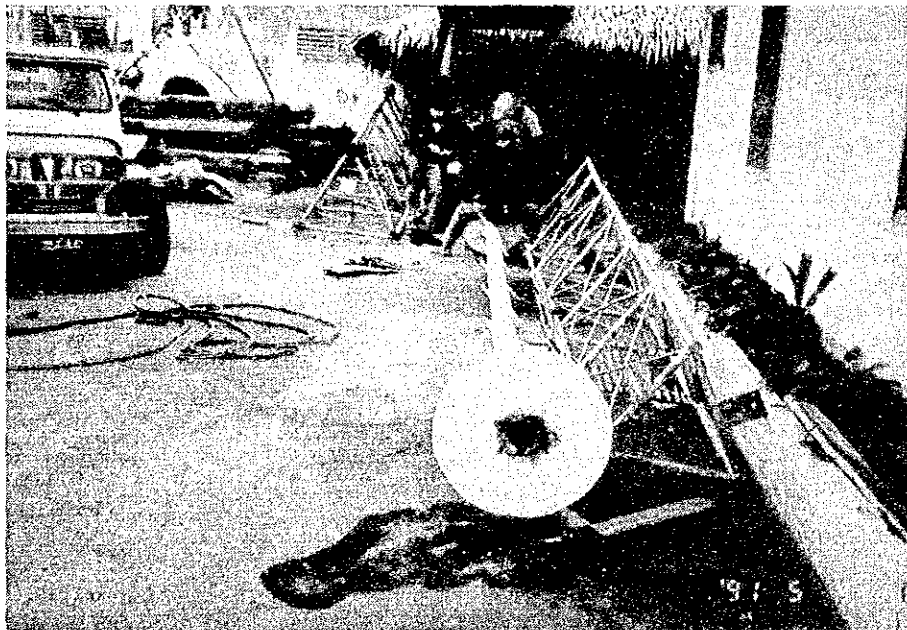
Seq. No.	Name	Batangas LB	Survey Date	May 4, 1991	Location	Batangas City
<u>Outline of Facility</u> Structure : Height of tower is low and hardly visible from sea. : Tower is presently under construction, to increase height.						
<u>Maintenance & Operation</u> - Maintenance is at a very good level.						
<u>Evaluation</u>		Excel- lent	Good Ave- rage	Poor Very Poor	<u>Recommendation for Improvement</u>	
1. Location				v	- Complete tools for maintenance should be supplied.	
2. Building				v		
3. Light		v				
4. Operation			v			
5. Maintenance		v

Picture 6-1 : The site of tower
construction in Batangas

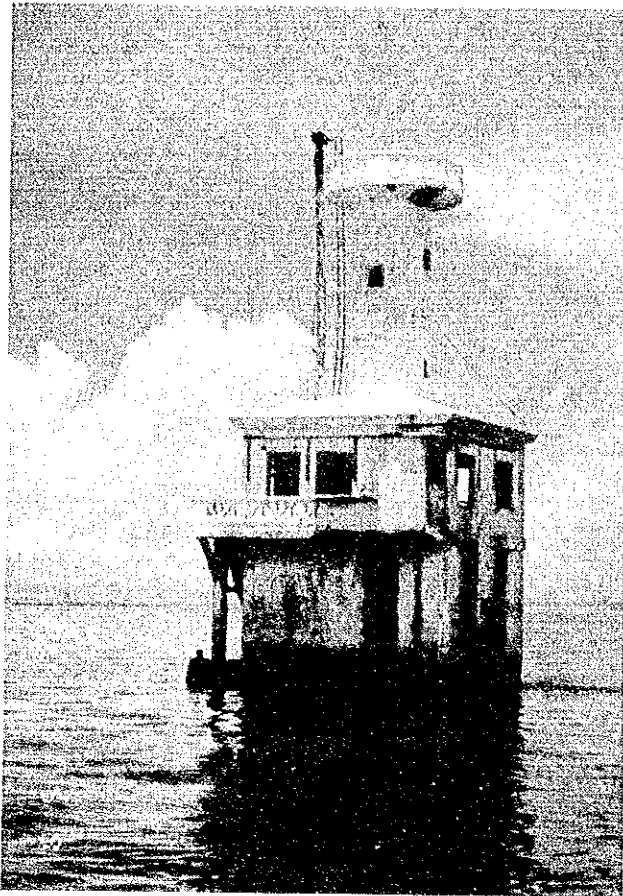
Picture 7-1

Seq. No.	Name	Louis Ledge LII	Survey Date	May 9, 1991	Location	Cebu Port
<u>Outline of Facility</u>						
Tower : The structure base was well constructed. : Upper part of the power room, apparatus room and some storage rooms are almost destroyed. : Many parts of the ceiling/wall are broken down, with reinforcing steels bars of concrete wall/ceiling exposed.						
Lighting : Lighting apparatus functioning well.						
Apparatus : Lead battery not kept in good condition. : Base plate of lantern covered with rust. : No spare parts and tools for maintenance/operation.						
Lantern : There is no lantern house; a small lantern is temporarily used. : There is not enough space for a standard lantern.						
Others : Concrete handrail missing.						
<u>Evaluation</u>	Excel- lent	Good	Ave- rage	Poor	Very Poor	<u>Recommendation for Improvement</u>

Overview of Laois
Ledge LH

1) Location		v				- A large size lantern should be installed.
2) Building				v		- Luminous intensity should be much higher.
3) Light			v			- The windows should be enclosed with glass bricks.

4) Operation					v	- A jetty has should be installed on the other side of the tower.
5) Maintenance				v		- A handrail should be installed.

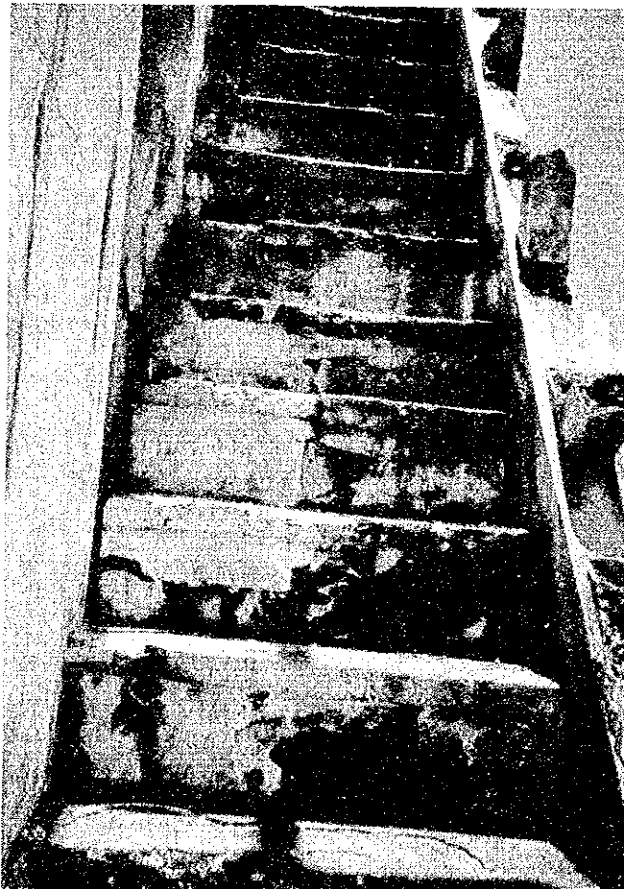
Picture 7-2

Damaged Starway

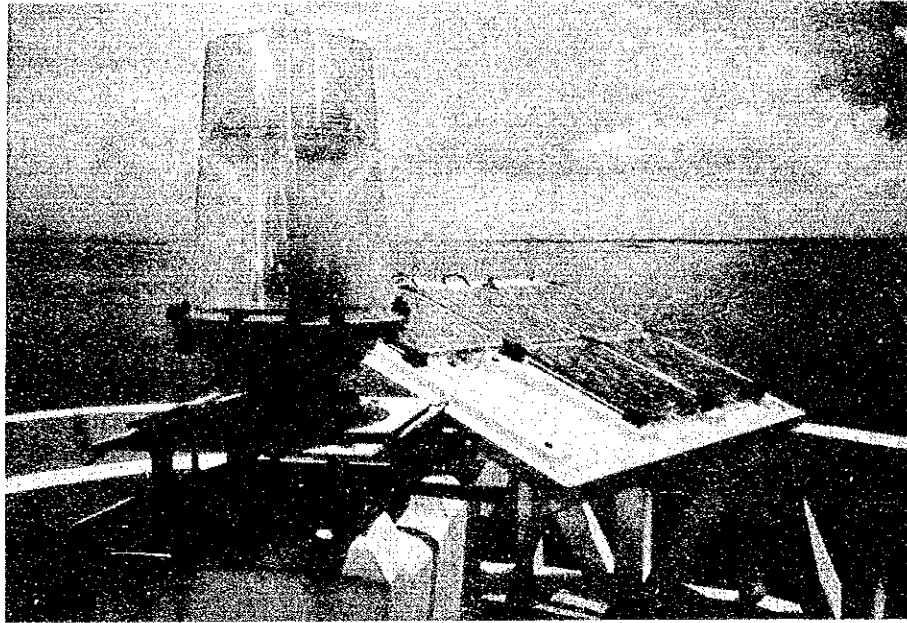
Picture 7-3 : Lantern and Solar Pannel

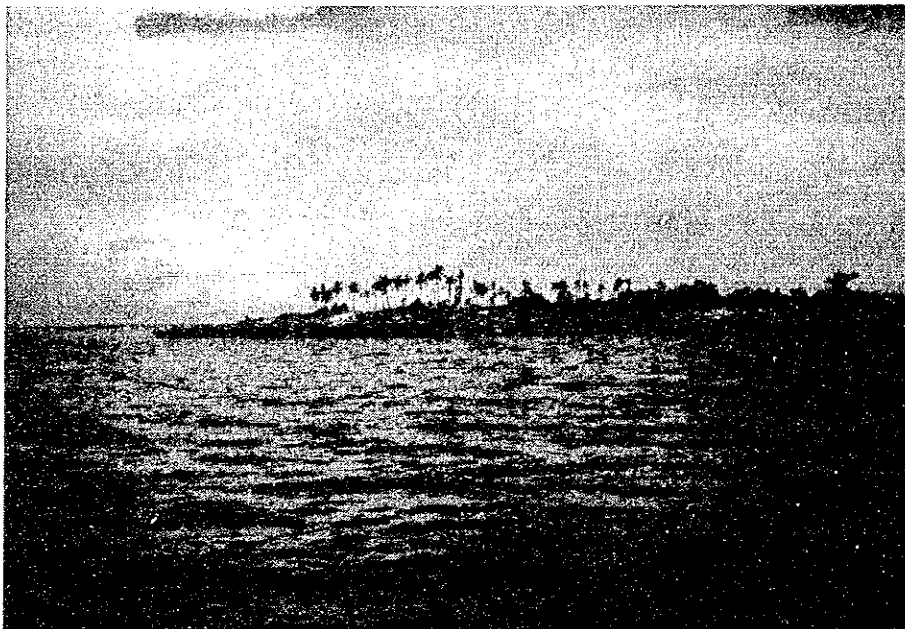
Seq. No.	Name	Panguian Pt.	Survey Date	May 9, 1991	Location	Mactan Island, Cebu
<u>Site Examination</u>						
- Panguian Pt. is the bifurcation point between the north entrance of Cebu Port and Hihitangan Channel. - It is located at the northernmost tip of Mactan Island. - Land elevation is less than 5 meters above sea level and the terrain is flat.						
<u>Proposal for Construction</u>						
- A medium size light beacon should be installed. - Solar power should be used for power supply. - An access path should be provided for maintenance.

Picture 8-1 : Proposed Site at
Panguian Pt.

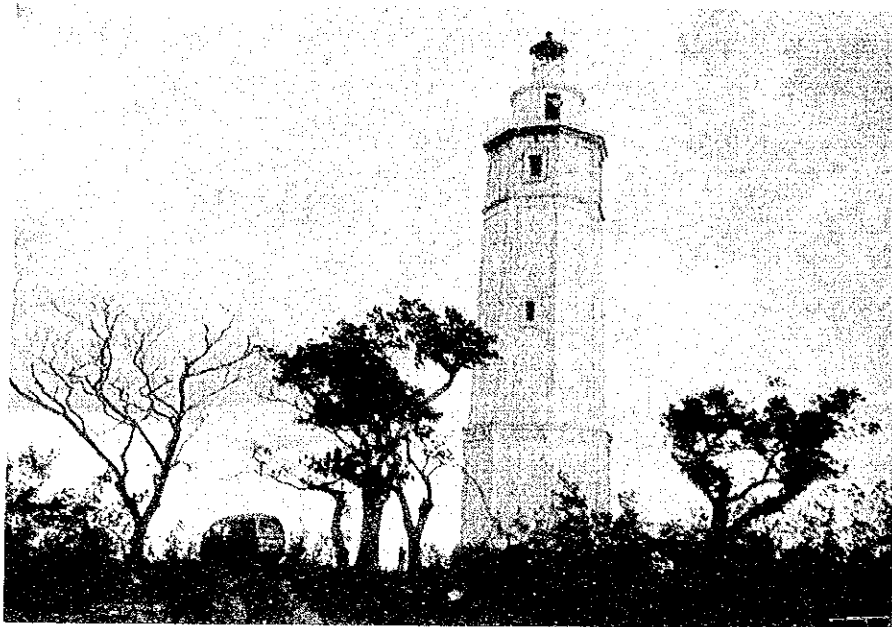
Seq. No.	Name	Bagacay LH	Survey Date	May 9, 1991	Location	Lilo-an, Cebu
<u>Outline of Facility</u>						
Tower	:	Tower was built in 1904; structure is still good. : Windows are broken; some closed with wooden boards. : There are no lighting rod and appropriate wiring. : Rain leaks through broken windows, lower platform. : Upper door can not be completely closed due to broken hinge. : Platform floor has cracks, allowing water to seep through, causing decay of concrete structures below.				
Building	:	Lightkeeper's house destroyed by strong typhoon and is unlivable. : Power supply house roof also destroyed by typhoon; engine is wet every time it rains.				
Light Apparatus	:	Old apparatus not functioning. : Spare parts and tools not available. : New light is in good operation, although luminous intensity is very poor, as a landfall mark, considering that this is a major lighthouse. : Lantern glasses are unsealed.

Picture 9-1 : Overview of Bagacay Lighthouse

<u>Evaluation</u>		Excel- lent	Good Ave- range	Poor 	Very Poor	<u>Recommendation for Improvement</u>
1. Location			v			- The platform floor should be immediated replaced with a water-proof concrete floor immediately.

2. Building				v		- Temporary apparatus should be replaced with rotary lighting system, and local electricity should be introduced for main power supply system. Engine/generator should be used for emergency power supply.

3. Light					v	- The original apparatus should be placed in other facilities (e.g. museum).
4. Operation					v	- The destroyed house/power supply building should be reconstructed.

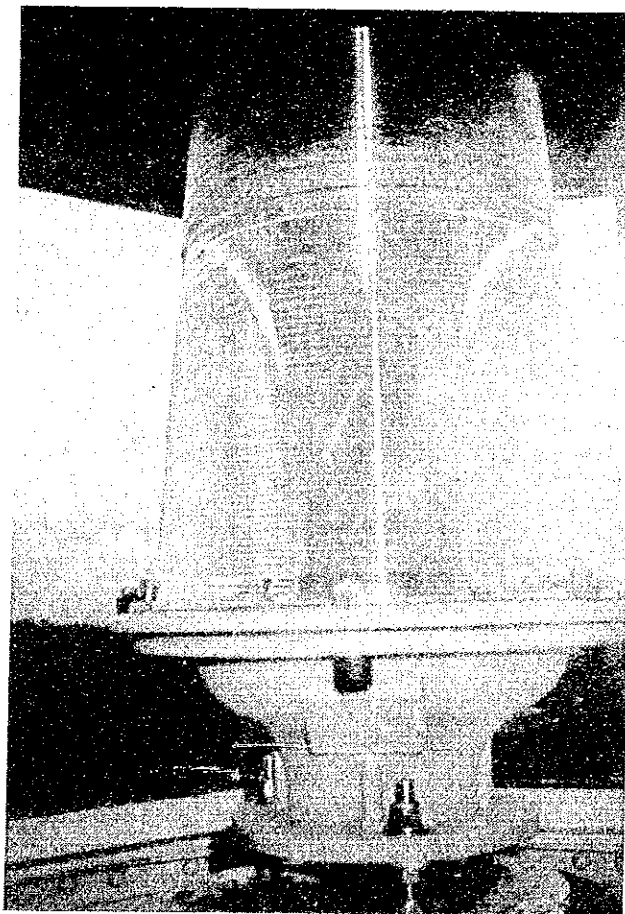
Picture 9-2 Lantern Apparatus

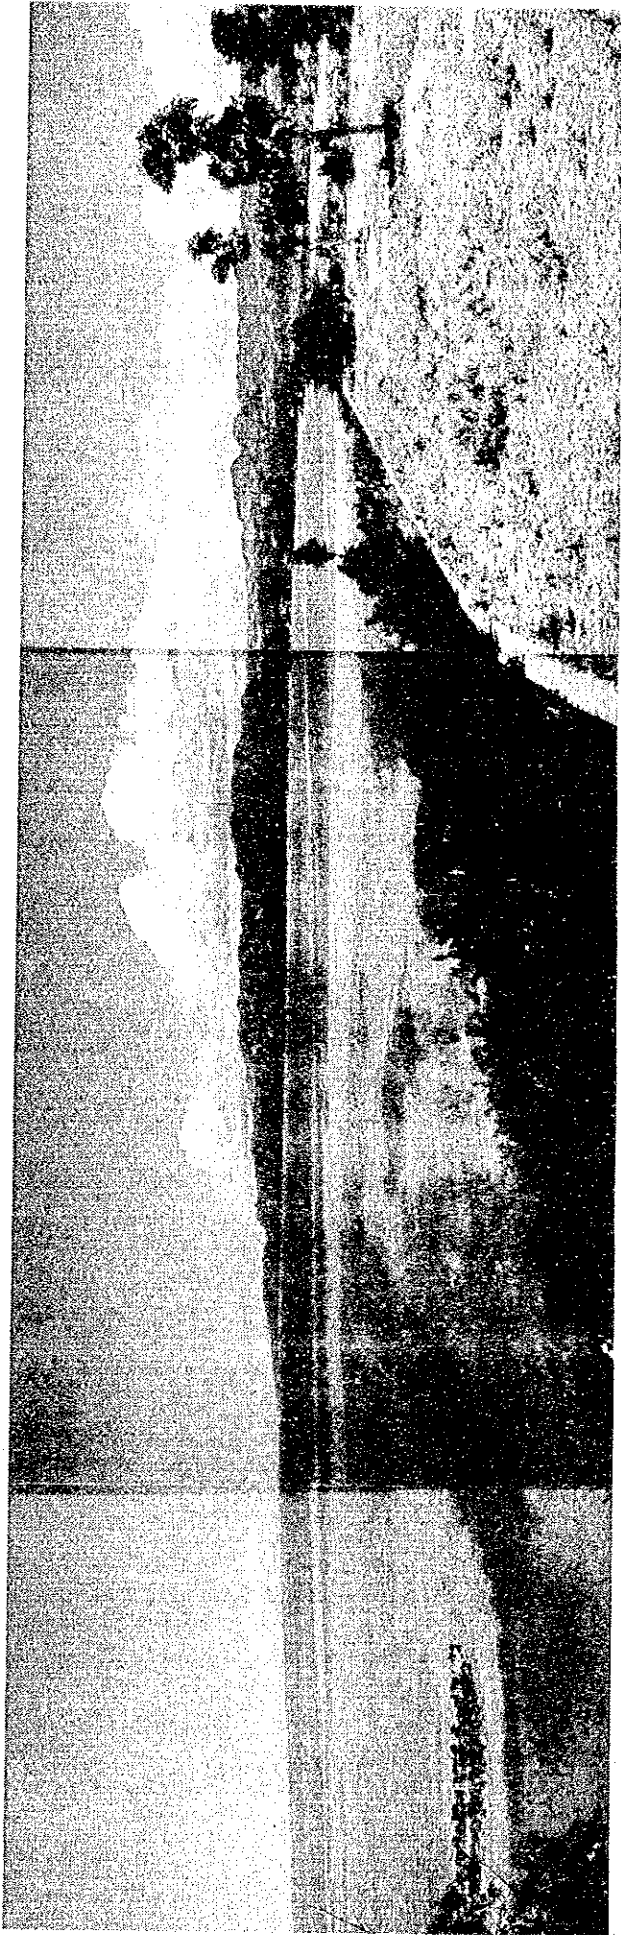
Seq. No.	Name	Binongkalan Pt.	Survey Date	May 10, 1991	Location	Binongkalan, Cebu
<u>Site Examination</u>						
- Point faces main traffic route between Manila to Cebu. - Point is situated between two major lighthouses (i.e., Capitancillo and Bagacay Pt.). - Luminous ranges of both lighthouses do not overlap. - Site has inadequate land elevation.						
<u>Proposal for Construction</u>						
- A large type of light beacon should be built. - Local power source should be used for main power supply.

Picture 10-1 Proposed Site
