MASTER PLAN OF 5-YEAR REHABILITATION/RENOVATION OF POWER FACILITIES

CHAPTER 6 MASTER PLAN OF 5-YEAR REHABILITATION/RENOVATION OF POWER FACILITIES

6.1 Thermal Power Plants

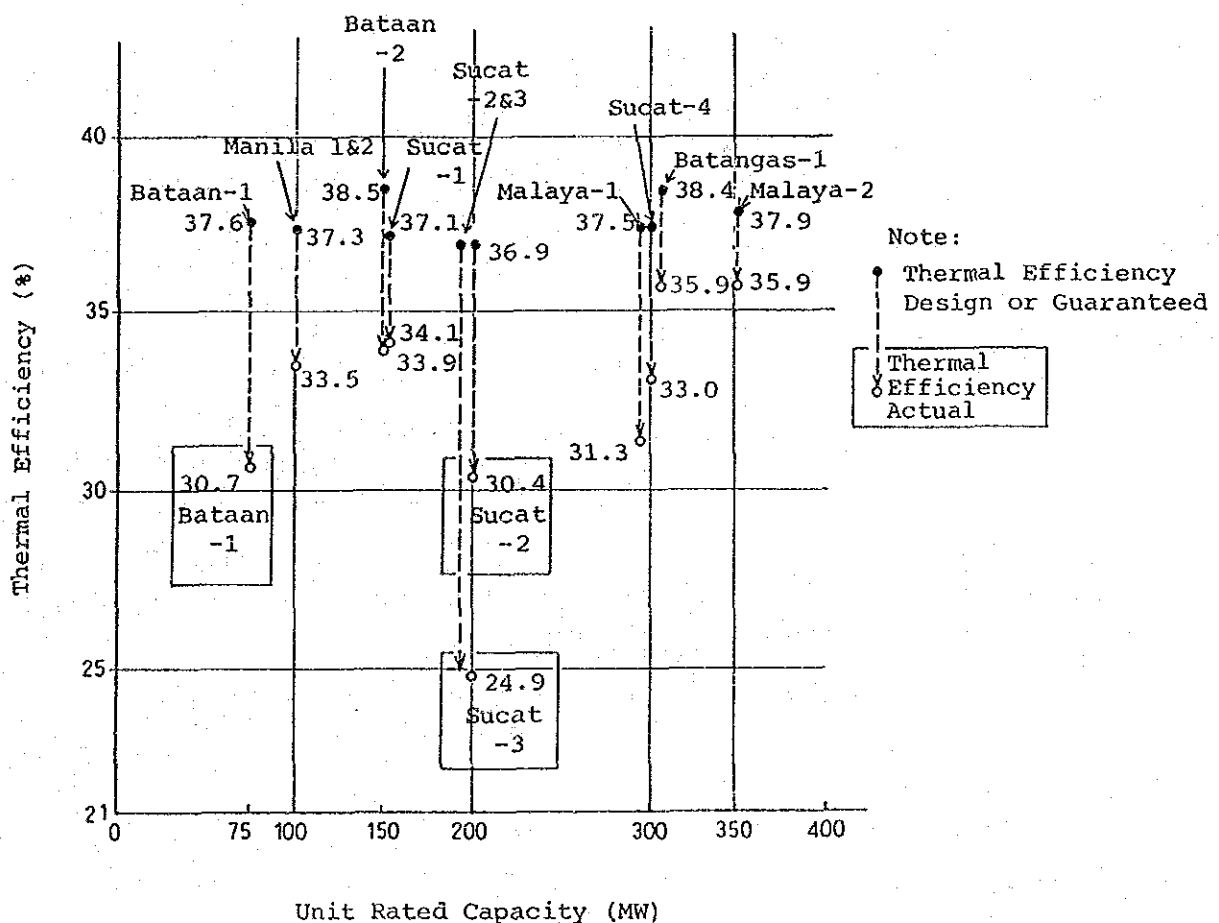
Fig. 6-1-1 Present Status of Thermal Efficiency at Thermal Power Plants
(As of June, 1991)

With all units, the heat rates (or thermal efficiency) have fallen below the design or guaranteed heat rates owing to the deterioration caused by age. (refer to Table 6-1-3 c/a; c = current heat rate, a = designed or guaranteed heat rate)

The worst three are the Sucat No. 3 (c/a = 1.483), Bataan No. 1 (c/a = 1.226) and Sucat No. 2 (c/a = 1.214).

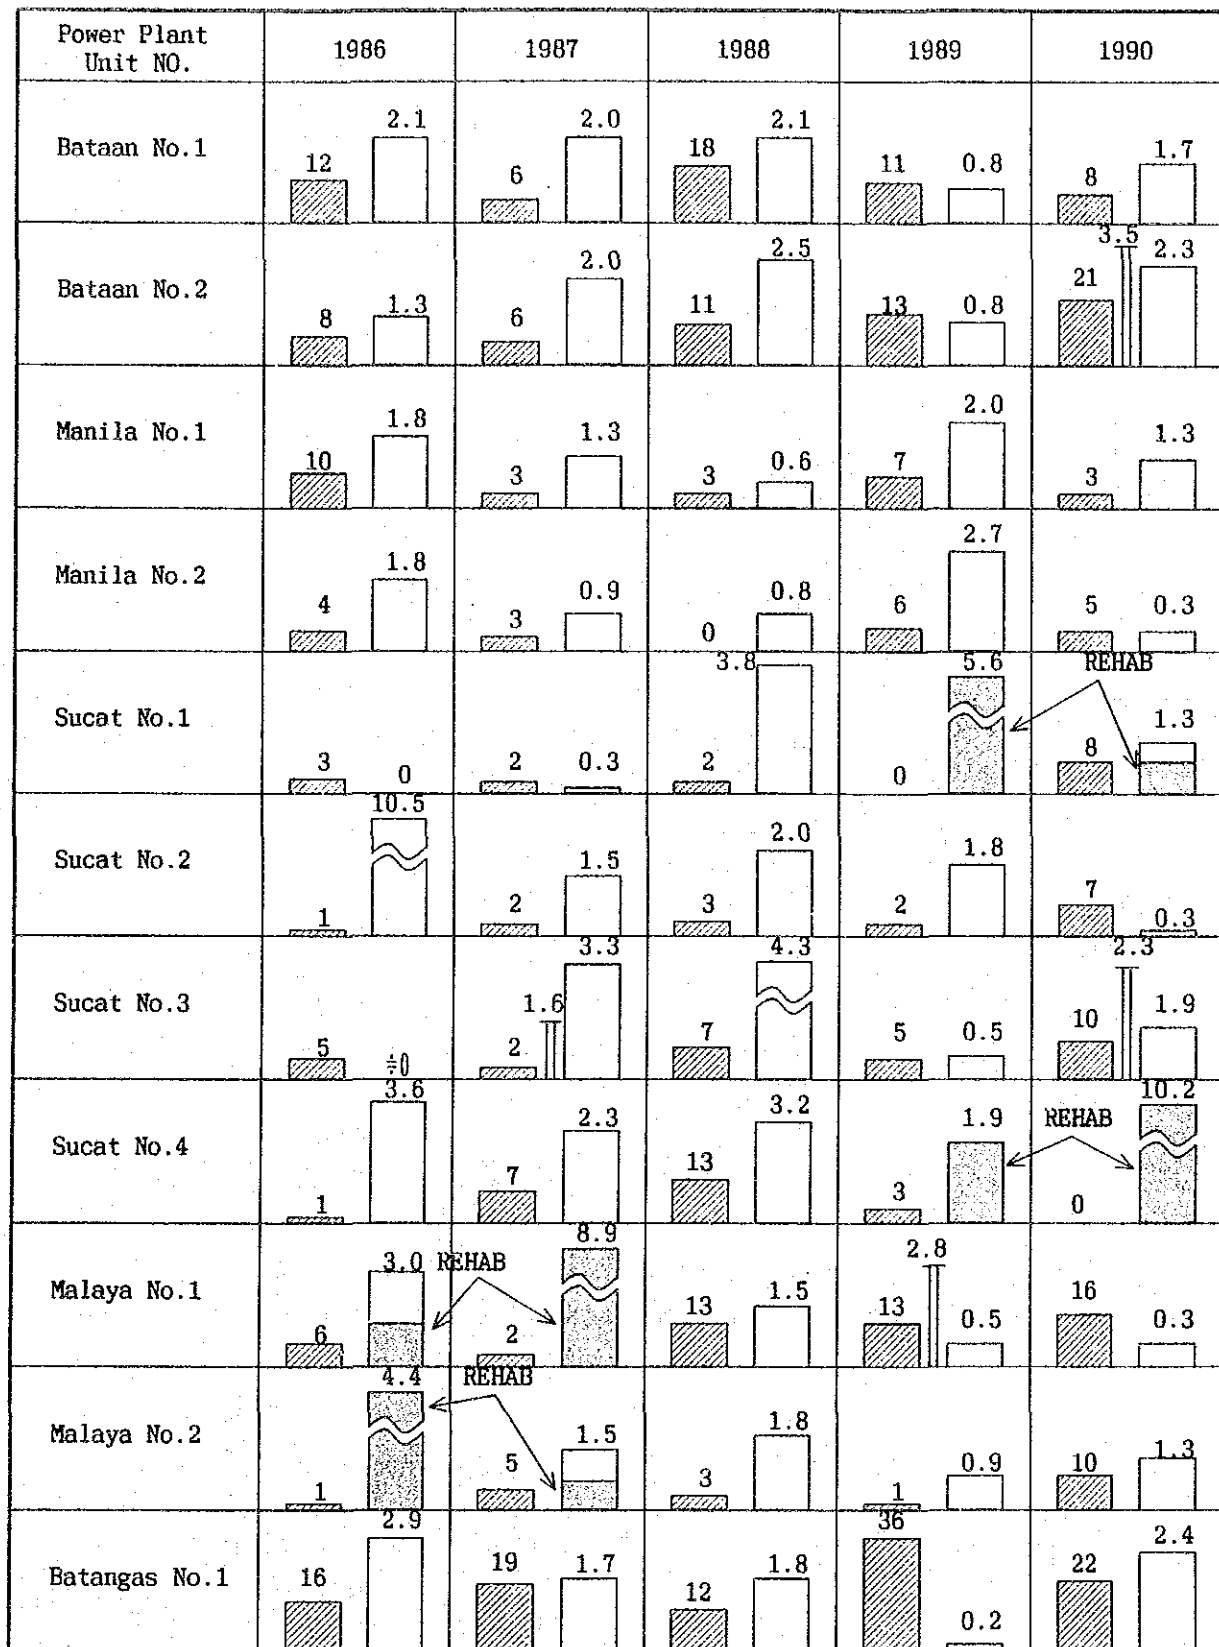
Fig. 6-1-2 Annual Forced Outage Times and Annual Maintenance Outage Hours

- a. With Bataan No. 2, an increasing tendency is noted in the number of forced outages and in the length of maintenance outages.
- b. With Sucat No. 2 & 3, the annual maintenance outage period exceeded 3 months in some different years. Also, an increasing tendency is observed in their numbers of annual forced outages, which had been relatively small previously.

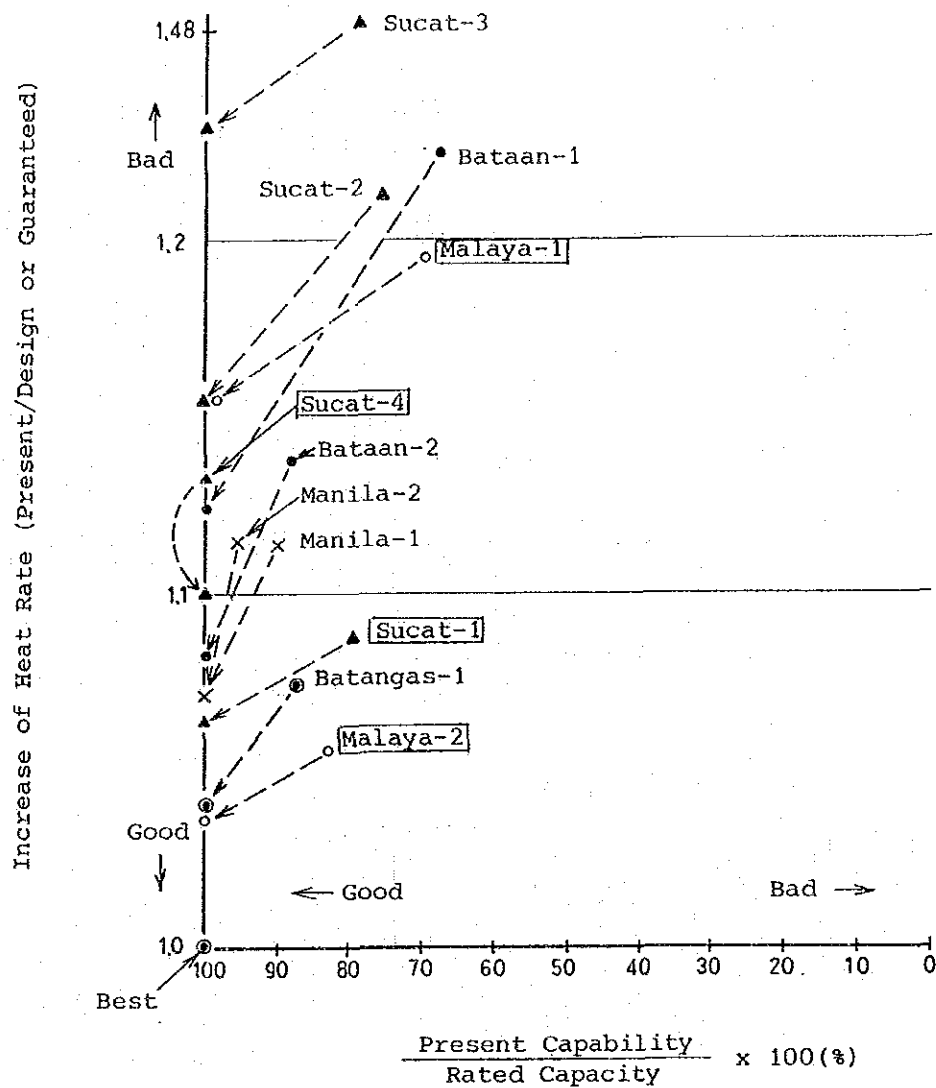
Fig. 6-1-3 Present Conditions of Thermal Power Plants
(Capacity and heat rate)

As the aged deterioration with these units is advanced, appropriate rehabilitation or planned maintenance is called for.
