3. Present Status of Power Plant Facilities

6.2.3 Formulation of Rehabilitation Plan

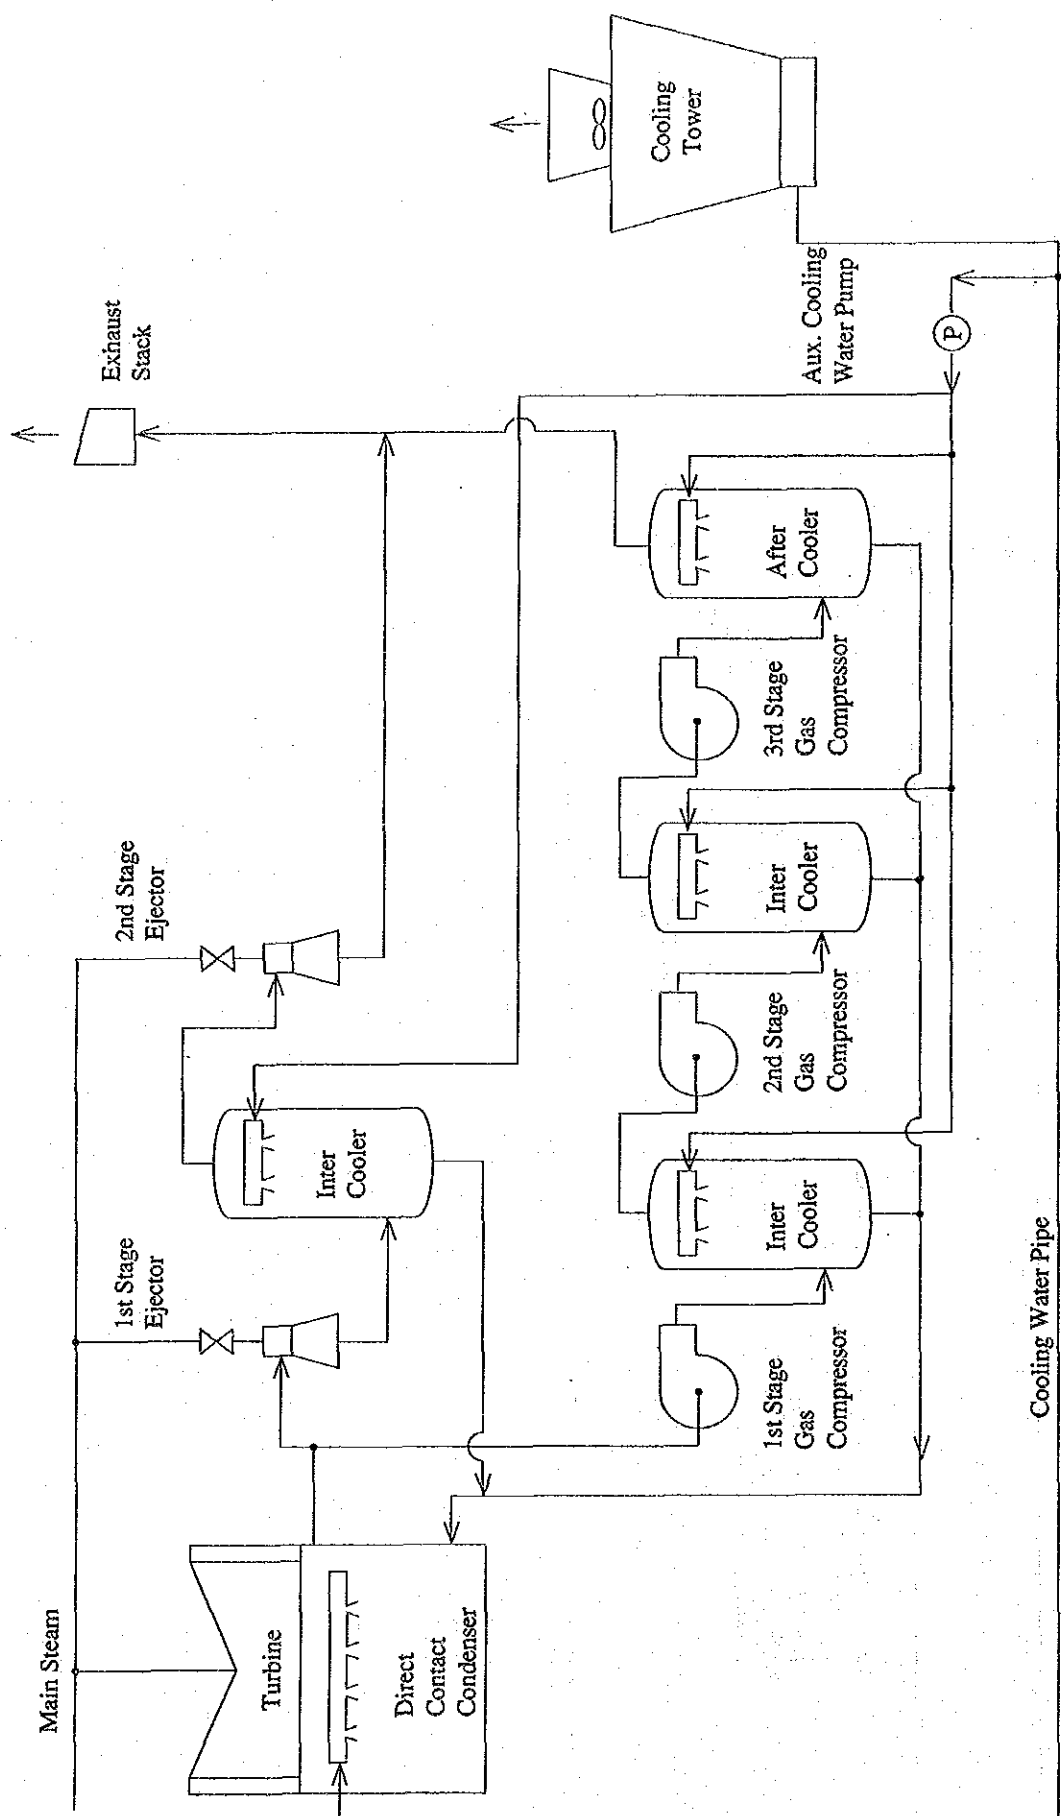
Fig. 6-2-8 (1) Mak-Ban Geothermal Power Plant Gas Extraction System Diagram (Existing)
(No.1 ~ No.4 Unit)

At present, the gas compressors suffer surging and corrosion has progressed extensively. Thus, it is judged that the gas compressors cannot be used any longer.

For the steam ejectors to be used normally without troubles, it is advisable to add after-condensers to the steam ejectors and protect the surrounding equipment from corrosion due to the discharged steam condensate. And further it is advised that the discharge from the ejectors be led to the outlet of forced draft of the cooling towers to effect better diffusion and decrease the ground concentration of H_2S gas. (Fig. 6-2-8 (1), (2) and (3))
