付属資料 VI 農村建築の震害とその原因

RURAL BUILDINGS IN TURKEY THAT HAVE SUFFERED DAMAGES
IN RECENT EARTHQUAKES AND THEIR MAIN CAUSES

M.HASAN BODUROGLU

Structural Damage due to the 1976 Çaldıran Earthquake

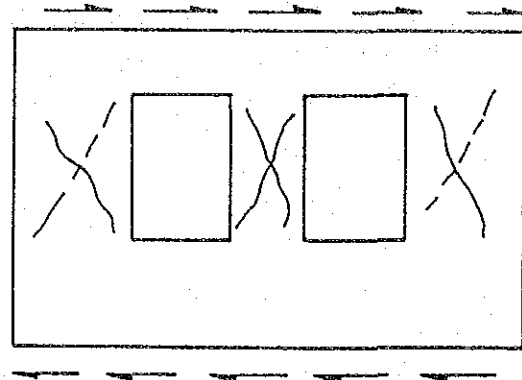
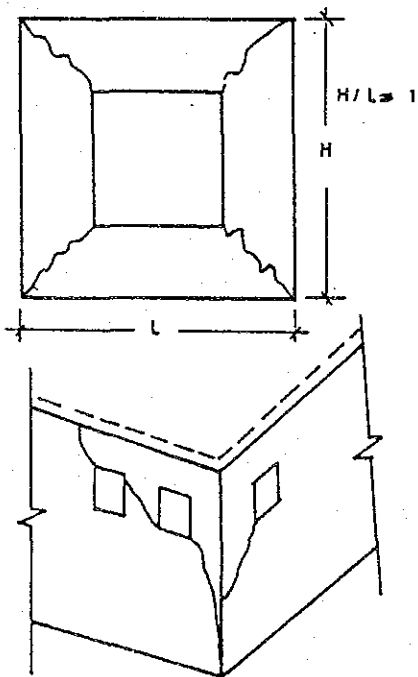
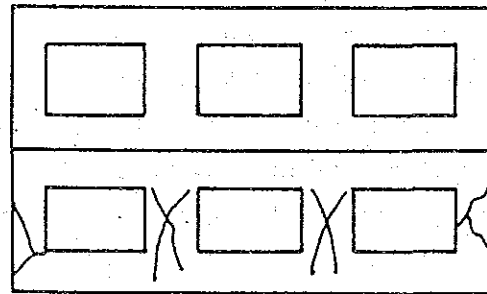
FIGURE 4. Various forms of earthquake crack formation in brick Walls

The damage pattern of brick masonry buildings show some differences from the other masonry buildings. Different crack patterns can be observed as shown in Figures 4,5 and 6.

Diagonal Tension Cracking in Brick Walls

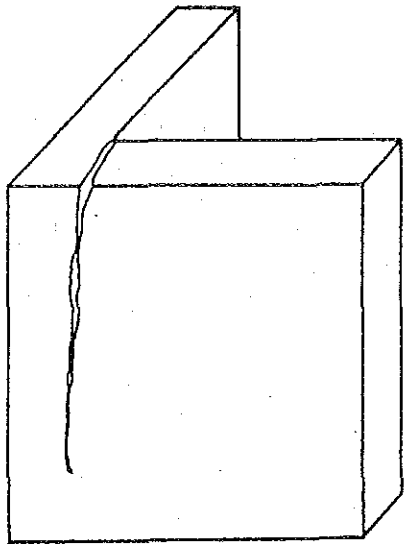
a) Damage in a Poorly Connected Corner of a Brick Masonry Building

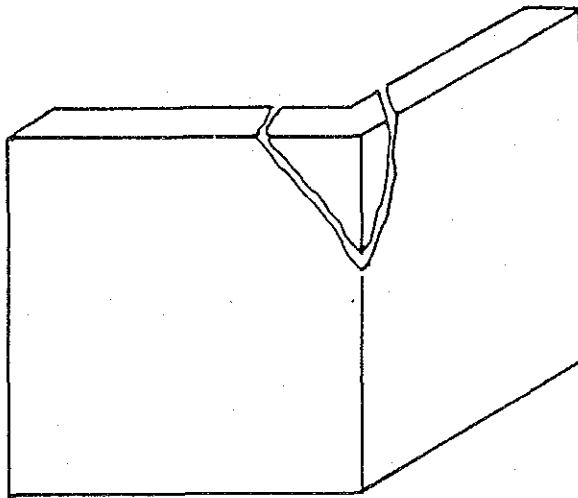
b) Corner Damage in a Masonry Building Having a Flexible Roof System

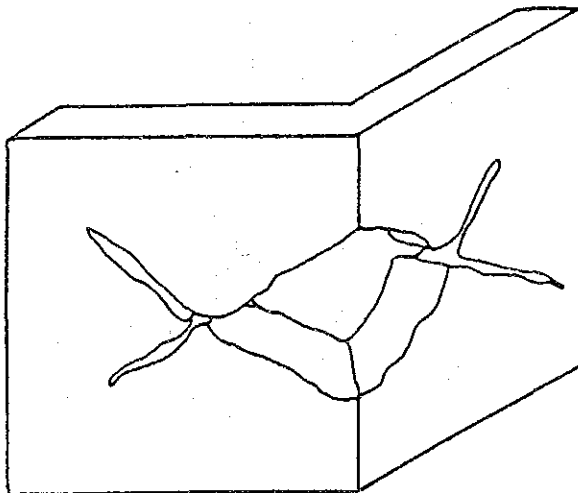
c) Corner Damage in a Brick Masonry Building Due to Large Earthquake Forces

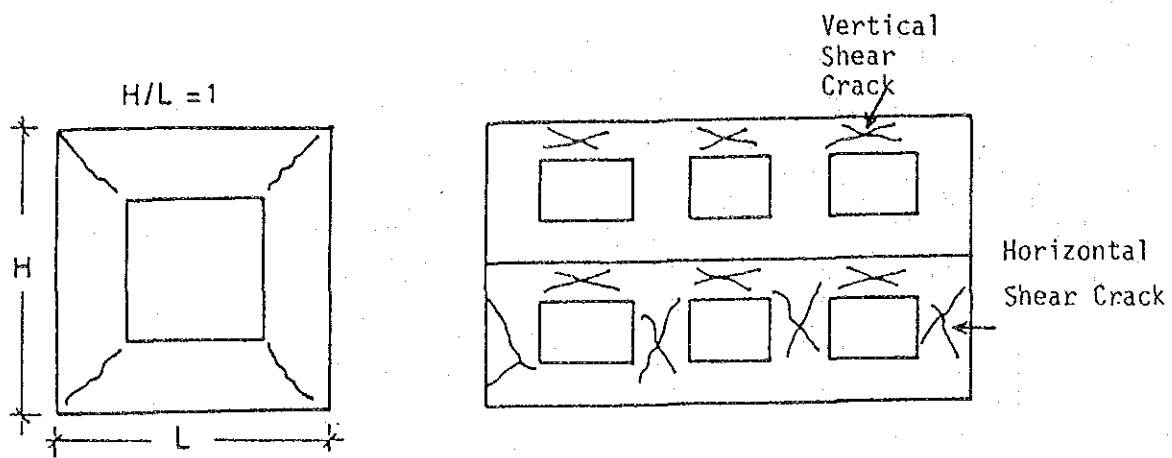
a) Shear Cracking in walls Due to Earthquakes

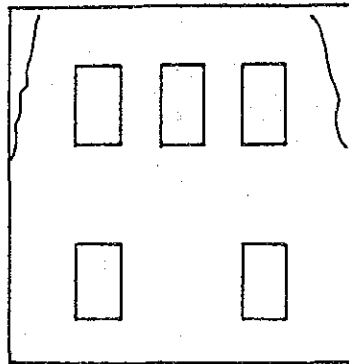
c) Settlement Cracks in Brick Masonry Buildings

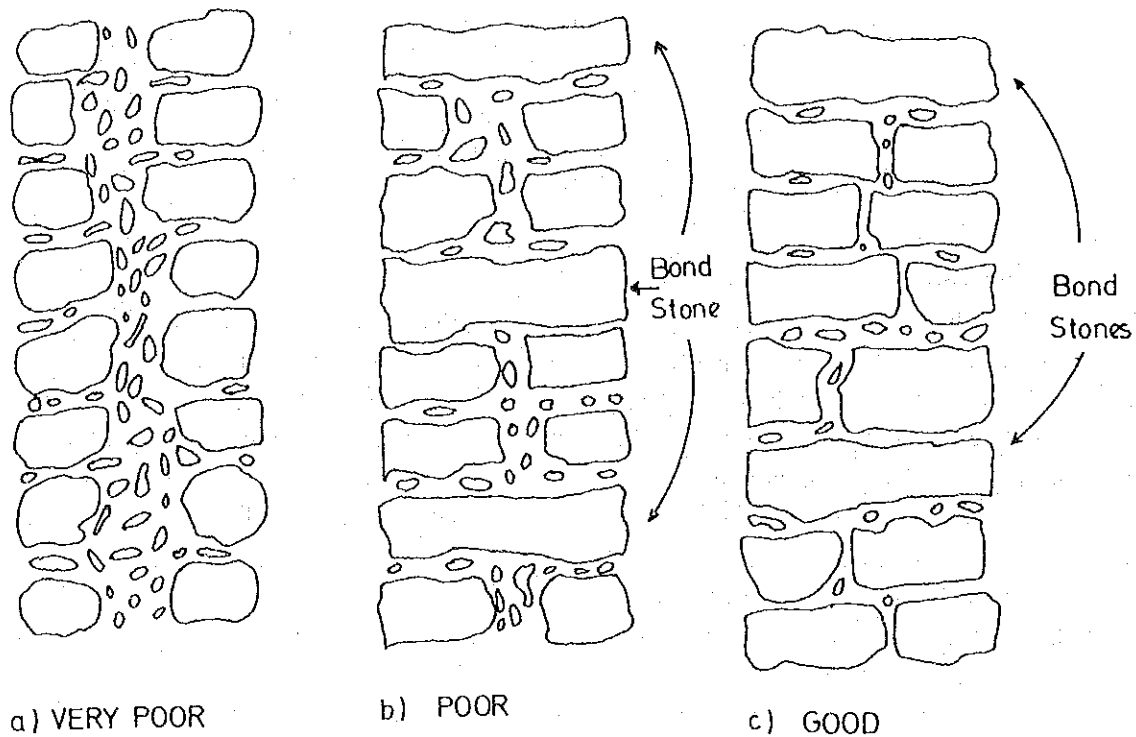
Lack of bond stones which extend from one face of the wall to the other face which keep the outer and inner stones and prevent the splitting of the wall into two, is another factor that contributes to the failure of this type of dwelling (Fig. 1).

Fig. 1 Typical Rubble Stone Masonry Workmanship in the Region and Suggested Solutions.

Use of bond stones (Fig. 1) would prevent the splitting of the wall into two (Fig. 10). To prevent the extension and enlargement of shear cracks, provision of continuous timber lintels at the top and bottom of window openings would be effective (Fig. 11). At the corners the presence of lintels will prevent or minimize the outward push of crossing walls. This is shown in Fig. 12. Taken in some other place in Eastern Anatolia in an earthquake of intensity V, the presence of timber lintels prevents the extension of damage at the corner. The most effective precaution would be to use cement-lime or at least lime mortars in the wall and to use stones whose largest dimension does not exceed the wall thickness.

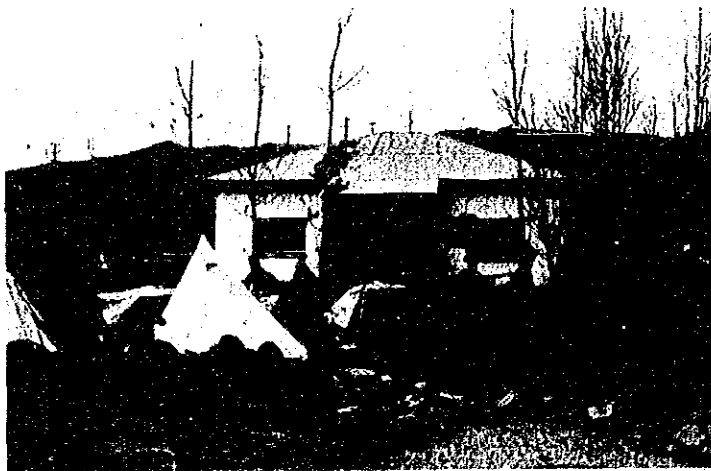
Fig. 28 Slightly Damaged Local Dwelling in Muradiye.

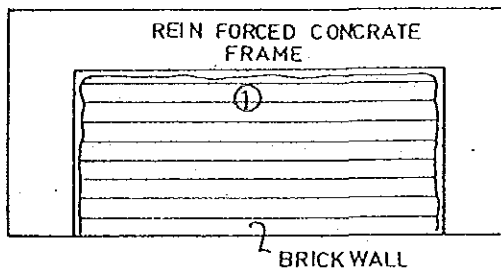
CRACKS BETWEEN FRAME AND WALL ① INTENSITIES VI-VII

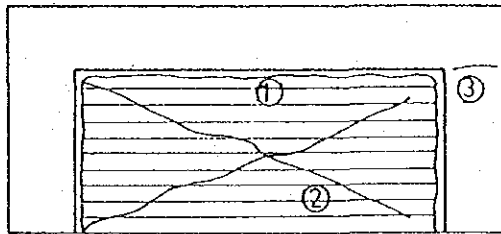
CRACKS BETWEEN FRAME AND WALL ①. X-CRACKING IN THE WALL ②. START OF HINGING IN THE COLUMN ③ INTENSITIES VIII-IX

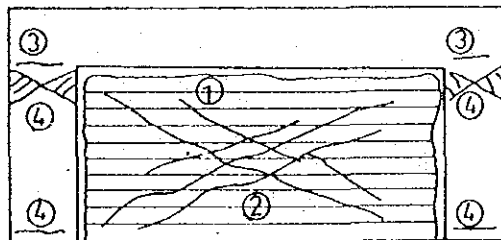
CRACKS BETWEEN FRAME AND WALL ①. X-CRACKING IN THE WALL ②, COMPLETE HINGE FORMATION IN THE COLUMN ④ AND TENSION CRACKS IN COLUMN ③, INTENSITIES X-XI

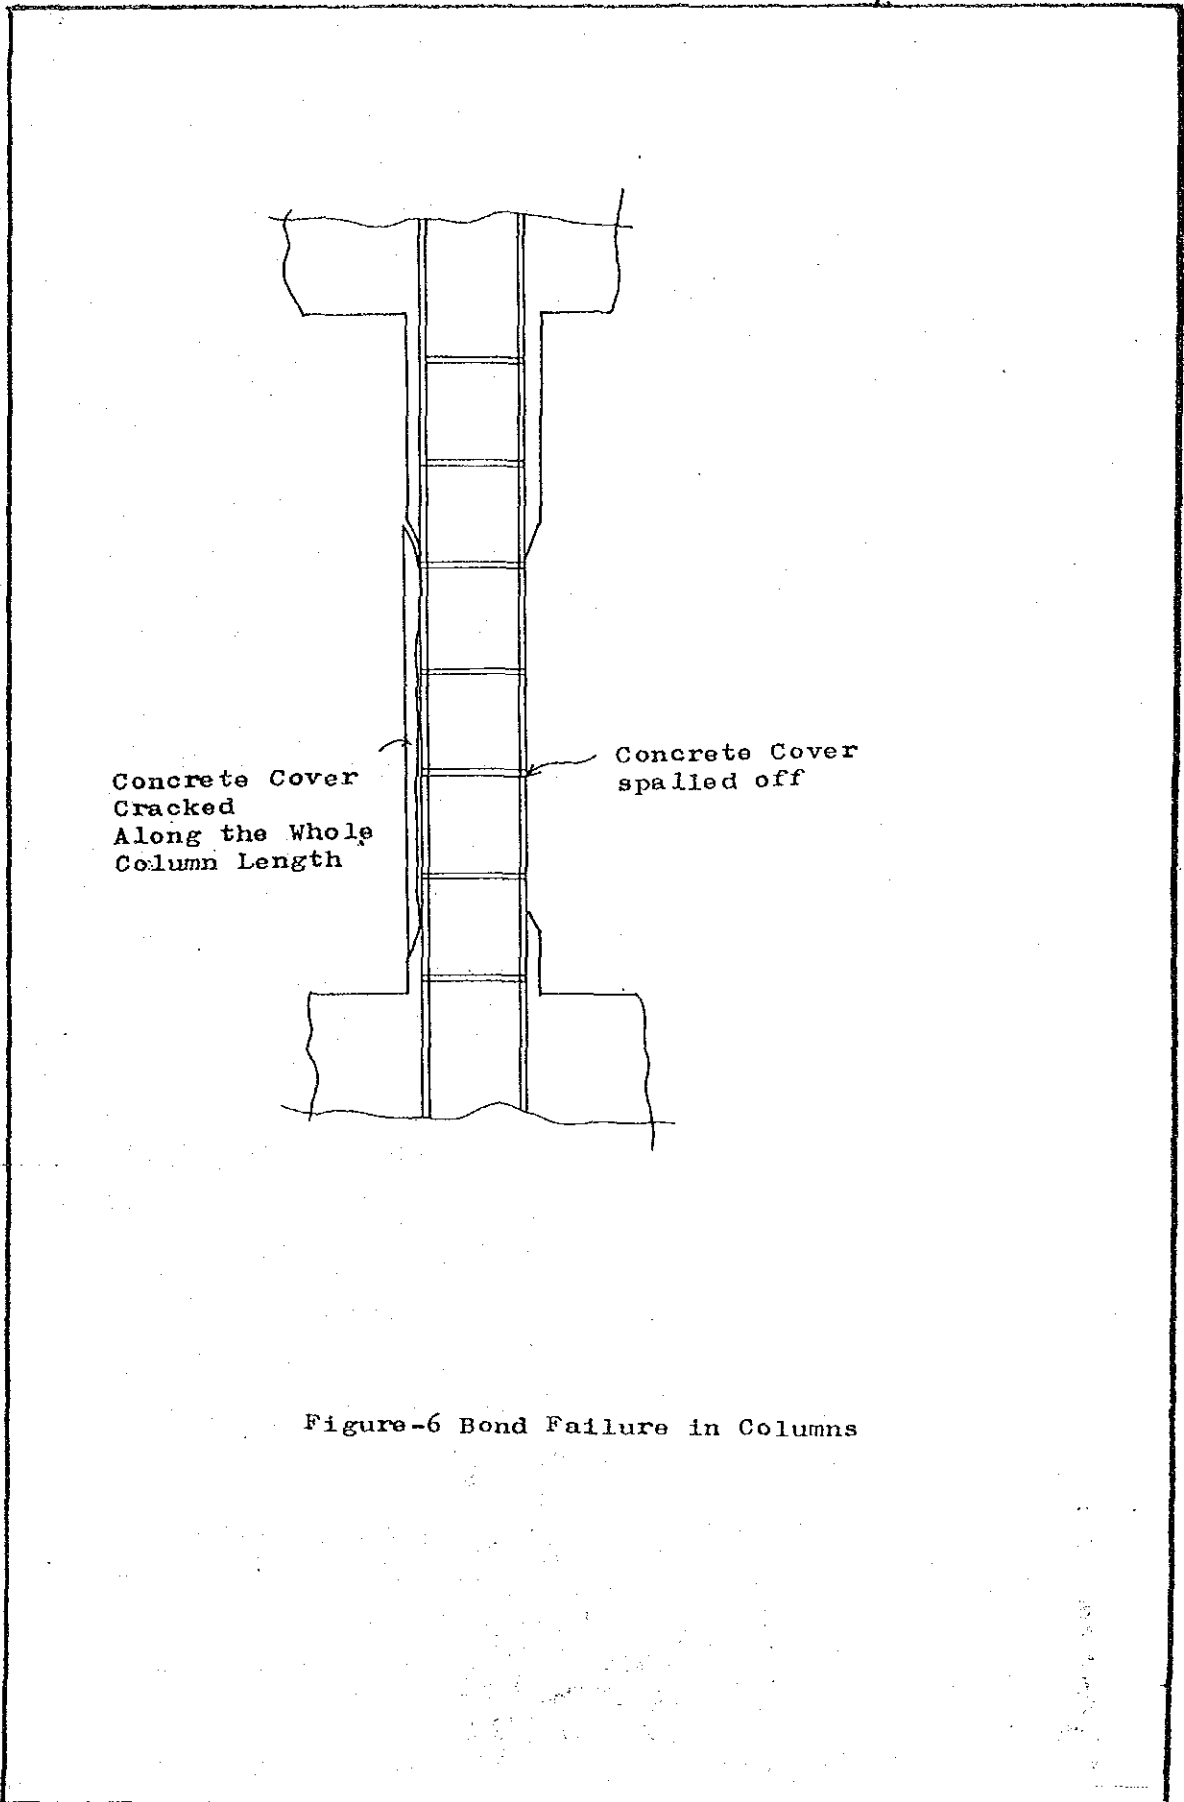
art column failure of reinforced concrete columns
quently observed.

Figure-6 Bond Failure in Columns

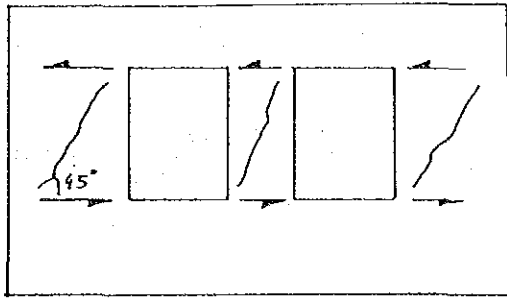
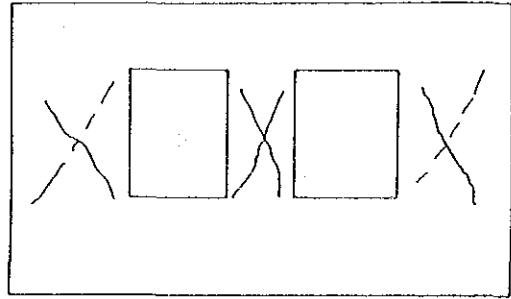
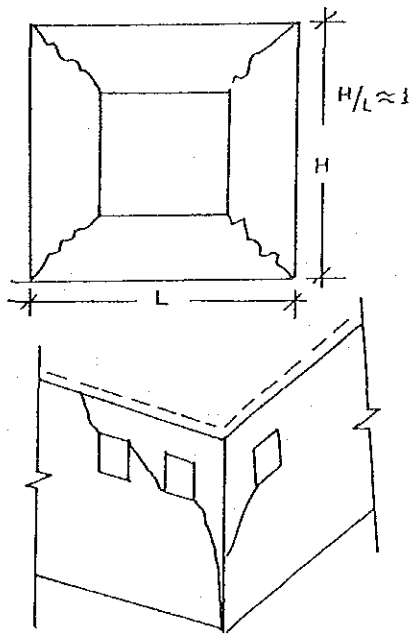
Figure-17 Various Forms of Earthquake Formation in Brick Walls

Diagonal Tension Cracking in Brick Walls

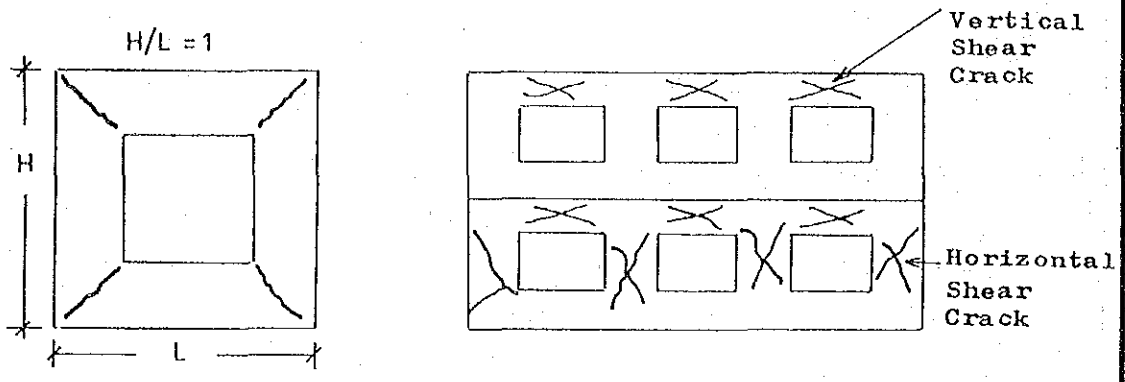
a) Shear Cracking in Walls Due to Earthquakes

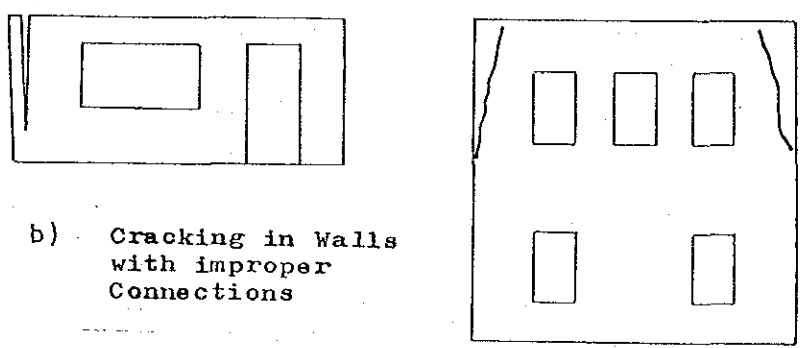
b) Cracking in Walls with improper Connections

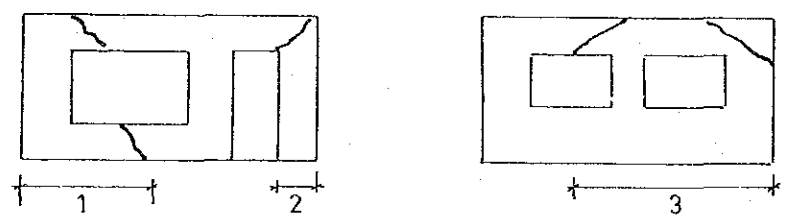
c) Settlement Cracks in Brick Masonry Buildings

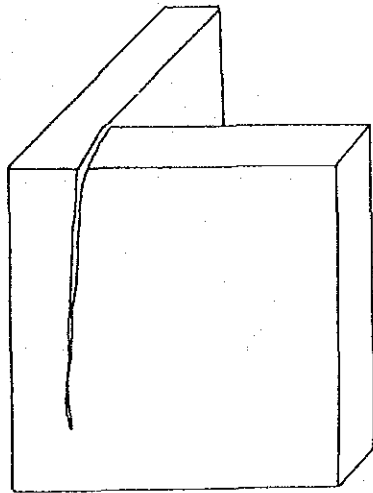
a) Damage in a Poorly Connected Corner of a Brick Masonry Building

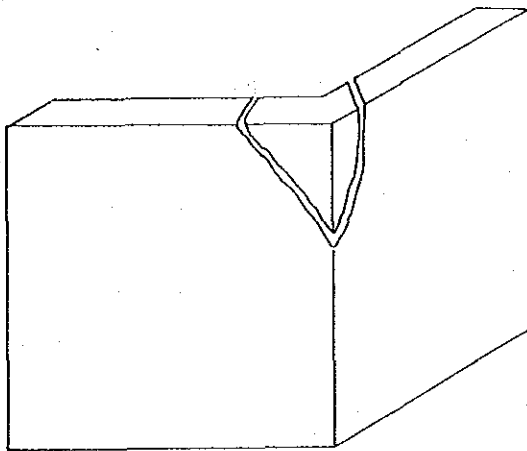
b) Corner Damage in a Masonry Building Having a Flexible Roof System

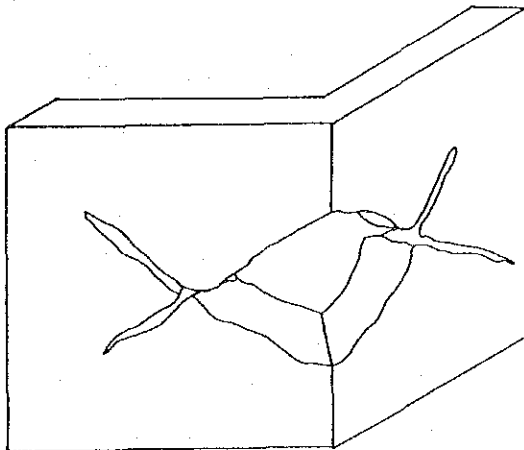
c) Corner Damage in a Brick Masonry Building Due to Large Earthquakes

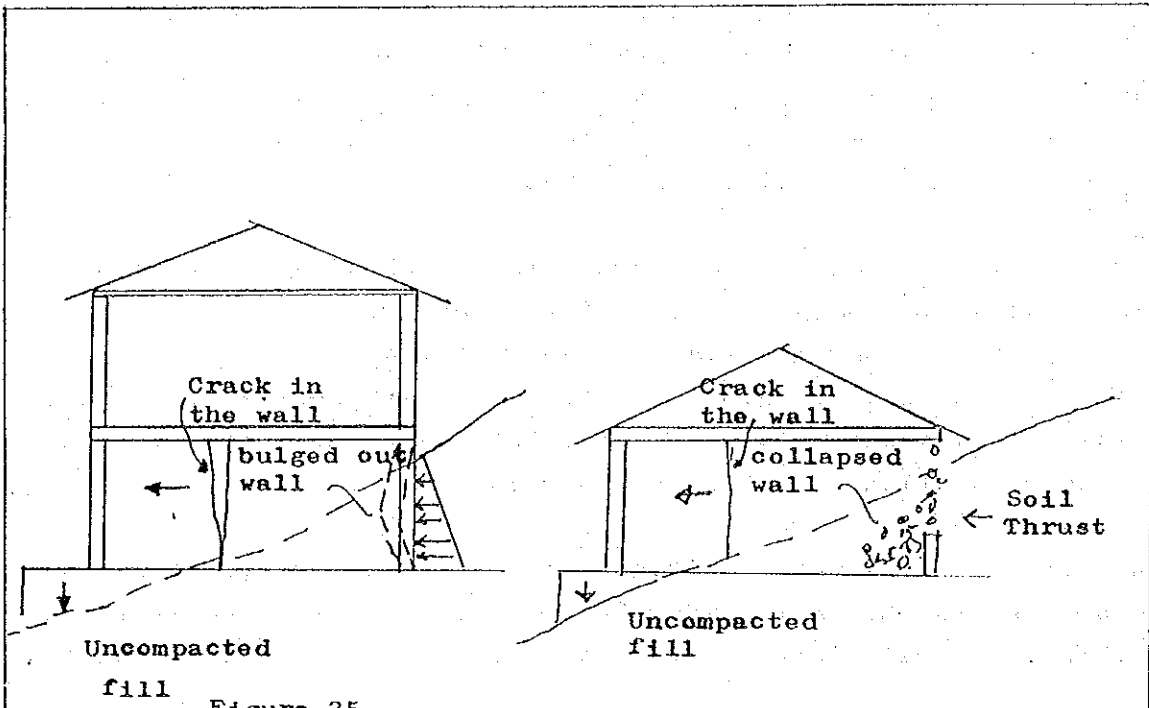
Figure-25

Back wall Damage in Houses on Sloping Ground

In villages on sloping ground the soil thrust on walls standing against the slope like a retaining wall sometimes damages the walls as shown on Figure-25. Houses on sloping ground are partially resting on fills. These fills usually settle during earthquakes and the front walls of the houses are damaged.
