**BASIC DESIGN STUDY REPORT**  
**ON**  
**THE PROJECT FOR PROTECTING REVETMENT**  
**ON THE BANK OF MEGHNA RIVER**  
**IN**  
**THE PEOPLE'S REPUBLIC OF BANGLADESH**

NOVEMBER 1992

PACIFIC CONSULTANTS INTERNATIONAL  
NIPPON KOEI CO. LTD.

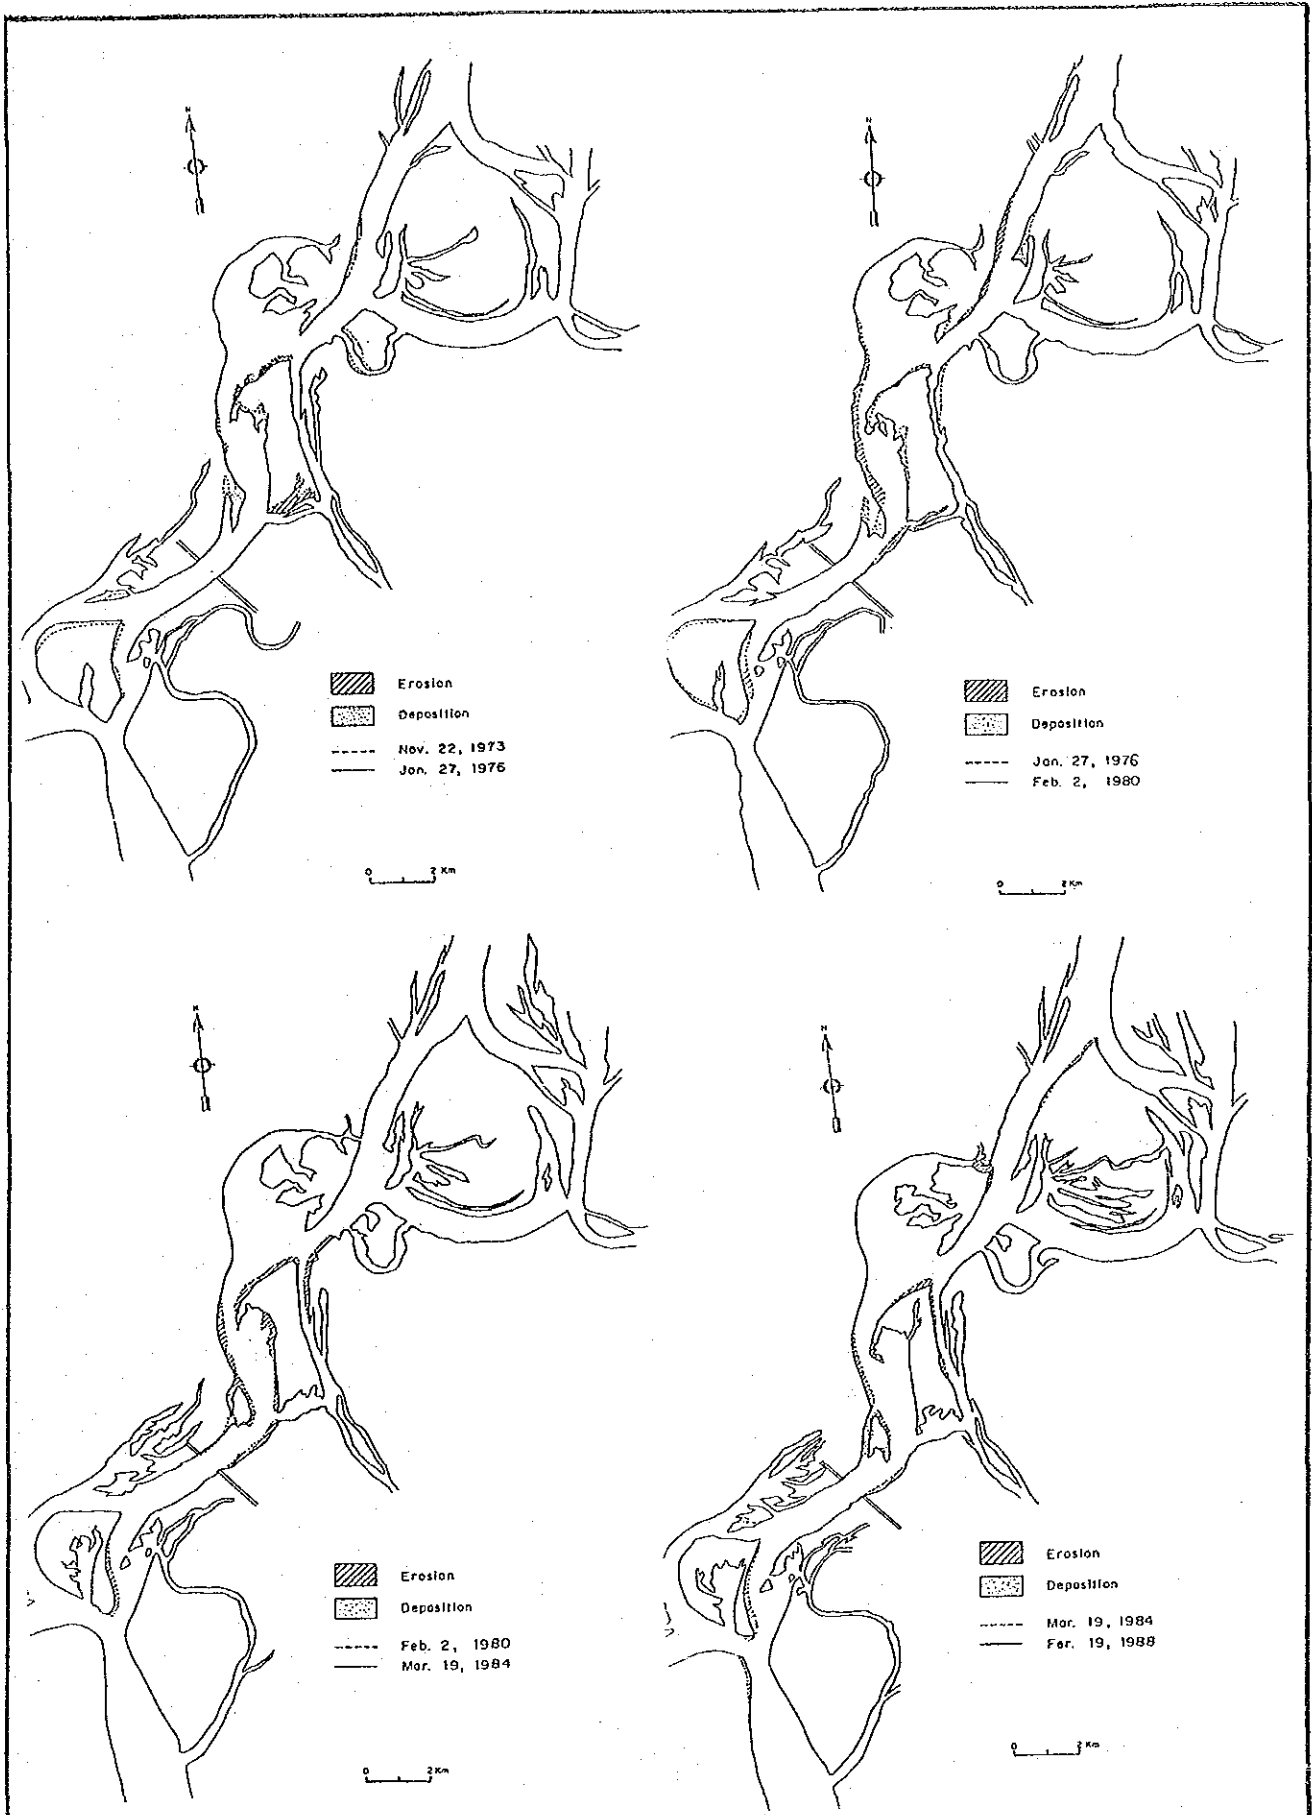
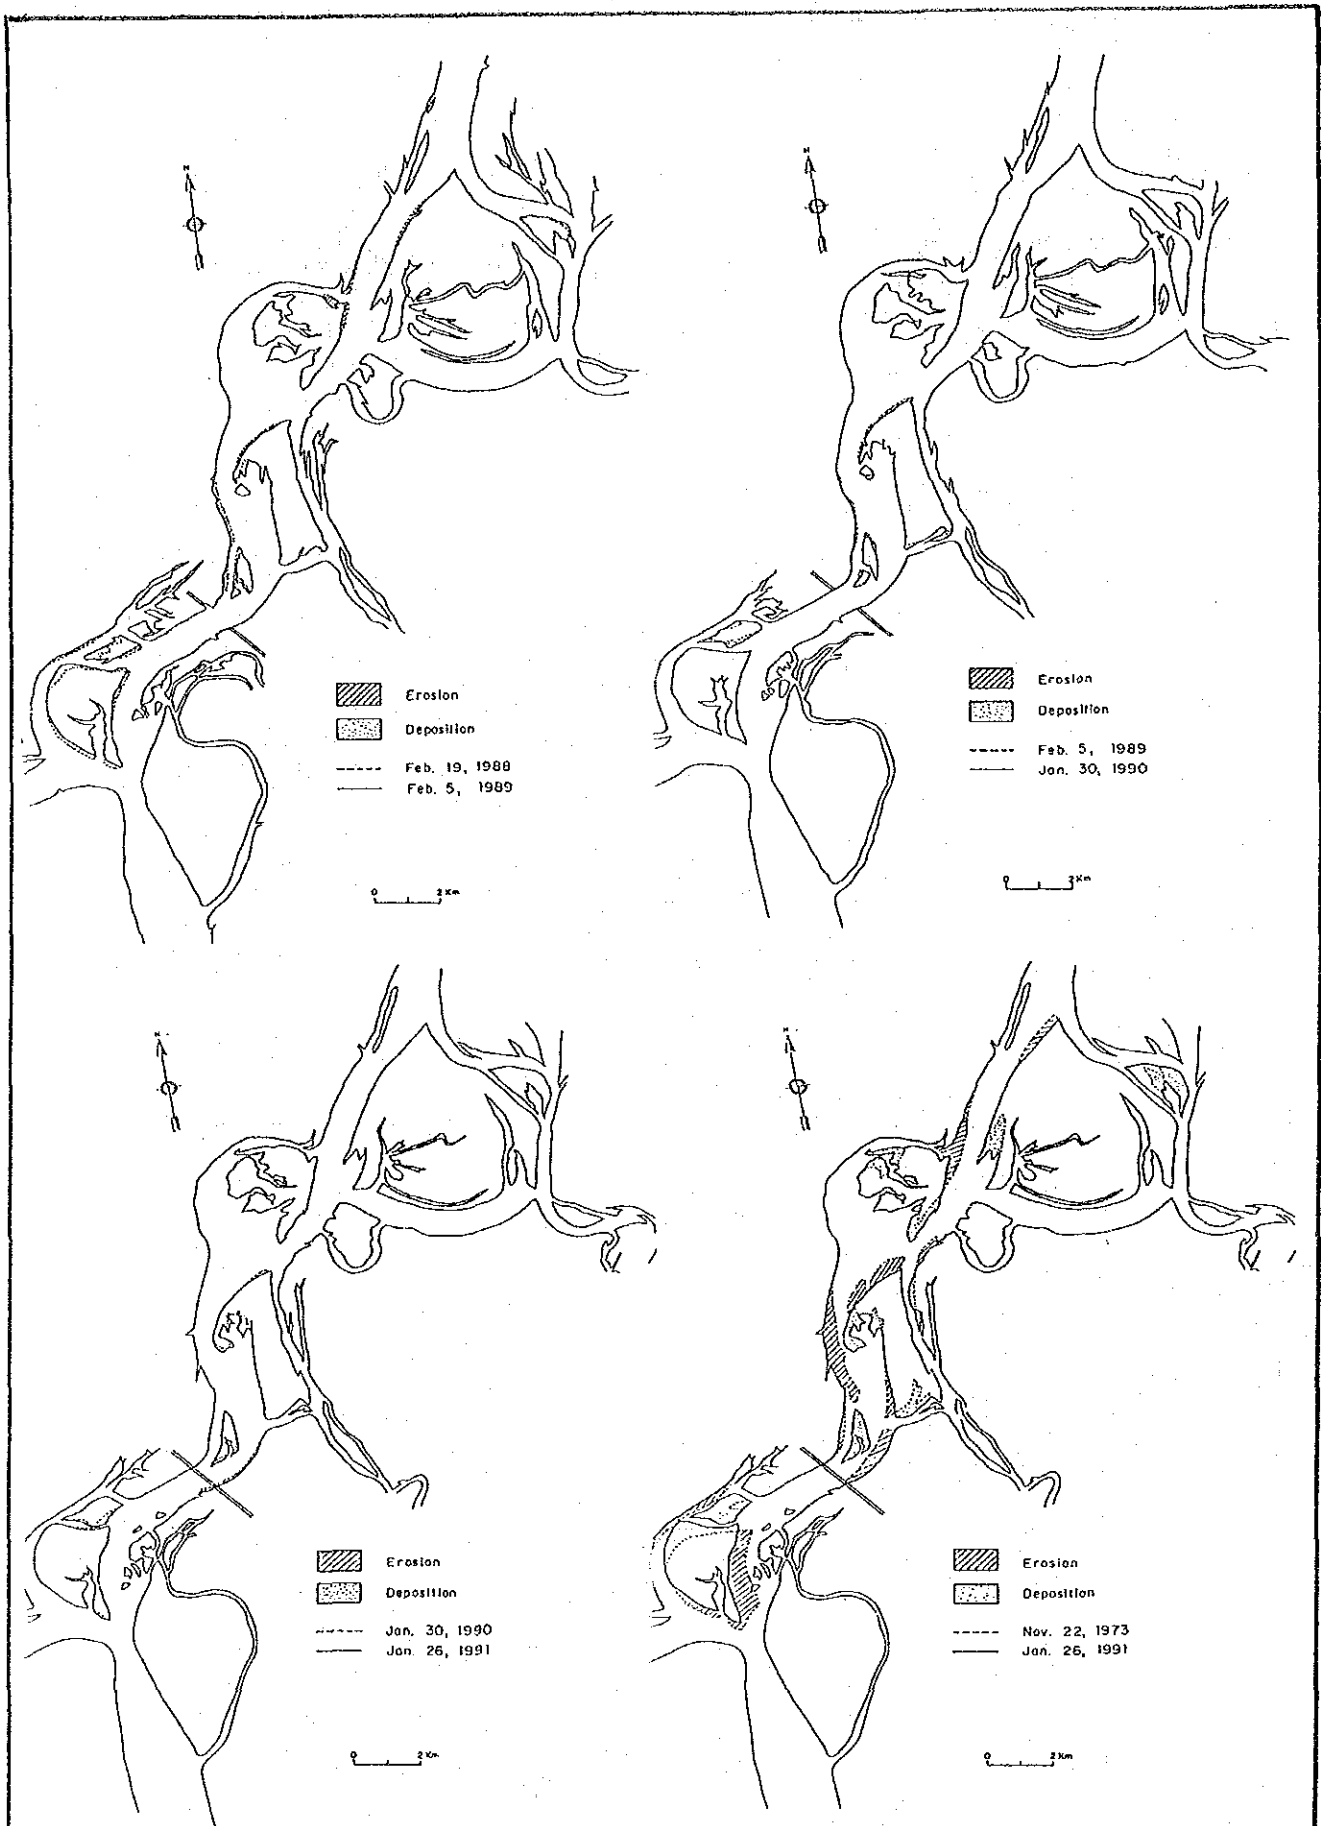
Fig. 5.3 COMPARISON OF SHORE LINES NEAR MEGHNA BRIDGE (1/2)

- The sand bar just upstream of the Bridge on the right bank was extended downstream between 1973 and 1976.
- The right bank from No. U10 to No. U6 and the left bank from No. U4 to No. U1 were eroded extensively between 1976 and 1984.

- The side channel (near the right bank) beside the sand bar at just upstream of the Bridge was formed between 1984 and 1988.
- As erosion between No. U10 and No. U6 on the right bank proceeded, the side channel beside the sand bar was widened after 1988.
- The sand bar expanded downstream and toward the left bank.

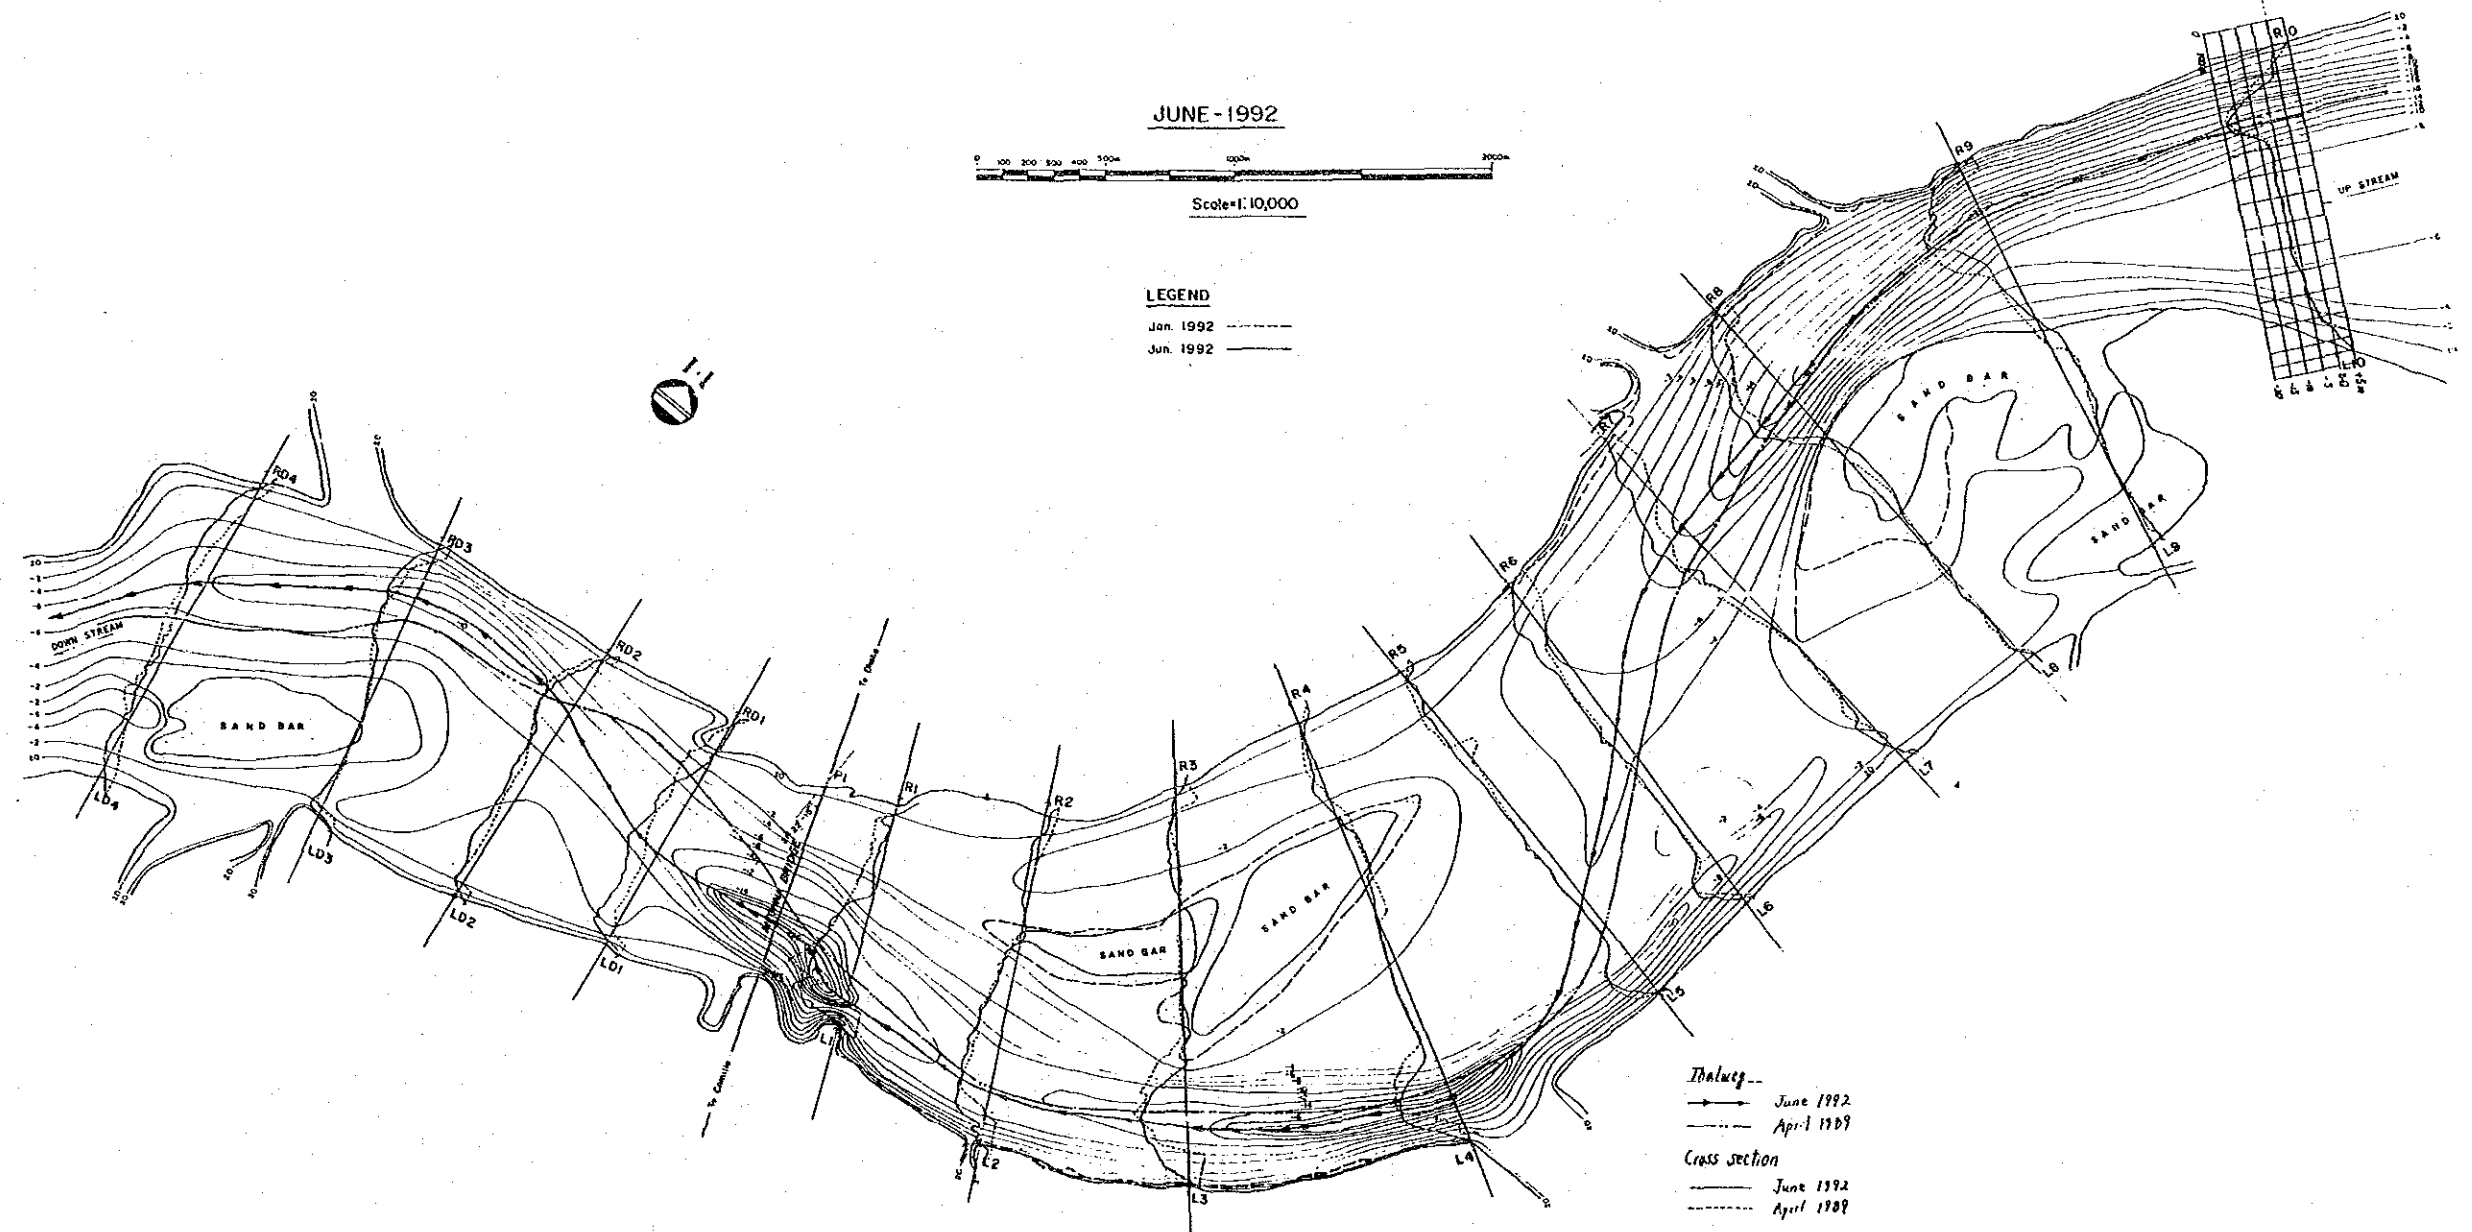
Fig. 5.5 CONTOUR MAP OF RIVER BED NEAR MEGHNA BRIDGE (JUNE 1992)

It is judged that the water colliding front at left bank is shifting downstream. At present, the main current from upstream meets the flow from the Branch Meghna at the confluence. It is deemed that turbulence of flow takes place and is causing local scouring of river bed which has developed along the shoreline.

- From No. U4 to No. U3  
Local scouring, with the maximum depth of R.L. -18 m, has occurred around 200 m from the left bank. The left bank has receded around 80 m since April 1989. As seen in section No. U3, siltation on the left side slope at the deepest point might cause the development of a sand bar near the left bank.

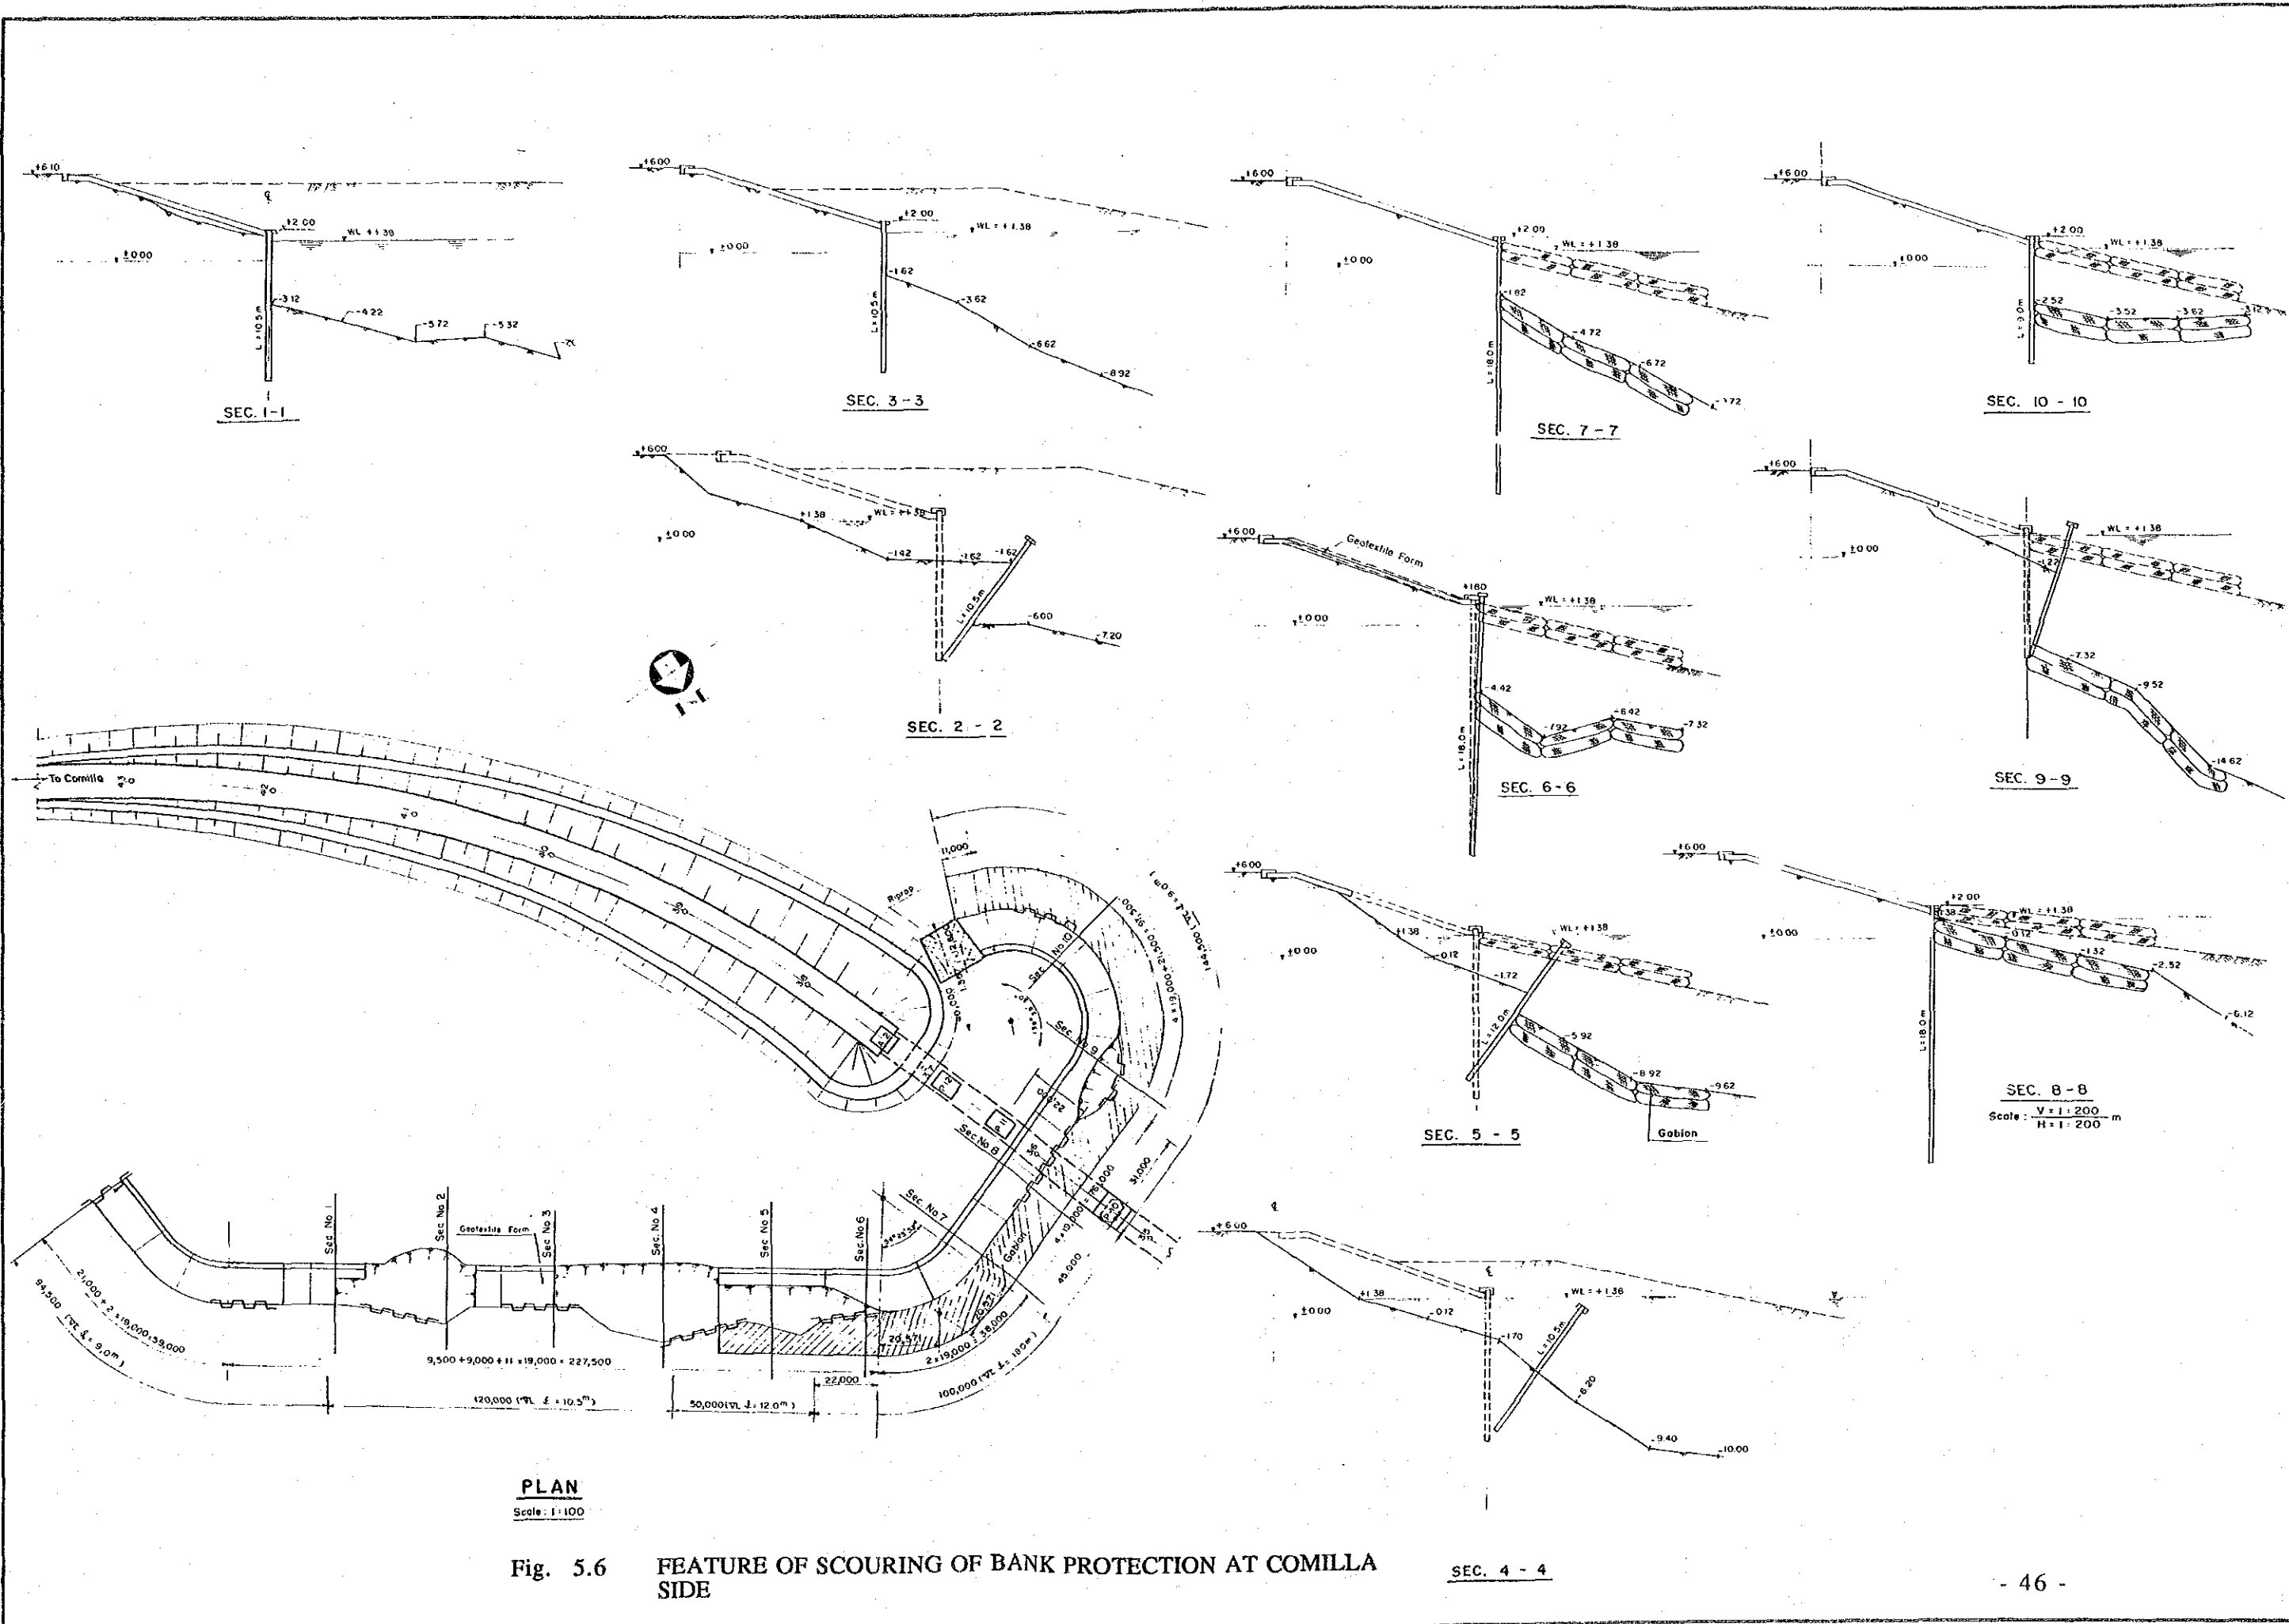
Fig. 5.6 FEATURE OF SCOURING OF BANK PROTECTION AT COMILLA SIDE

As seen in Fig. 5.6, the gabion mattress has crumbled down in front of the steel sheet piles. But sliding of the gabion toward the channel center is not significant. It is judged that its deformation was caused by erosion. Most serious erosion along the revetment took place near Section 9-9 in Fig. 5.6.

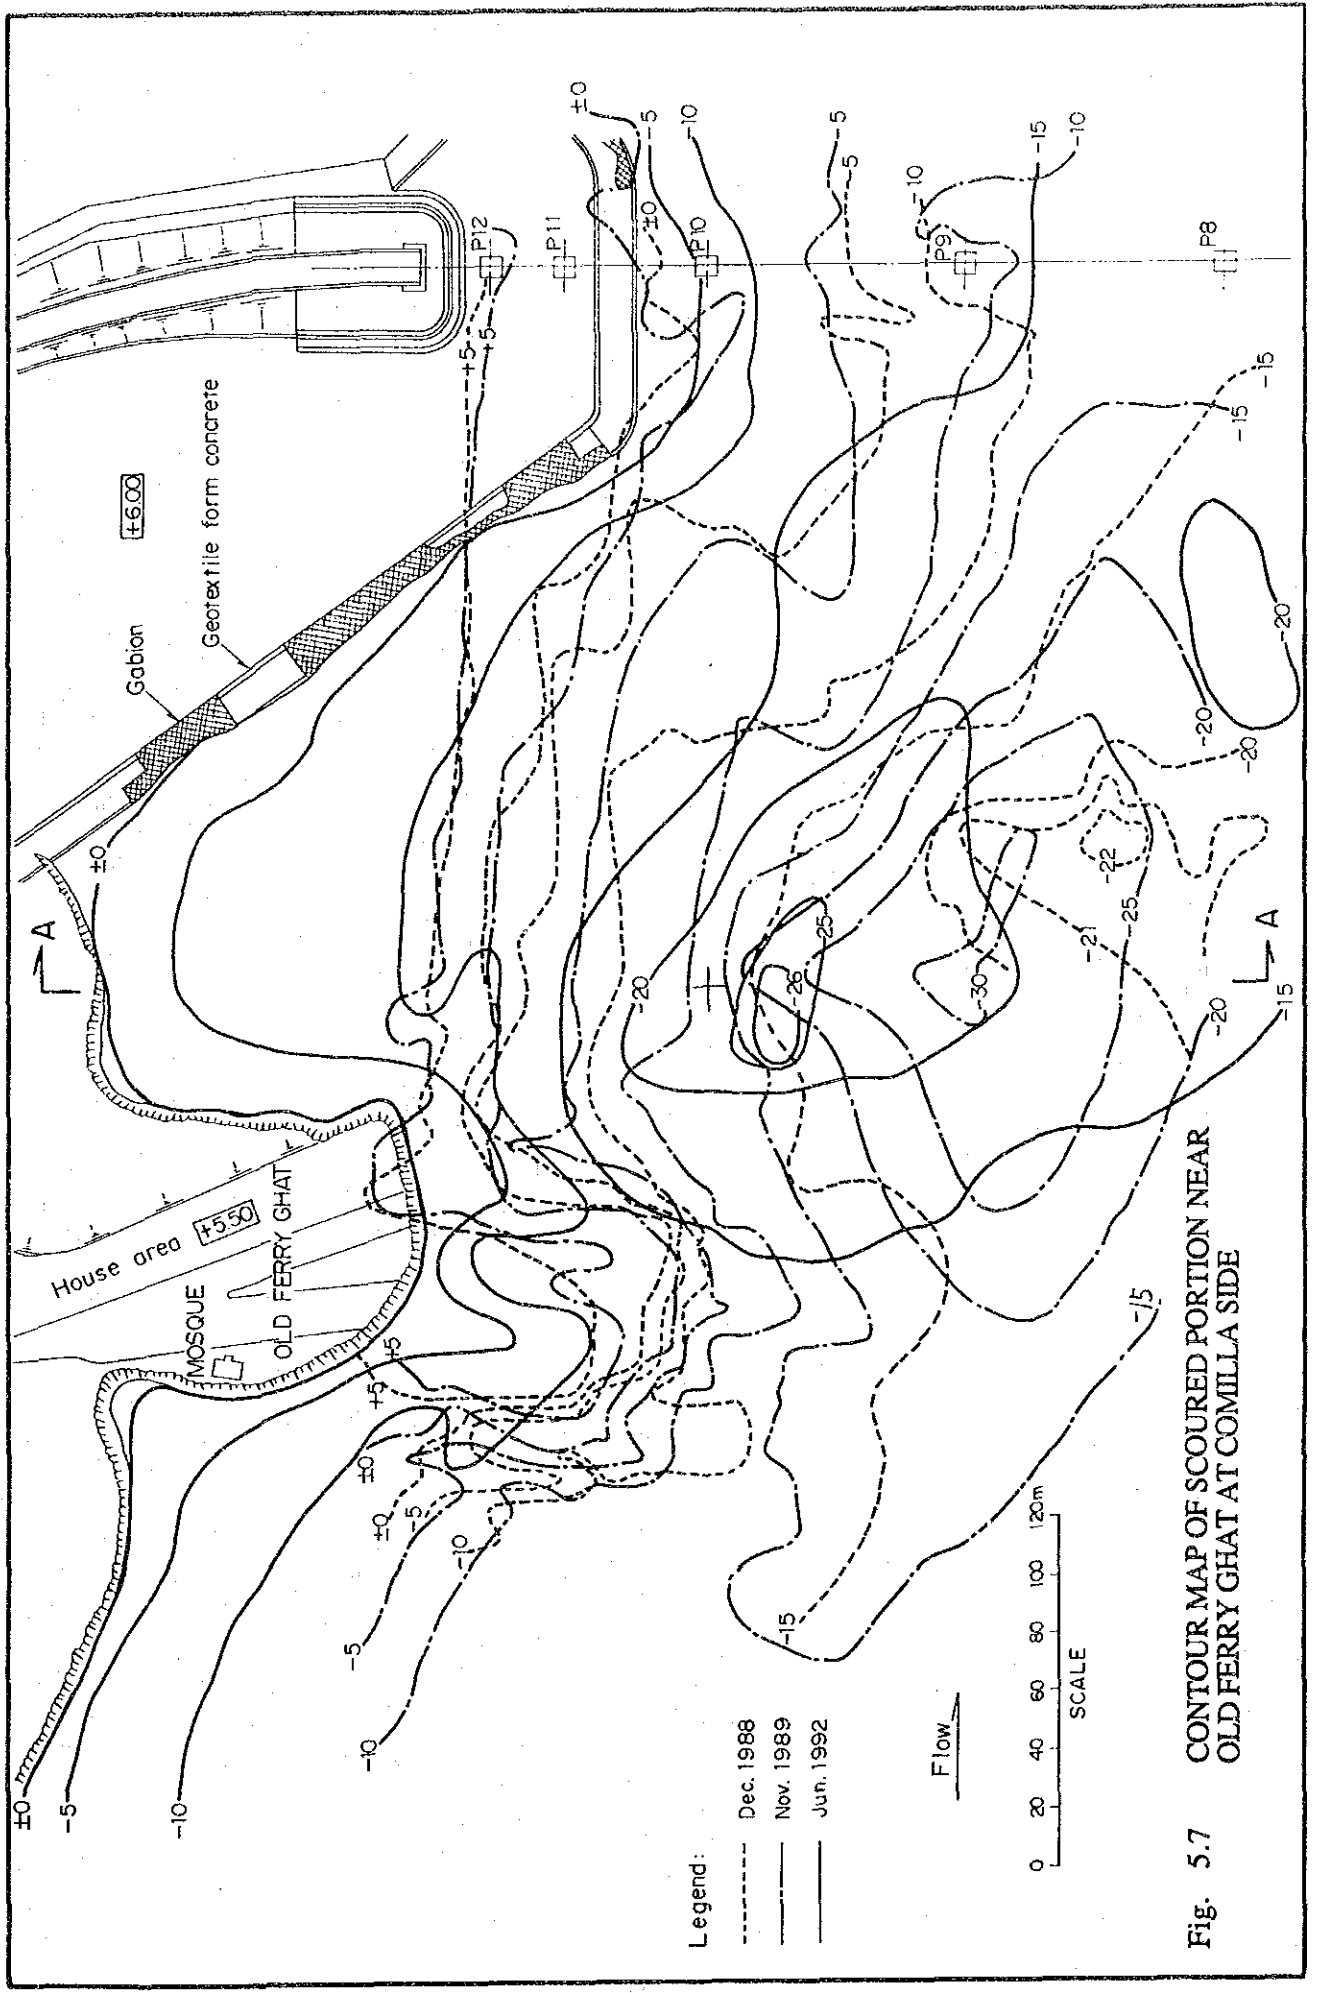
Fig. 5.7 CONTOUR MAP OF SCOURED PORTION NEAR OLD FERRY GHAT AT COMILLA SIDE

To obtain an idea of the erosion and scouring that are likely to occur on the Comilla side of the Bridge, river surveys were carried out in December 23, 1990, August 10, 1991 and in October 24, 1991. It is observed from a comparison of the survey data of December 1990 with that of August & October 1991 that significant erosion of the river bank and scouring of the bed is occurring towards the Comilla side of the Meghna Bridge. The extent of erosion is more severe near the old ferry ghat and adjacent downstream areas.

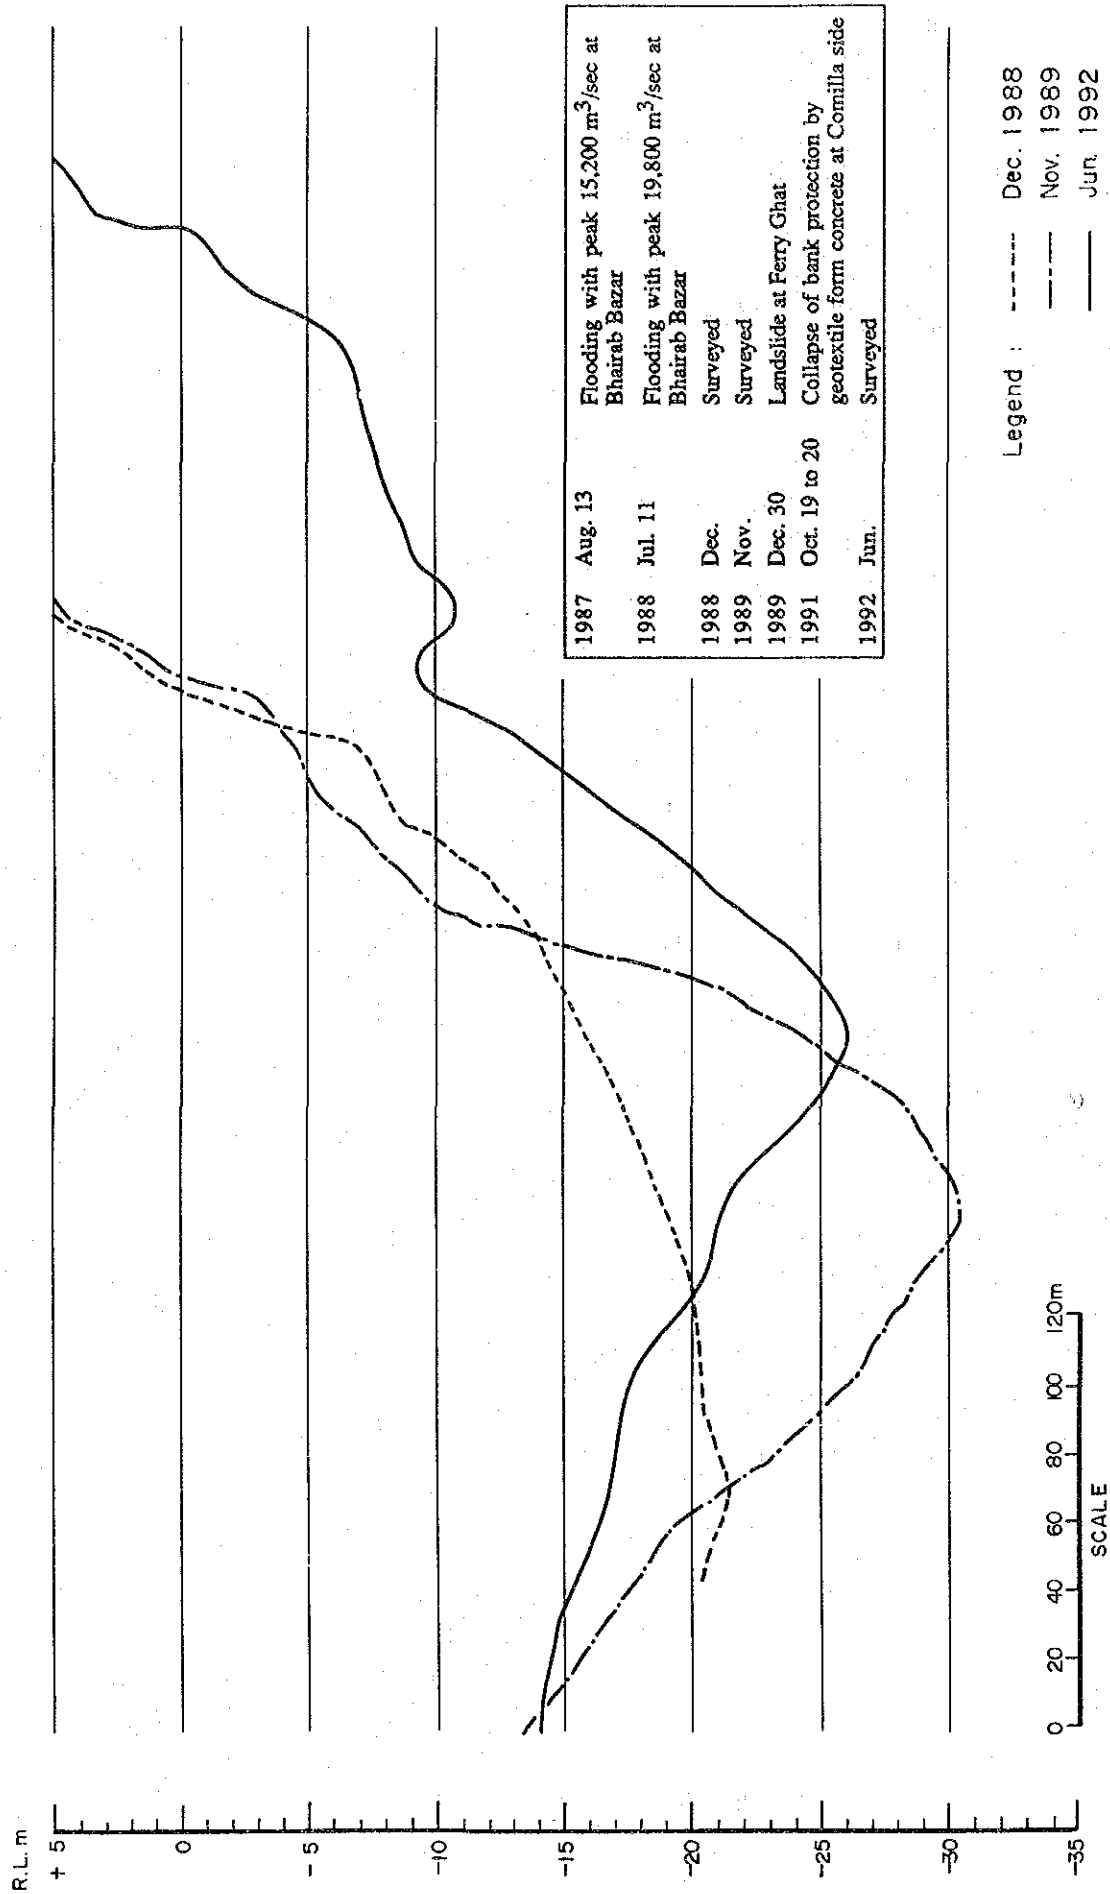
Fig. 5.8 PROFILE OF DEEPEST SCOURED PORTION NEAR MEGHNA BRIDGE (SECTION A-A)

- (4) The deep scour, R.L. -30 m, was confirmed in November 1989. One month after the survey, a large scale landslide occurred and a small bay was created. It can be judged that the sliding is primarily caused by deep scouring which has produced the steep slopes of 13 degree, at the deepest portions. On the same day when the incident happened, the water level and flow velocity recorded were R.L. 1.20 m and 0.40 m/sec at the Meghna Bridge. Drawdown speed of the water level was around 5 cm/day between Dec. 13 and Dec. 30, 1989.
