BASIC DESIGN STUDY REPORT
ON
THE PROJECT FOR REHABILITATION AND IMPROVEMENT
OF
CYCLONE-DAMAGED PORTS AND FORESHORE PROTECTION
IN
WESTERN SAMOA

DECEMBER 1992

NIPPON TETRAPOD CO., LTD.

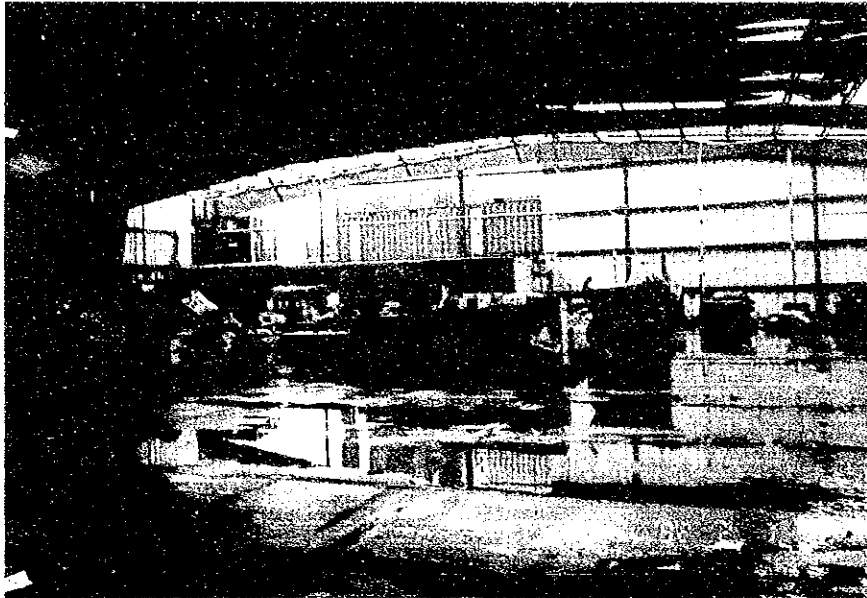
Shed No.1 has been damaged
unserviceable
with roof and wall
blown away.

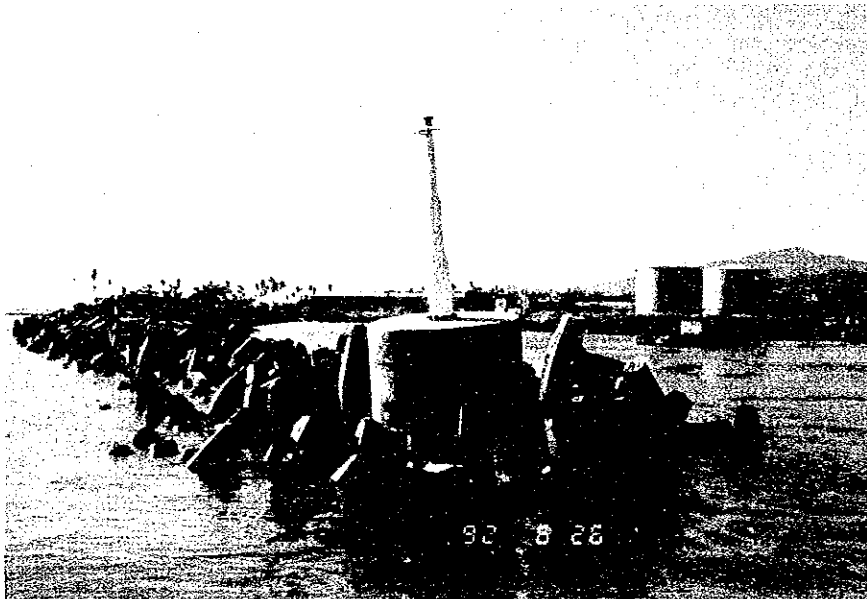
The breakwater has
been damaged on its
head section.

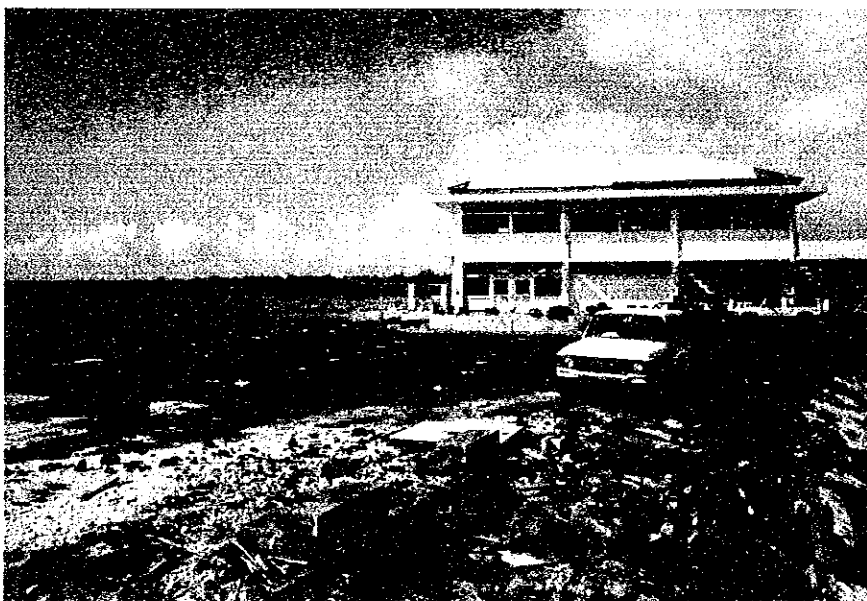
The terminal
building has been
damaged with its
roof totally blown
away.

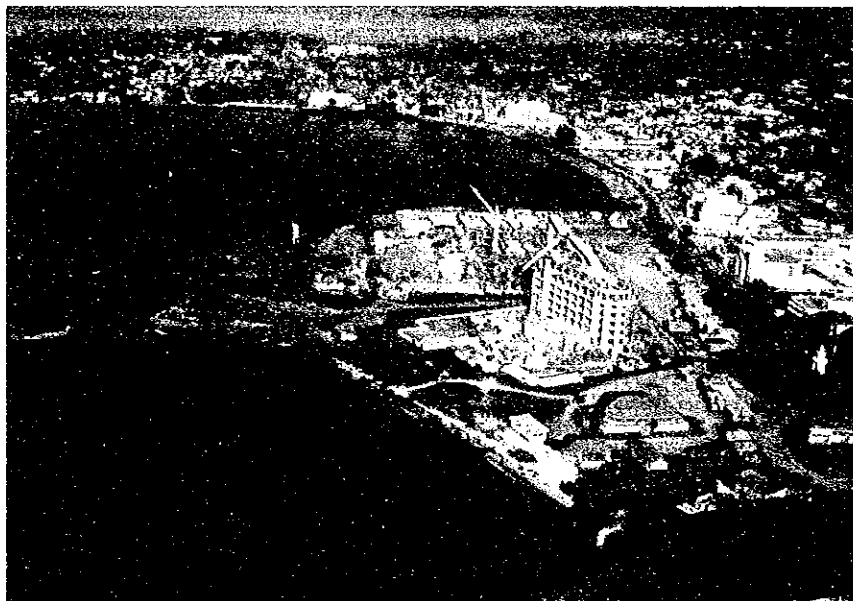
The reclamation area
is being eroded
through damaged
revetment.
