THE PROJECT FOR REHABILITATION AND IMPROVEMENT OF CYCLONE-DAMAGED PORTS AND FORESHORE PROTECTION

MINUTES OF DISCUSSIONS
OF
THE DRAFT REPORT OF THE BASIC DESIGN STUDY
OF
THE PROJECT FOR REHABILITATION AND IMPROVEMENT OF
CYCLONE-DAMAGED PORTS AND FORESHORE PROTECTION
IN WESTERN SAMOA

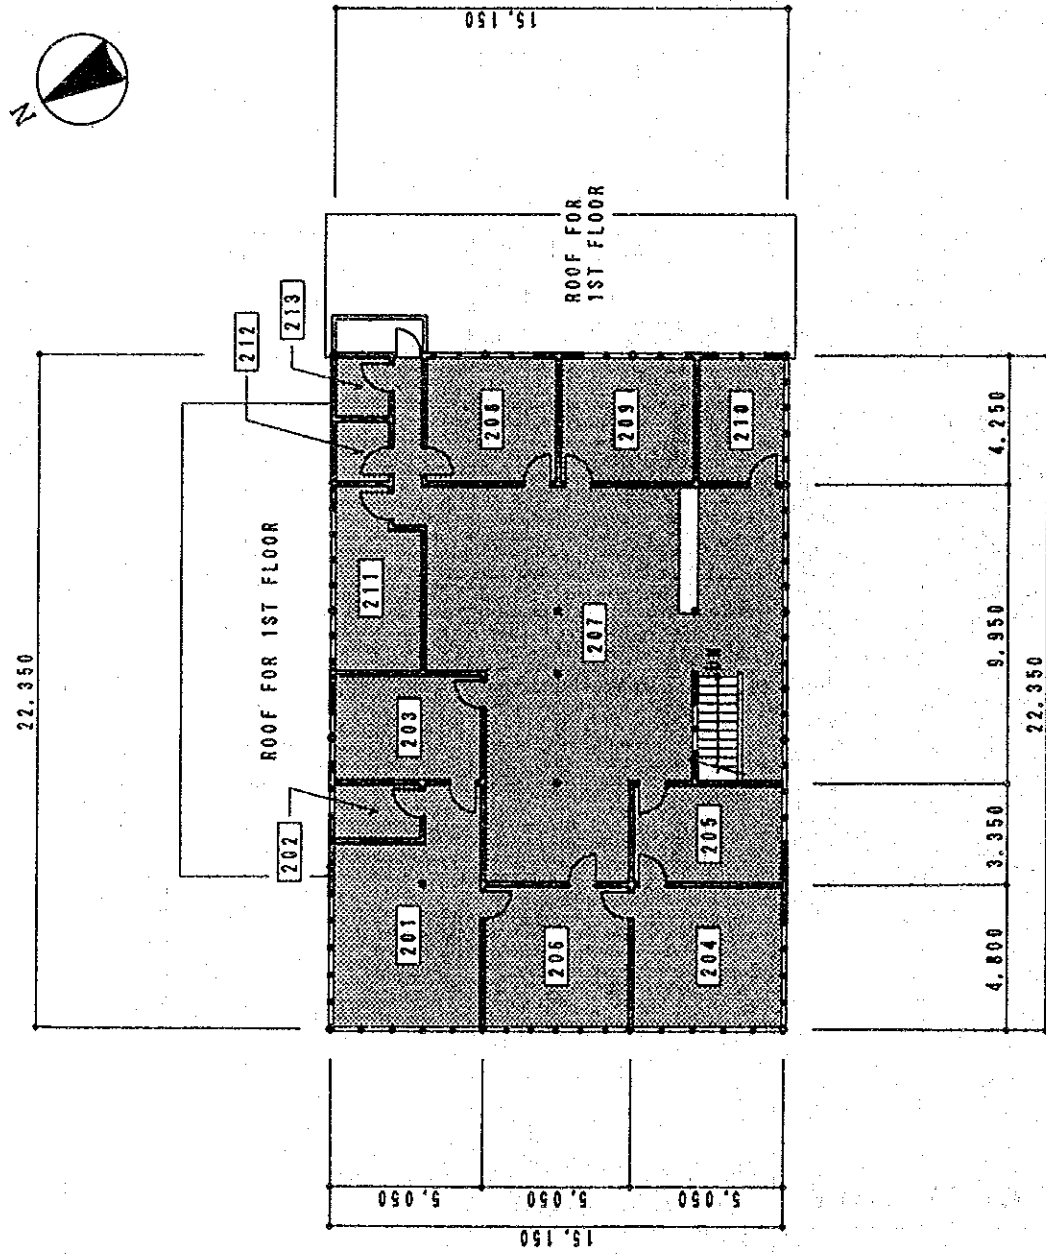
Fig. 5-11 1ST FLOOR PLAN OF MOT OFFICE

The main office of Ministry of Transport is endangered of unexpected collapse under strong wind due to displacement of the wall on the first floor and has been seriously damaged on its roof and wall. The resulting leakage of rain water has damaged electric services in the office. Temporary repairs have been done to the first floor but both floors are seriously affected by cyclone damages and about 20 office staffs working for port, airport and road are suffering troubles in daily administration works. The first floor of the office has been temporarily repaired by the government to accommodate increased staffs but it could collapse by cyclone wind.

Most part of ceiling, wall and floor of the first floor are damaged.

The office building needs urgent rehabilitation works in order to avoid further damage and collapse and to restore efficient port management and administration.

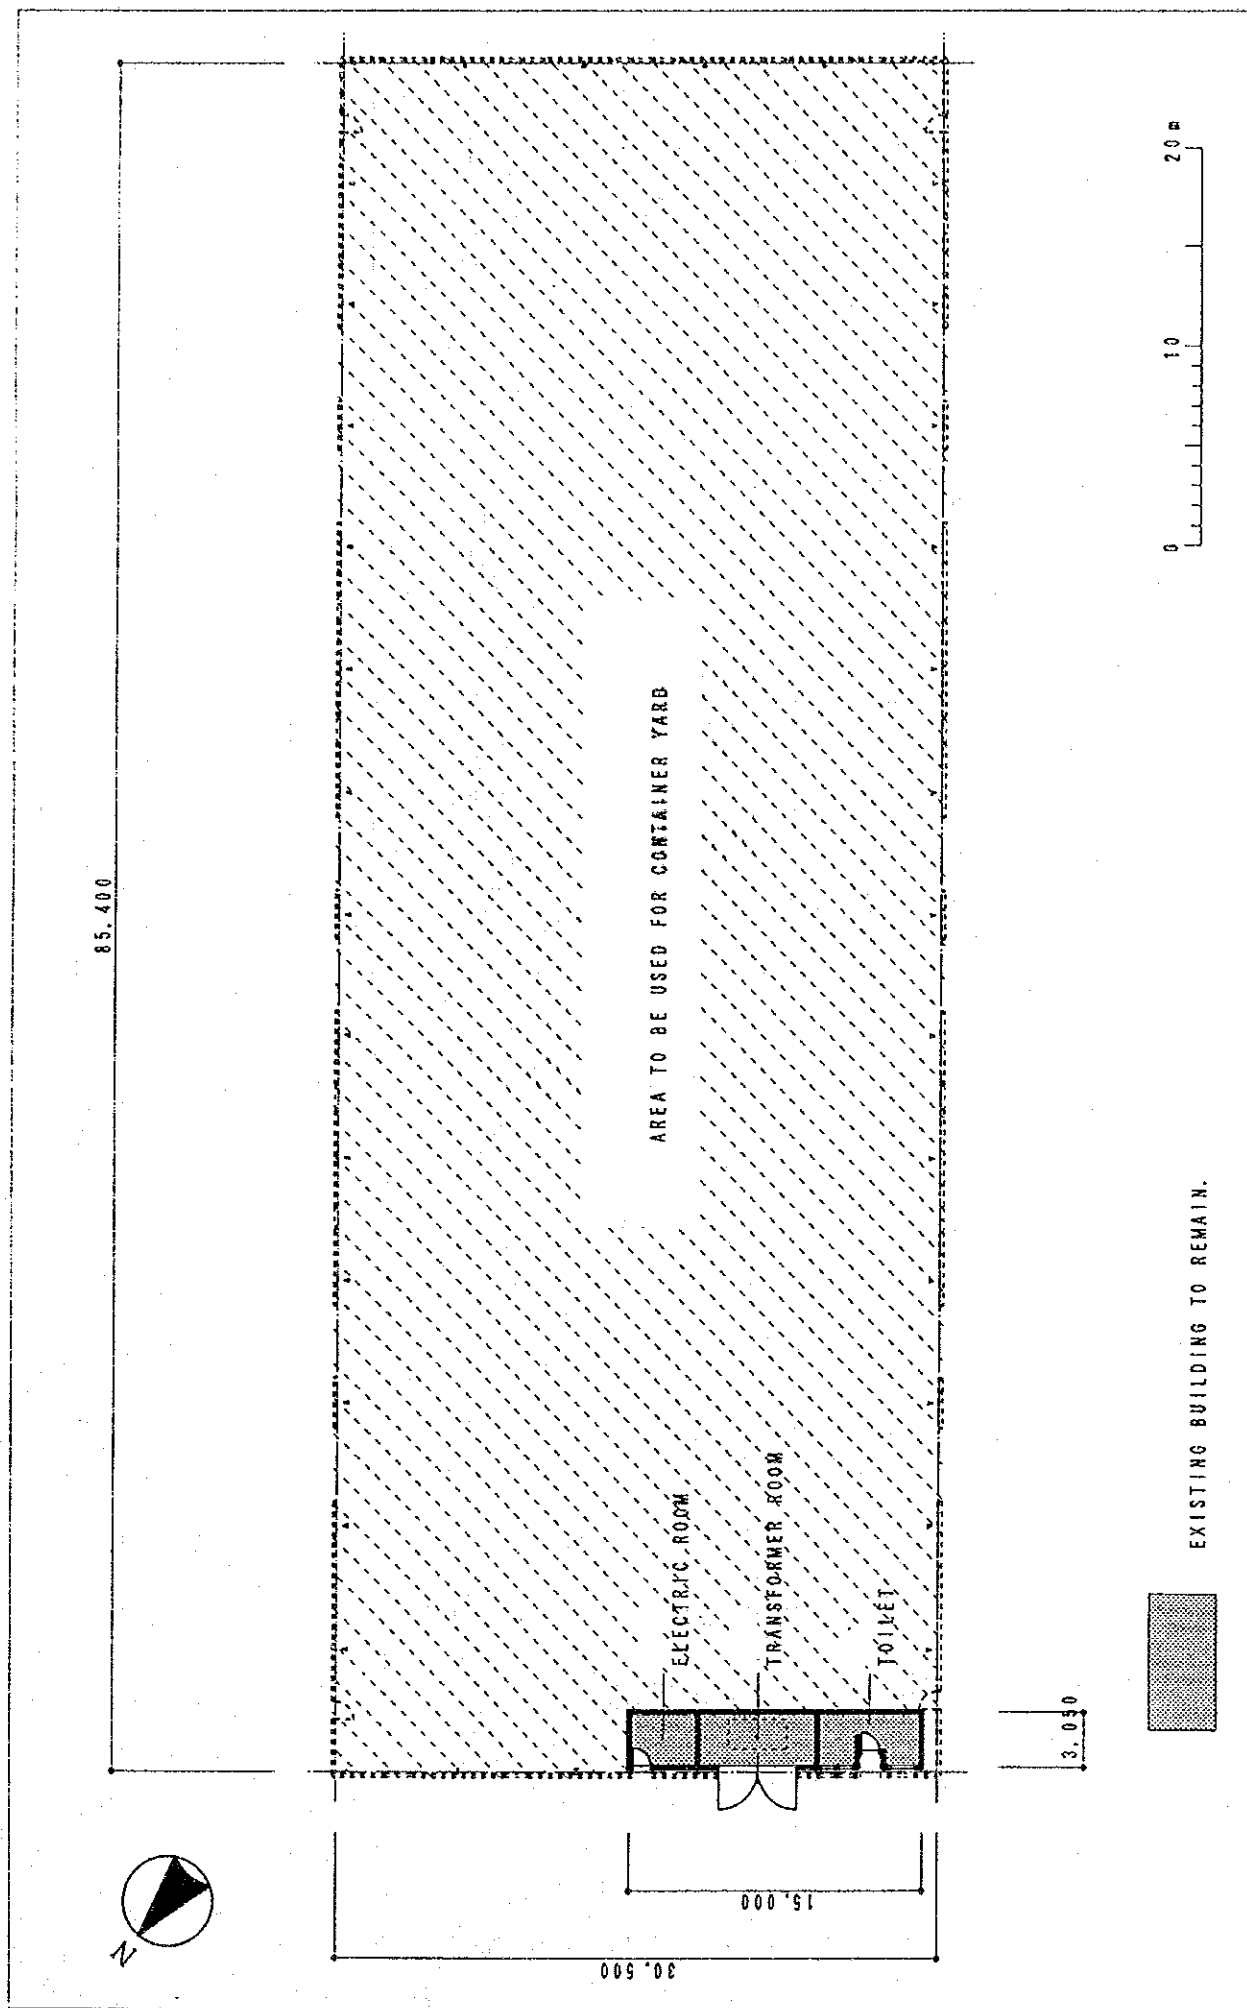
Fig. 5-14 LAYOUT PLAN OF SHED NO.1

Shed No. 1 was damaged by the cyclone "Ofa" and planned to be restored in the previous grant aid project. However, it has sustained further damage by the cyclone "Val" before commencing the restoration work resulting in exclusion of the work out of the scope. Shed No. 4 was not damaged by the cyclone "Ofa" but damaged by the cyclone "Val".

After the cyclone "Val", Shed No.1 is used for storing disused concrete blocks because of heavy damage, and Shed No. 4 used for storing cargoes.

Shed No.4 is used by covering cargoes with tarpaulin or placing them under the limited area free from rain water. The cargoes stored in the sheds are exposed to rain water and pilferage through broken roof and doors. To secure security of and prevent damage to cargoes urgent rehabilitation is required. About 70 % of cargoes handled in Apia Port are containerized and the containerization rate is expected to steadily increase. Container boxes can be advantageously placed near Main Wharf for shipment and container cargoes be stuffed/unstuffed in a covered shed in a innermost part of container yard to streamline the movement of cargoes, handling equipment, related traffic, etc. Through consideration of rehabilitation cost and flow of cargoes and cargo handling equipment, Shed No. 4 is planned to be fully rehabilitated and Shed No.1 is planned to be demolished and converted to a container yard.

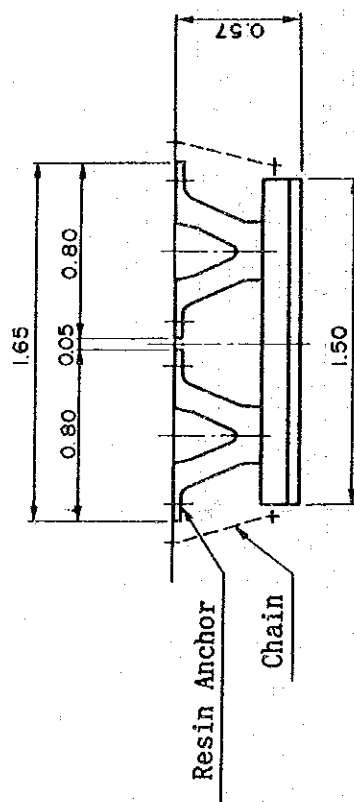
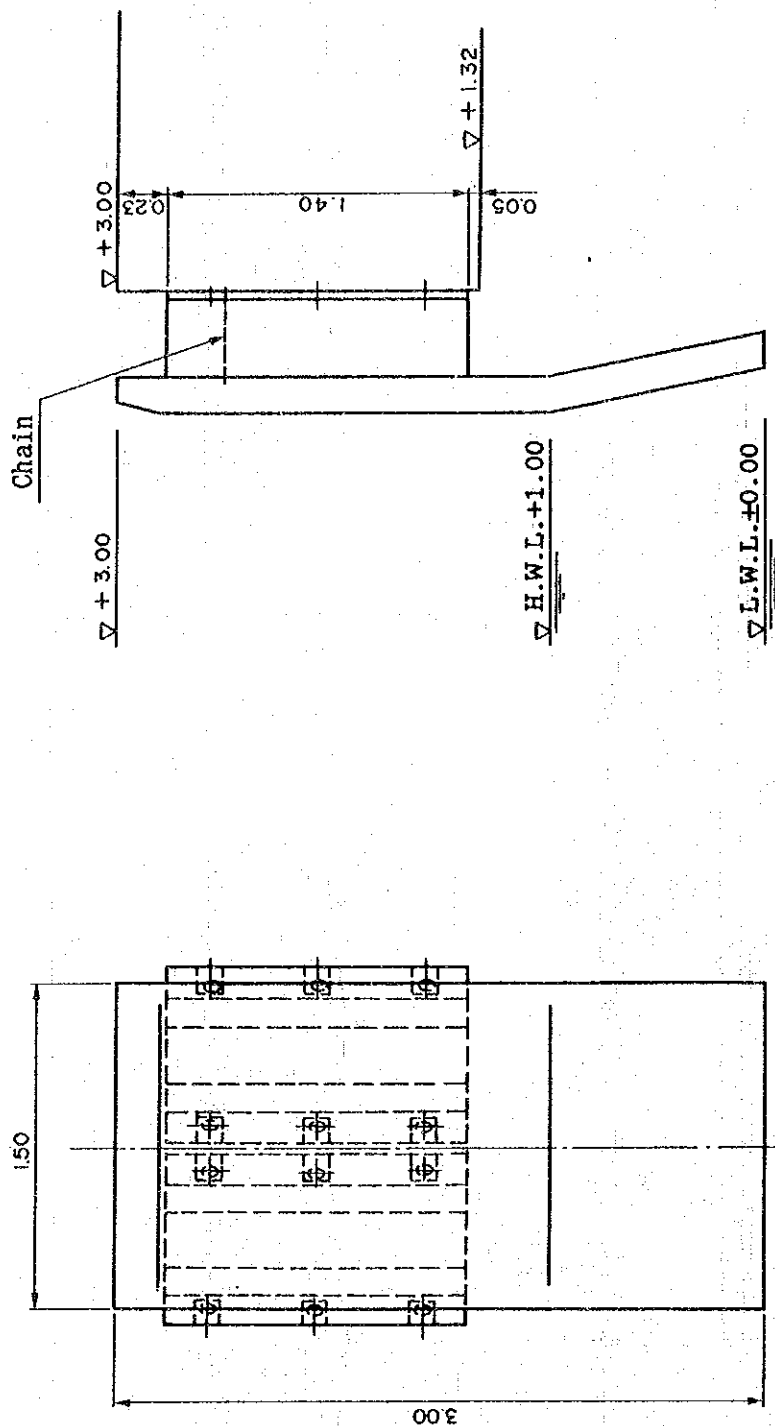
Fig. 5-17 TYPICAL CROSS SECTION OF RUBBER FENDER (FRONT SIDE)

Most of the rubber fenders installed in the frontage of Main Wharf have dropped or been torn off and as a temporary measure tires are suspended. Lack of fenders allows ships direct contact to anchor bolts of the broken fenders causing serious damages to ship's hull. Load to Main Wharf is restricted due to corrosion of the supporting piles. Berthing impact not buffered with fenders could damage the corroded piles. Fendering system of wooden pile plus rubber fender is installed at the back of Main Wharf for tug boats and the other small vessels. The piles were broken at the time of the cyclone "Ofa" and replacement work was done in the previous project. Further damages have been caused to the piles during the cyclone "Val" and the similar damages are likely to occur at inclement weather.

All the rubber fenders are cracked or torn off and shall be restored.

As the existing rubber fenders are fixed horizontally due to shortage of thickness of front concrete beam of the wharf, most of those were seriously damaged by movement of ship during cyclone. The new fenders of a pair of 400 H type covered with front steel pad shall be installed vertically.

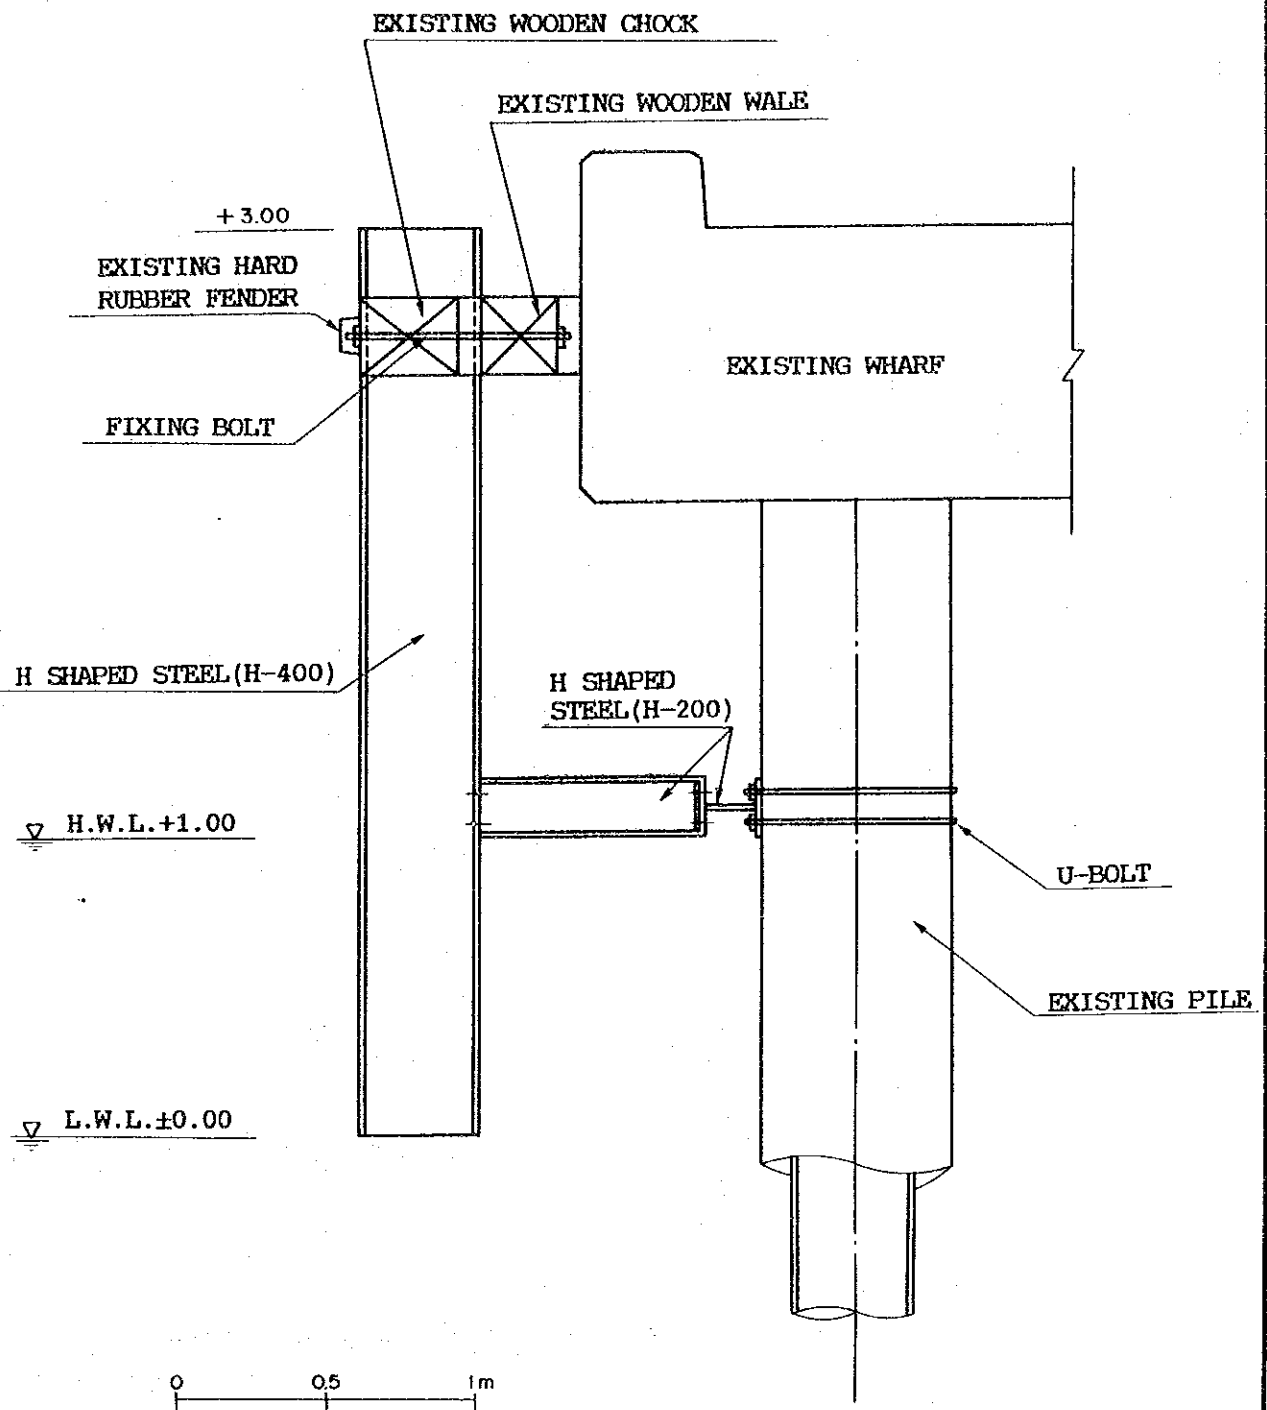
Fig. 5-18 TYPICAL CROSS SECTION OF WOODEN FENDER (BACK SIDE)

The existing wooden fenders for small boats located at the back of the main wharf are damaged by collision of boats during cyclone. Most of wooden piles and beams are broken and deformed. The 70m section except the 10m section which has been restored in the previous Project shall be restored in this project.

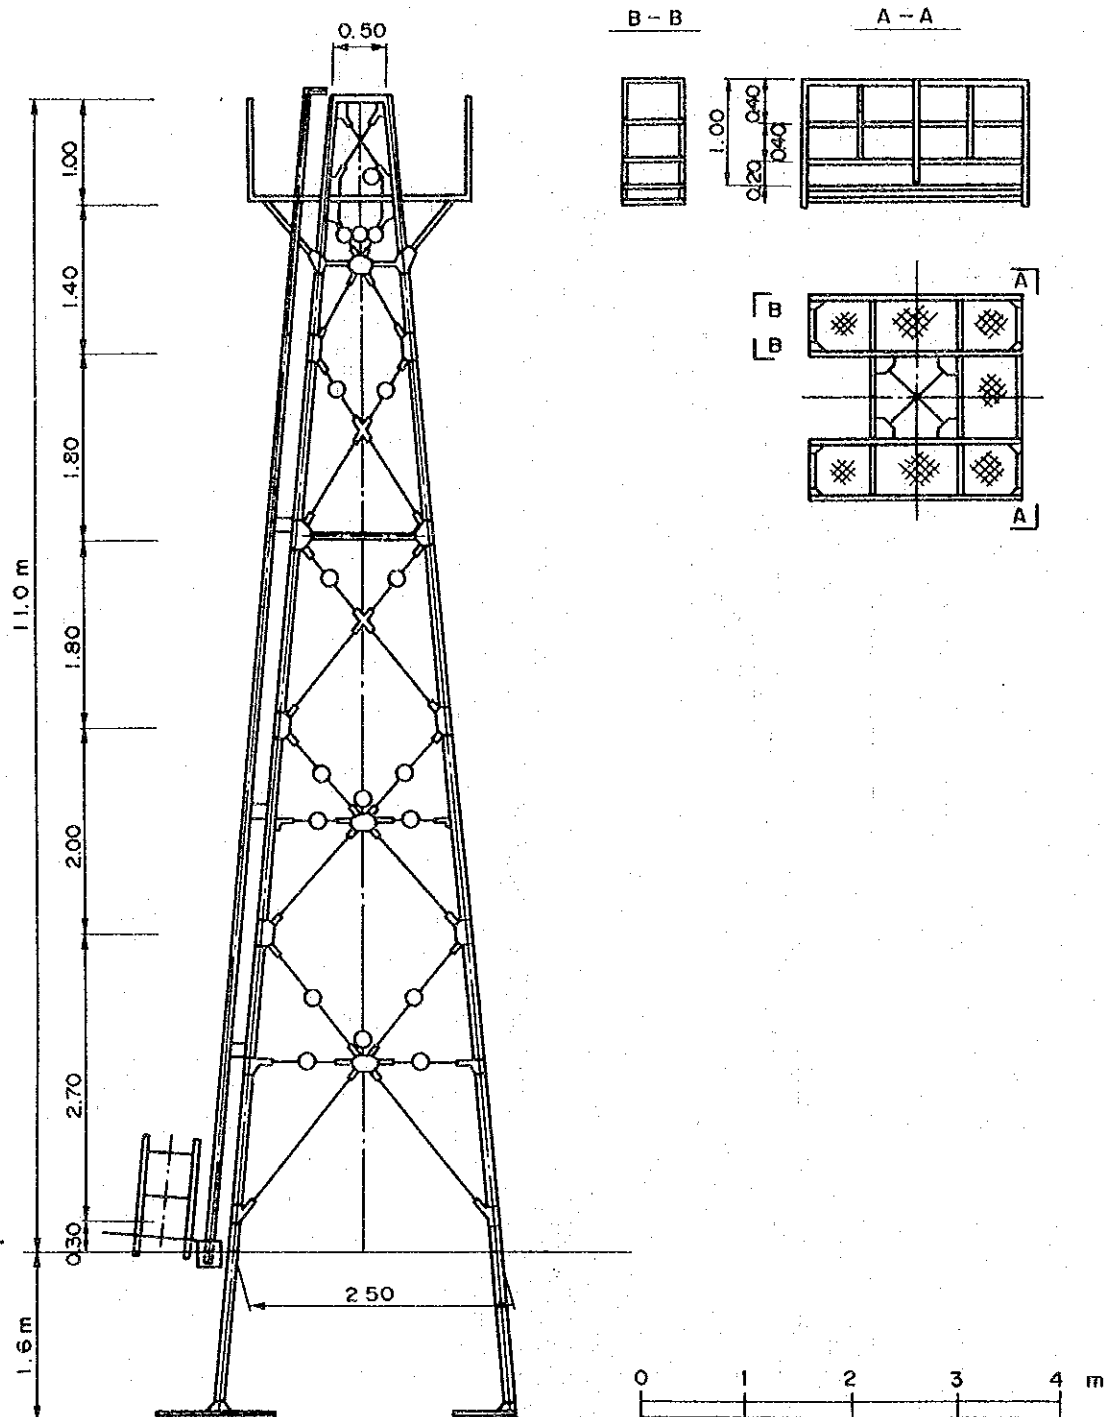
Fig. 5-21 CROSS SECTION OF TOWER OF BEACON

The leading beacons showing the approach channel to Apia Port was damaged on its lanterns by rain water with the day marks blown away by strong wind. Temporary repairs have been done but luminous intensity and reliability are considerably lost. A full scale rehabilitation to meet the original specifications noted on a marine chart shall be urgently implemented to secure safety of night navigation by taking into consideration obsolescence of the facilities and recent developments nearby affecting visibility.

The towers of both front and rear beacons are damaged by strong wind and the capacity of lanterns is deteriorated. Therefore, the front beacon shall be reconstructed at the same place and the rear beacon shall be reconstructed in a higher place to give a clearer visibility.

Considering working conditions for tower of the rear beacon to be erected high on the mountain, steel truss tower structure is adopted. Day marks shall be installed on the frontage of the tower.

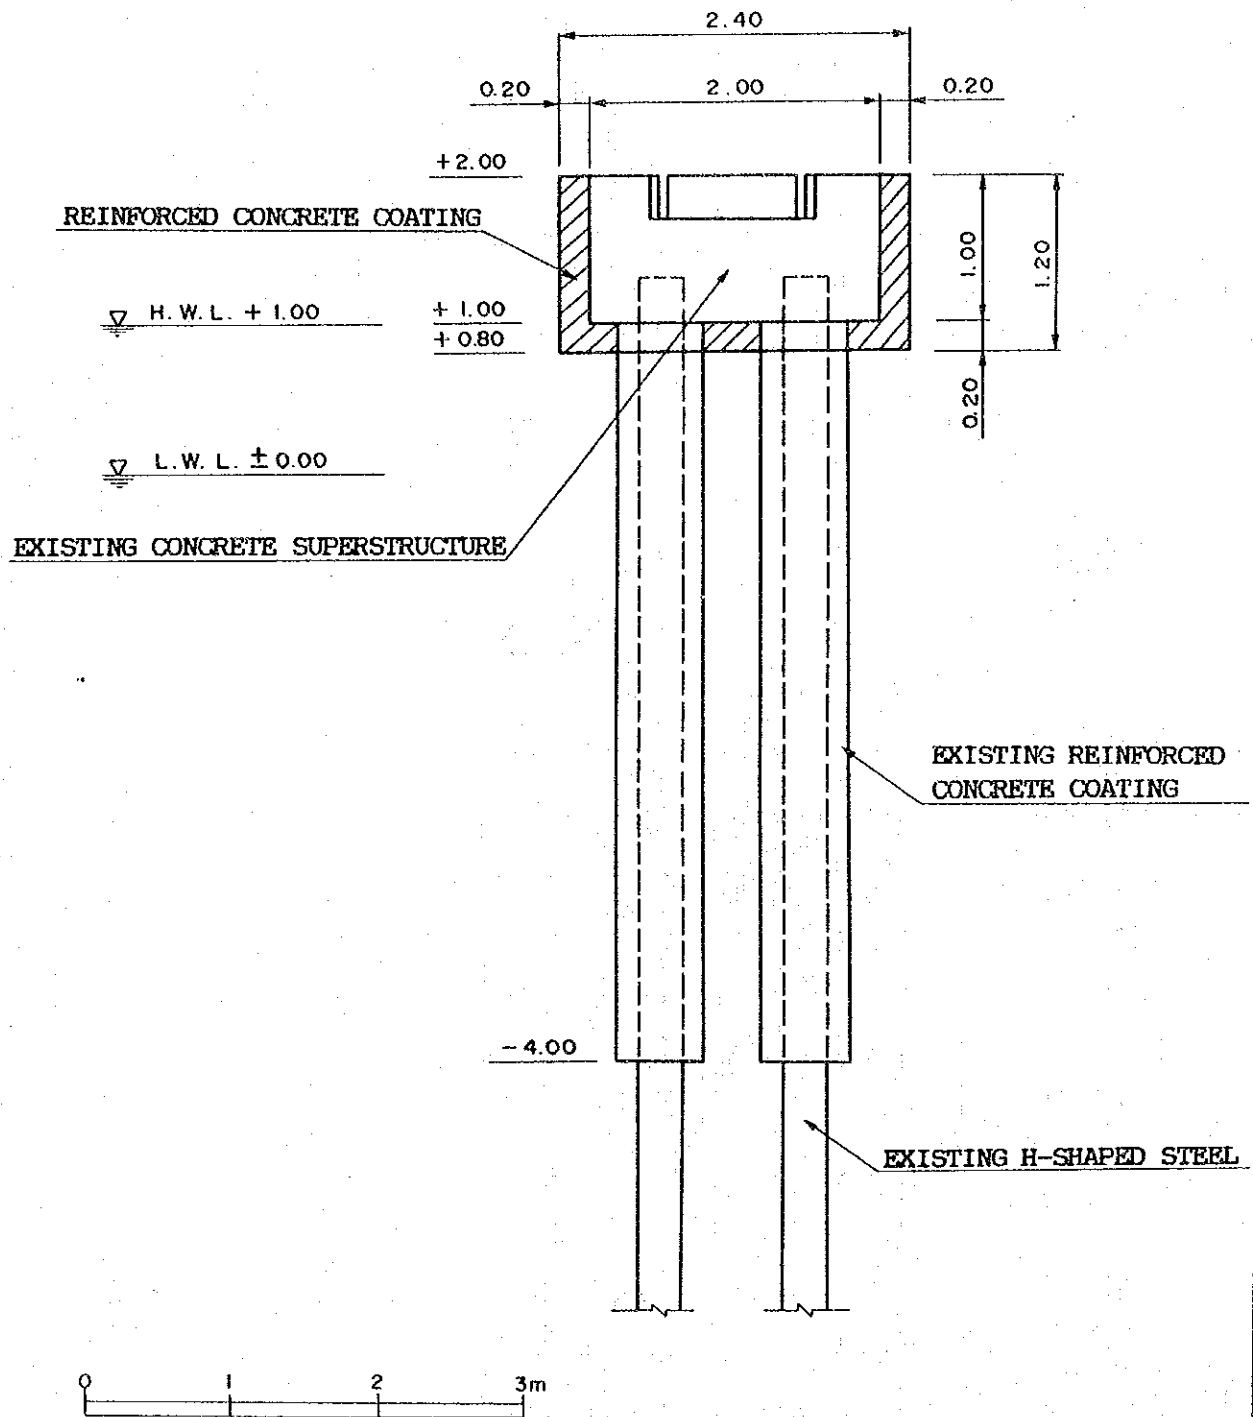
Fig. 5-23 TYPICAL CROSS SECTION OF MOORING DOLPHIN

The dolphin has sustained damage on its concrete superstructure with the reinforcing steel bars exposed and rehabilitation work covering the steel bars with concrete is urgently required to prevent further corrosion.

As a surface concrete of superstructure of the mooring dolphin has spalled off due to the collision by ship during cyclone, concrete covering work shall be conducted. Also, the lantern installed at the tip of the dolphin has been blown away, and a new lantern with the capacity of luminous range of 1 miles shall be installed at the same position.

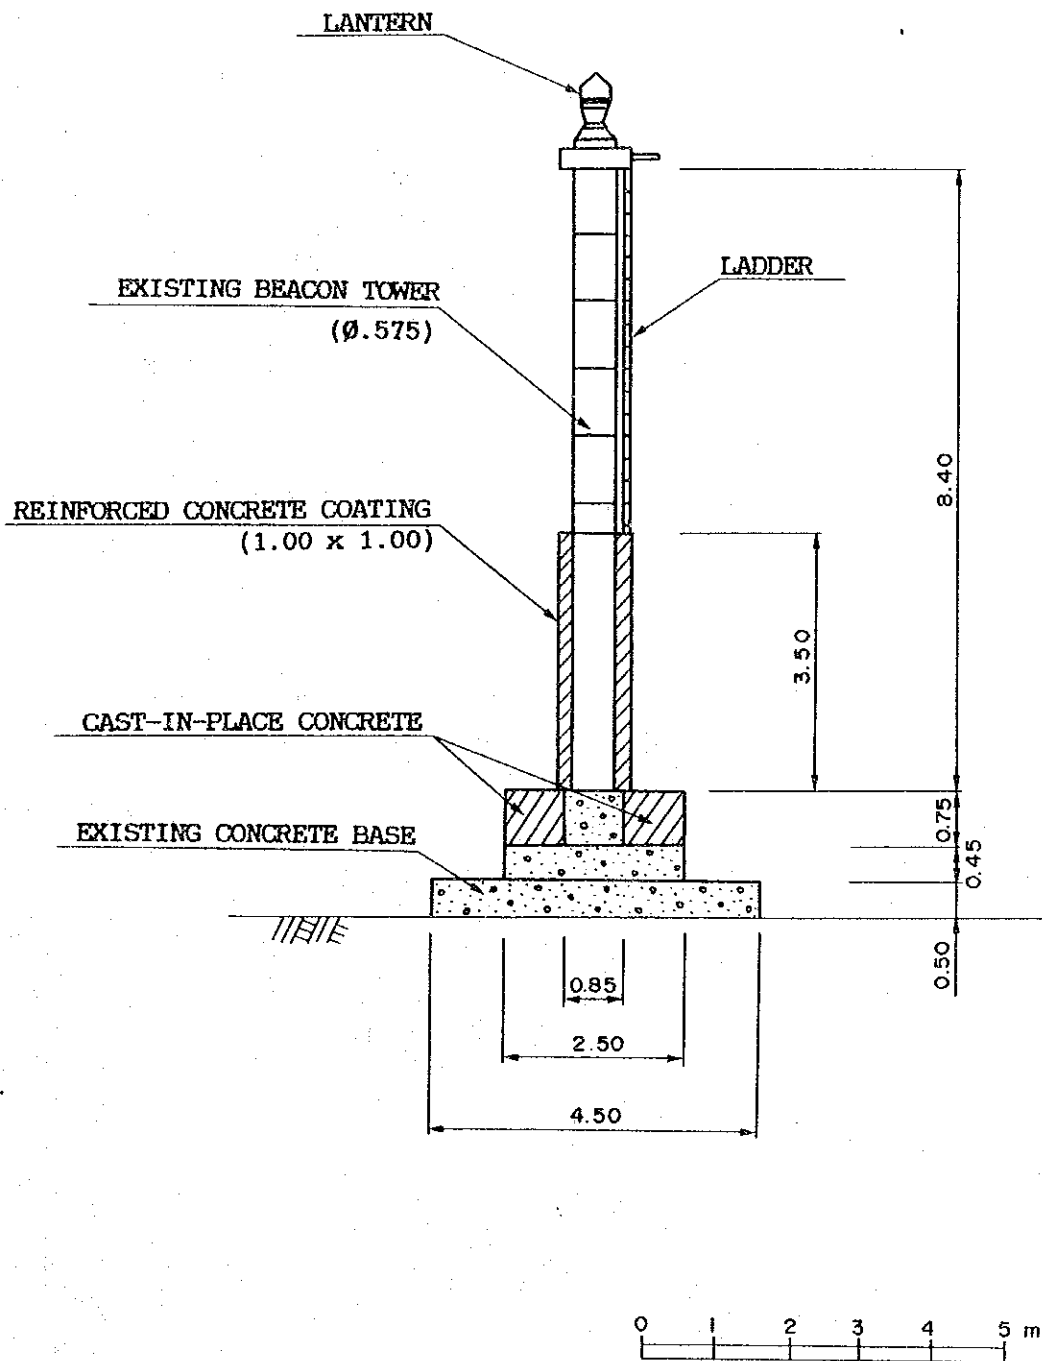
Fig. 5-26 CROSS SECTION OF INNER BEACON AT MULIFANUA PORT

The inner beacon installed in the sea has been cracked on its concrete tower in danger of collapse. Leading beacons installed on land have been damaged for both front and rear beacons imperiling safety of night navigation. Four spare floating buoys are used for marking water area silted up by cyclone waves.

The concrete tower of inner beacon in sea has been cracked and shall be covered with 20 cm thick reinforced concrete.

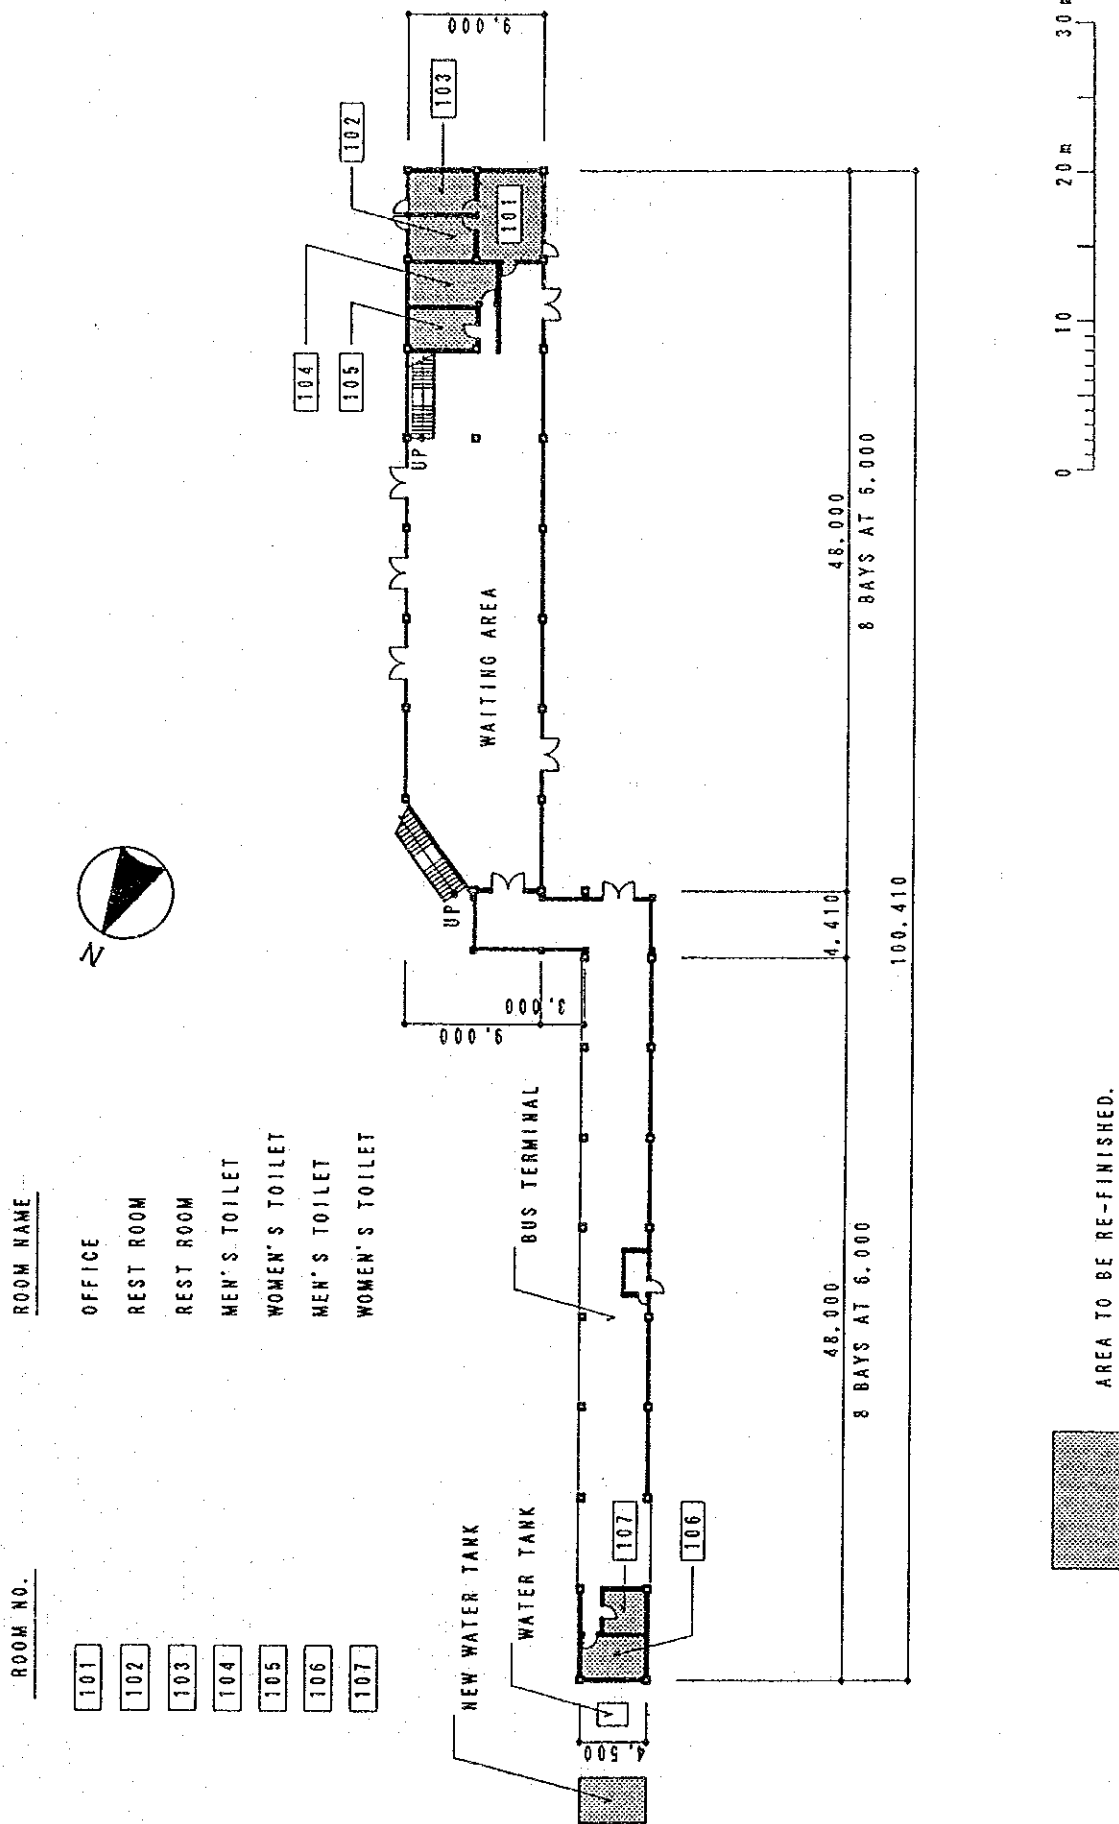
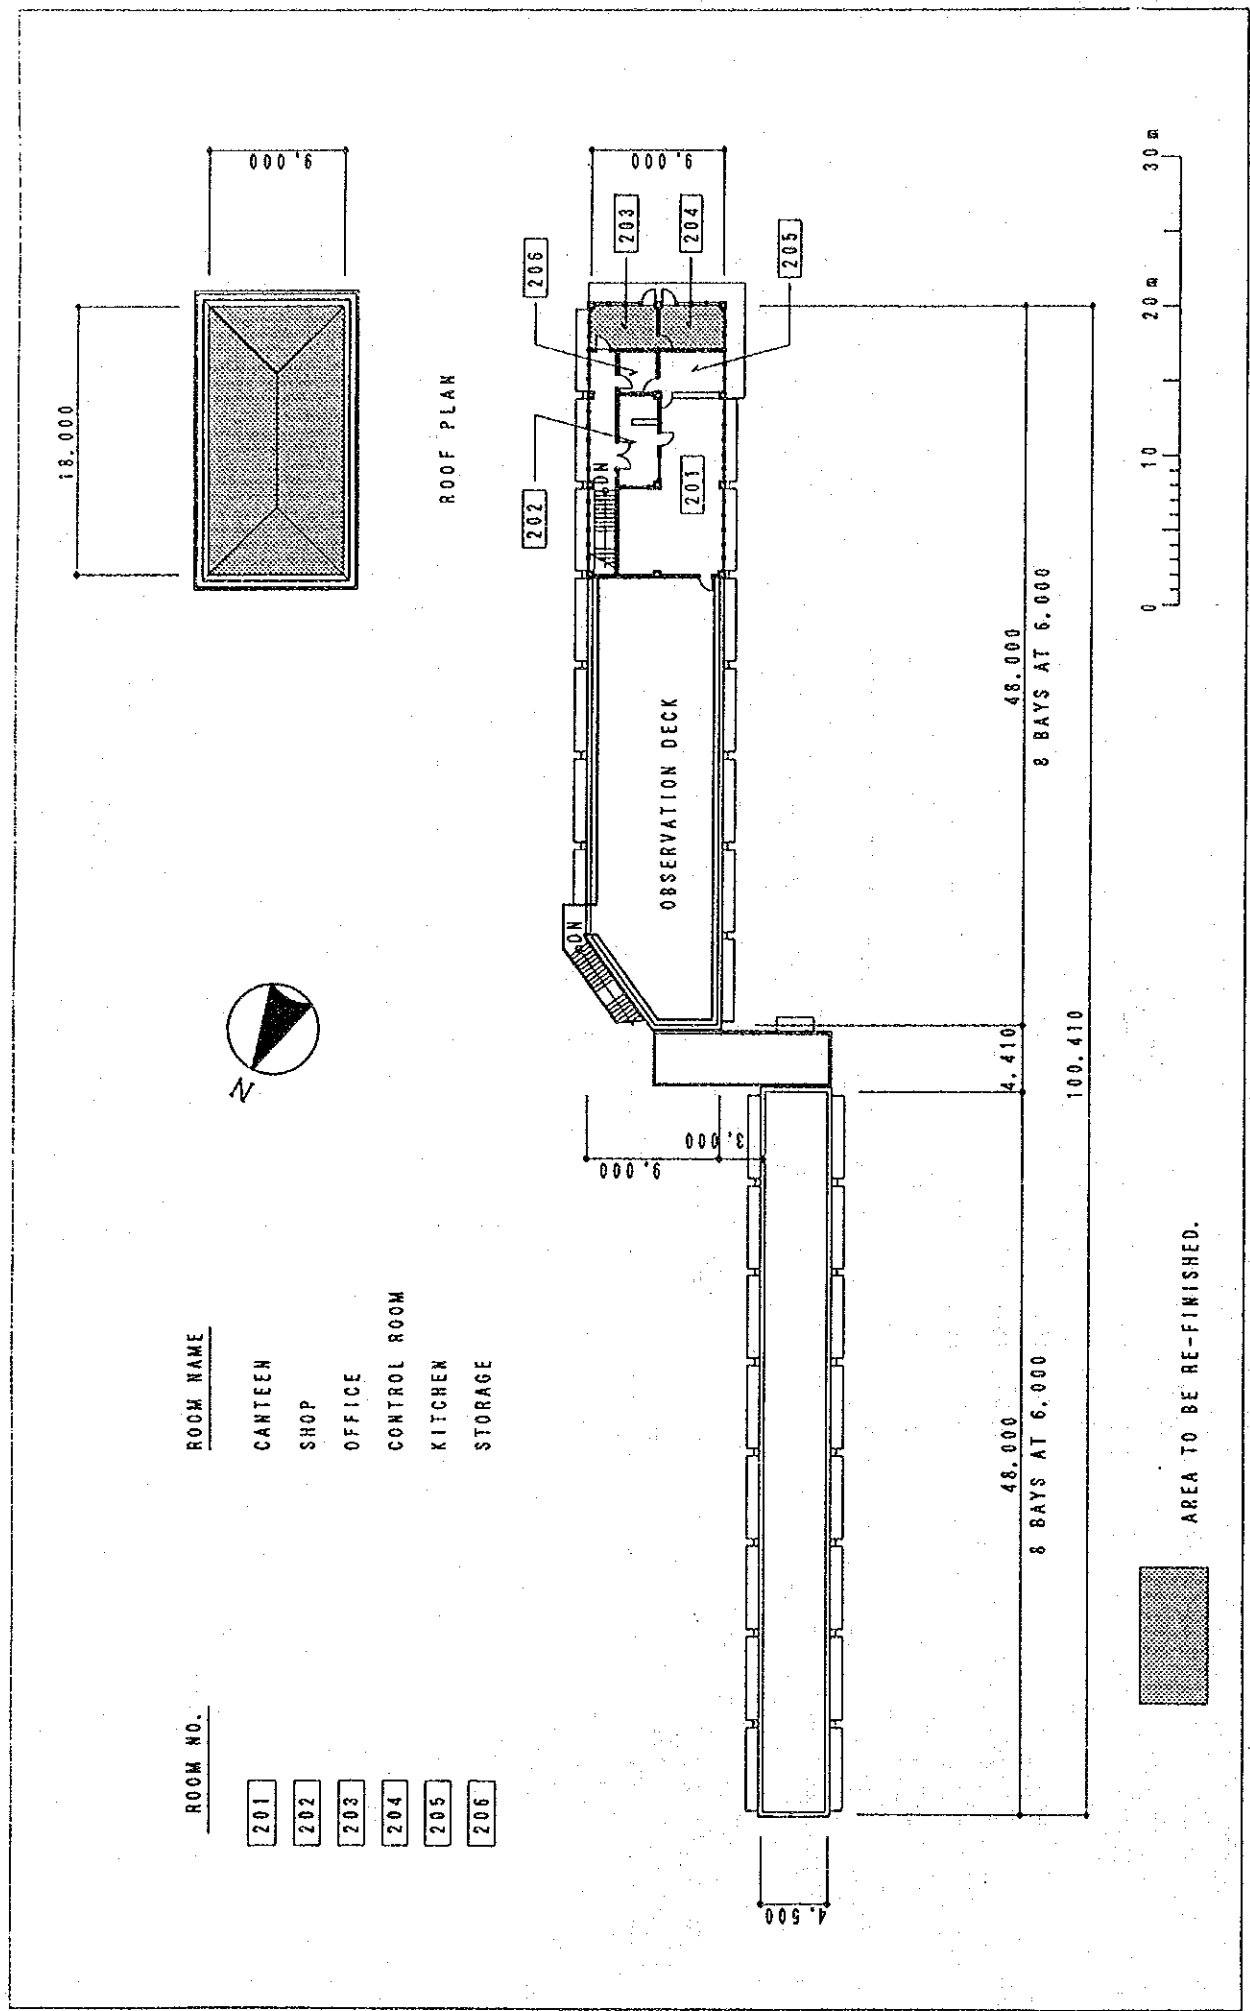
Fig. 5-28 GROUND FLOOR PLAN OF FERRY TERMINAL BUILDING
AT SALELOLOGA PORT

The ferry terminal building at Salelologa Port has sustained serious damages and causes serious inconvenience to ferry passengers. Especially, the damaged roof, if left unrepaired, will cause further secondary damage by rain water and wind.

The roof has been seriously damaged and shall be restored with color tin sheets as in Mulifanua Port. Damaged louvers, interior and partition walls, toilet facility, lights and gutters shall be restored. 5 t water tank shall be installed as in Mulifanua Port.

Urgent restoration works similar to those in Mulifanua Port shall be planned to prevent further damages and release ferry passengers from inconvenience.

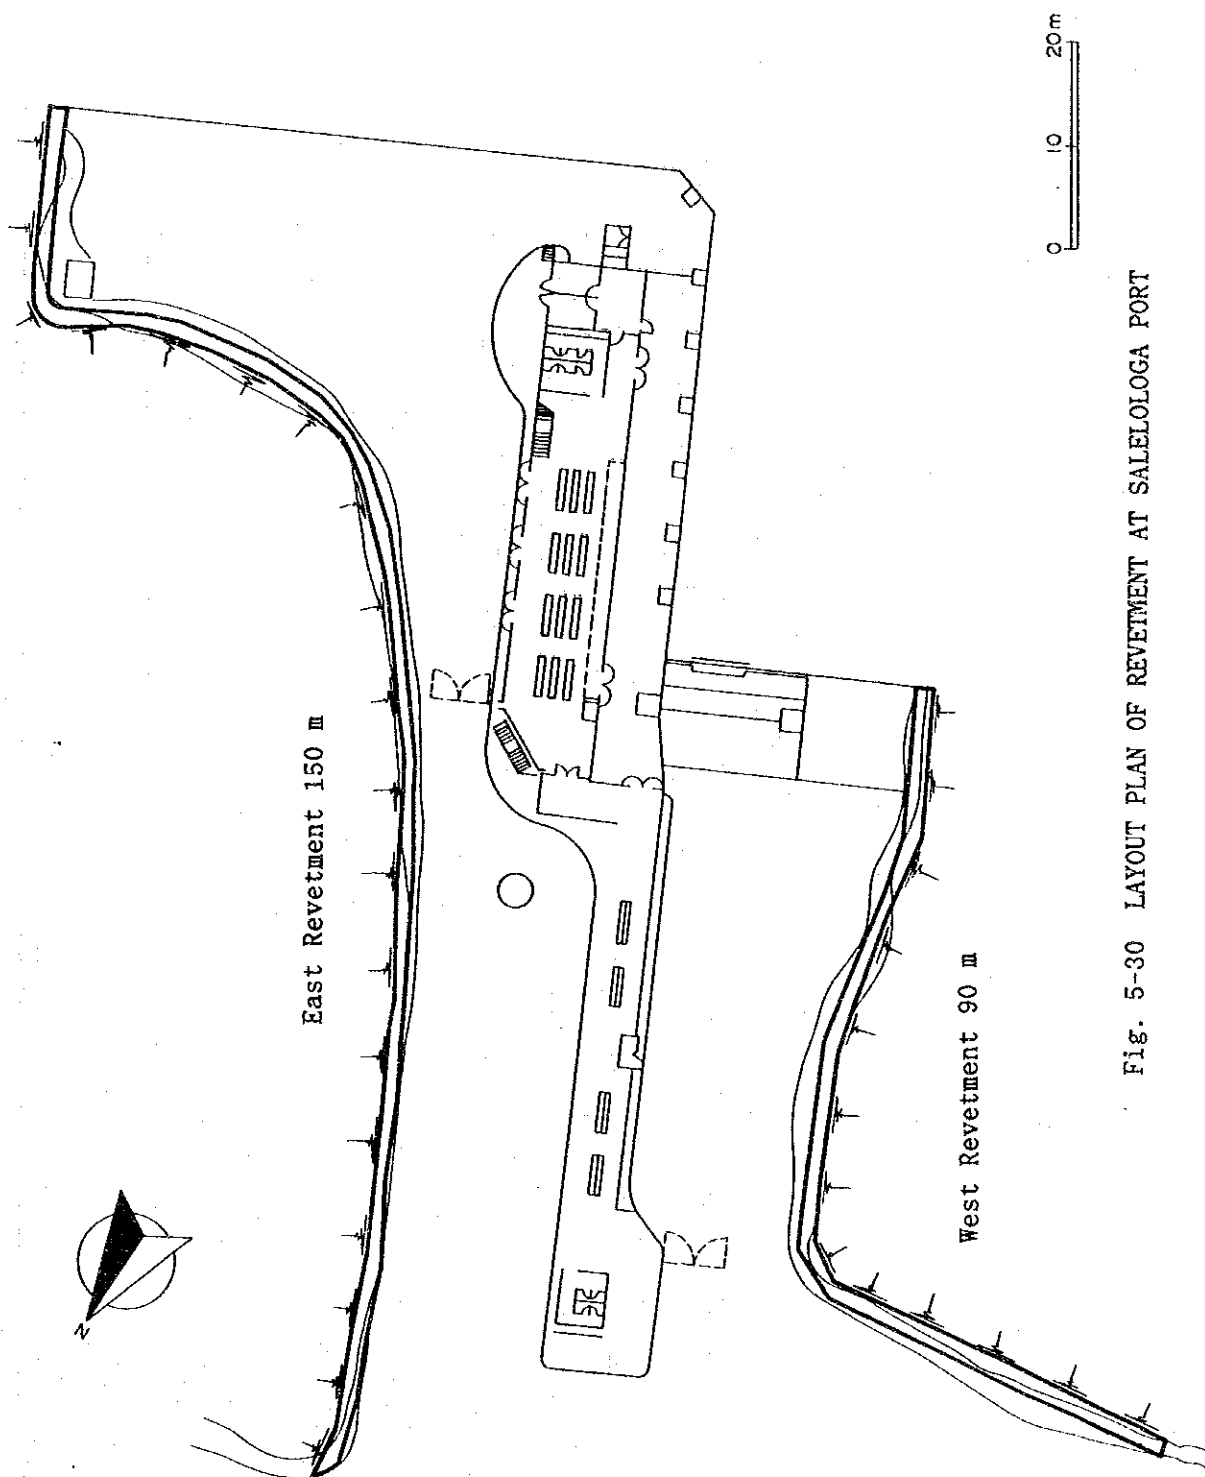
Fig. 5-30 LAYOUT PLAN OF REVETMENT AT SALELOLOGA PORT

The revetments have been damaged on their rubble slope, backfill and pavement. To prevent further damages to the access road, parking area, terminal building and ferry ramp, urgent restoration work shall be planned.

Rubble slope structure same as the existing one shall be adopted. The crown height is set at + 2.8 m which is 0.8 times $H_{1/3}$ above HHWL to meet the condition that the waves shall not over flow. The required weight of armour stone is 500 kg/piece.
