The Study on the Rehabilitation and Conservation Program of Bridges in The Republic of Chile

Final Report

March 1993

Japan International Cooperation Agency

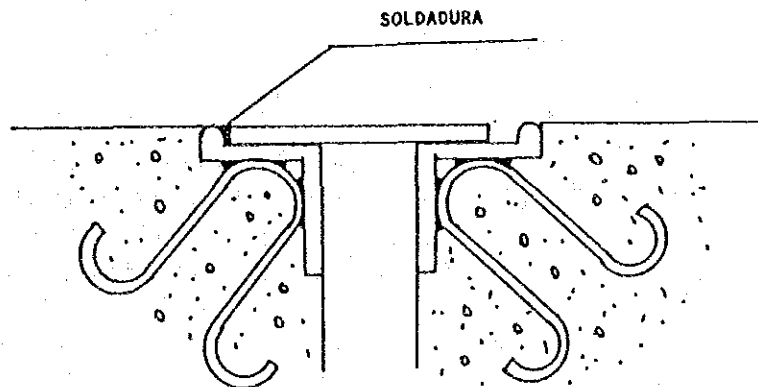
Figure 2-16 Expansion Joint

Cover plate expansion joints are used for most road bridges in Chile. The cover plate is welded at the construction site and its reliability is suspect. The joint's durability is questionable because most bridge joints were judged by the survey teams to have been damaged after only two years of use. As well, operation accuracy is poor and this has had an adverse affect on the main body of the bridge by creating abnormal sounds and increasing impact effect. (Refer to Figure 2-16)

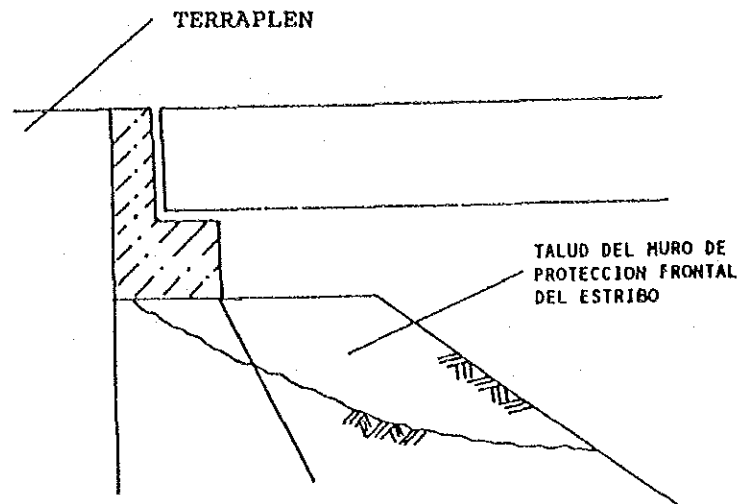
Figure 2-17 Filling

The protection of fill is extremely poor in the areas where fill touches the bridge. In order to reduce fill pressure, pier-abutment and pier-type abutment bridge bases have often been used. There is however is a high possibility that the fill on the backside of the abutment (approach) will sink as a result of poor compaction and lack of protection of the fill at the front. It is necessary to discuss protection methods for filling. (Refer to Figure 2-17)

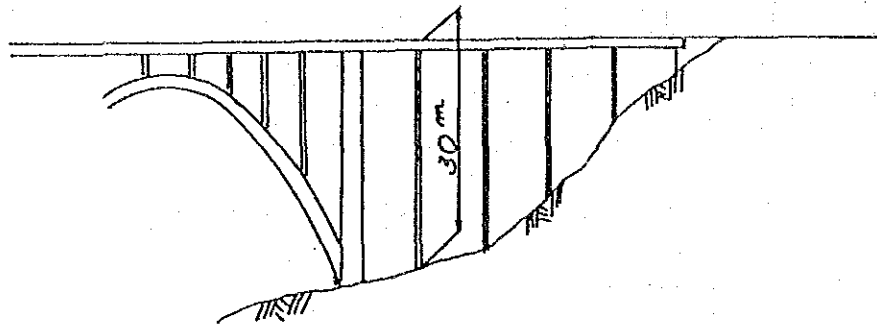
Figure 2-20 Pillars for Arched Bridges

The pillars used for arched bridges are too thin. Rigidity of the pillars is questionable as they are 30 meters in length and only 70 centimeters in thickness, furthermore, there are no middle crossbeams. Pillar elastic deformation does not seem to have been considered and significant bridge damage as a result of pillar thinness was observed in the southern part of the country. (Refer to Figure 2-20)

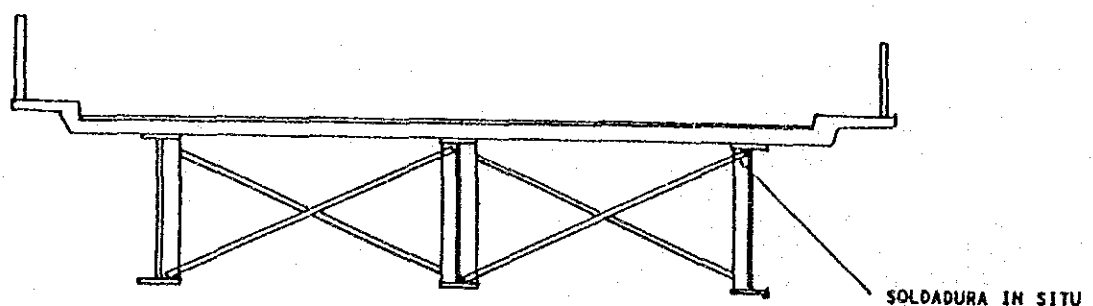
Figure 2-21 Crossbeam Structure

Floor framing was composed of the floor beam only and in rare case, both crossbeams and the floor beam are used. Connection with the main girders was done by on-site welding and was not carefully done. Breaks in the welding and repairs were seen at no less than 10 bridges. (Refer to Figure 2-21)
