3-1-4 Survey Results and Examination

3-2 Load Test

Chapter 4 Bridge Repair Design and Cost Estimation

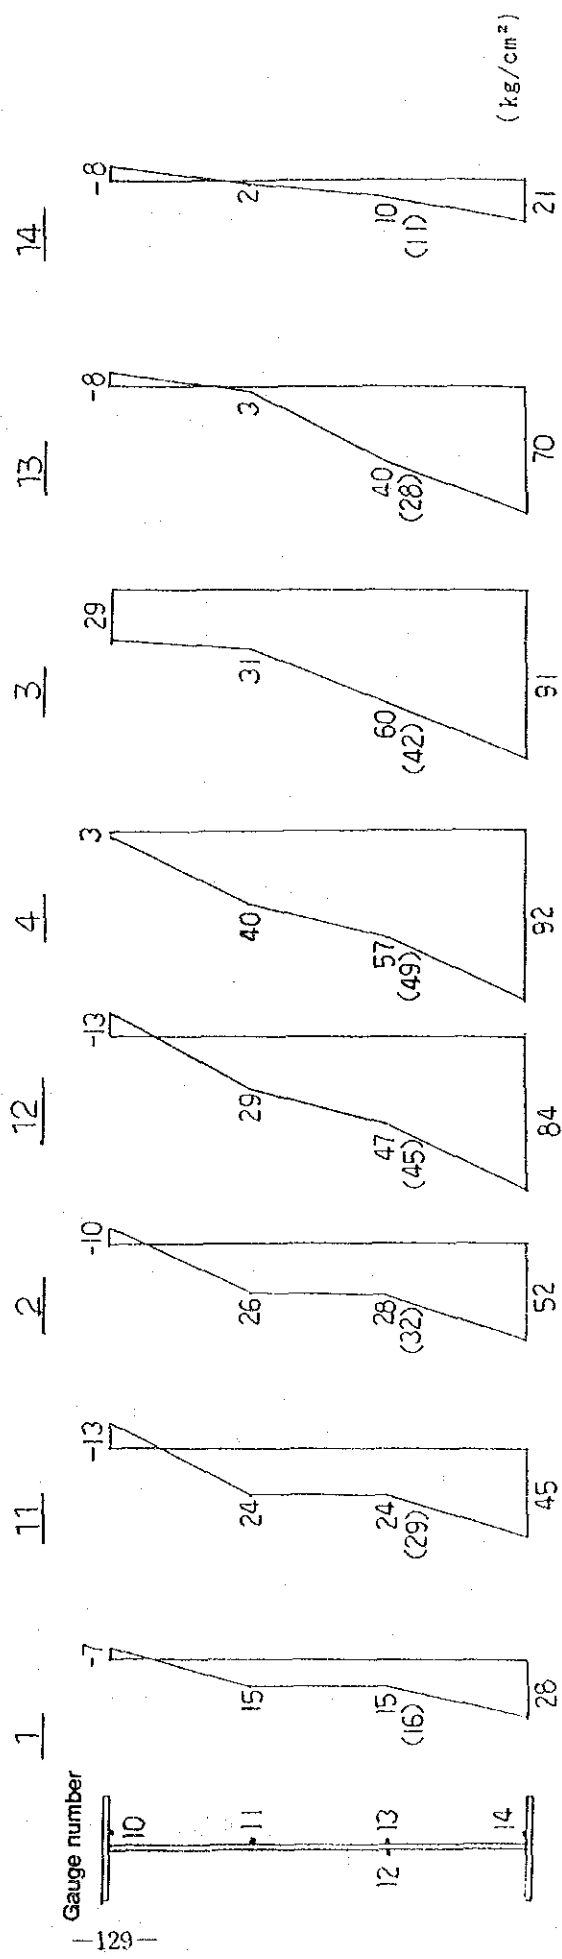
Figure 3-43 Main Girder Stress Distribution Near the Span Center

Table 3- 17 shows the main girder stress. Table 3-18 shows the stress of the floor beam and stiffener. Figure 3-43 shows the stress distribution of the main girder cross-section. The following tendencies were noted as a result of testing.

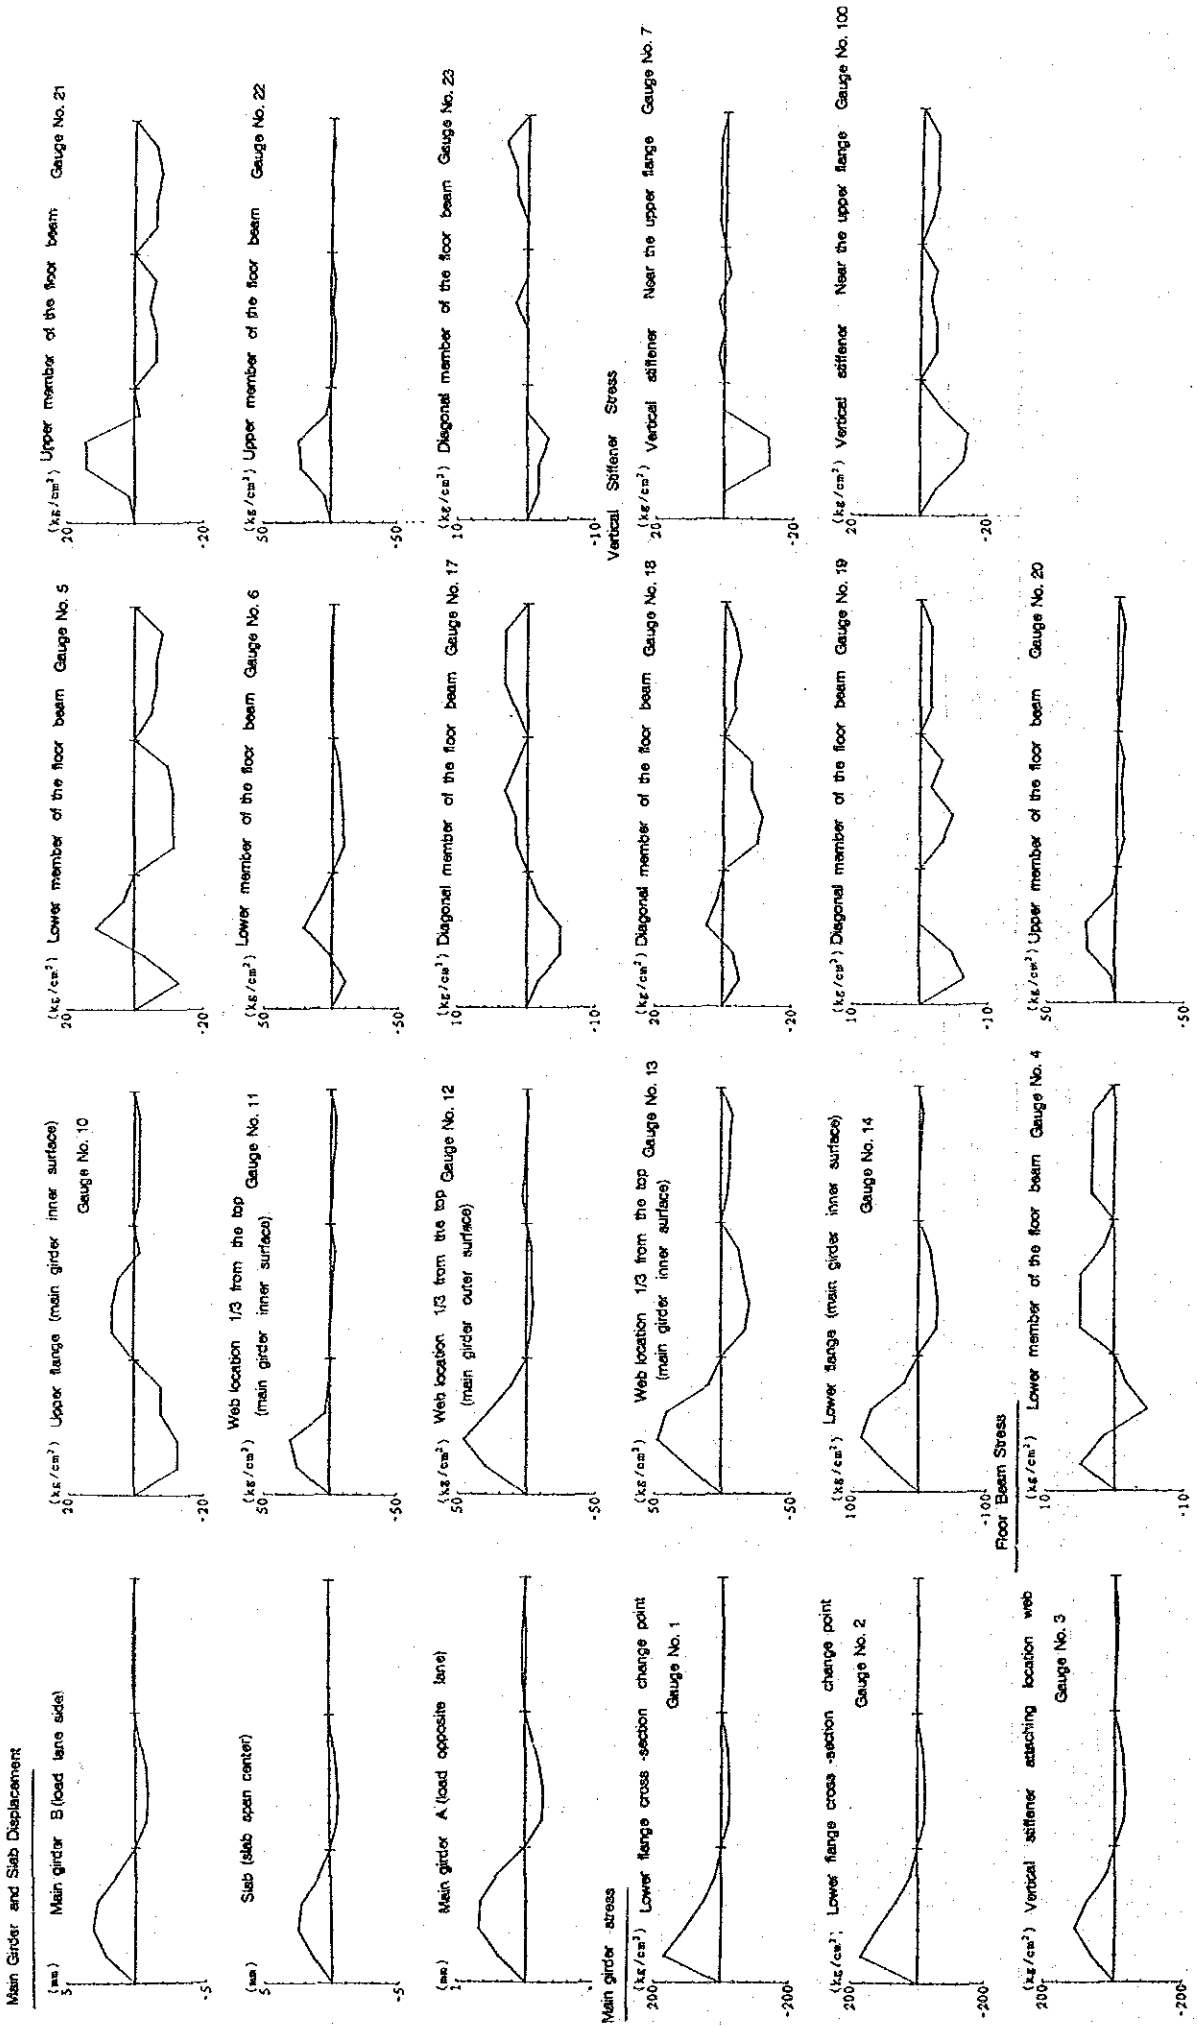
Figure 3-45 Stress and Displacement Wave during Moving Static Load

Figure 3-45 shows the stress at the location examined and the shape of the influence line of strain. Due to the restrictions of the measuring method and the sensitivity of the instrumentation, the line's shape was not perfect. However, in general, the characteristics of the continuous span bridge from the influence line of main girder stress and strain were observed (positive on the first and third span, and negative on the second span). At the same time, based on the influence line of the lower members of the floor beams and the diagonal members, a tendency for a reversal of the positive and negative was observed near the monitored cross-section.

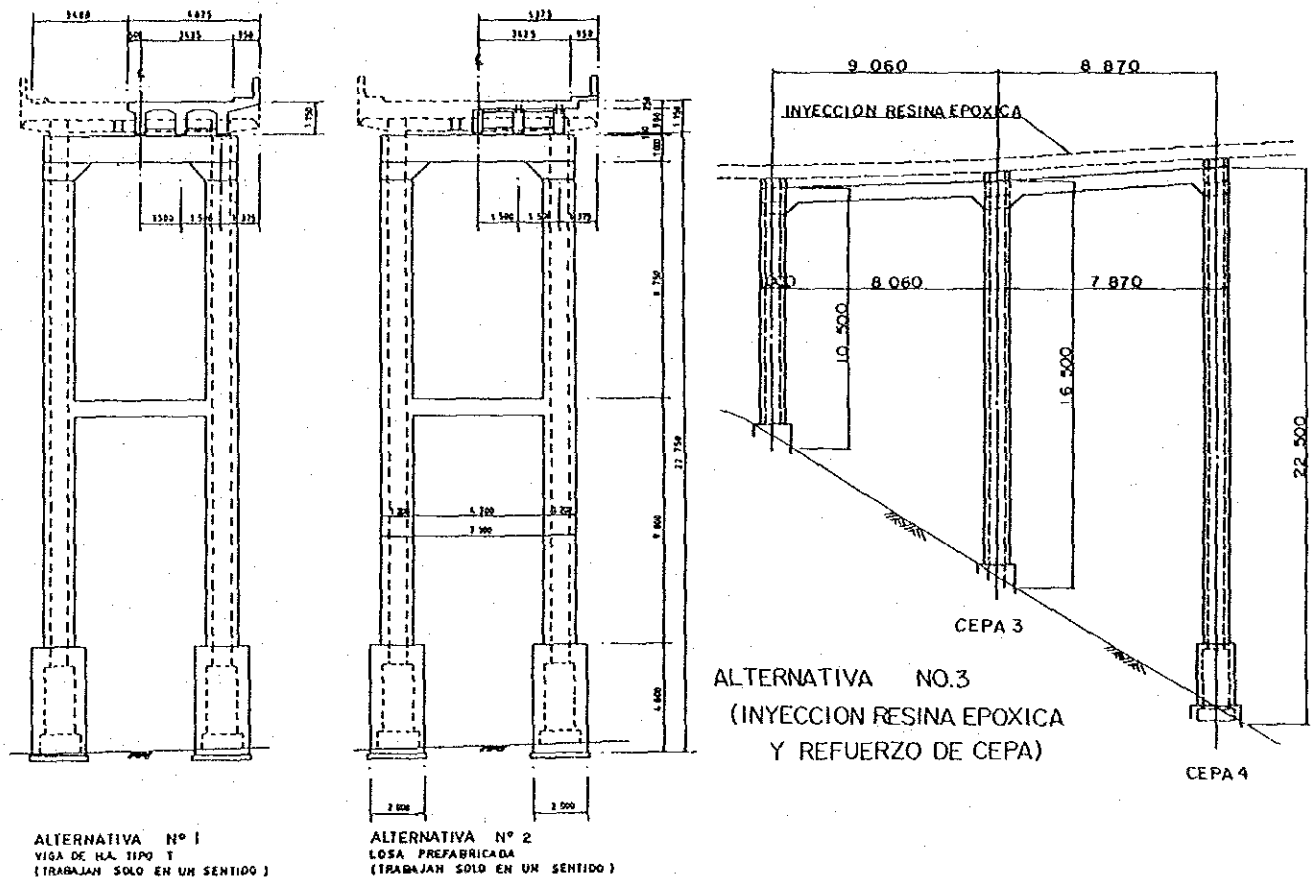
Figure 4-6 Repair of Amolanas

crowns, the deflection is today visible by sight. The detailed survey revealed the crowns of the piers to have been displaced uniformly towards the abutments and towards the downstream side in the direction orthogonal to the bridge axis. A possible reason for this is that the cross-sections of the columns are too small in relation to the superstructure load. Perhaps it is because of this that the floor slabs are tied together with reinforcement bars on the bridge at present, but it would be more effective to provide a structure less prone to displacement at the pier crowns. There is a need, in other words, to implement cross-sectional reinforcement on the columns and to either construct beams at the pier crowns to create a rigid-frame structure or to create a wall structure as has been done in the case of Pier No. 1. (Refer to Figure 4-6)
